## 2004 Isuzu Ascender LS

## BUZZERS, RELAYS & TIMERS

## COMPONENT LOCATION GRAPHICS

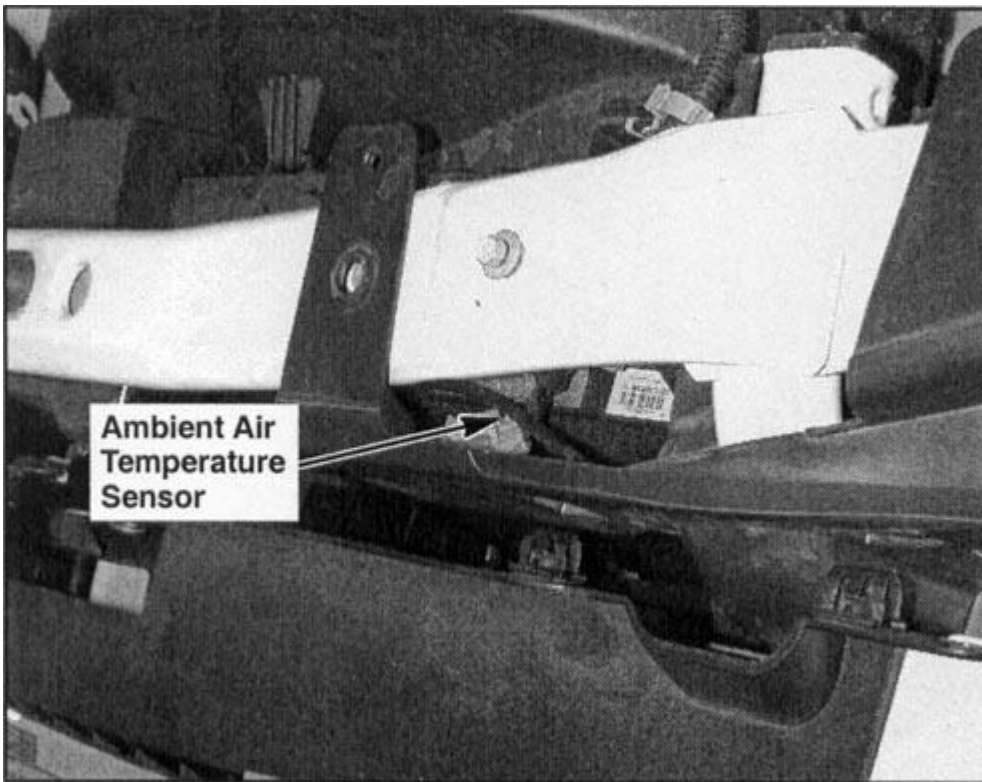
**Fig. 1: Above Left Side Of Grille**  
**Courtesy of ISUZU MOTOR CO.**

| Component | Location |
|---|---|
| Ambient Air Temperature Sensor | Above left side of grille. See <b>Fig. 1</b> . |

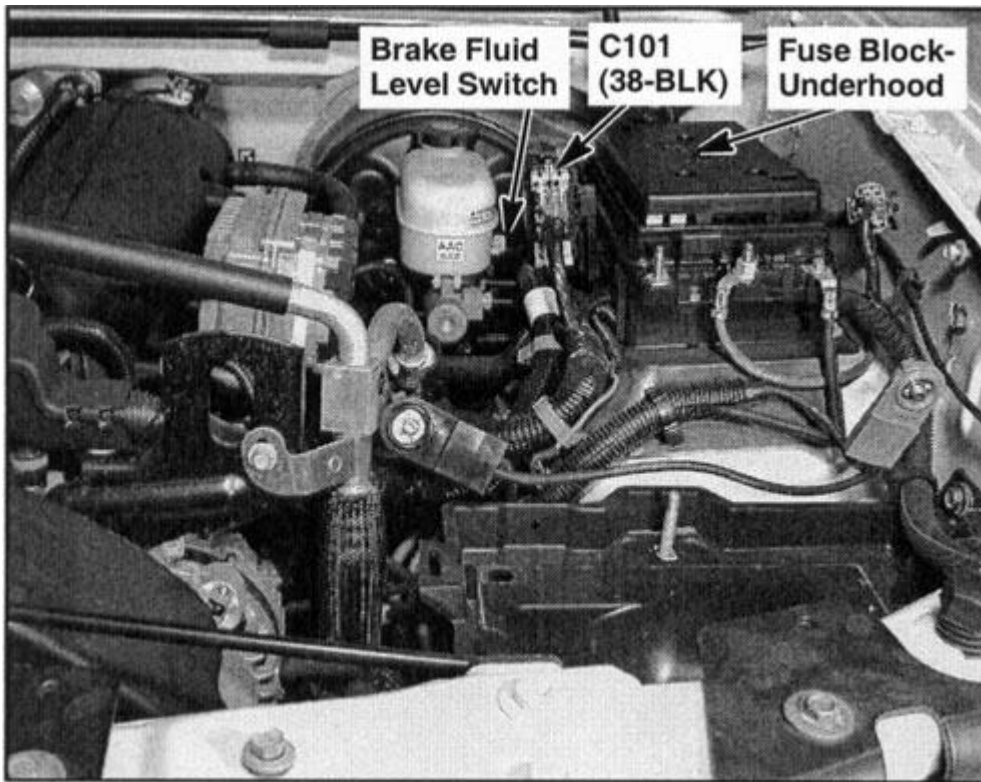
**Fig. 3: Left Side Of Engine Compartment**  
Courtesy of ISUZU MOTOR CO.

| Component | Location |
|---|---|
| Underhood Fuse Block | On left side of engine compartment. See <a href="#">Fig. 3</a> . |

| Component | Location |
|---|---|
| Brake Fluid Level Switch | In brake master cylinder fluid reservoir. See <a href="#">Fig. 3</a> . |

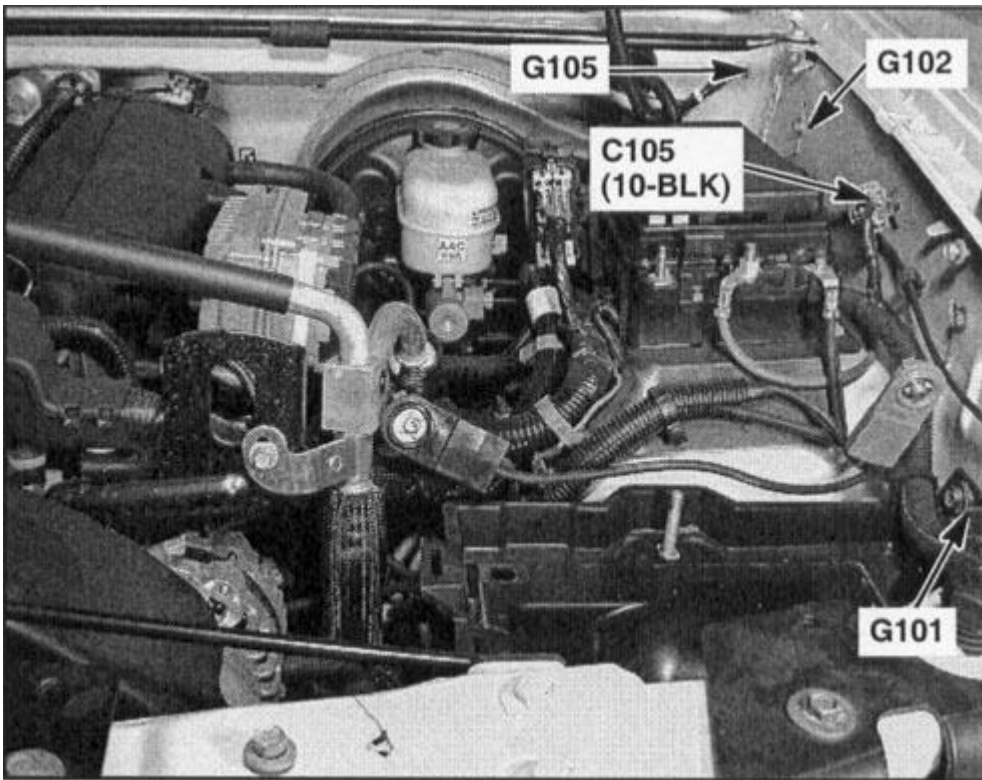
G00288902

**Fig. 4: Left Side Of Engine Compartment**  
Courtesy of ISUZU MOTOR CO.

| Component | Location |
|---|---|
| C105 (Black, 10 Pin) | Left rear of engine compartment. See <a href="#">Fig. 4</a> . |

| Component | Location |
|---|---|
| G101 | At left side of engine compartment. See <a href="#">Fig. 4</a> . |

| G102 | At left side of engine compartment. See <a href="#">Fig. 4</a> . |
| G105 | At left side of engine compartment. See <a href="#">Fig. 4</a> . |

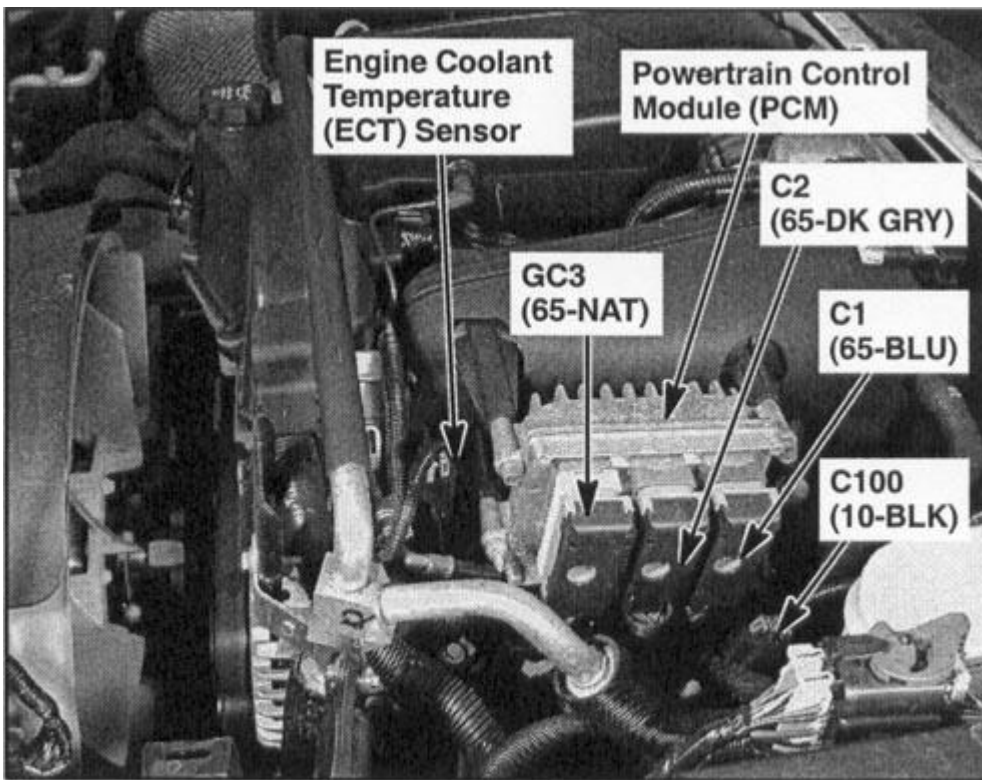
**Fig. 5: Left Front Of Engine (4.2L)**  
Courtesy of ISUZU MOTOR CO.

| Powertrain Control Module (PCM) (4.2L) | On left front of engine. See <b>Fig. 5</b> . |

| Component | Location |
|---|---|
| Engine Coolant Temperature (ECT) Sensor (4.2L) | On left front of engine, near generator. See <b>Fig. 5</b> . |

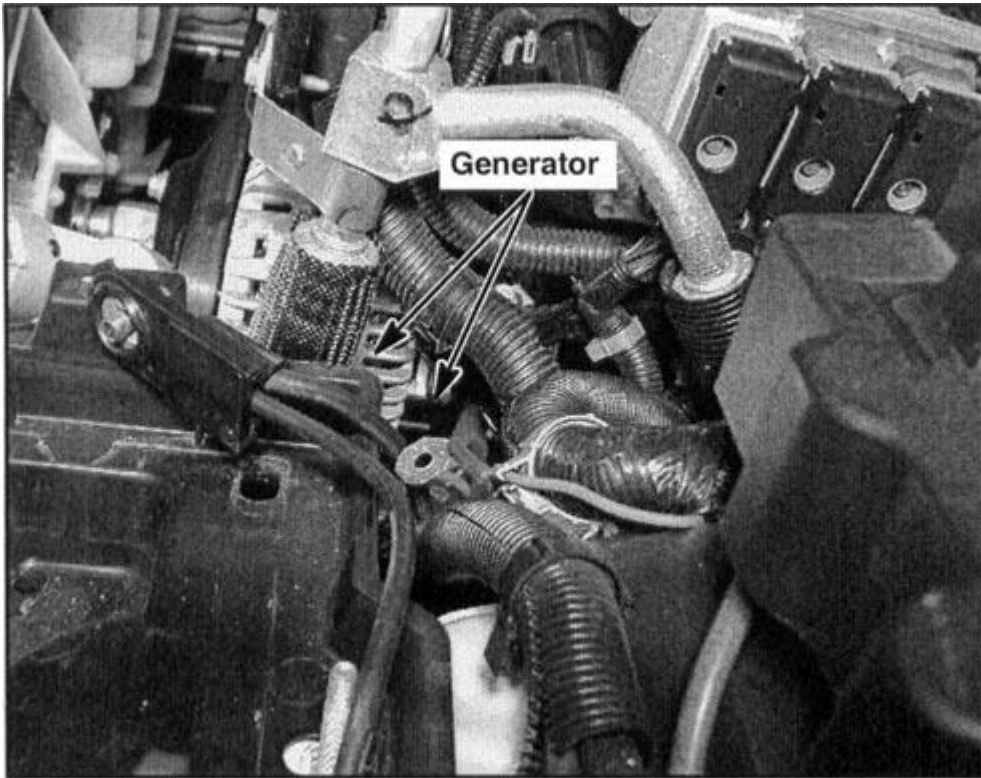
G00288904

**Fig. 6: Top Rear Of Engine (4.2L)**  
Courtesy of ISUZU MOTOR CO.

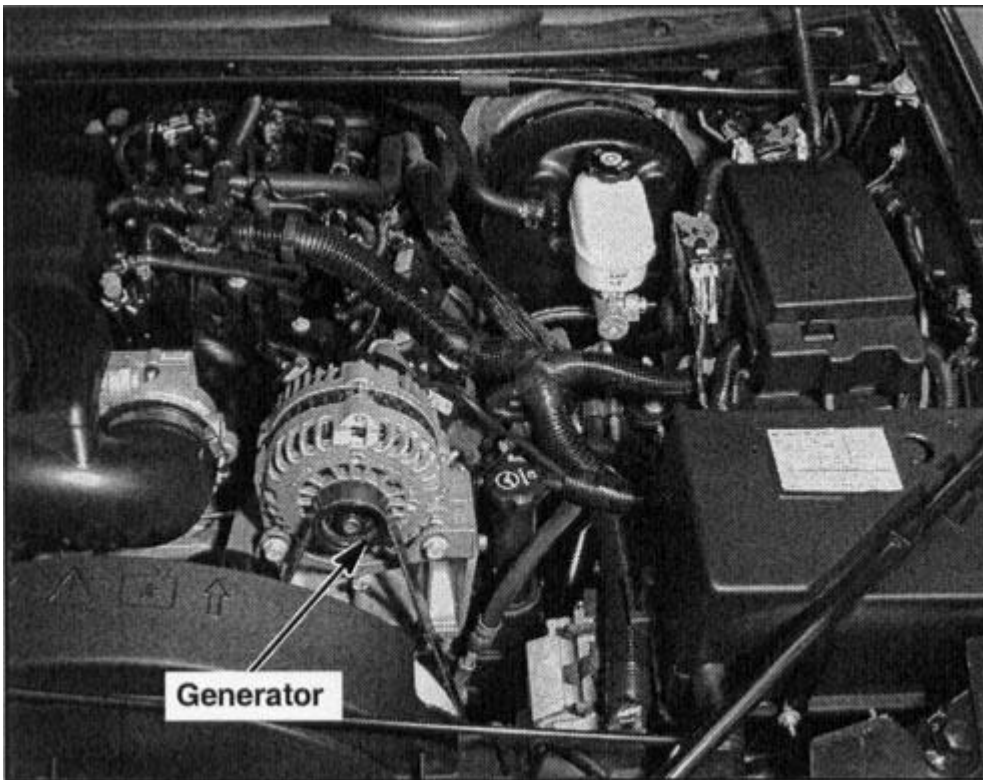
G00288905

**Fig. 7: Left Front Of Engine (4.2L)**  
Courtesy of ISUZU MOTOR CO.

| Generator (4.2L) | Left front of engine. See <a href="#">Fig. 7</a> . |

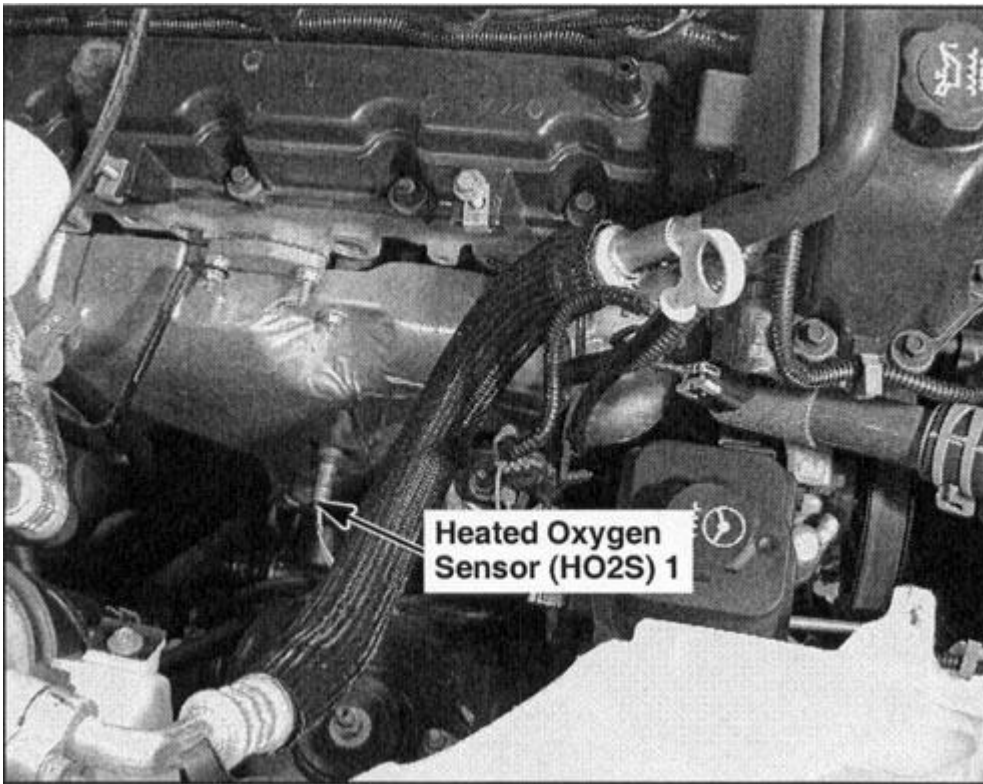
**Fig. 13: Right Front Of Engine (4.2L)**  
Courtesy of ISUZU MOTOR CO.

| Heated Oxygen Sensor (HO2S) 1 (4.2L) | Right side of engine, on exhaust manifold. See <b>Fig. 13</b> . |

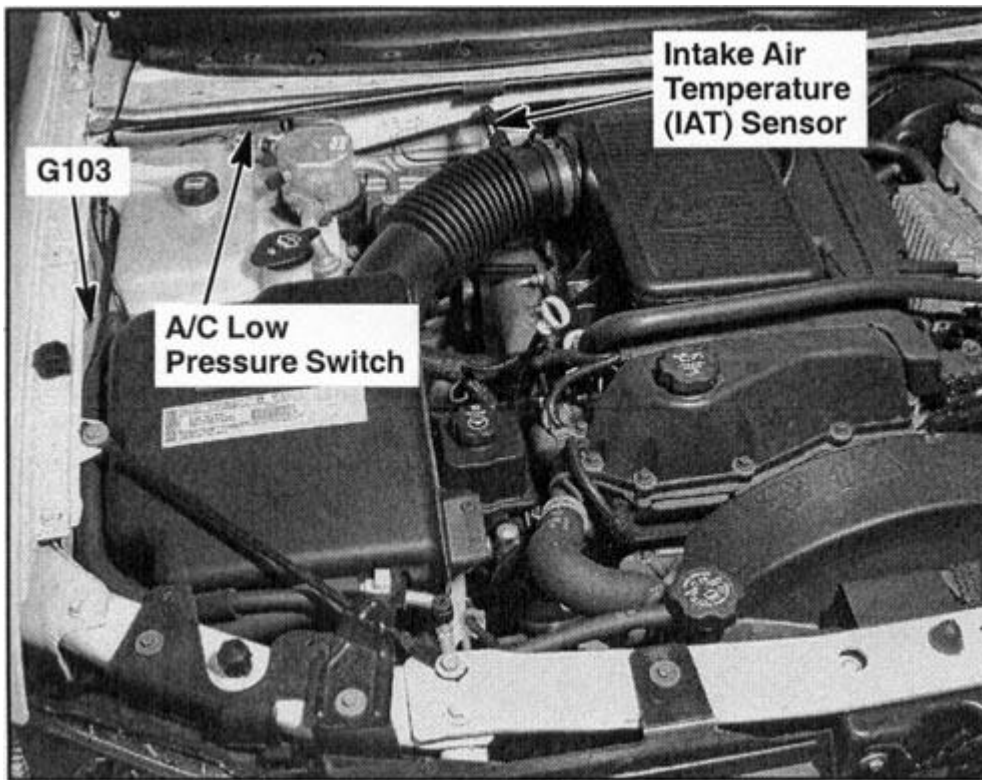
**Fig. 15: Right Rear Of Engine Compartment (4.2L)**  
Courtesy of ISUZU MOTOR CO.

| Intake Air Temperature (IAT) Sensor (4.2L) | In air intake duct, on top right of engine. See <b>Fig. 15</b> . |

| Component | Location |
|---|---|
| A/C Low Pressure Switch | At right rear of underhood compartment. See <a href="#">Fig. 15</a> . |

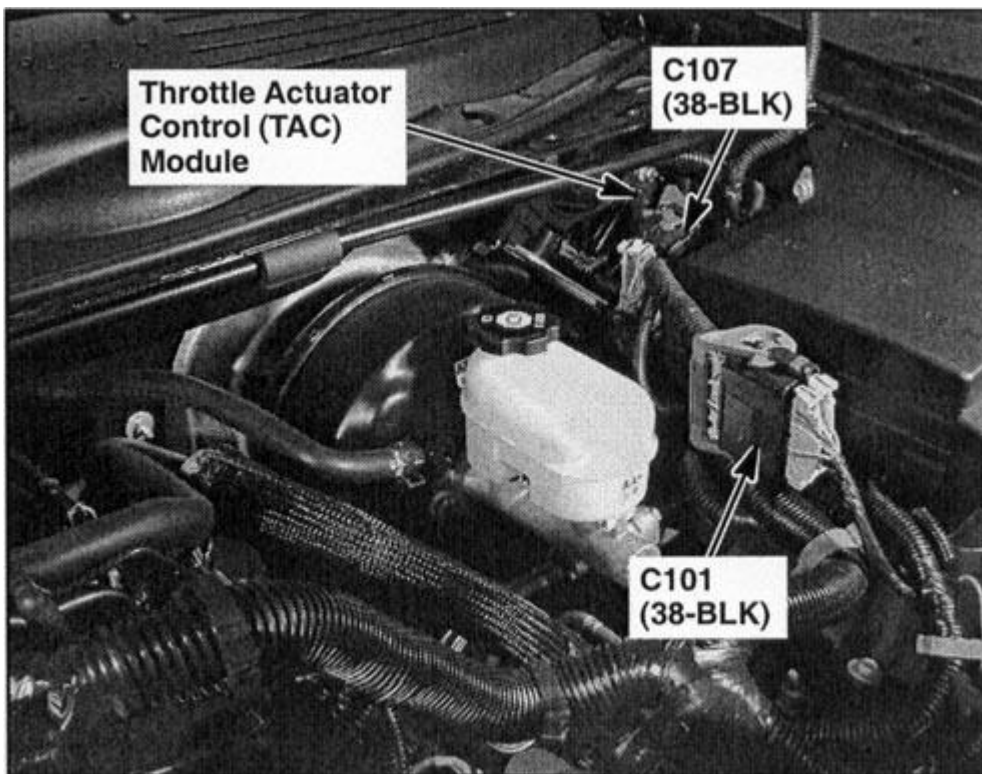
G00288915

**Fig. 17: Under Cowl Cover (Cover Removed)**  
Courtesy of ISUZU MOTOR CO.

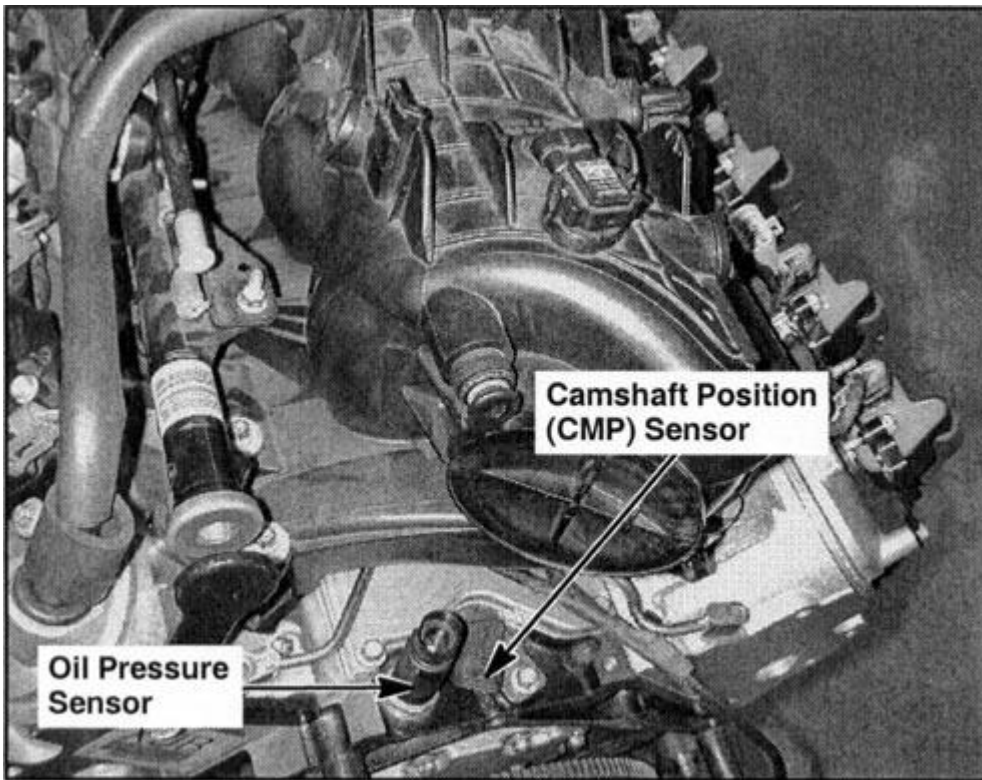
**Fig. 19: Top Rear Of Engine (5.3L)**  
Courtesy of ISUZU MOTOR CO.

| Component | Location |
|---|---|
| Camshaft Position (CMP) Sensor (5.3L) | On top rear of engine, near transmission. See <b>Fig. 19</b> . |

| Oil Pressure Sensor (5.3L) | On top rear of engine, near transmission. See <b>Fig. 19</b> . |

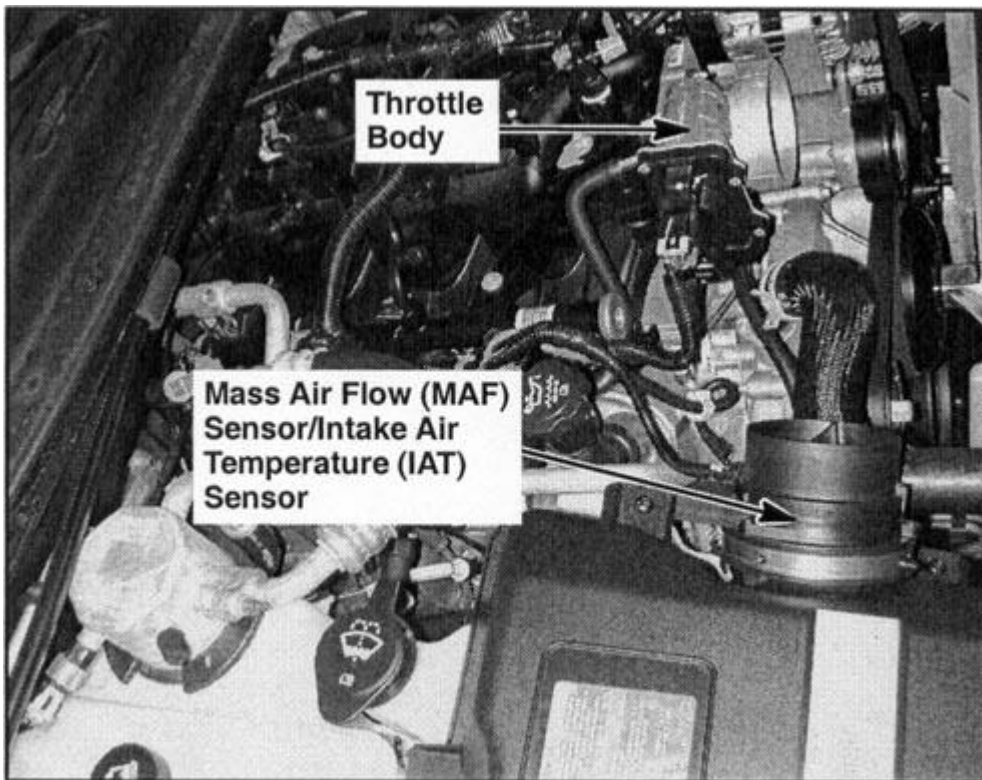
G00288918

**Fig. 20: Top Right Side Of Engine (5.3L)**  
Courtesy of ISUZU MOTOR CO.

| Ignition Coil 2 (5.3L) | Top right side of engine. See <a href="#">Fig. 20</a> . |
| Ignition Coil 4 (5.3L) | Top right side of engine. See <a href="#">Fig. 20</a> . |
| Ignition Coil 6 (5.3L) | Top right side of engine. See <a href="#">Fig. 20</a> . |
| Ignition Coil 8 (5.3L) | Top right side of engine. See <a href="#">Fig. 20</a> . |

| Component | Location |
|---|---|
| C108 (Light Gray, 8 Pin) | On top right side of engine. See <a href="#">Fig. 20</a> . |

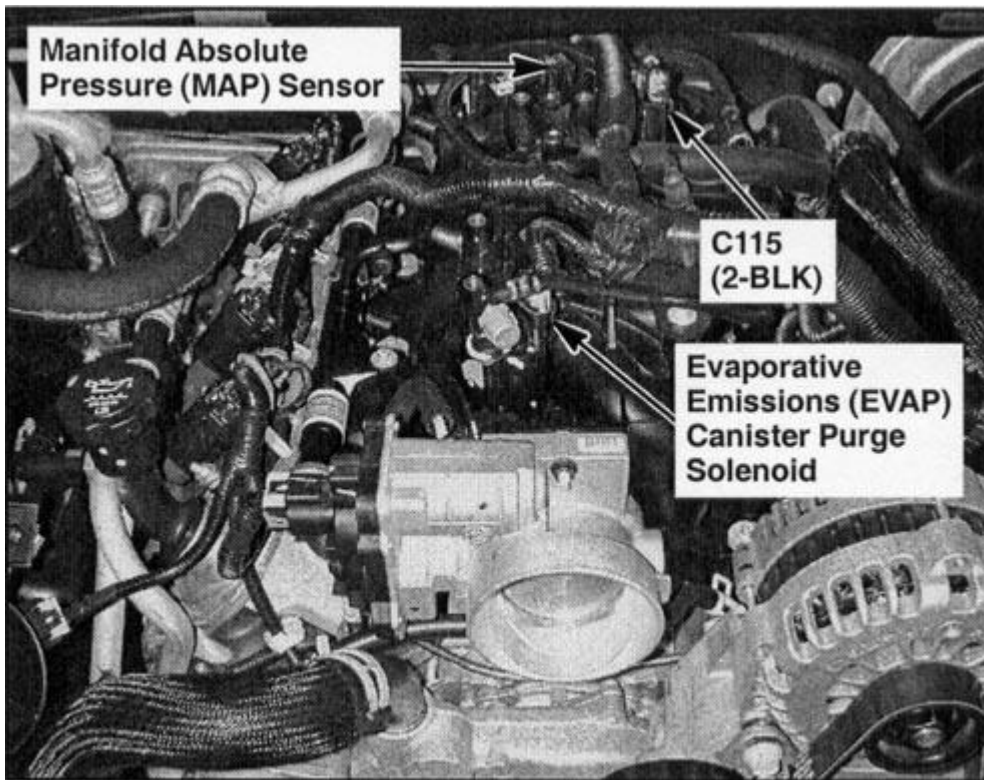
**Fig. 22: Top Of Engine (5.3L)**  
Courtesy of ISUZU MOTOR CO.

| Manifold Absolute Pressure (MAP) Sensor (5.3L) | On top of engine. See <b>Fig. 22</b> . |

| Evaporative Emission (EVAP) Canister Purge Solenoid (5.3L) | On left side of engine block. See <a href="#">Fig. 22</a> . |

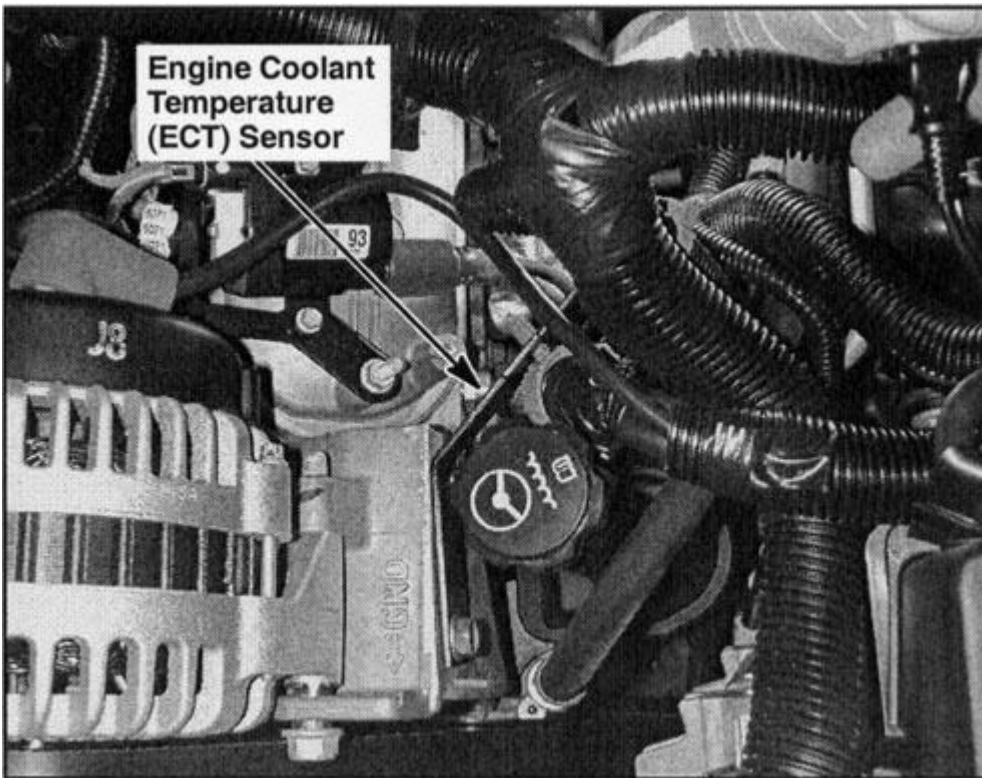
G00288921

**Fig. 23: Top Left Side Of Engine (5.3L)**  
Courtesy of ISUZU MOTOR CO.

| Ignition Coil 1 (5.3L) | Top left side of engine. See <a href="#">Fig. 23</a> . |
| Ignition Coil 3 (5.3L) | Top left side of engine. See <a href="#">Fig. 23</a> . |
| Ignition Coil 5 (5.3L) | Top left side of engine. See <a href="#">Fig. 23</a> . |
| Ignition Coil 7 (5.3L) | Top left side of engine. See <a href="#">Fig. 23</a> . |

| C109 (Light Gray, 8 Pin) | On top left side of engine. See <a href="#">Fig. 23</a> . |

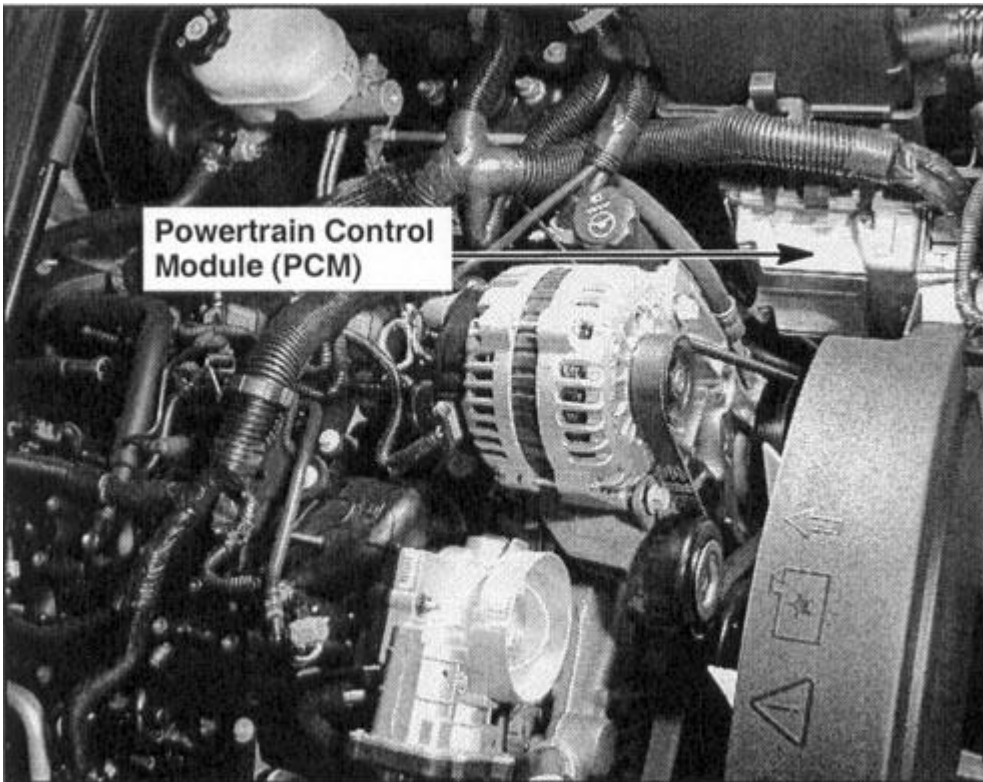
**Fig. 25: Left Front Of Engine Compartment (5.3L)**  
Courtesy of ISUZU MOTOR CO.

| Powertrain Control Module (PCM) (5.3L) | On left front of engine compartment. See <b>Fig. 25</b> . |

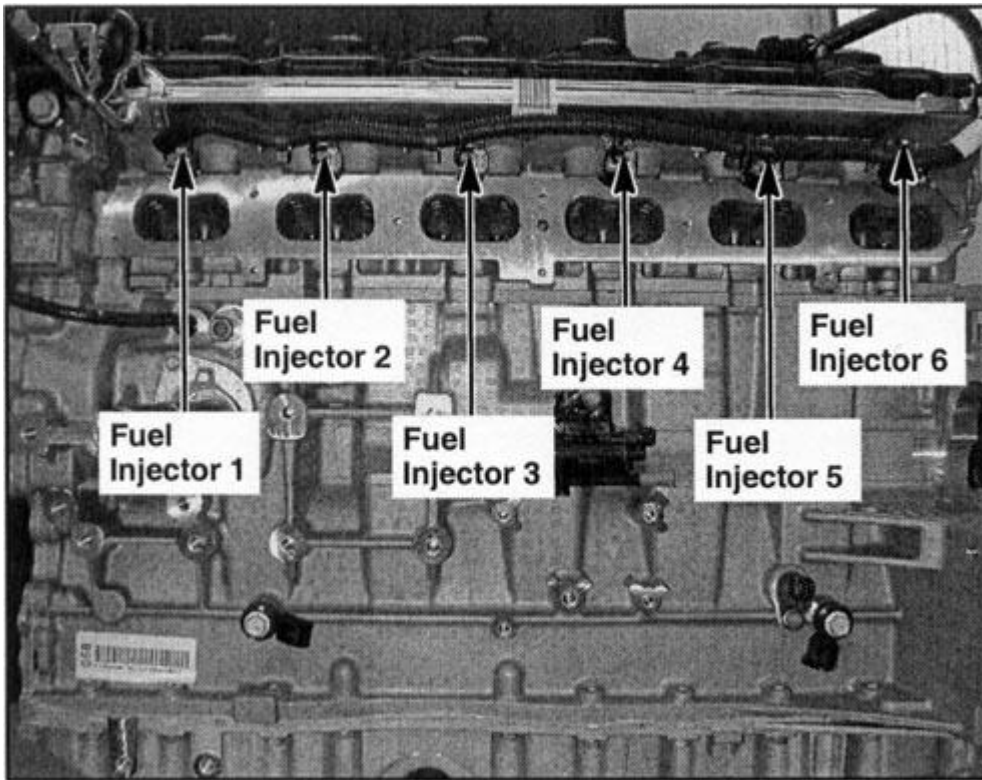
**Fig. 26: Left Side Of Engine (4.2L)**  
Courtesy of ISUZU MOTOR CO.

| Fuel Injector 1 (4.2L) | Left side of engine. See <a href="#">Fig. 26</a> . |

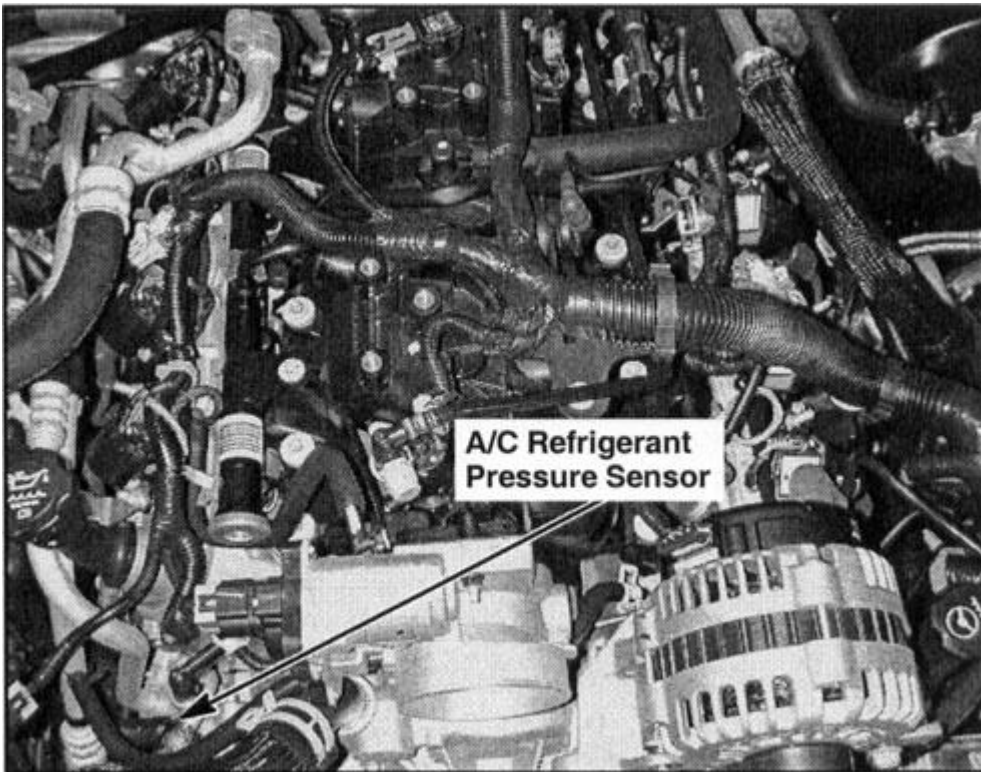
G00288925

**Fig. 27: Left Side Of Engine (4.2L)**  
Courtesy of ISUZU MOTOR CO.

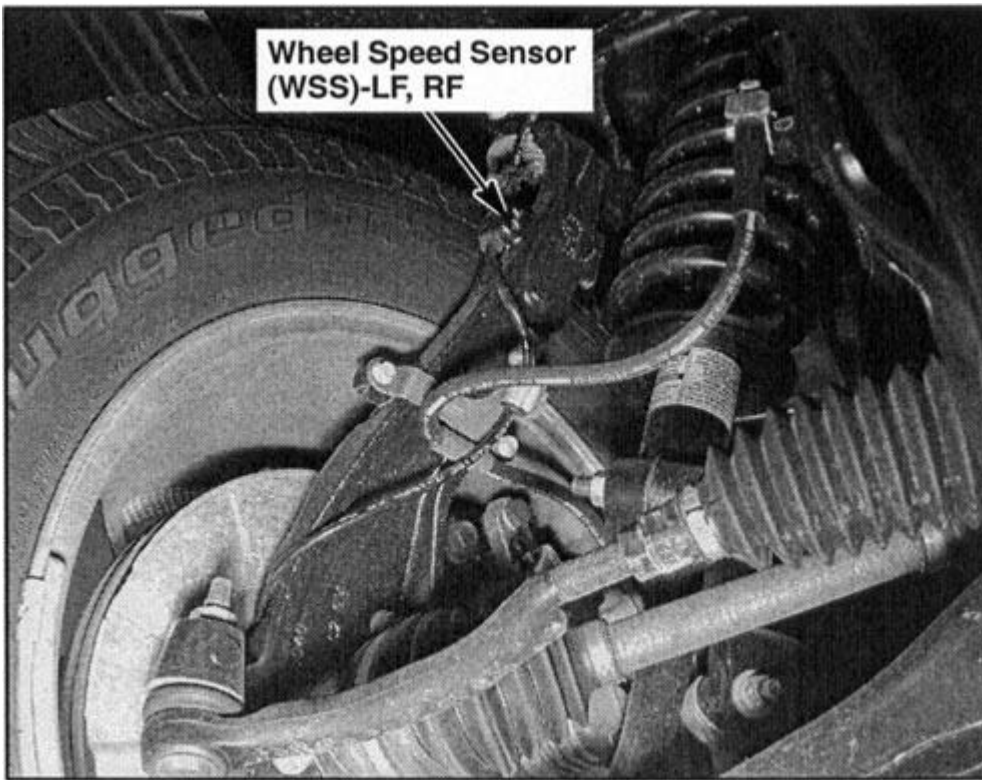
**Fig. 29: Left Front Wheel Housing (Right Similar)**  
Courtesy of ISUZU MOTOR CO.

| Wheel Speed Sensor (Left Front) | On left front wheelhousing. See <b>Fig. 29</b> . |
| Wheel Speed Sensor (Right Front) | On right front wheelhousing. See <b>Fig. 29</b> . |

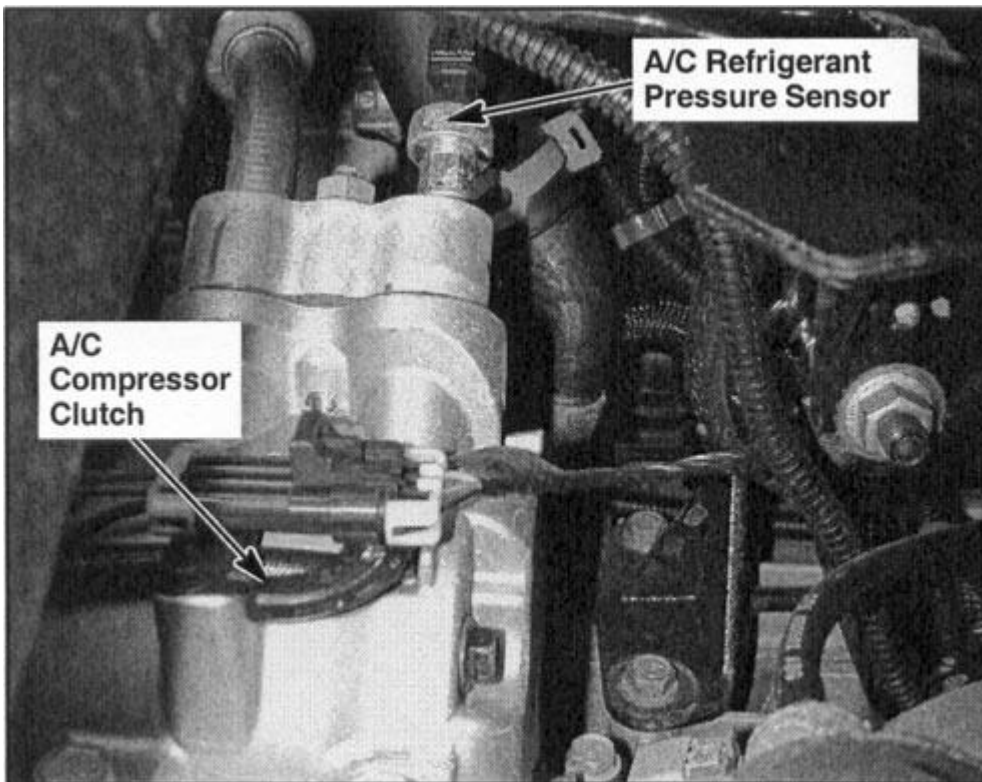
**Fig. 31: Bottom Left Front Of Engine (4.2L)**  
Courtesy of ISUZU MOTOR CO.

| Component | Location |
|---|---|
| A/C Refrigerant Pressure Sensor (4.2L) | Bottom left front of engine. See <b>Fig. 31</b> . |

| Component | Location |
|---|---|
| A/C Compressor Clutch (4.2L) | Bottom left front of engine. See <b>Fig. 31</b> . |

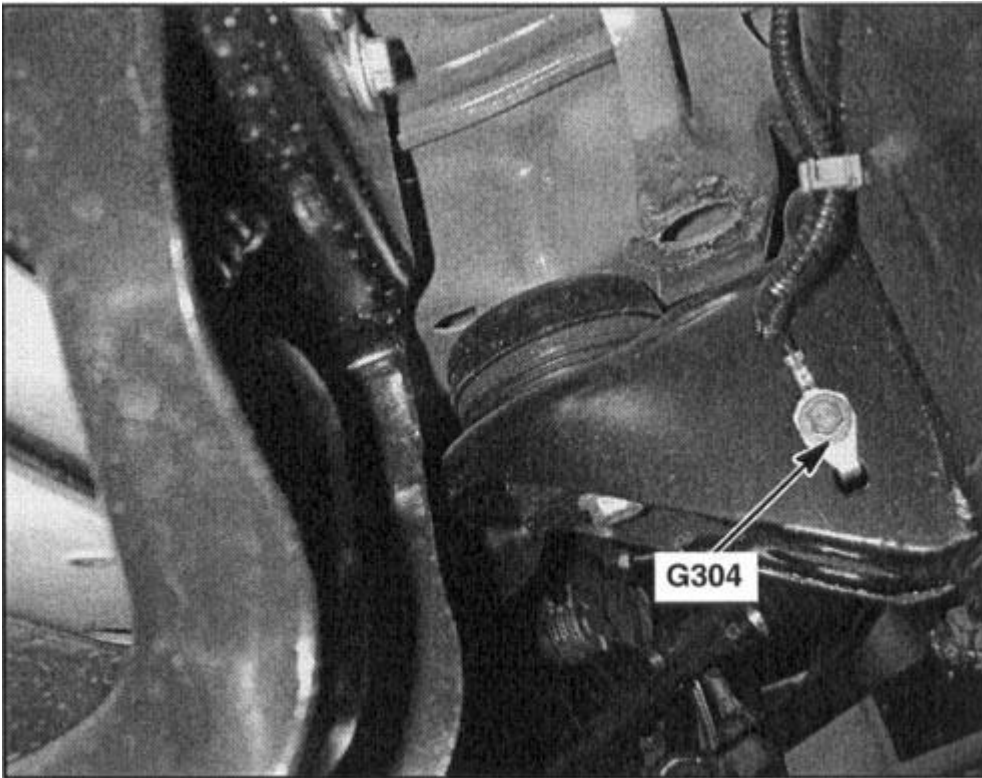
G00288932

**Fig. 33: Left Front Wheel Well (Near Upper Control Arm)**  
Courtesy of ISUZU MOTOR CO.

| G106 | On left front wheelwell. See <a href="#">Fig. 33</a> . |

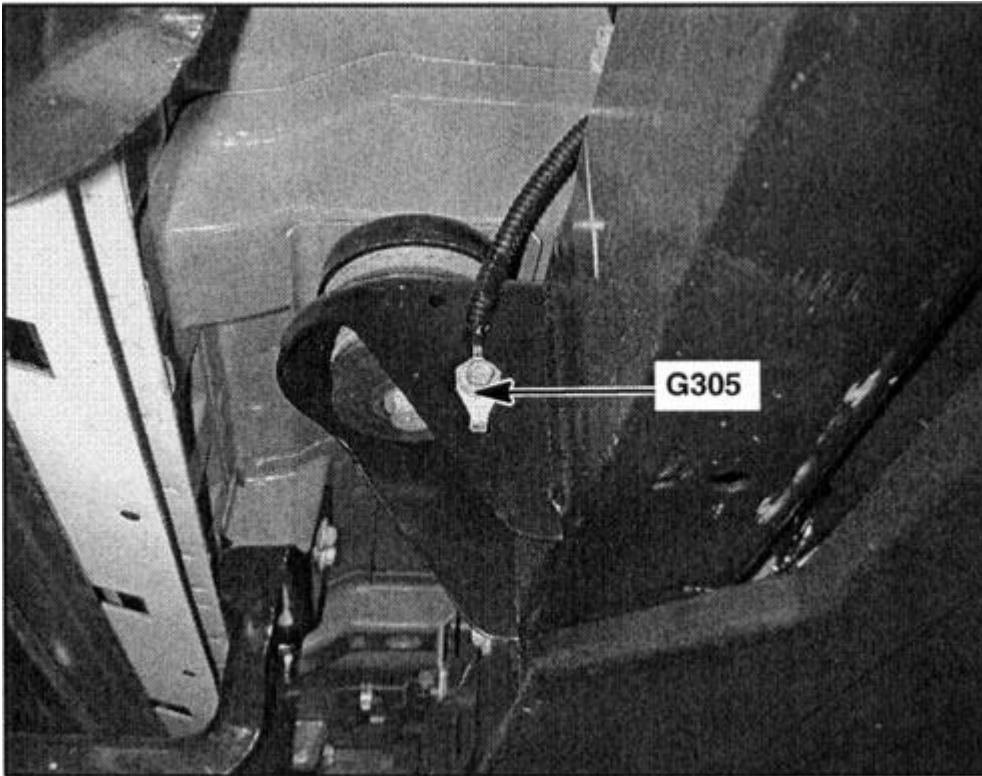
G00288933

**Fig. 34: Outside Of Left Frame Rail (Near EBCM)**  
Courtesy of ISUZU MOTOR CO.

| G304 | Outside of left frame rail, near electronic brake control module. See <a href="#">Fig. 34</a> . |

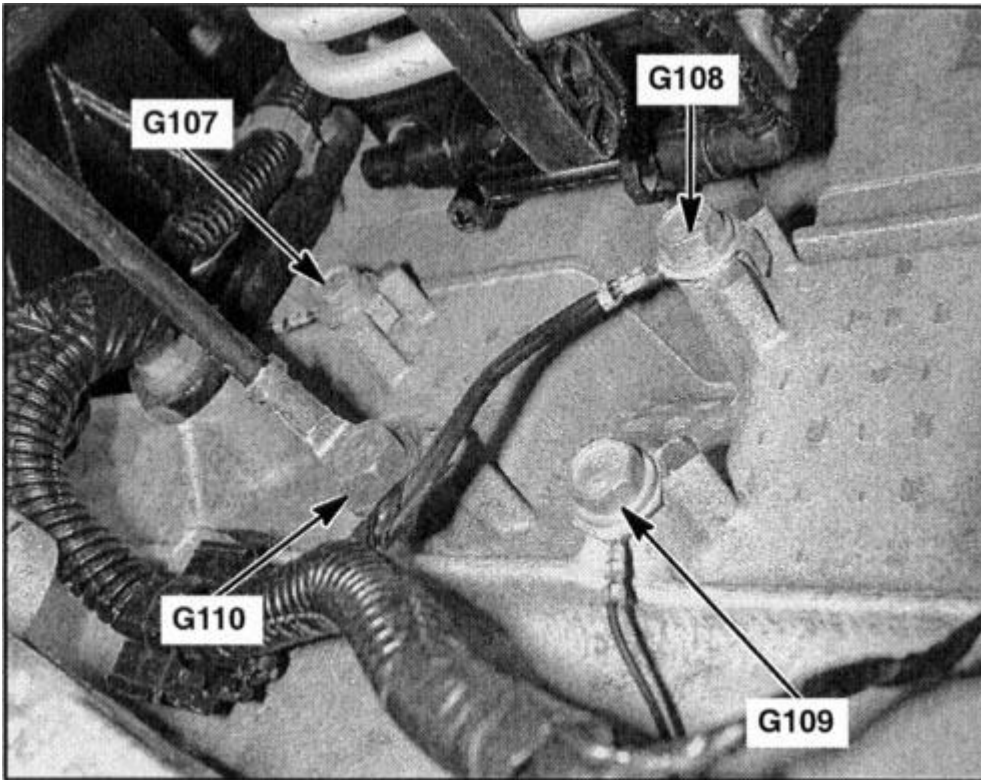
G00288934

**Fig. 35: Outside Of Left Frame Rail (Near Fuel Tank)**  
Courtesy of ISUZU MOTOR CO.

| G107 (4.2L) | On lower left side of engine. See <a href="#">Fig. 35</a> . |
| G305 | On outside of left frame rail, near fuel tank. See <a href="#">Fig. 35</a> . |

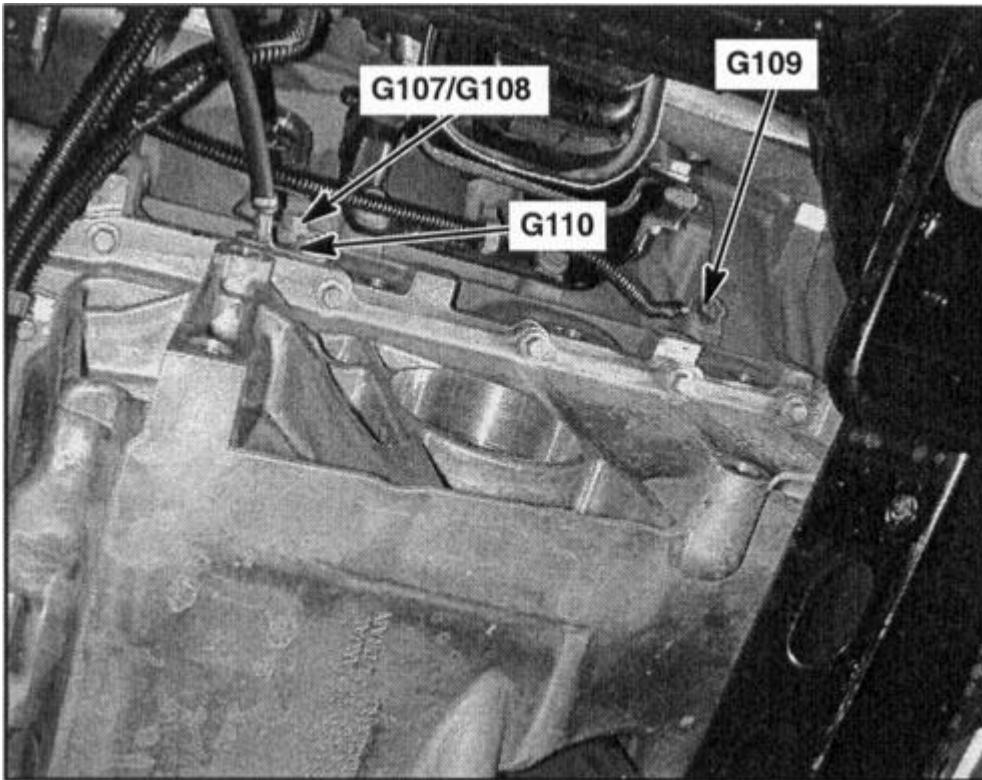
G00288935

**Fig. 36: Lower Left Side Of Engine (4.2L)**  
Courtesy of ISUZU MOTOR CO.

| G108 (4.2L) | On lower left side of engine. See <a href="#">Fig. 36</a> . |
| G109 (4.2L) | On lower left side of engine. See <a href="#">Fig. 36</a> . |
| G110 (4.2L) | On lower left side of engine. See <a href="#">Fig. 36</a> . |

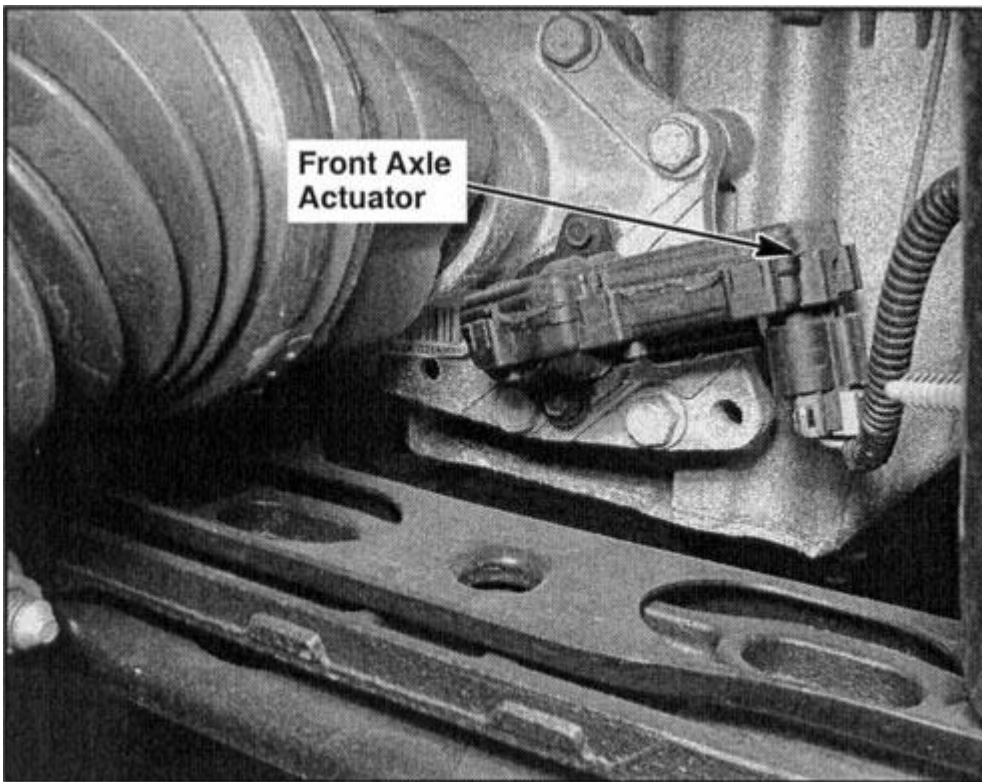
**Fig. 38: Lower Right Front Of Engine (On Oil Pan)**  
Courtesy of ISUZU MOTOR CO.

| Component | Location |
|---|---|
| Front Axle Actuator | Lower right front of engine, on oil pan. See <b>Fig. 38</b> . |

| Front Axle Actuator | Lower right front of engine, on oil pan. See <a href="#">Fig. 38</a> . |

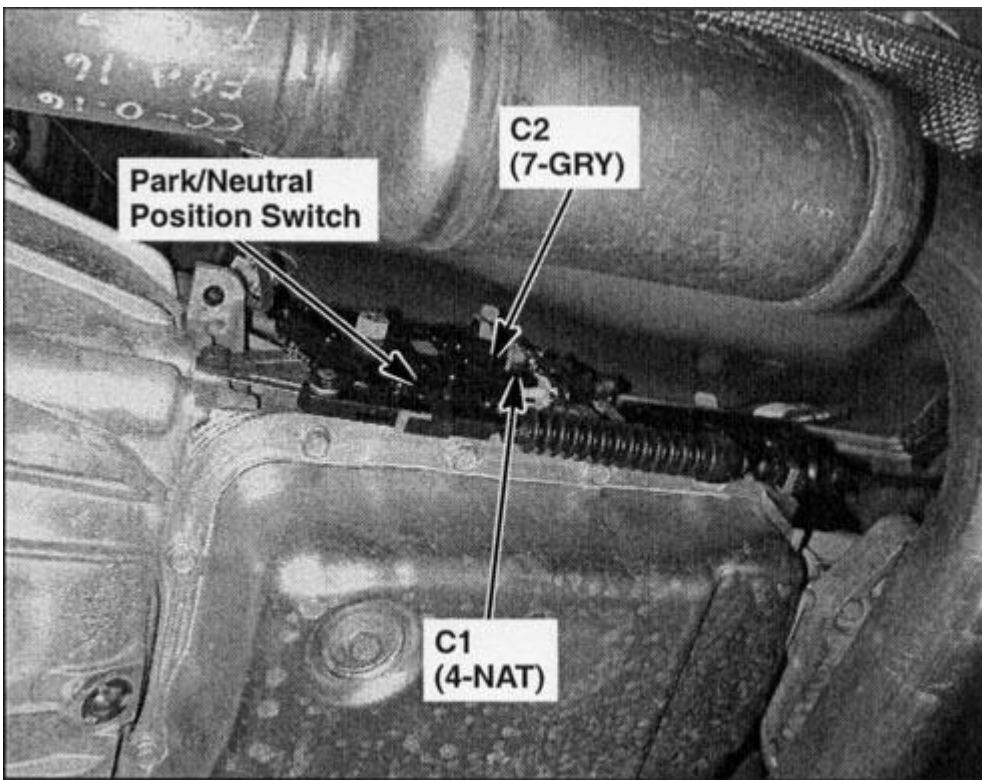
**Fig. 39: Left Side Of Transmission (4WD Similar)**  
Courtesy of ISUZU MOTOR CO.

| Component | Location |
|---|---|
| Park/Neutral Position Switch | On left side of transmission. See <a href="#">Fig. 39</a> . |

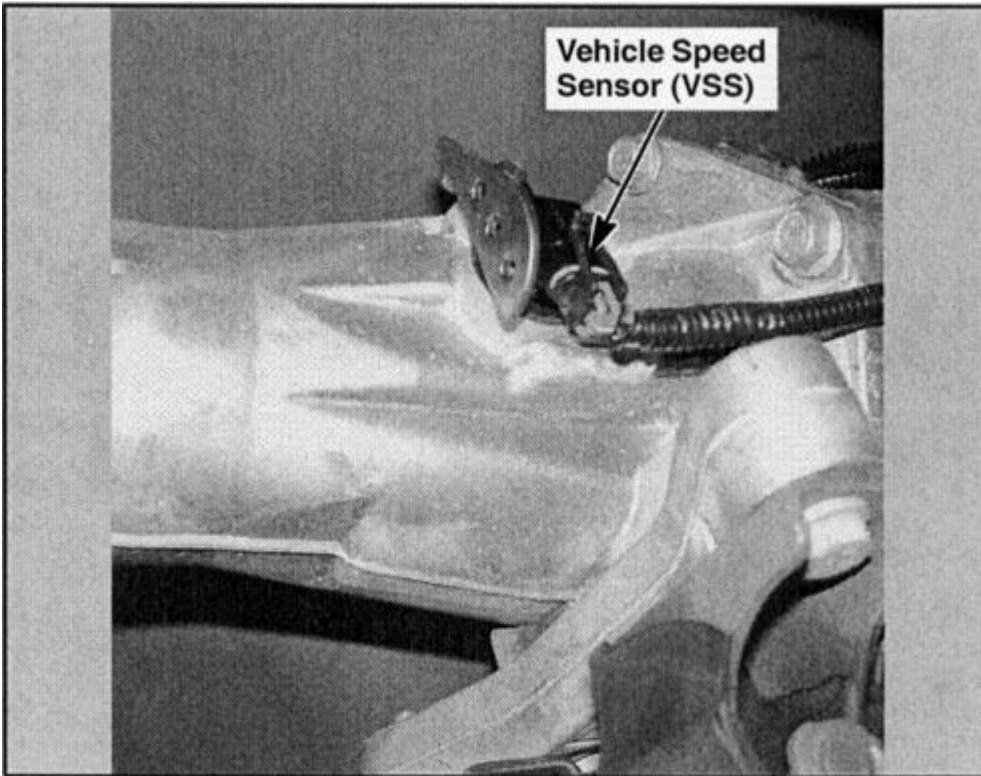
G00288939

**Fig. 40: Inner Left Side Of Frame Rail (Near Transmission)**  
Courtesy of ISUZU MOTOR CO.

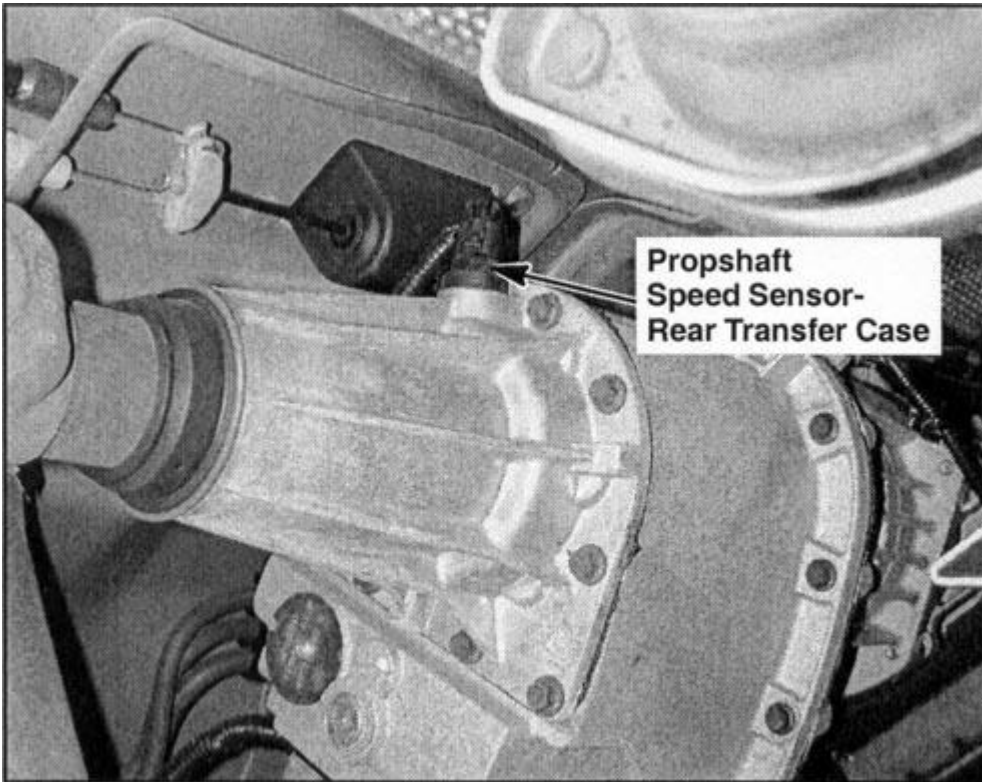
**Fig. 42: Right Rear Of Transfer Case**  
Courtesy of ISUZU MOTOR CO.

| Propshaft Speed Sensor (Rear Transfer Case) | On right rear of transfer case. See <b>Fig. 42</b> . |

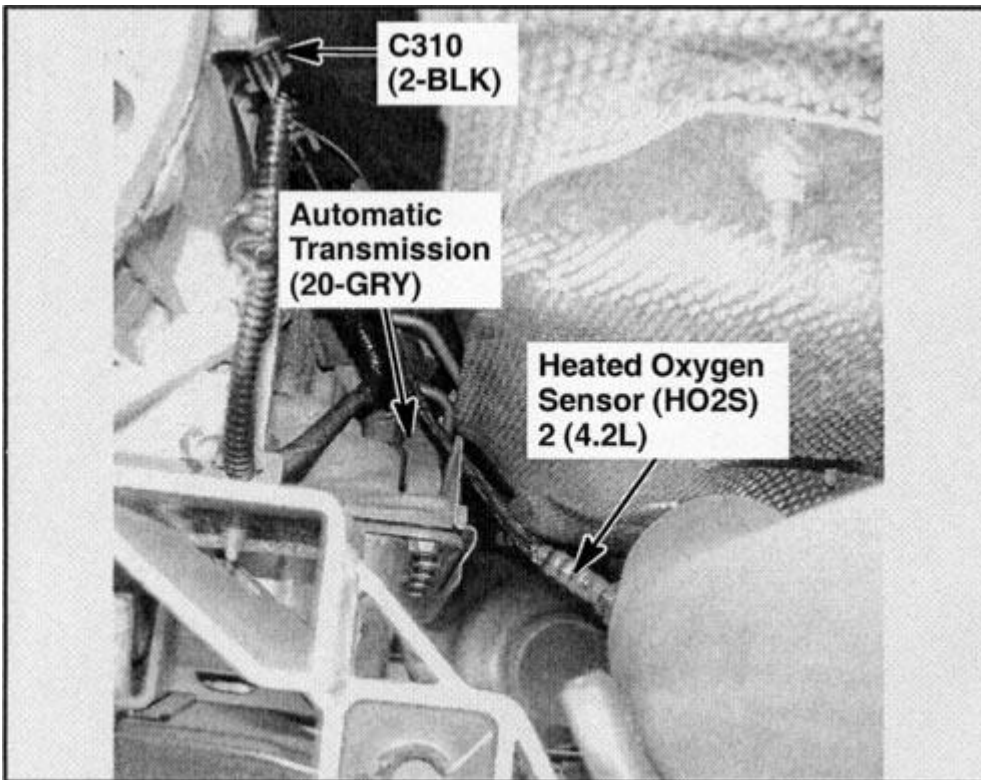
G00288942

**Fig. 43: Left Rear Of Transfer Case**  
Courtesy of ISUZU MOTOR CO.
