## 2004 Isuzu Ascender LS

## BUZZERS, RELAYS & TIMERS

## COMPONENT LOCATION GRAPHICS

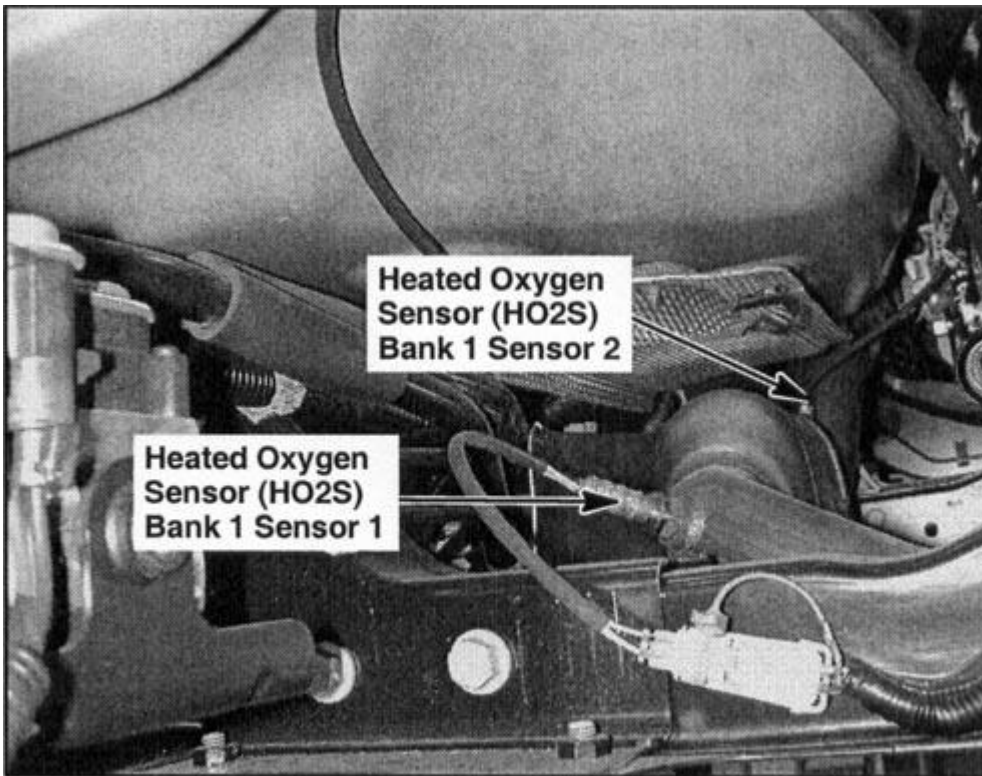
G00288944

**Fig. 45: Right Exhaust Downpipe (5.3L)**  
Courtesy of ISUZU MOTOR CO.

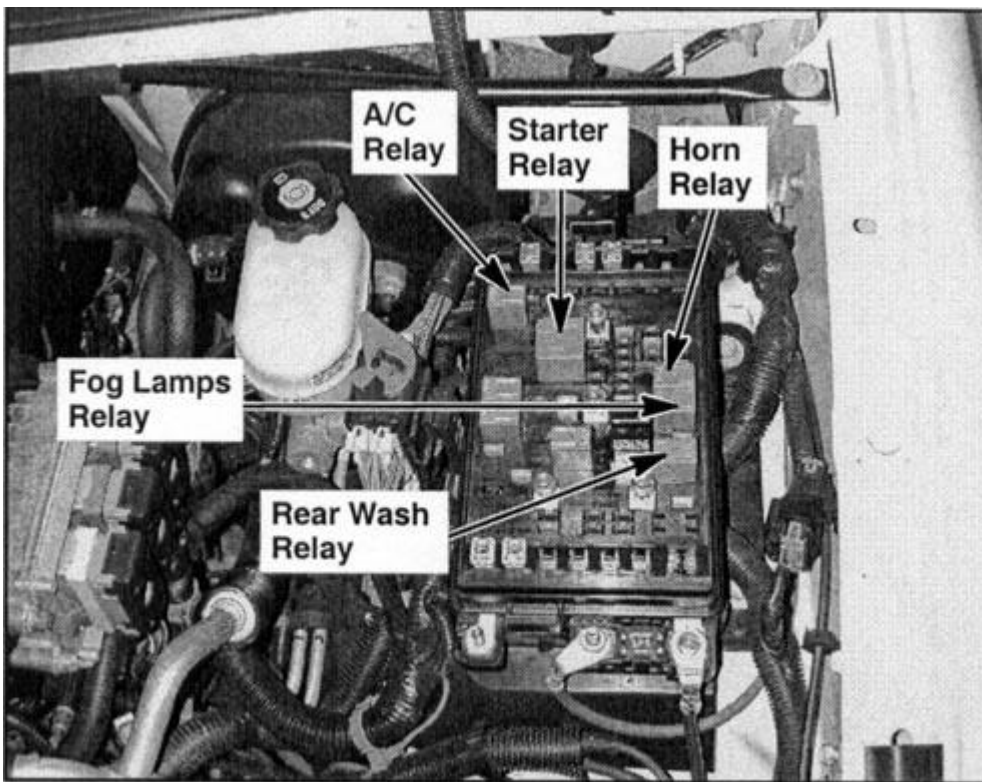
**Fig. 48: Underhood Fuse Block (Cover Removed)**  
Courtesy of ISUZU MOTOR CO.

| Component | Location |
|---|---|
| A/C Relay | In underhood fuse block. See <a href="#">Fig. 48</a> . |
| Fog Lamps Relay | In underhood fuse block. See <a href="#">Fig. 48</a> . |
| Horn Relay | In underhood fuse block. See <a href="#">Fig. 48</a> . |
| Rear Wash Relay | In underhood fuse block. See <a href="#">Fig. 48</a> . |
| Starter Relay | In underhood fuse block. See <a href="#">Fig. 48</a> . |

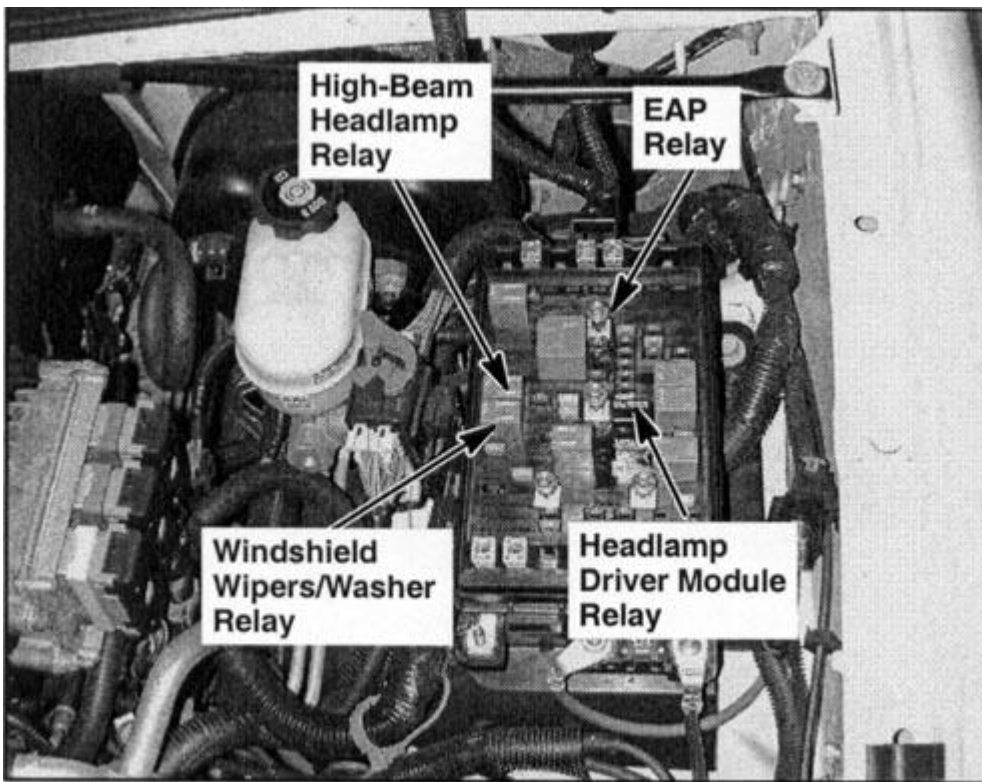
**Fig. 49: Underhood Fuse Block (Cover Removed)**  
Courtesy of ISUZU MOTOR CO.

| Component | Location |
|---|---|
| EAP Relay | In underhood fuse block. See <a href="#">Fig. 49</a> . |
| Headlamp Driver Module Relay 46 | In underhood fuse block. See <a href="#">Fig. 49</a> . |
| High Beam Headlamp Relay | In underhood fuse block. See <a href="#">Fig. 49</a> . |
| Windshield Wipers/Washer Relay | In underhood fuse block. See <a href="#">Fig. 49</a> . |

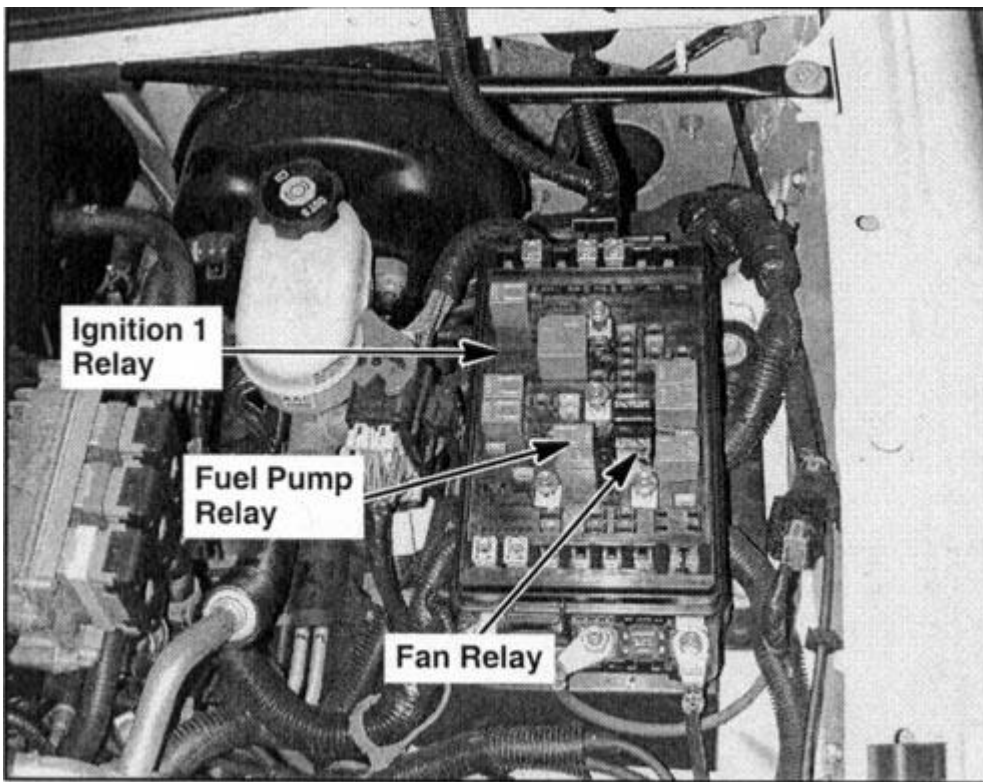
**Fig. 50: Underhood Fuse Block (Cover Removed)**  
Courtesy of ISUZU MOTOR CO.

| Component | Location |
|---|---|
| Fan Relay | In underhood fuse block. See <a href="#">Fig. 50</a> . |
| Fuel Pump Relay 41 | In underhood fuse block. See <a href="#">Fig. 50</a> . |
| Ignition 1 Relay | In underhood fuse block. See <a href="#">Fig. 50</a> . |

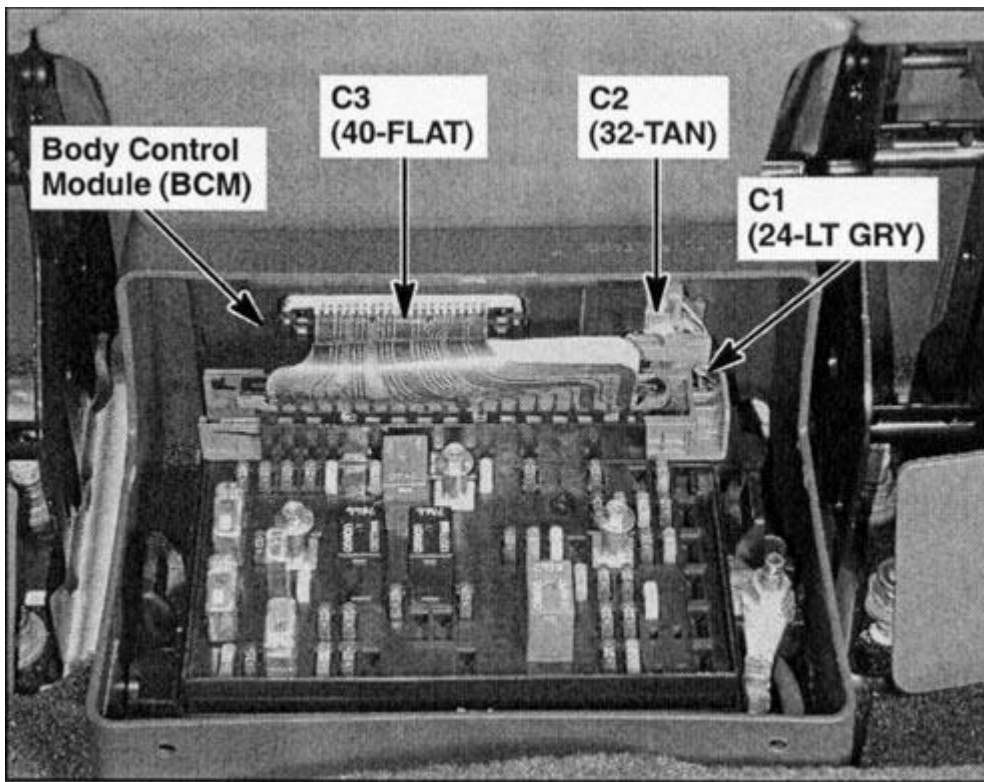
G00288950

**Fig. 51: Under Left Rear Seat**  
**Courtesy of ISUZU MOTOR CO.**

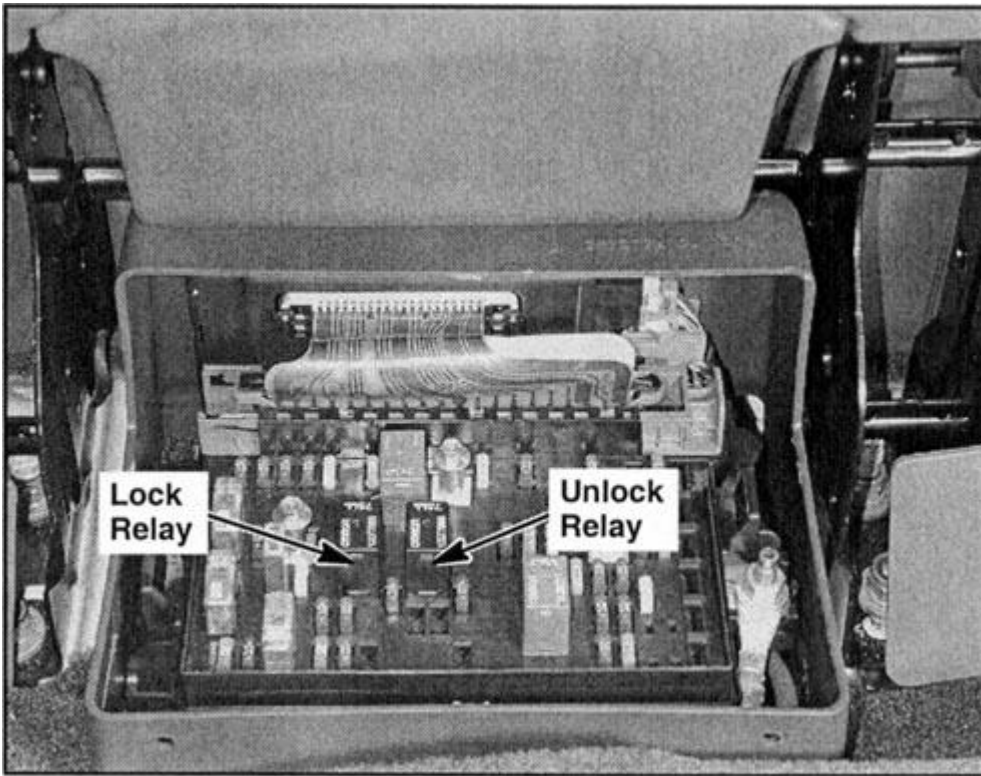
G00288951

**Fig. 52: Rear Fuse Block (Cover Removed)**  
Courtesy of ISUZU MOTOR CO.

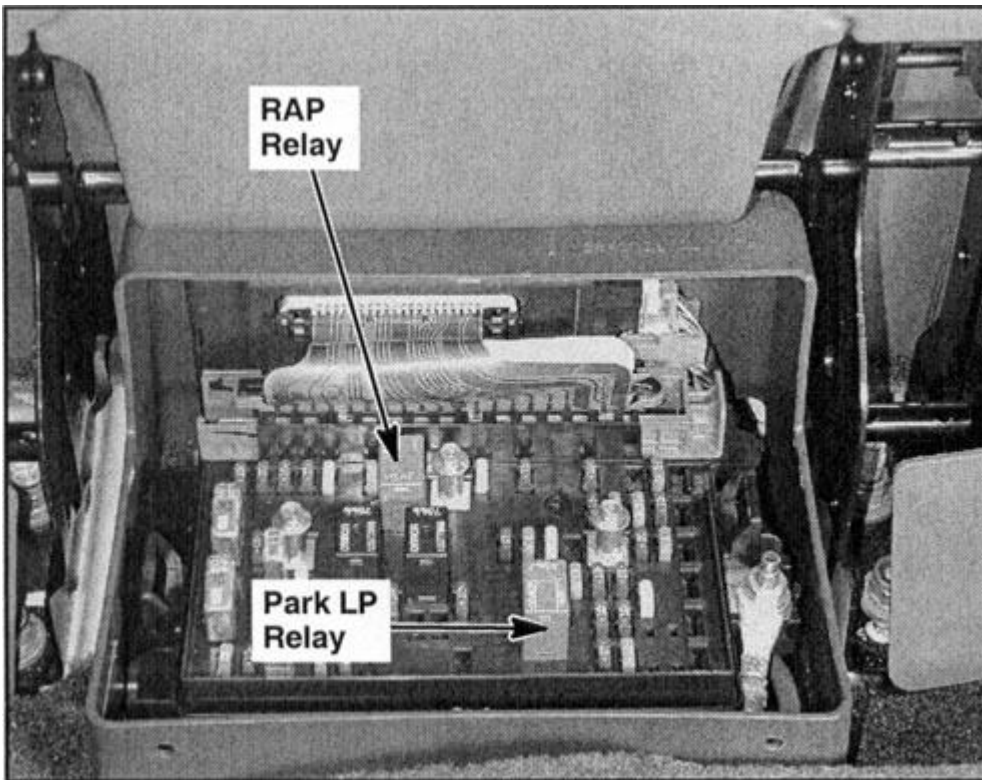
**Fig. 54: Rear Fuse Block (Cover Removed)**  
Courtesy of ISUZU MOTOR CO.

| Component | Location |
|---|---|
| Park LP Relay | On rear fuse block. See <a href="#">Fig. 54</a> . |
| RAP Relay | On rear fuse block. See <a href="#">Fig. 54</a> . |

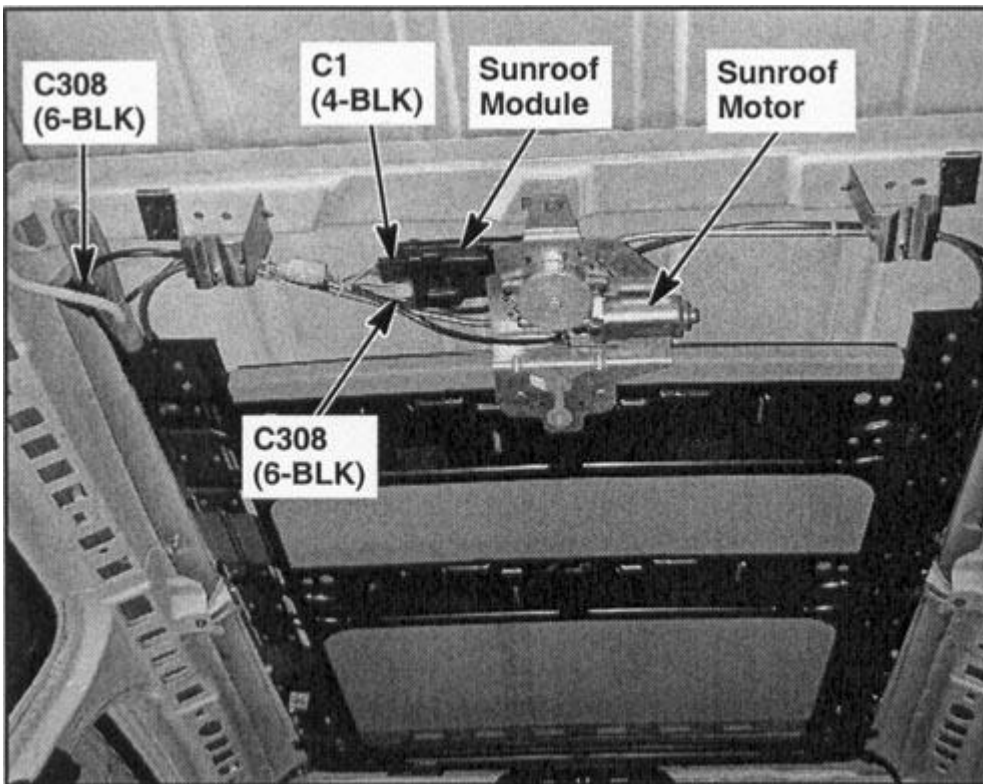
**Fig. 55: Middle Of Roof (Headliner Removed)**  
Courtesy of ISUZU MOTOR CO.

| Sun Roof Module | Above headliner, at rear of sun roof. See <b>Fig. 55</b> . |

| Sun Roof Motor | Above headliner, at rear of sun roof. See <b>Fig. 55</b> . |

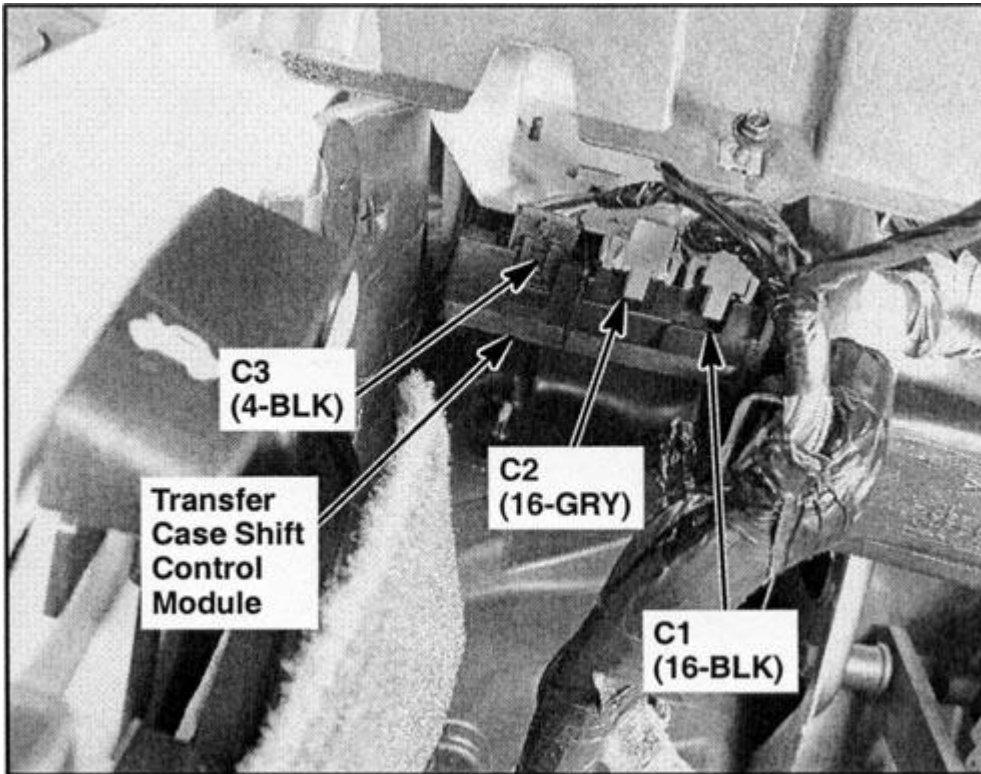
G00288955

**Fig. 56: Below Left Side Of I/P**  
Courtesy of ISUZU MOTOR CO.

| Turn Signal/Hazard Flasher Module | Behind left side of dash. See <b>Fig. 56</b> . |

| SP205 | Below left side of I/P. See <a href="#">Fig. 56</a> . |

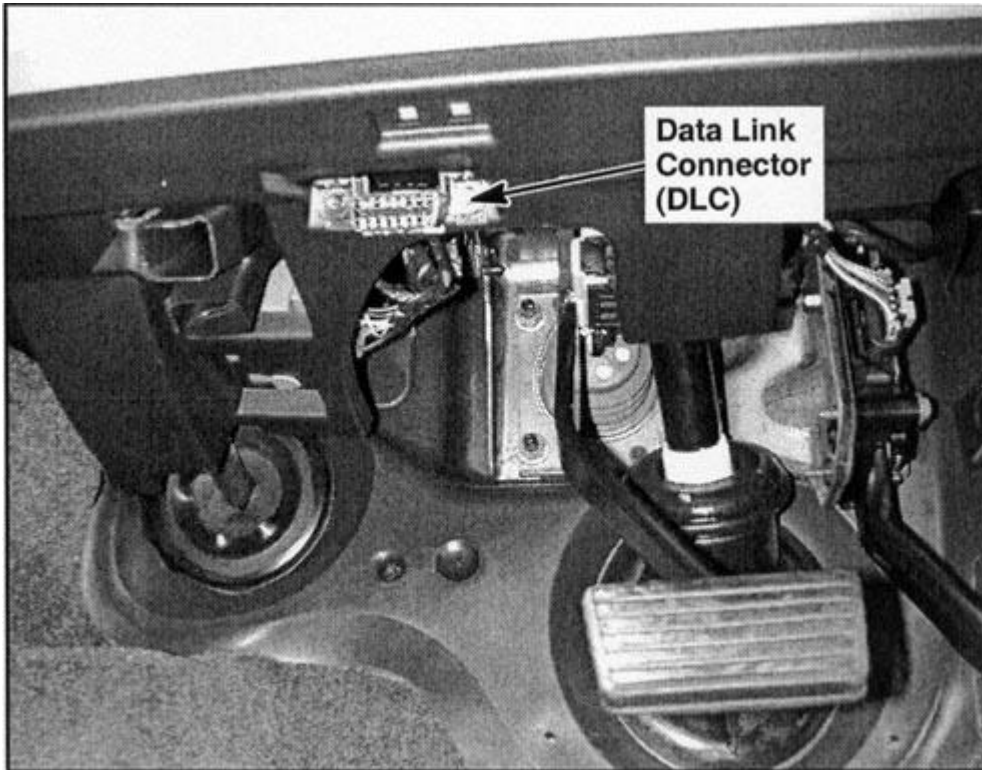
G00288956

**Fig. 57: Below Left Side Of I/P**  
Courtesy of ISUZU MOTOR CO.

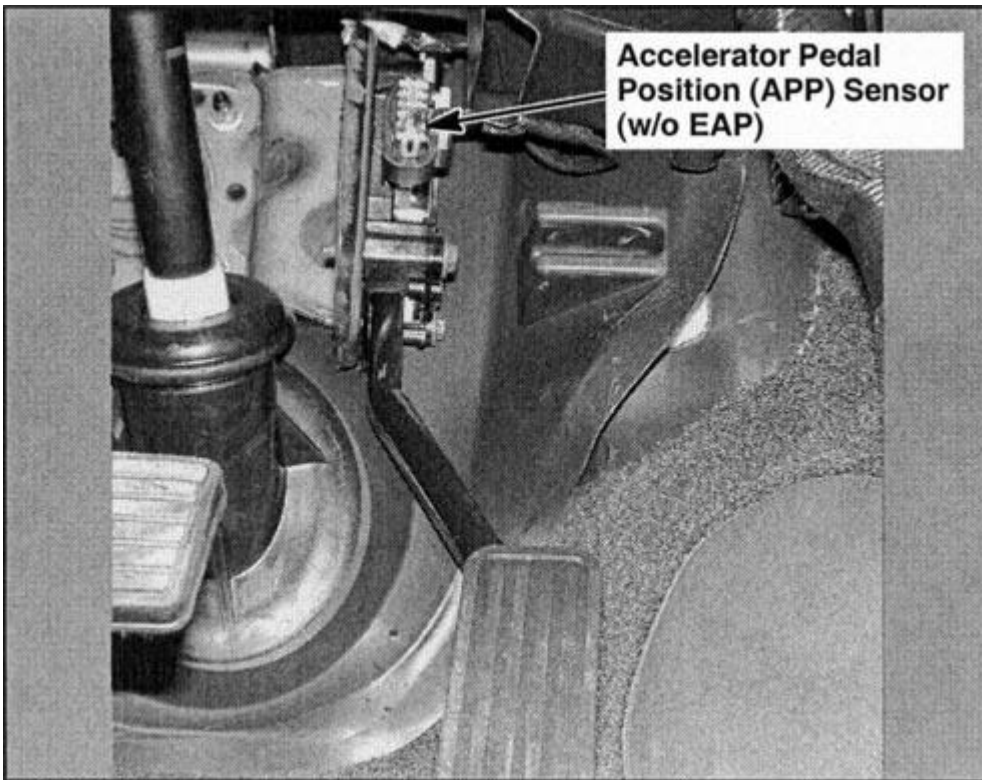
**Fig. 60: Below Left Side Of I/P**  
Courtesy of ISUZU MOTOR CO.

| Component | Location |
|---|---|
| Accelerator Pedal Position (APP) Sensor (W/O EAP) | On accelerator bracket. See <b>Fig. 60</b> . |

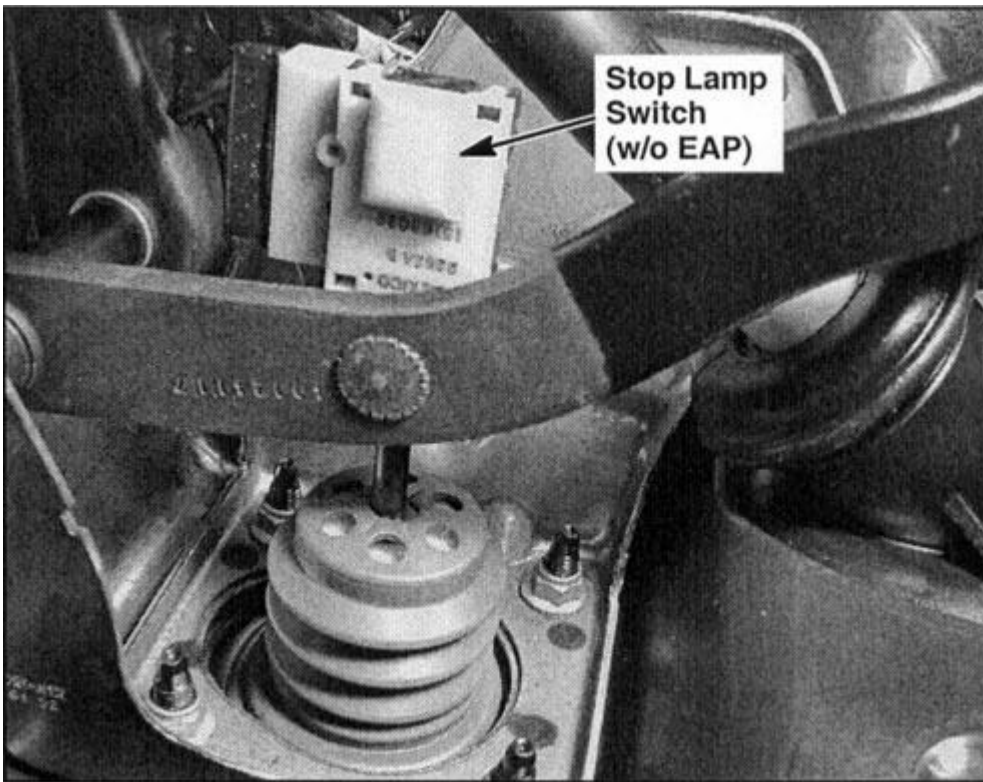
**Fig. 61: Below Left Side Of I/P**  
Courtesy of ISUZU MOTOR CO.

| Component | Location |
|---|---|
| Stoplamp Switch (W/O EAP) | On brake pedal support. See <a href="#">Fig. 61</a> . |

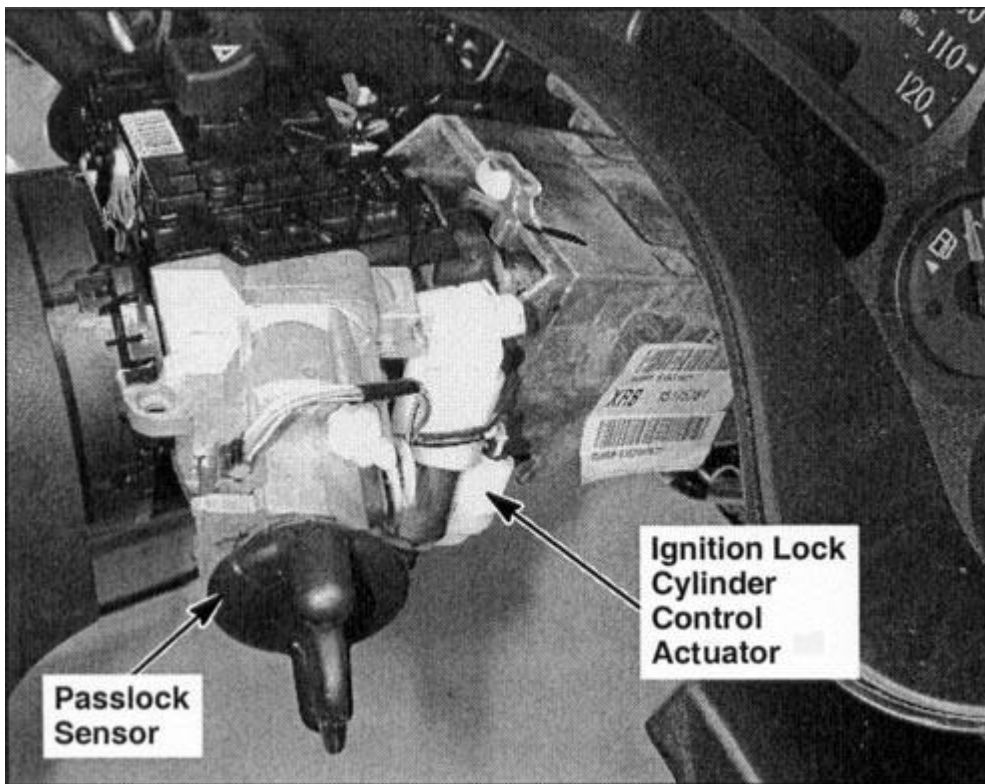
**Fig. 64: Right Side Of Steering Column**  
Courtesy of ISUZU MOTOR CO.

| Passlock Sensor | In steering column. See <b>Fig. 64</b> . |

| Ignition Lock Cylinder Control Actuator | In steering column. See <a href="#">Fig. 64</a> . |

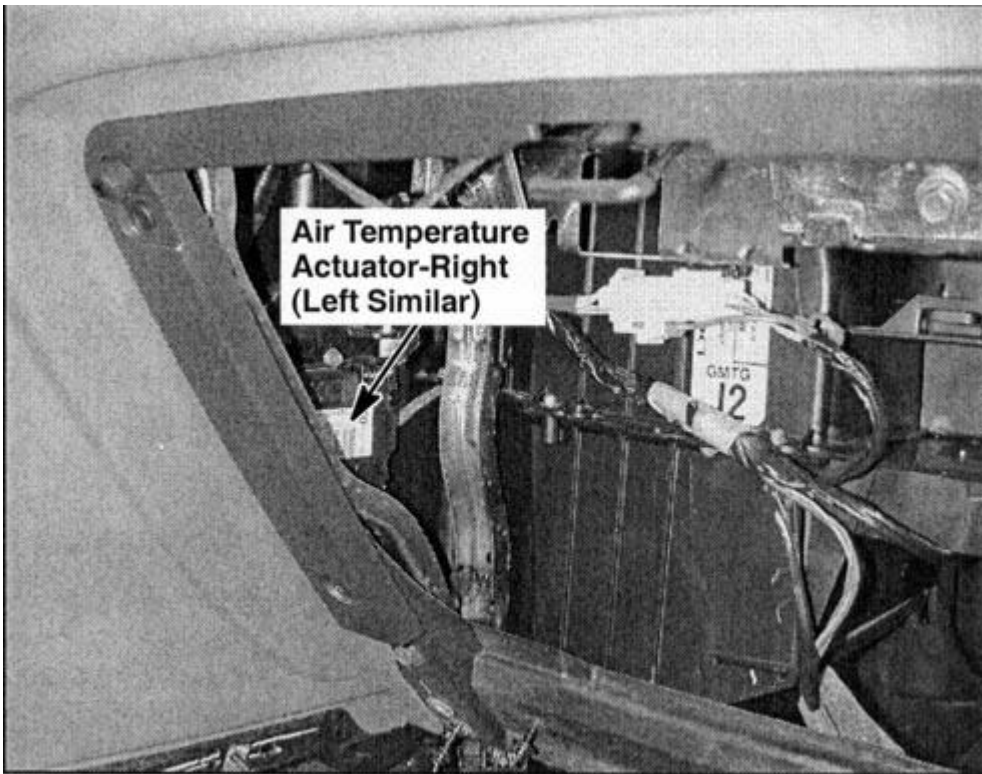
**Fig. 67: Behind Glove Box**  
Courtesy of ISUZU MOTOR CO.

| Inflatable Restraint I/P Module | Right side of I/P. See <a href="#">Fig. 67</a> . |

| C203 (Yellow, 4 Pin) | On lower right side of dash. See <a href="#">Fig. 67</a> . |

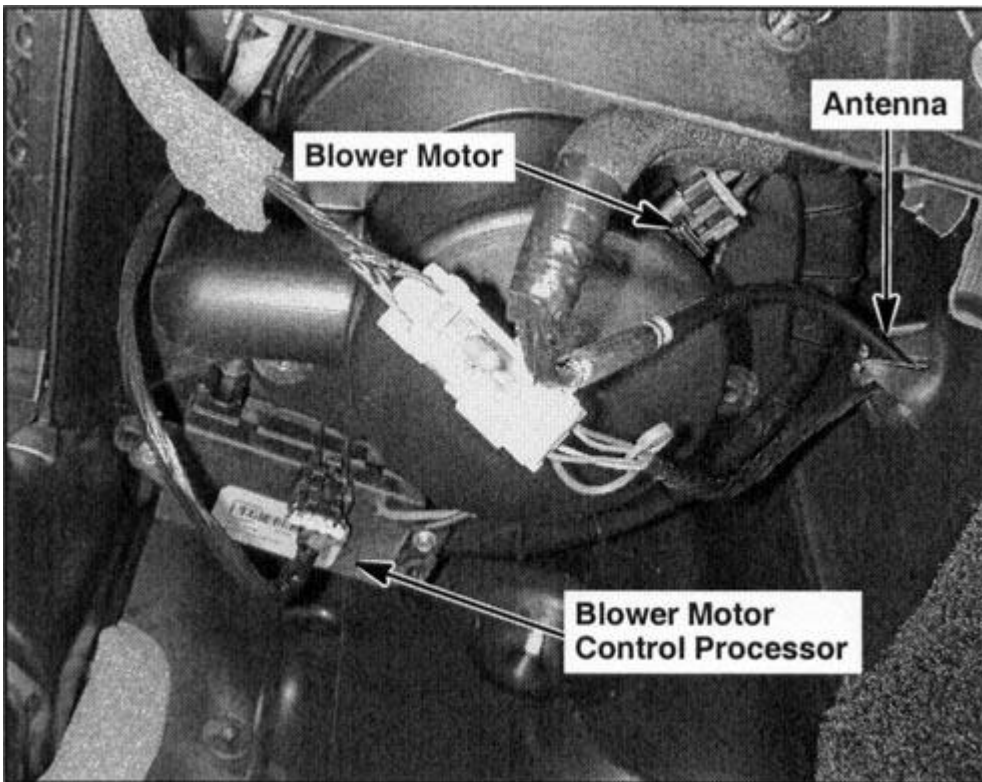
**Fig. 69: Lower Right Side Of I/P**  
Courtesy of ISUZU MOTOR CO.

| Component | Location |
|---|---|
| Blower Motor Control Processor | Below right side of dash. See <a href="#">Fig. 69</a> . |

| Component | Location |
|---|---|
| Blower Motor | Below right side of dash. See <b>Fig. 69</b> . |

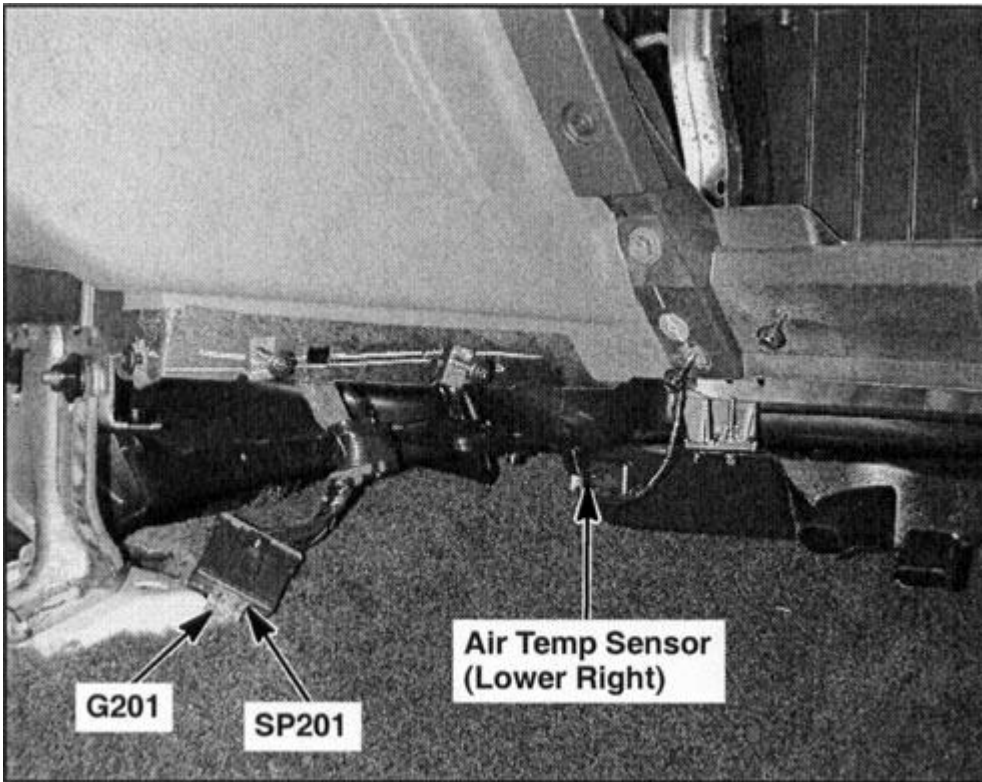
**Fig. 70: Lower Right Center Of I/P**  
Courtesy of ISUZU MOTOR CO.

| Component | Location |
|---|---|
| Air Temperature Sensor (Lower Right) | In lower right air duct assembly. See <b>Fig. 70</b> . |

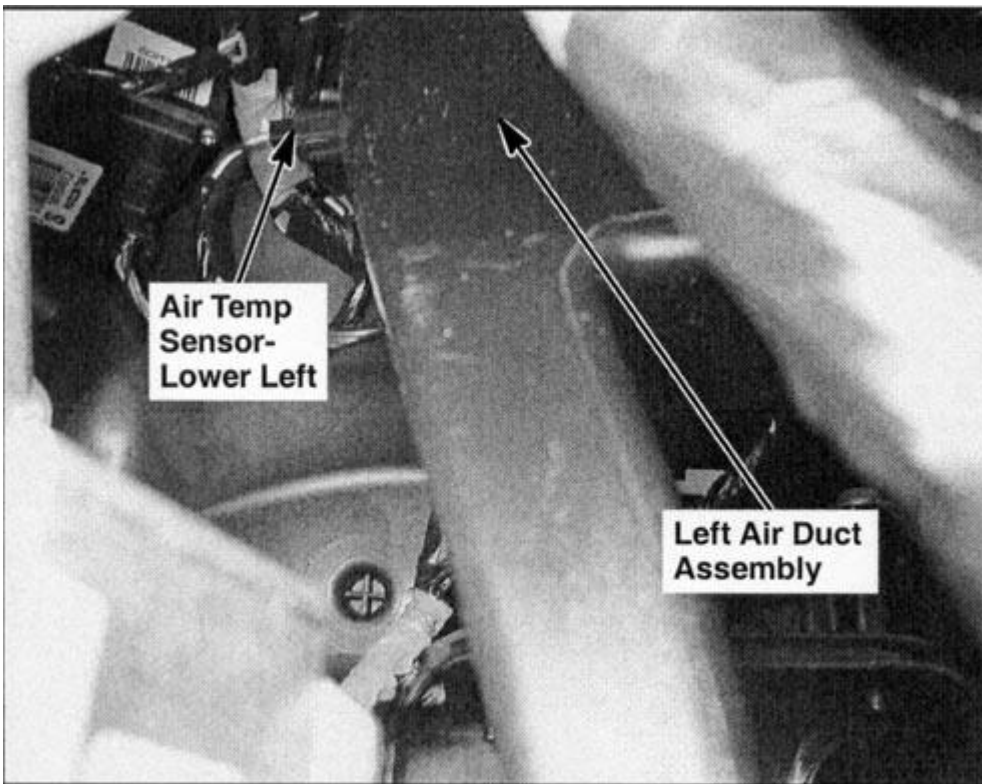
**Fig. 71: Lower Left Center Of I/P**  
Courtesy of ISUZU MOTOR CO.

| Component | Location |
|---|---|
| Air Temperature Sensor (Lower Left) | In lower left air duct assembly. See <b>Fig. 71</b> . |

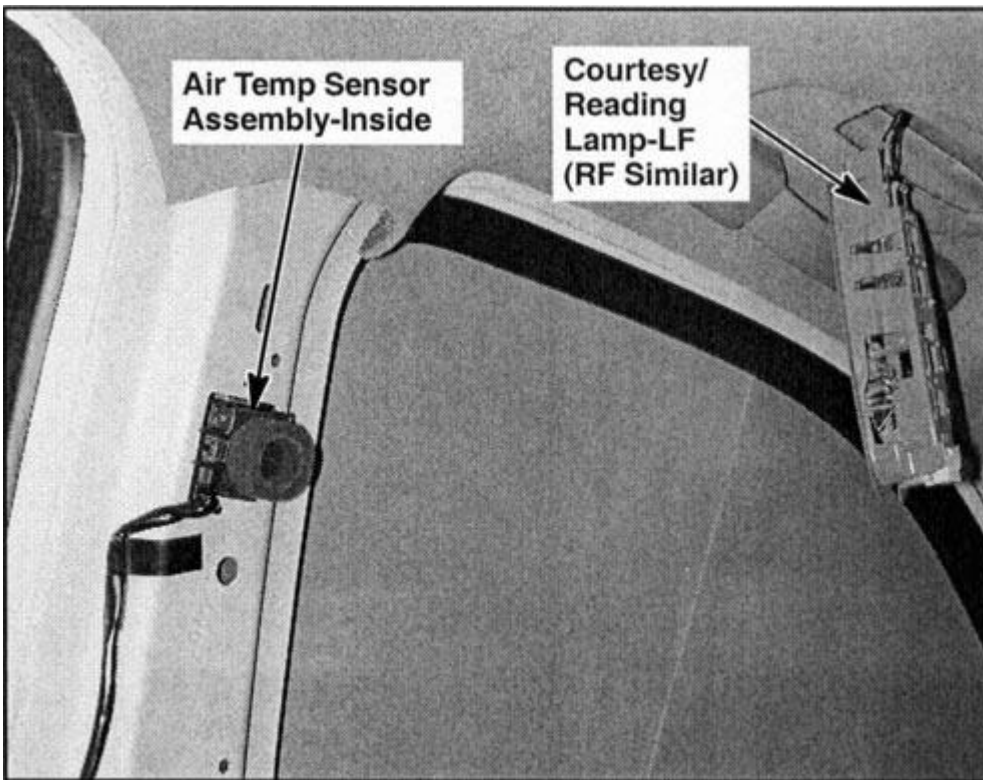
**Fig. 72: Left "B" Pillar**  
Courtesy of ISUZU MOTOR CO.

| Component | Location |
|---|---|
| Air Temperature Sensor Assembly (Inside) | In left "B" pillar. See <b>Fig. 72</b> . |

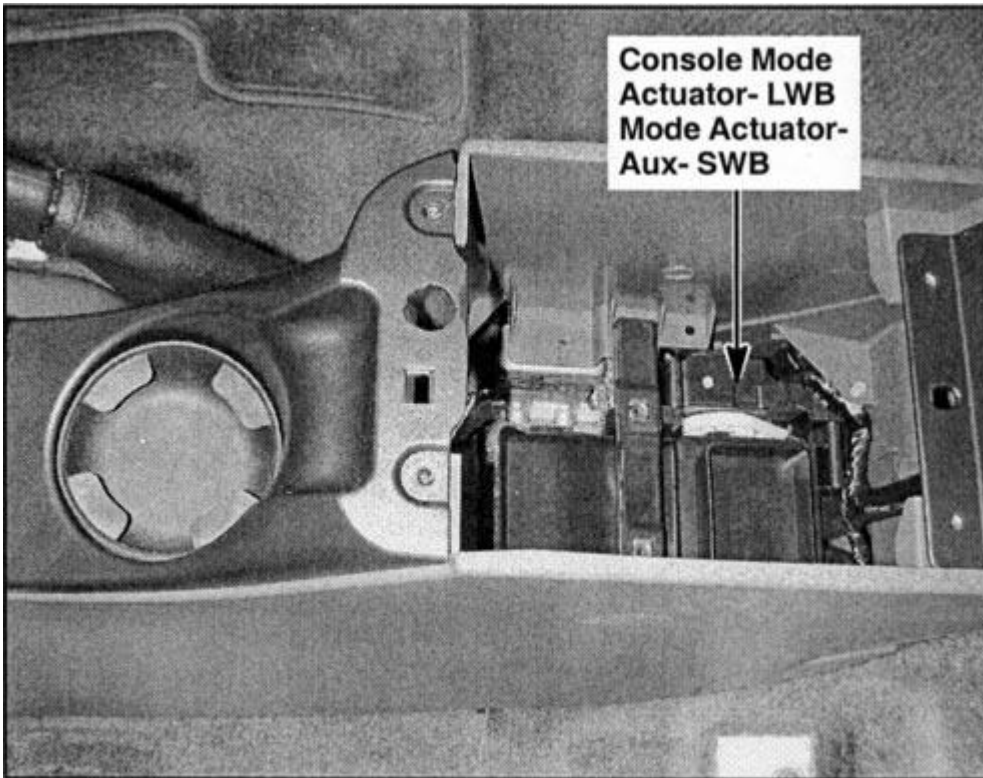
**Fig. 73: Left Center Of I/P**  
Courtesy of ISUZU MOTOR CO.

| Component | Location |
|---|---|
| Defrost Actuator | Behind upper left center of dash. See <b>Fig. 73</b> . |

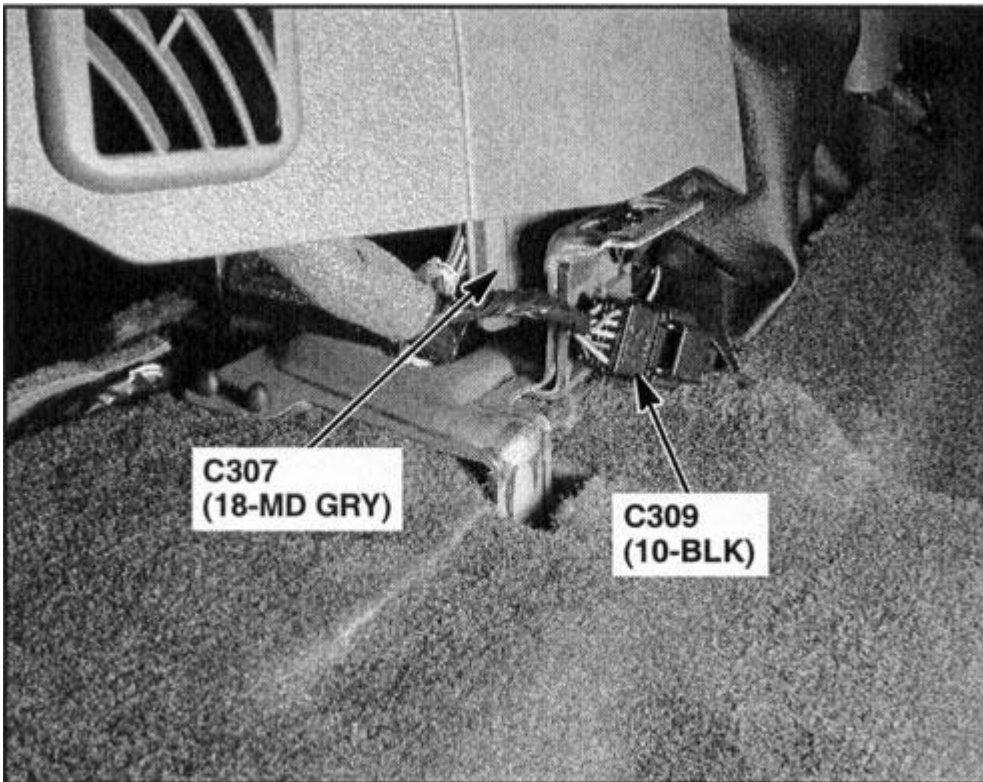
**Fig. 75: Under Rear Of Lower Console**  
Courtesy of ISUZU MOTOR CO.

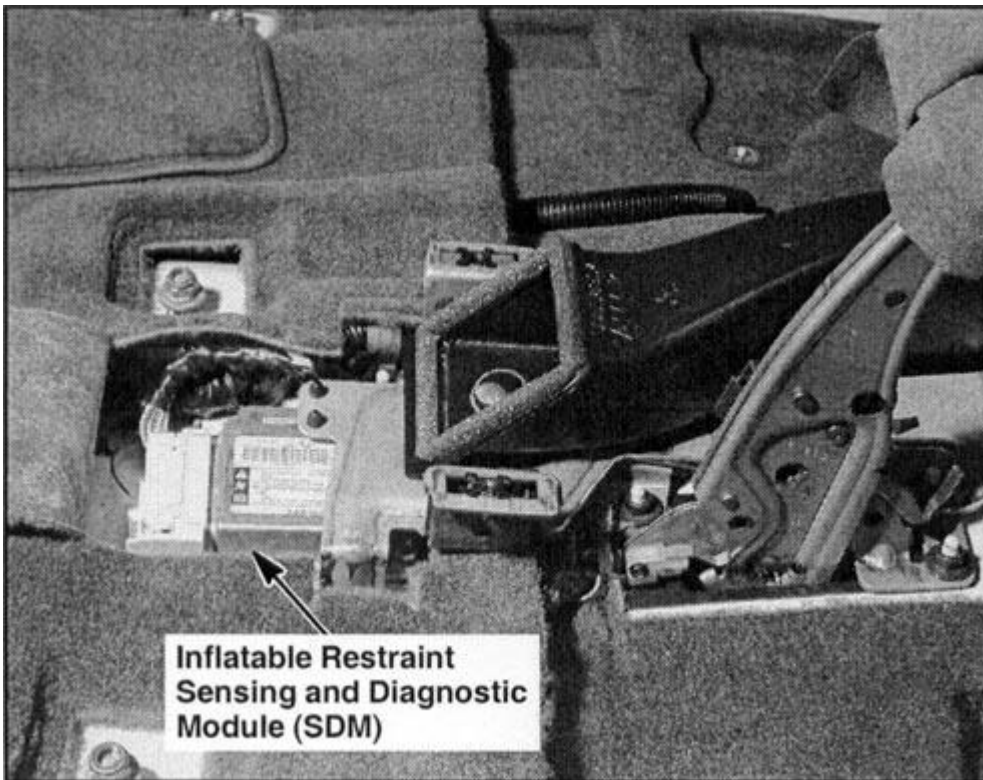
| C307 (Gray, 18 Pin) | Beneath rear of lower console. See <a href="#">Fig. 75</a> . |
| C309 (Black, 10 Pin) | Under rear lower console. See <a href="#">Fig. 75</a> . |

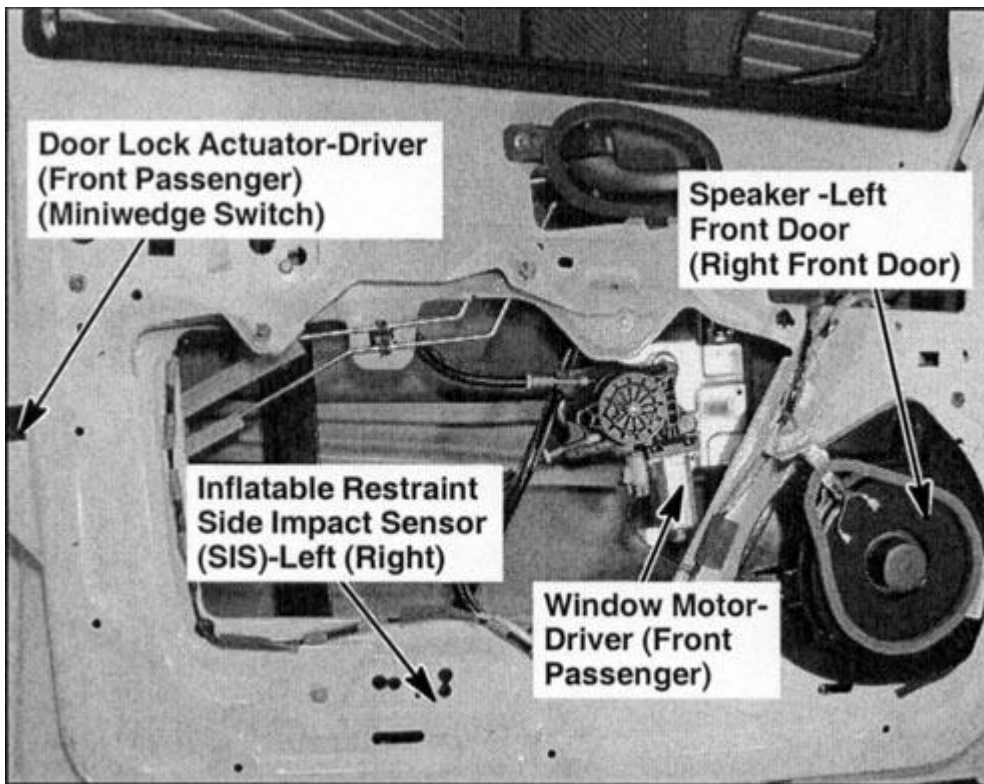
**Fig. 83: Left Front Door (Right Similar)**  
Courtesy of ISUZU MOTOR CO.

| Window Motor (Driver's) | In driver's door. See <b>Fig. 83</b> . |
| Window Motor (Front Passenger's) | In right front door. See <b>Fig. 83</b> . |

| Inflatable Restraint Side Impact Sensor (Left) | In left front door. See <b>Fig. 83</b> . |
| Inflatable Restraint Side Impact Sensor (Right) | In right front door. See <b>Fig. 83</b> . |

| Component | Location |
|---|---|
| Door Lock Actuator (Driver's) | In driver's door. See <b>Fig. 83</b> . |
| Door Lock Actuator (Front Passenger's) | In right front door. See <b>Fig. 83</b> . |

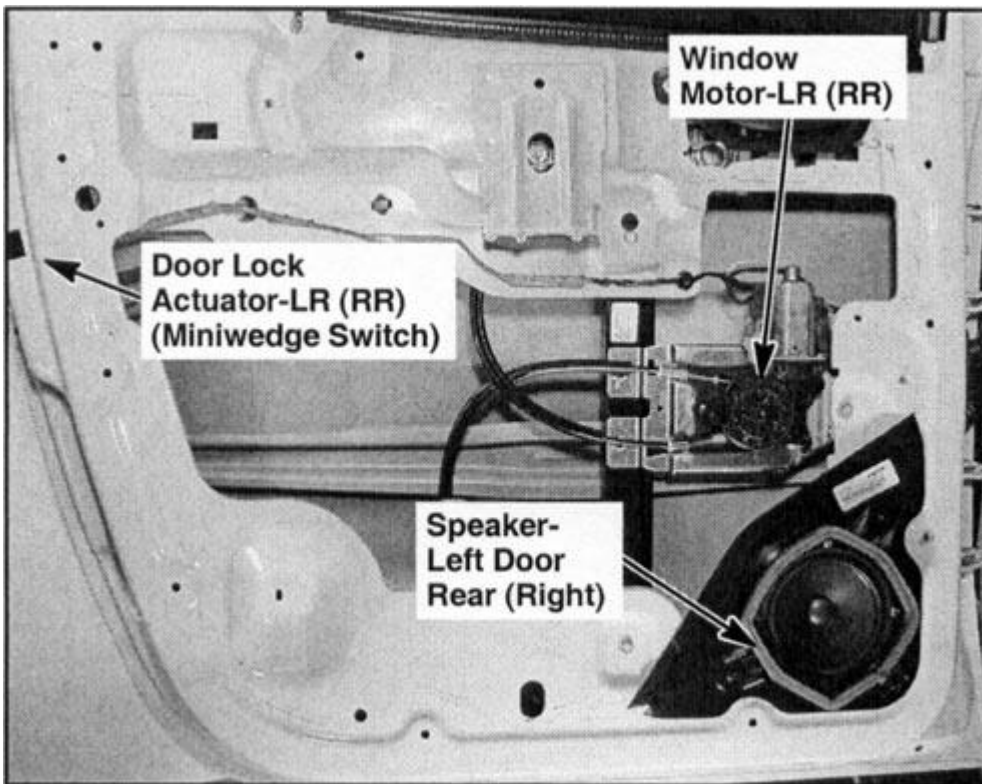
**Fig. 84: Left Rear Door (Right Similar)**  
Courtesy of ISUZU MOTOR CO.

| Window Motor (Left Rear) | In left rear door. See <b>Fig. 84</b> . |
| Window Motor (Right Rear) | In right rear door. See <b>Fig. 84</b> . |

| Component | Location |
|---|---|
| Door Lock Actuator (Left Rear) | In left rear door. See <b>Fig. 84</b> . |

| Door Lock Actuator (Right Rear) | In right rear door. See <a href="#">Fig. 84</a> . |

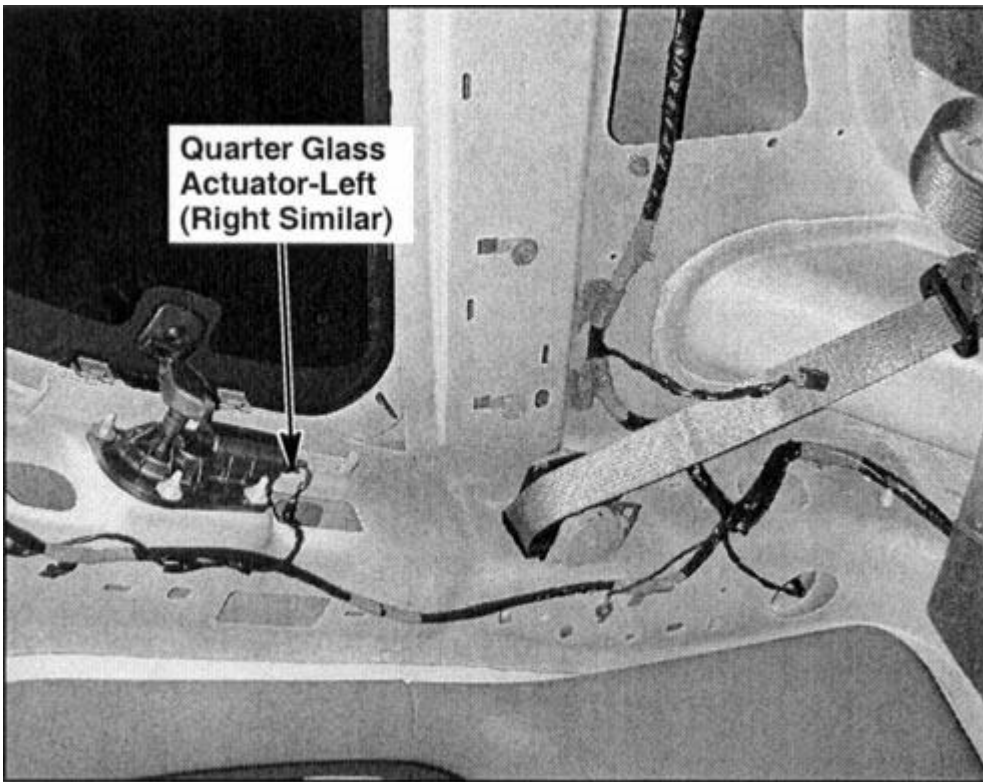
**Fig. 91: Left Quarter Panel**  
Courtesy of ISUZU MOTOR CO.

| G306 | On body panel, left of rear door. See <a href="#">Fig. 91</a> . |
| G401 | On lower left "D" pillar. See <a href="#">Fig. 91</a> . |

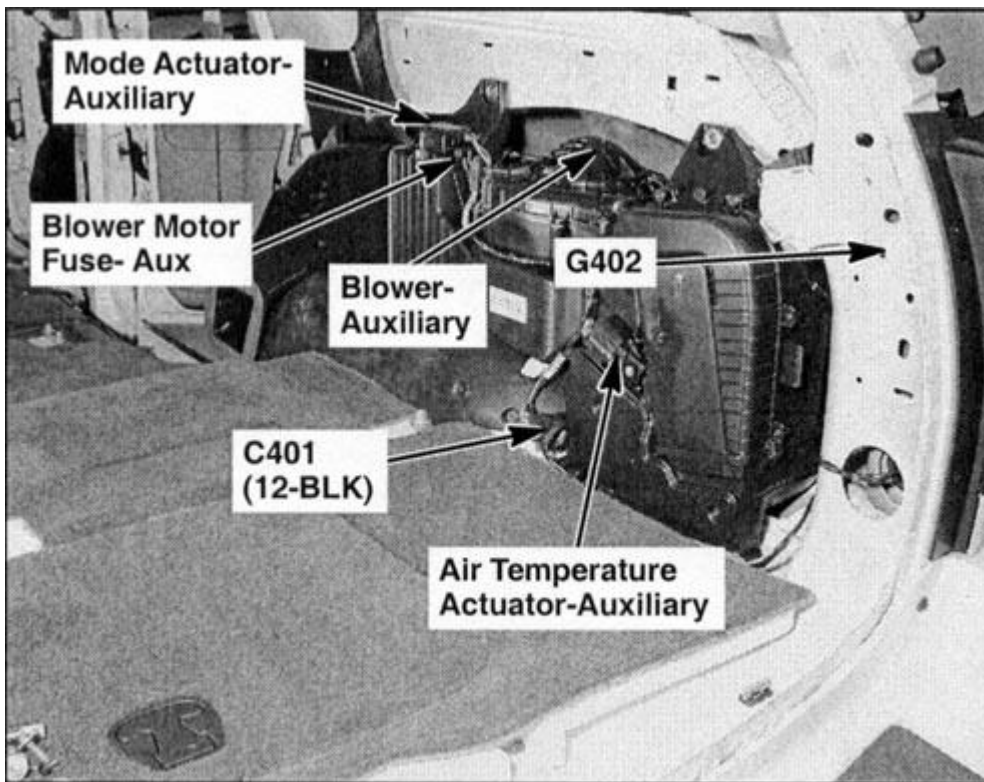
**Fig. 93: Right Quarter Panel**  
Courtesy of ISUZU MOTOR CO.

| Component | Location |
|---|---|
| Blower Motor Fuse (Auxiliary) | At right quarter panel. See <a href="#">Fig. 93</a> . |

| Component | Location |
|---|---|
| Air Temperature Actuator (Auxiliary) | On rear HVAC module, behind right rear interior body panel. See <b>Fig. 93</b> . |
| Blower Motor (Auxiliary) | Behind interior right rear trim panel. See <b>Fig. 93</b> . |
| Mode Actuator (Auxiliary) | At right quarter panel. See <b>Fig. 93</b> . |

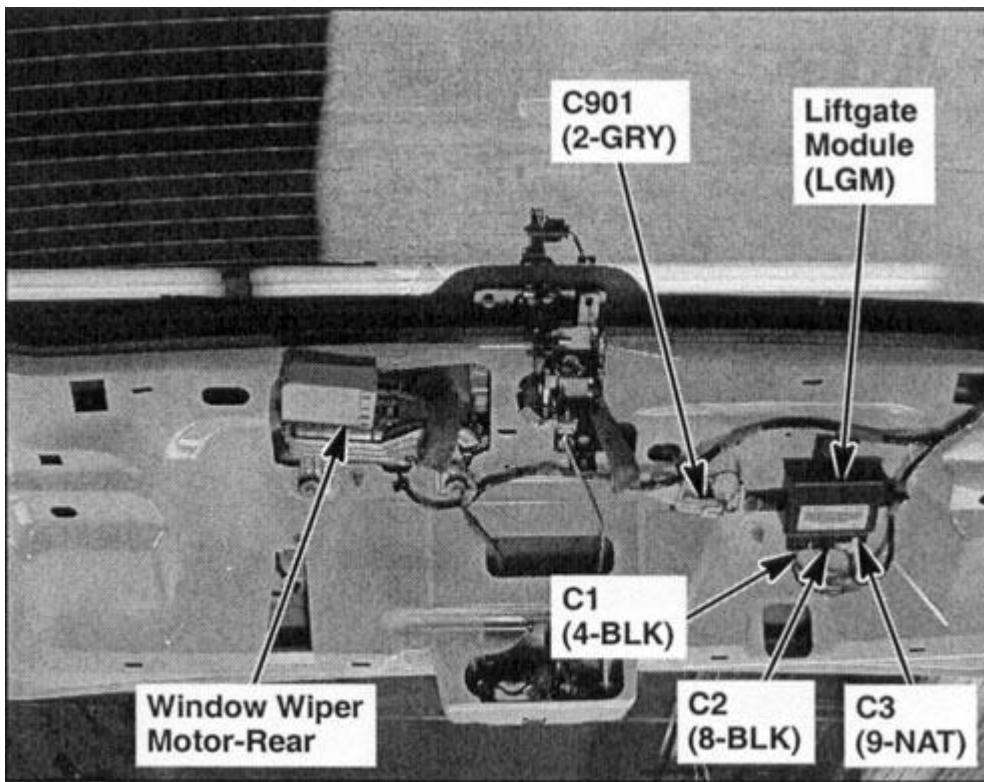
**Fig. 94: On Liftgate (Panel Removed)**  
Courtesy of ISUZU MOTOR CO.

| Liftgate Module | Inside liftgate. See <b>Fig. 94</b> . |

| Window Wiper Motor (Rear) | Inside liftgate. See <b>Fig. 94</b> . |

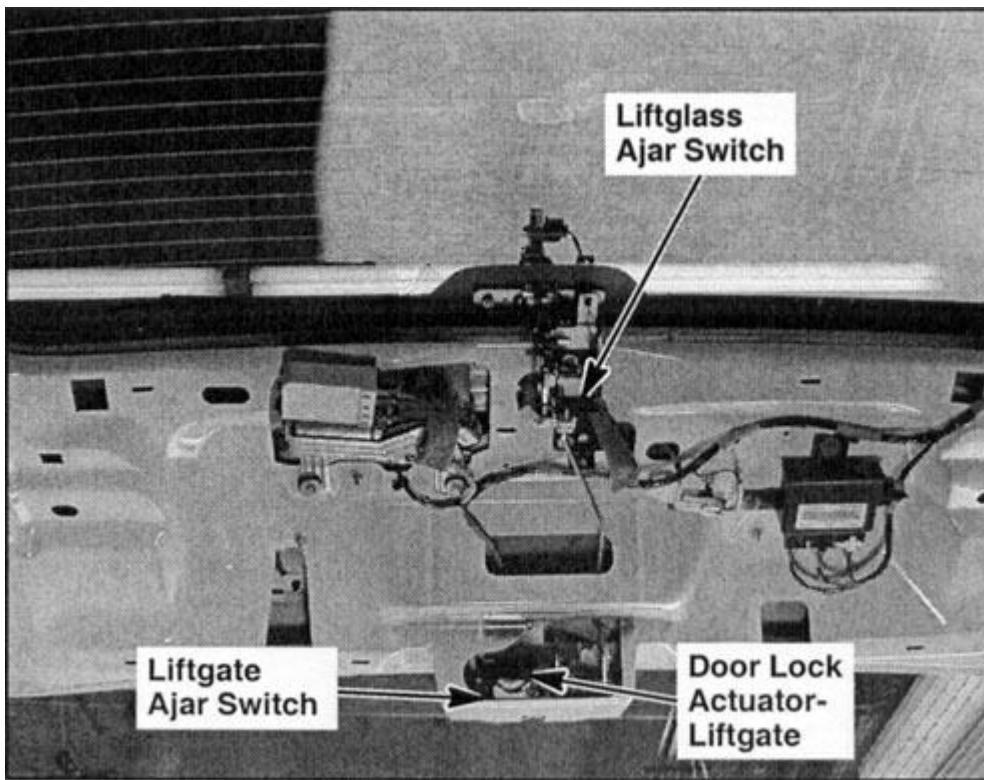
**Fig. 95: On Liftgate (Panel Removed)**  
Courtesy of ISUZU MOTOR CO.

| Door Lock Actuator (Liftgate) | In liftgate. See <a href="#">Fig. 95</a> . |

| Component | Location |
|---|---|
| Liftgate Ajar Switch | On liftgate. See <a href="#">Fig. 95</a> . |
| Liftglass Ajar Switch | Inside top of liftgate. See <a href="#">Fig. 95</a> . |
