## 2004 Isuzu Ascender LS

## BUZZERS, RELAYS & TIMERS

## COMPONENT LOCATION GRAPHICS

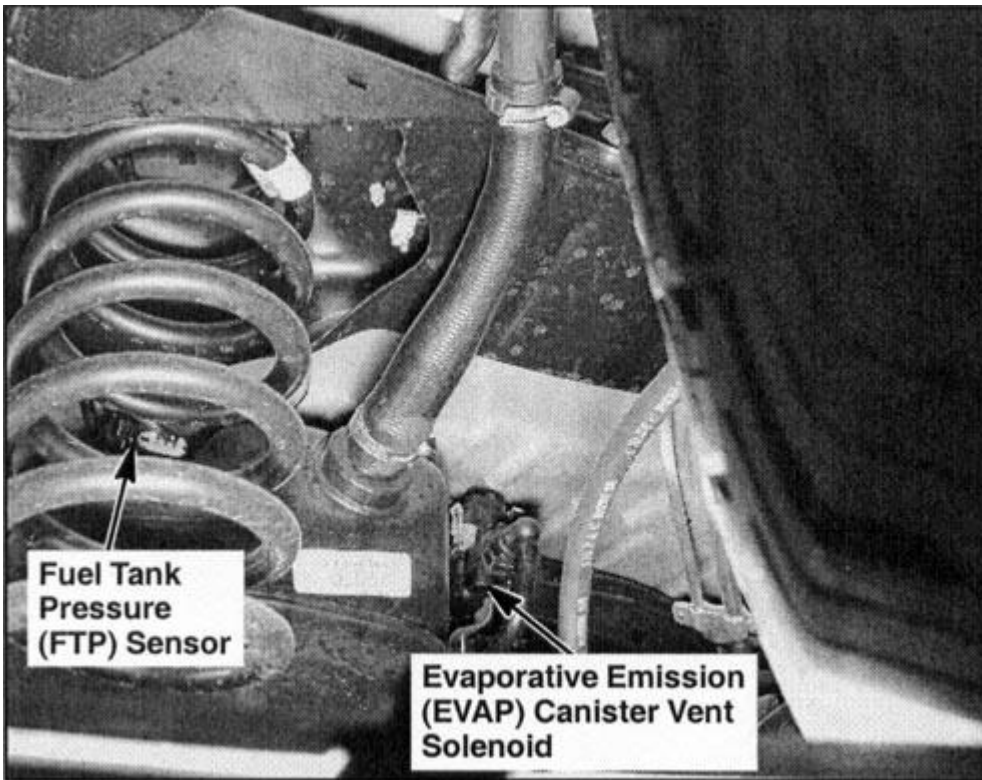
**Fig. 96: Rear Of Fuel Tank**  
Courtesy of ISUZU MOTOR CO.

| Component | Location |
|---|---|
| Fuel Tank Pressure Sensor | At top left rear of fuel tank. See <b>Fig. 96</b> . |

| Evaporative Emission Canister Vent Solenoid | Rear of fuel tank. See <a href="#">Fig. 96</a> . |

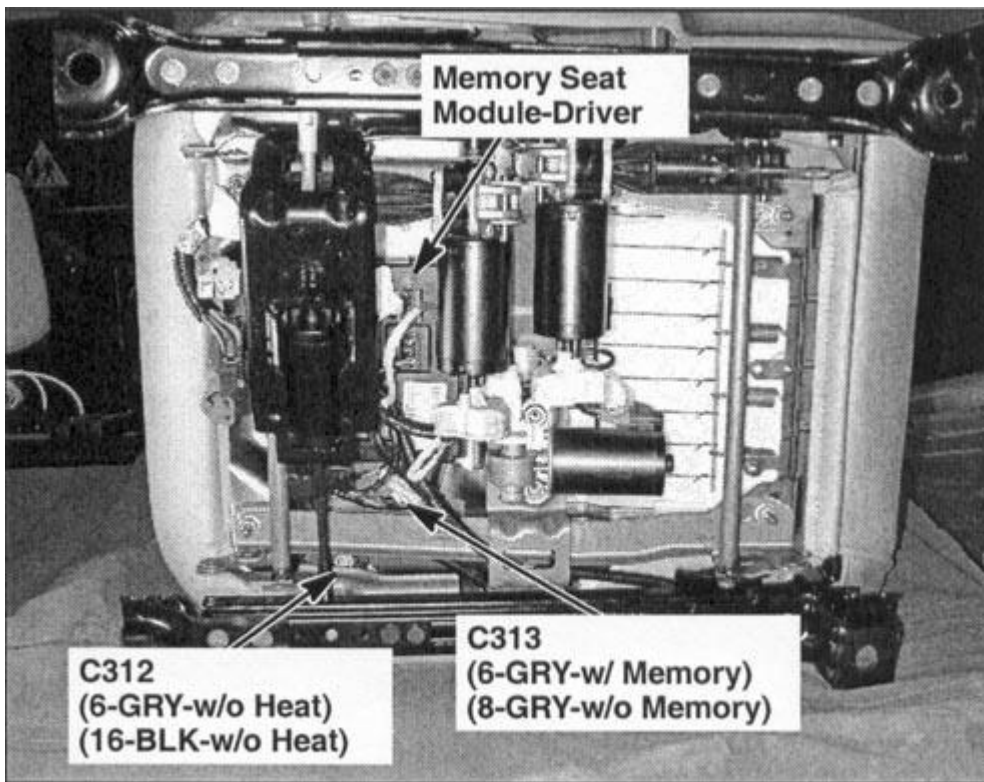
**Fig. 99: Under Driver's Seat**  
Courtesy of ISUZU MOTOR CO.

| Memory Seat Module (Driver's) | Under driver's seat. See <b>Fig. 99</b> . |

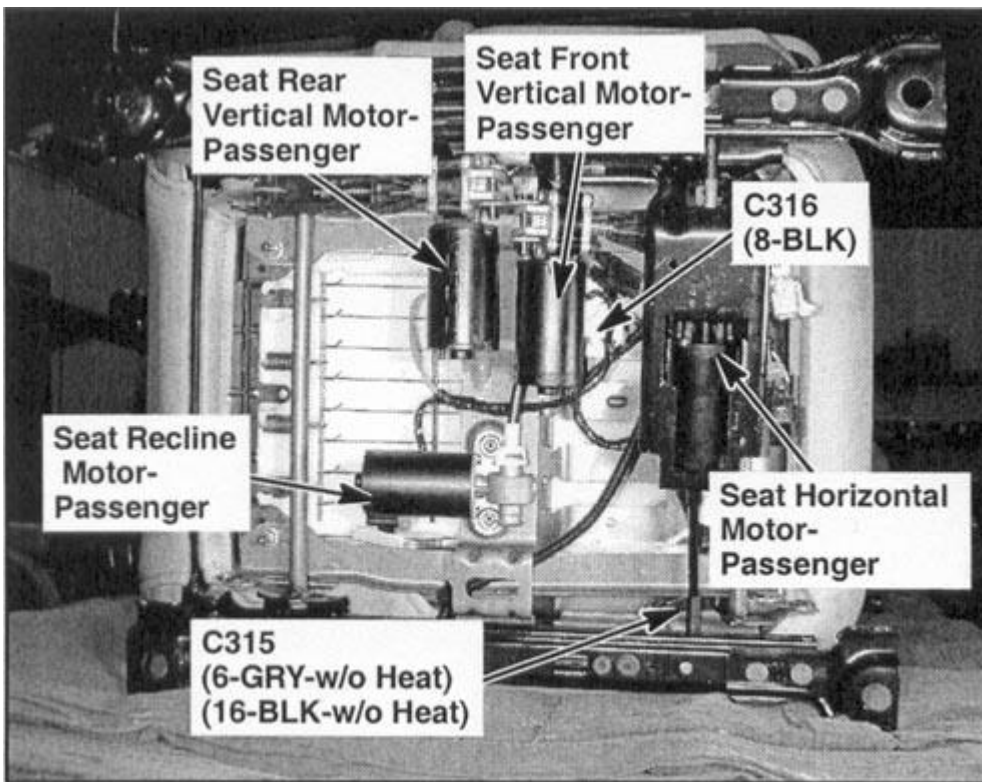
**Fig. 101: Under Front Passenger's Seat**  
Courtesy of ISUZU MOTOR CO.

| Component | Location |
|---|---|
| Seat Front Vertical Motor (Passenger's) | Under passenger's seat. See <b>Fig. 101</b> . |
| Seat Horizontal Motor (Passenger's) | Under passenger's seat. See <b>Fig. 101</b> . |

| Seat Rear Vertical Motor (Passenger's) | Under passenger's seat. See <b>Fig. 101</b> . |
| Seat Recline Motor (Passenger's) | Under passenger's seat. See <b>Fig. 101</b> . |

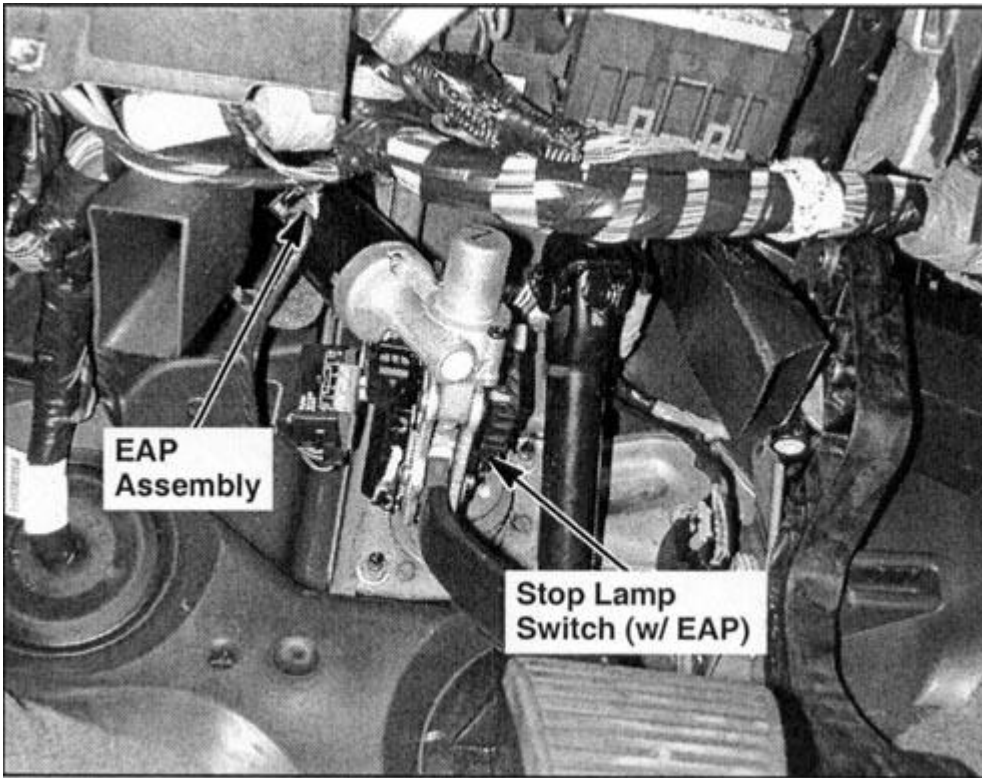
**Fig. 104: Below Left Side Of I/P**  
Courtesy of ISUZU MOTOR CO.

| Component | Location |
|---|---|
| EAP Relay (Inside) | Under left side of dash. See <a href="#">Fig. 104</a> . |

| C225 (Black, 10 Pin) | Under left side of I/P. See <a href="#">Fig. 104</a> . |
| C316 (Black, 8 Pin) | Under left side of I/P. See <a href="#">Fig. 104</a> . |

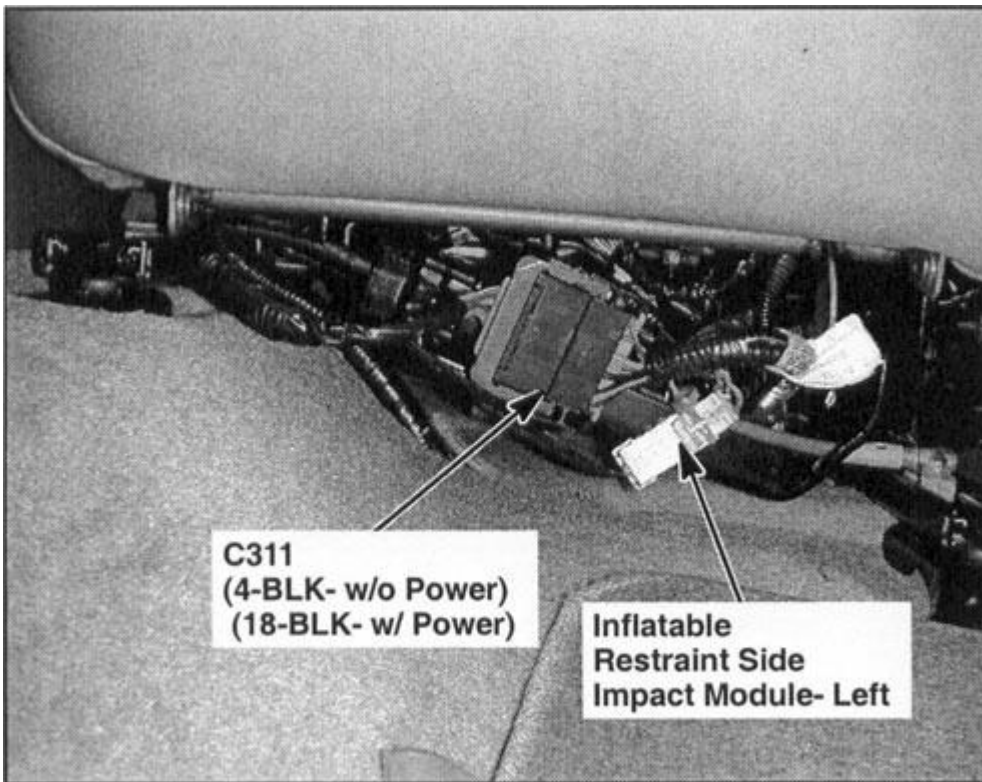
**Fig. 106: Under Front Of Driver's Seat**  
Courtesy of ISUZU MOTOR CO.
