2004 Isuzu Ascender LS

2004 ENGINE Engine Mechanical - 4.8L, 5.3L, and 6.0L - Ascender

Engine Mechanical - 4.8L, 5.3L, and 6.0L - Ascender

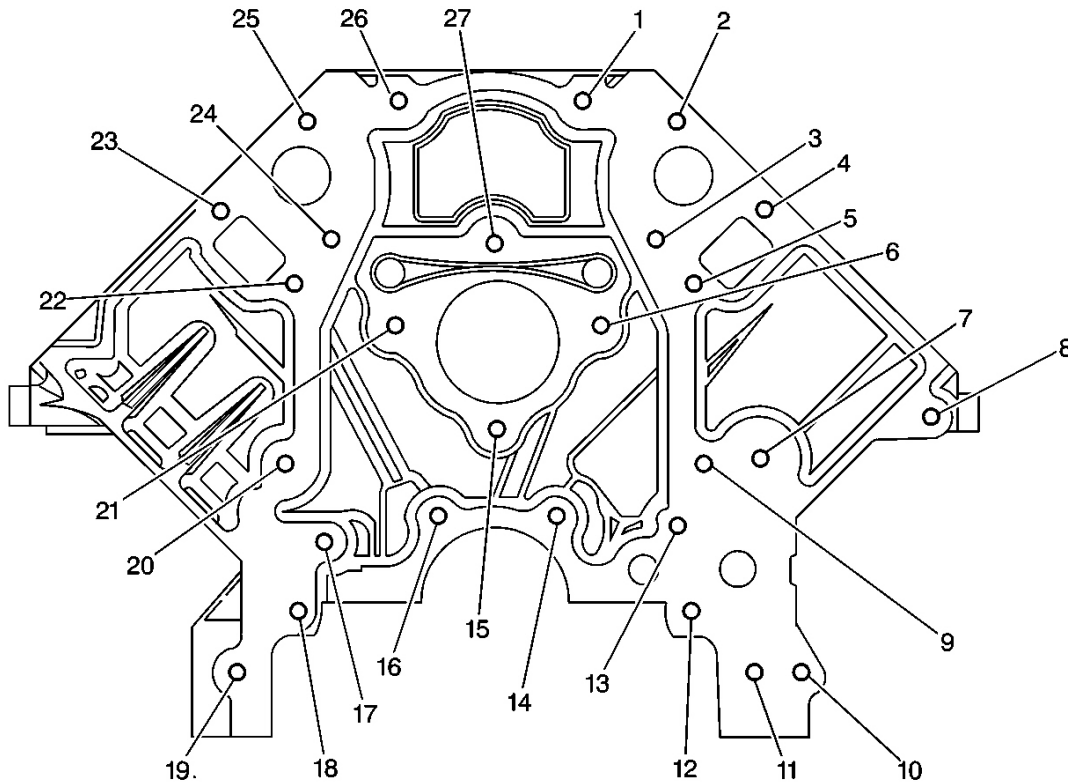
Fig. 1: Engine Block Bolt Holes - Front View
Courtesy of GENERAL MOTORS CORP.

Engine Block - Front View

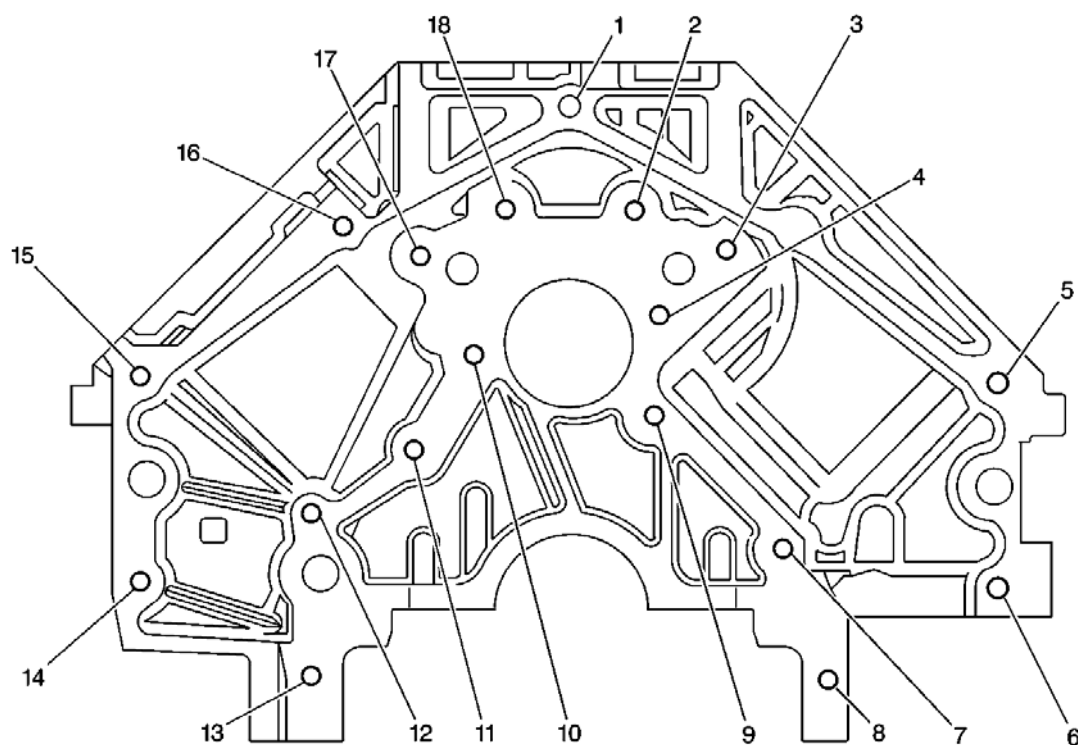
Fig. 2: Engine Block Bolt Holes - Rear View
Courtesy of GENERAL MOTORS CORP.

Engine Block - Rear View

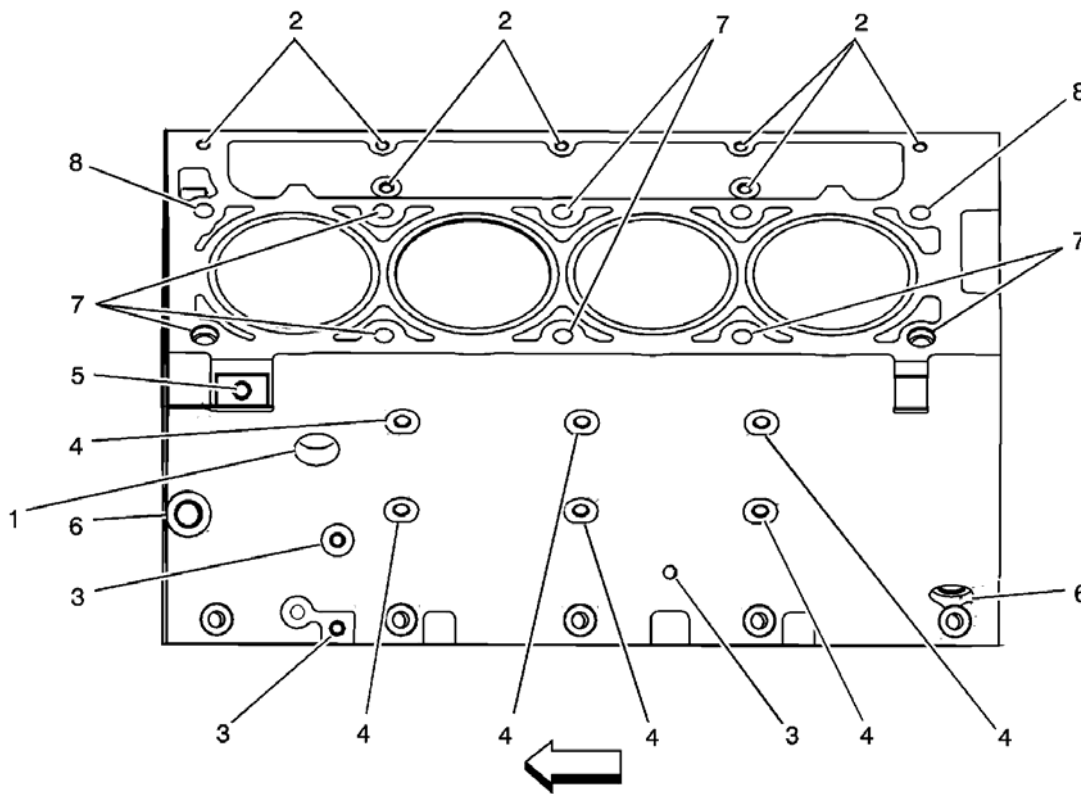
Fig. 3: Engine Block Bolt Holes - Left Side View
 Courtesy of GENERAL MOTORS CORP.

Engine Block - Left Side View

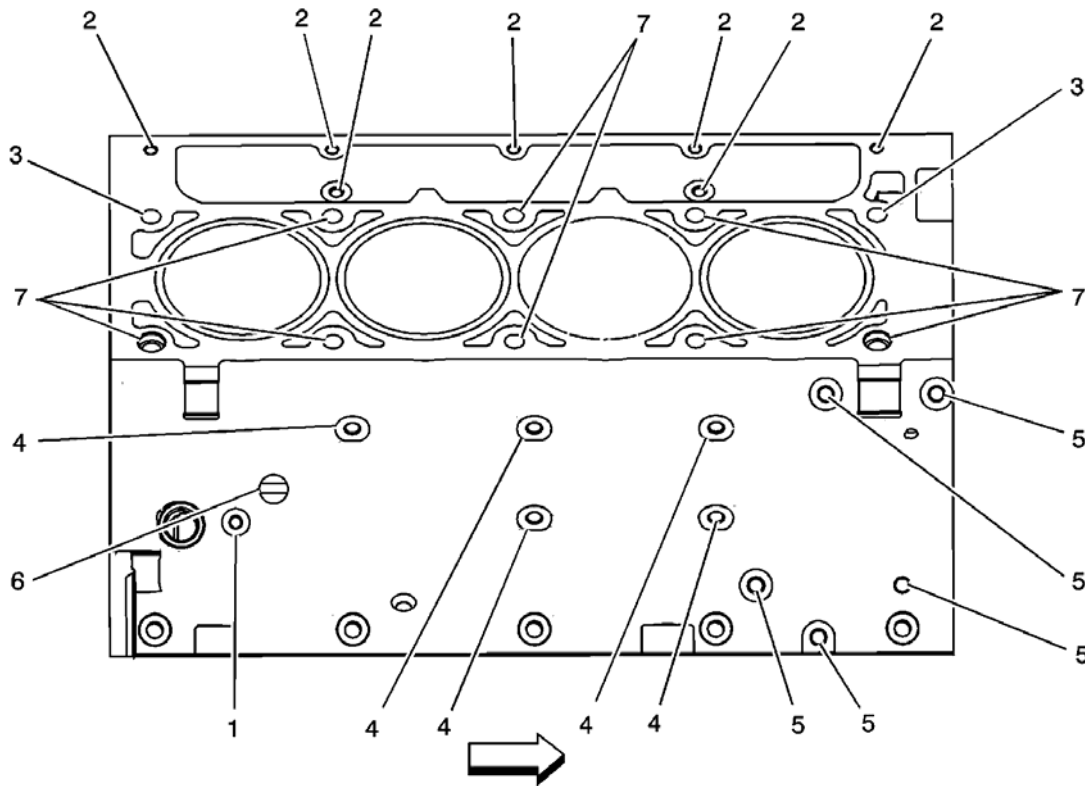
Fig. 4: Engine Block Bolt Holes - Right Side View
Courtesy of GENERAL MOTORS CORP.

Engine Block - Right Side View

7	2.0 First Design	108	105	N/A	106	107	124.0 (4.88)	115.0 (4.52)
7	M11 x 2.0 Second Design	108	105	N/A	106	107	69.0 (2.72)	60.0 (2.36)
<ul style="list-style-type: none"> Bolt holes 7, second design, and 3 have a 30 mm (1.18 in) counterbore included in the 69.0 mm (2.72 in) drill depth. Use sleeve J 42385-315 with the drill and tap. Bolt holes 7, first design, have a 85 mm (3.34 in) counterbore included in the 124.0 mm (4.88 in) drill depth.

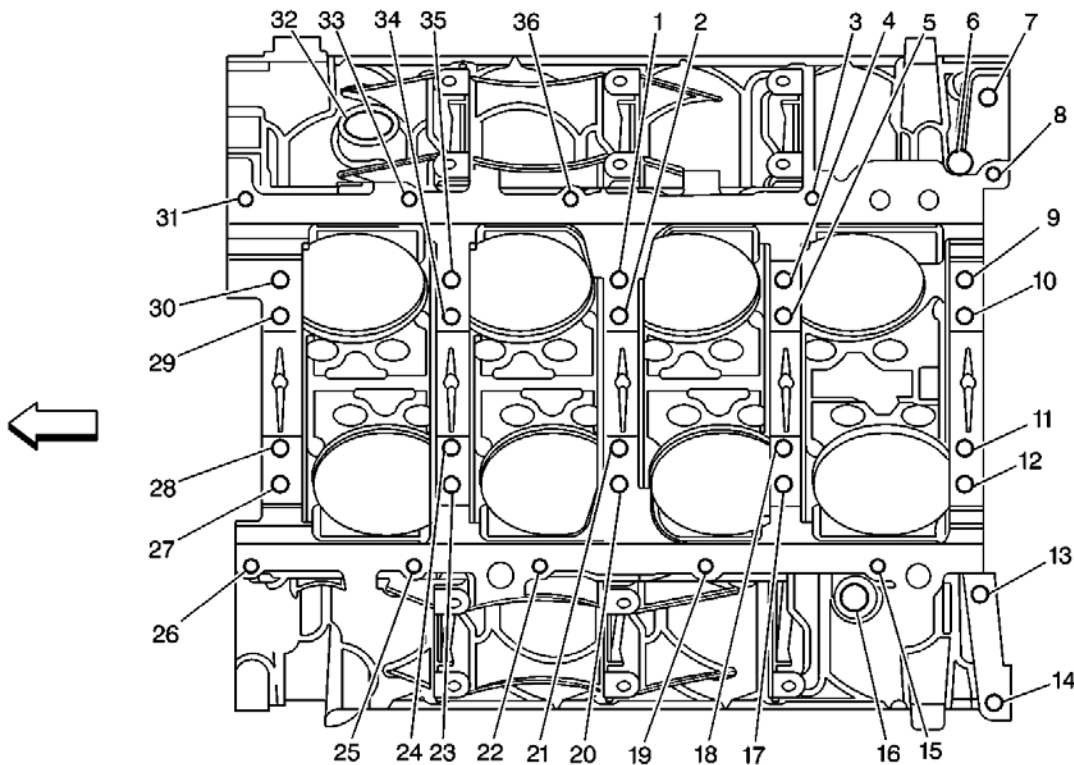
Fig. 5: Engine Block Bolt Holes - Bottom View
Courtesy of GENERAL MOTORS CORP.

Engine Block - Bottom View

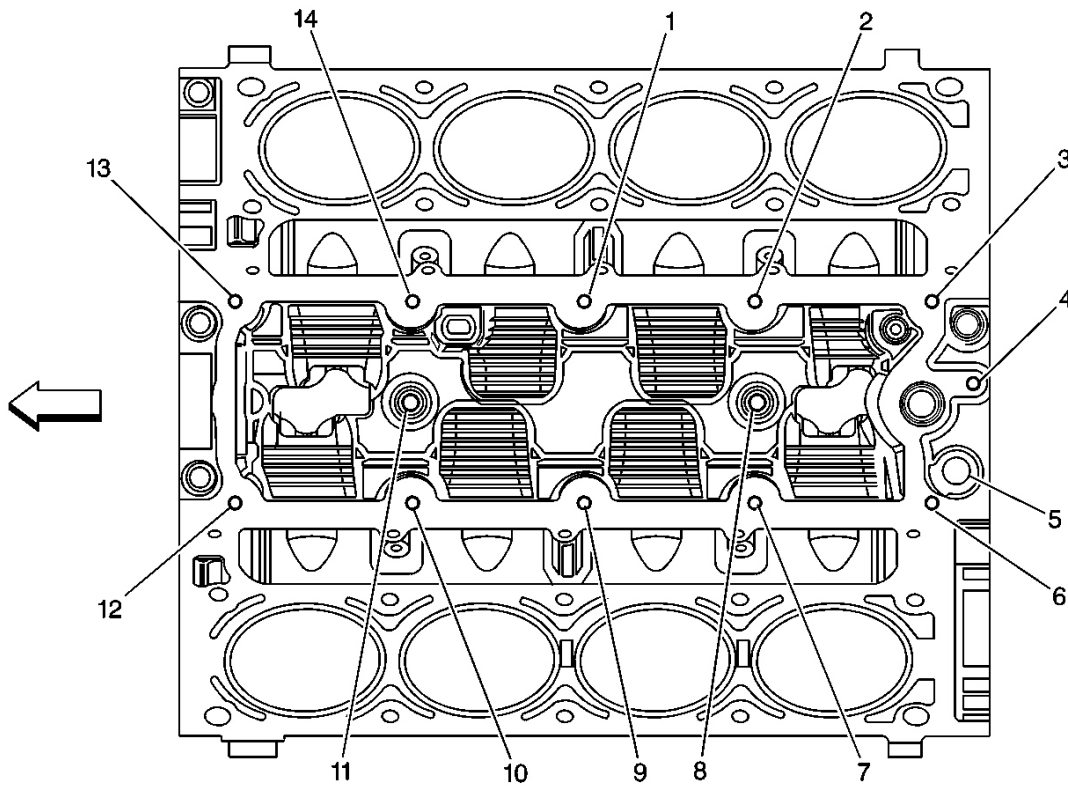
Fig. 6: Engine Block Bolt Holes - Top View
Courtesy of GENERAL MOTORS CORP.

Engine Block - Top View

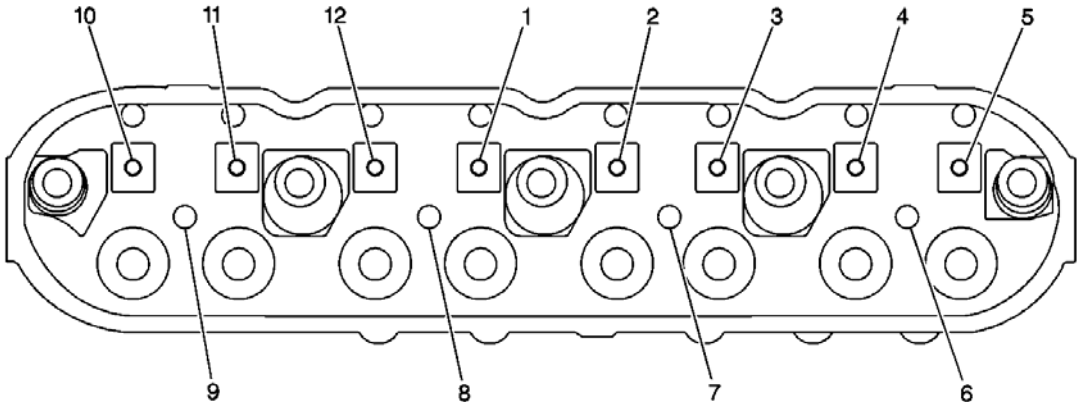
Fig. 7: Cylinder Head Bolt Holes - Top View
 Courtesy of GENERAL MOTORS CORP.

Cylinder Head - Top View

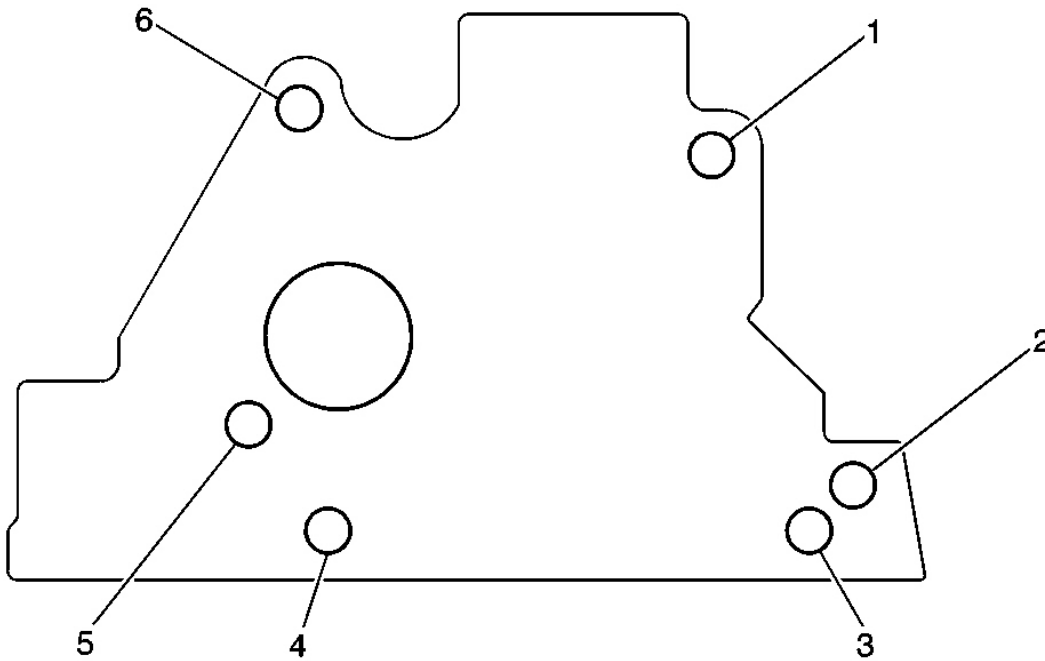
Fig. 8: Cylinder Head Bolt Holes - End View
Courtesy of GENERAL MOTORS CORP.

Cylinder Head - End View

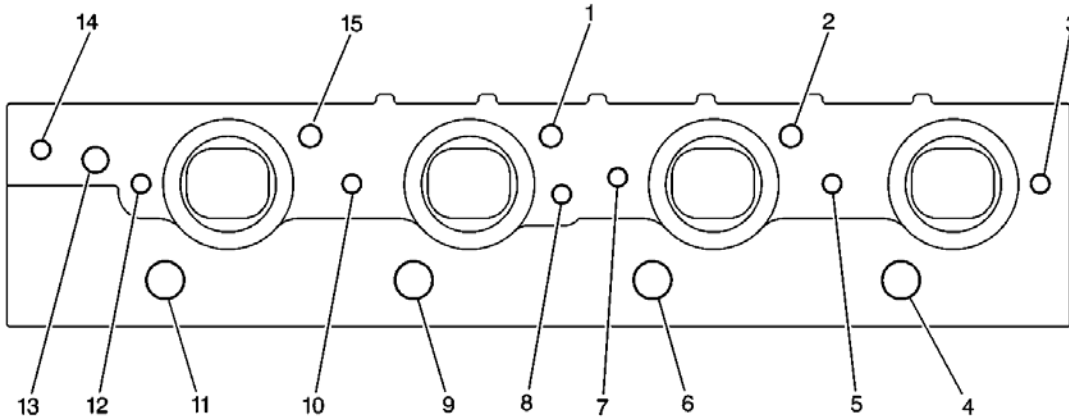
Fig. 9: Cylinder Head Bolt Holes - Exhaust Manifold Deck View
Courtesy of GENERAL MOTORS CORP.

Cylinder Head - Exhaust Manifold Deck View

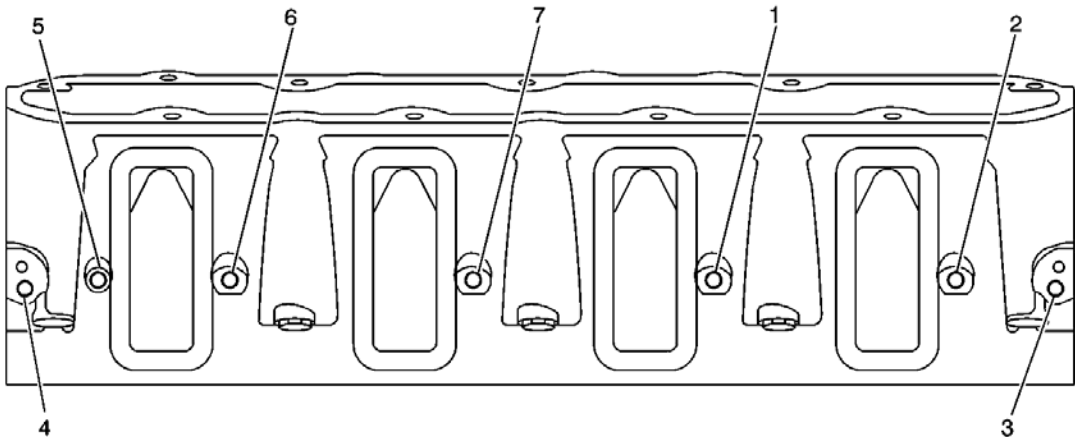
Fig. 10: Cylinder Head Bolt Holes - Intake Manifold Deck View
 Courtesy of GENERAL MOTORS CORP.

Cylinder Head - Intake Manifold Deck View

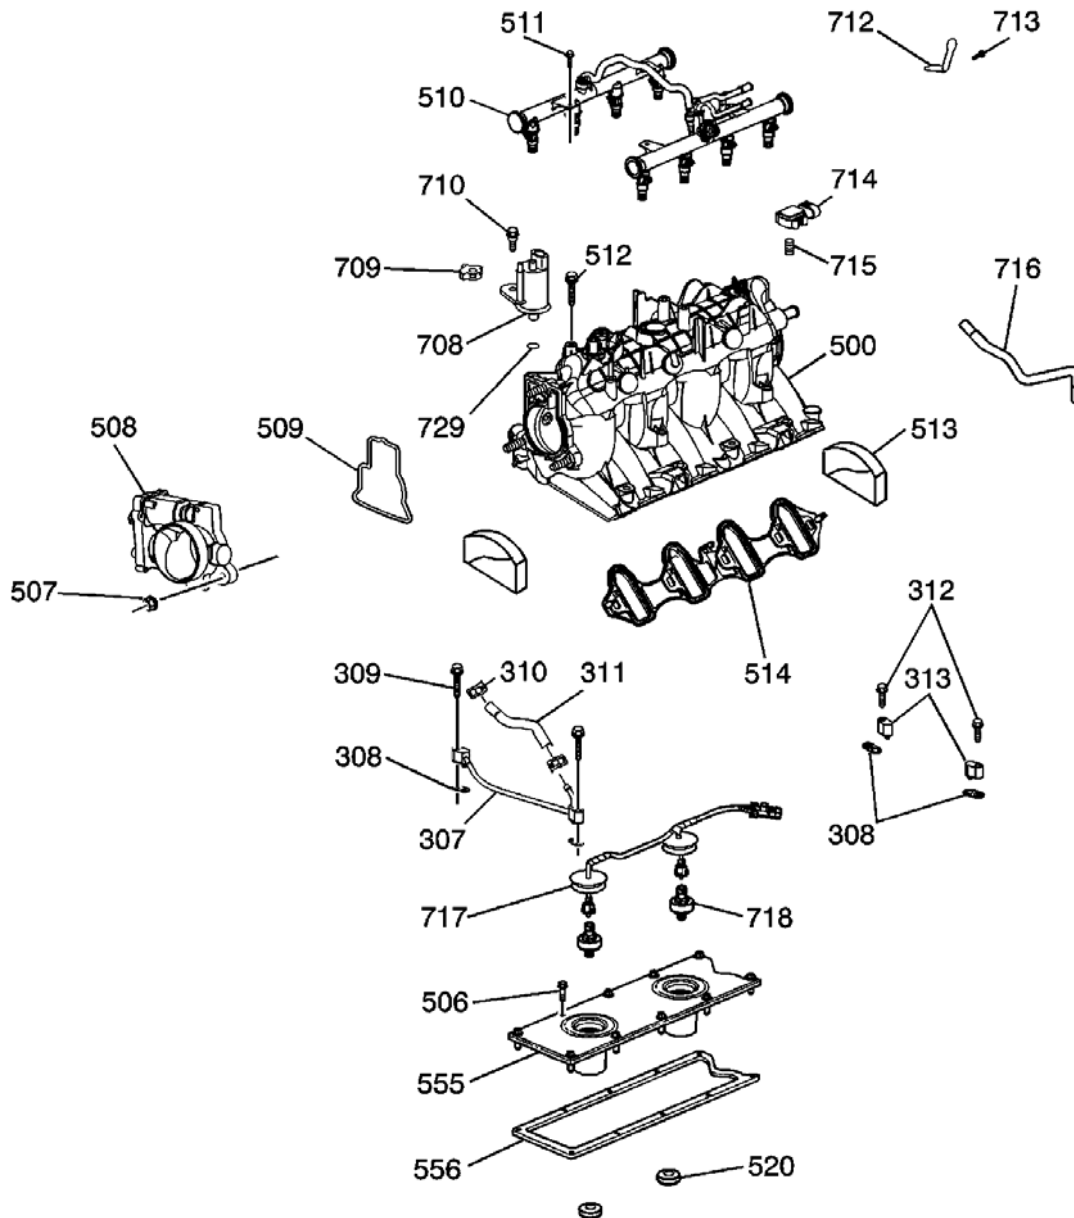
Fig. 11: Intake Manifold/Upper Engine
Courtesy of GENERAL MOTORS CORP.

Callouts For Fig. 11

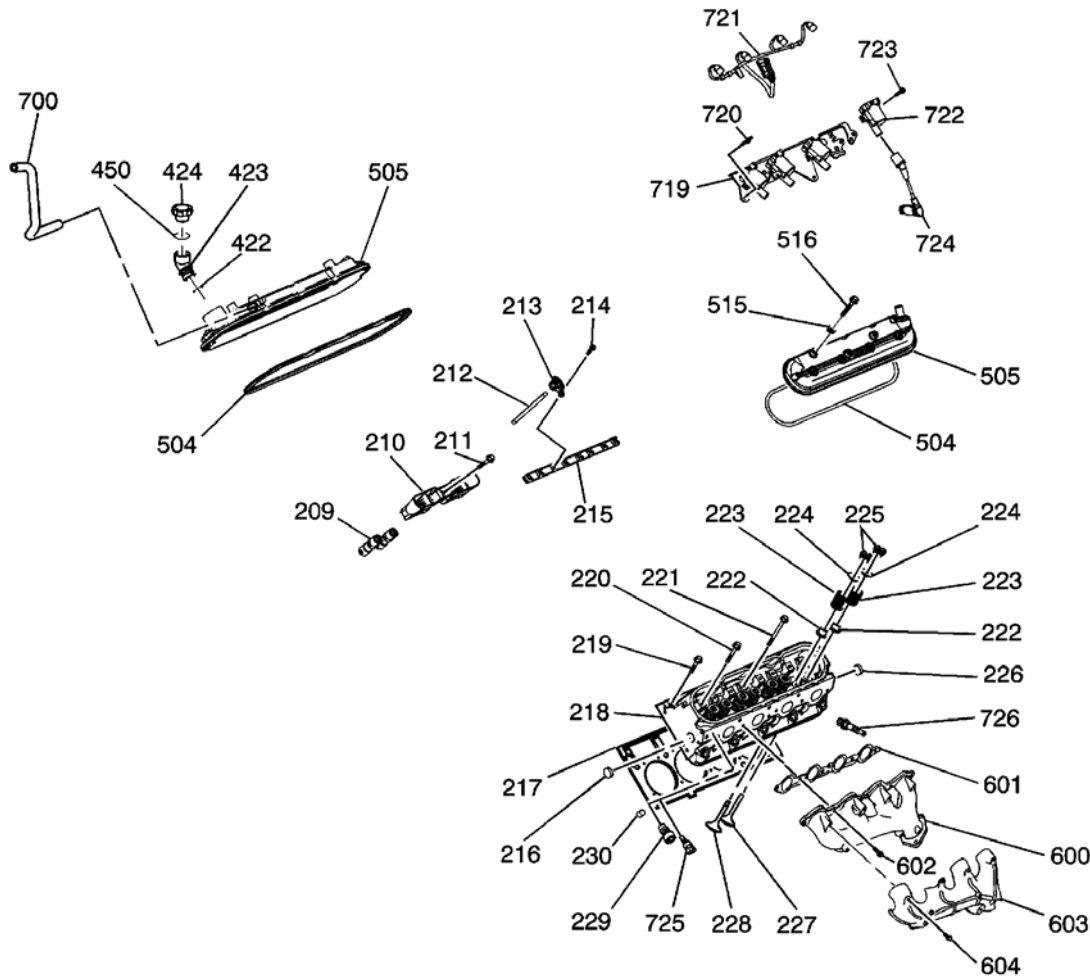
Fig. 12: Cylinder Head/Upper Engine
Courtesy of GENERAL MOTORS CORP.

Callouts For Fig. 12

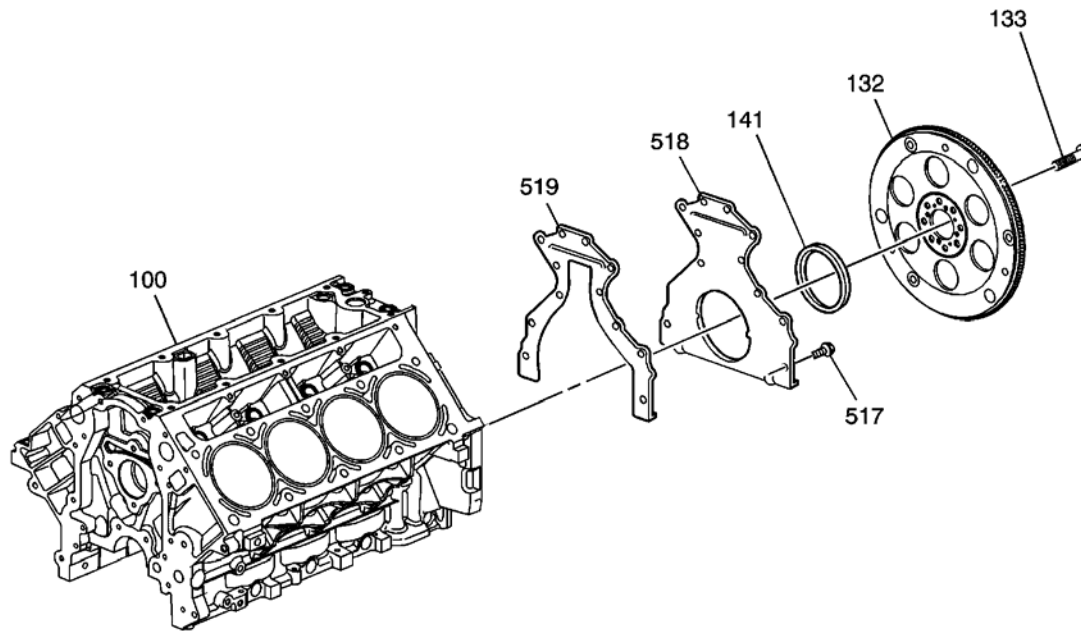
Fig. 14: Rear of Engine

Callouts For Fig. 14

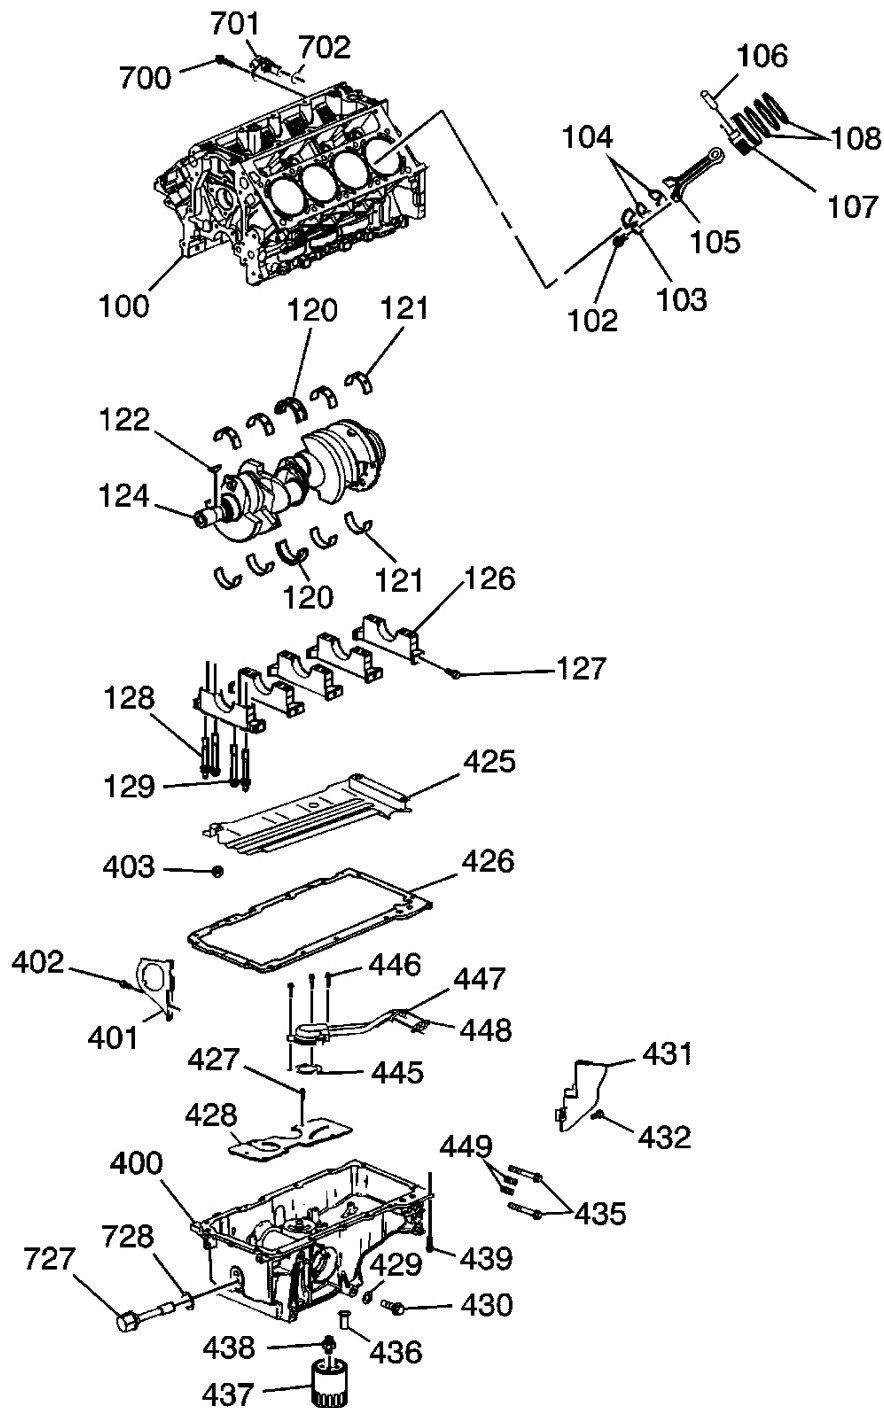
Fig. 15: Lower Engine Assembly
Courtesy of GENERAL MOTORS CORP.

Callouts For Fig. 15

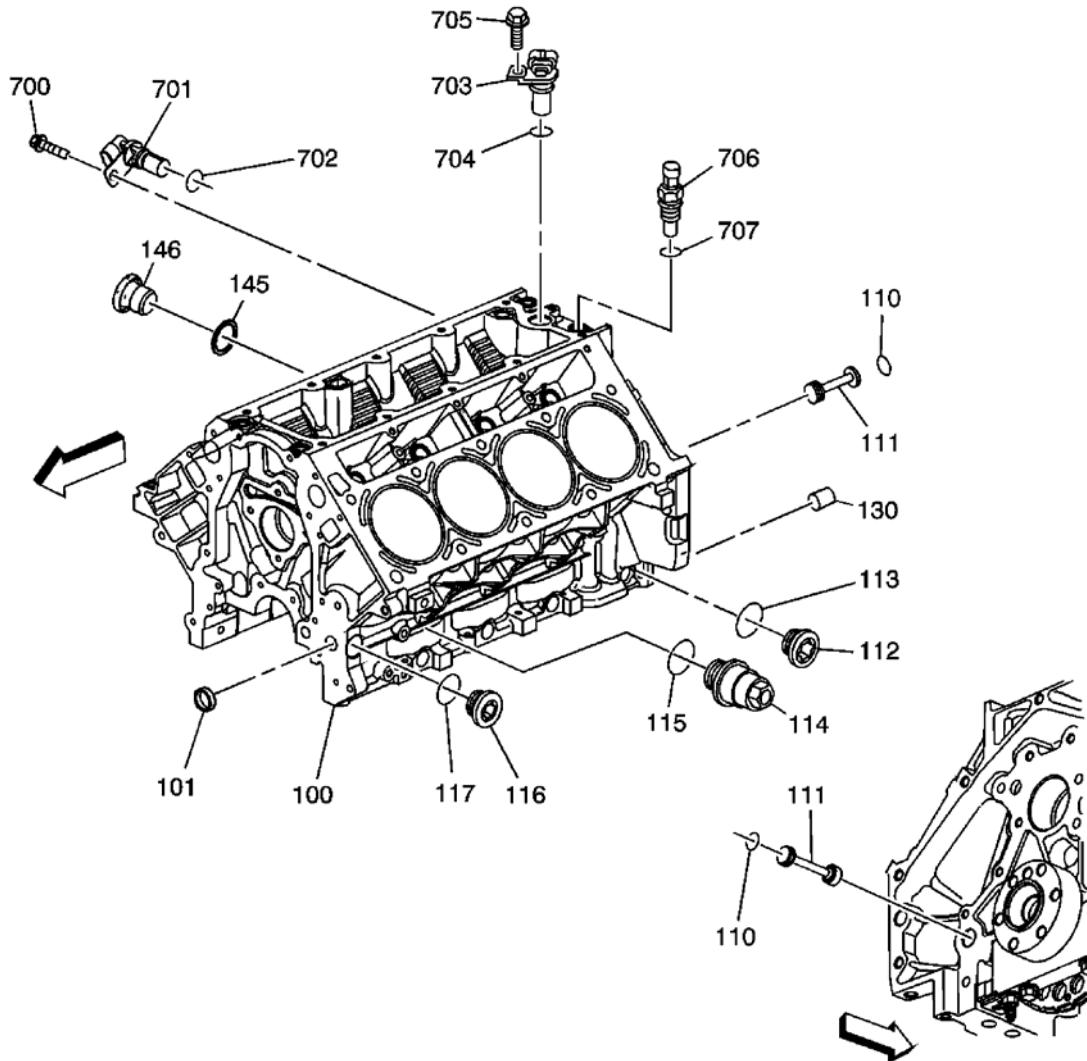
Fig. 16: Engine Block Plugs/Sensors
Courtesy of GENERAL MOTORS CORP.

Callouts For Fig. 16

110	Engine Block Rear Oil Gallery Plug O-Ring
110	Engine Block Rear Oil Gallery Plug O-Ring
111	Engine Block Rear Oil Gallery Plug
111	Engine Block Rear Oil Gallery Plug
112	Oil Gallery Plug
113	Oil Gallery Plug Washer
114	Coolant Heater
115	Coolant Heater Washer
116	Oil Gallery Plug
117	Oil Gallery Plug Washer
130	Transmission Housing Locating Pin
145	Coolant Drain Plug Washer - Right
146	Coolant Drain Plug - Right
700	Crankshaft Position (CKP) Sensor Bolt
701	CKP Sensor
702	CKP Sensor O-Ring
703	Camshaft Position (CMP) Sensor
704	CMP Sensor O-Ring
705	CMP Sensor Bolt
706	Oil Pressure Sensor
707	Oil Pressure Sensor Washer

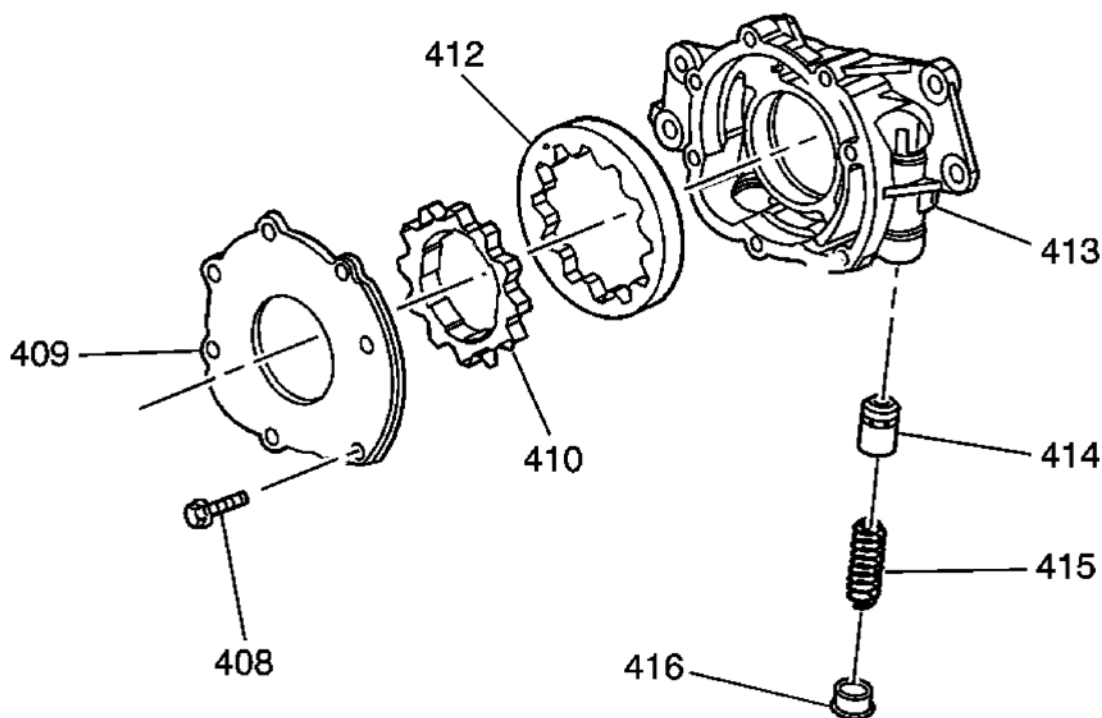
Fig. 17: Exploded View Of Oil Pump Assembly
Courtesy of GENERAL MOTORS CORP.

Callouts For Fig. 17

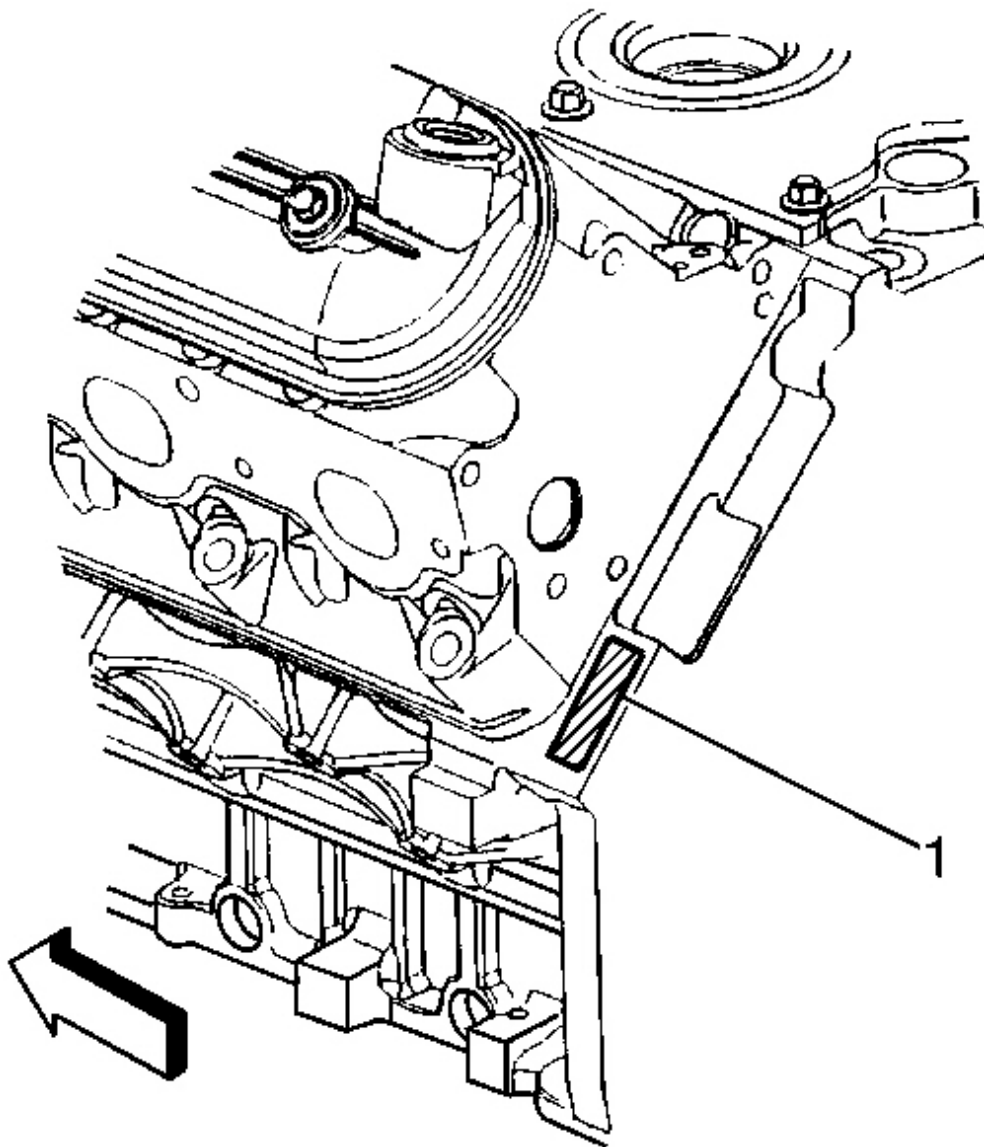
Fig. 18: Engine Identification Location
Courtesy of GENERAL MOTORS CORP.

The vehicle identification number (VIN) is located on the left side rear of the engine block (1) and is typically a nine digit number stamped or laser-etched onto the engine at the vehicle assembly plant.

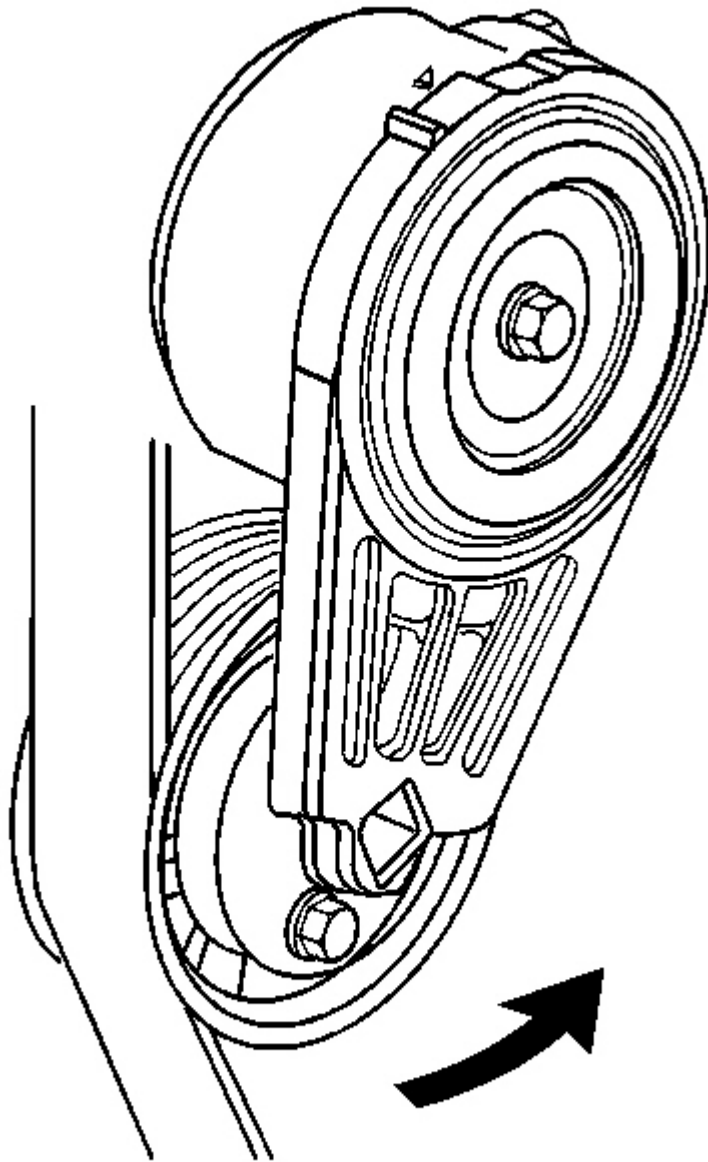
Fig. 20: Releasing Drive Belt Tension
Courtesy of GENERAL MOTORS CORP.

1. Remove the drive belt. Refer to **Drive Belt Replacement - Accessory** or **Drive Belt Replacement - Air Conditioning**.
2. Move the drive belt tensioner through its full travel.
 - The movement should feel smooth.
 - There should be no binding.
 - The tensioner should return freely.
3. If any binding is observed, replace the drive belt tensioner. Refer to **Drive Belt Tensioner Replacement - Accessory** or **Drive Belt Tensioner Replacement - Air Conditioning**.
4. Install the drive belt. Refer to of **Drive Belt Replacement - Accessory** or **Drive Belt Replacement - Air Conditioning**.

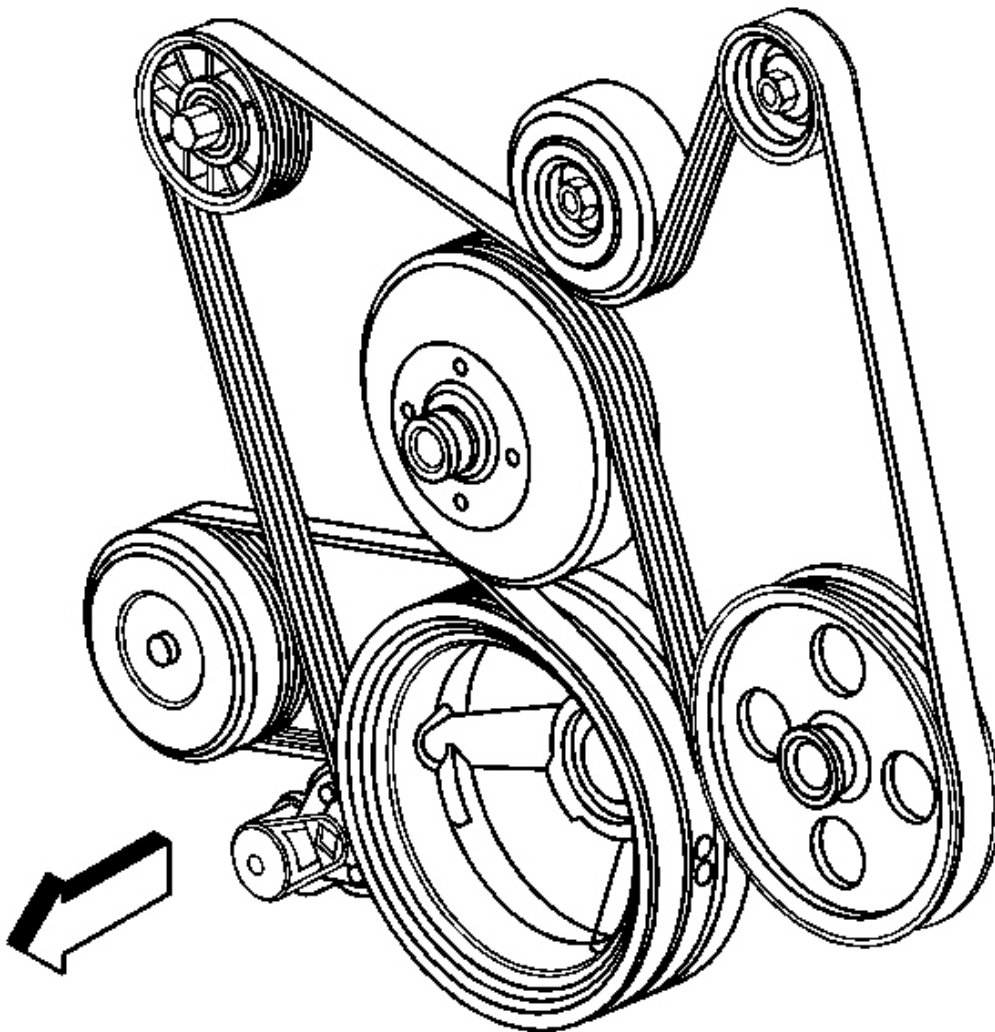
Fig. 21: View Of Accessory Drive Belt & Pulley
Courtesy of GENERAL MOTORS CORP.

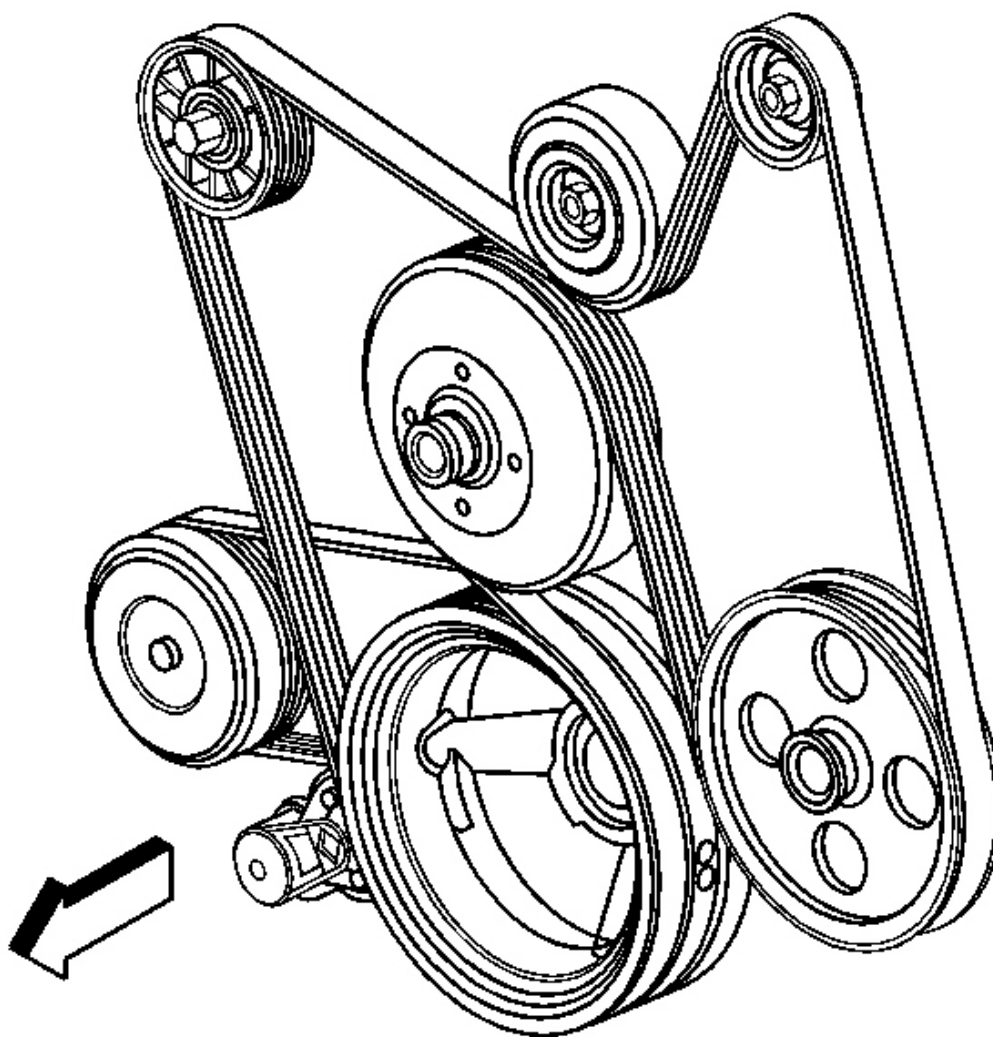
Fig. 22: View Of Accessory Drive Belt & Pulley

1. Route the drive belt around all the pulleys except the generator pulley.
2. Install the breaker bar with hex-head socket to the belt tensioner bolt.
3. Rotate the belt tensioner clockwise in order to relieve the tension on the belt.
4. Install the drive belt on the generator pulley.
5. Slowly release the tension on the belt tensioner.
6. Remove the breaker bar and socket from the belt tensioner bolt.
7. Inspect the drive belt for proper installation and alignment.
8. Install the air cleaner outlet duct. Refer to **Air Cleaner Resonator Outlet Duct Replacement** in Engine Controls.

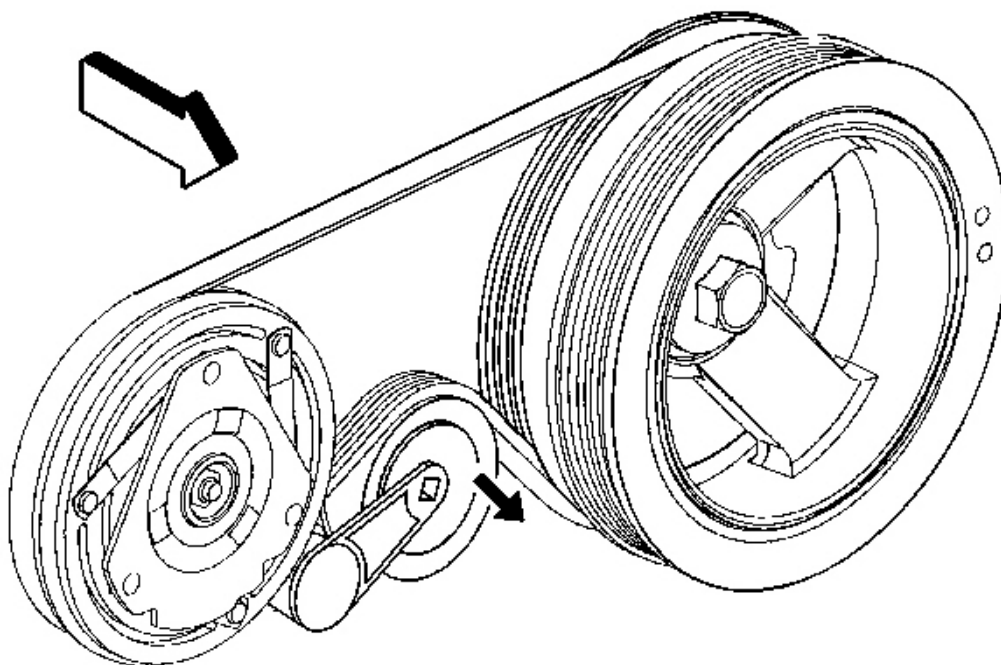
**Fig. 23: A/C Belt Tensioner****Courtesy of GENERAL MOTORS CORP.**

1. Remove the accessory drive belt. Refer to **Drive Belt Replacement - Accessory**.
2. Raise the vehicle. Refer to **Lifting and Jacking the Vehicle** in General Information.
3. Install a ratchet into the square opening of the air conditioning (A/C) belt tensioner.
4. Rotate the A/C belt tensioner clockwise in order to relieve tension on the belt.
5. Remove the A/C belt from the pulleys.
6. Slowly release the tension on the A/C belt tensioner.
7. Remove the ratchet from the A/C belt tensioner.
8. Clean and inspect the belt surfaces of all the pulleys.

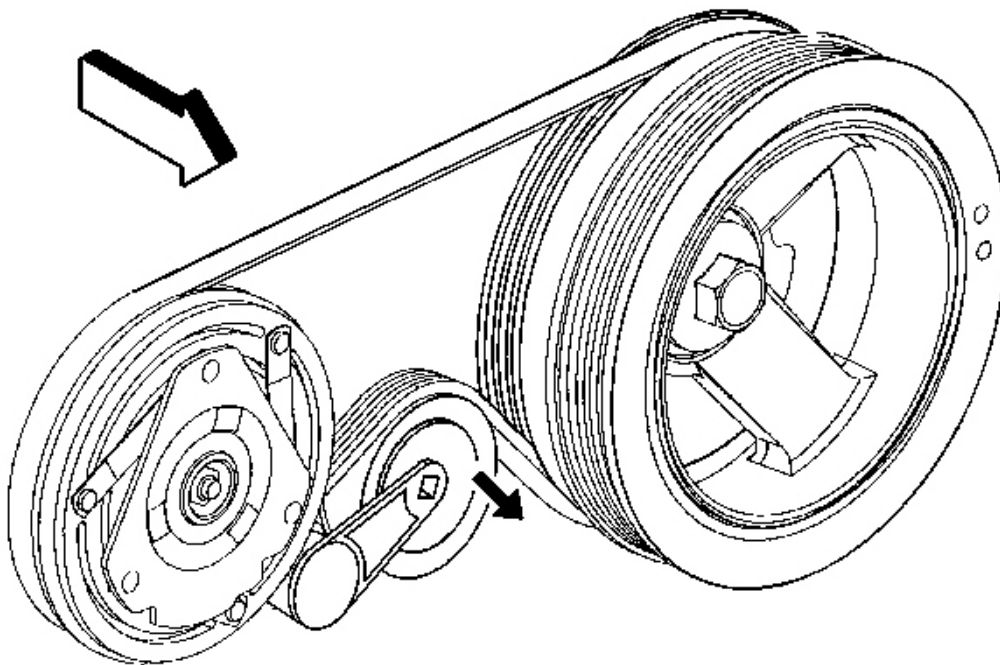
Fig. 24: A/C Belt Tensioner
Courtesy of GENERAL MOTORS CORP.

1. Install the A/C belt around the crankshaft balancer.
2. Install a ratchet into the square opening of the A/C drive belt tensioner.
3. Rotate the A/C belt tensioner clockwise in order to relieve tension on the belt.
4. Install the A/C belt over the idler pulley.

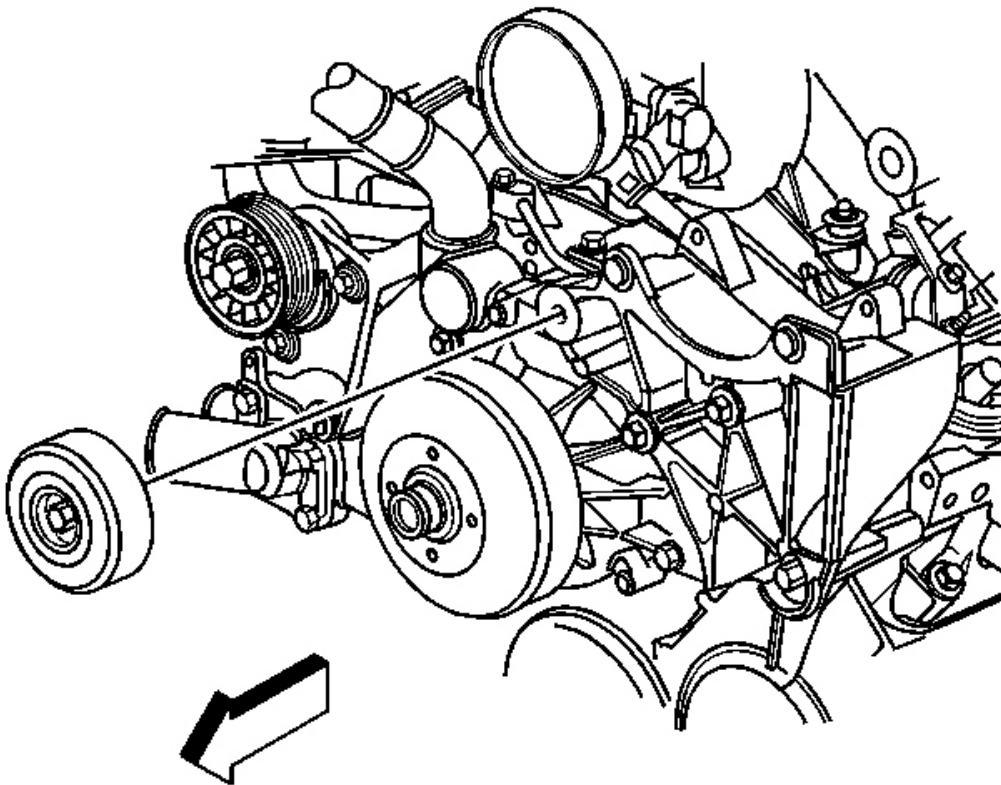
Fig. 25: View Of Accessory Drive Belt Idler Pulley
Courtesy of GENERAL MOTORS CORP.

1. Remove the accessory drive belt. Refer to **Drive Belt Replacement - Accessory**.
2. Remove the drive belt idler pulley and bolt.

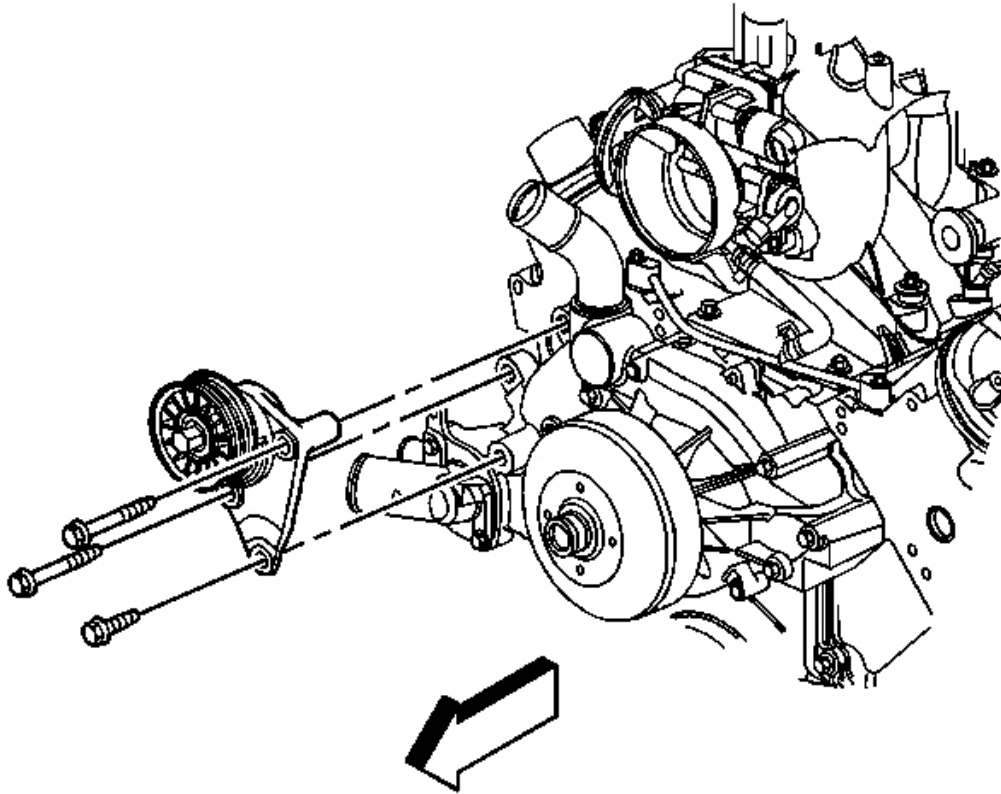
Fig. 27: View Of Drive Belt Tensioner & Bolts
Courtesy of GENERAL MOTORS CORP.

1. Remove the accessory drive belt. Refer to **Drive Belt Replacement - Accessory**.
2. Remove the drive belt tensioner bolts.
3. Remove the drive belt tensioner.

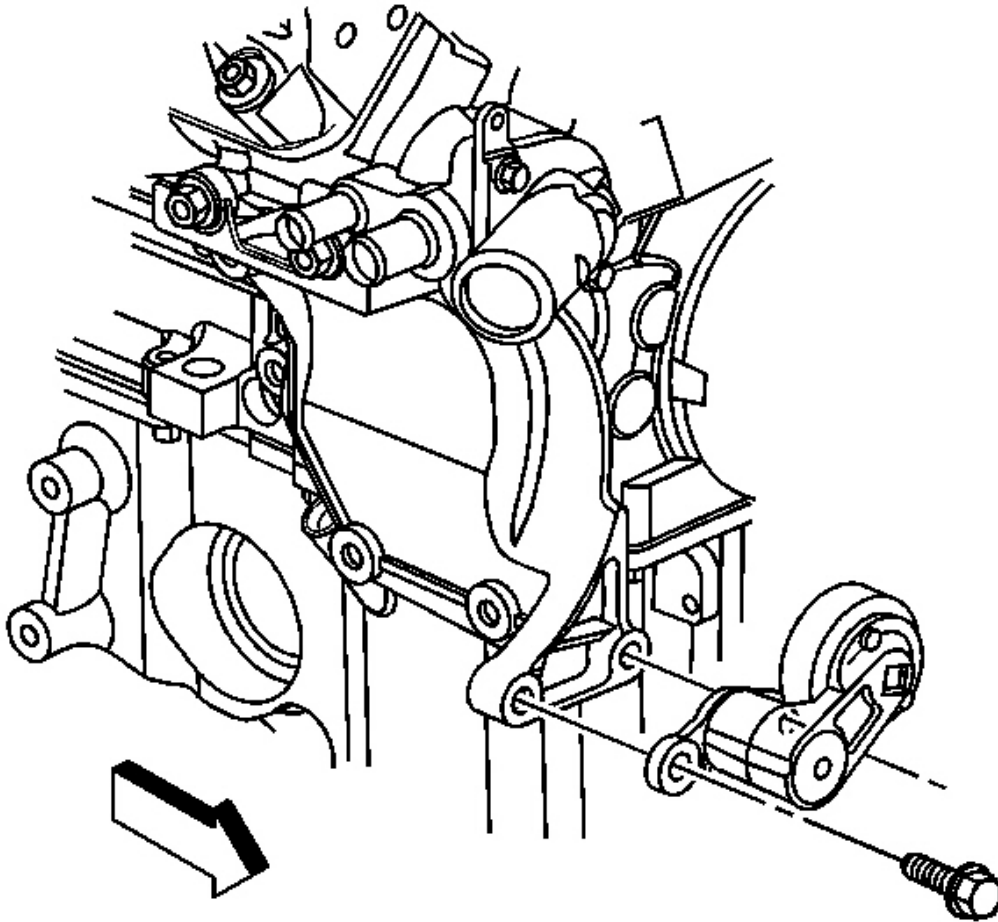
Fig. 29: View Of A/C Drive Belt Tensioner & Bolts
Courtesy of GENERAL MOTORS CORP.

1. Remove the air conditioning (A/C) drive belt. Refer to **Drive Belt Replacement - Air Conditioning**.
2. Raise and suitably support the vehicle. Refer to **Lifting and Jacking the Vehicle** in General Information.
3. Remove the A/C belt tensioner bolts.
4. Remove the A/C belt tensioner.
