2004 Isuzu Ascender LS

2004 ENGINE Engine Mechanical - 4.8L, 5.3L, and 6.0L - Ascender

Engine Mechanical - 4.8L, 5.3L, and 6.0L - Ascender

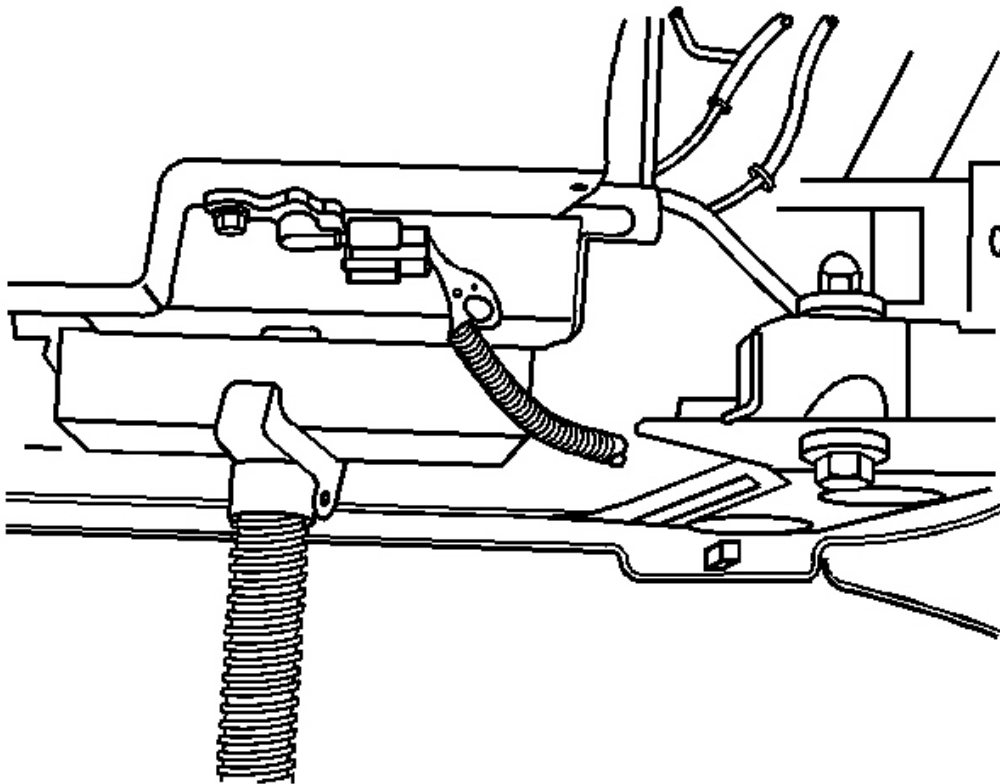
Fig. 31: Block Of Wood Between Engine Oil Pan And Pole Jack
Courtesy of GENERAL MOTORS CORP.

2. Insert a block of wood between the engine oil pan and the pole jack.
3. Raise the jack until the wooden block contacts the engine oil pan.
4. Raise the engine in order to place a slight tension on the rubber cushion. Observe both mounts while raising the engine.

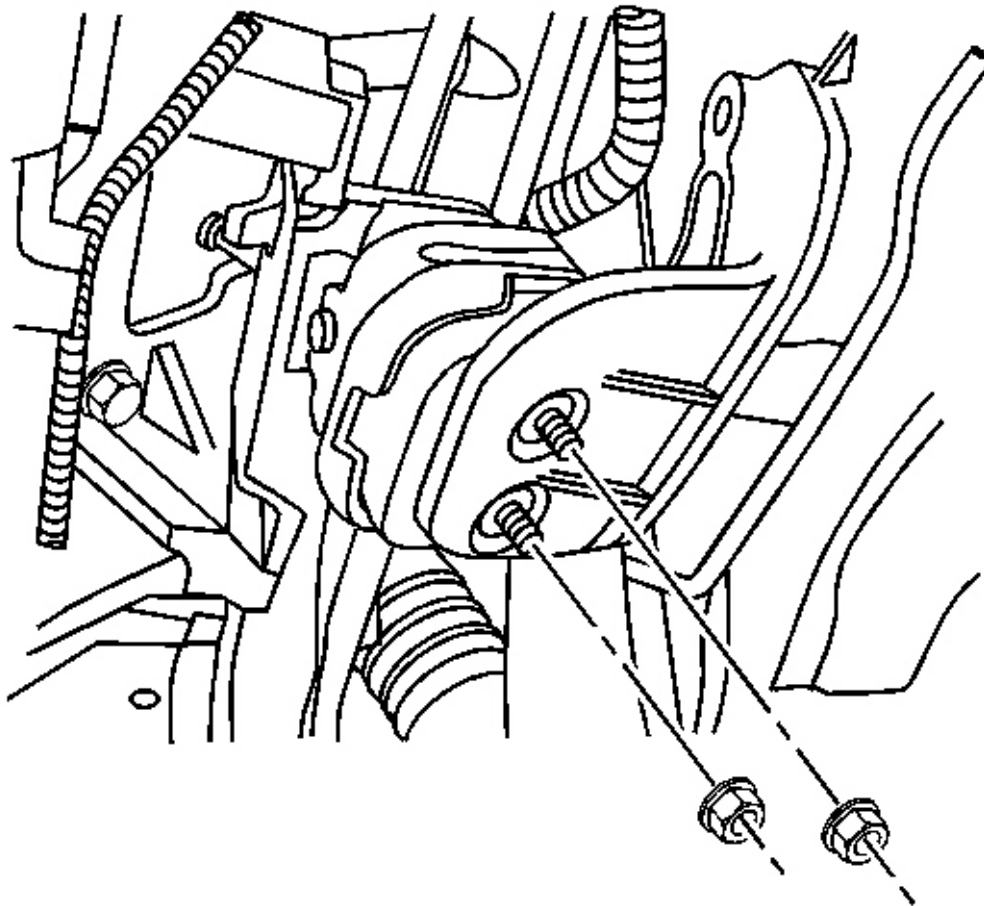
Fig. 32: View Of Left Lower Engine Mount
Courtesy of GENERAL MOTORS CORP.

7. Remove the lower engine mount retaining nuts from the engine mount frame bracket.

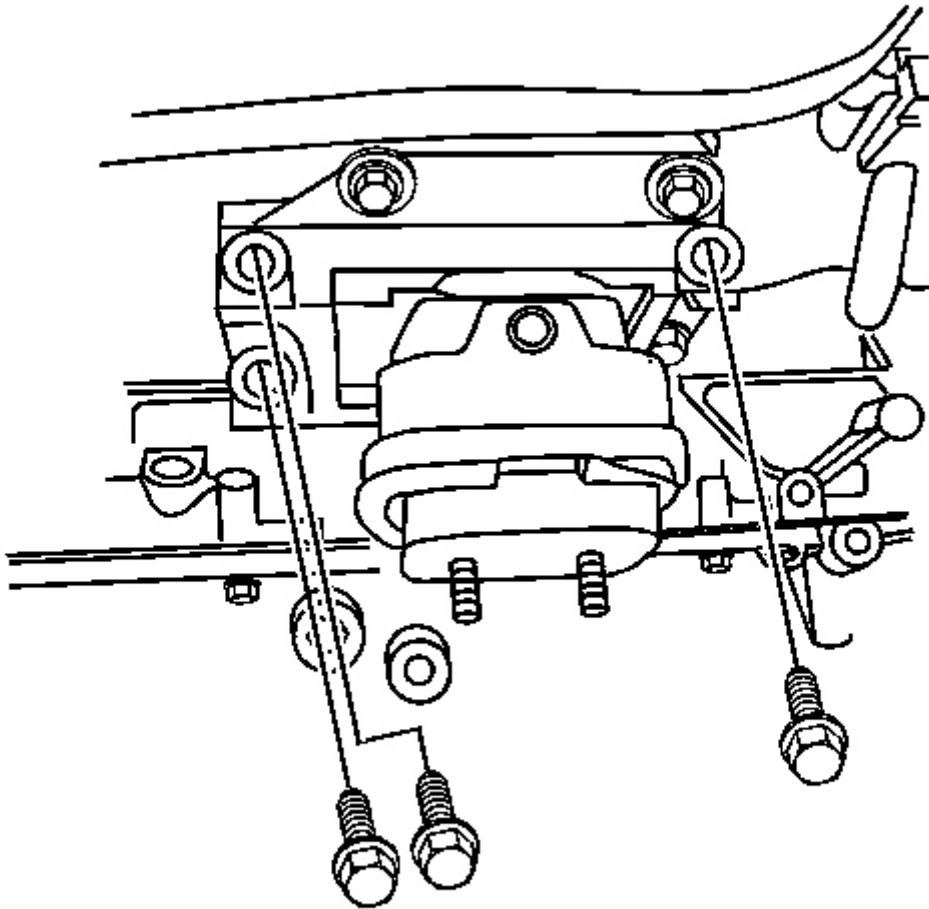
Fig. 33: Identifying Upper Engine Mount Assembly
Courtesy of GENERAL MOTORS CORP.

8. Remove the 3 mounting bolts from the upper engine mount bracket to engine block bracket.

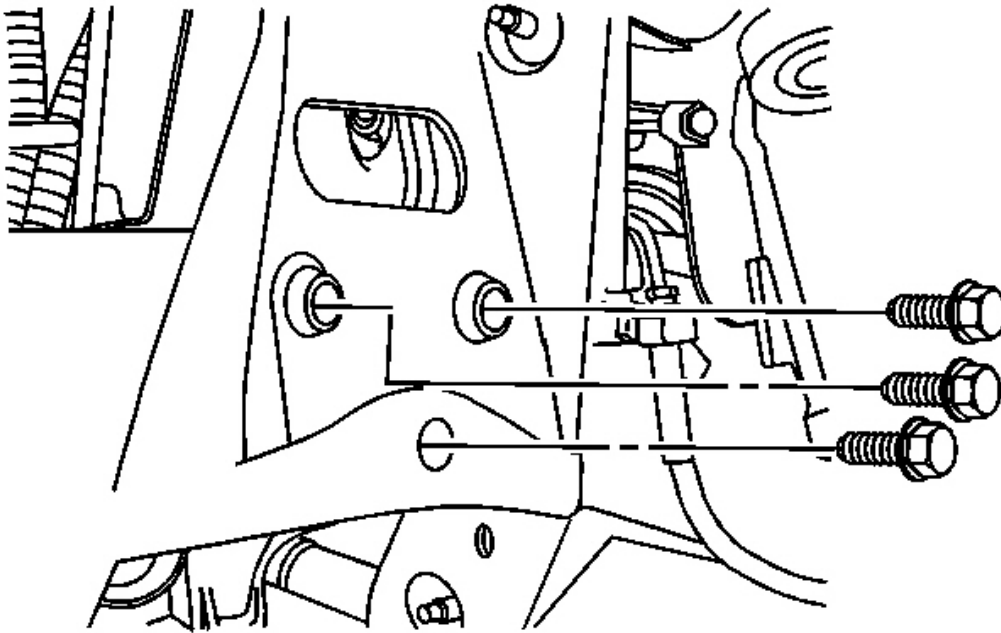
Fig. 34: View Of Frame Engine Mount Bracket Bolt Locations
Courtesy of GENERAL MOTORS CORP.

9. Remove the 3 frame engine mount bracket retaining bolts.

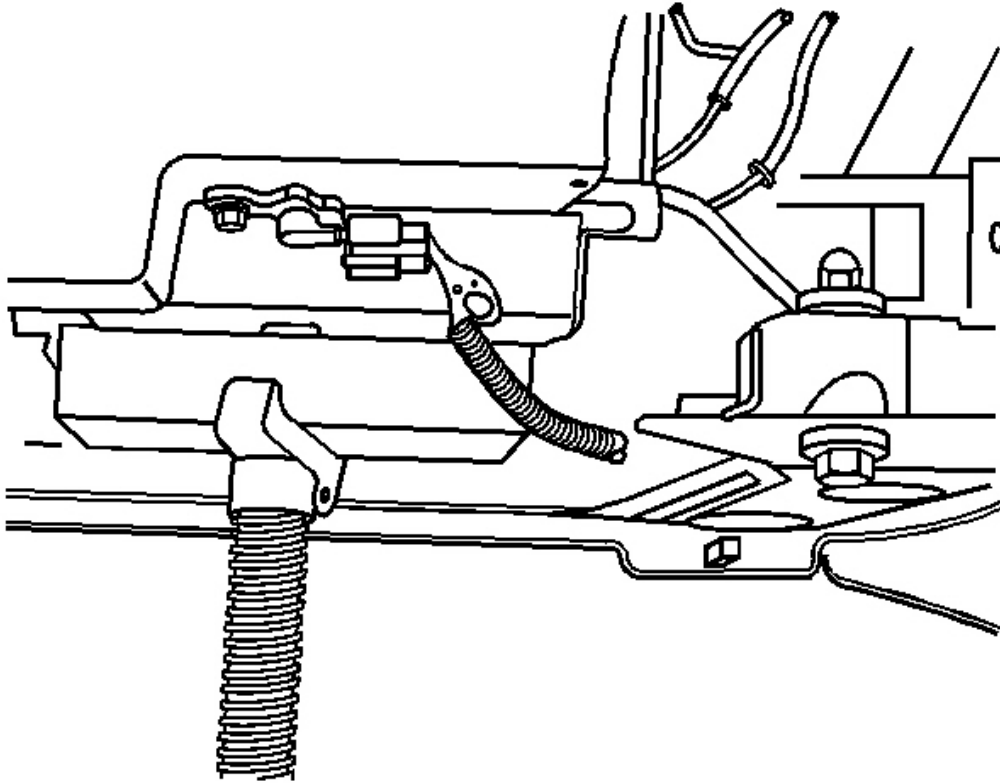
Fig. 35: Block Of Wood Between Engine Oil Pan And Pole Jack
Courtesy of GENERAL MOTORS CORP.

10. Install a pole jack underneath the oil pan.
11. Insert a block of wood between the oil pan and the pole jack.

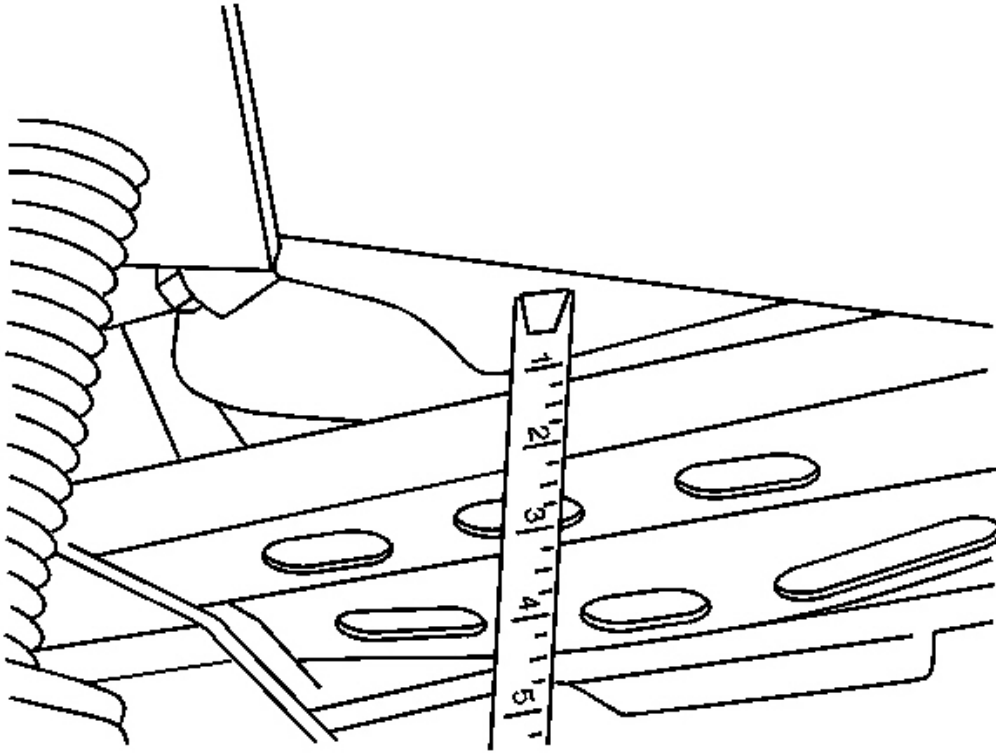
Fig. 36: Measuring Engine Elevation
Courtesy of GENERAL MOTORS CORP.

12. Raise the engine 2 1/4 inches measuring from the bottom of the oil pan to the front edge of the transmission support crossmember.

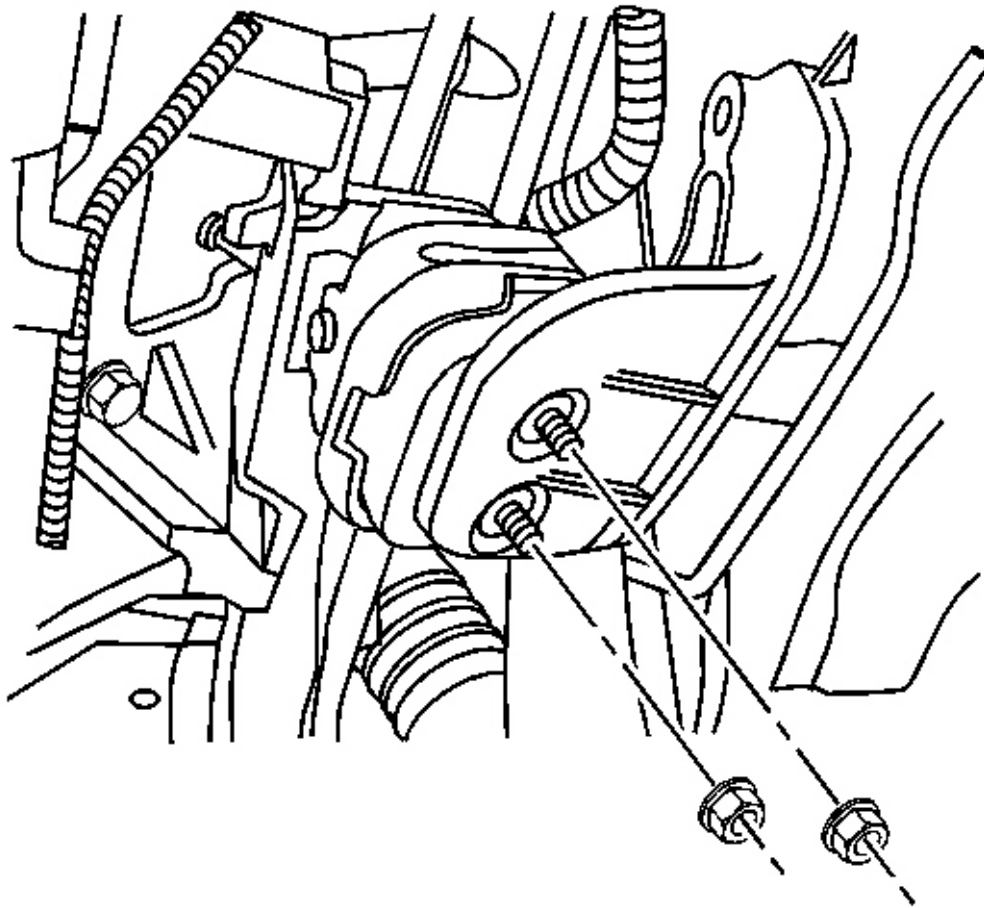
Fig. 37: View Of Left Lower Engine Mount
Courtesy of GENERAL MOTORS CORP.

13. Remove the engine mount frame bracket from the frame.

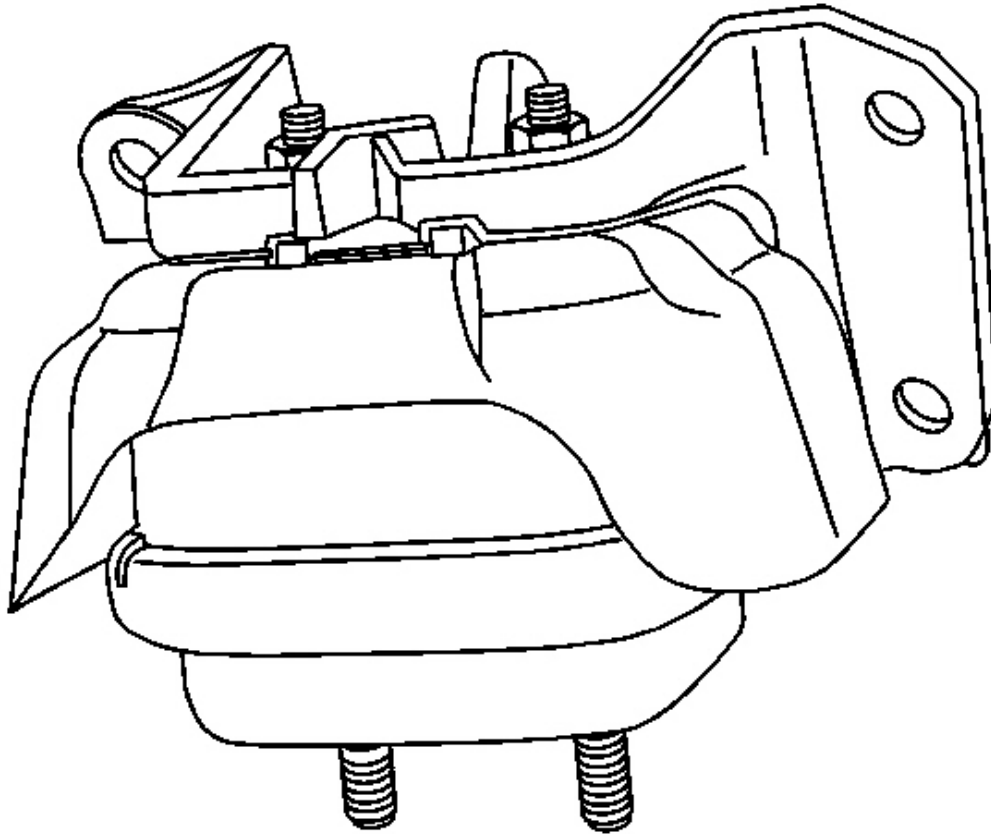
Fig. 38: View Of Engine Mount

14. Remove the engine mount with upper engine mount bracket as an assembly.
15. Separate the engine mount from the upper engine mount bracket.

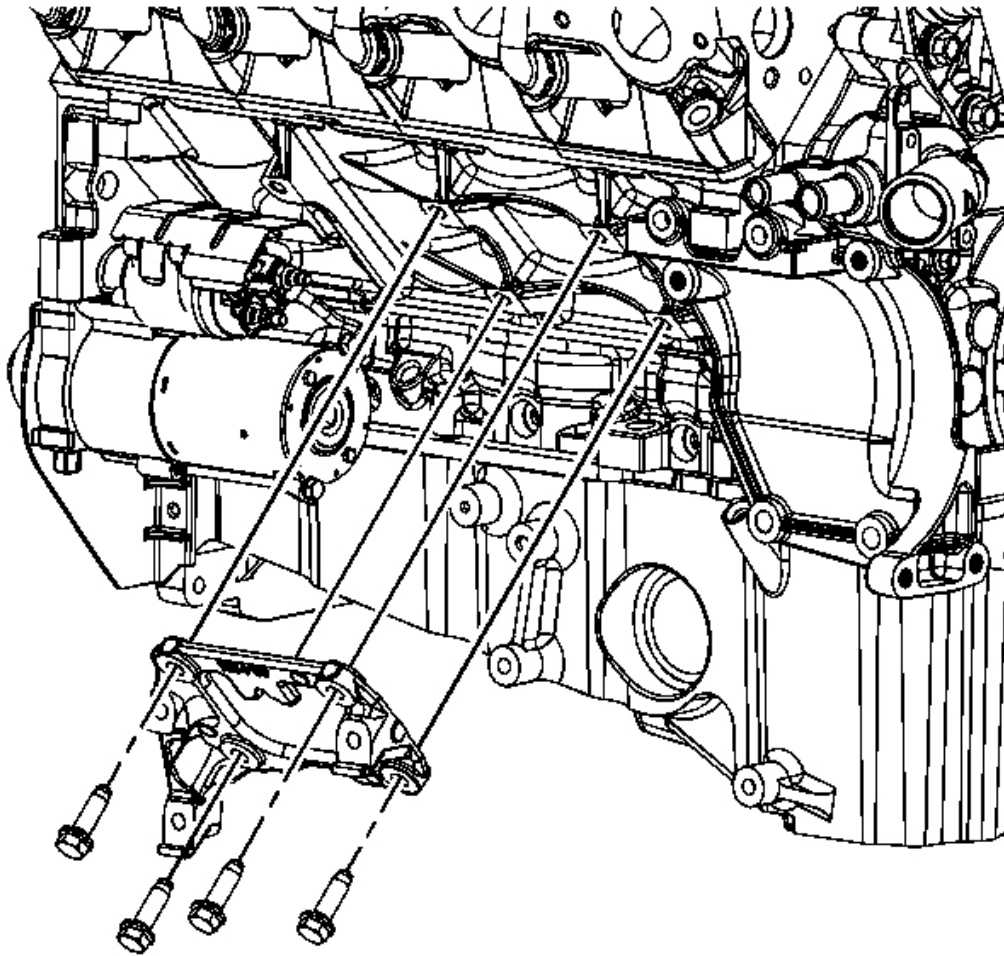
Fig. 39: Removing/Installing Engine Mounting Bracket
Courtesy of GENERAL MOTORS CORP.

16. Remove the engine mount bracket spacer if damaged.

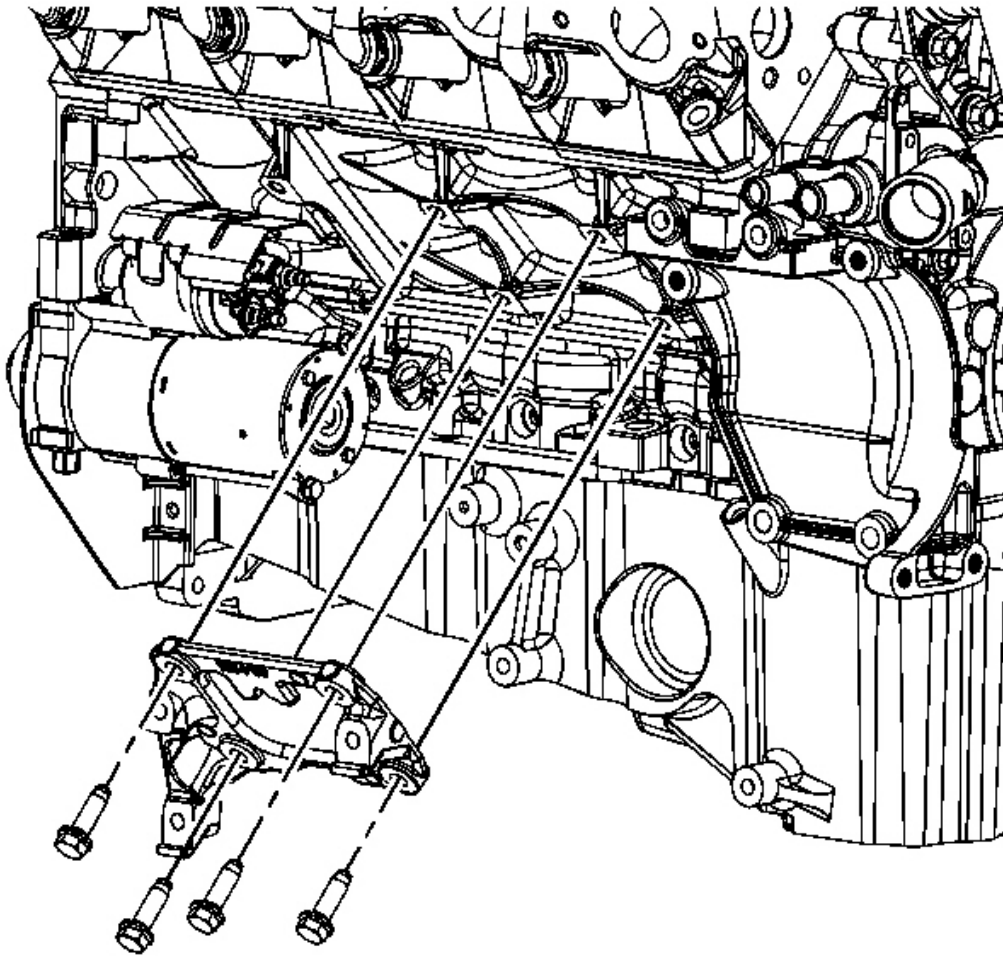
Fig. 40: Removing/Installing Engine Mounting Bracket
Courtesy of GENERAL MOTORS CORP.

1. Install the engine mount bracket spacer if it has been replaced.

Tighten: Torque the engine mount bracket spacer bolts to 50 N.m (37 lb ft).

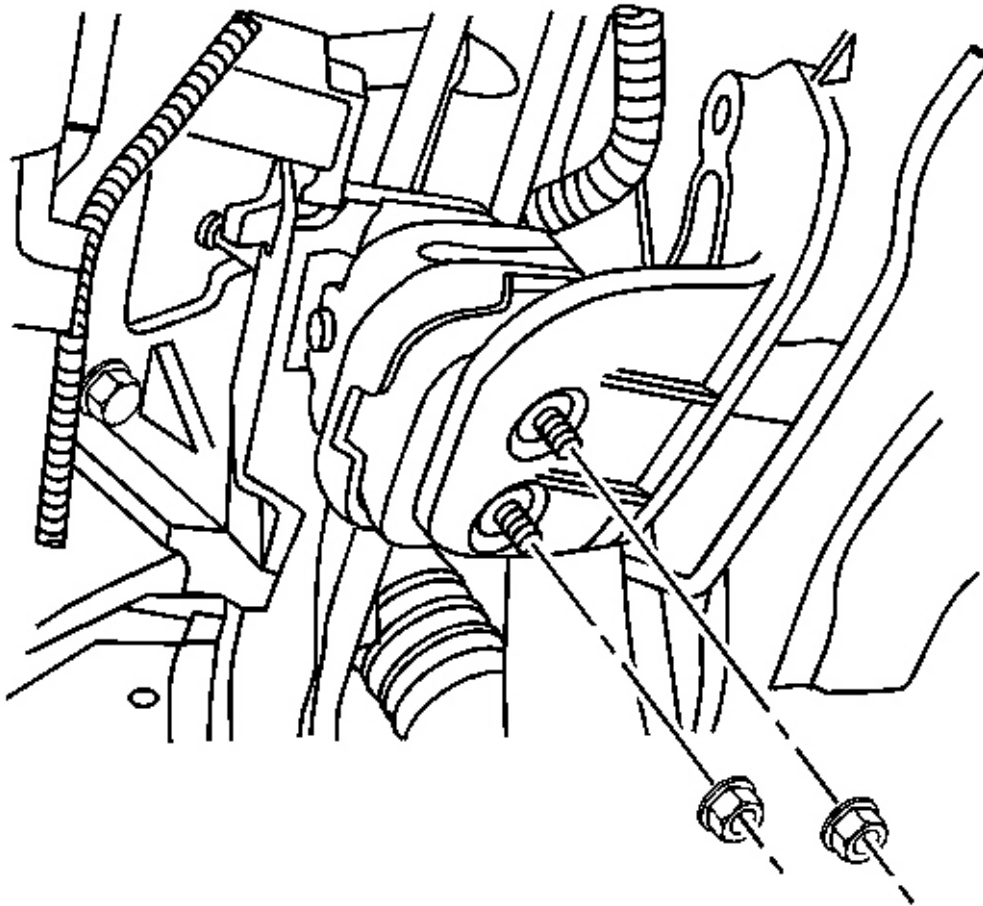
Fig. 43: View Of Left Lower Engine Mount
Courtesy of GENERAL MOTORS CORP.

8. Lower the engine, making sure to align engine mount studs with holes in frame bracket.
9. Remove the pole jack and block of wood.
10. Tighten the engine mount nuts.

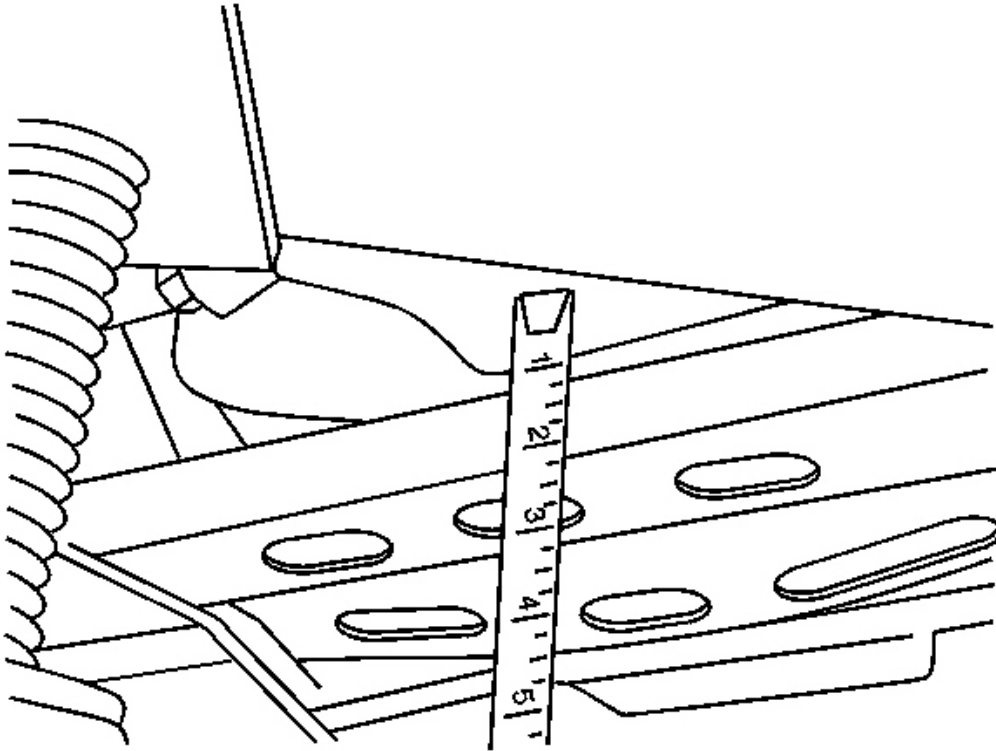
Fig. 48: Measuring Engine Elevation
Courtesy of GENERAL MOTORS CORP.

10. Raise the engine 2 1/4 inches measuring from the bottom of the oil pan to the front edge of the transmission support crossmember.

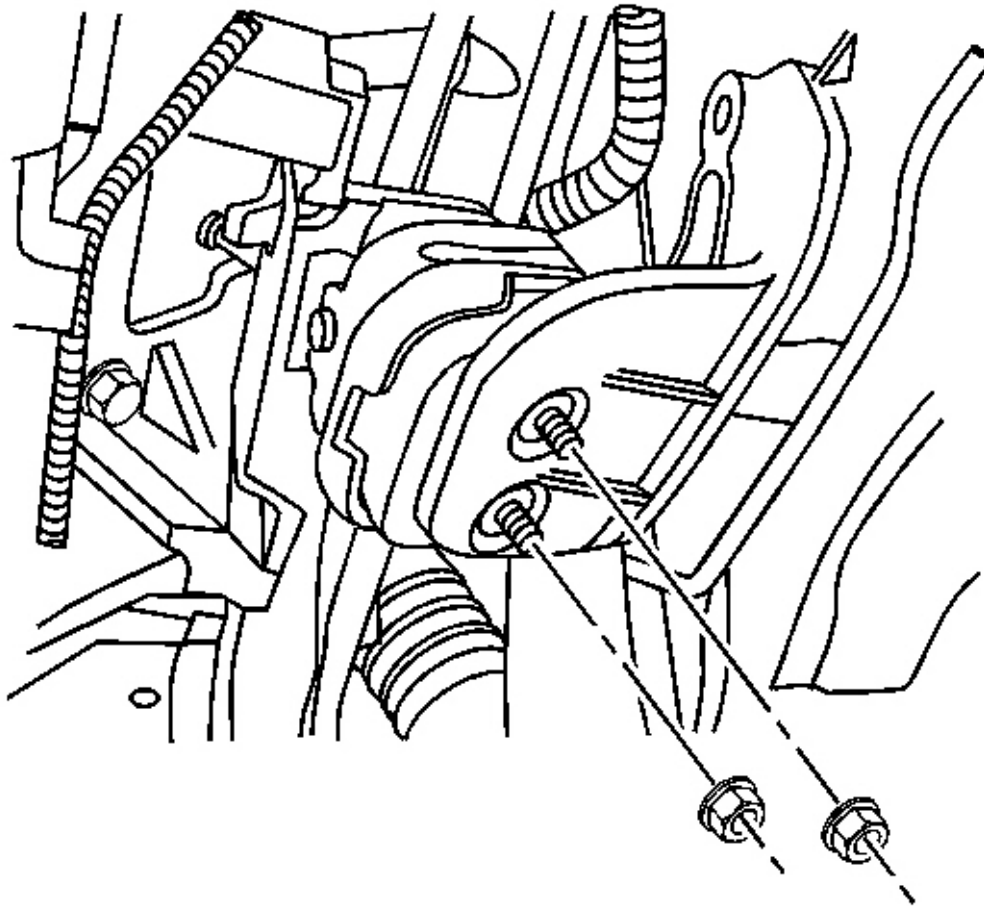
Fig. 67: View Of Left Lower Engine Mount
Courtesy of GENERAL MOTORS CORP.

9. Lower the engine, making sure to align engine mount studs with holes in frame bracket.
10. Remove the pole jack and block of wood.
11. Tighten the engine mount nuts.

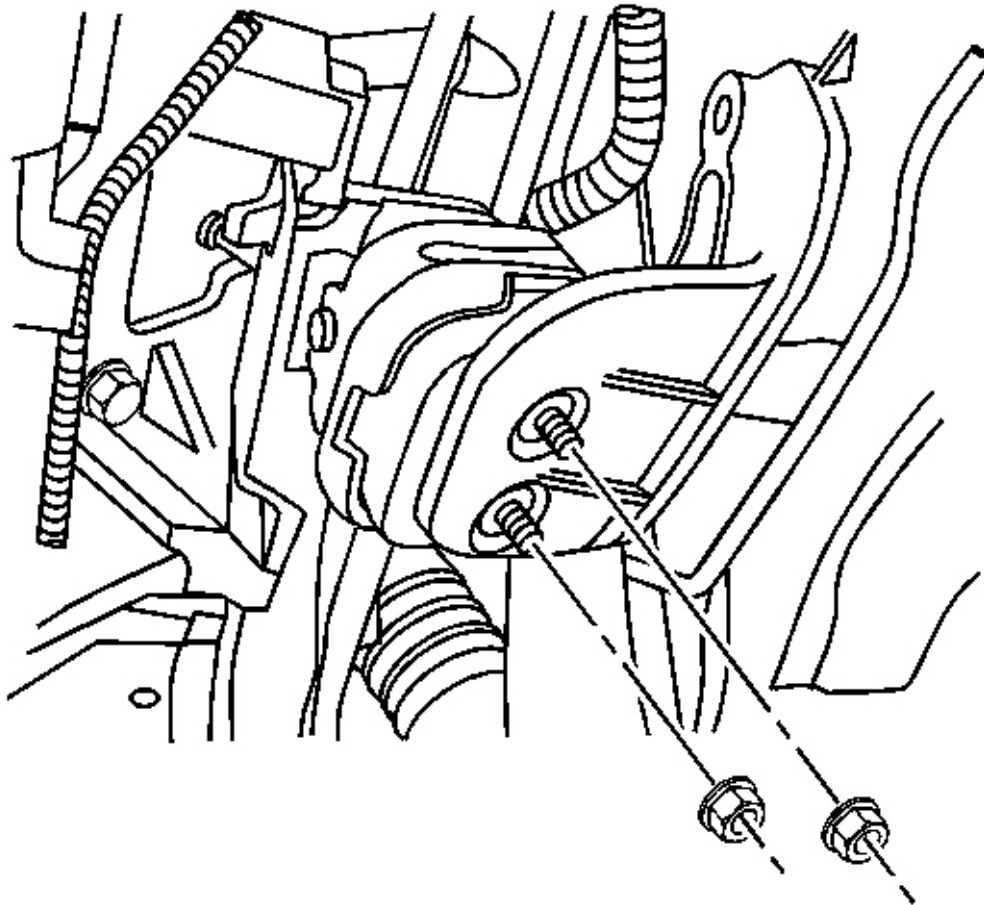
Fig. 79: View Of Left Lower Engine Mount
Courtesy of GENERAL MOTORS CORP.

9. Lower the engine, making sure to align engine mount studs with holes in frame bracket.
10. Remove the pole jack and block of wood.
11. Tighten the engine mount nuts.

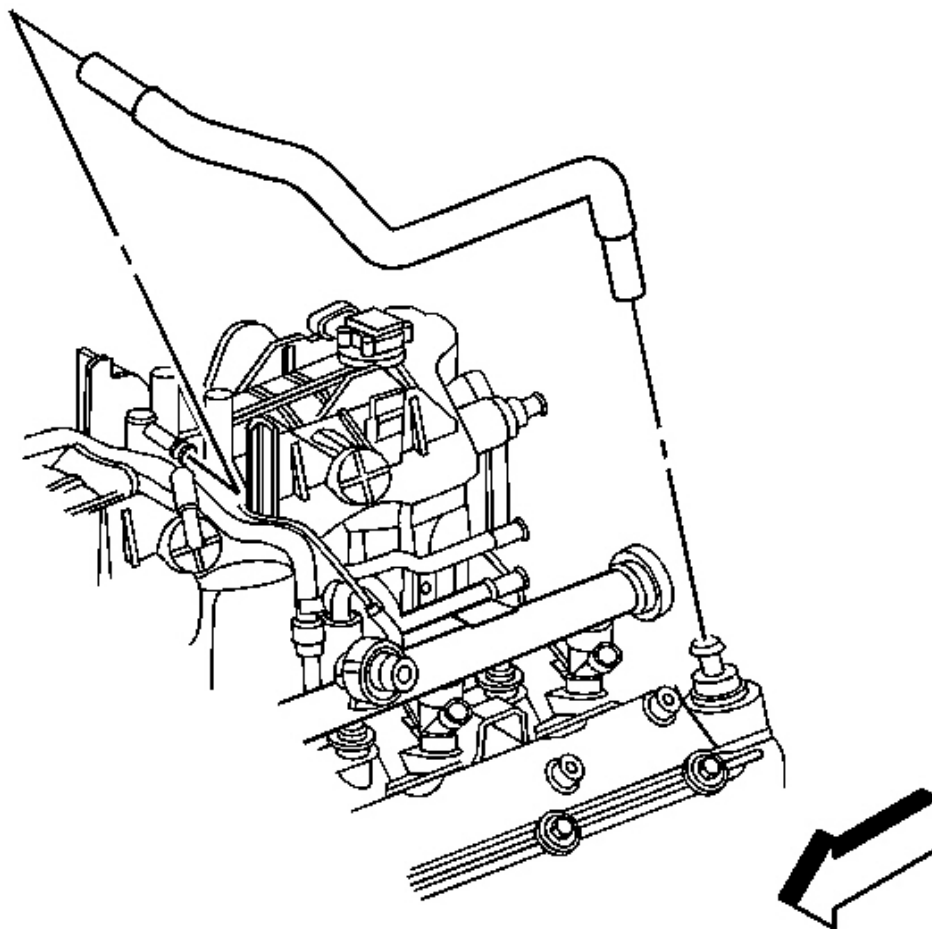
Fig. 80: View Of PCV Foul Air Hose
Courtesy of GENERAL MOTORS CORP.

1. Remove the positive crankcase ventilation (PCV) foul air hose from the intake manifold and valve rocker arm cover.
2. Remove the air cleaner resonator outlet duct. Refer to **Air Cleaner Resonator Outlet Duct Replacement** in Engine Controls.

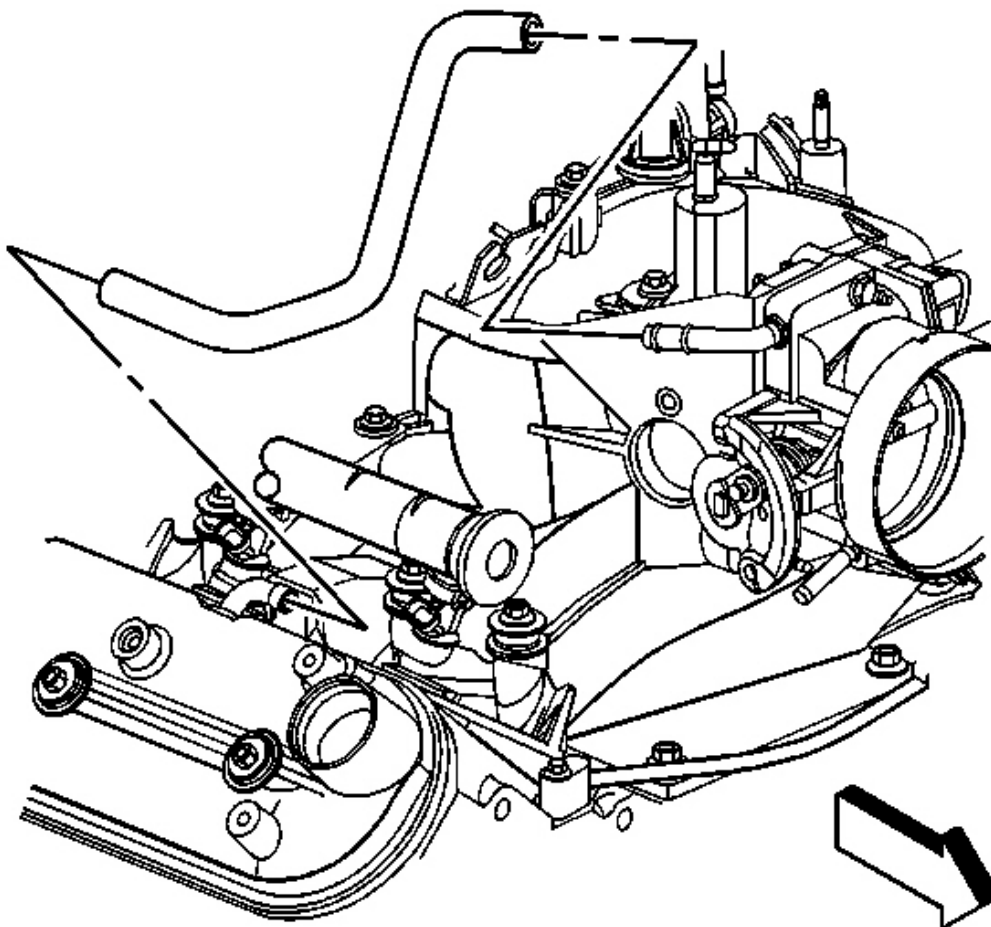
Fig. 81: Locating Breather Hose
Courtesy of GENERAL MOTORS CORP.

3. Remove the PCV fresh air hose from the throttle body and the valve rocker arm cover.

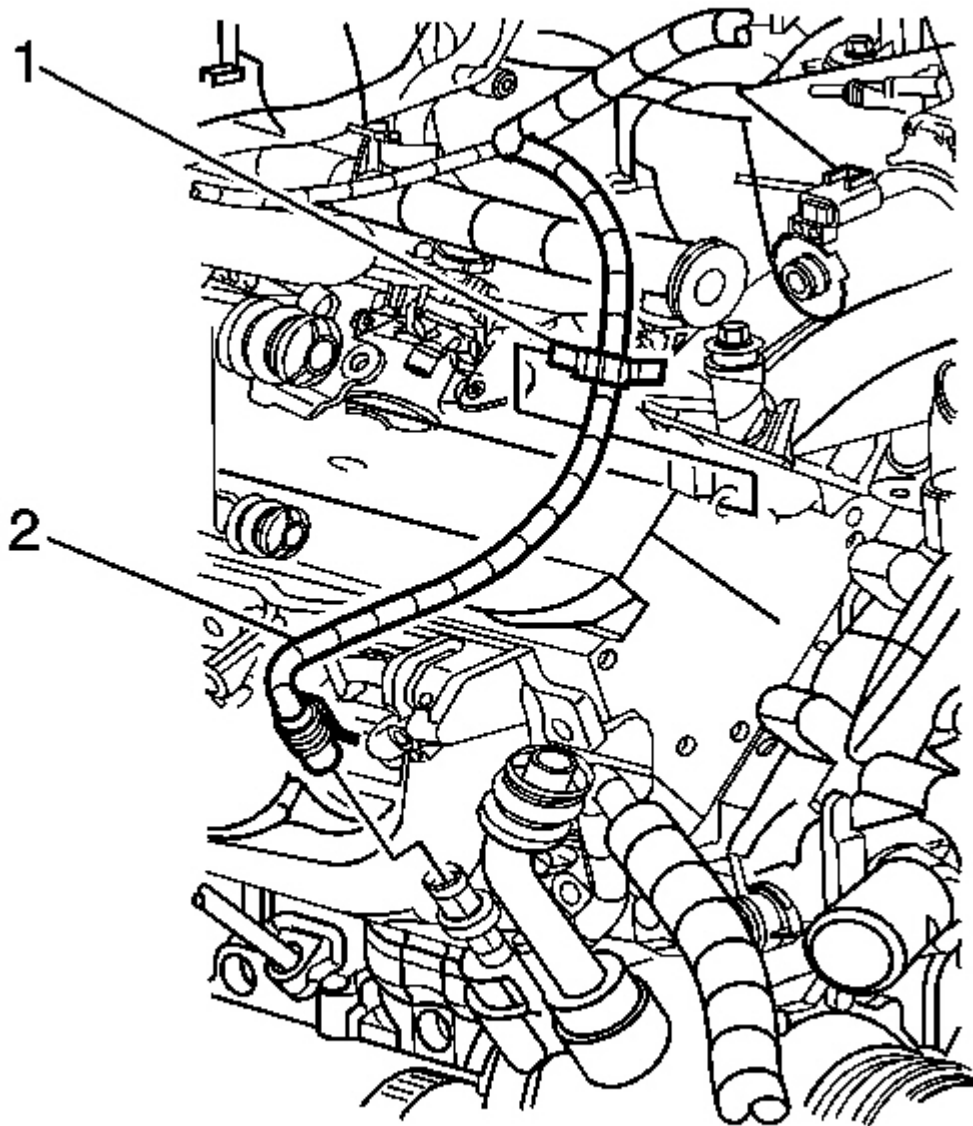
Fig. 84: View Of A/C Compressor Pressure Switch Electrical Connector & Retaining Clip
Courtesy of GENERAL MOTORS CORP.

3. Disconnect the air conditioning (A/C) compressor pressure switch electrical connector (2).
4. Remove the harness clip from the cylinder head.

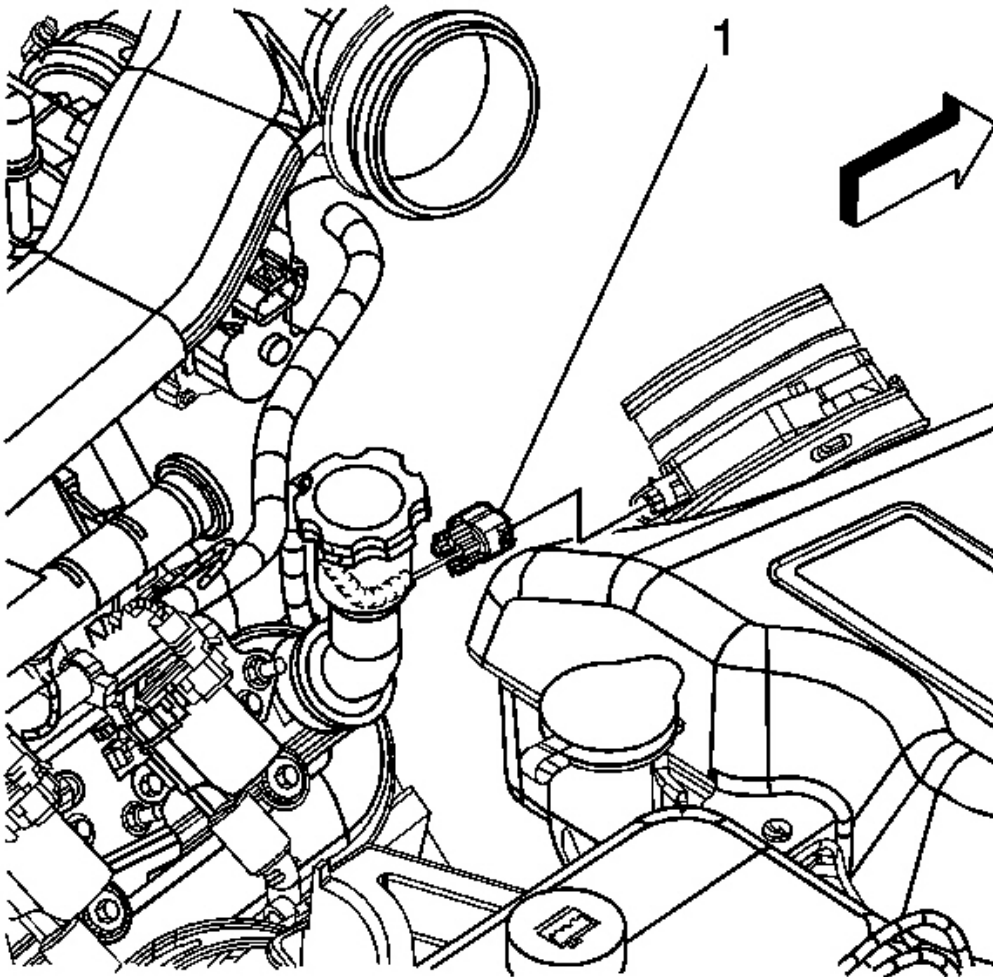
Fig. 85: View Of MAF/IAT Sensor Electrical Connector
Courtesy of GENERAL MOTORS CORP.

5. Disconnect the mass air flow (MAF)/intake air temperature (IAT) sensor electrical connector (1).
6. Remove the harness clips from the fuel rail.

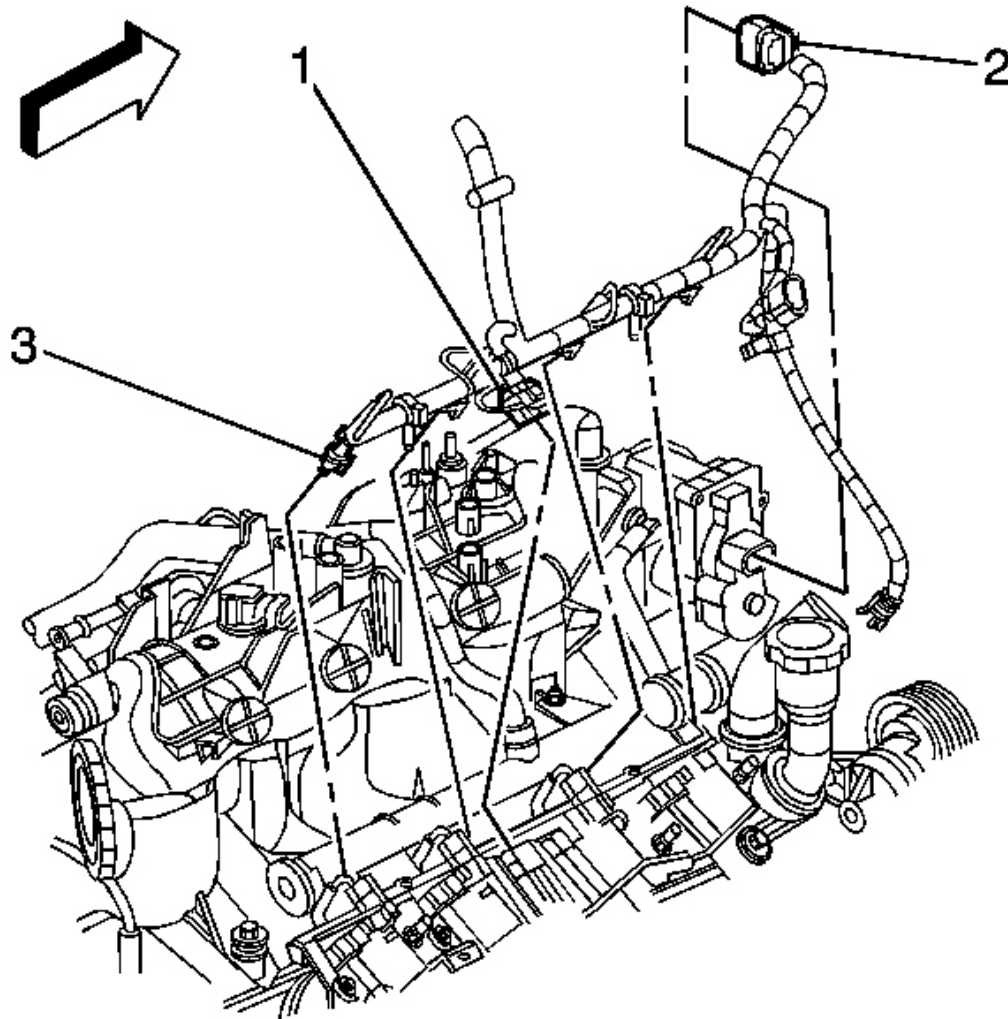
Fig. 86: Locating Electrical Components At Top Of Engine
Courtesy of GENERAL MOTORS CORP.

7. Disconnect the following electrical connectors:

- Main coil (1)
- Electronic throttle control (ETC) (2)
- Fuel injectors (3)

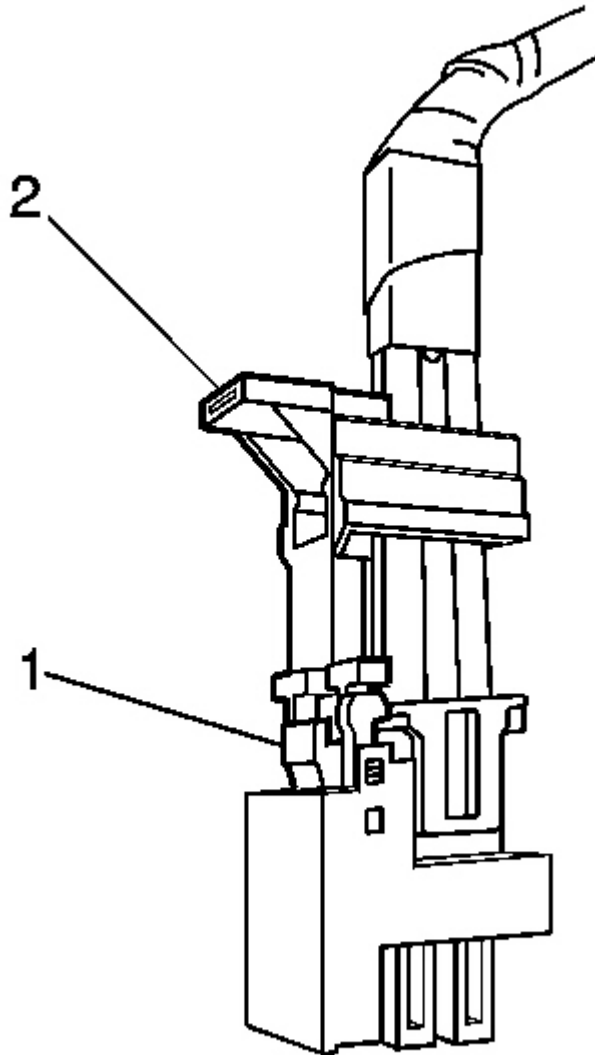
Fig. 87: View Of CPA Retainer & Tab
Courtesy of GENERAL MOTORS CORP.

8. Perform the following steps in order to disconnect the fuel injector electrical connector.
 1. Mark the connectors to their corresponding injectors to ensure correct reassembly.
 2. Pull the connector position assurance (CPA) retainer (2) on the connector up 1 click.
 3. Push the tab (1) on the connector in.
 4. Disconnect the fuel injector electrical connector.

5. Repeat the steps for each injector electrical connector.

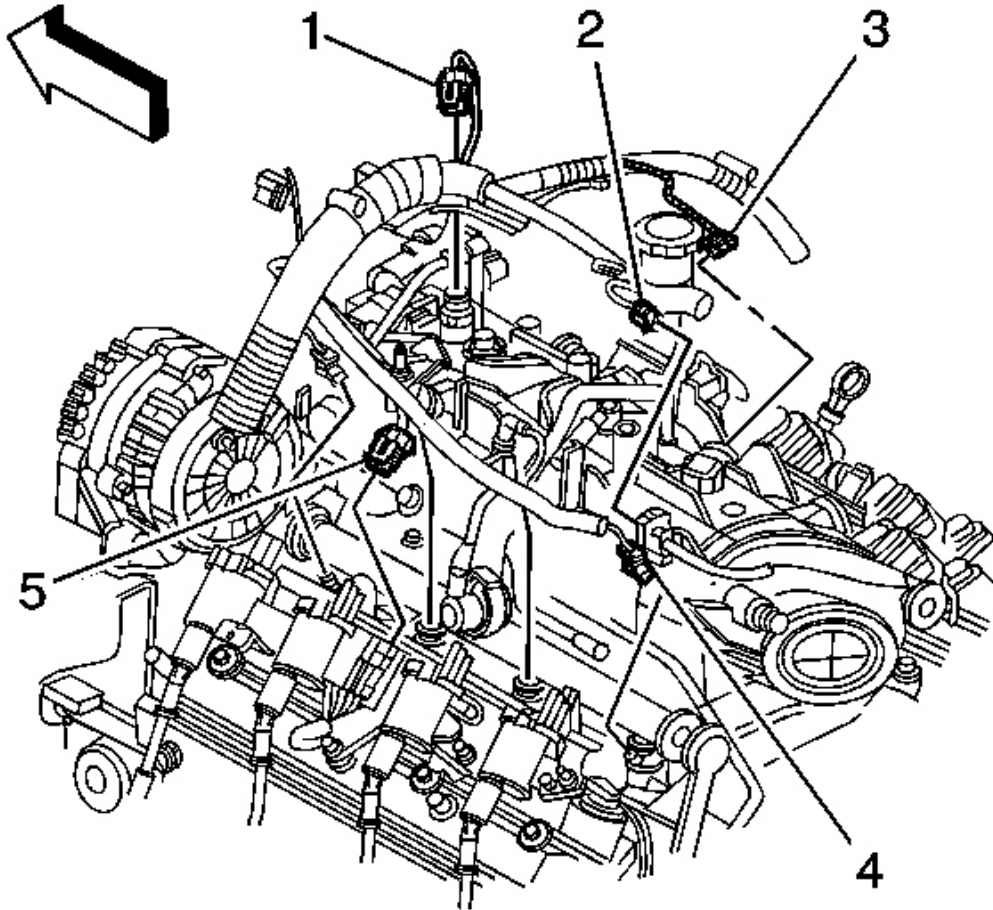
Fig. 89: Top Of Engine Wiring Harness View
Courtesy of GENERAL MOTORS CORP.

10. Disconnect the following electrical connectors:
 - Evaporative emission (EVAP) purge solenoid (1)
 - Knock sensor (2)
 - Manifold absolute pressure (MAP) sensor (3)
 - Main coil (5)
 - Fuel injectors (4)
11. Remove the electrical harness clips from the fuel rail.
12. Remove the knock sensor harness electrical connector from the intake manifold.

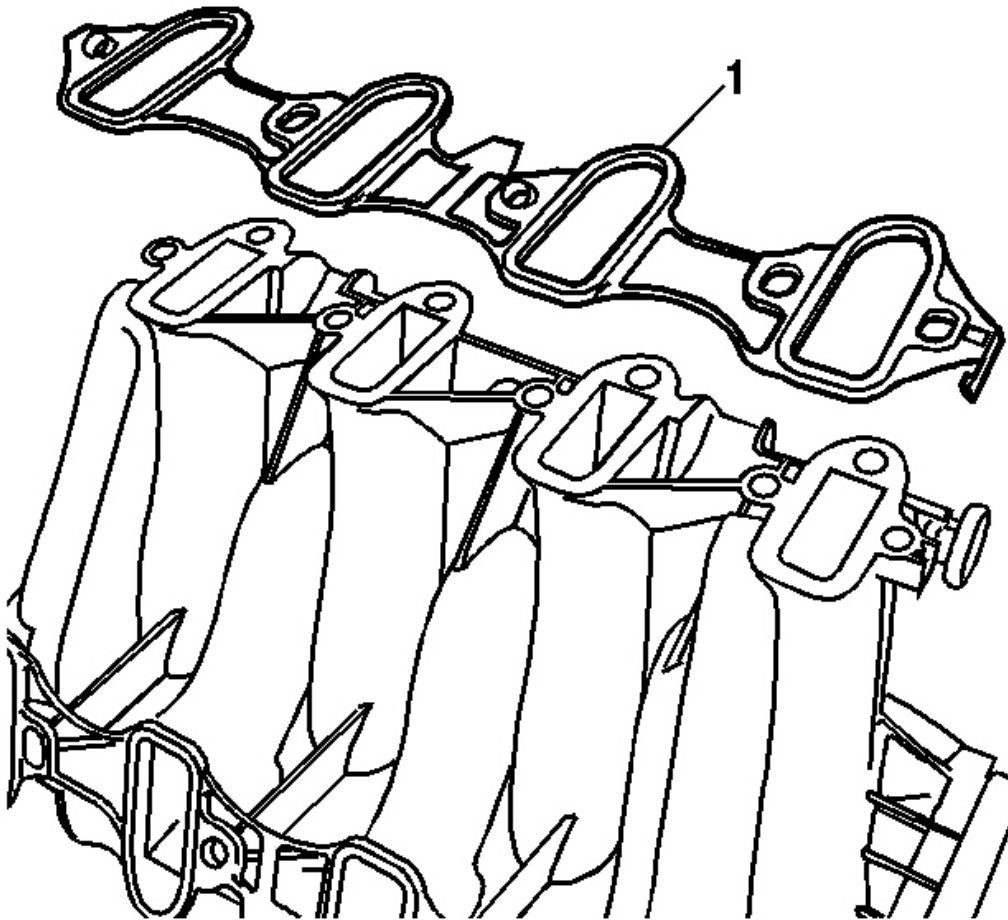
Fig. 97: View Of Intake Manifold Gasket
Courtesy of GENERAL MOTORS CORP.

1. Install NEW intake manifold gaskets (1) to the intake manifold.

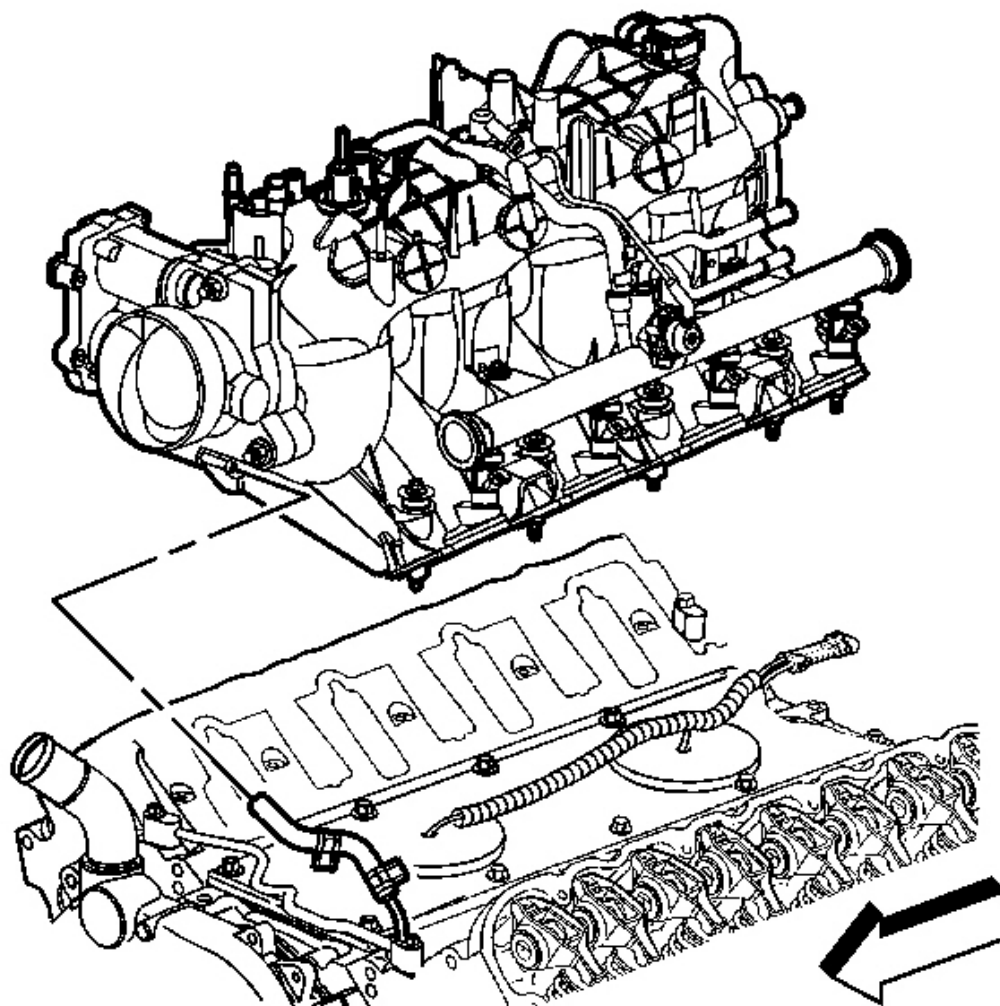
Fig. 98: View Of Intake Manifold & Bolts
Courtesy of GENERAL MOTORS CORP.

2. Install the intake manifold.
3. Apply a 5 mm (0.20 in) bead of threadlock GM P/N 12345382, (Canadian P/N 10953489) or equivalent to the threads of the intake manifold bolts.

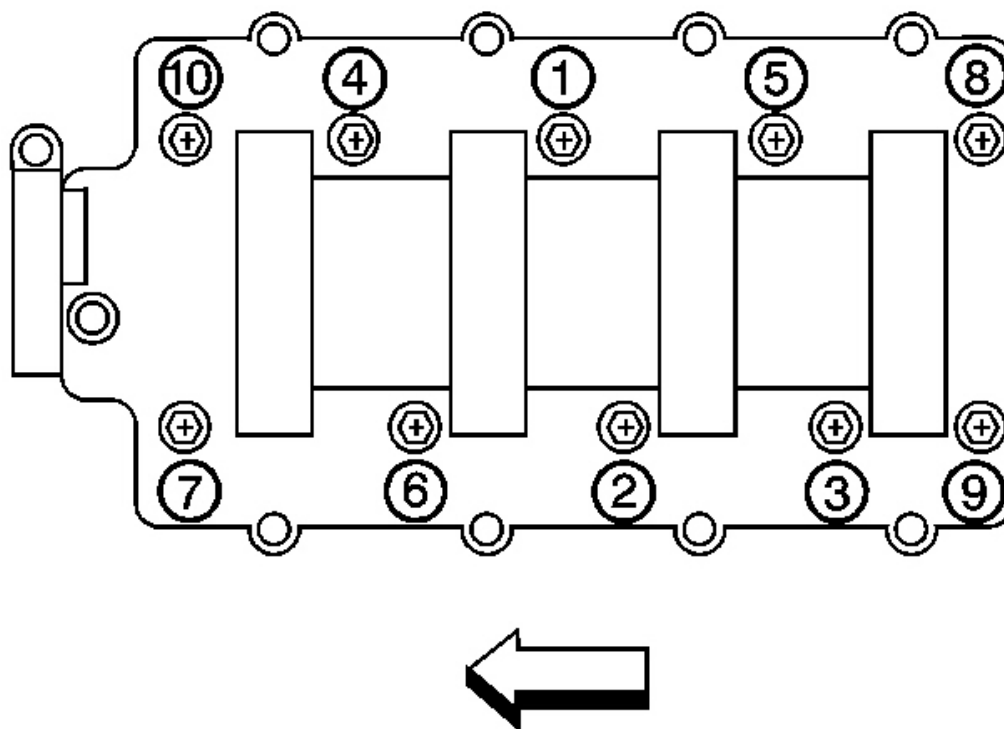
Fig. 99: Identifying Intake Manifold Bolt Tightening Sequence
Courtesy of GENERAL MOTORS CORP.
