2004 Isuzu Ascender LS

2004 ENGINE Engine Mechanical - 4.8L, 5.3L, and 6.0L - Ascender

Engine Mechanical - 4.8L, 5.3L, and 6.0L - Ascender

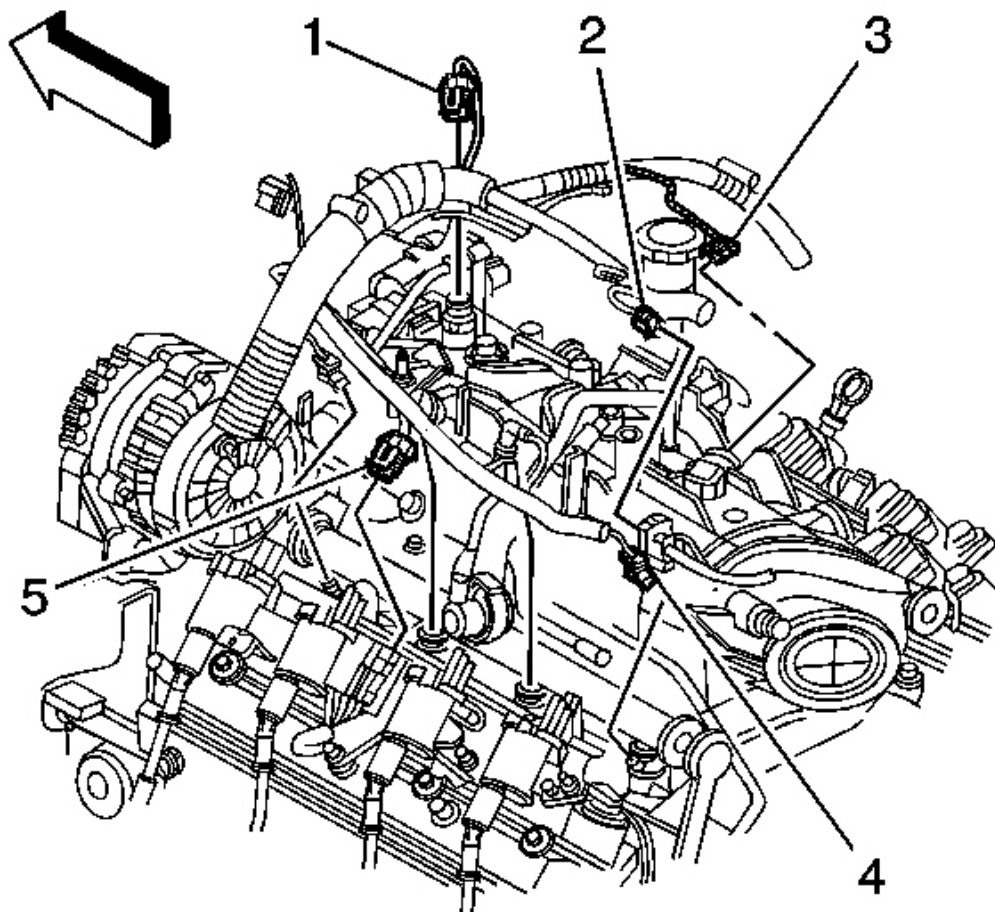
Fig. 105: Top Of Engine Wiring Harness View
Courtesy of GENERAL MOTORS CORP.

12. Connect the following electrical connectors:

- EVAP purge solenoid (1)
- Knock sensor (2)
- MAP sensor (3)
- Main coil (5)
- Fuel injectors (4)

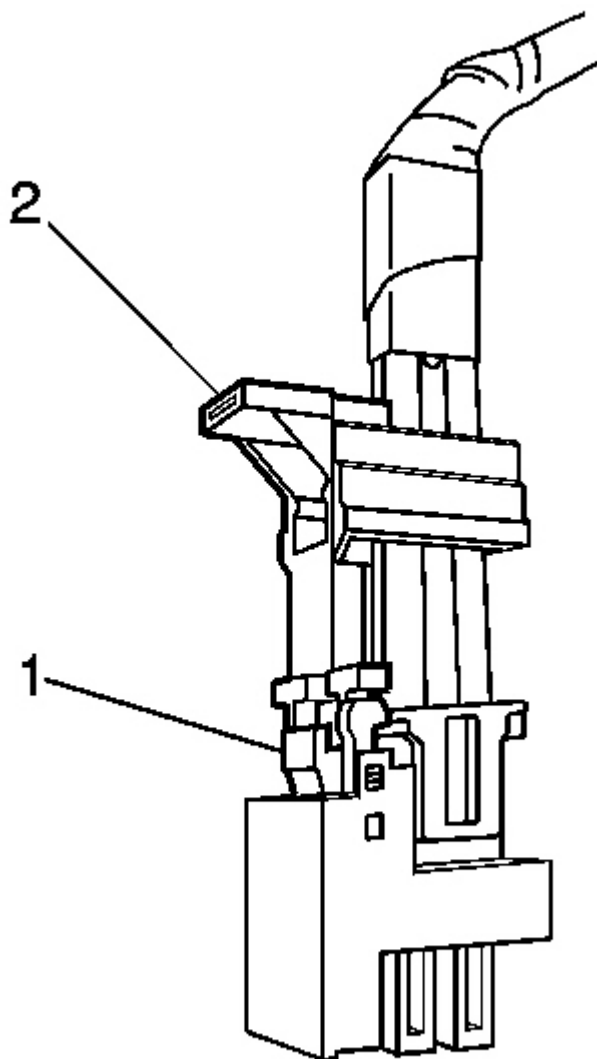
Fig. 106: View Of CPA Retainer & Tab
Courtesy of GENERAL MOTORS CORP.

13. Perform the following steps in order to connect the fuel injector electrical connectors.
 1. Install the connectors to their corresponding injectors to ensure correct reassembly.
 2. Connect the fuel injector electrical connector.
 3. Push the CPA retainer (2) on the connector in one click.
 4. Repeat the steps for each injector electrical connector.

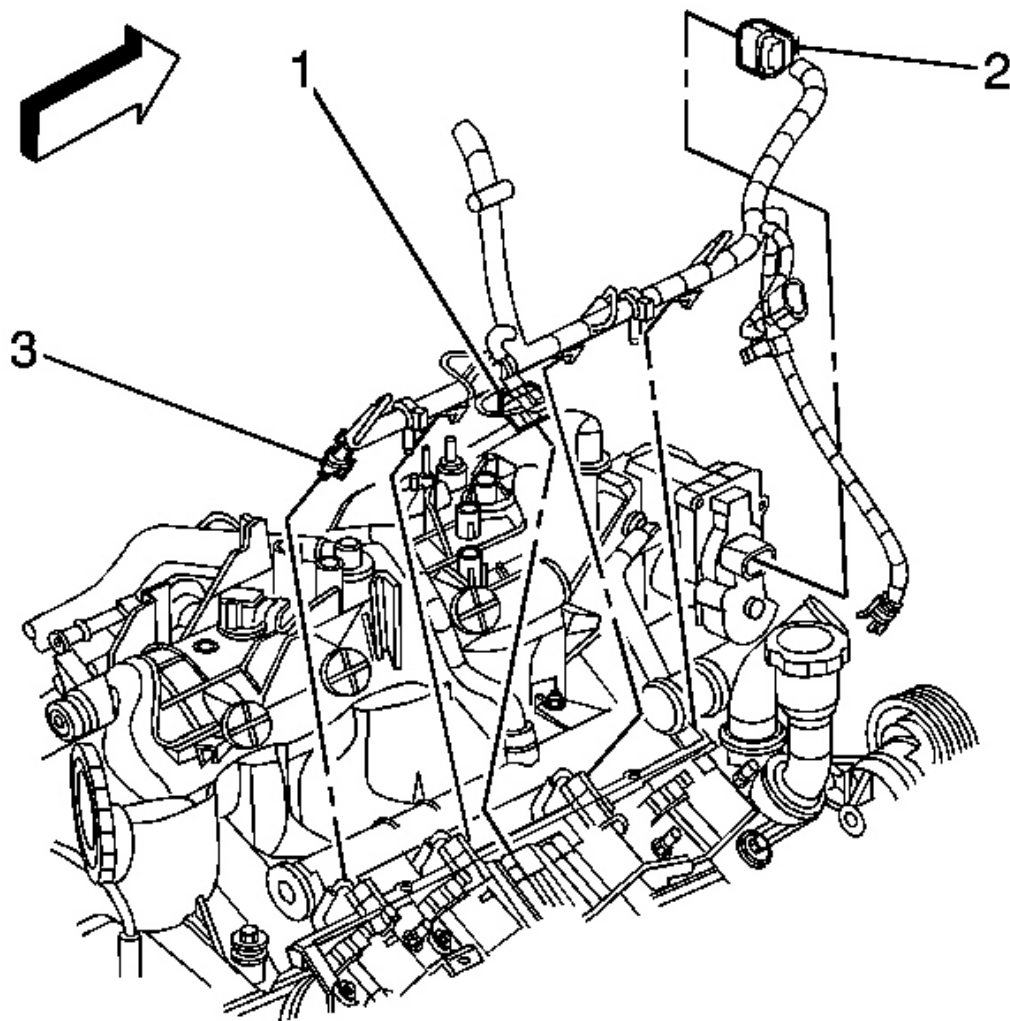
Fig. 108: Locating Electrical Components At Top Of Engine
Courtesy of GENERAL MOTORS CORP.

16. Connect the following electrical connectors:
 - Main coil (1)
 - ETC (2)
 - Fuel injectors (3)
17. Install the electrical harness clips to the fuel rail.

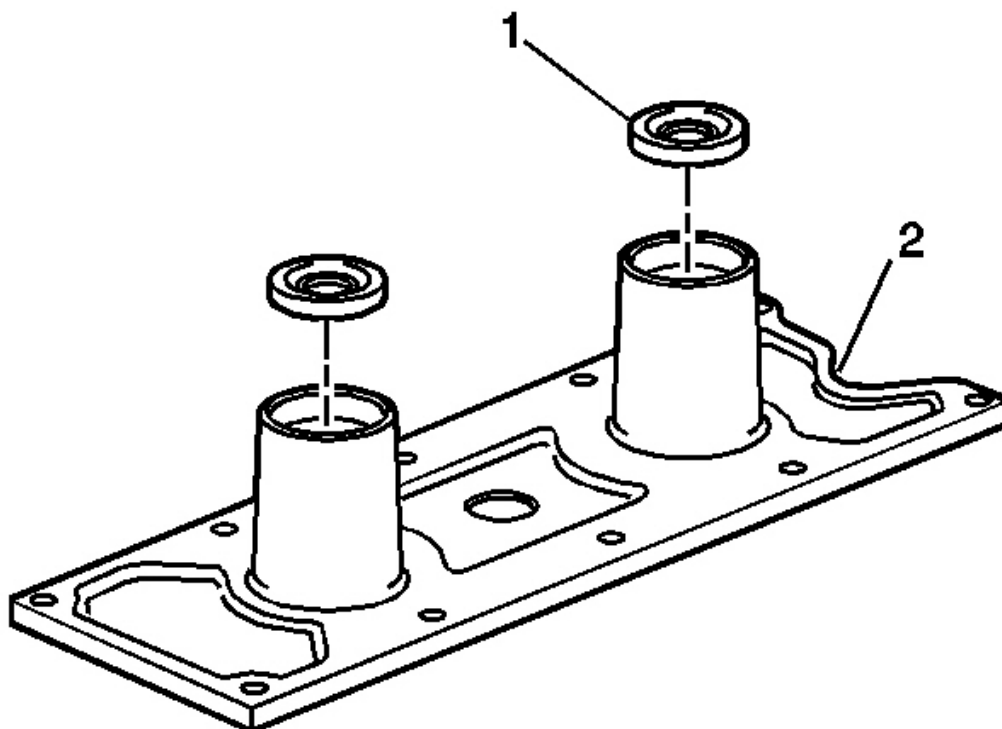
Fig. 114: View Of Knock Sensor Oil Seals & Cover
Courtesy of GENERAL MOTORS CORP.

8. Remove the knock sensor oil seals (1) from the cover (2).
9. Clean and inspect the engine valley cover. Refer to **Engine Valley Cover Cleaning and Inspection**.

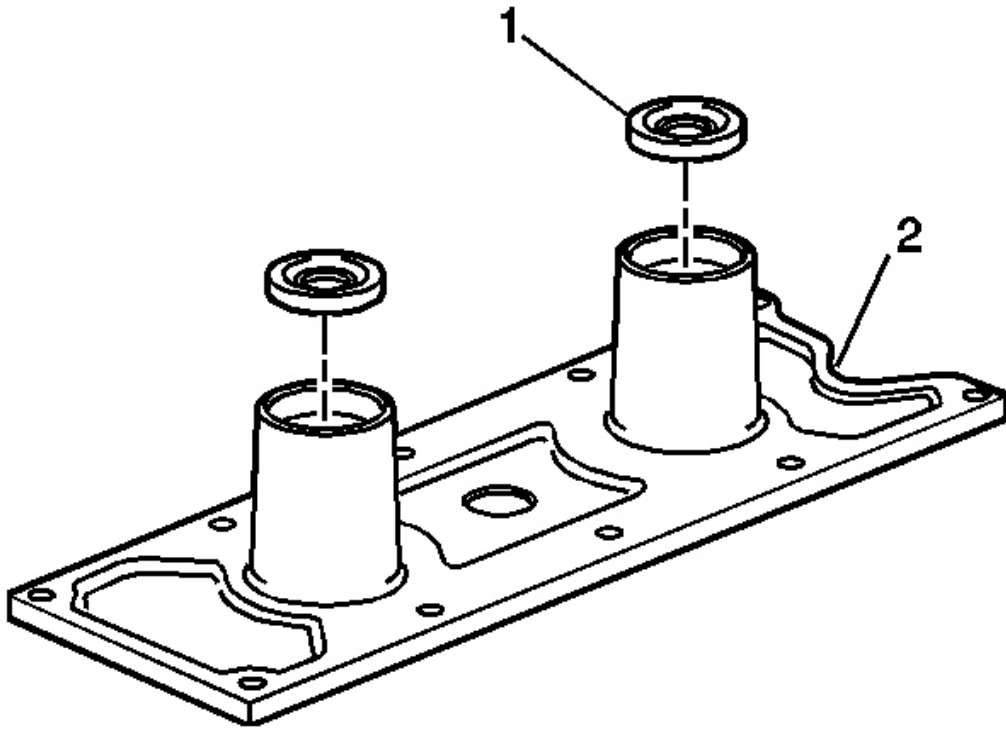
Fig. 115: View Of Knock Sensor Oil Seals & Cover
Courtesy of GENERAL MOTORS CORP.

1. Lubricate the NEW knock sensor seals (1) with clean engine oil.
2. Install the knock sensor oil seals (1) into the engine valley cover (2).

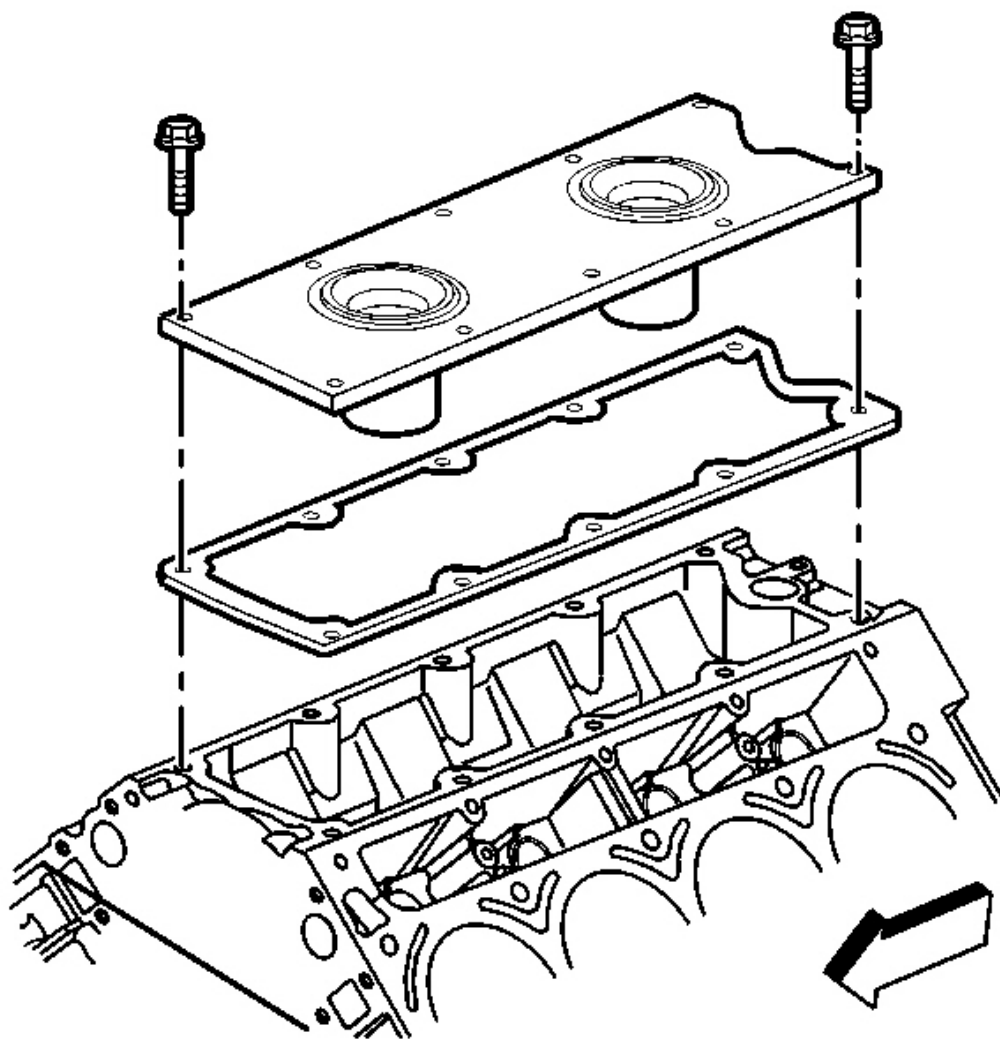
Fig. 116: View Of Engine Valley Cover, Gasket & Bolts
Courtesy of GENERAL MOTORS CORP.

3. Install the engine valley cover and a NEW gasket onto the engine block.
4. Install the engine valley cover bolts.

Tighten: Tighten the bolts to 25 N.m (18 lb ft).

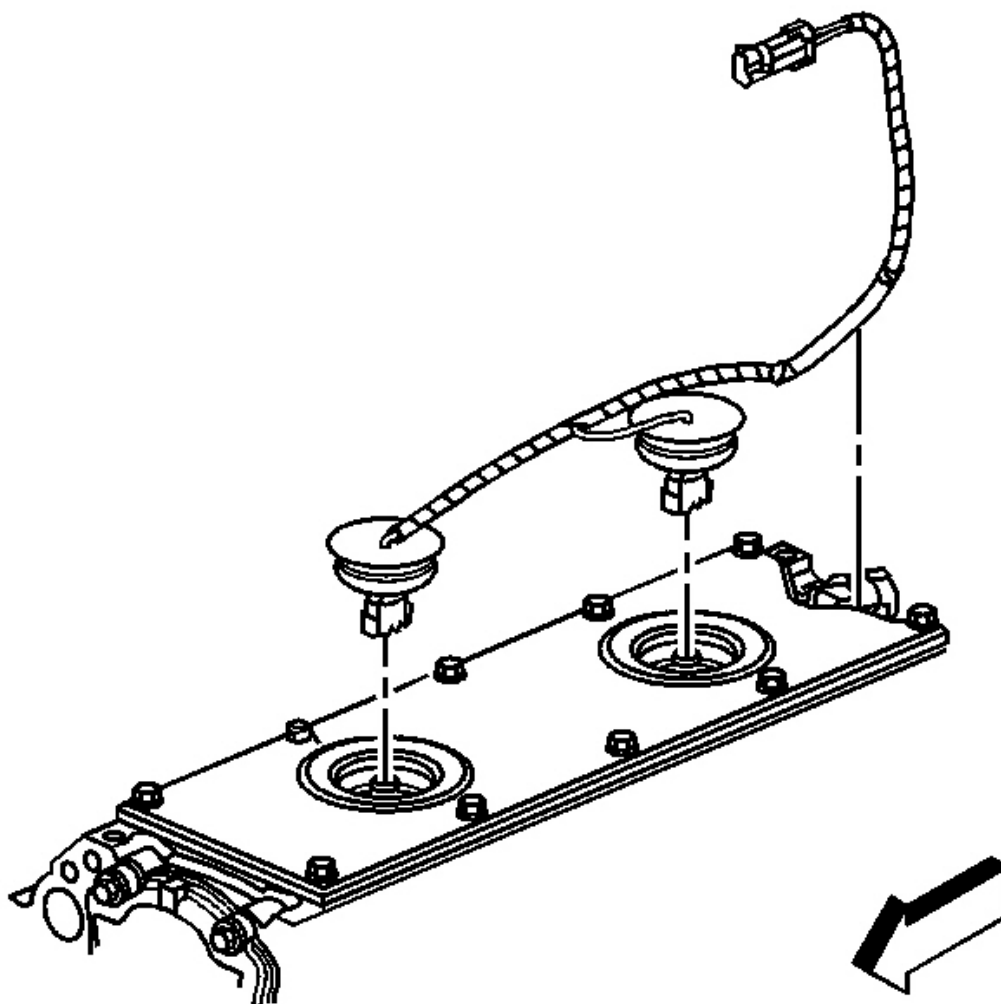
Fig. 118: View Of Rubber Covers
Courtesy of GENERAL MOTORS CORP.

6. Connect the knock sensor electrical connectors.
7. Push down on the rubber covers.
8. Install the intake manifold. Refer to **Intake Manifold Replacement**.

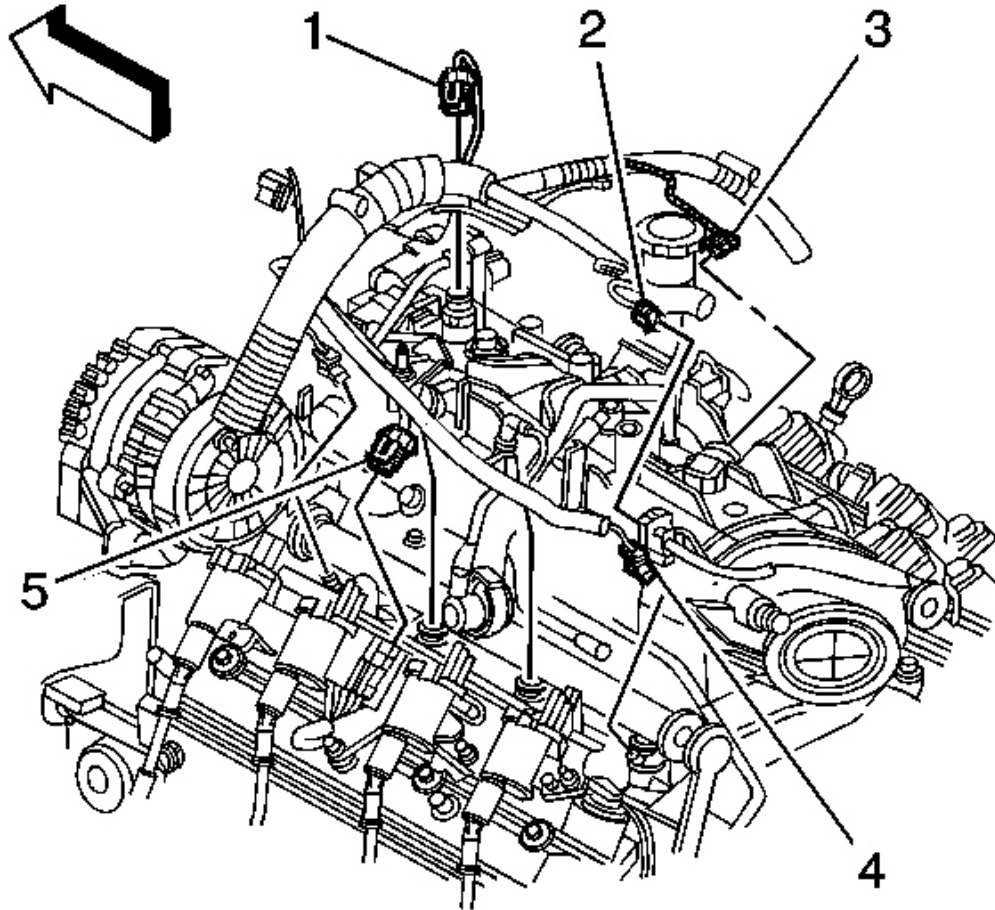
Fig. 119: Top Of Engine Wiring Harness View
Courtesy of GENERAL MOTORS CORP.

1. Remove the connector position assurance (CPA) lock.
2. Disconnect the main electrical connector (5) to the ignition coil wire harness.
3. Remove the harness clips.
4. Reposition the engine harness, if necessary.
5. Remove the spark plug wires from the ignition coils.
 - Twist each plug wire 1/2 turn.
 - Pull only on the boot in order to remove the wire from the ignition coil.

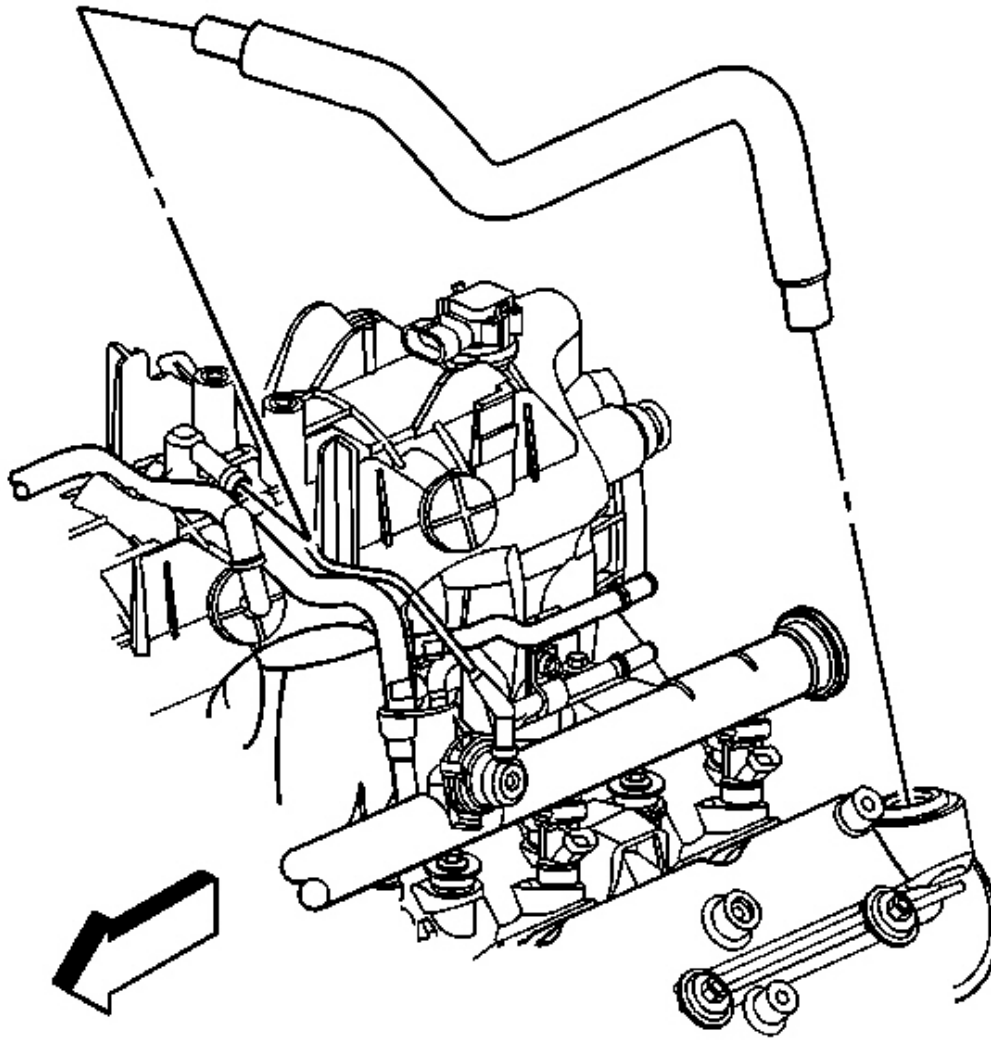
Fig. 121: Breather Crossover Tube View
Courtesy of GENERAL MOTORS CORP.

8. Remove the positive crankcase ventilation (PCV) hose from the rocker arm cover.

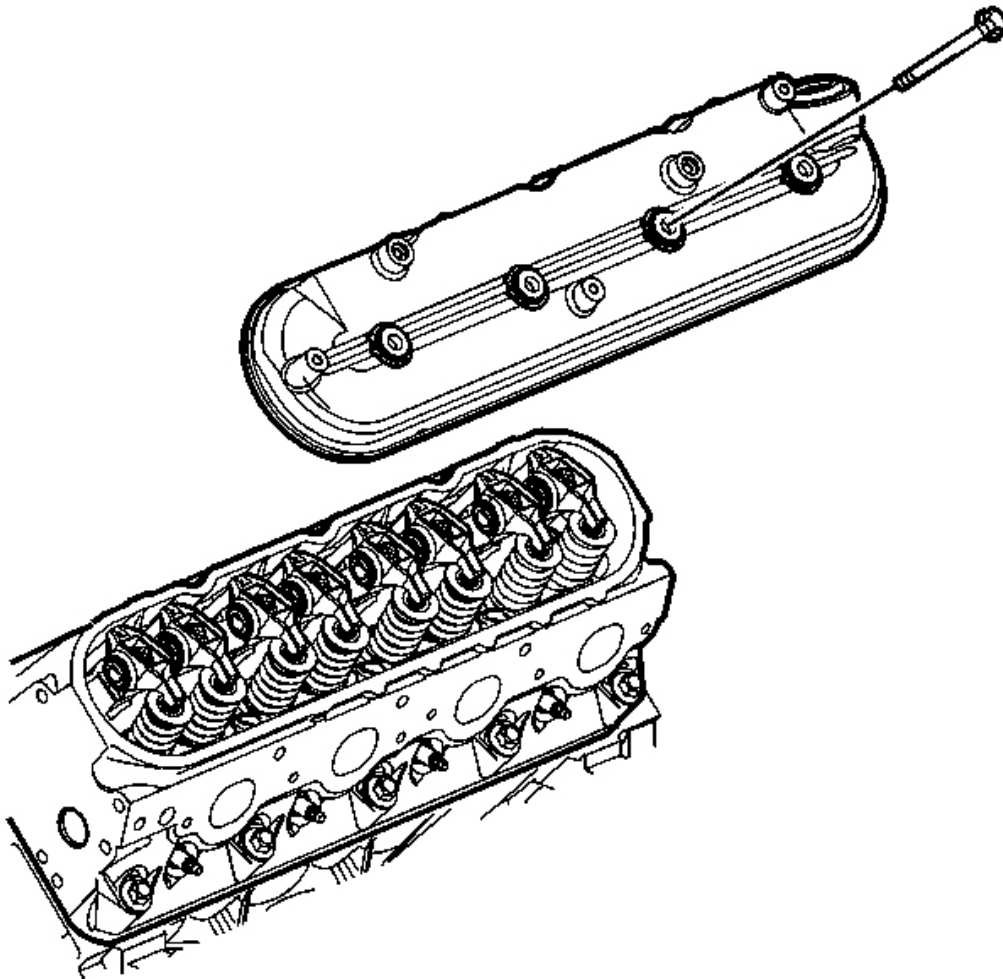
Fig. 122: Valve Cover To Cylinder Head View
Courtesy of GENERAL MOTORS CORP.

9. Remove the valve rocker arm cover bolts.
10. Remove the valve rocker arm cover.

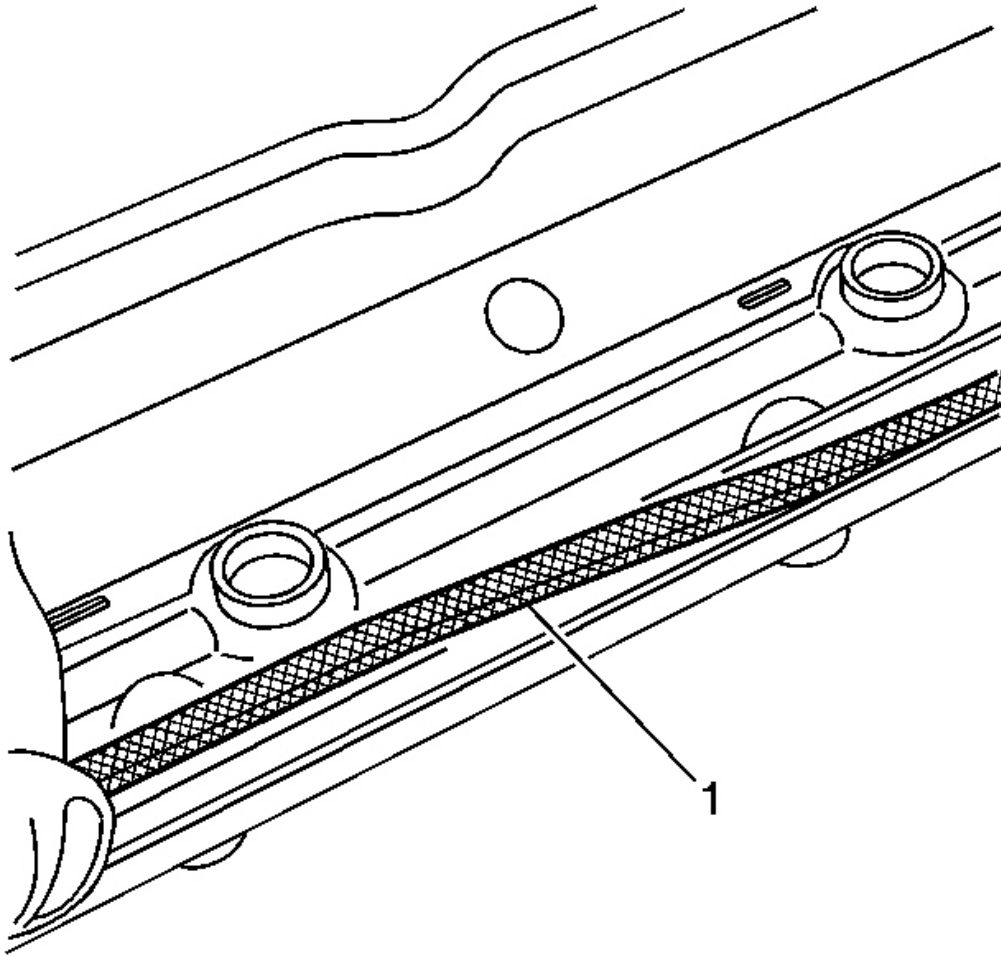
Fig. 123: Rocker Arm Cover Gasket
Courtesy of GENERAL MOTORS CORP.

11. Remove the gasket (1) from the rocker cover.
12. Discard the OLD gasket.

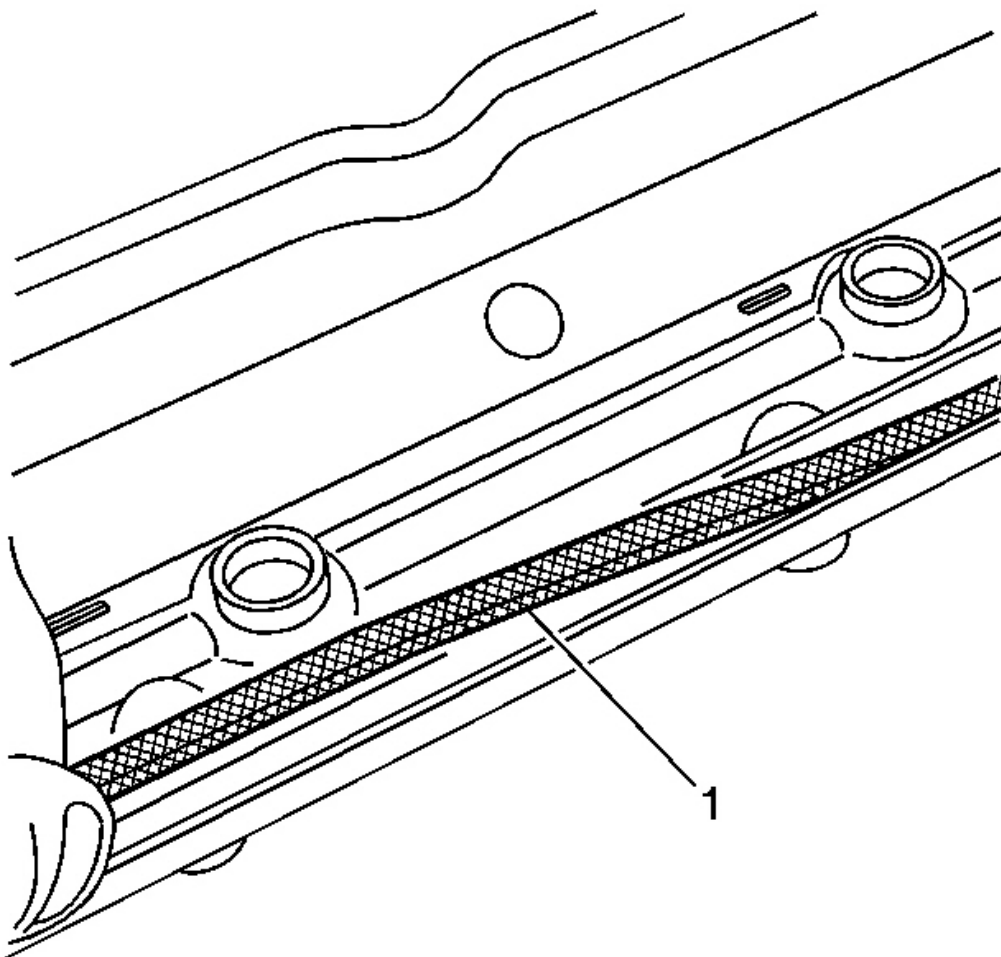
Fig. 124: Rocker Arm Cover Gasket
Courtesy of GENERAL MOTORS CORP.

1. Install a NEW rocker cover gasket (1) into the groove of the valve rocker arm cover.

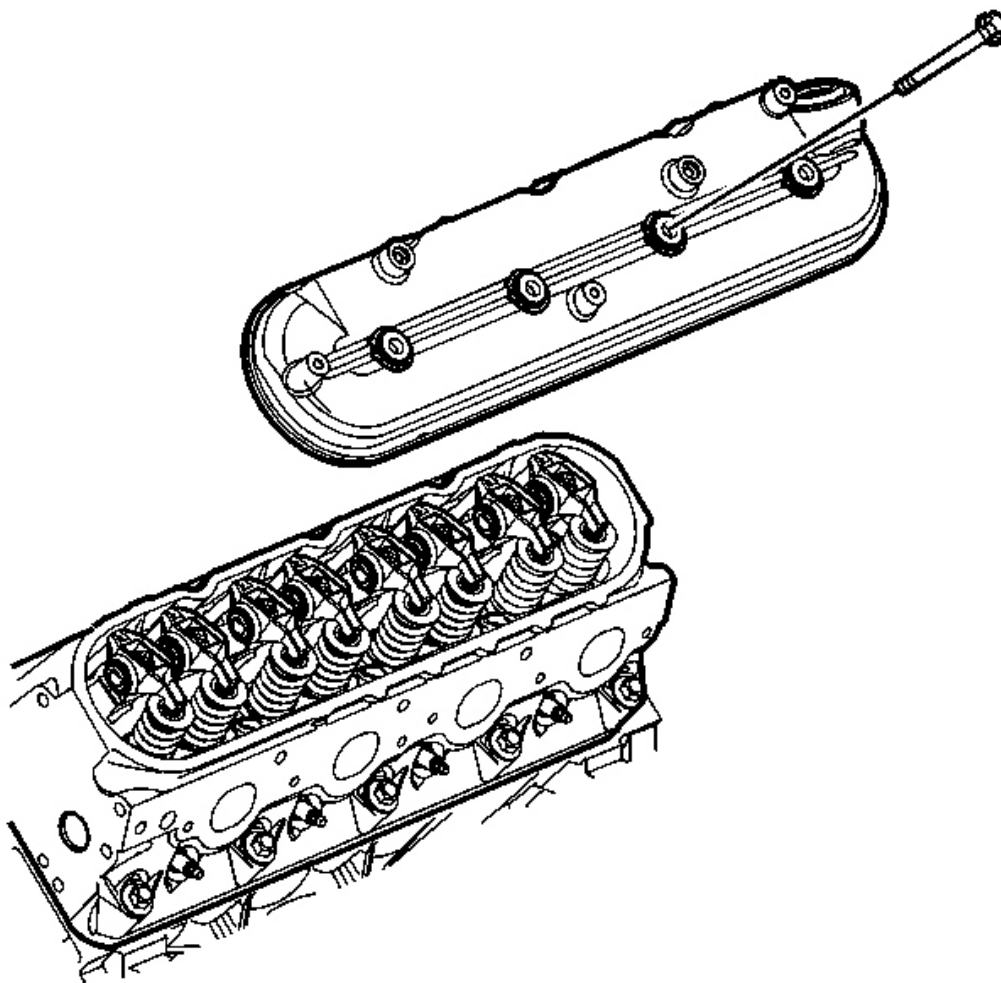
Fig. 125: Valve Cover To Cylinder Head View
Courtesy of GENERAL MOTORS CORP.

2. Install the valve rocker arm cover onto the cylinder head.
3. Install new rocker arm cover grommets, if necessary.

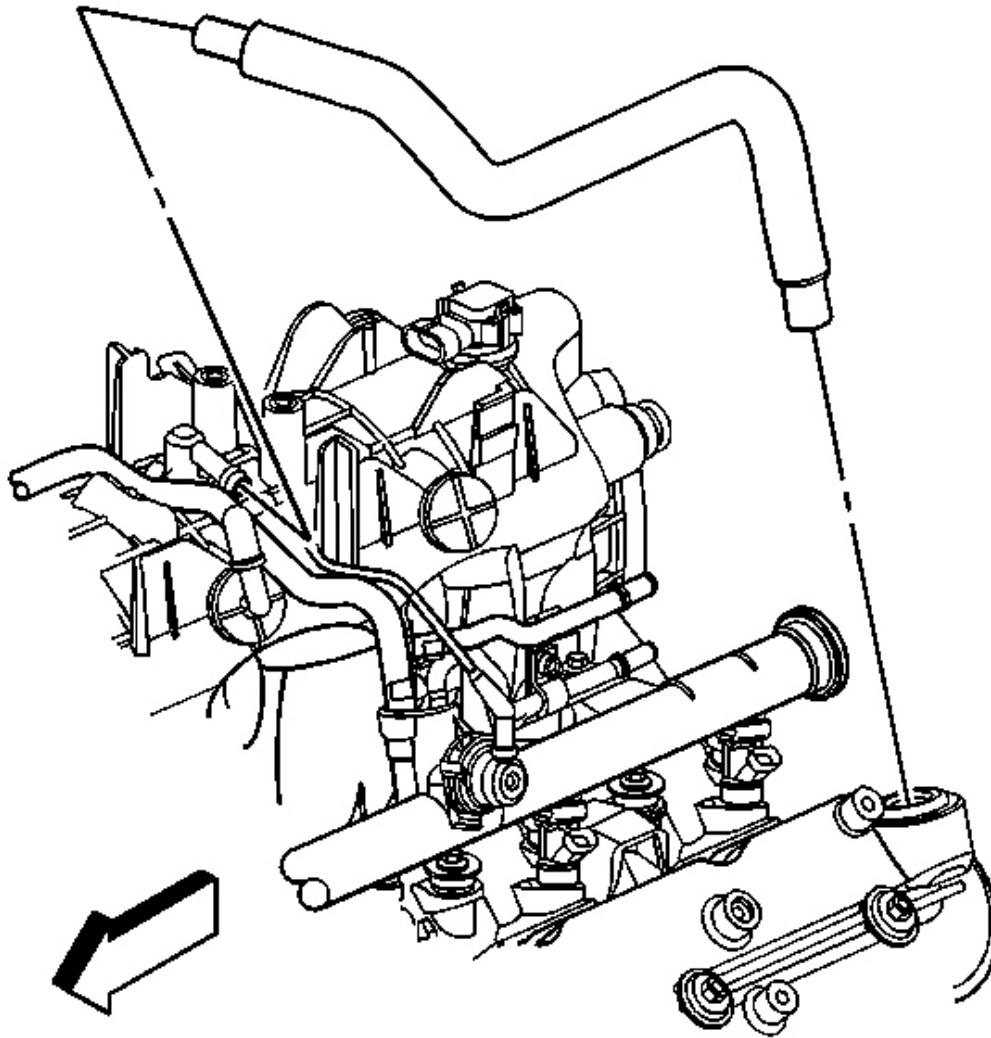
Fig. 126: Breather Crossover Tube View
Courtesy of GENERAL MOTORS CORP.

5. Install the PCV hose to the rocker arm cover.

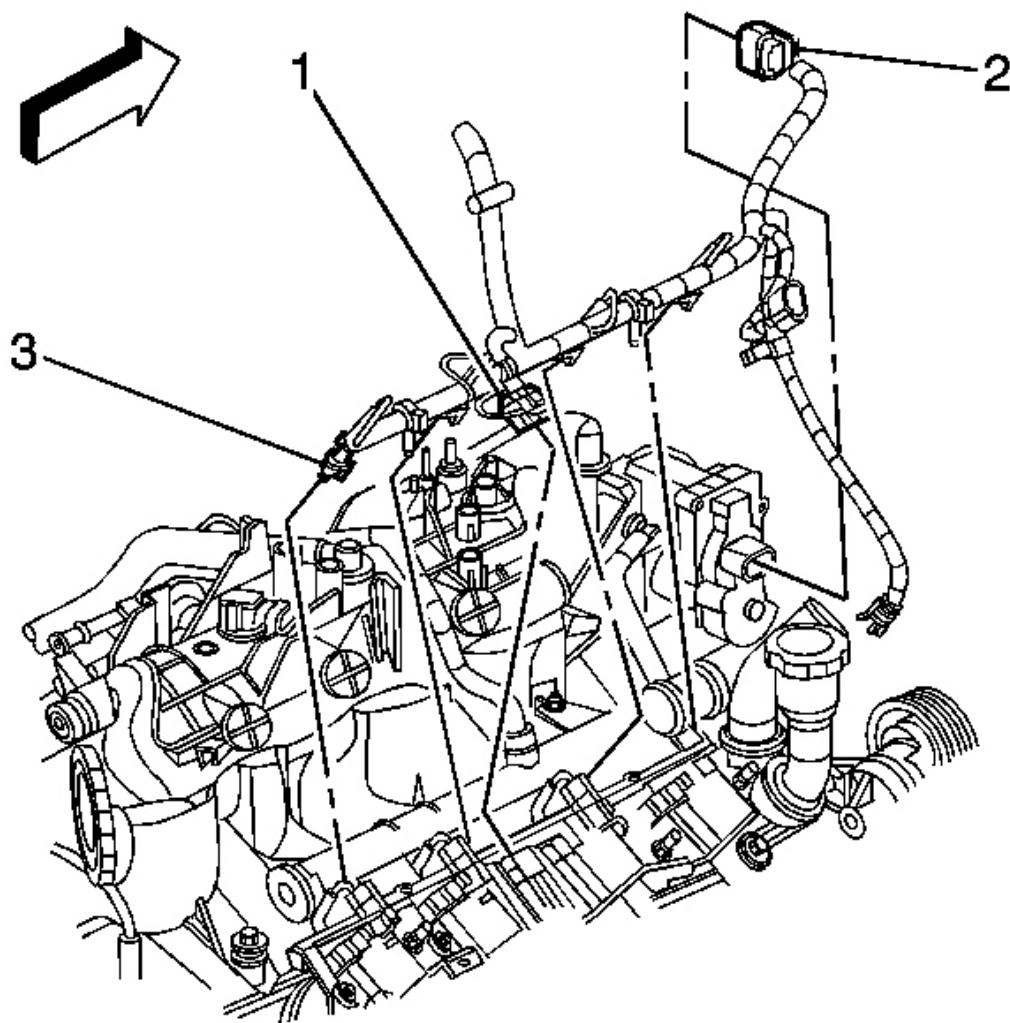
Fig. 129: Locating Electrical Components At Top Of Engine
Courtesy of GENERAL MOTORS CORP.

1. Remove the air conditioning (A/C) compressor hose. Refer to **Compressor Hose Assembly Replacement (Short Wheel Base)** or **Compressor Hose Assembly Replacement (Long Wheel Base)** in Heating, Ventilation, and Air Conditioning.
2. Remove the connector position assurance (CPA) lock.
3. Disconnect the main electrical connector (1) to the ignition coil wire harness.
4. Remove the harness clips.
5. Reposition the engine harness, if necessary.

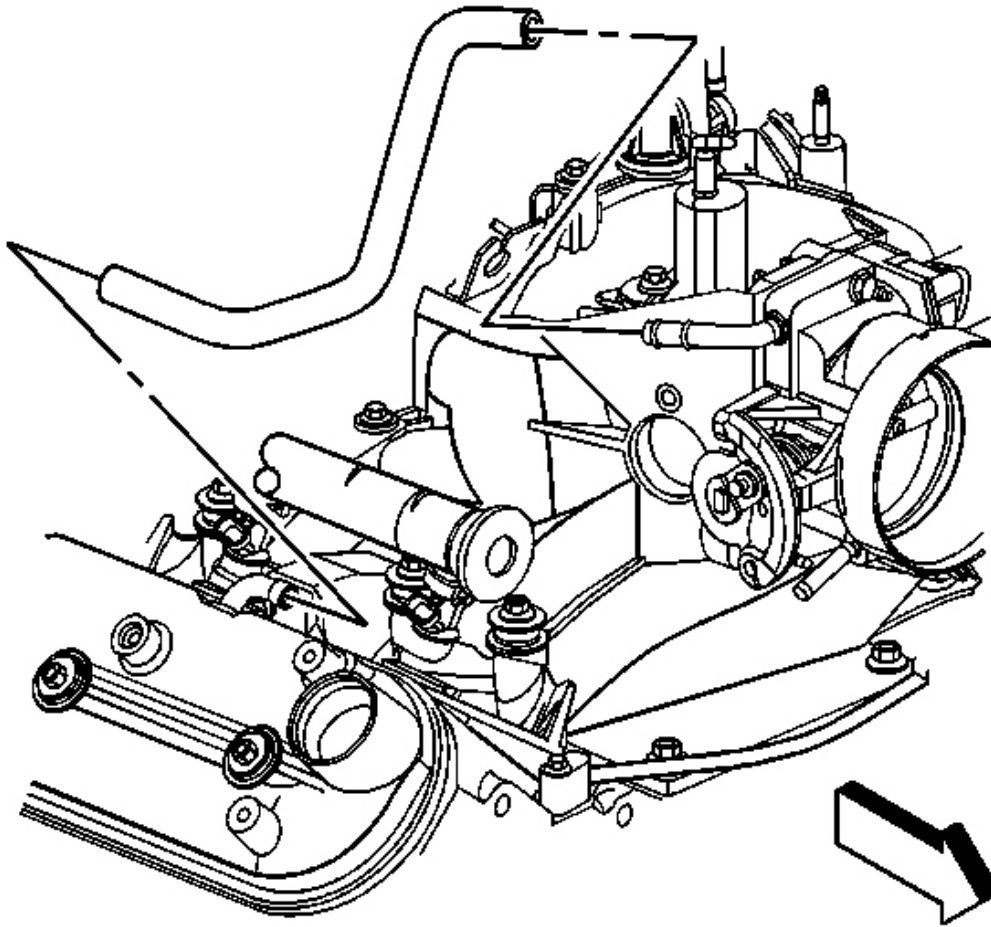
Fig. 131: Locating Breather Hose
Courtesy of GENERAL MOTORS CORP.

9. Remove the vent hose from the throttle body and valve rocker arm cover.

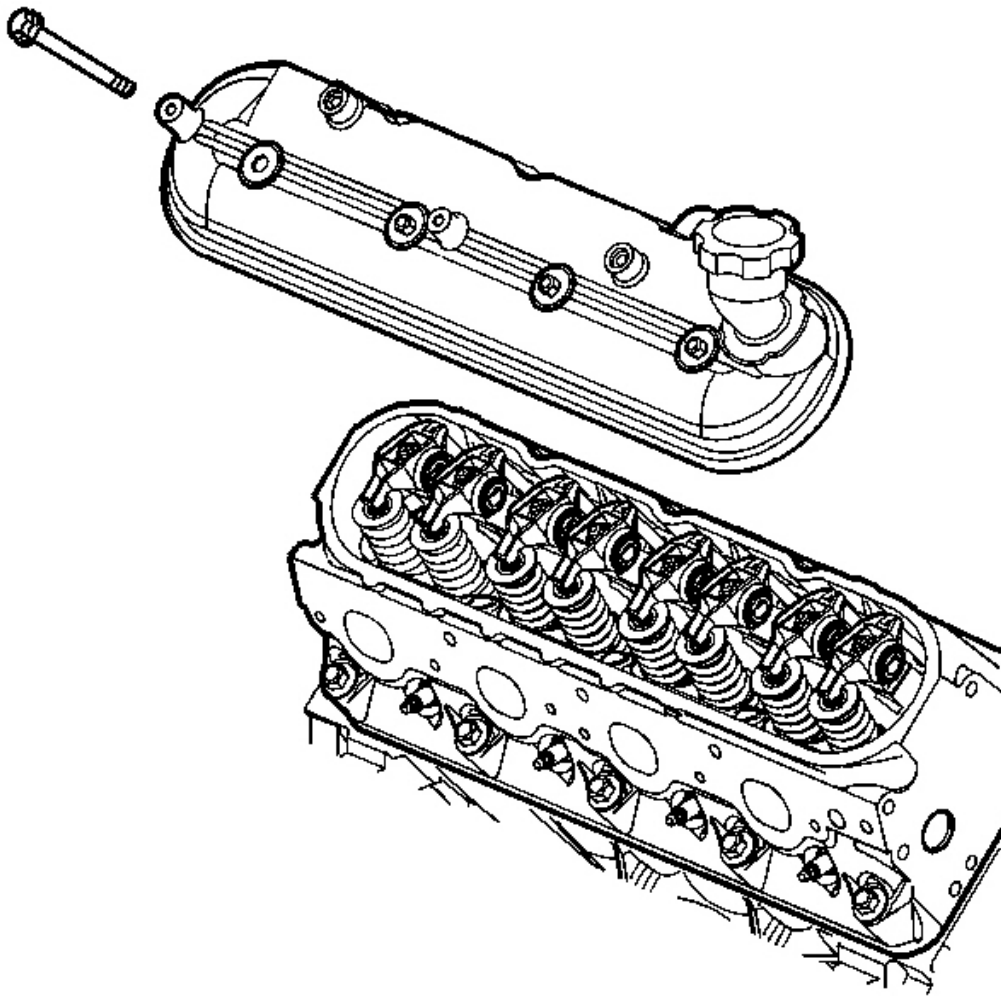
Fig. 132: View Of Valve Rocker Arm Cover & Bolts (Right)
Courtesy of GENERAL MOTORS CORP.

10. Remove the valve rocker arm cover bolts.
11. Remove the valve rocker arm cover.

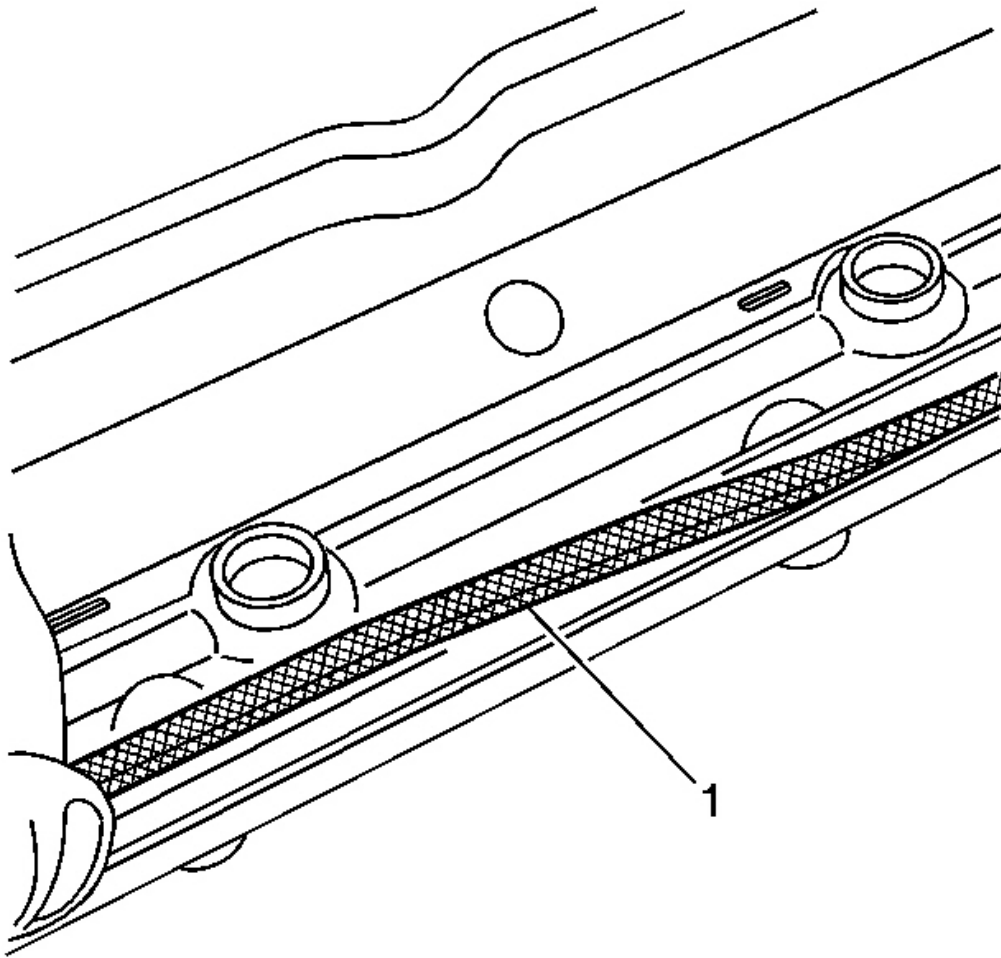
Fig. 133: Rocker Arm Cover Gasket
Courtesy of GENERAL MOTORS CORP.

12. Remove the gasket (1) from the rocker cover.
13. Discard the OLD gasket.

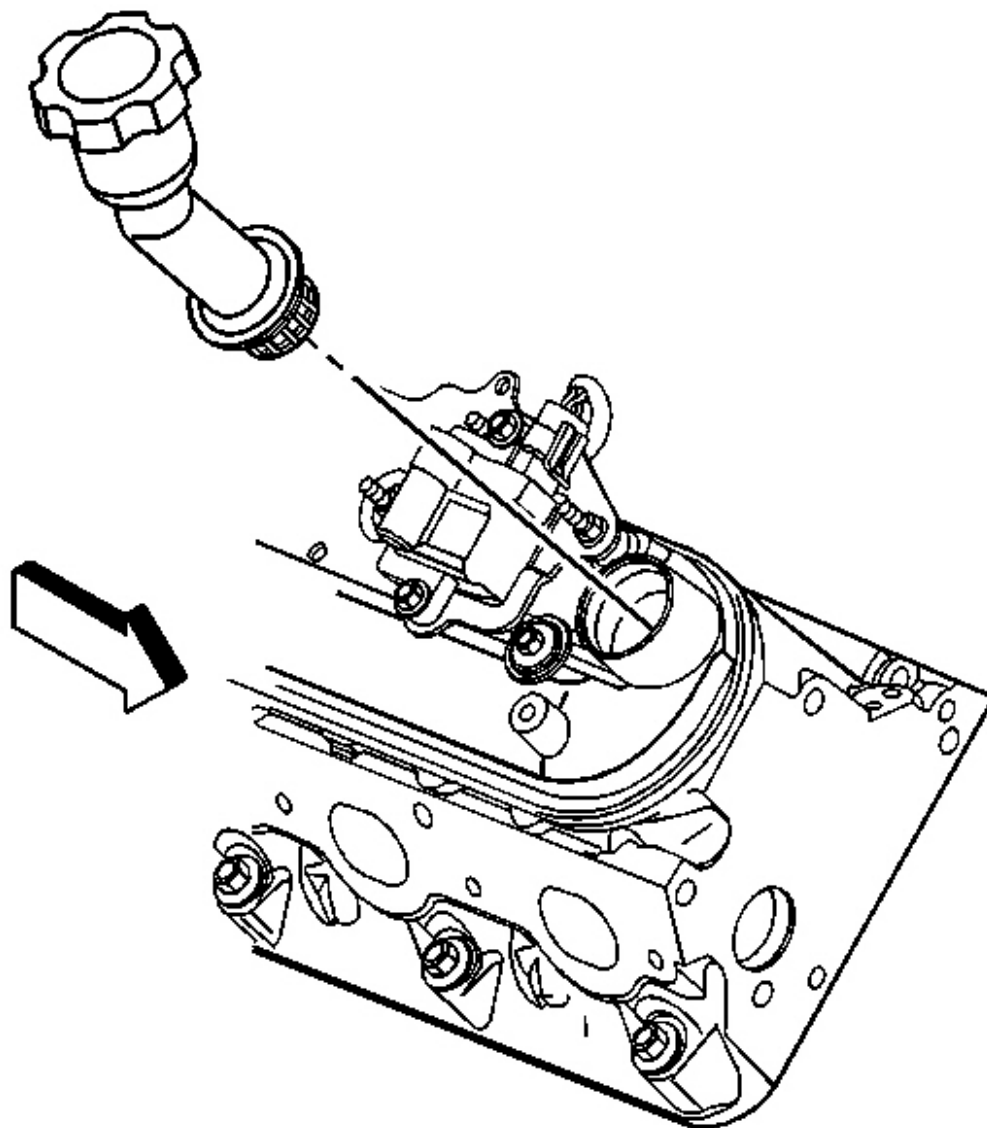
Fig. 134: View Of Oil Fill Tube
Courtesy of GENERAL MOTORS CORP.

14. Remove the oil fill cap from the oil fill tube.
15. Remove the oil fill tube from the rocker cover, if required.
16. Discard the oil fill tube.

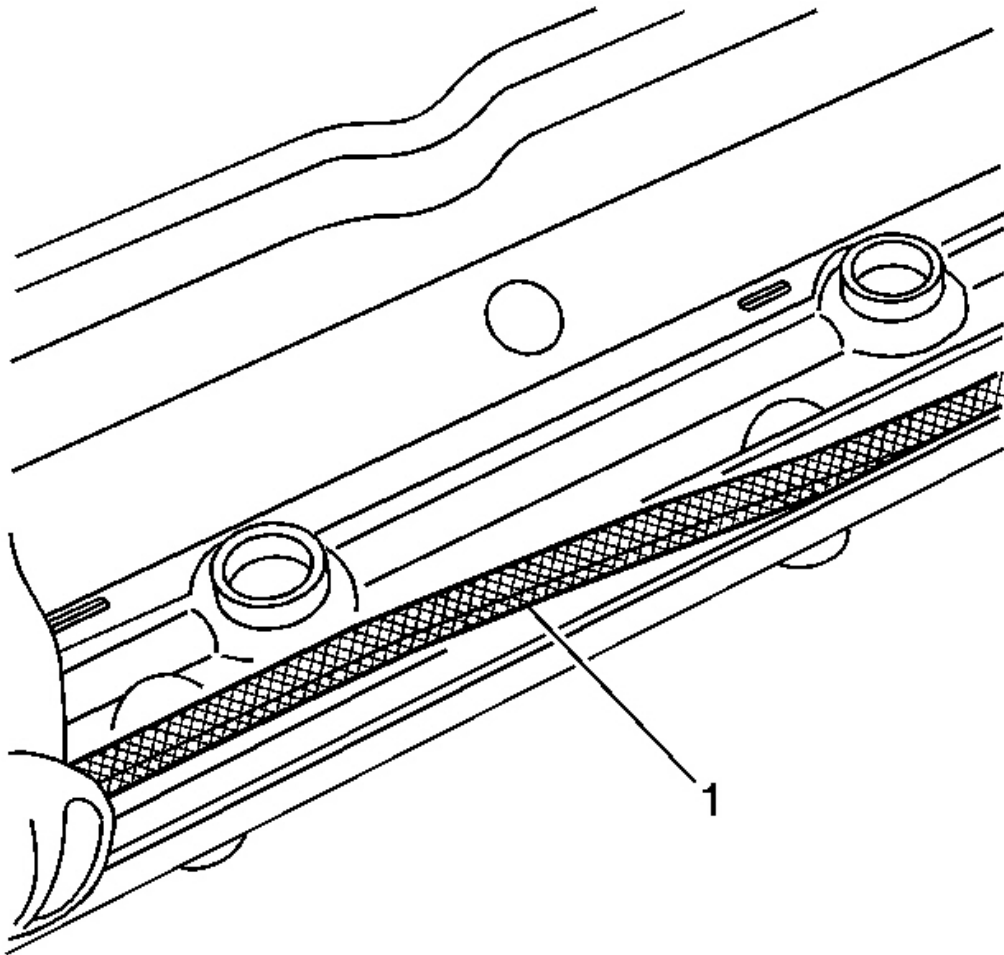
Fig. 136: Rocker Arm Cover Gasket
Courtesy of GENERAL MOTORS CORP.

4. Install a NEW rocker cover gasket (1) into the valve rocker arm cover.

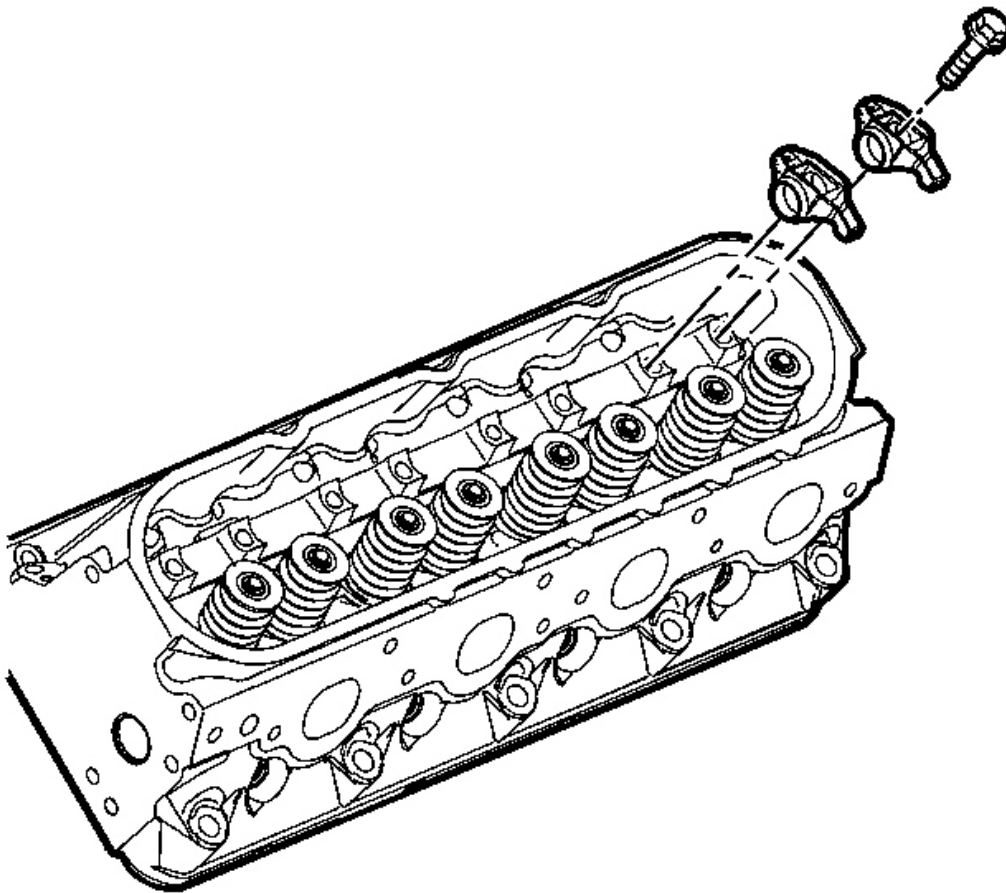
Fig. 141: View Of Rocker Arms & Bolts
Courtesy of GENERAL MOTORS CORP.

IMPORTANT: Place the valve rocker arms, pushrods, and pivot support, in a rack so that the can be installed in the same location from which they were removed.

2. Remove the valve rocker arm bolts.
3. Remove the valve rocker arms.

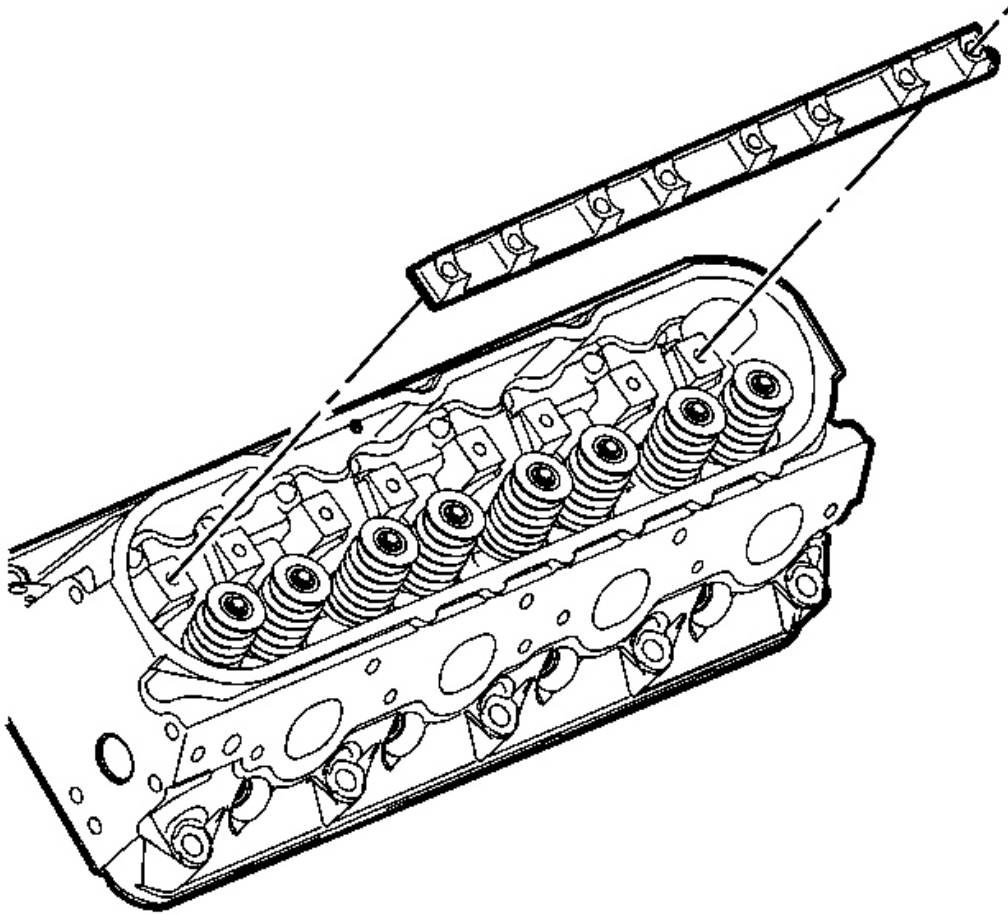
Fig. 142: View Of Valve Rocker Arm Pivot Support
Courtesy of GENERAL MOTORS CORP.

4. Remove the valve rocker arm pivot support.

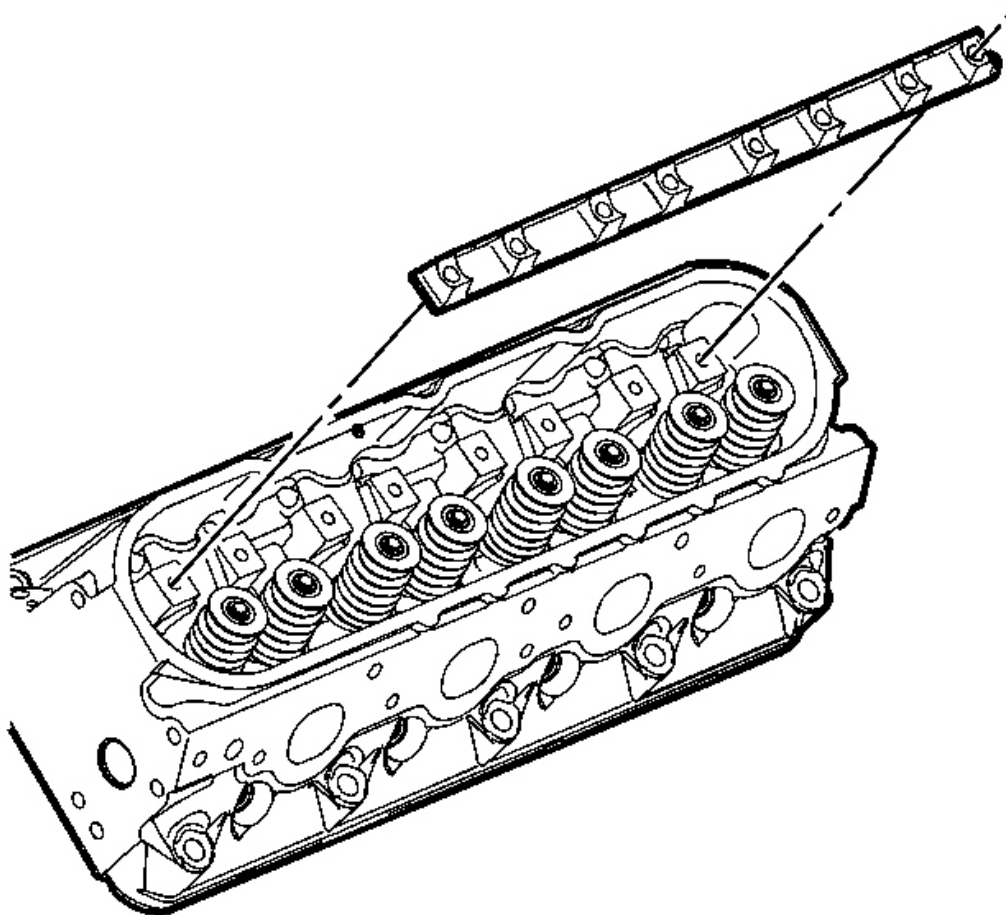
Fig. 144: View Of Valve Rocker Arm Pivot Support
Courtesy of GENERAL MOTORS CORP.

1. Lubricate the valve rocker arms and pushrods with clean engine oil.
2. Lubricate the flange of the valve rocker arm bolts with clean engine oil.
