2004 Isuzu Ascender LS

2004 ENGINE Engine Mechanical - 4.8L, 5.3L, and 6.0L - Ascender

Engine Mechanical - 4.8L, 5.3L, and 6.0L - Ascender

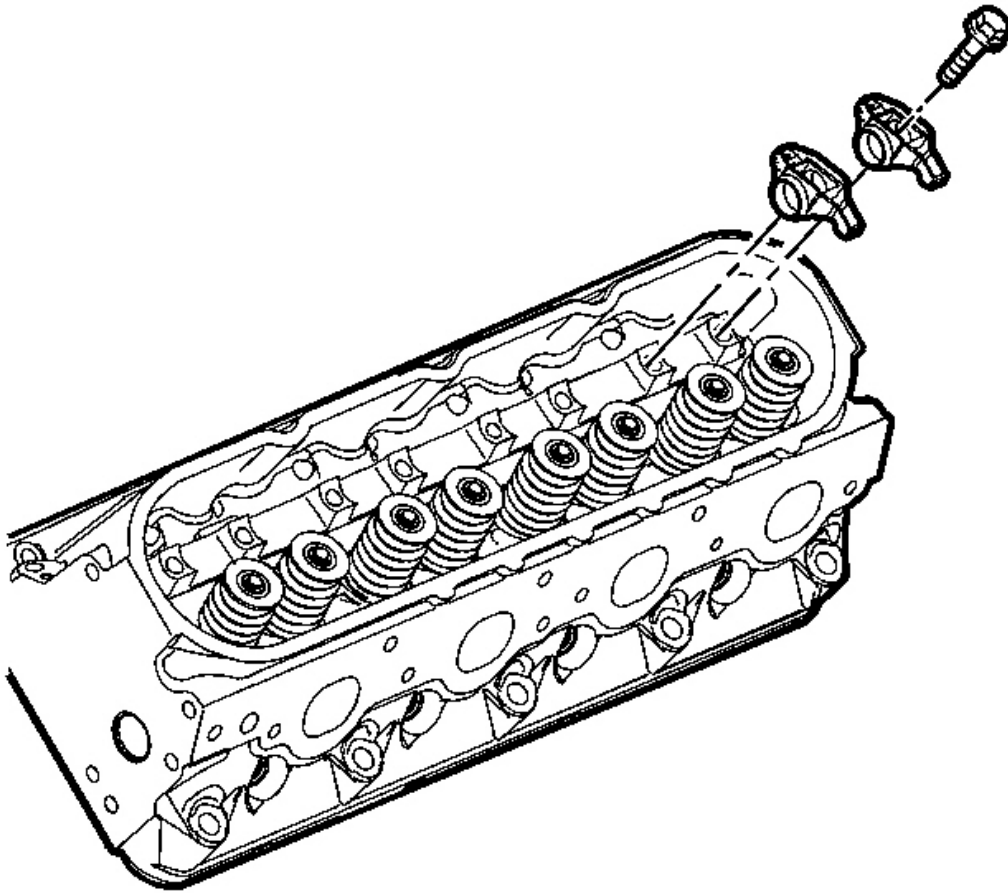
Fig. 146: View Of Rocker Arms & Bolts
Courtesy of GENERAL MOTORS CORP.

IMPORTANT: Make sure that the pushrods seat properly to the ends of the rocker arms.
DO NOT tighten the rocker arm bolts at this time.

5. Install the rocker arms and bolts.

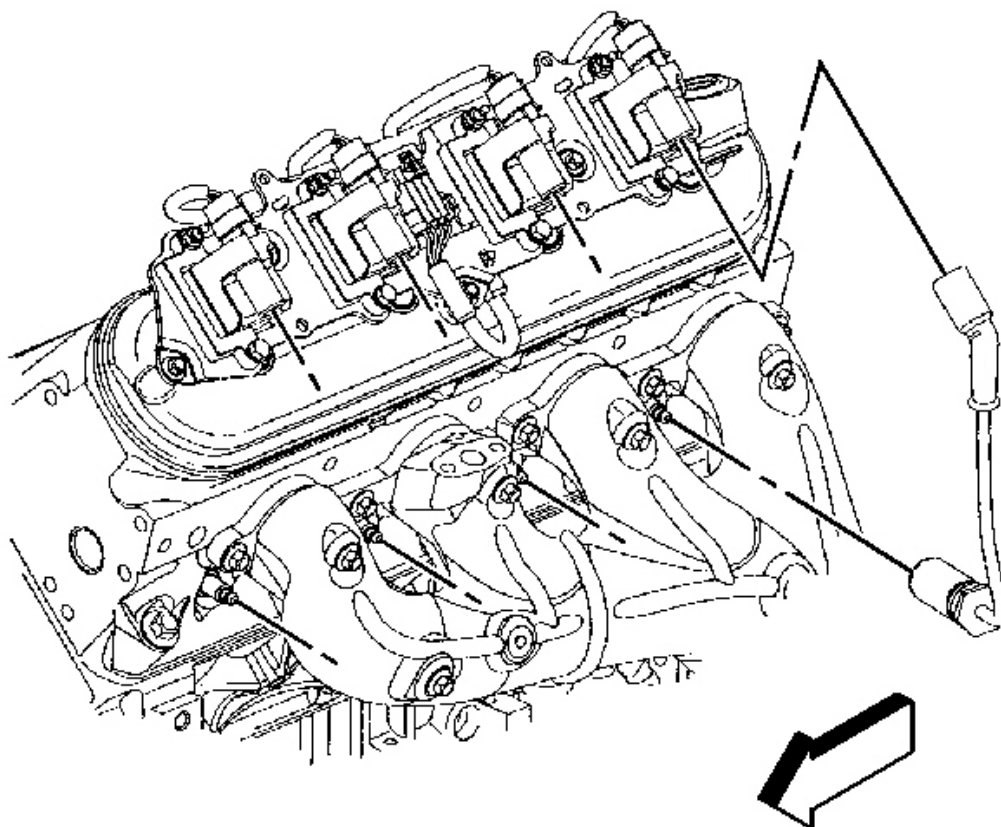
Fig. 148: View Of Spark Plug Wire & Boot
Courtesy of GENERAL MOTORS CORP.

1. Remove the valve rocker arm. Refer to **Valve Rocker Arm and Push Rod Replacement**.
2. Disconnect the spark plug wire at the spark plug.
 - Twist each plug wire boot 1/2 turn.
 - Pull only on the boot in order to remove the wire from the spark plug.

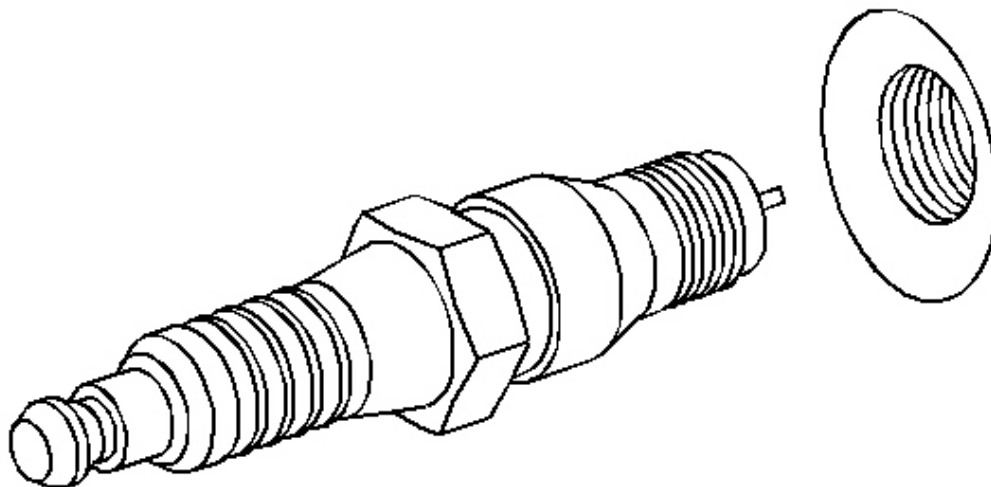
Fig. 149: View Of Spark Plug And Sparkplug Seat
Courtesy of GENERAL MOTORS CORP.

IMPORTANT: Remove the spark plugs from the cylinder head with the engine at room temperature.

3. Loosen the spark plug 1 or 2 turns.
4. Brush or air blast away any dirt or debris from around the spark plug.
5. Remove the spark plug.

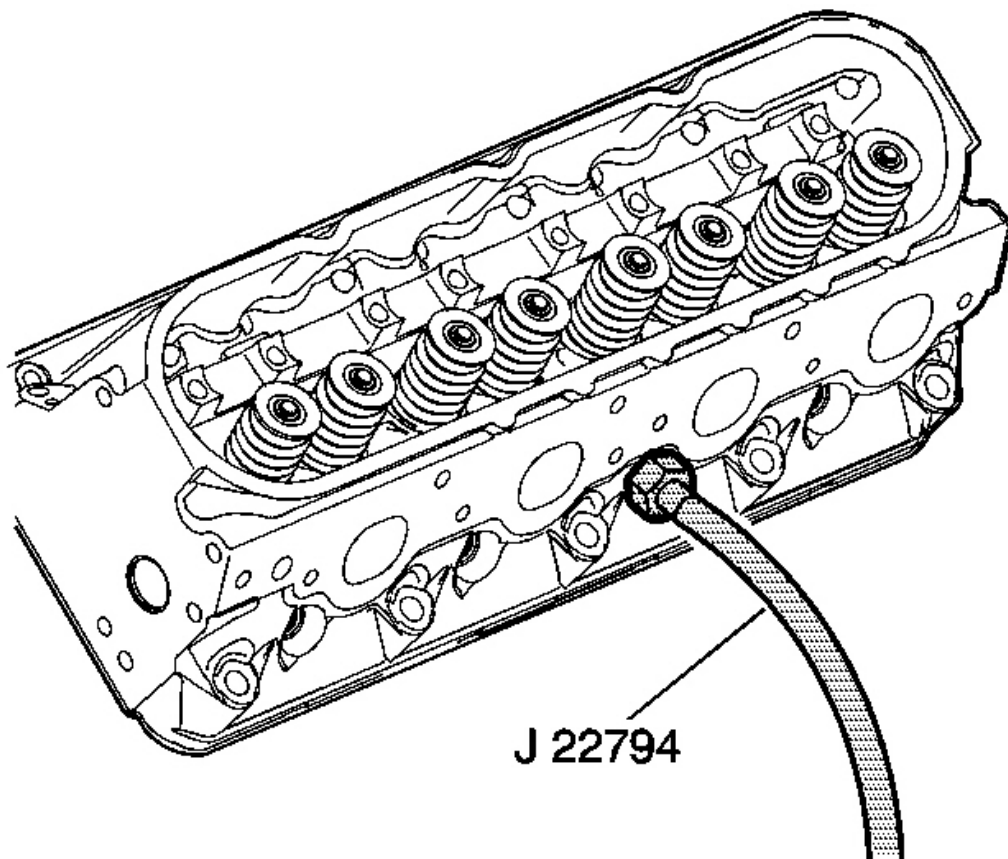
Fig. 150: View Of J 22794

6. Install **J 22794** into the spark plug hole. See **Special Tools and Equipment**.
7. Attach an air hose to **J 22794** . See **Special Tools and Equipment**.
8. Apply compressed air to **J 22794** in order to hold the valves in place. See **Special Tools and Equipment**.

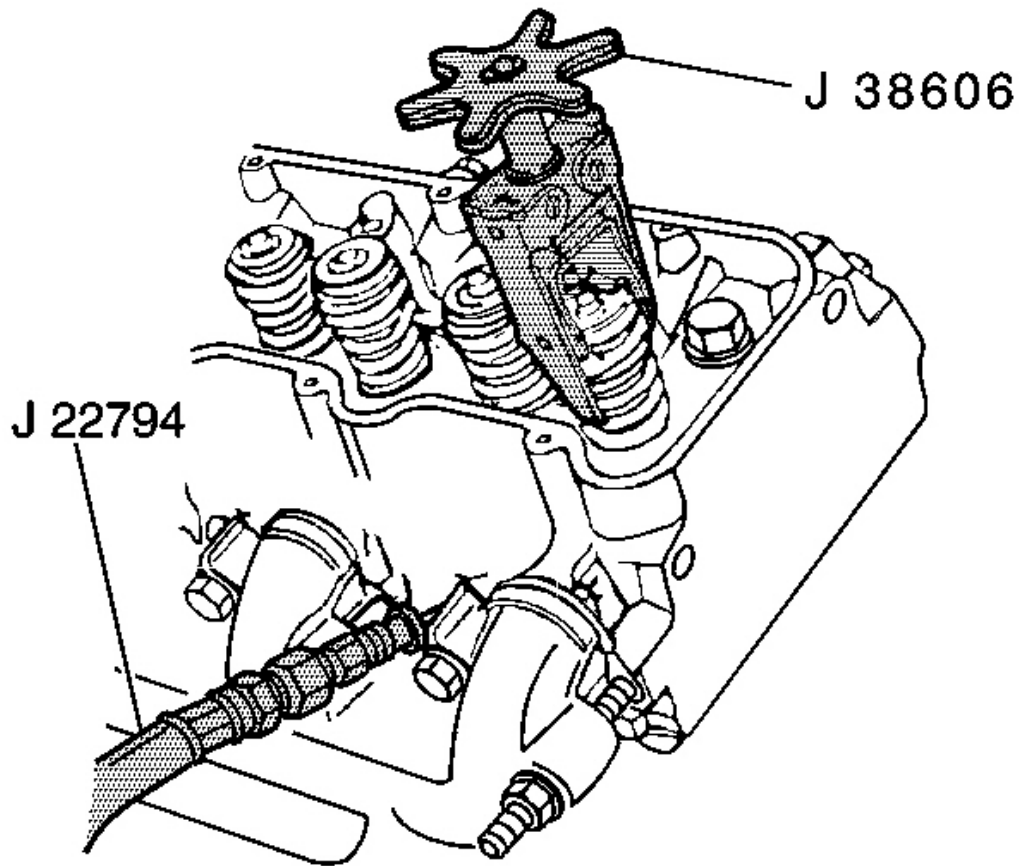
Fig. 151: Compress The Valve Spring (Cylinder Head Installed) Using Special Tools
Courtesy of GENERAL MOTORS CORP.

9. Use **J 38606** in order to compress the valve spring. See **Special Tools and Equipment**.

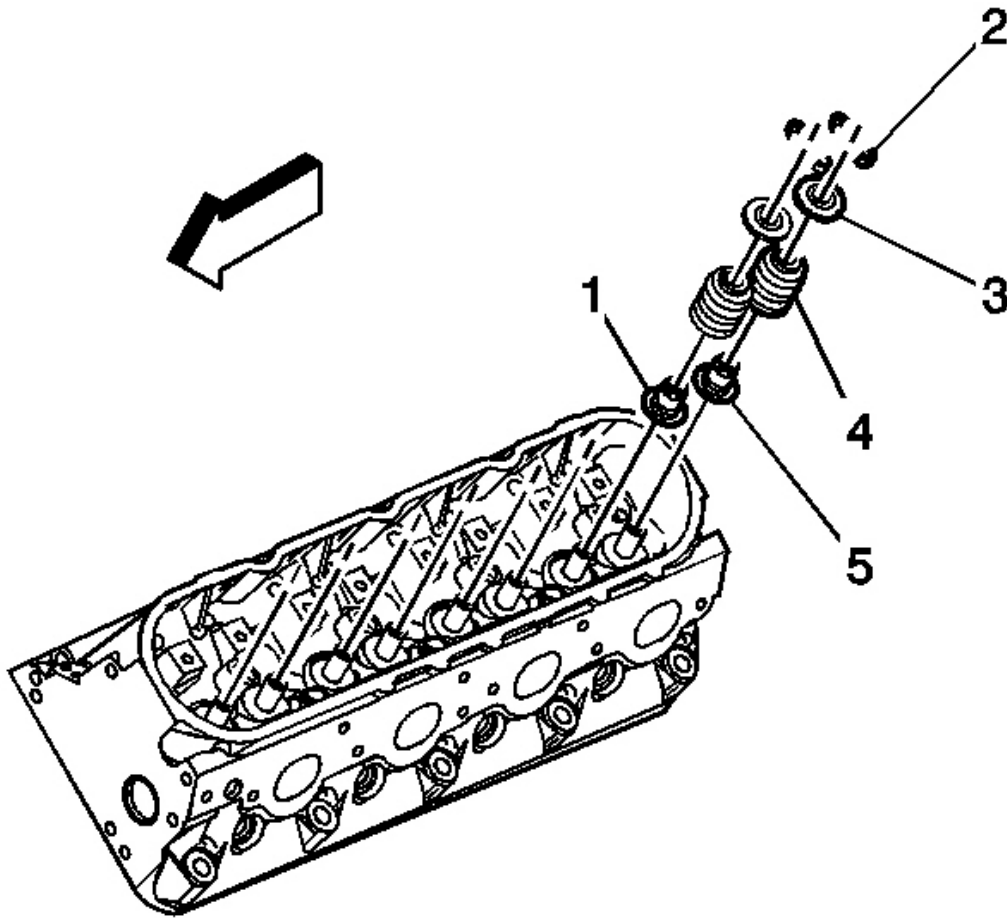
Fig. 152: View Of Valve Stem & Valve Spring Components
Courtesy of GENERAL MOTORS CORP.

10. Remove the valve stem keys (2).
11. Carefully release the valve spring tension.
12. Remove the **J 38606** . See **Special Tools and Equipment**.
13. Remove the valve spring cap (3).
14. Remove the valve spring (4).
15. Remove the valve stem oil seal and shim (1, 5).

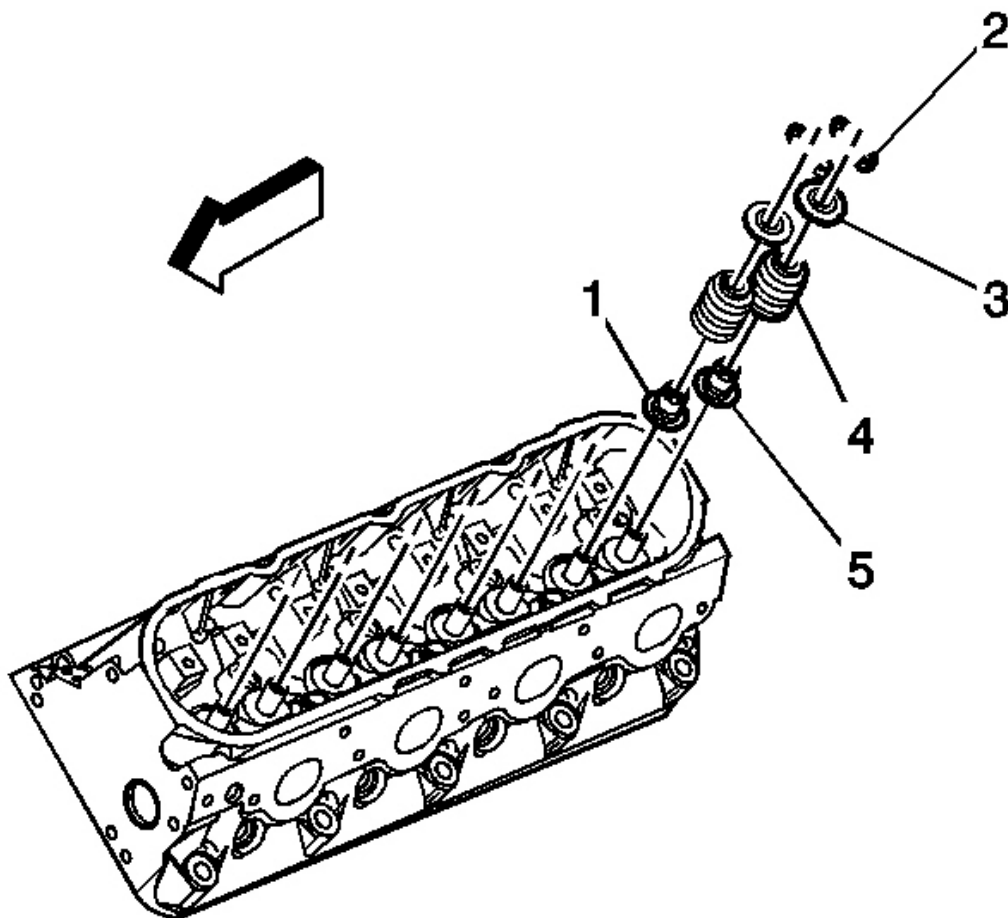
Fig. 153: View Of Valve Stem & Valve Spring Components
Courtesy of GENERAL MOTORS CORP.

1. Clean the cylinder head valve spring seat and/or shim area.
2. Lubricate the valve guide and valve stem oil seal with clean engine oil.
3. Install the valve stem oil seal and shim (1, 5).
4. Install the valve spring (4).
5. Install the valve spring cap (3).

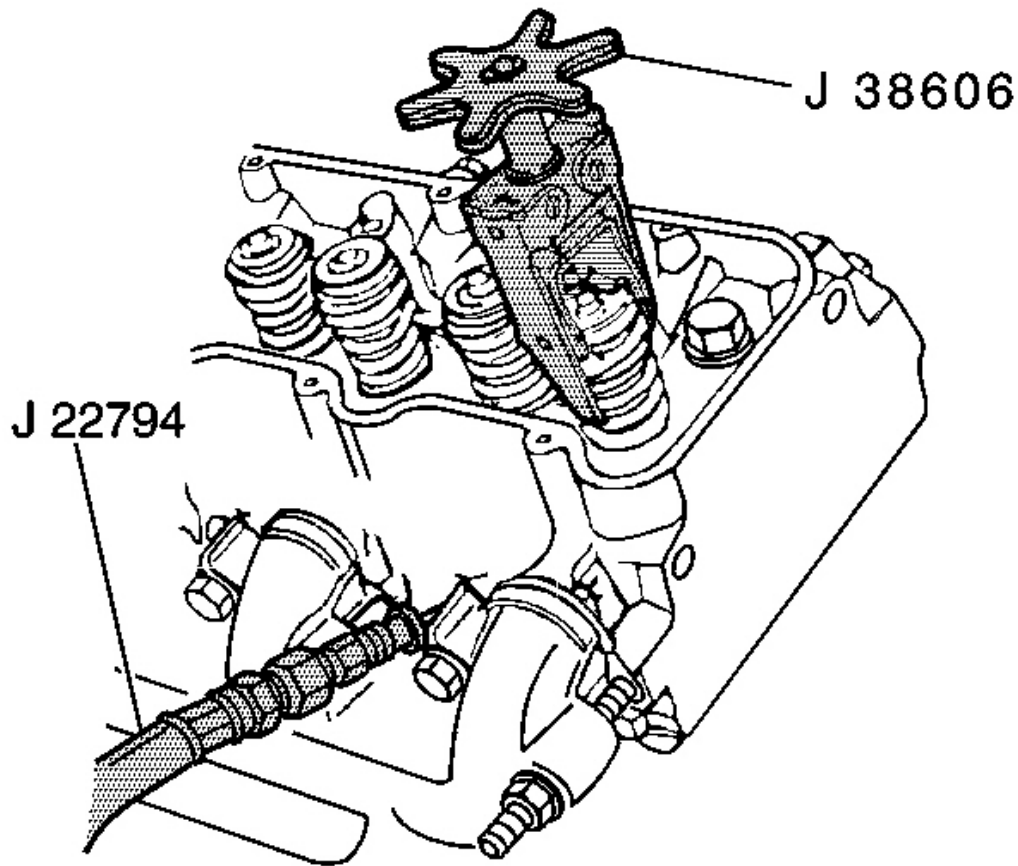
Fig. 154: Compress The Valve Spring (Cylinder Head Installed) Using Special Tools
Courtesy of GENERAL MOTORS CORP.

6. Compress the valve spring using the **J 38606** . See **Special Tools and Equipment**.
7. Install the valve keys.
 1. Use grease in order to hold the valve keys in place.
 2. Make sure the keys seat properly in the groove of the valve stem.
 3. Carefully release the valve spring pressure, making sure the valve keys stay in place.
 4. Remove the **J 38606** . See **Special Tools and Equipment**.
 5. Tap the end of the valve stem with a plastic faced hammer to seat the keys (if necessary).

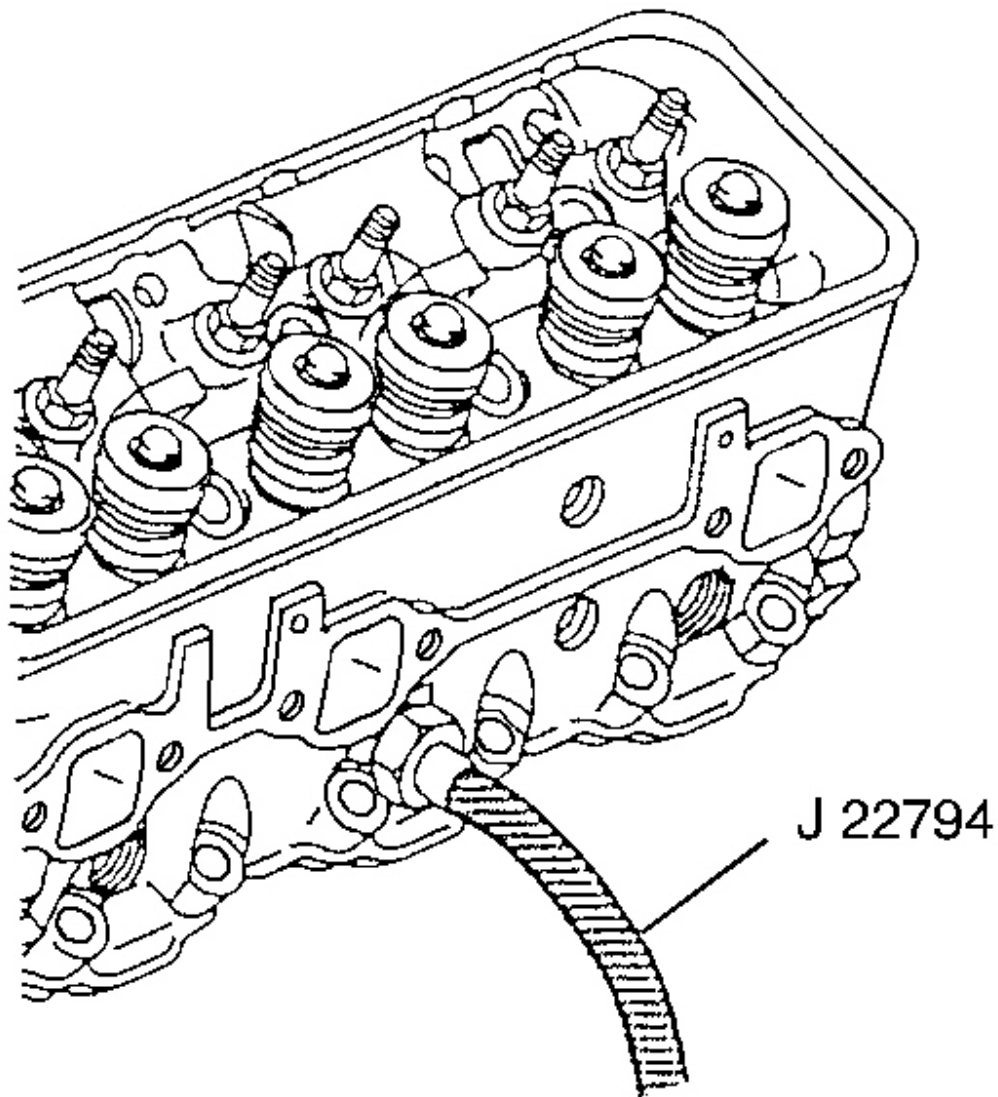
Fig. 155: Removing J 22794

8. Remove **J 22794** from the spark plug port. See **Special Tools and Equipment**.

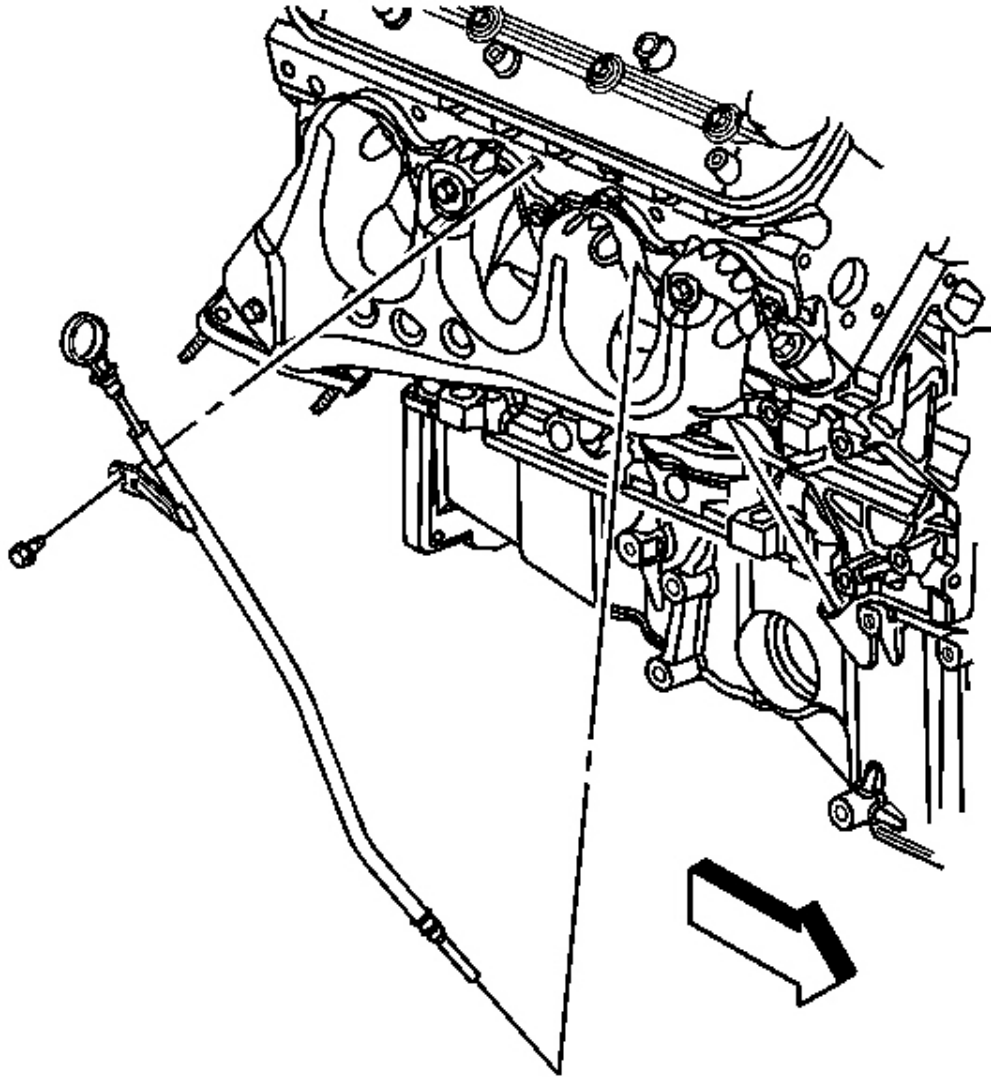
Fig. 157: View Of Oil Level Indicator Tube
Courtesy of GENERAL MOTORS CORP.

1. Remove the cylinder number 2 spark plug and wire. Refer to **Spark Plug Replacement** in Engine Controls - 4.8L, 5.3L, and 6.0L.
2. Remove the oil level indicator from the tube.
3. Remove the oil level indicator tube bolt.
4. Remove the oil level indicator tube from the engine block.

IMPORTANT: The O-ring seal may be reused if not cut or damaged.

5. Inspect the O-ring seal for cuts or damage.
6. Remove the O-ring seal from the tube (if required).

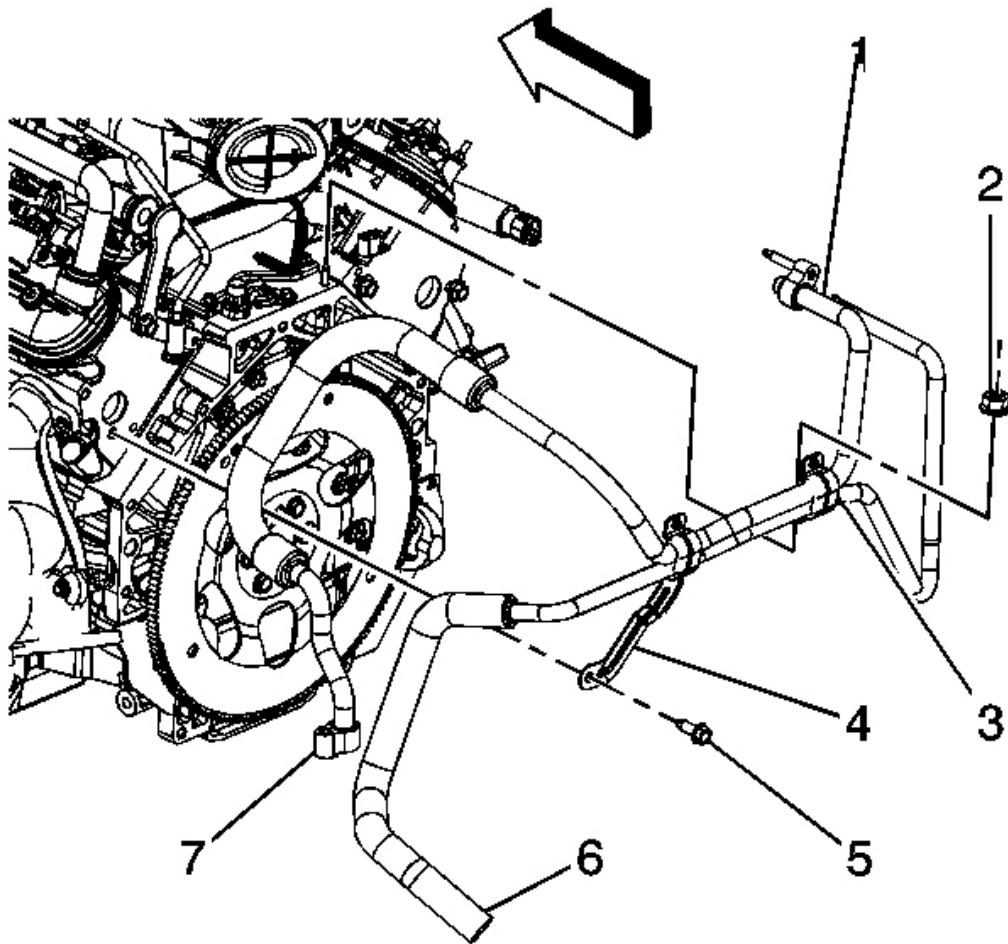
Fig. 159: View Of Rear A/C Lines
Courtesy of GENERAL MOTORS CORP.

1. Remove the generator bracket. Refer to **Generator Bracket Replacement (5.3L Engine)** in Engine Electrical.
2. Remove the coolant air bleed pipe. Refer to **Coolant Air Bleed Pipe Assembly Replacement (5.3L Engine)** in Engine Cooling.
3. Remove the left exhaust manifold. Refer to **Exhaust Manifold Replacement - Left (5.3L Engine)** in Engine Exhaust.
4. Remove the pushrods. Refer to **Valve Rocker Arm and Push Rod Replacement**.
5. If equipped, remove the auxiliary air conditioning (A/C) bracket bolt (5).

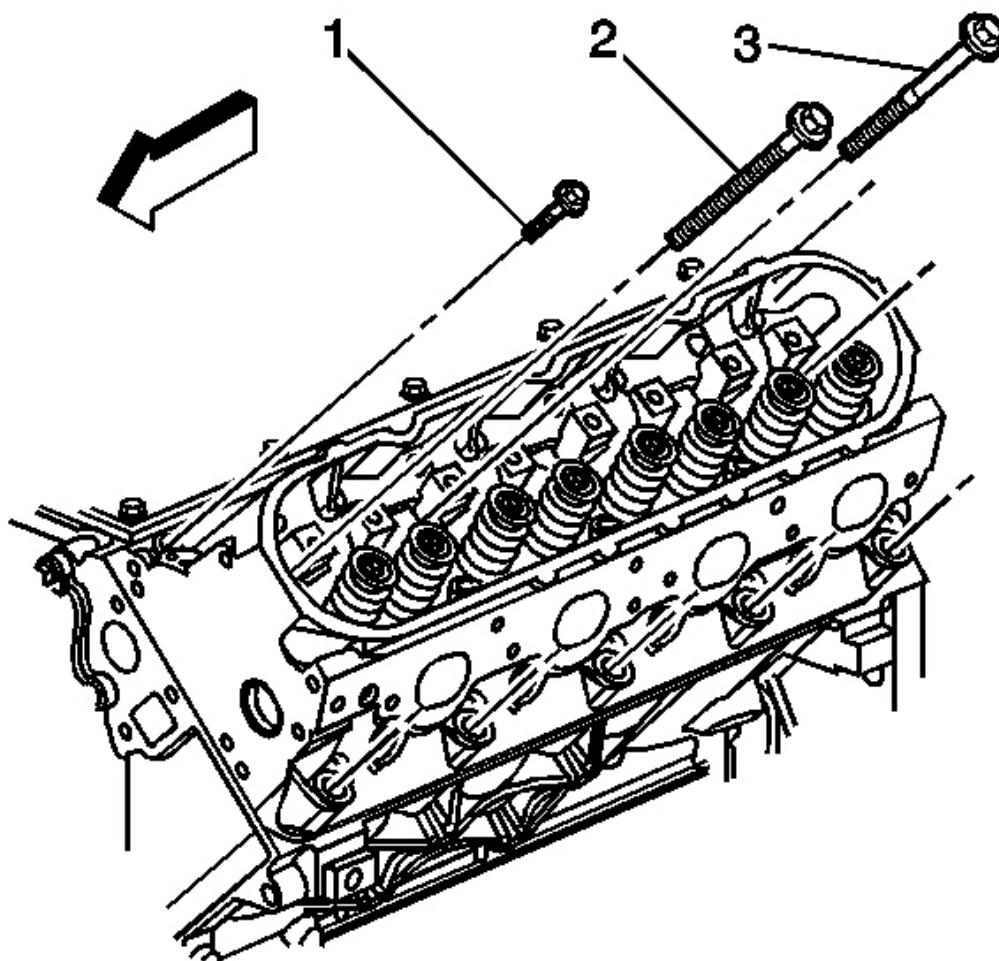
Fig. 160: View Of Cylinder Head Bolts
Courtesy of GENERAL MOTORS CORP.

IMPORTANT: The cylinder head bolts are NOT reusable.

6. Remove and discard the cylinder head bolts (1, 2, 3).

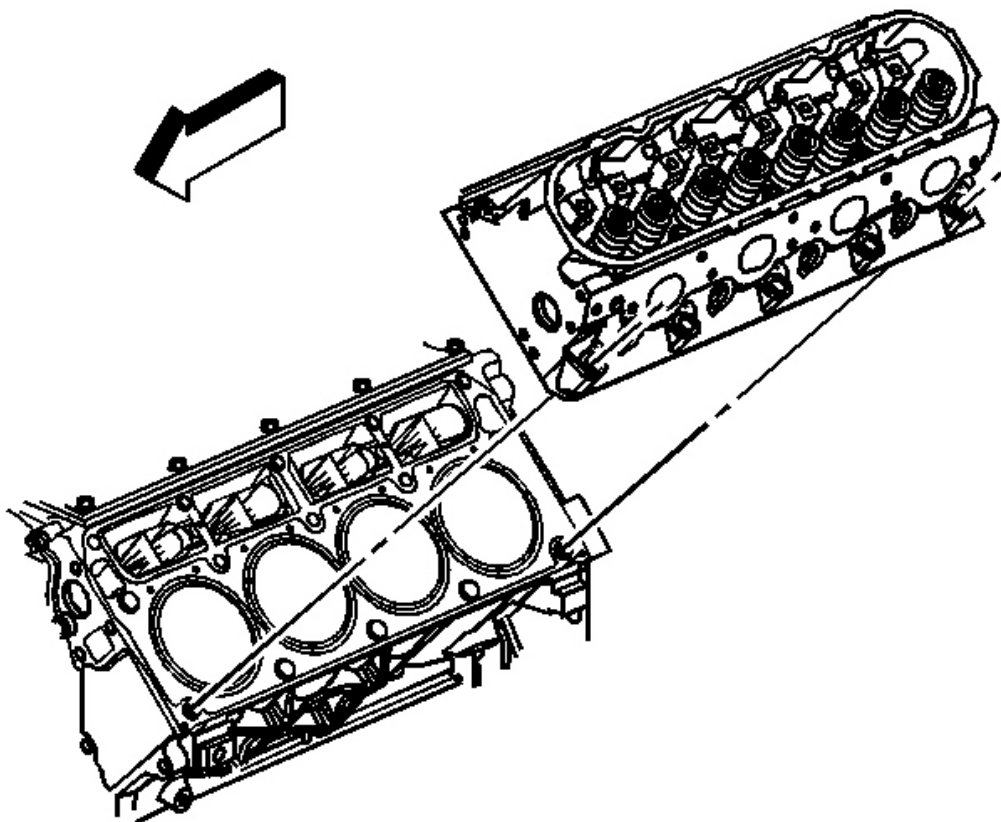
Fig. 161: View Of Left Cylinder Head
Courtesy of GENERAL MOTORS CORP.

NOTE: After removal, place the cylinder head on two wood blocks to prevent damage to the sealing surfaces.

7. Remove the cylinder head.

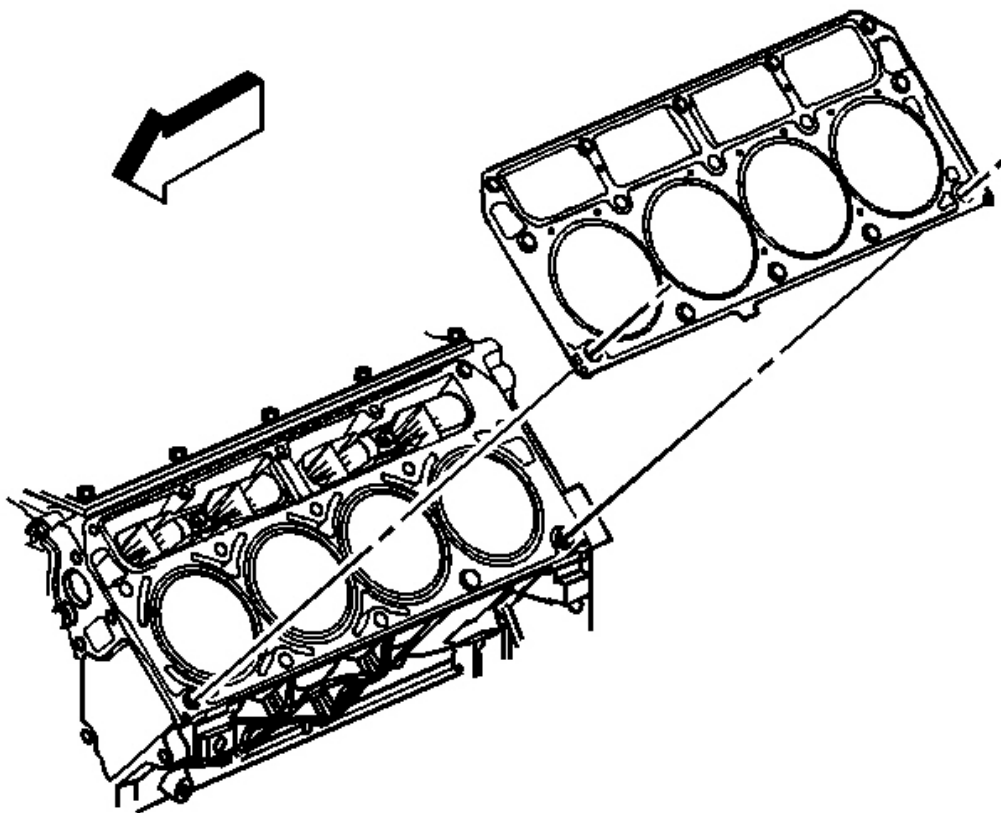
Fig. 162: View Of Cylinder Head Gasket
Courtesy of GENERAL MOTORS CORP.

8. Remove and discard the cylinder head gasket.
9. Clean and inspect the cylinder head. Refer to Cylinder Head Cleaning and Inspection.

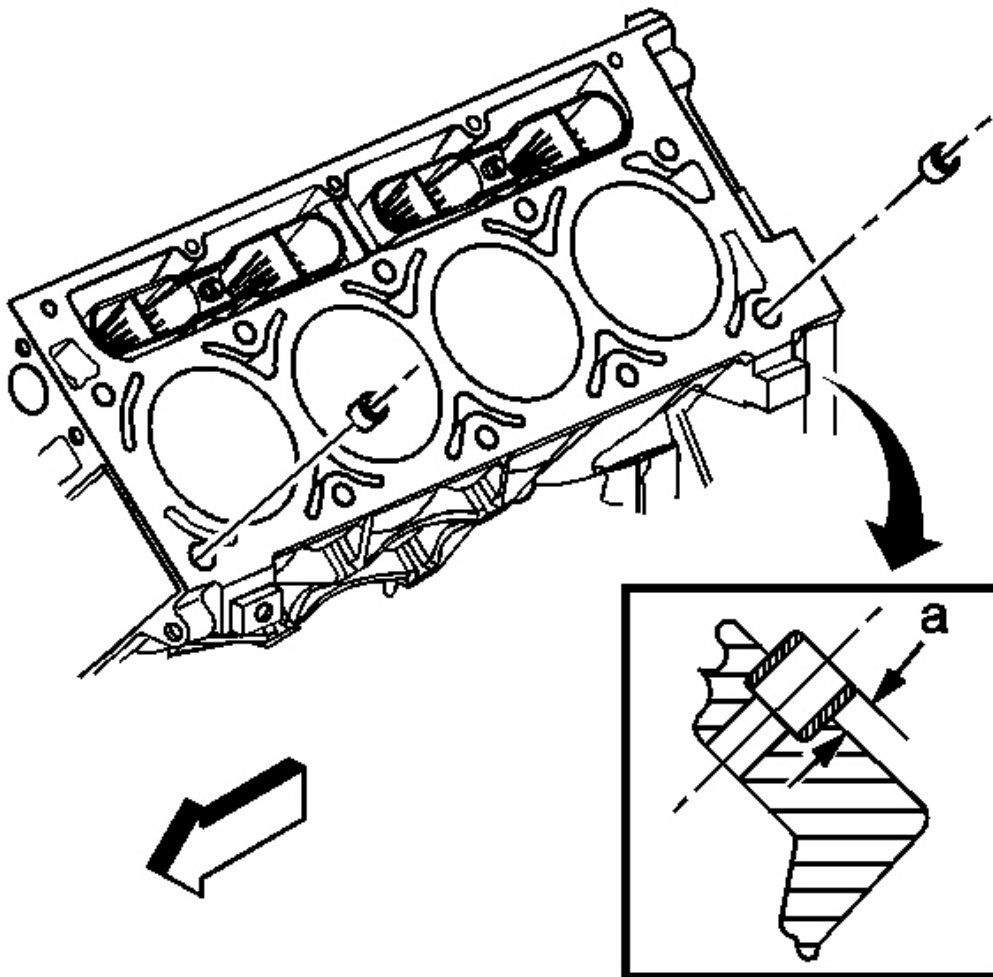
Fig. 163: Checking Cylinder Head Bolt Holes
Courtesy of GENERAL MOTORS CORP.

1. Clean the engine block cylinder head bolt holes (if required).

Thread repair tool J 42385-107, found in **J 42385-200** may be used to clean the threads of old threadlocking material. See **Special Tools and Equipment**.

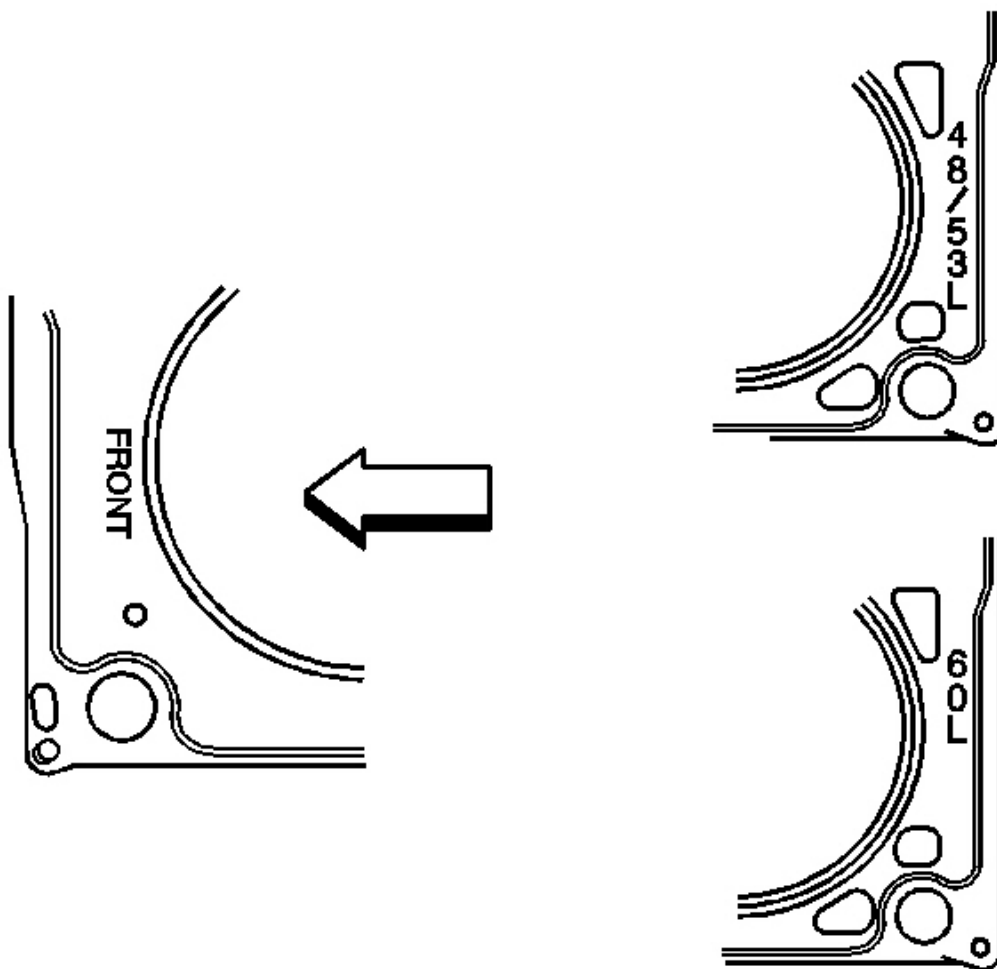
2. Use spray cleaner GM P/N 12346139, or GM P/N 12377981 (Canadian P/N 10953463), or equivalent into the hole.
3. Clean the cylinder head bolt holes with compressed air.
4. Check the cylinder head locating pins for proper installation, location (a) 8.3 mm (0.327 in).

Fig. 164: View Of Proper Location For Cylinder Head Gasket Tab
Courtesy of GENERAL MOTORS CORP.

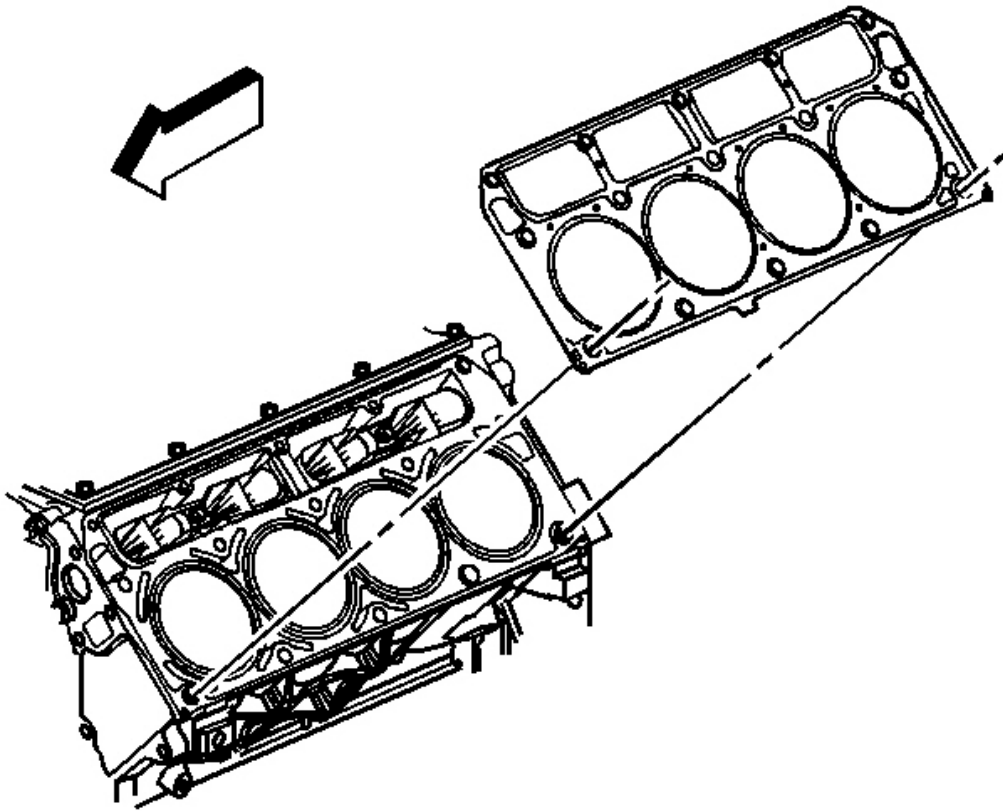
Fig. 165: View Of Cylinder Head Gasket
Courtesy of GENERAL MOTORS CORP.

5. When properly installed, with FRONT on the left side, the tab on the cylinder head gasket should be

located left of center or closer to the front of the engine.

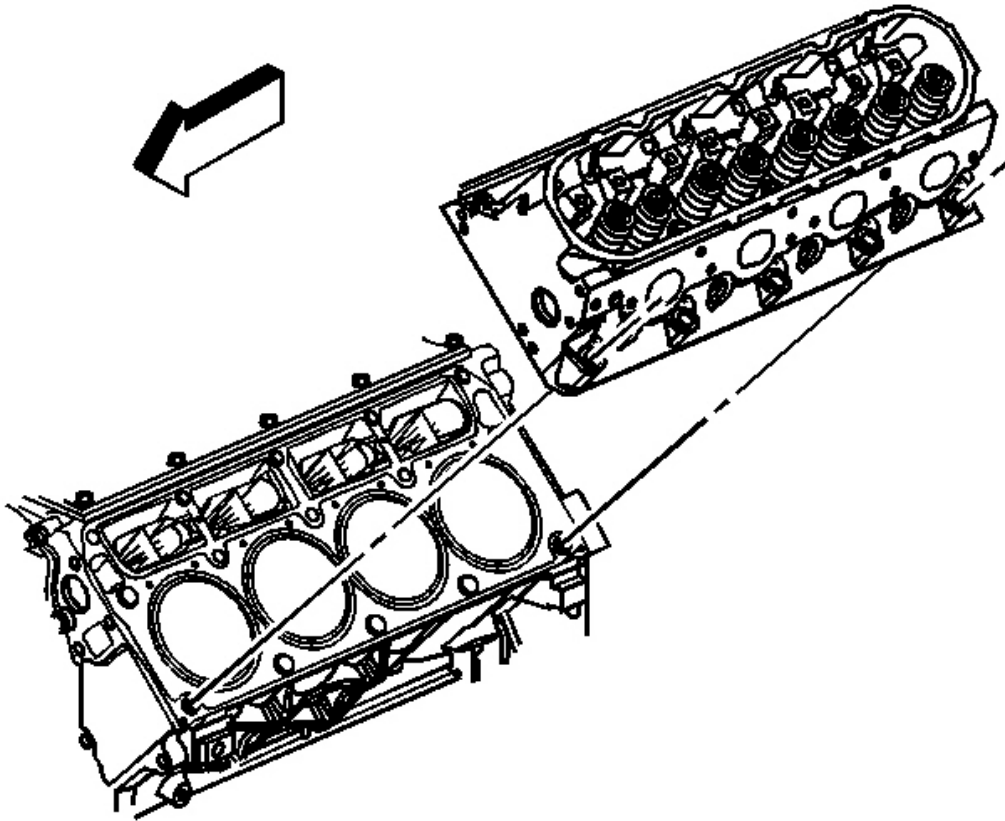
Fig. 166: View Of Left Cylinder Head
Courtesy of GENERAL MOTORS CORP.

6. Install the NEW cylinder head gasket.

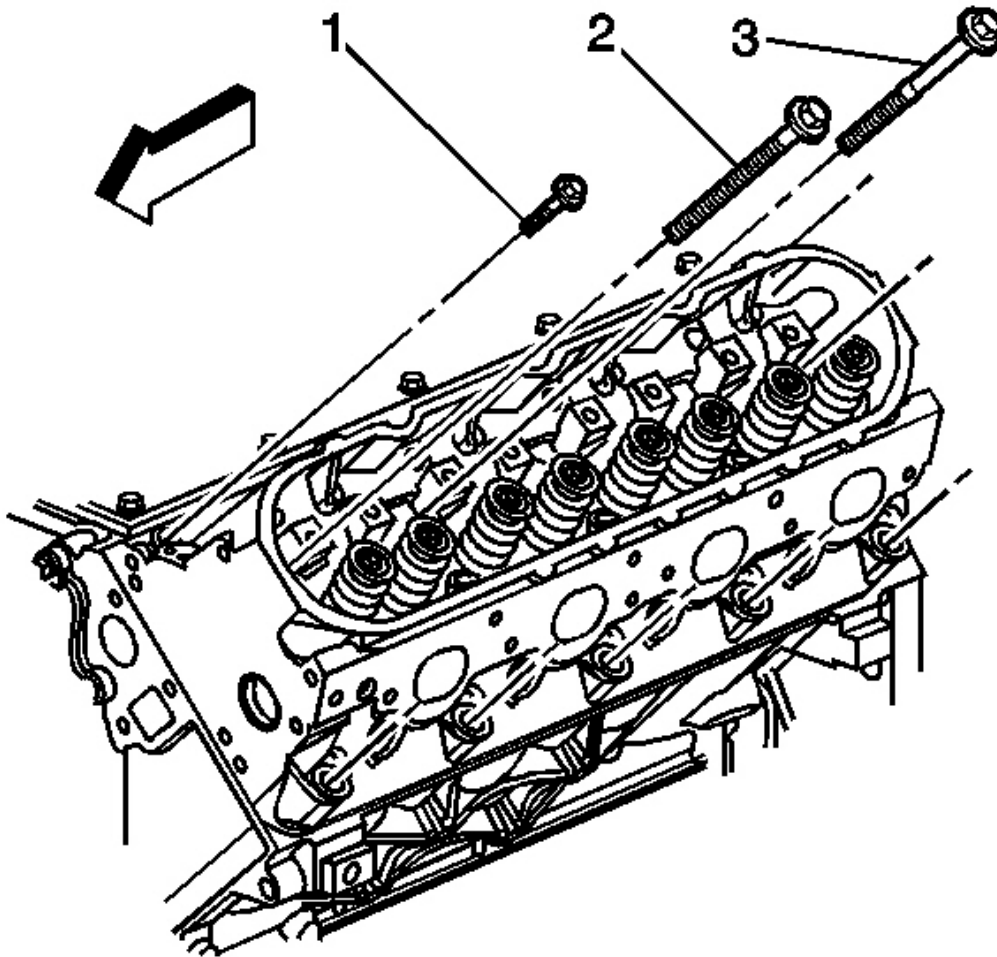
Fig. 167: View Of Cylinder Head Bolts
Courtesy of GENERAL MOTORS CORP.

8. Install NEW cylinder head bolts (1, 2, 3).

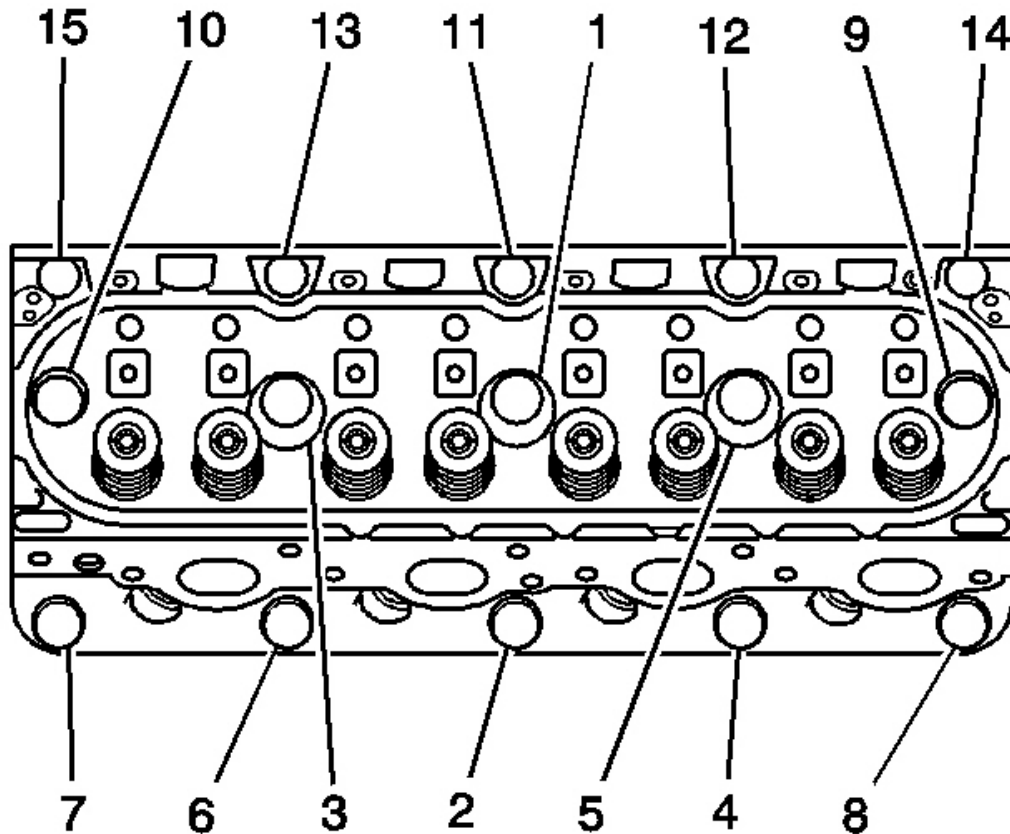
Fig. 168: Tightening Sequence For Cylinder Head Bolts

1. Tighten the M11 bolts a first pass in sequence to 30 N.m (22 lb ft).
2. Tighten the M11 bolts a second pass in sequence to 90 degrees using J 36660-A .
3. Tighten the M11 bolts (1, 2, 3, 4, 5, 6, 7, 8) to 90 degrees and the M11 bolts (9 and 10) to 50 degrees a final pass in sequence using J 36660-A .
4. Tighten the M8 bolts (11, 12, 13, 14, 15) to 30 N.m (22 lb ft). Begin with the center bolt (11) and alternating side-to-side, work outward tightening all of the bolts.

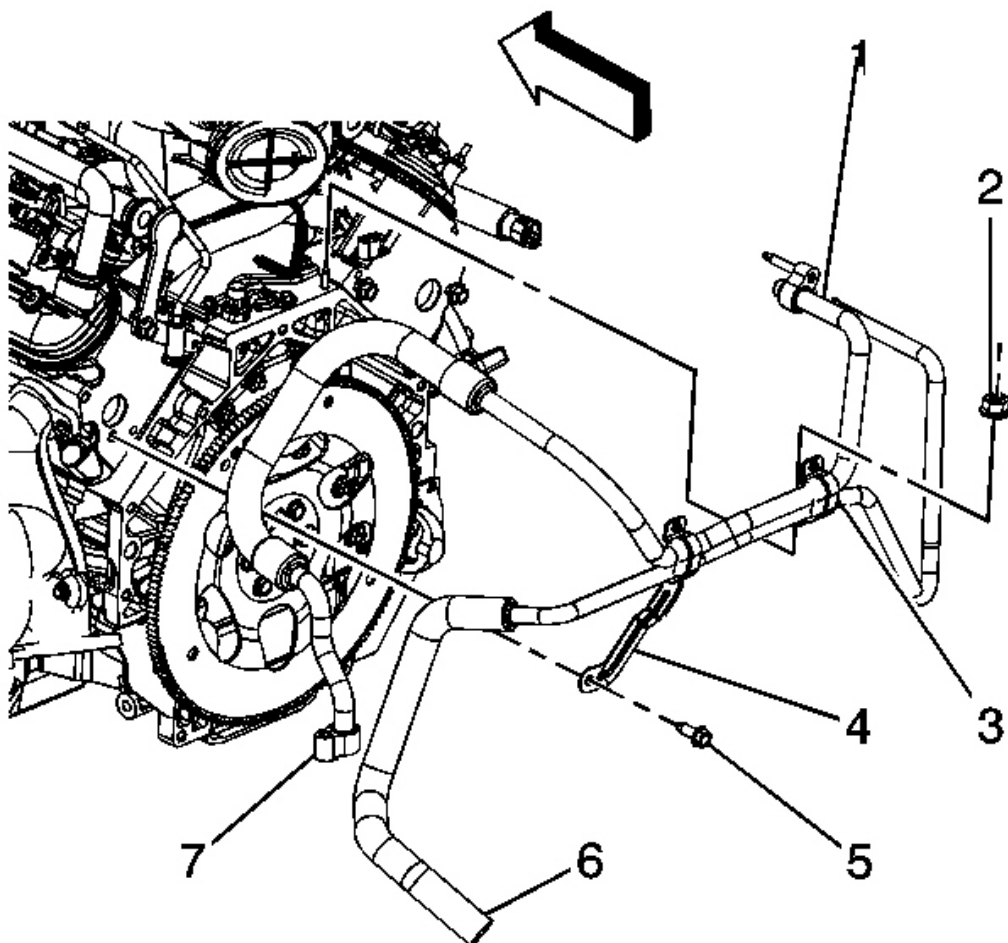
Fig. 169: View Of Rear A/C Lines
 Courtesy of GENERAL MOTORS CORP.

10. If equipped, install the auxiliary A/C bracket bolt (5).

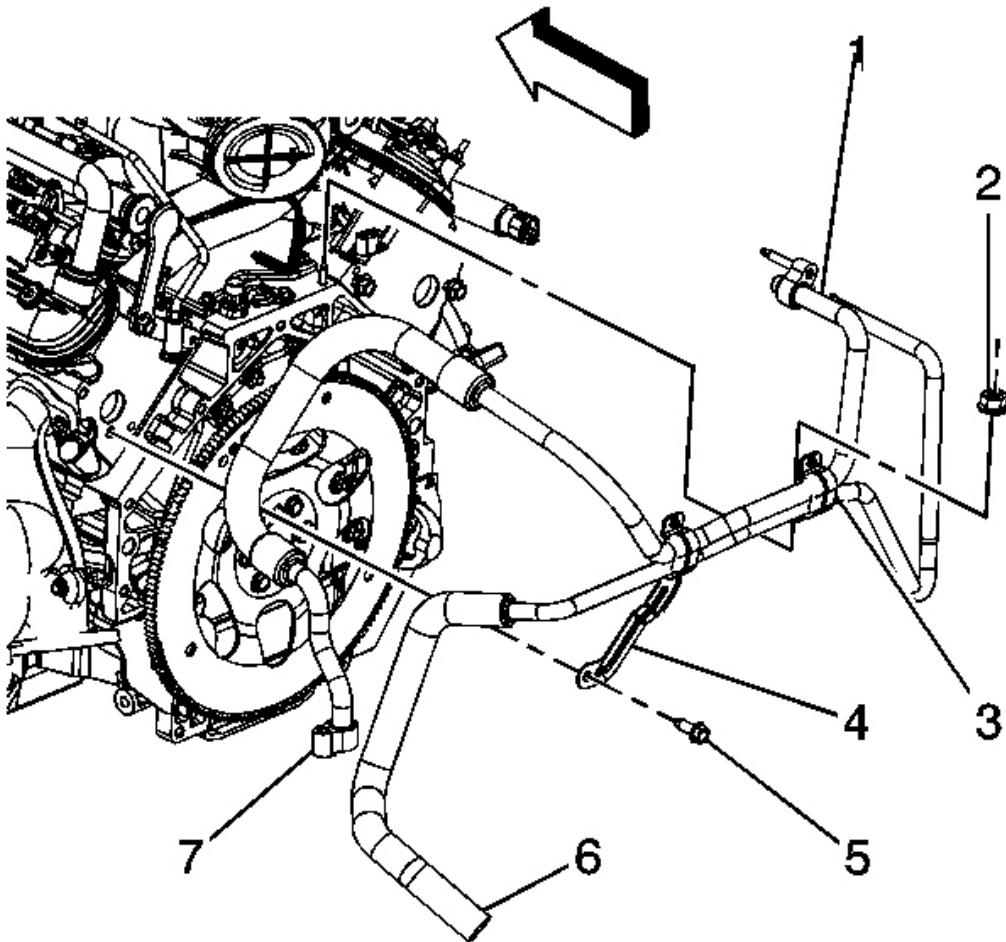
Fig. 170: View Of Rear A/C Lines
Courtesy of GENERAL MOTORS CORP.

1. Remove the oil level indicator. Refer to **Oil Level Indicator and Tube Replacement**.
2. Remove the coolant air bleed pipe. Refer to **Coolant Air Bleed Pipe Assembly Replacement (5.3L Engine)** in Engine Cooling.
3. Remove the right exhaust manifold. Refer to **Exhaust Manifold Replacement - Right (5.3L Engine)** in Engine Exhaust.
4. Remove the pushrods. Refer to **Valve Rocker Arm and Push Rod Replacement**.
5. If equipped, remove the auxiliary air conditioning (A/C) bracket nut (2).

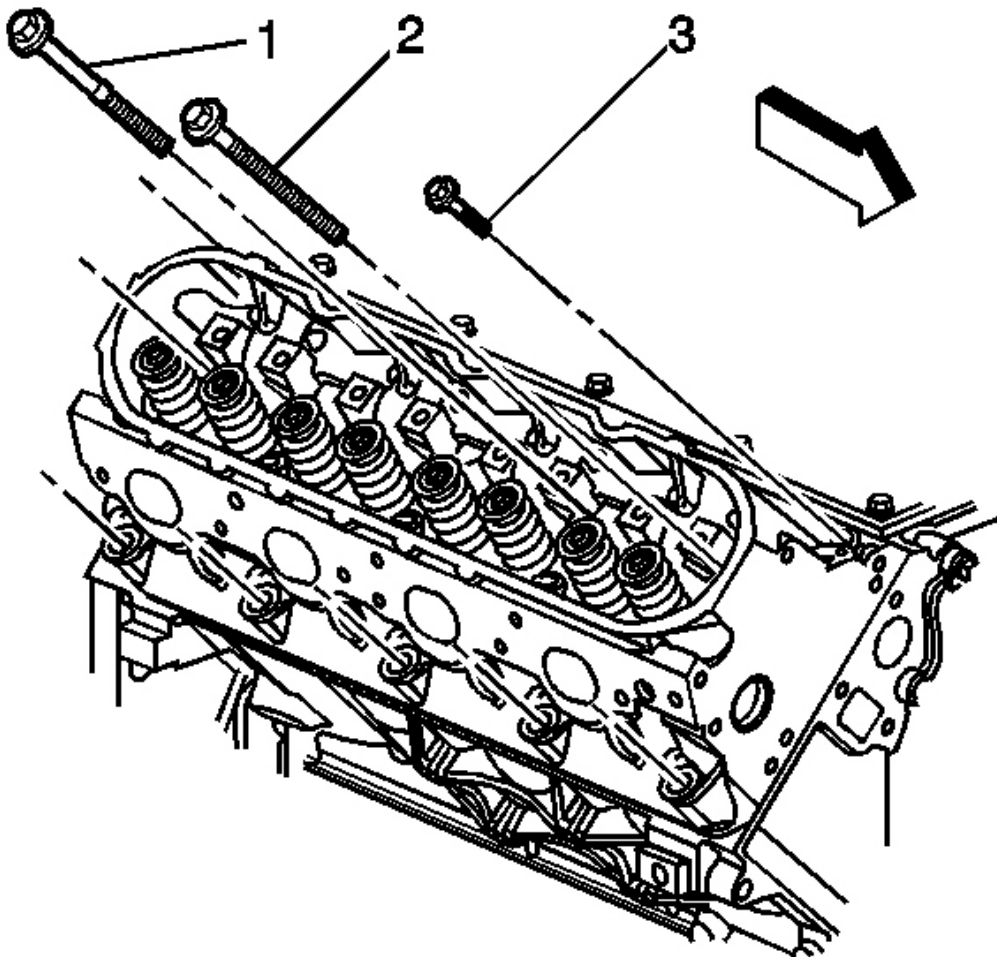
Fig. 171: View Of Cylinder Head Bolts
Courtesy of GENERAL MOTORS CORP.

IMPORTANT: The cylinder head bolts are NOT reusable.

6. Remove and discard the cylinder head bolts (1, 2, 3).
