2004 Isuzu Ascender LS

2004 ENGINE Engine Mechanical - 4.8L, 5.3L, and 6.0L - Ascender

Engine Mechanical - 4.8L, 5.3L, and 6.0L - Ascender

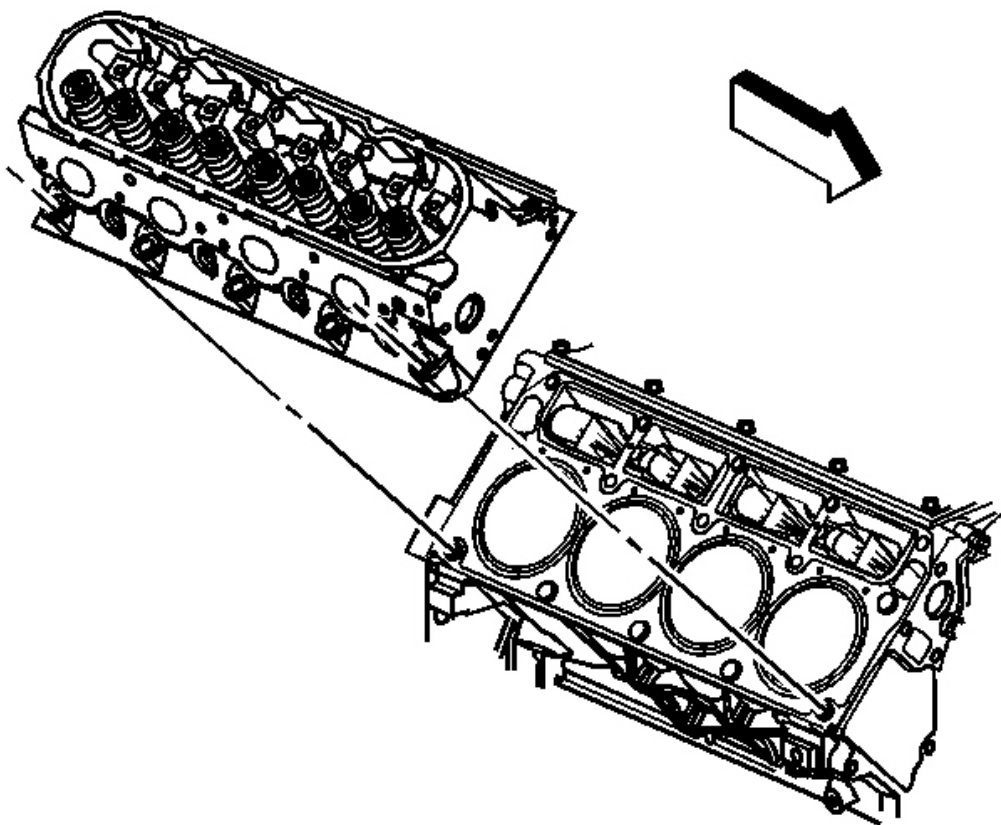
Fig. 172: View Of Right Cylinder Head
Courtesy of GENERAL MOTORS CORP.

NOTE: After removal, place the cylinder head on two wood blocks to prevent damage to the sealing surfaces.

7. Remove the cylinder head.

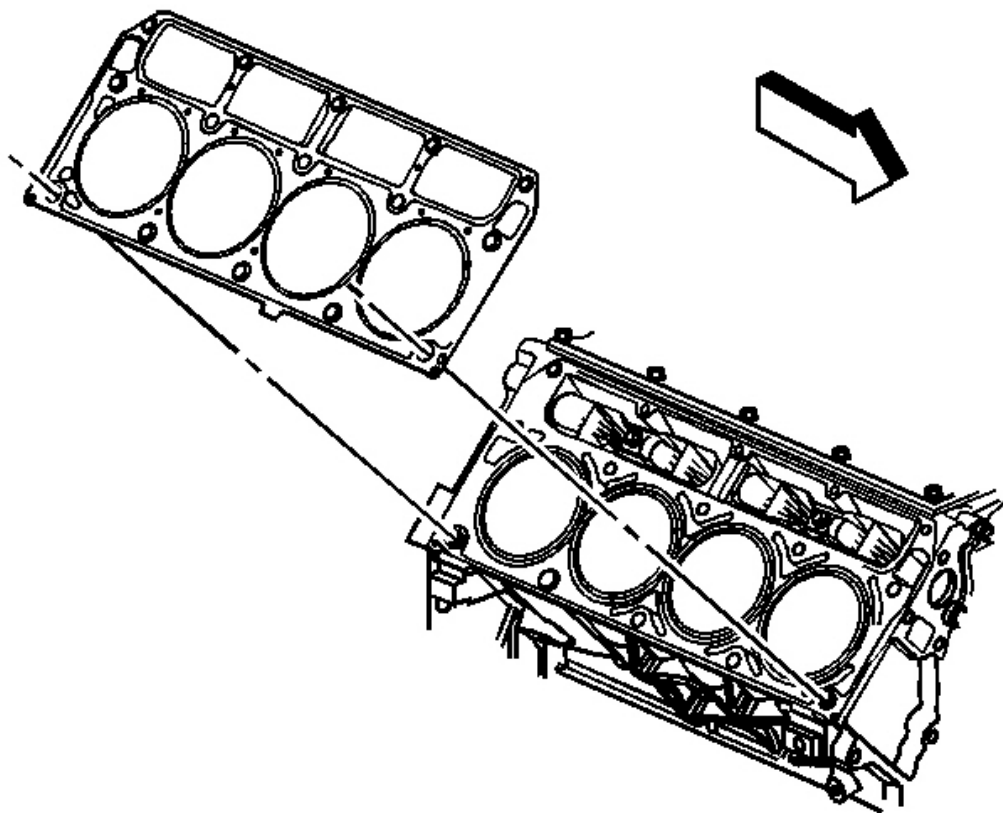
Fig. 173: View Of Right Cylinder Head Gasket
Courtesy of GENERAL MOTORS CORP.

8. Remove and discard the cylinder head gasket.
9. Clean and inspect the cylinder head. Refer to Cylinder Head Cleaning and Inspection.

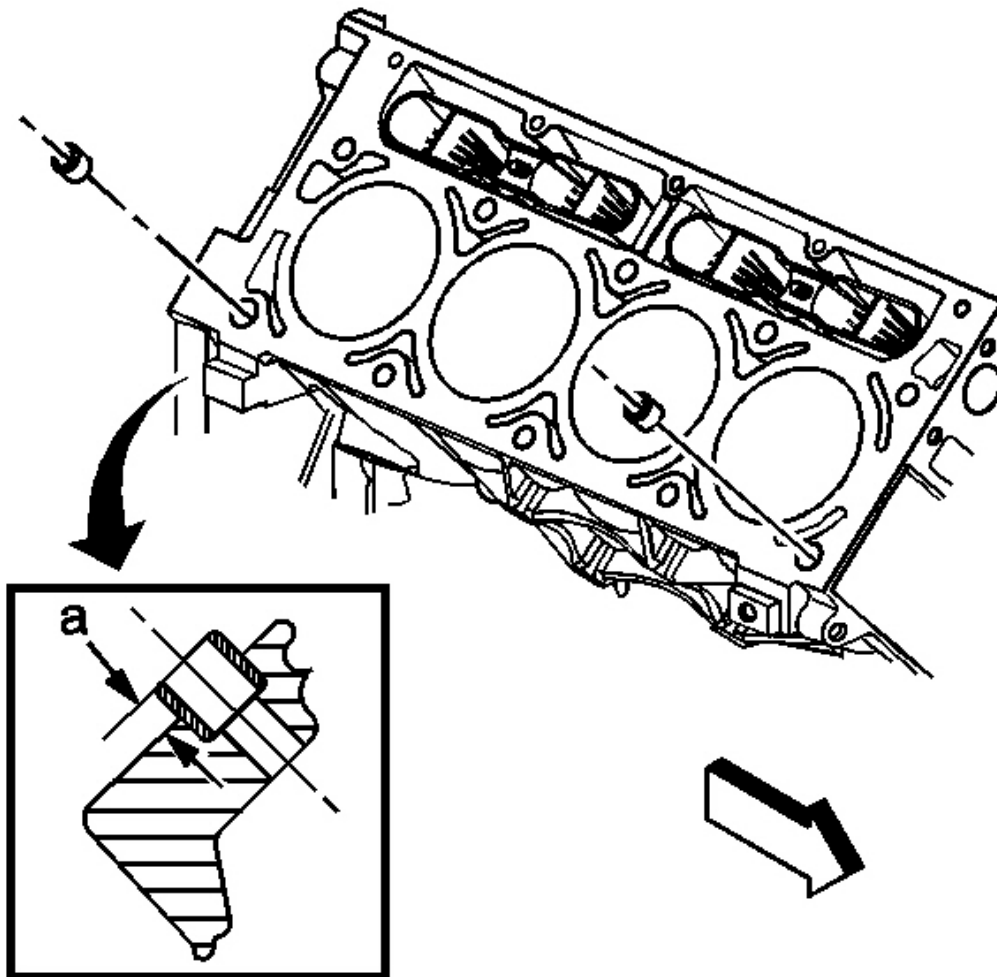
Fig. 174: View Of Right Cylinder Head Bolt Holes
Courtesy of GENERAL MOTORS CORP.

1. Clean the engine block cylinder head bolt holes, if required.

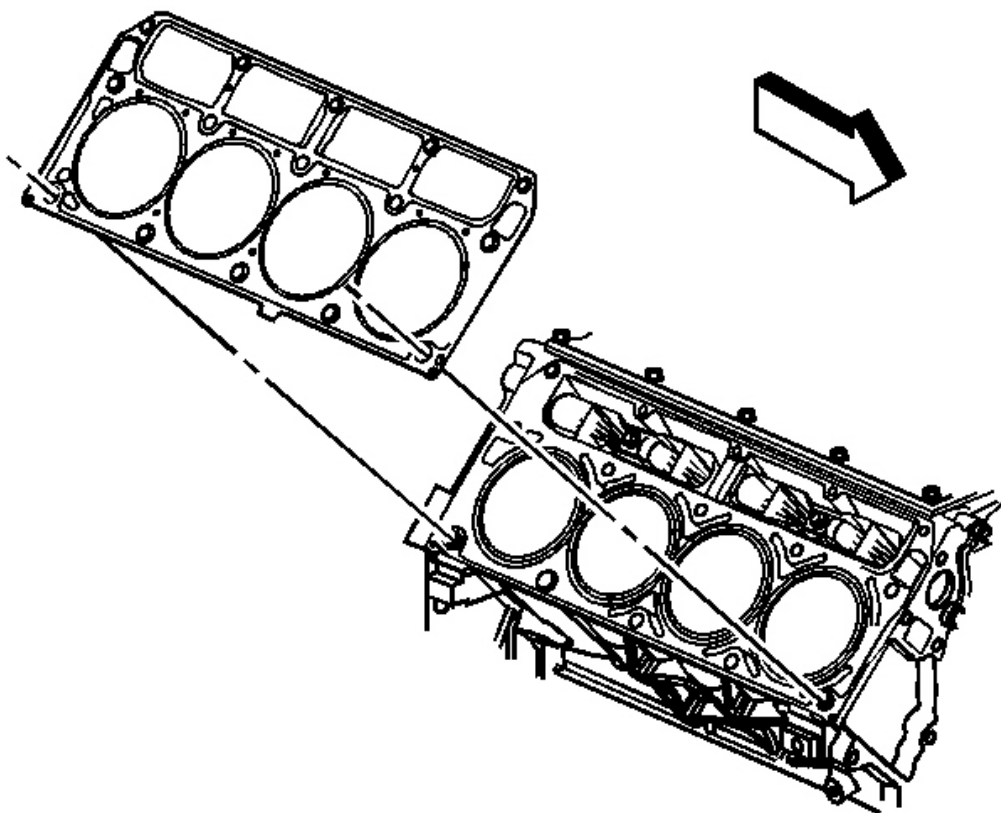
Fig. 176: View Of Right Cylinder Head Gasket
Courtesy of GENERAL MOTORS CORP.

6. Install the NEW cylinder head gasket.

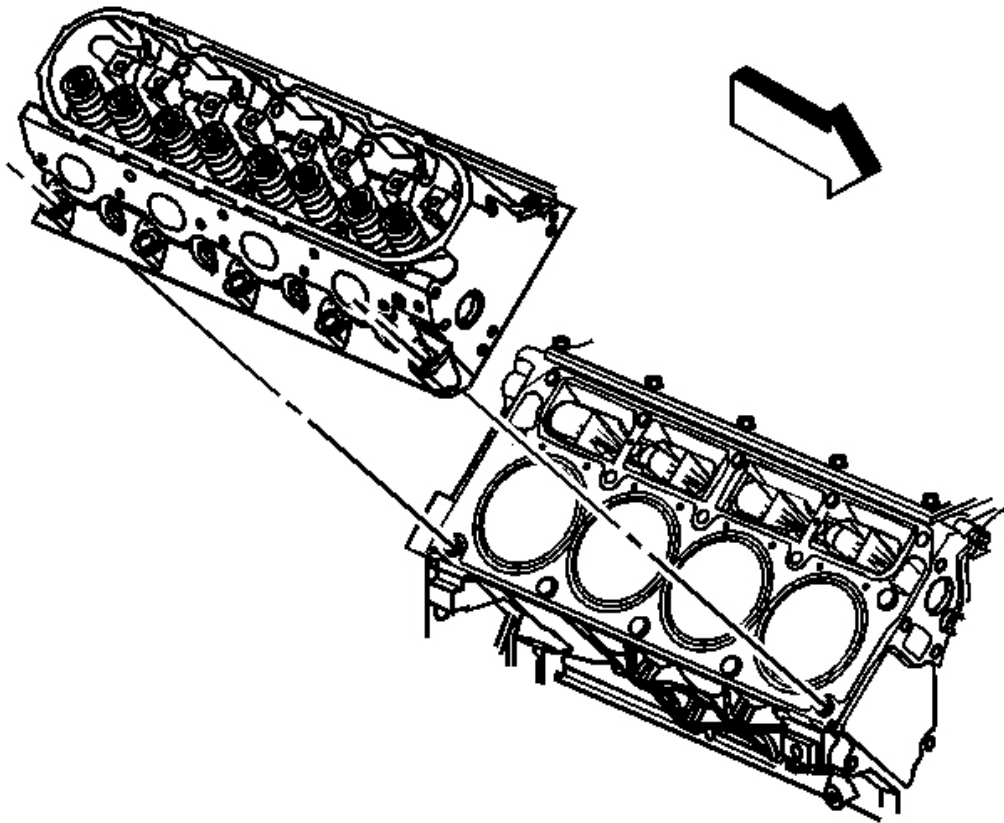
Fig. 177: View Of Right Cylinder Head
Courtesy of GENERAL MOTORS CORP.

7. Install the cylinder head.

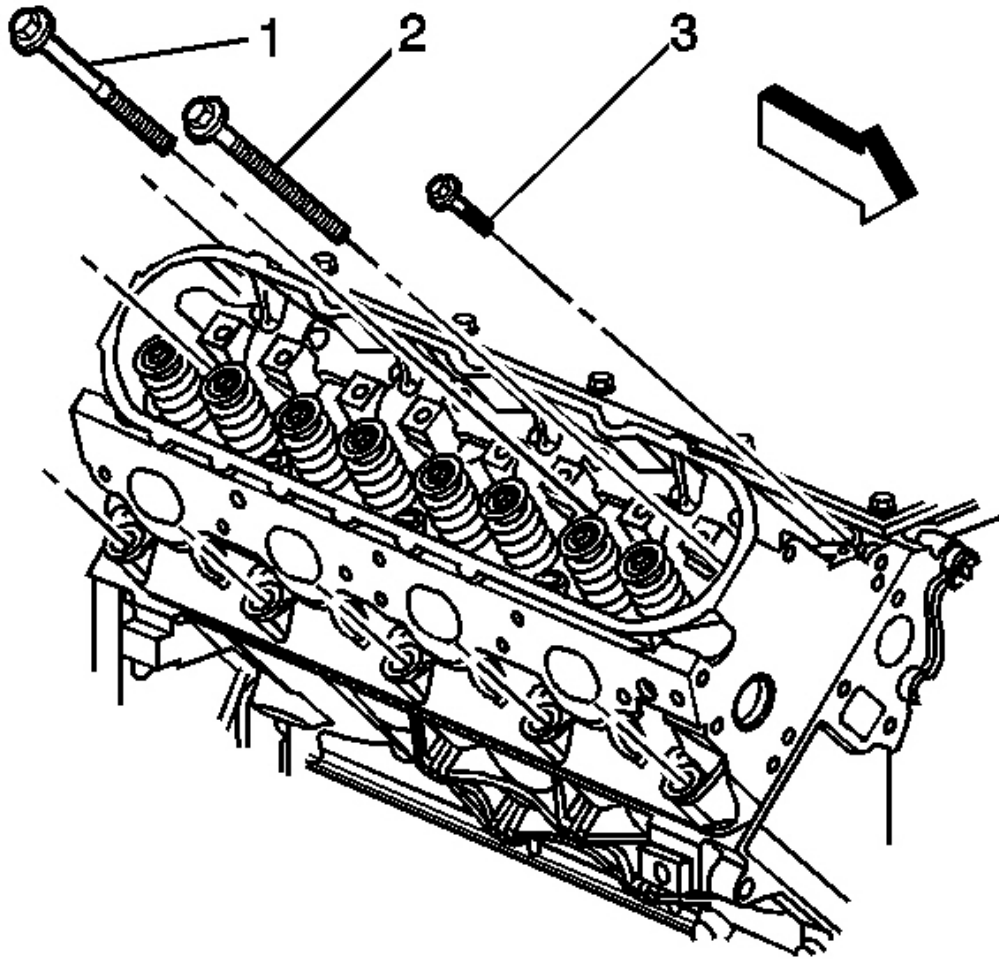
Fig. 178: View Of Cylinder Head Bolts
Courtesy of GENERAL MOTORS CORP.

8. Install the NEW cylinder head bolts (1, 2, 3).

1. Tighten the M11 bolts a first pass in sequence to 30 N.m (22 lb ft).
2. Tighten the M11 bolts a second pass in sequence to 90 degrees using J 36660-A .
3. Tighten the M11 bolts (1,2,3,4,5,6,7,8) to 90 degrees and the M11 bolts (9 and 10) to 50 degrees a final pass in sequence using J 36660-A .
4. Tighten the M8 bolts (11,12,13,14,15) to 30 N.m (22 lb ft). Begin with the center bolt (11) and alternating side-to-side, work outward tightening all of the bolts.

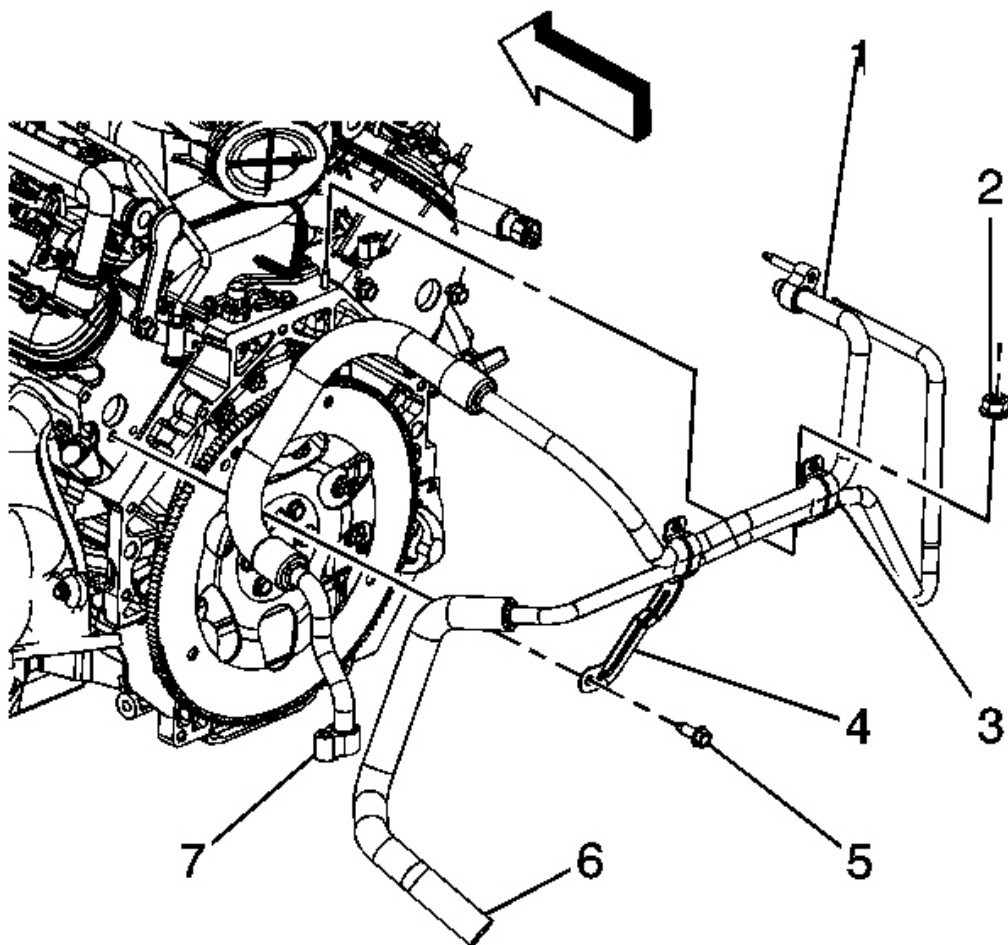
Fig. 180: View Of Rear A/C Lines
 Courtesy of GENERAL MOTORS CORP.

10. If equipped, install the auxiliary air conditioning (A/C) bracket nut (2).

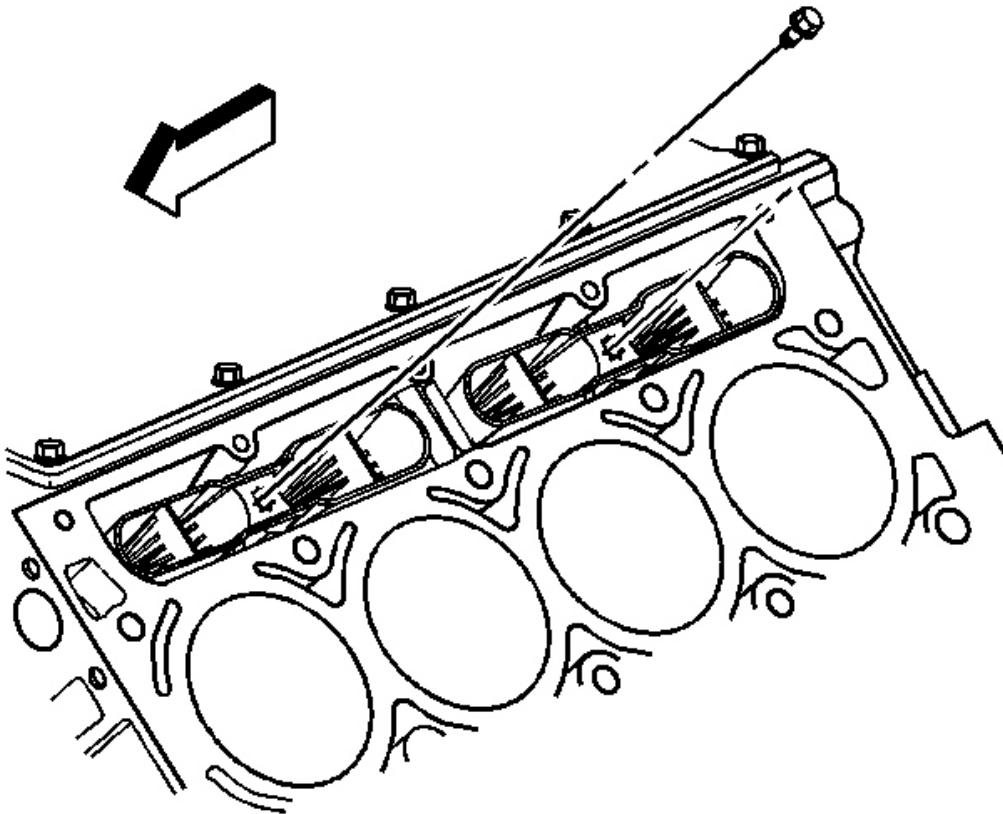
Fig. 181: View Of Valve Lifter Guide Bolts
Courtesy of GENERAL MOTORS CORP.

1. Remove the cylinder head and gasket. Refer to Cylinder Head Replacement - Left or Cylinder Head Replacement - Right.
2. Remove the valve lifter guide bolts.

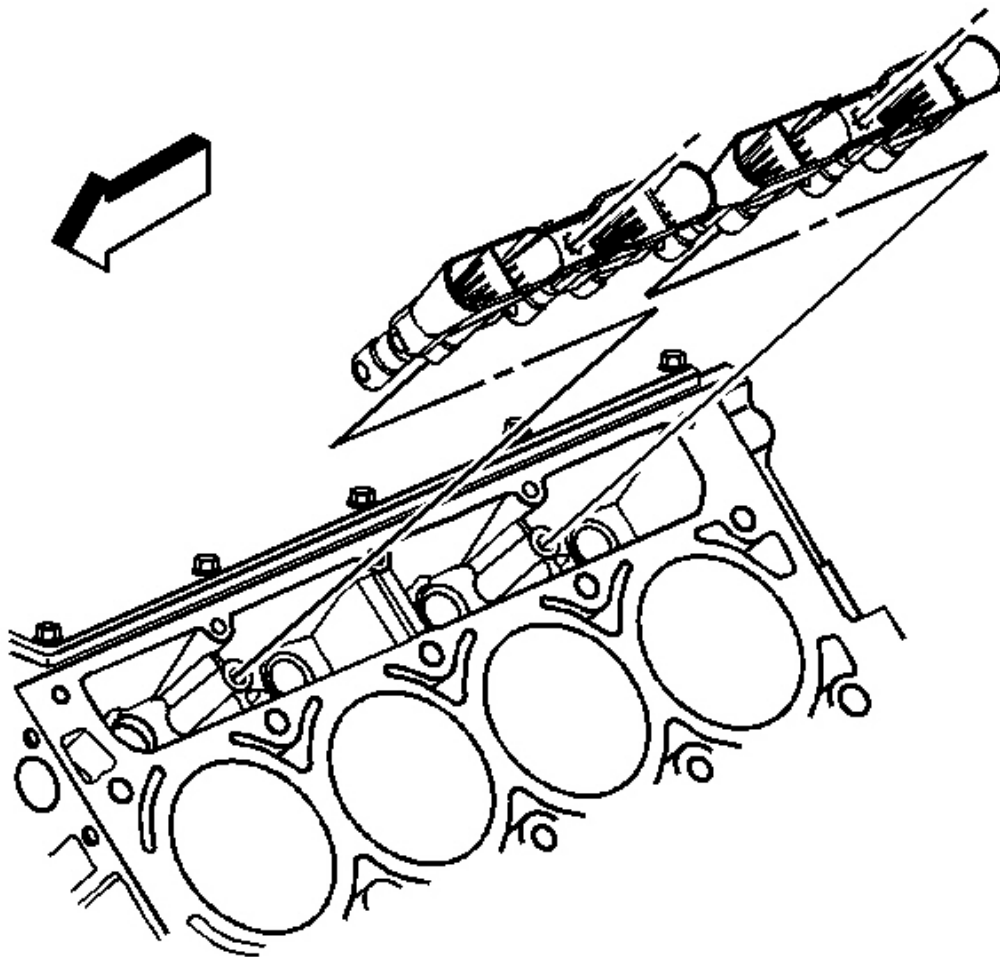
Fig. 182: View Of Valve Lifters & Guide
Courtesy of GENERAL MOTORS CORP.

IMPORTANT: Some valve lifters may be stuck in their bores because of gum or varnish deposits.

3. Remove the valve lifters and guide.
4. Use **J 3049-A** or equivalent in order to remove the valve lifters (if required). See **Special Tools and Equipment**.

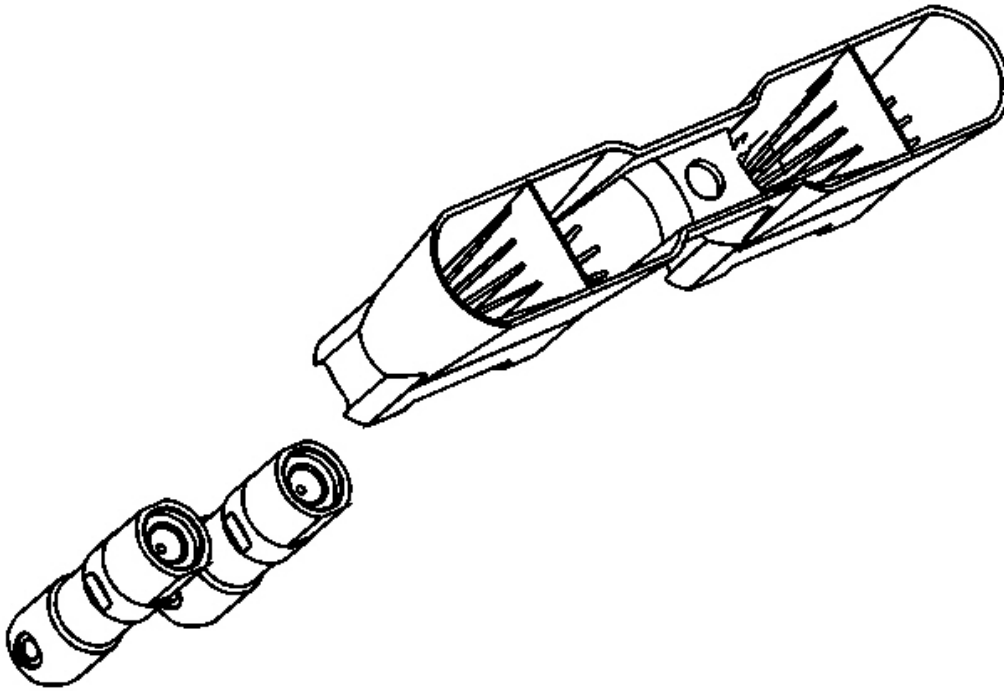
Fig. 183: View Of Valve Lifters & Lifter Guides
Courtesy of GENERAL MOTORS CORP.

5. Remove the valve lifters from the guide.
6. Organize or mark the components so that they can be installed in the same location from which they were removed.
7. Clean and inspect the valve lifters. Refer to **Valve Lifters and Guides Cleaning and Inspection**.

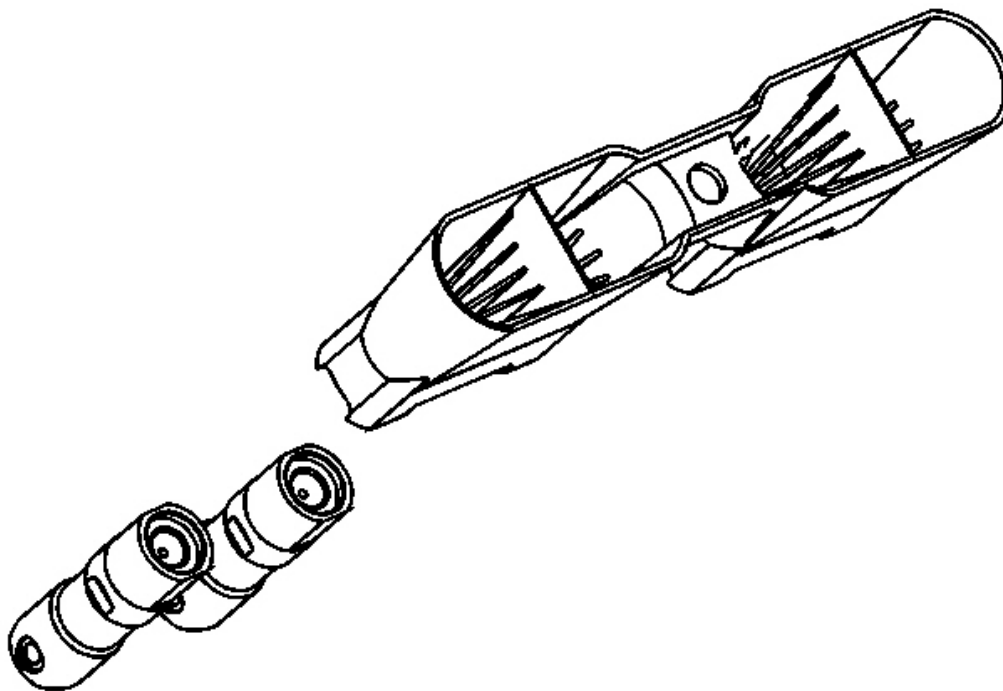
Fig. 184: View Of Valve Lifters & Lifter Guides
Courtesy of GENERAL MOTORS CORP.

1. Lubricate the valve lifters and engine block valve lifter bores with clean engine oil.
2. Insert the valve lifters into the lifter guides.

Align the flat area on the top of the lifter with the flat area in the lifter guide bore. Push the lifter completely into the guide bore.

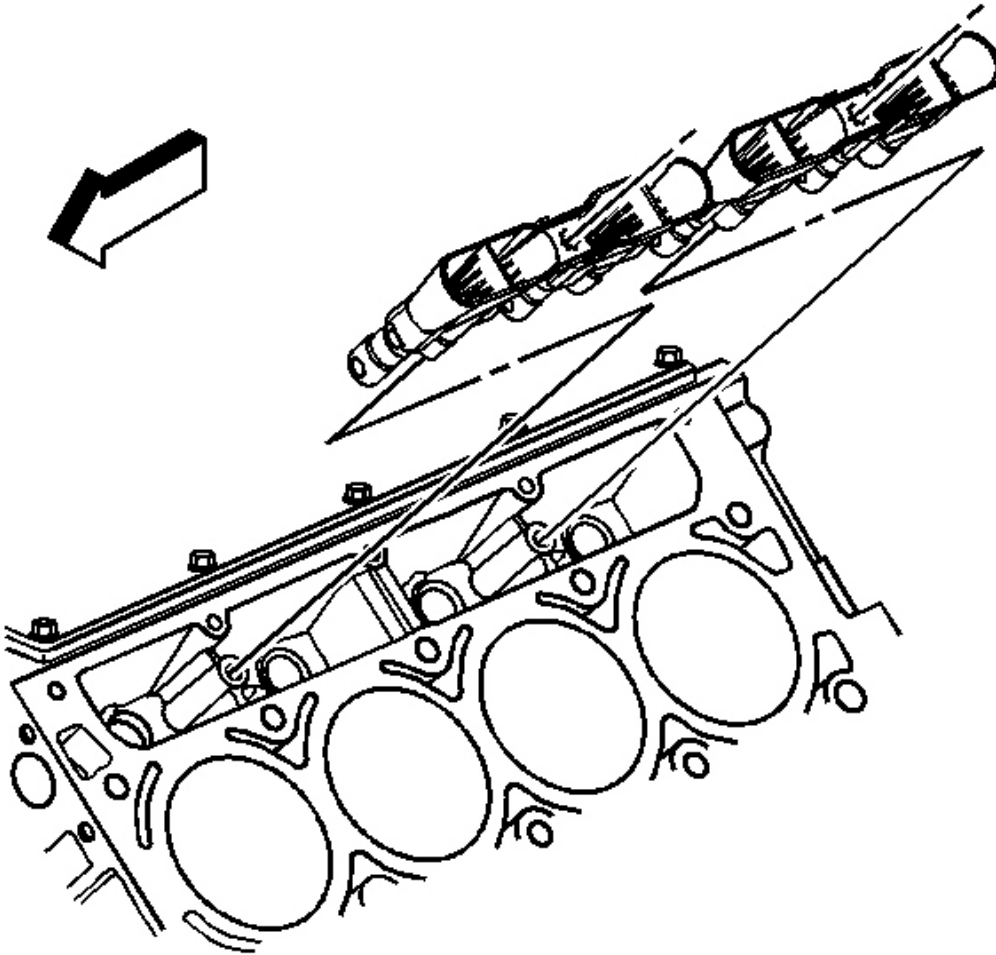
Fig. 185: View Of Valve Lifters & Guide
Courtesy of GENERAL MOTORS CORP.

3. Install the valve lifters and guide to the engine block.

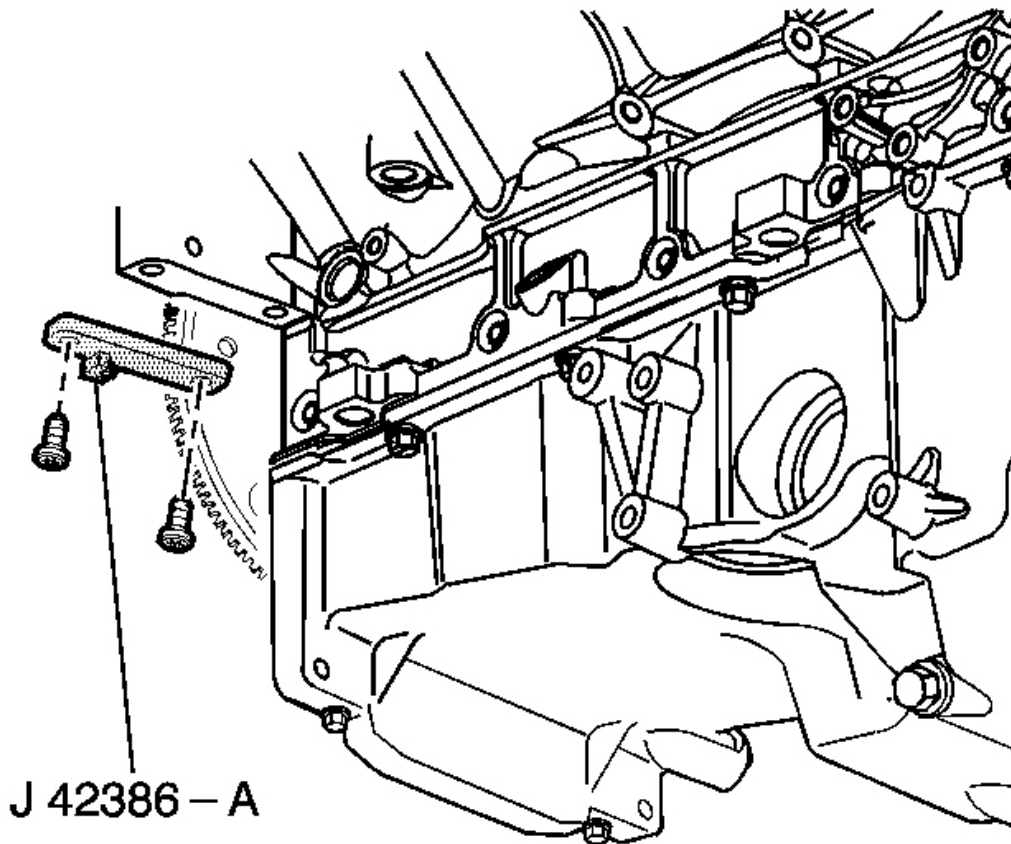
Fig. 187: View Of J 42386-A Flywheel Tool
Courtesy of GENERAL MOTORS CORP.

Use one M10-1.5 x 120 mm and one M10-1.5 x 45 mm bolt for proper tool operation.

Tighten: Tighten J 42386-A bolts to 50 N.m (37 lb ft). See Special Tools and Equipment.

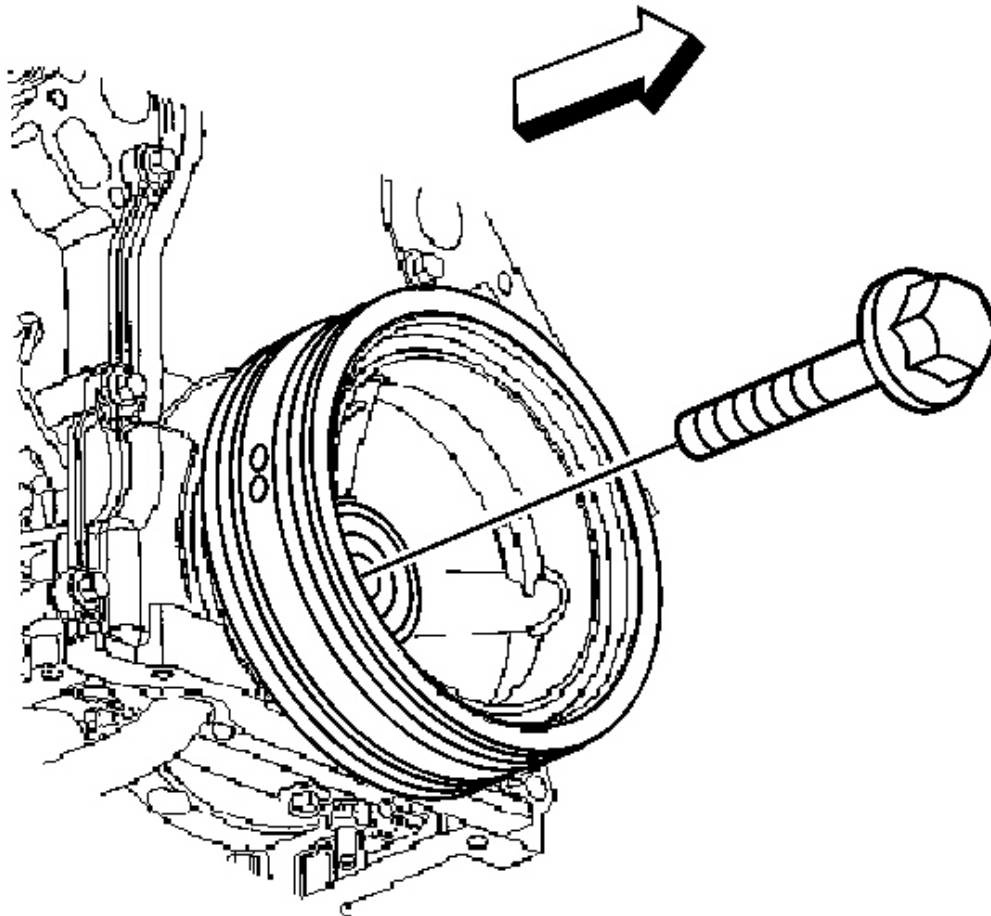
Fig. 188: Crankshaft Balancer And Retaining Bolt
Courtesy of GENERAL MOTORS CORP.

6. Remove the crankshaft balancer bolt.

Do not discard the crankshaft balancer bolt. The balancer bolt will be used during the balancer installation procedure.

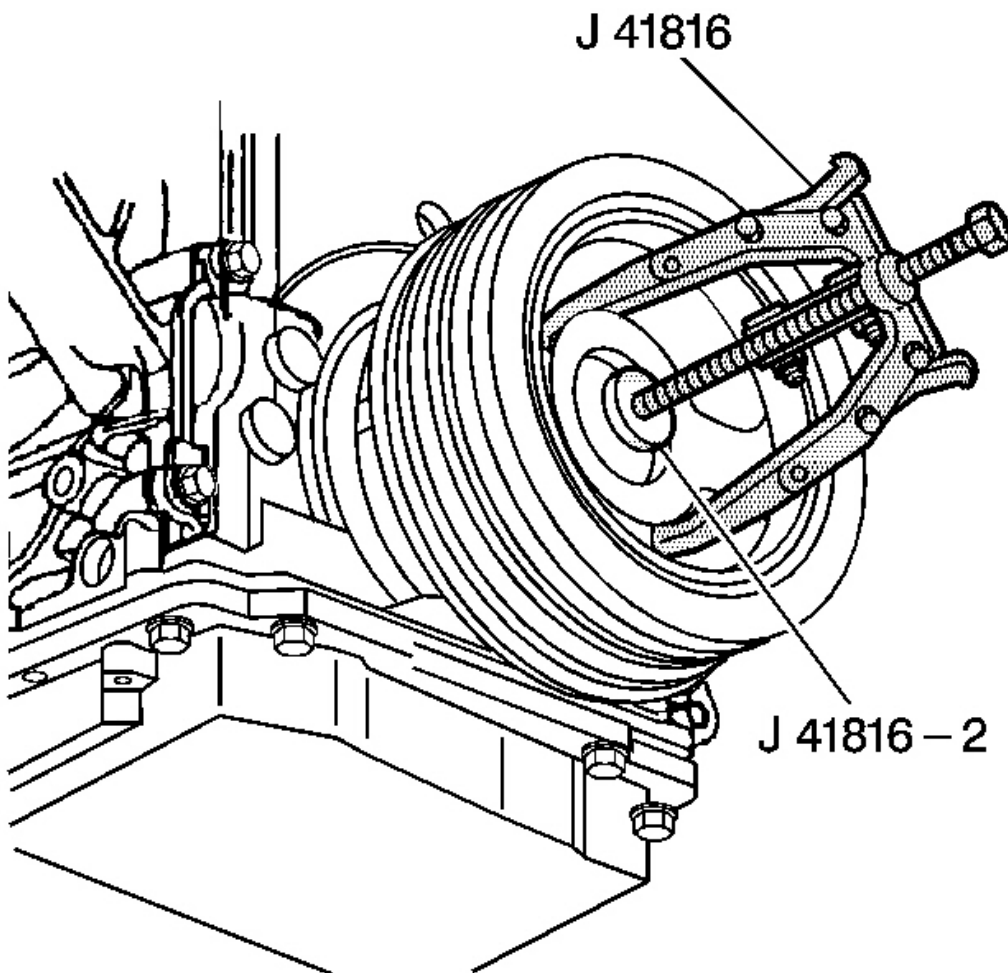
Fig. 189: Removing The Crankshaft Balancer
Courtesy of GENERAL MOTORS CORP.

7. Use **J 41816** and in order to remove the crankshaft balancer. See **Special Tools and Equipment.J 41816-2**.

8. Remove **J 41816** and from the crankshaft balancer. See **Special Tools and Equipment.J 41816-2** .
9. Clean and inspect the crankshaft balancer. Refer to **Crankshaft Balancer Cleaning and Inspection**.

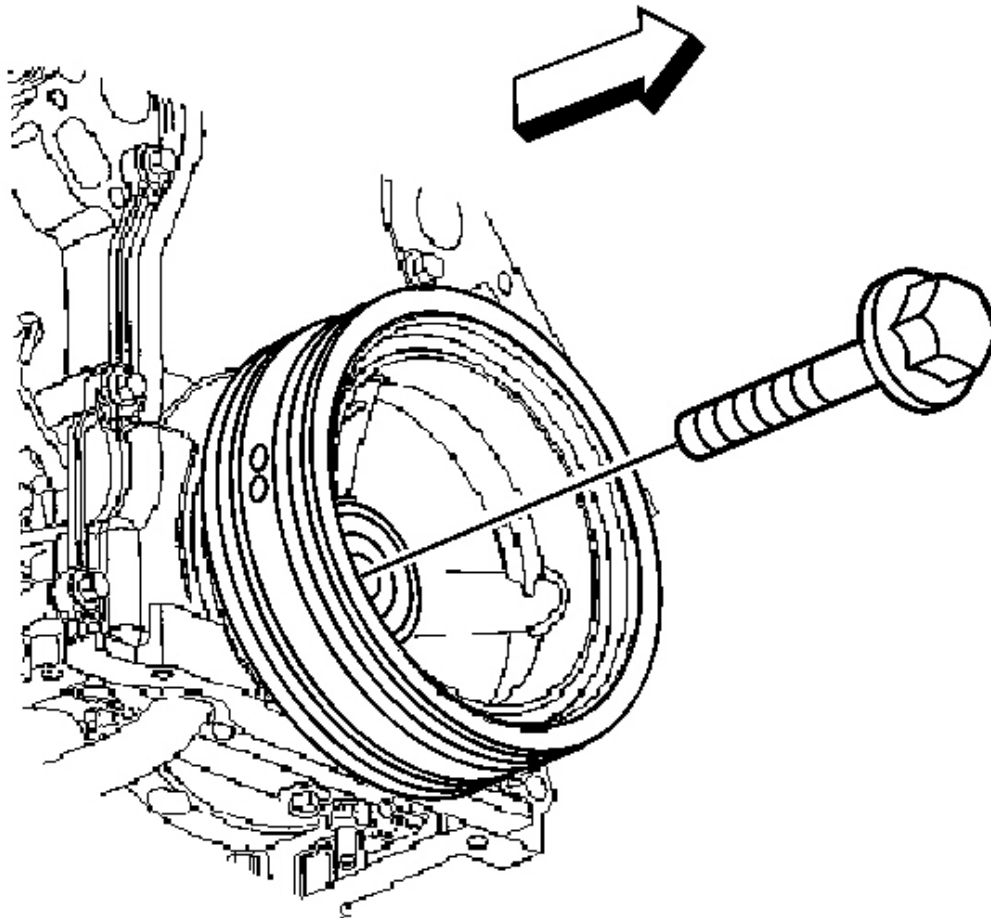
Fig. 190: Crankshaft Balancer And Retaining Bolt
Courtesy of GENERAL MOTORS CORP.

IMPORTANT: Position the balancer onto the end of the crankshaft as straight as possible prior to tool installation.

1. Install the crankshaft balancer onto the end of the crankshaft.

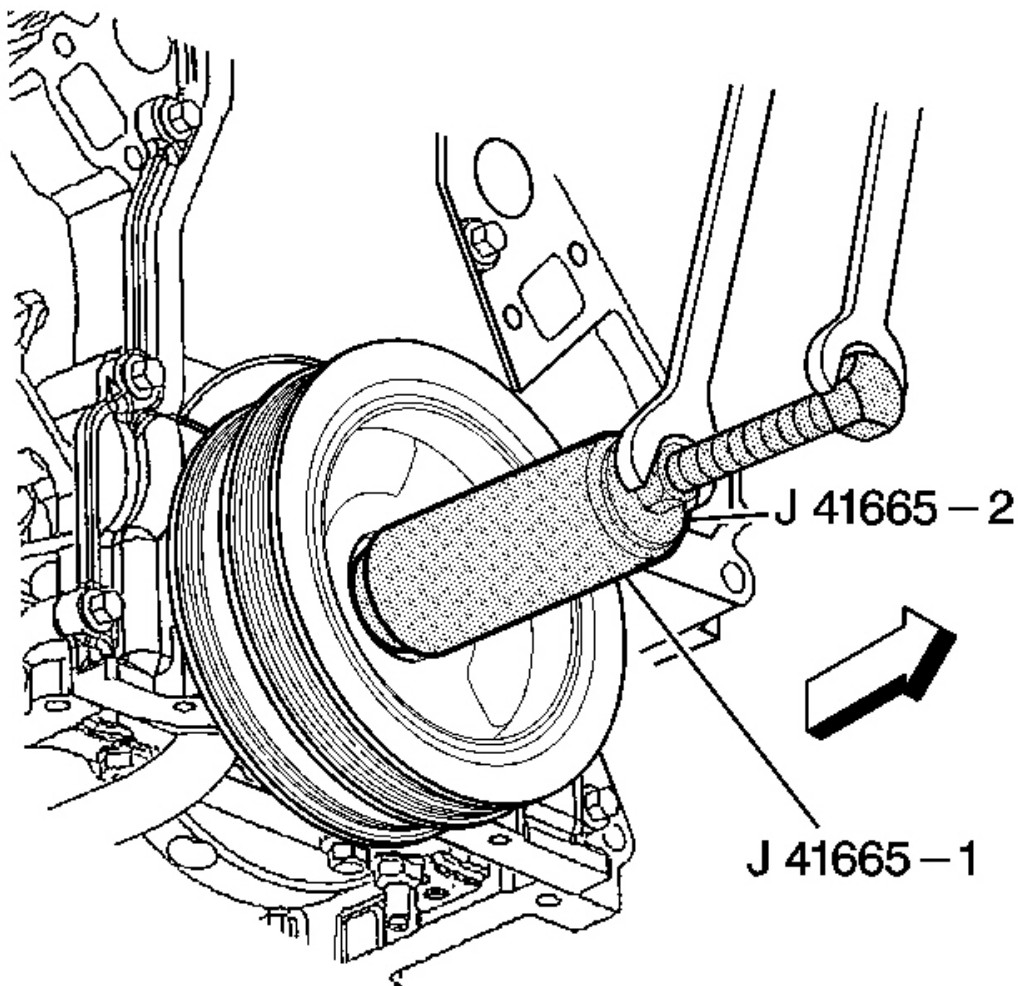
Fig. 191: Installing Balancer Using J 41665
Courtesy of GENERAL MOTORS CORP.

2. Use **J 41665** in order to install the crankshaft balancer. See **Special Tools and Equipment**.

Position the larger end of the installer against the front of the balancer.

5. Use a wrench and hold the hex end of the threaded rod.
6. Use a second wrench and rotate the installation tool nut clockwise until the balancer is installed onto the crankshaft.
7. Remove the balancer installation tool.

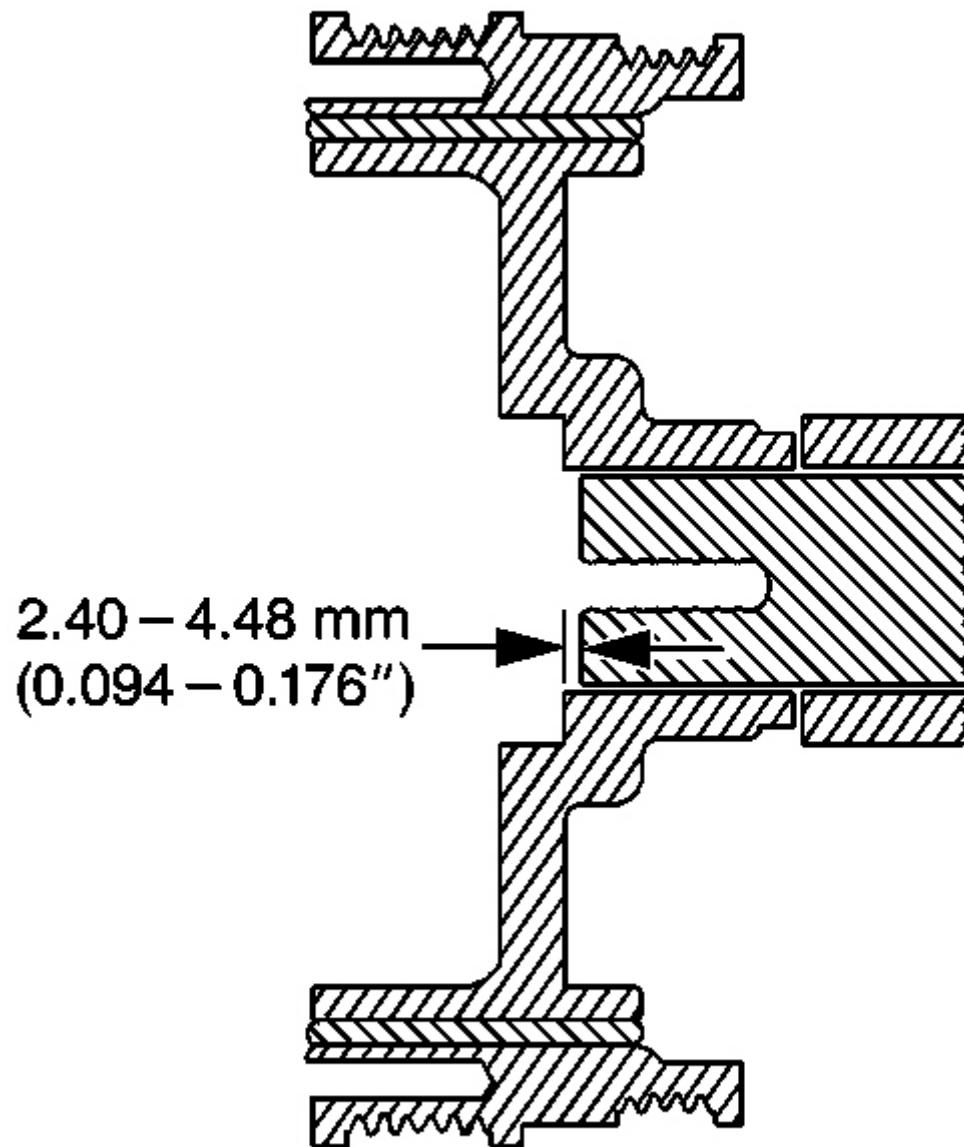
Fig. 192: Identifying Hub To Crankshaft Distance
Courtesy of GENERAL MOTORS CORP.

1. Tighten the bolt a first pass to 50 N.m (37 lb ft).
 2. Tighten the bolt a final pass to 140 degrees using J 36660-A .
7. Remove **J 42386-A** and bolts. See **Special Tools and Equipment**.
 8. Install the starter motor. Refer to **Starter Motor Replacement (4.2L Engine)** or **Starter Motor Replacement (5.3L Engine)** in Engine Electrical.
 9. Install the fan shroud. Refer to **Cooling Fan and Shroud Replacement** in Engine Cooling.
 10. Install the A/C drive belt, if equipped. Refer to **Drive Belt Replacement - Air Conditioning**.
 11. Install the accessory drive belt. Refer to **Drive Belt Replacement - Accessory**.
 12. Perform the crankshaft position (CKP) system variation learn procedure. Refer to **CKP System Variation Learn Procedure** in Engine Controls.

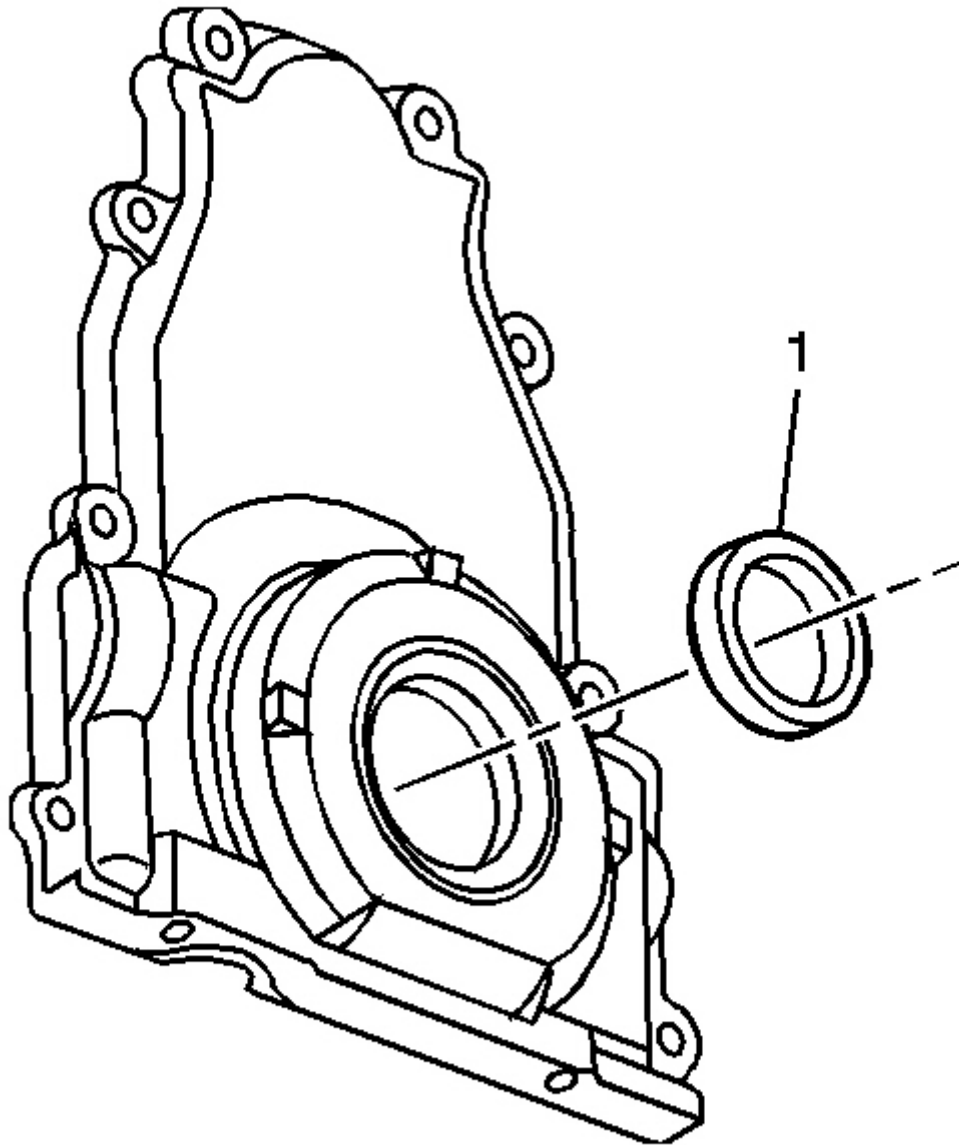
Fig. 194: View Of Crankshaft Front Oil Seal
Courtesy of GENERAL MOTORS CORP.

1. Lubricate the outer edge of the oil seal (1) with clean engine oil.
2. Lubricate the front cover oil seal bore with clean engine oil.

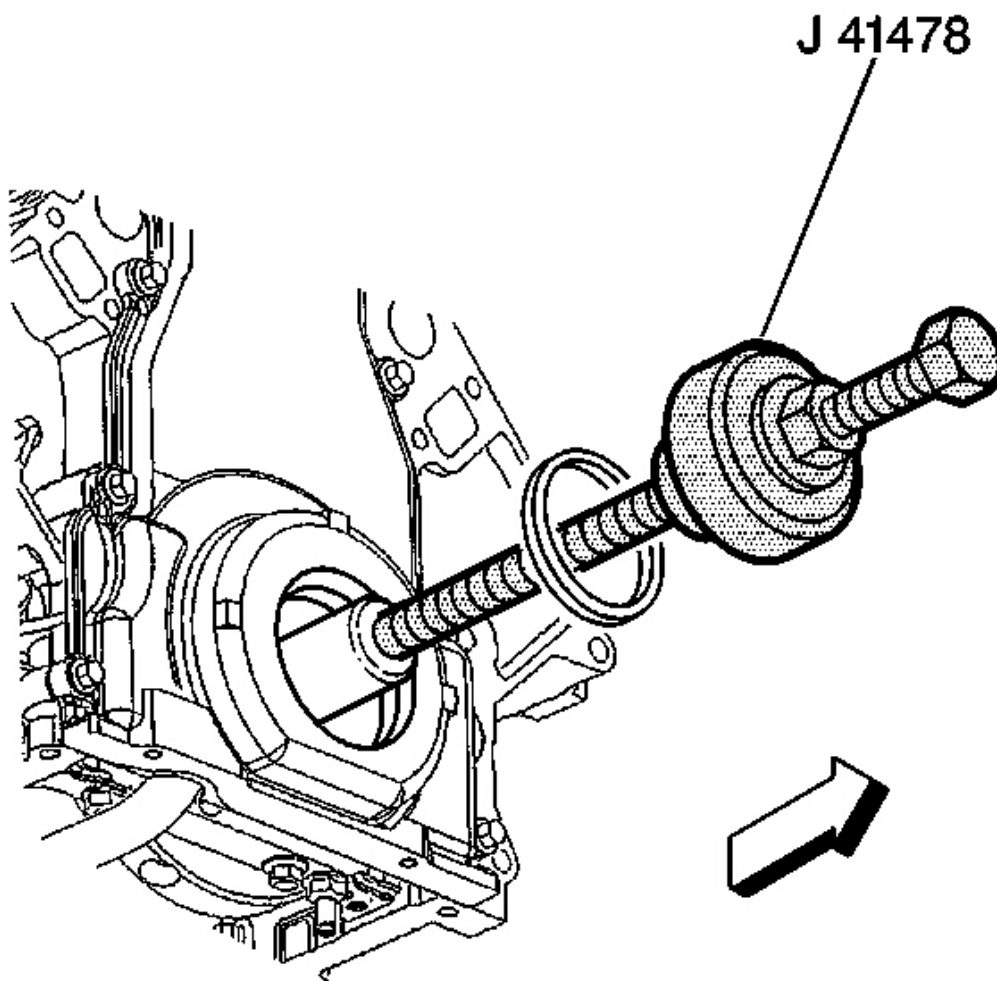
Fig. 195: Installing The Crankshaft Front Oil Seal Using J 41478
Courtesy of GENERAL MOTORS CORP.

3. Install the crankshaft front oil seal onto the **J 41478** guide.
4. Install the **J 41478** threaded rod (with nut, washer, guide, and oil seal) into the end of the crankshaft.
5. Use the **J 41478** in order to install the oil seal into the cover bore.
 1. Use a wrench and hold the hex on the installer bolt.
 2. Use a second wrench and rotate the installer nut clockwise until the seal bottoms in the cover bore.
 3. Remove the **J 41478**.
 4. Inspect the oil seal for proper installation.

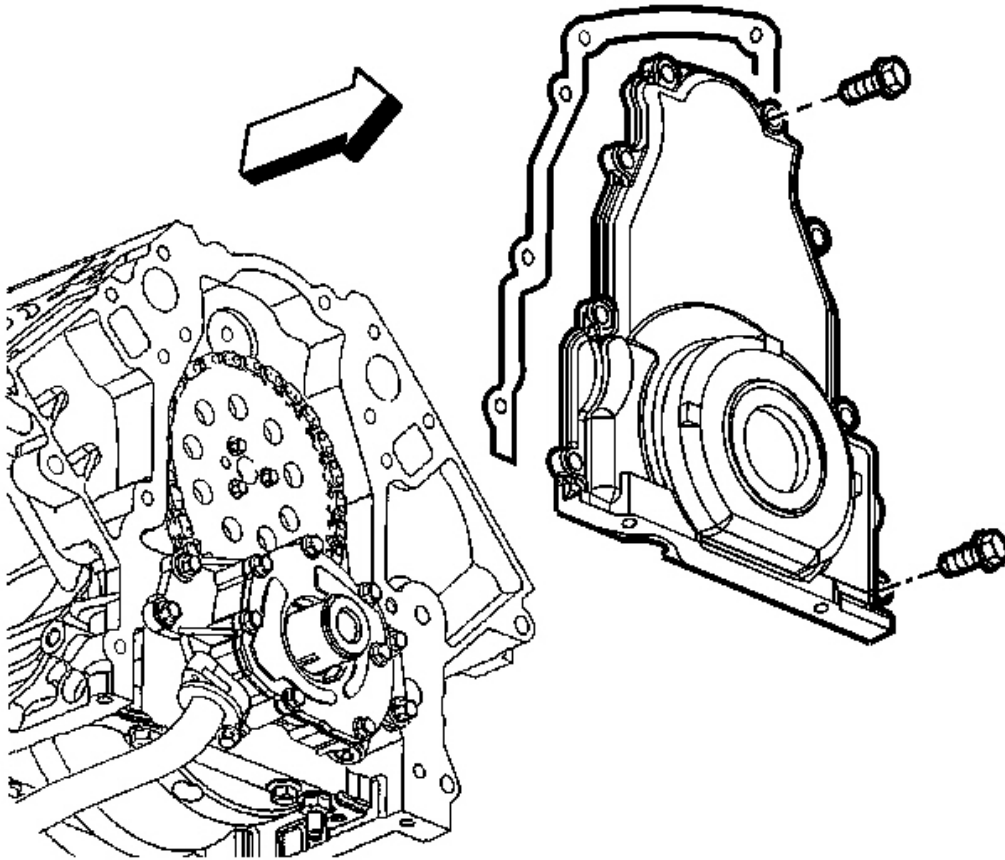
Fig. 197: View Of Front Cover & Gasket
Courtesy of GENERAL MOTORS CORP.

1. Apply a 5 mm (0.20 in) bead of sealant GM P/N 12378190, or equivalent 20 mm (0.80 in) long to the oil pan to engine block junction.
2. Install the front cover gasket and cover.
3. Install the front cover bolts until snug. Do not overtighten.
4. Install the oil pan-to-front cover bolts until snug. Do not over tighten.

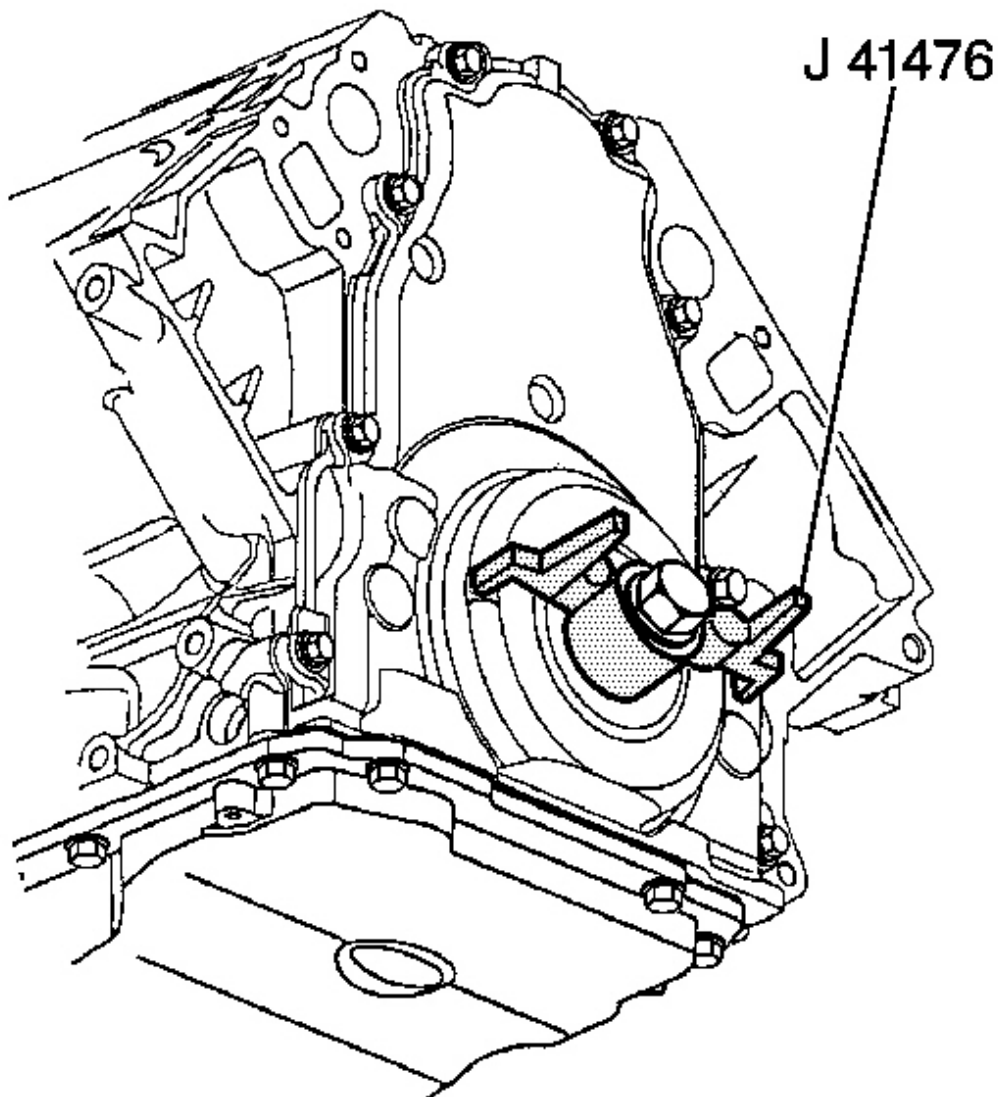
Fig. 198: View of J 41476 Installed To Front Cover
Courtesy of GENERAL MOTORS CORP.

5. Install **J 41476** to the front cover. See **Special Tools and Equipment**.
6. Align the tapered legs of the **J 41476** with the machined alignment surfaces on the front cover. See **Special Tools and Equipment**.

1. Tighten the oil pan to front cover bolts to 25 N.m (18 lb ft).
2. Tighten the engine front cover bolts to 25 N.m (18 lb ft).
8. Remove the **J 41476** . See **Special Tools and Equipment**.
9. Install a NEW crankshaft front oil seal. Refer to **Crankshaft Front Oil Seal Replacement**.
10. Install the water pump. Refer to **Water Pump Replacement (LL8)** or **Water Pump Replacement (LM4)** in Engine Cooling.
11. Install the A/C compressor and bracket. Refer to **Compressor Replacement (Short Wheel Base)** or **Compressor Replacement (Long Wheel Base)** in Heating, Ventilation, and Air Conditioning.

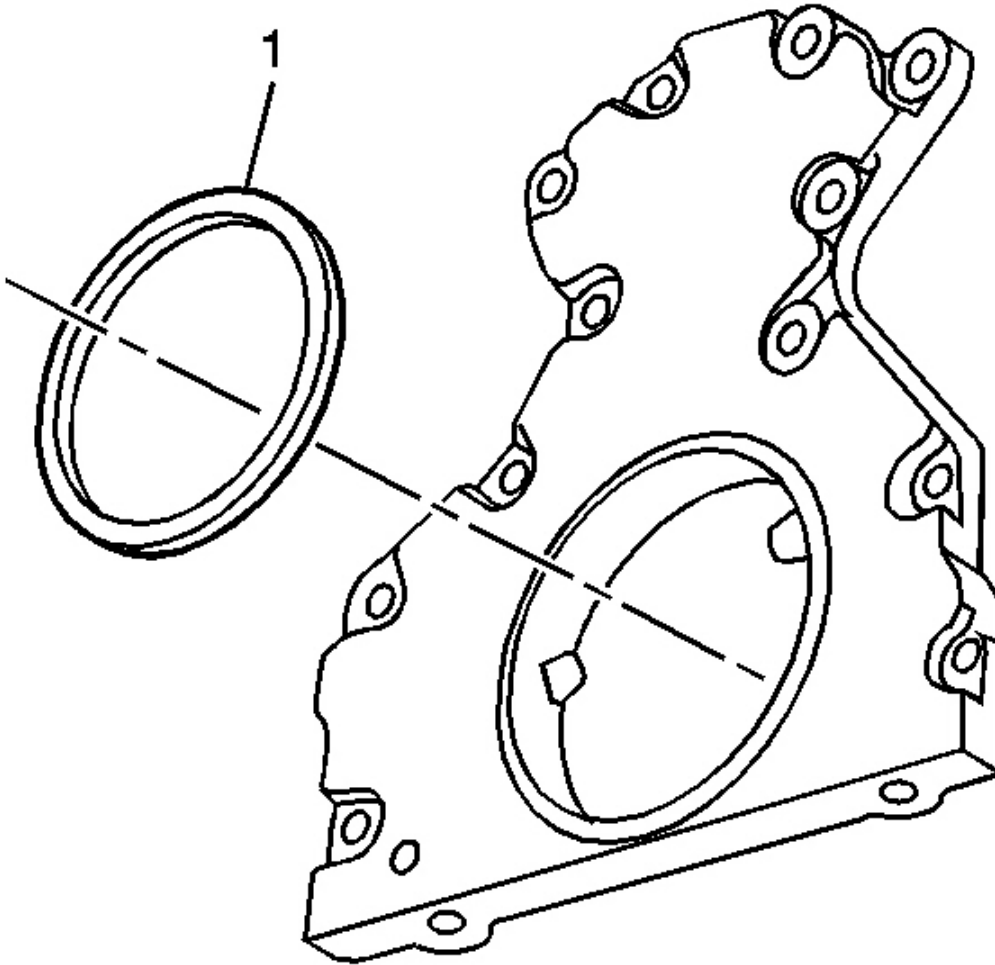
Fig. 199: View Of Crankshaft Rear Oil Seal
Courtesy of GENERAL MOTORS CORP.

1. Remove the engine flywheel. Refer to **Engine Flywheel Replacement**.
2. Remove the crankshaft rear oil seal (1) from the rear cover.
