2004 Isuzu Ascender LS

2004 ENGINE Engine Mechanical - 4.8L, 5.3L, and 6.0L - Ascender

Engine Mechanical - 4.8L, 5.3L, and 6.0L - Ascender

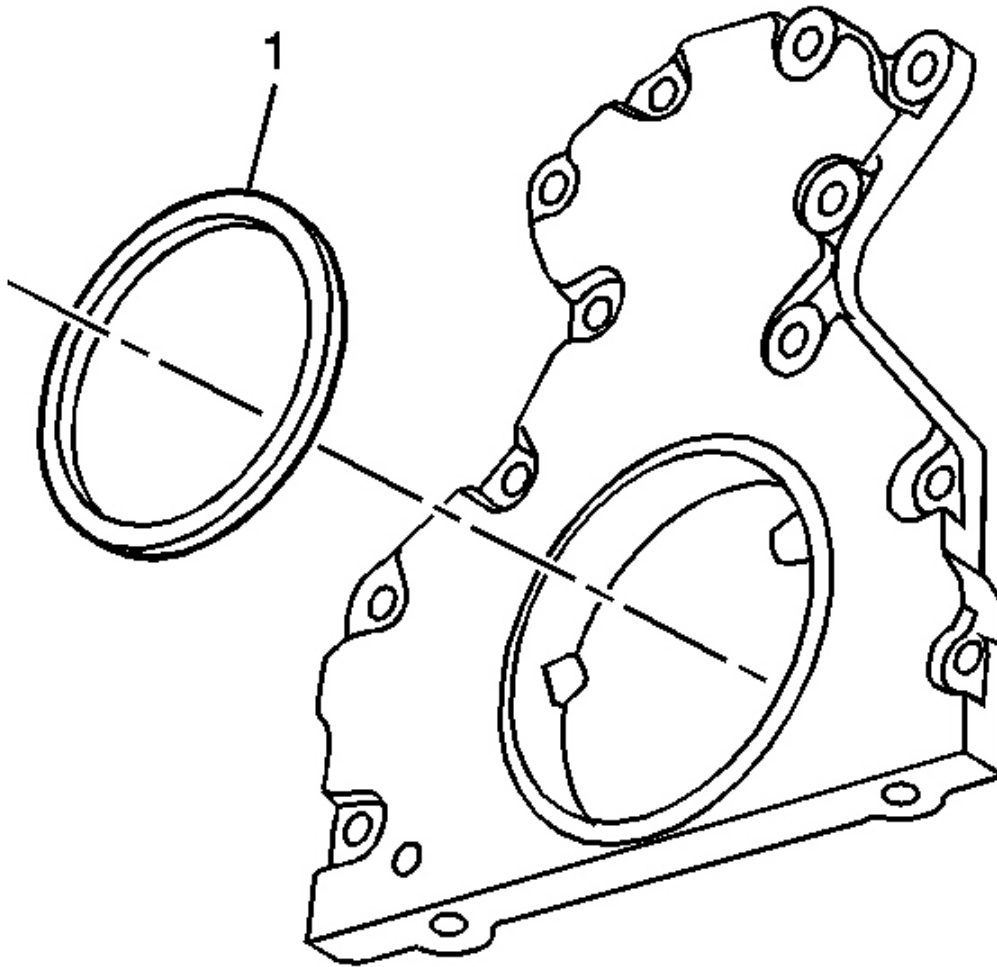
Fig. 200: View Of Crankshaft Rear Oil Seal
Courtesy of GENERAL MOTORS CORP.

1. Lubricate the outside diameter (OD) of the oil seal (1) with clean engine oil.

2. Lubricate the rear cover oil seal bore with clean engine oil.

DO NOT allow oil or other lubricants to contact the crankshaft surface.

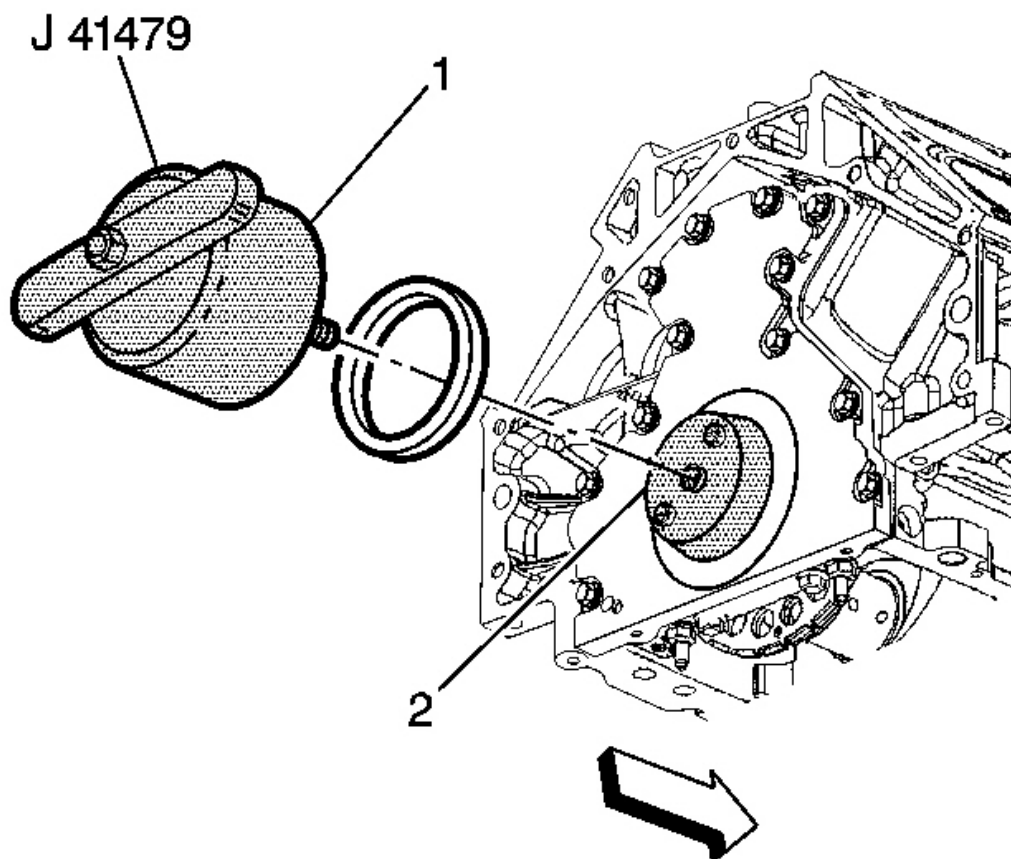
Fig. 201: Installing Crankshaft Rear Oil Seal Using J 41479
Courtesy of GENERAL MOTORS CORP.

3. Install the **J 41479** tapered cone (2) and bolts onto the rear of the crankshaft. See **Special Tools and Equipment**.
4. Tighten the bolts until snug. Do not overtighten.
5. Install the rear oil seal onto the tapered cone (2) and push the seal to the rear cover bore.
6. Thread the **J 41479** threaded rod into the tapered cone until the tool (1) contacts the oil seal. See **Special Tools and Equipment**.
7. Align the oil seal into the tool (1).
8. Rotate the handle of the tool (1) clockwise until the seal enters the rear cover and bottoms into the cover bore.
9. Remove the **J 41479** . See **Special Tools and Equipment**.
10. Install the engine flywheel. Refer to **Engine Flywheel Replacement**.

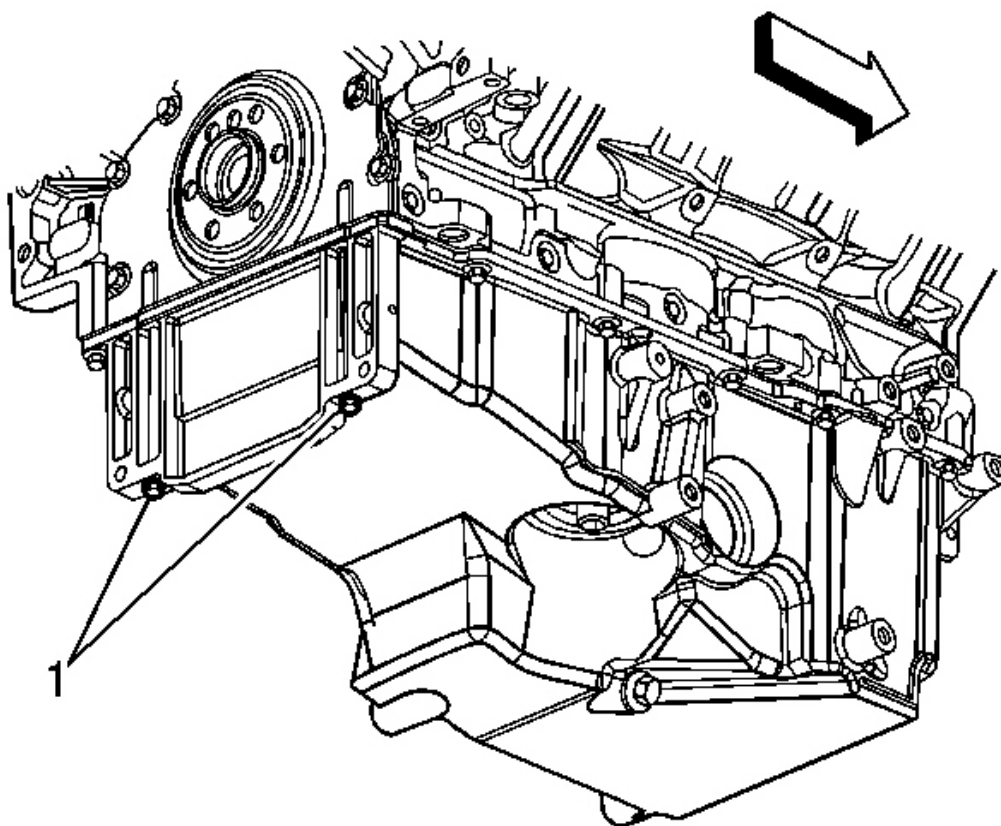
Fig. 202: View Of Oil Pan-To-Rear Cover Bolts
Courtesy of GENERAL MOTORS CORP.

1. Remove the engine flywheel. Refer to **Engine Flywheel Replacement**.
2. Remove the oil pan-to-rear cover bolts (1).

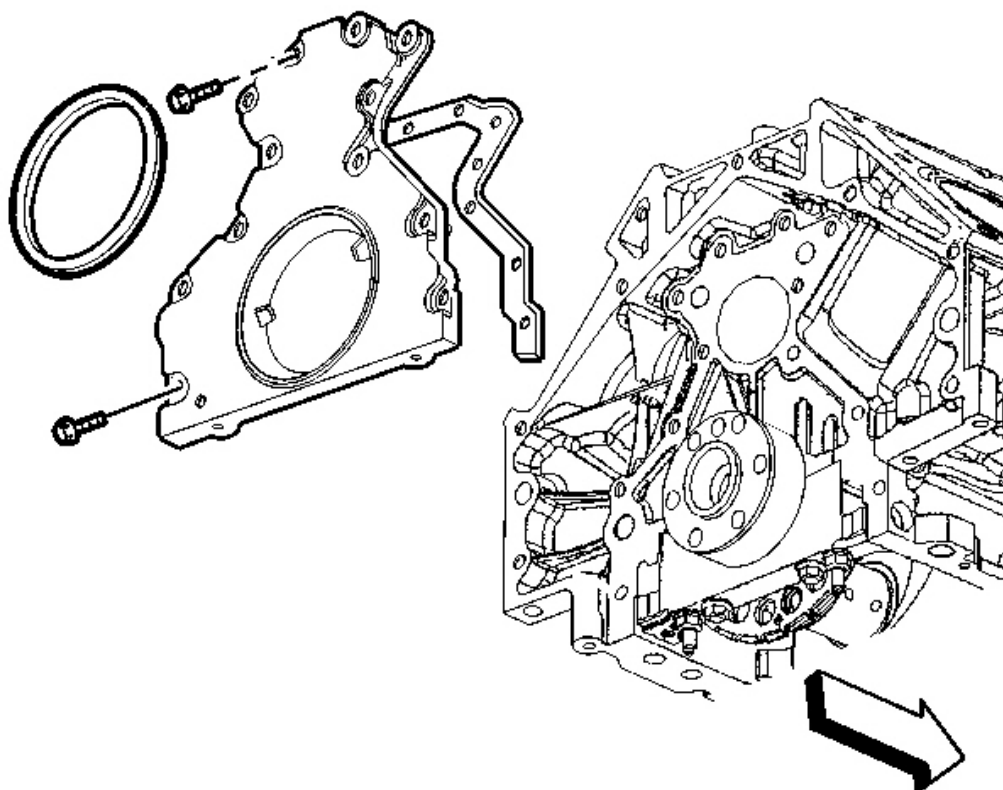
Fig. 203: View Of Rear Cover, Bolts & Gasket
Courtesy of GENERAL MOTORS CORP.

3. Remove the rear cover bolts.
4. Remove the rear cover and gasket.
5. Discard the rear cover gasket.
6. Clean and inspect the rear cover. Refer to Engine Rear Cover Cleaning and Inspection.

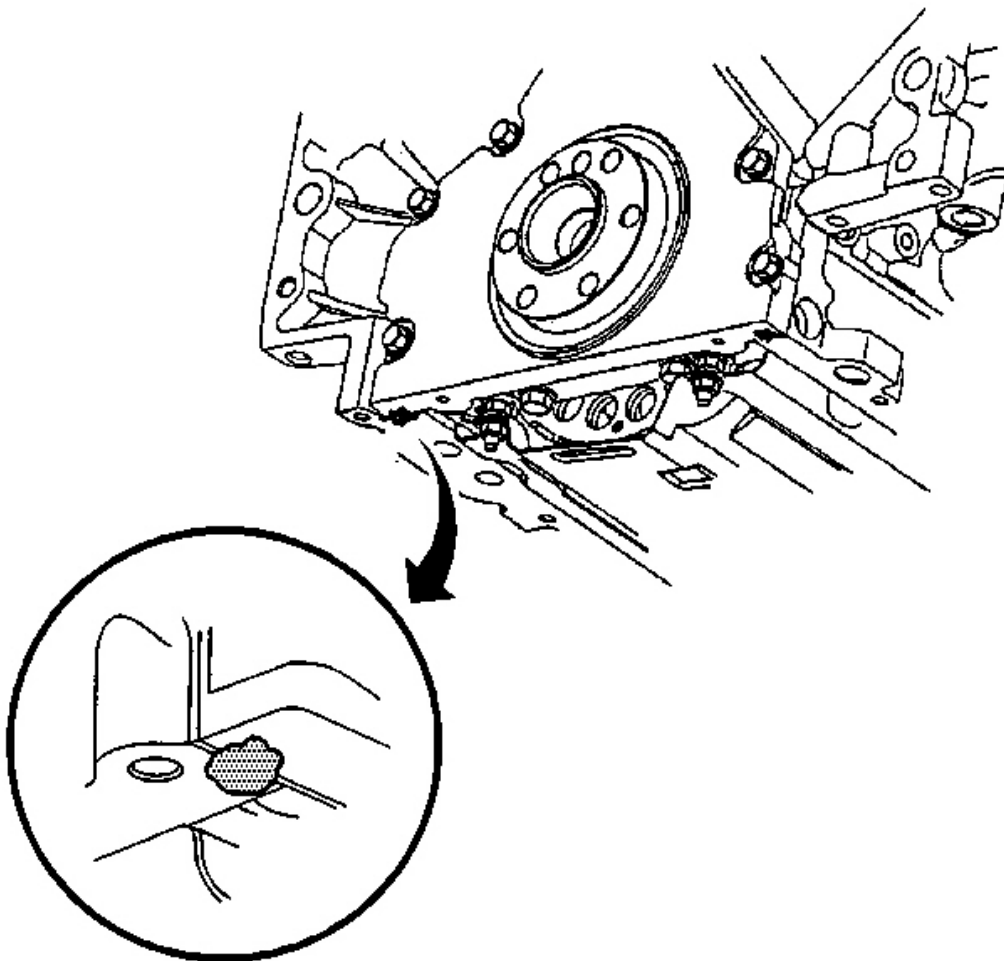
- All gasket surfaces should be free of oil or other foreign material during assembly.
- The crankshaft rear oil seal **MUST** be centered in relation to the crankshaft.
- An improperly aligned rear cover may cause premature rear oil seal wear and/or engine assembly oil leaks.

Fig. 204: View Of Sealant Applied To Rear Oil Pan-To-Engine Block Junction

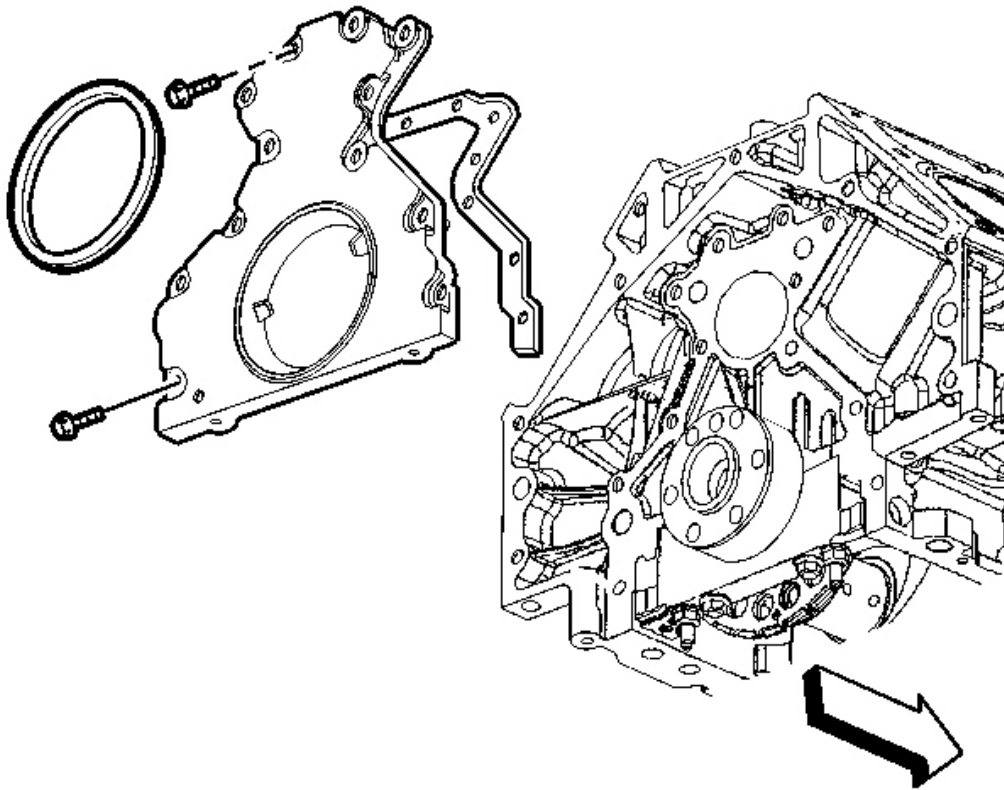
Fig. 205: View Of Rear Cover, Bolts & Gasket
Courtesy of GENERAL MOTORS CORP.

2. Install the rear cover gasket and cover.
3. Install the rear cover bolts until snug. Do not overtighten.

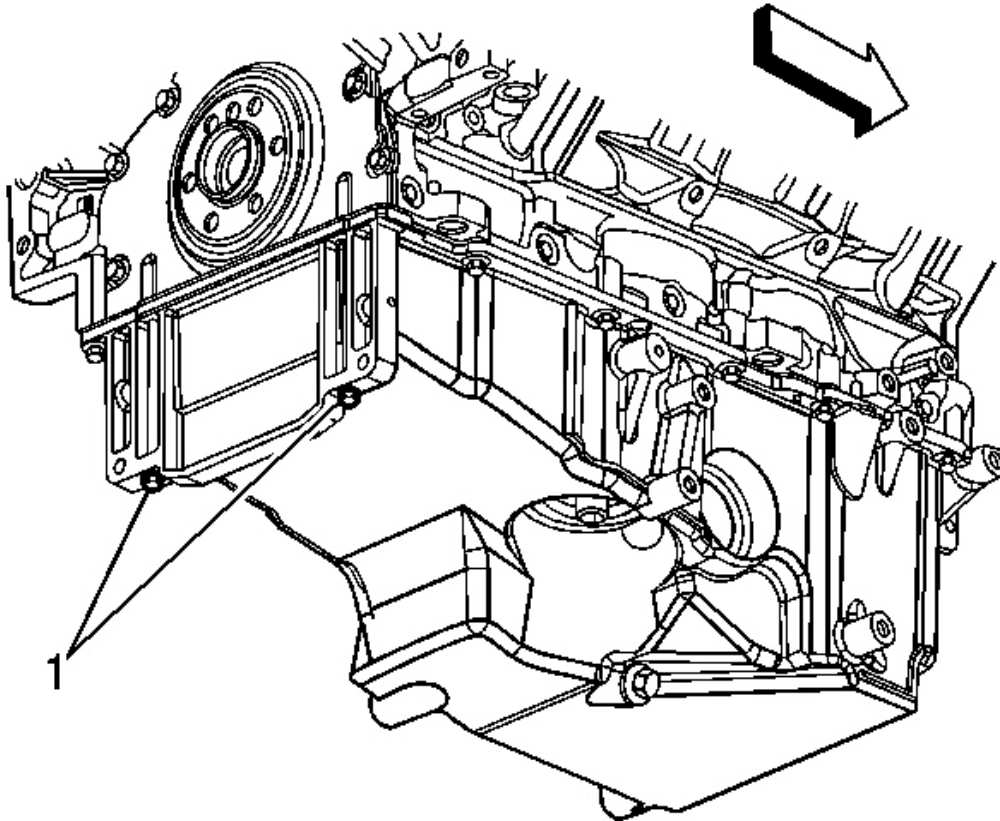
Fig. 206: View Of Oil Pan-To-Rear Cover Bolts
Courtesy of GENERAL MOTORS CORP.

4. Install the oil pan-to-rear cover bolts (1) until snug. Do not overtighten.

1. Tighten the oil pan-to-rear cover bolts to 12 N.m (106 lb in).
2. Tighten the engine rear cover bolts to 25 N.m (18 lb ft).
8. Remove the **J 41476** . See **Special Tools and Equipment**.
9. Install a NEW crankshaft rear oil seal. Refer to **Crankshaft Rear Oil Seal Replacement**.
10. Install the engine flywheel. Refer to **Engine Flywheel Replacement**.

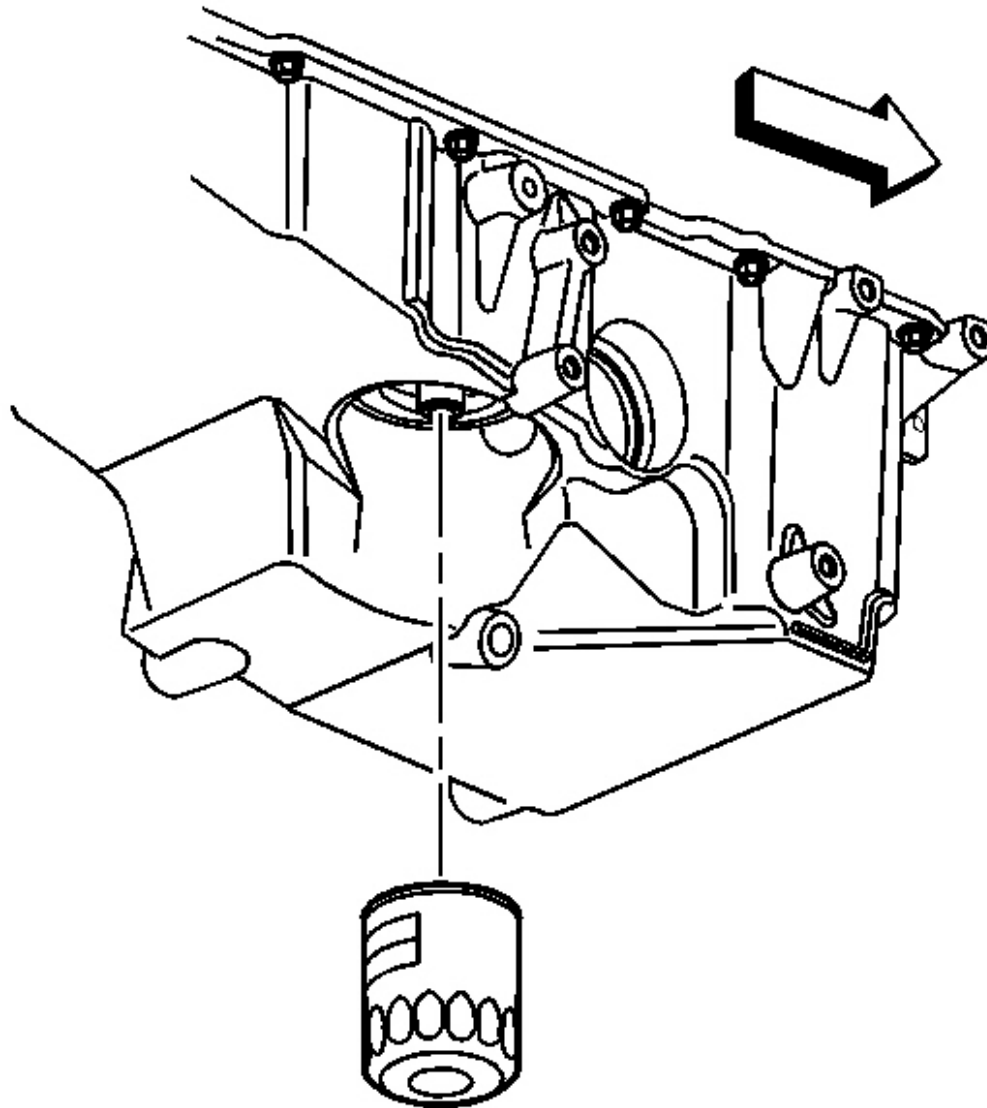
Fig. 208: Locating Oil Filter

1. Remove the oil filter. Refer to **Engine Oil and Oil Filter Replacement**.

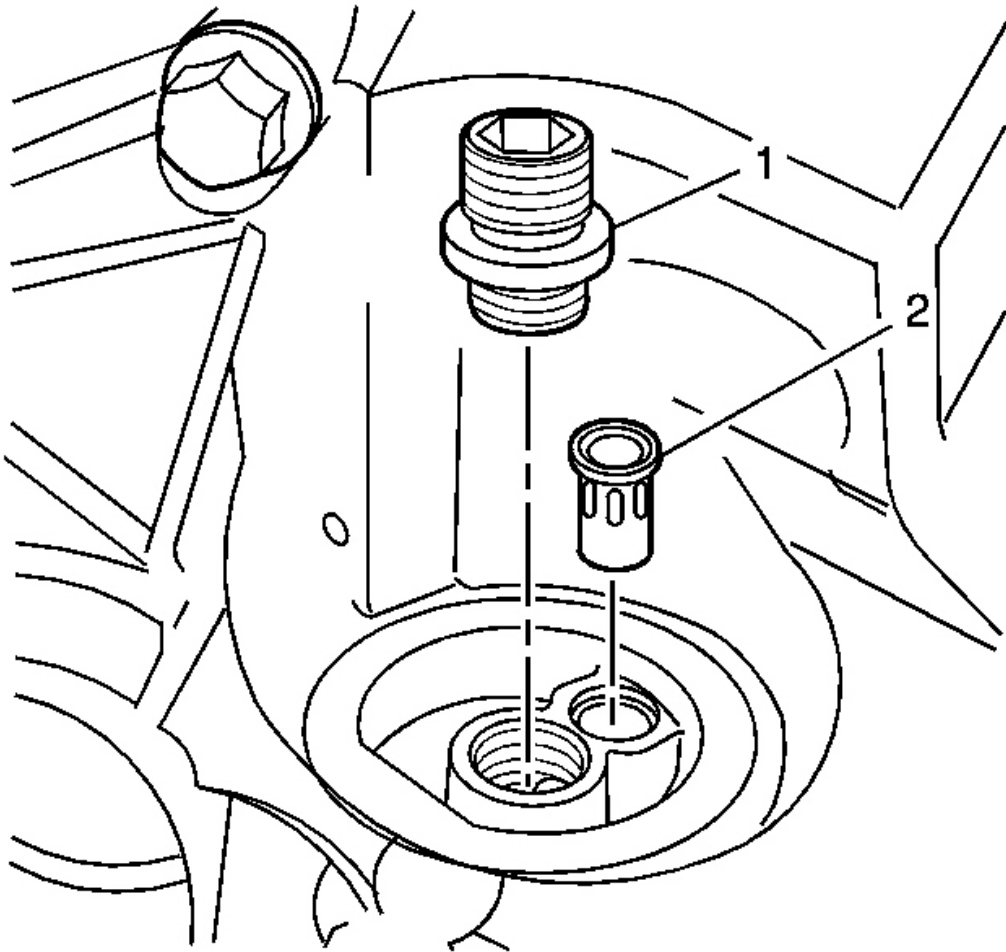
Fig. 209: View Of Oil Filter Adapter & Bypass Valve
Courtesy of GENERAL MOTORS CORP.

2. Remove the oil filter adapter (1).

1. Install the oil filter adapter (1).

Tighten: Tighten the adapter to 55 N.m (40 lb ft).

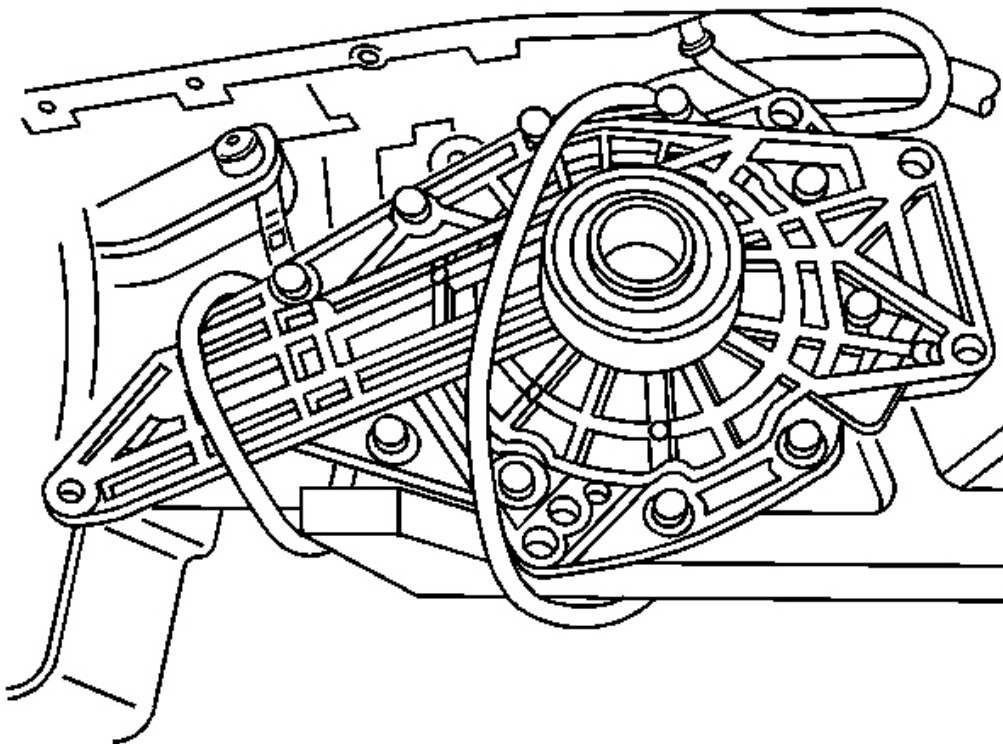
Fig. 216: Securing Front Differential To Frame
Courtesy of GENERAL MOTORS CORP.

3. Remove the front differential and secure to the frame. Refer to **Differential Carrier Assembly Replacement (4.8L, 5.3L, 6.0L V-8)** In Front Drive Axle.
4. Drain the engine oil. Refer to **Engine Oil and Oil Filter Replacement**.

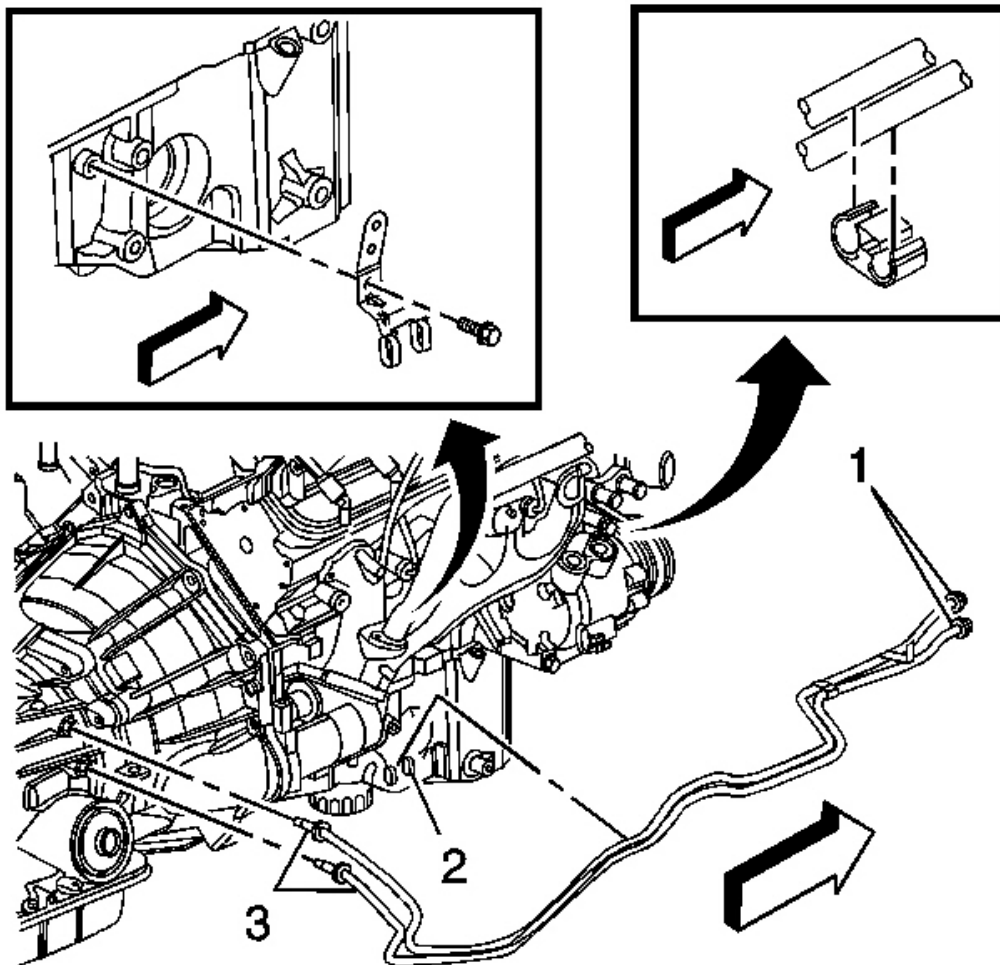
Fig. 217: View Of Transmission Oil Cooler Lines
Courtesy of GENERAL MOTORS CORP.

5. Remove the transmission oil cooler lines from the retainer.

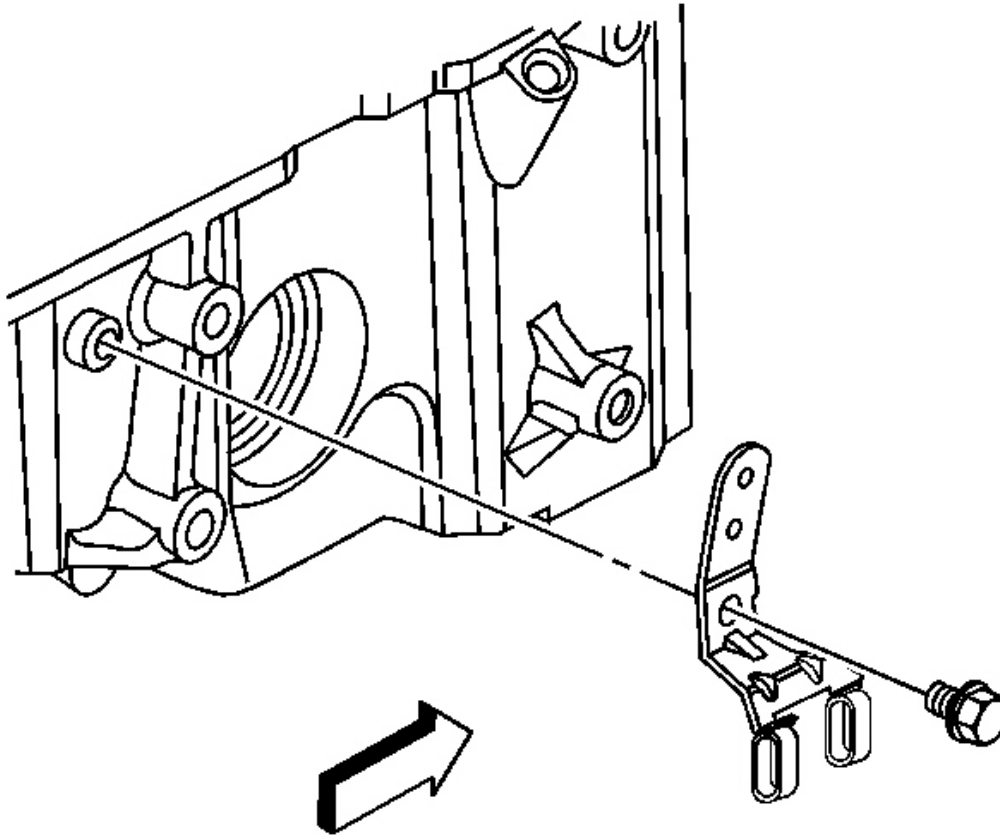
Fig. 218: View Of Transmission Oil Cooler Line Retaining Bracket & Bolt
Courtesy of GENERAL MOTORS CORP.

6. Remove the transmission oil cooler line retaining bracket bolt and bracket.
7. Remove the starter. Refer to **Starter Motor Replacement (4.2L Engine)** and/or **Starter Motor Replacement (5.3L Engine)** in Engine Electrical.
8. Remove the Flywheel inspection cover from the left side of the transmission.

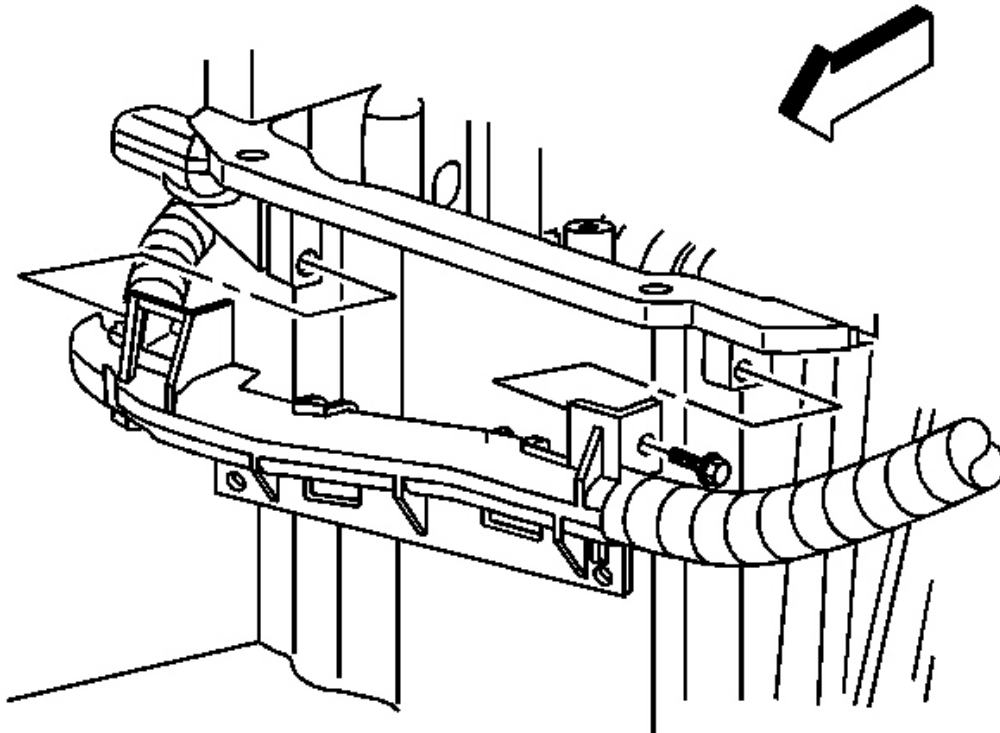
Fig. 219: View Of Battery Cable Channel & Bolt
Courtesy of GENERAL MOTORS CORP.

9. Remove the battery cable channel bolt from the front of the oil pan.
10. Remove the battery cable channel from the oil pan.

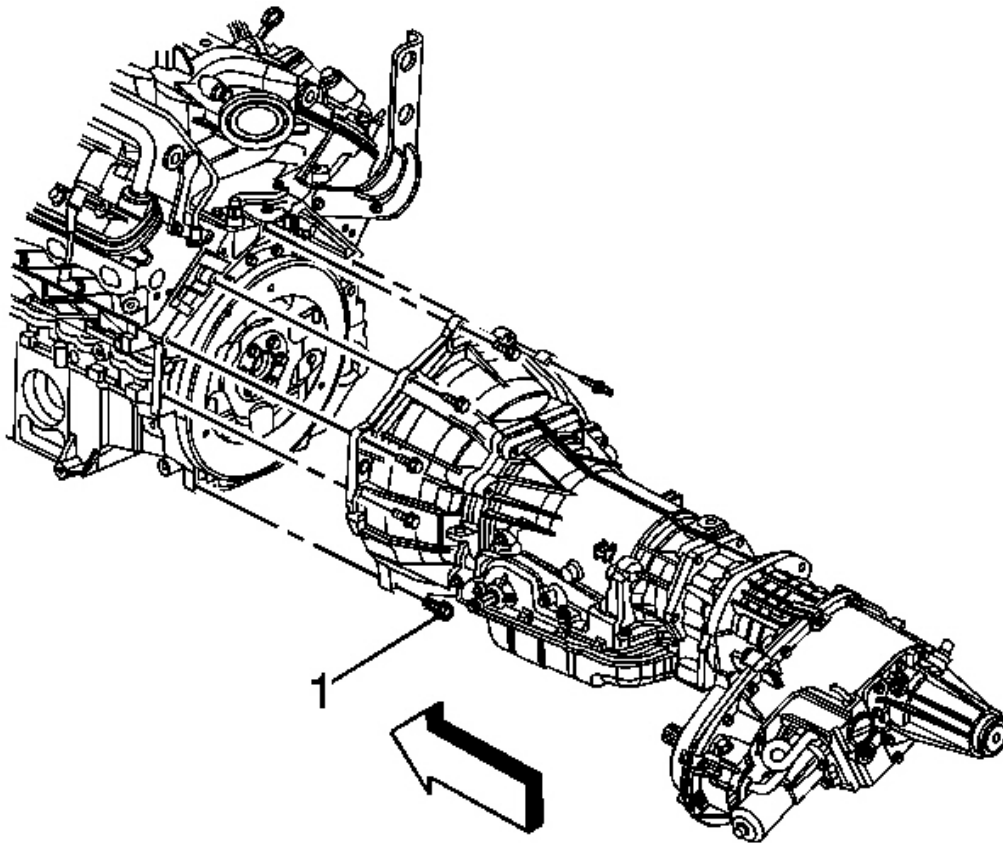
Fig. 221: View Of Lower Bellhousing Bolts
Courtesy of GENERAL MOTORS CORP.

13. Remove the 2 lower bellhousing bolts.

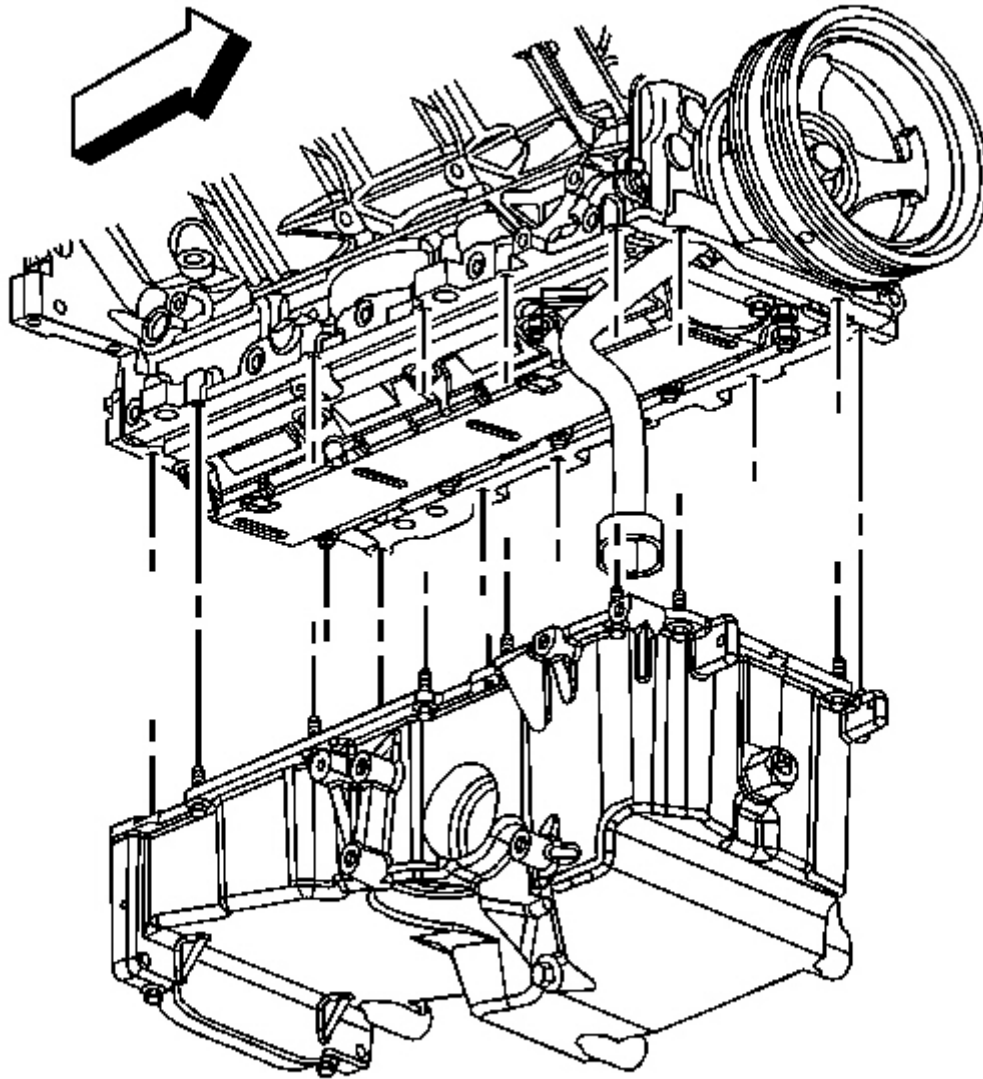
Fig. 222: View Of Oil Pan & Bolts
Courtesy of GENERAL MOTORS CORP.

14. Remove the oil pan bolts.
15. Remove the oil pan by tilting the rear of the oil pan down to clear the transmission, pull the oil pan rearward past the front wire harness, then lower the oil pan clear of the vehicle.

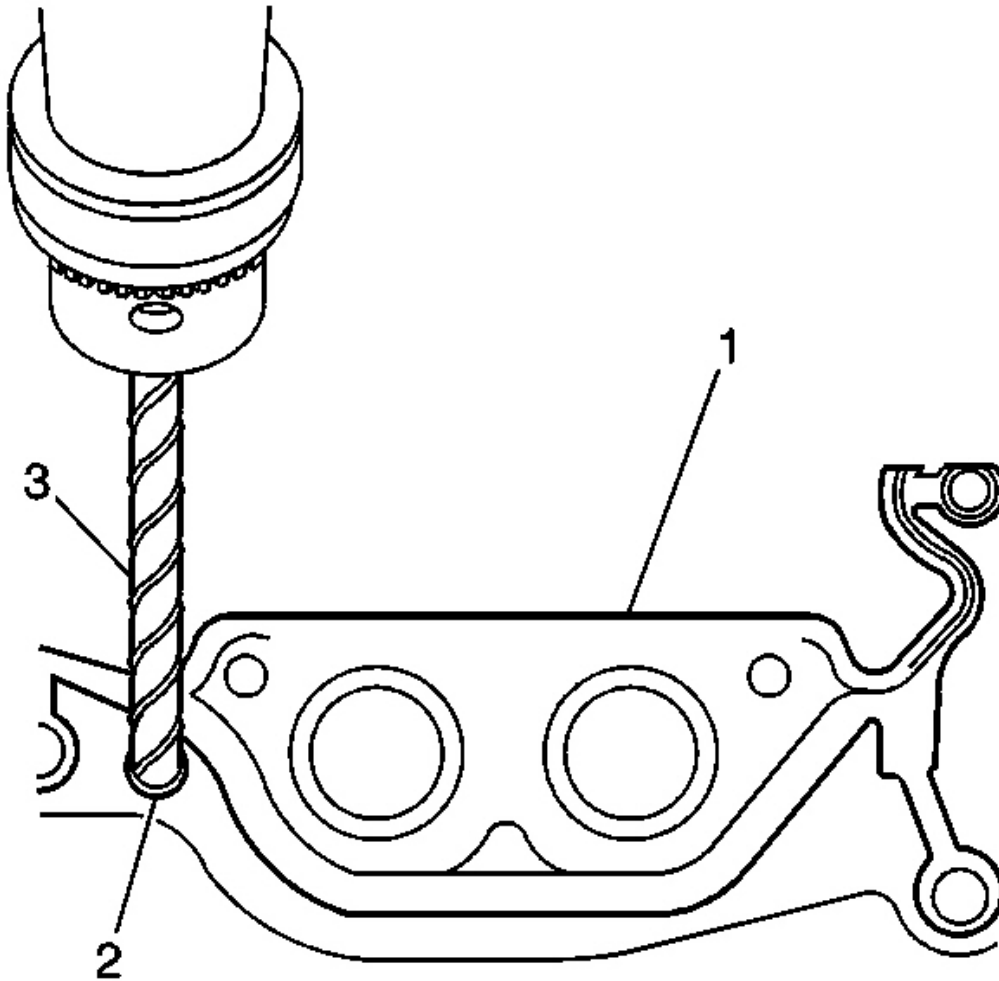
IMPORTANT: The oil pan gasket is reusable. It is **NOT** necessary to remove the oil pan

gasket unless damaged.

Fig. 223: View Of Oil Pan Gasket & Retaining Rivets
Courtesy of GENERAL MOTORS CORP.

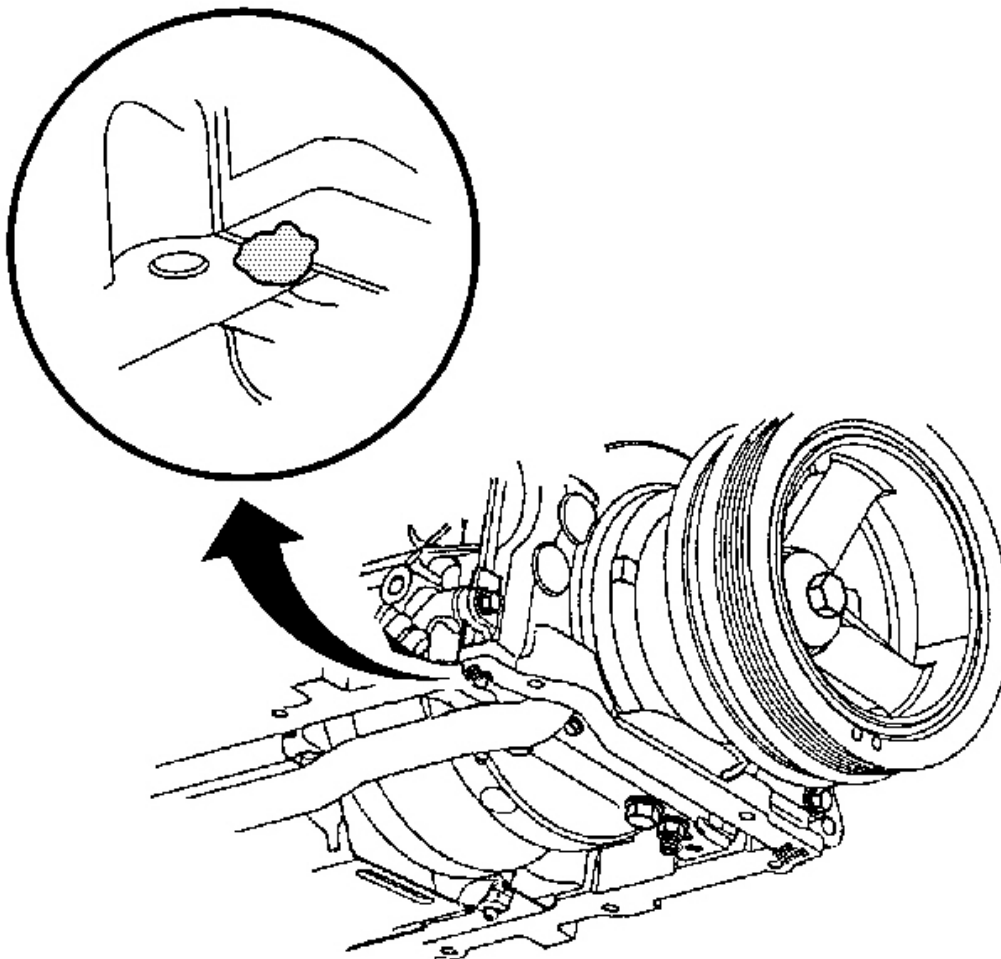
Fig. 224: View Of Sealant Applied To Front Oil Pan-To-Engine Block Junction
Courtesy of GENERAL MOTORS CORP.

1. Apply a 5 mm (0.20 in) bead of sealant GM P/N 12378190, or equivalent 20 mm (0.80 in) long to the engine block. Apply the sealant directly onto the tabs of the front cover gasket that protrudes into the oil pan surface.

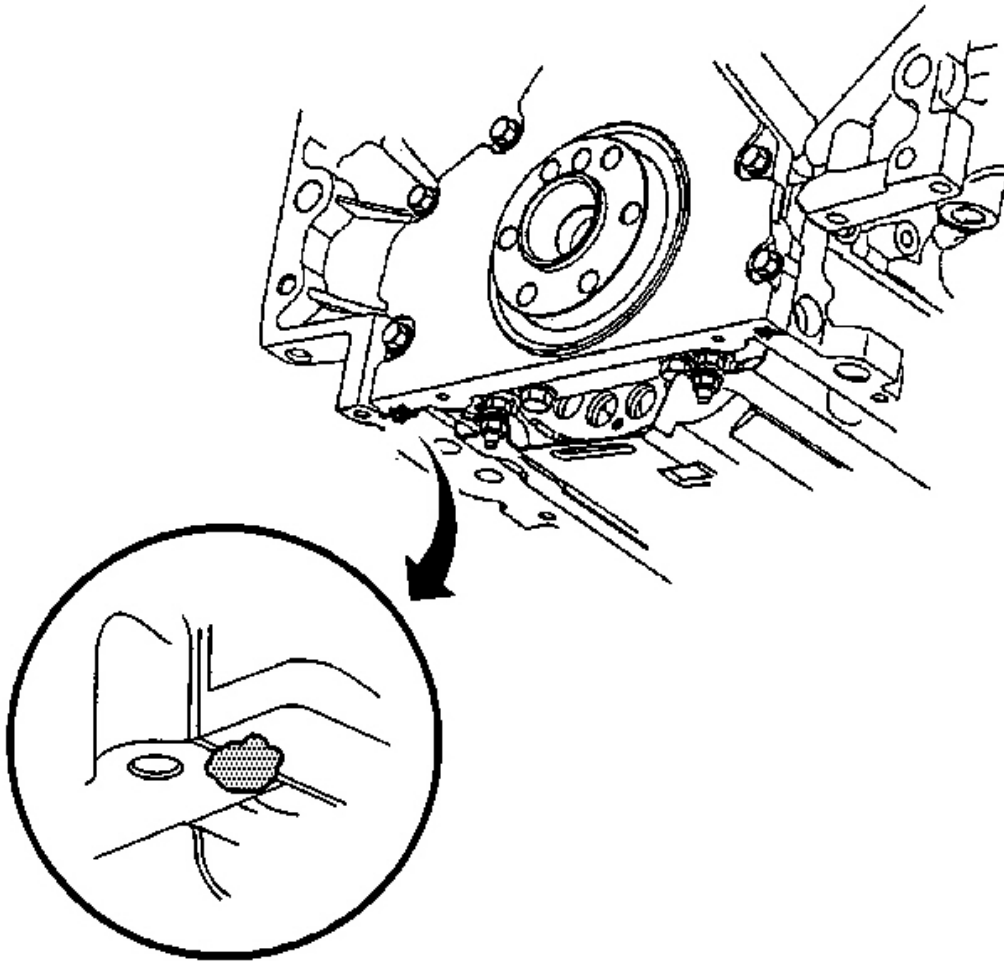
Fig. 225: View Of Sealant Applied To Rear Oil Pan-To-Engine Block Junction
Courtesy of GENERAL MOTORS CORP.

2. Apply a 5 mm (0.20 in) bead of sealant GM P/N 12378190, or equivalent 20 mm (0.80 in) long to the engine block. Apply the sealant directly onto the tabs of the rear cover gasket that protrudes into the oil pan surface.

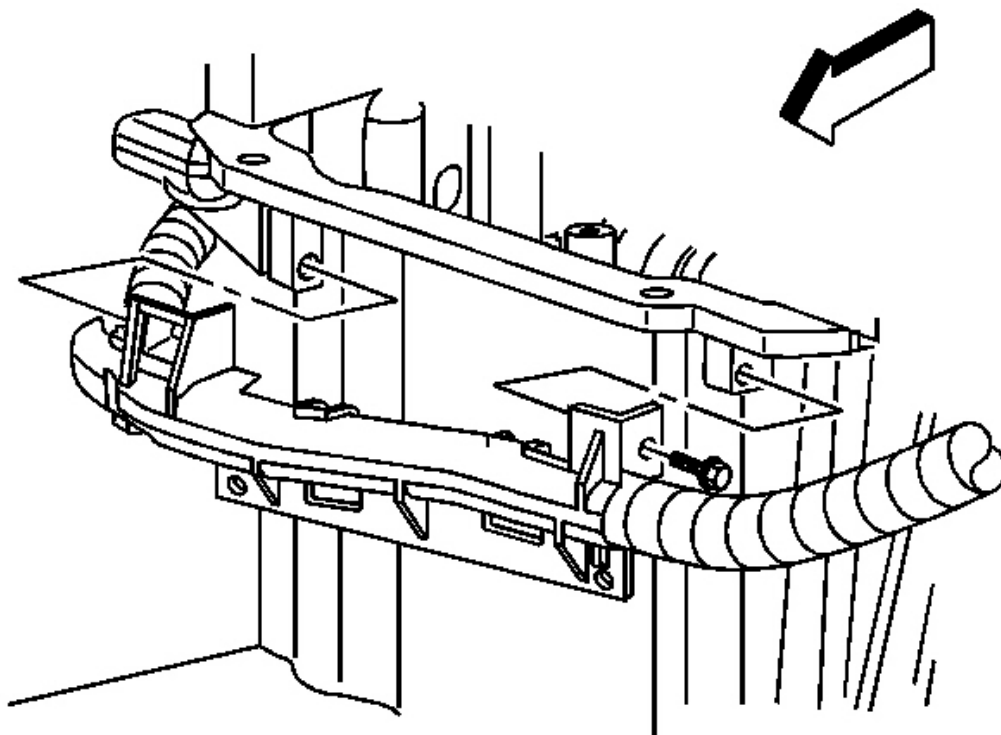
Fig. 229: View Of Battery Cable Channel & Bolt
Courtesy of GENERAL MOTORS CORP.

9. Install the battery cable channel to the oil pan.
10. Install the battery cable channel bolt to the oil pan.

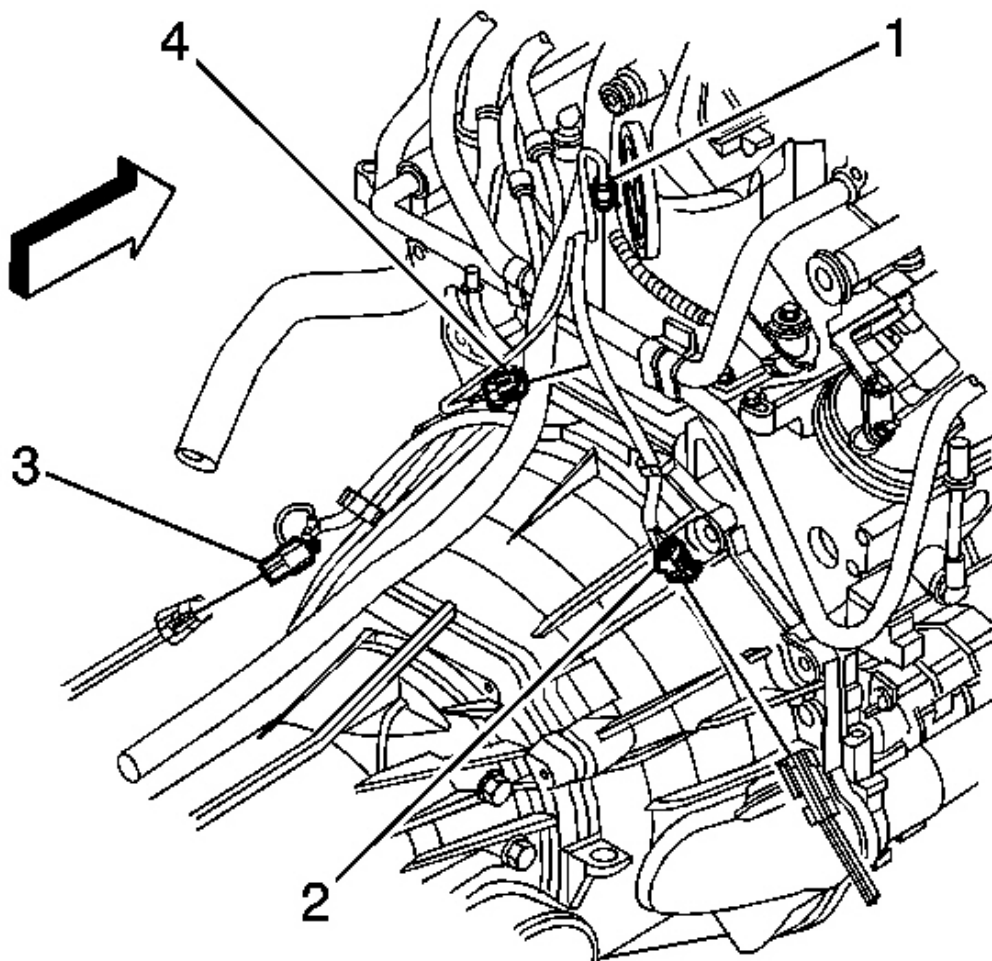
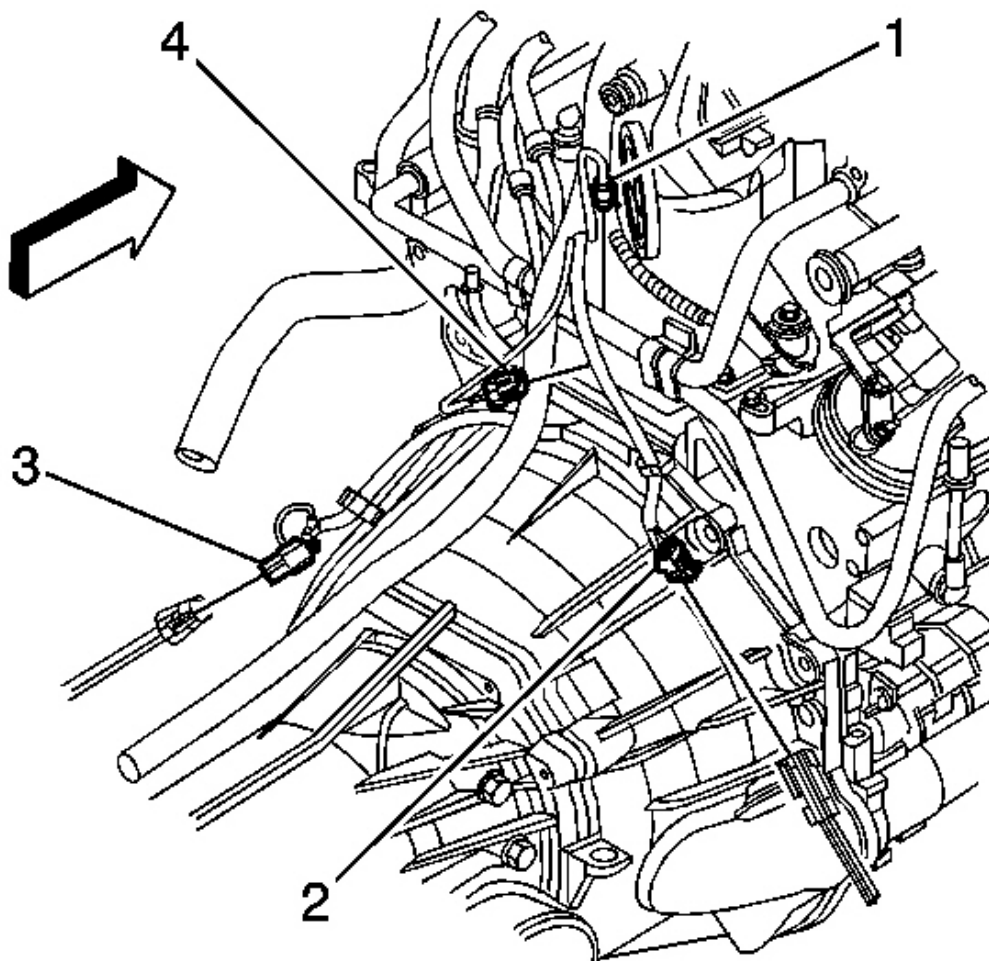
Fig. 233: Locating Components Connectors At Rear Of Engine
Courtesy of GENERAL MOTORS CORP.

1. Remove the intake manifold. Refer to **Intake Manifold Replacement**.
2. Disconnect the oil pressure sensor electrical connector (1).

3. Connect the oil pressure sensor electrical connector (1).
4. Install the intake manifold. Refer to **Intake Manifold Replacement**.

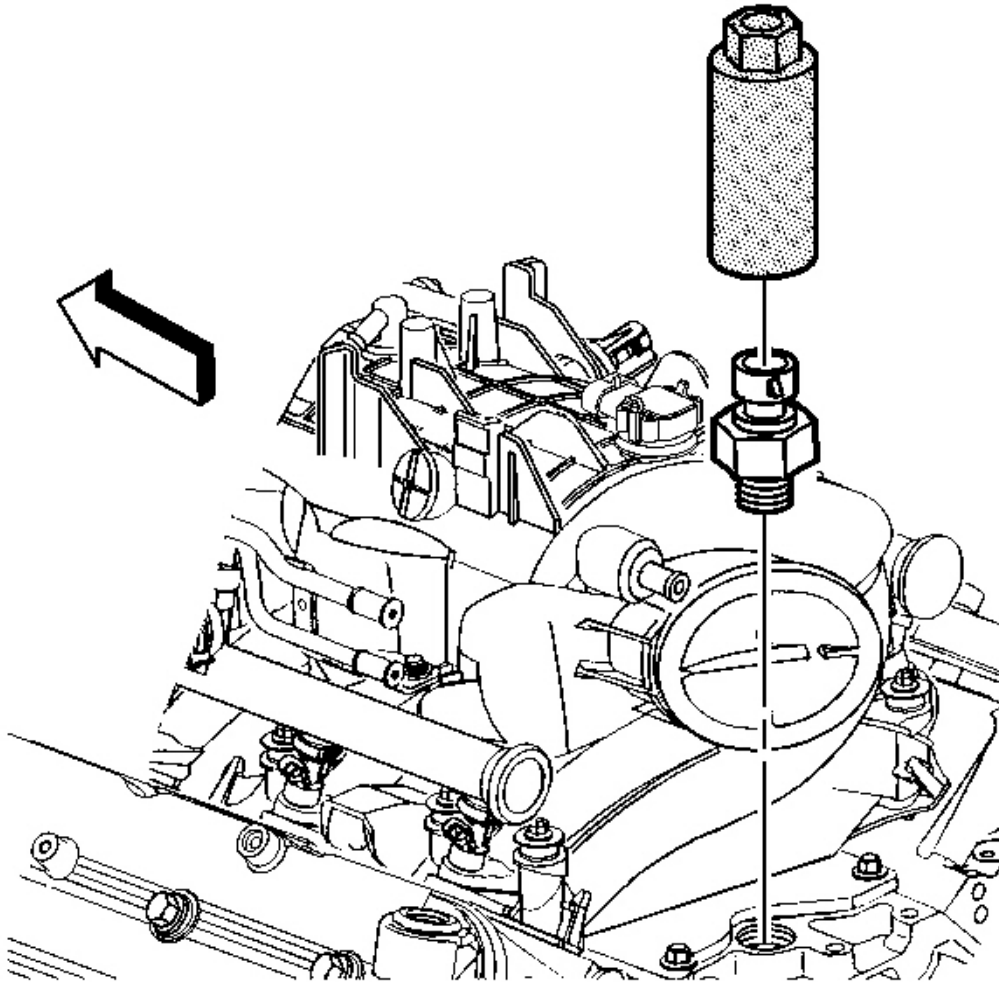
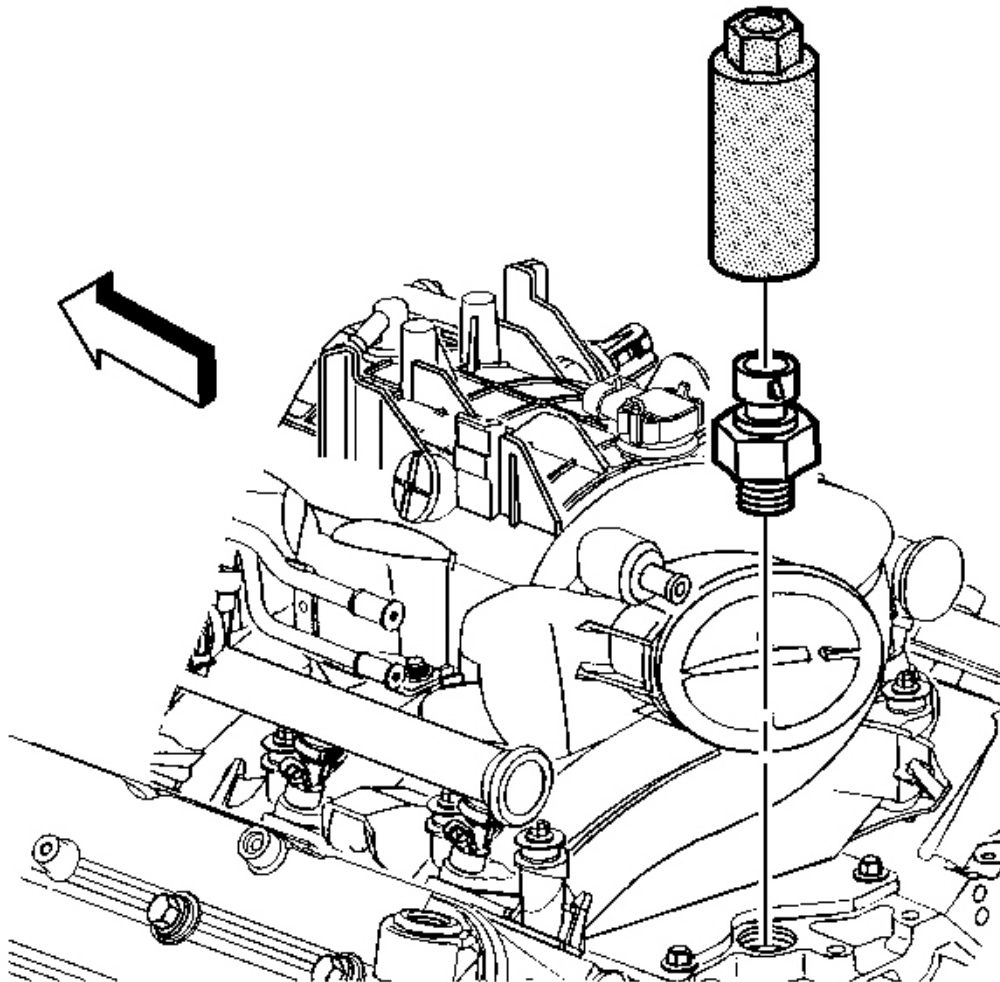
Fig. 234: View Of Oil Pressure Sensor & J 41712
Courtesy of GENERAL MOTORS CORP.

3. Using **J 41712** or equivalent, remove the oil pressure sensor. See **Special Tools and Equipment**.

1. Apply sealant GM P/N 12346004 (Canadian P/N 10953480) or equivalent, to the threads of the oil pressure sensor.
2. Using **J 41712** or equivalent, install the oil pressure sensor. See **Special Tools and Equipment**.

Tighten: Tighten the sensor to 20 N.m (15 lb ft).
