2004 Isuzu Ascender LS

2004 ENGINE Engine Mechanical - 4.8L, 5.3L, and 6.0L - Ascender

Engine Mechanical - 4.8L, 5.3L, and 6.0L - Ascender

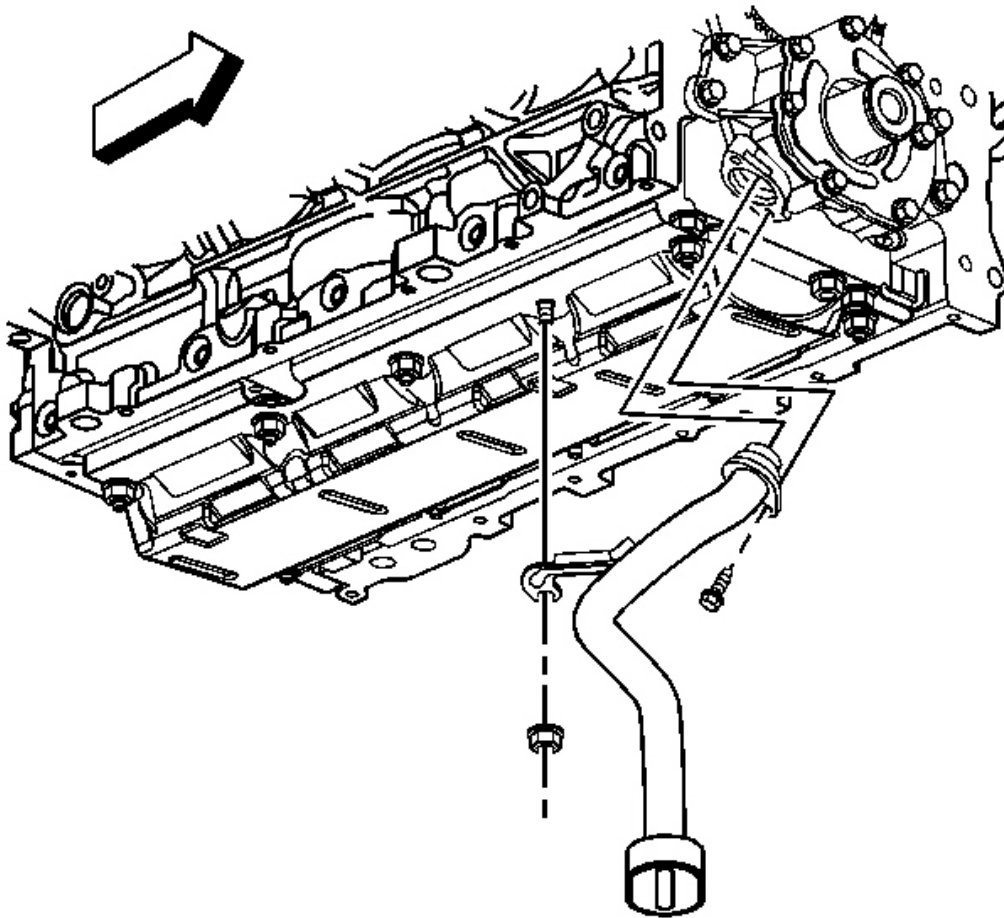
Fig. 237: View Of Oil Pump, Screen & Components
Courtesy of GENERAL MOTORS CORP.

1. Remove the oil pan. Refer to **Oil Pan Replacement**.
2. Remove the engine front cover. Refer to **Engine Front Cover Replacement**.
3. Remove the oil pump screen bolt and nuts.
4. Remove the oil pump screen with O-ring seal.
5. Remove the O-ring seal from the pump screen.
6. Discard the O-ring seal.

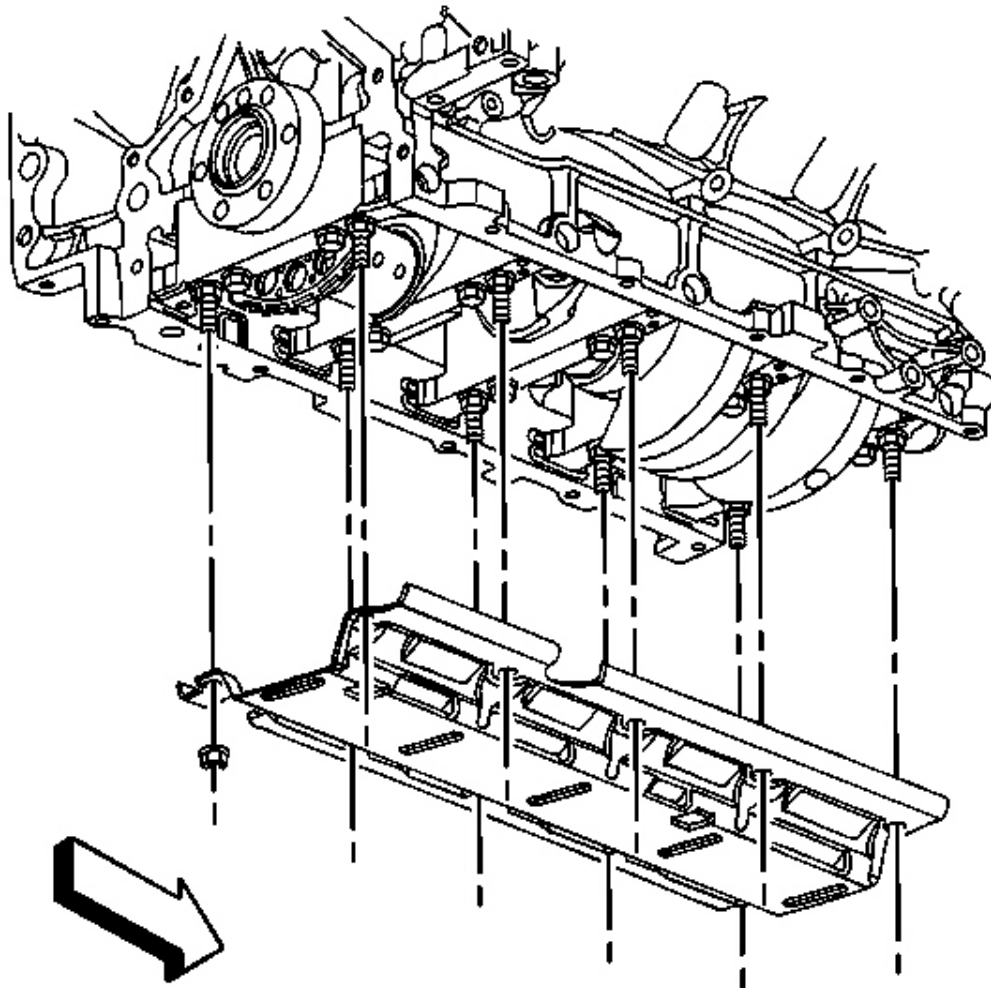
Fig. 238: View Of Crankshaft Oil Deflector & Nuts
Courtesy of GENERAL MOTORS CORP.

7. Remove the remaining crankshaft oil deflector nuts.
8. Remove the crankshaft oil deflector.

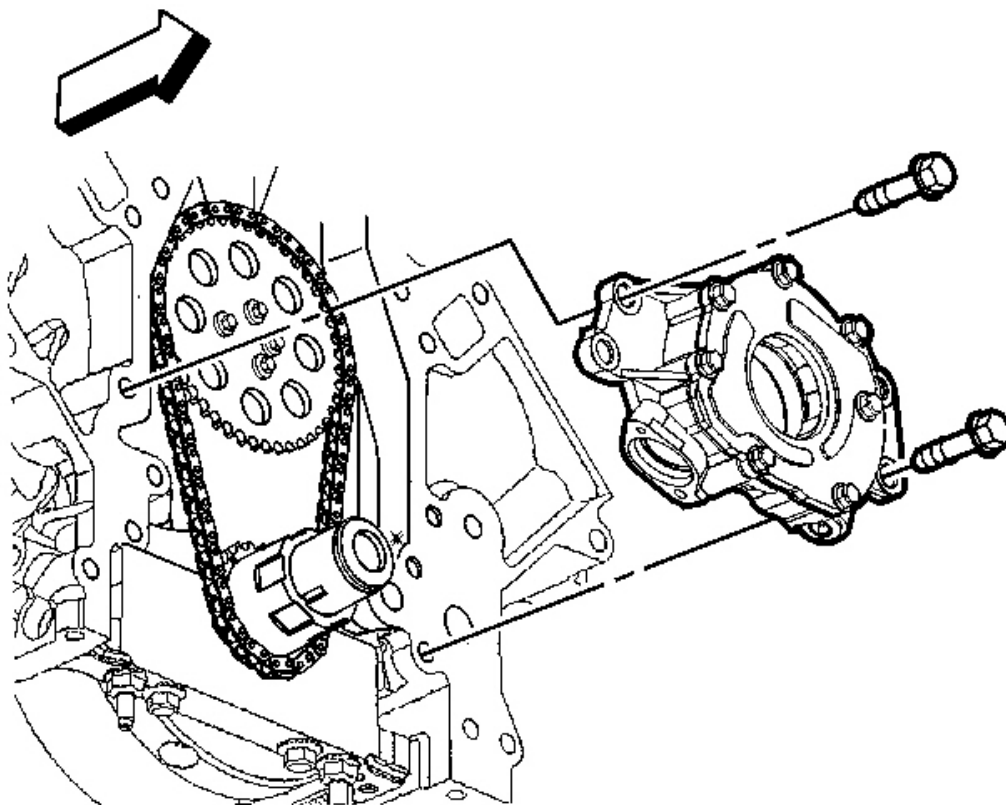
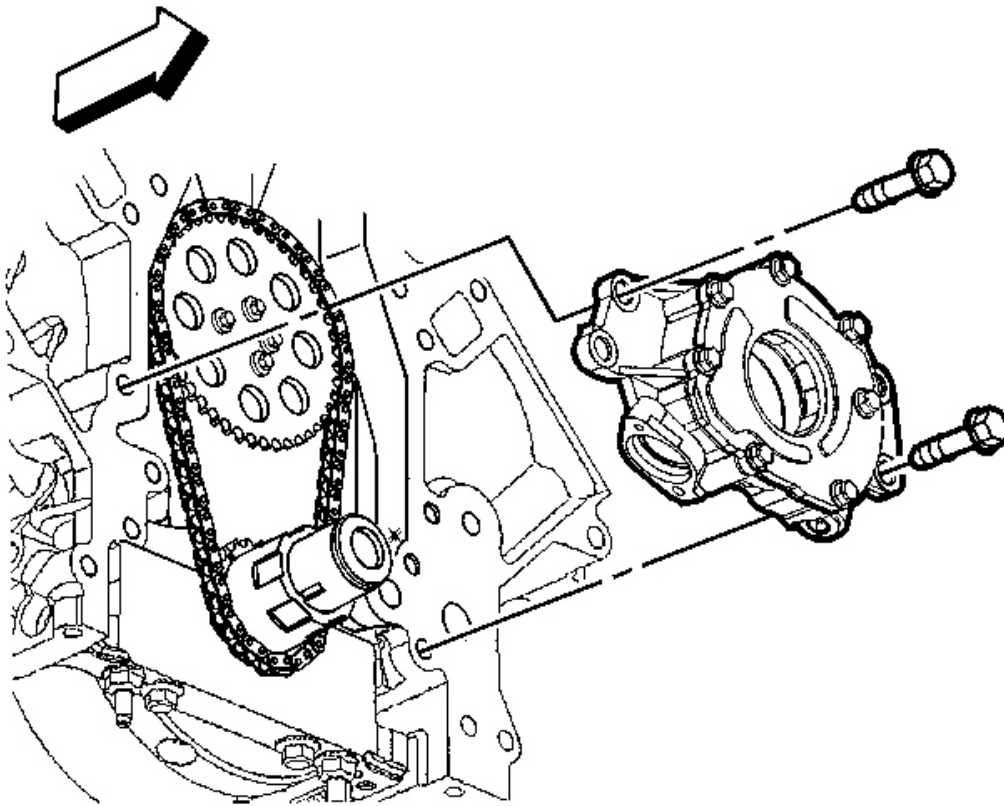
Fig. 239: View Of Oil Pump & Bolt
Courtesy of GENERAL MOTORS CORP.

9. Remove the oil pump bolts.
10. Remove the oil pump.
11. Clean and inspect the oil pump. Refer to **Oil Pump Cleaning and Inspection**

1. Align the splined surfaces of the crankshaft sprocket and the oil pump drive gear and install the oil pump.
2. Install the oil pump onto the crankshaft sprocket until the pump housing contacts the face of the engine block.

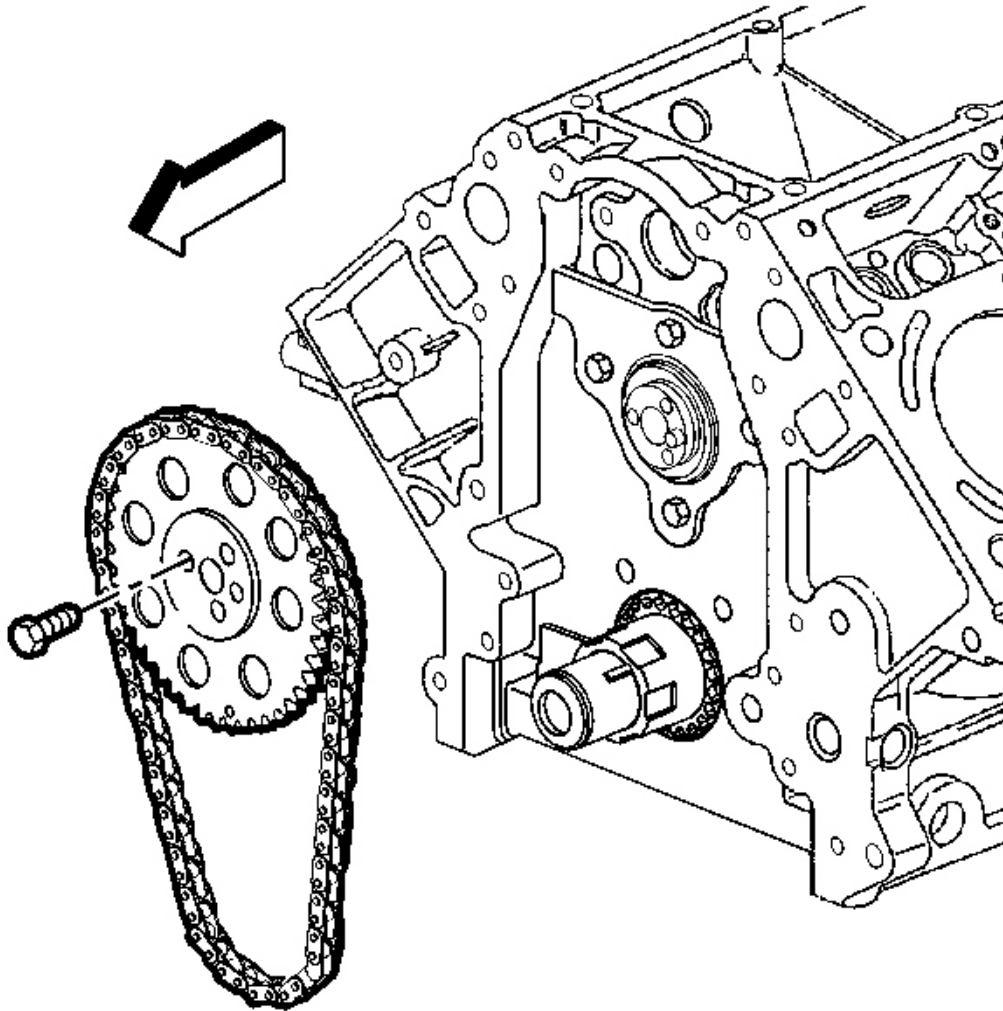
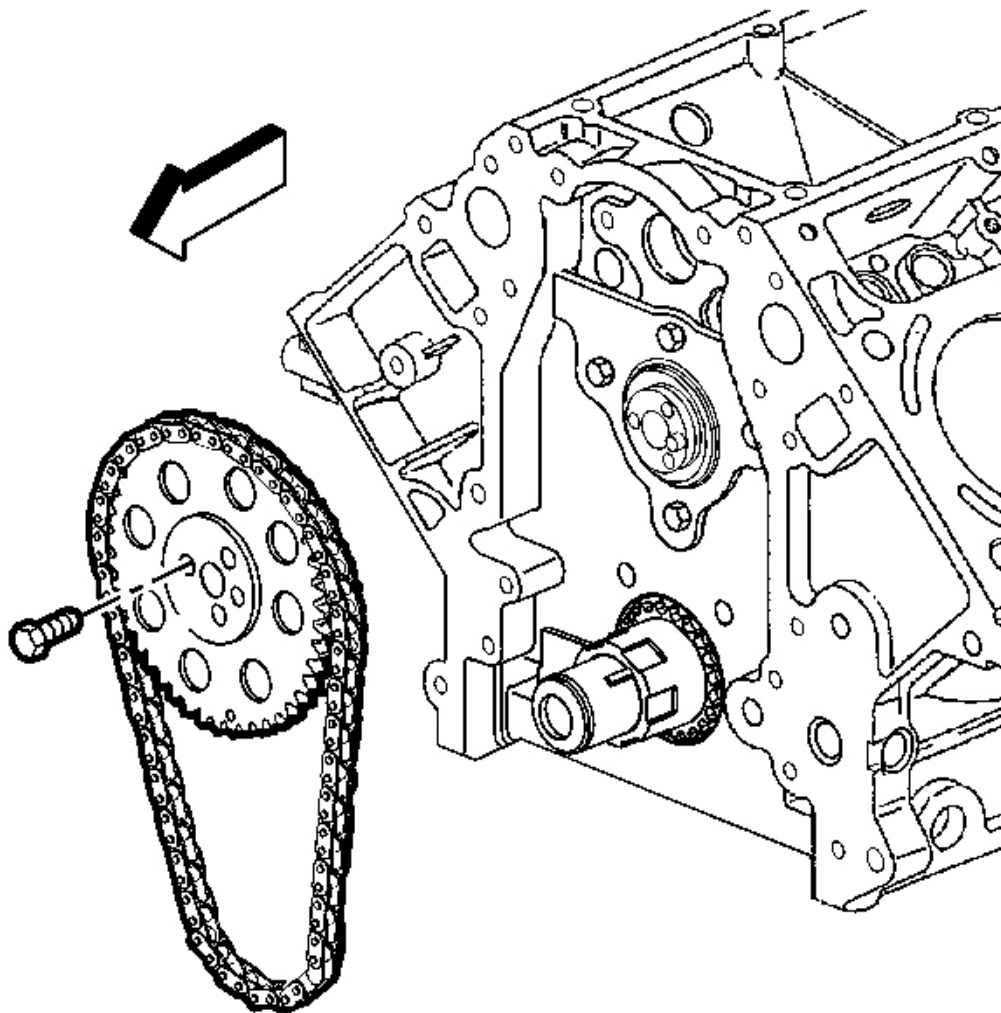
Fig. 243: Camshaft Sprocket, Bolt & Timing Chain
Courtesy of GENERAL MOTORS CORP.

3. Remove the camshaft sprocket bolts.

4. Remove the camshaft sprocket and timing chain.

5. Remove the camshaft sprocket bolts.

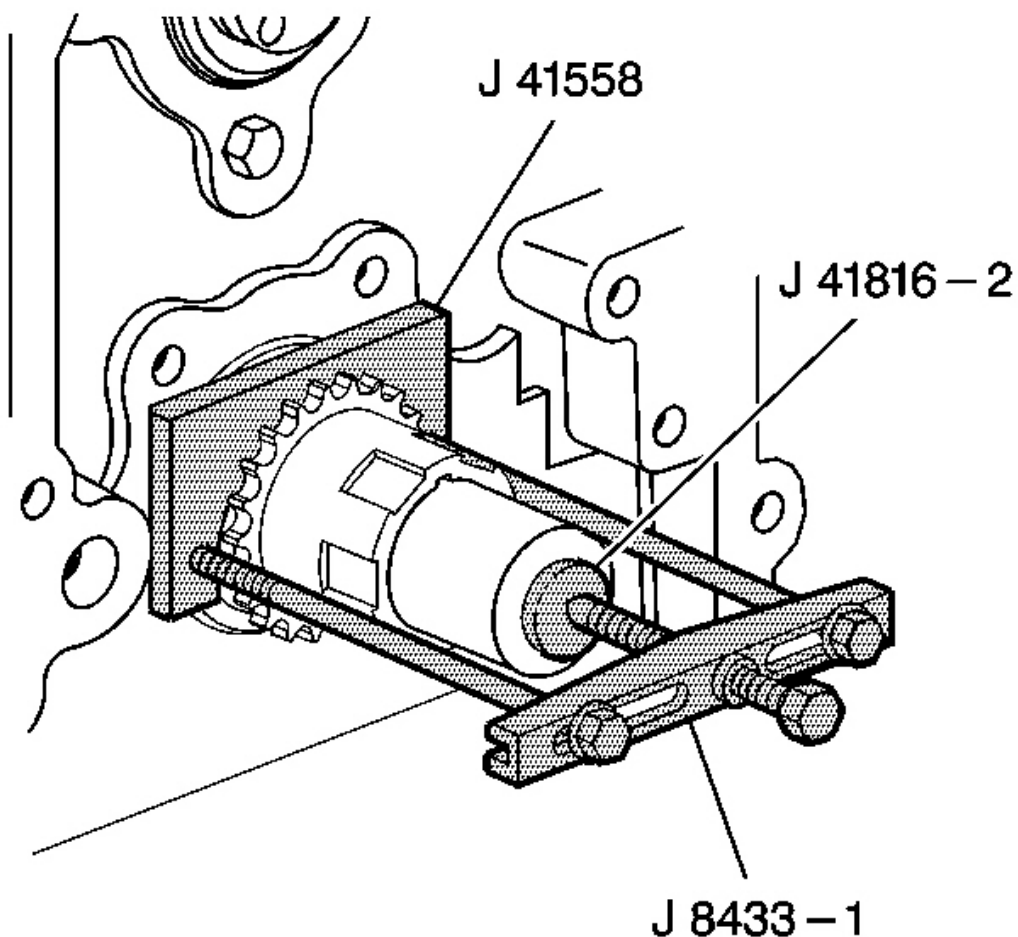
Fig. 244: Removing The Crankshaft Sprocket Using J 8433-1, J 41816-2 & J 41558
Courtesy of GENERAL MOTORS CORP.

5. Use the J 8433 , the **J 41816-2** and the **J 41558** in order to remove the crankshaft sprocket. See **Special Tools and Equipment**.

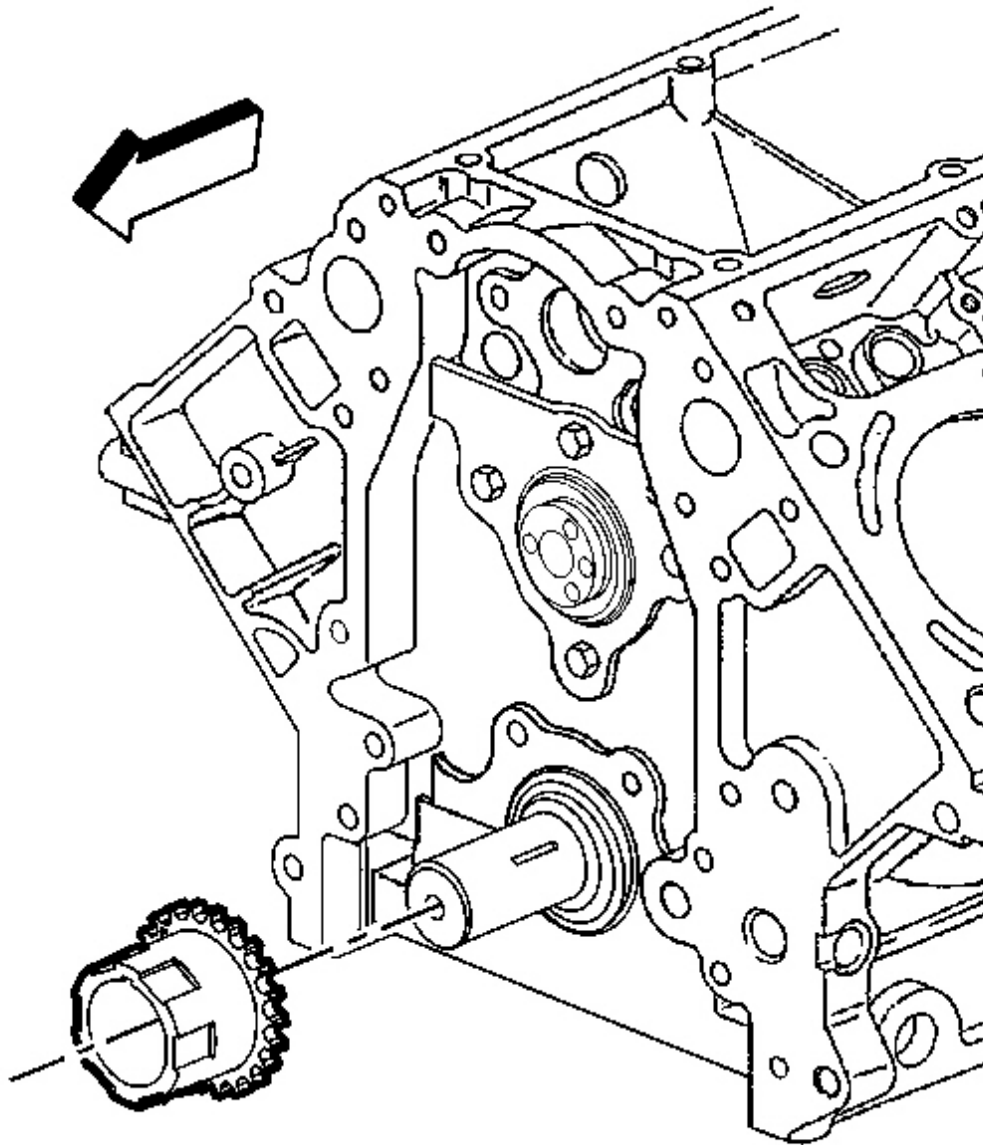
Fig. 245: View Of Crankshaft Sprocket
Courtesy of GENERAL MOTORS CORP.

6. Remove the crankshaft sprocket.

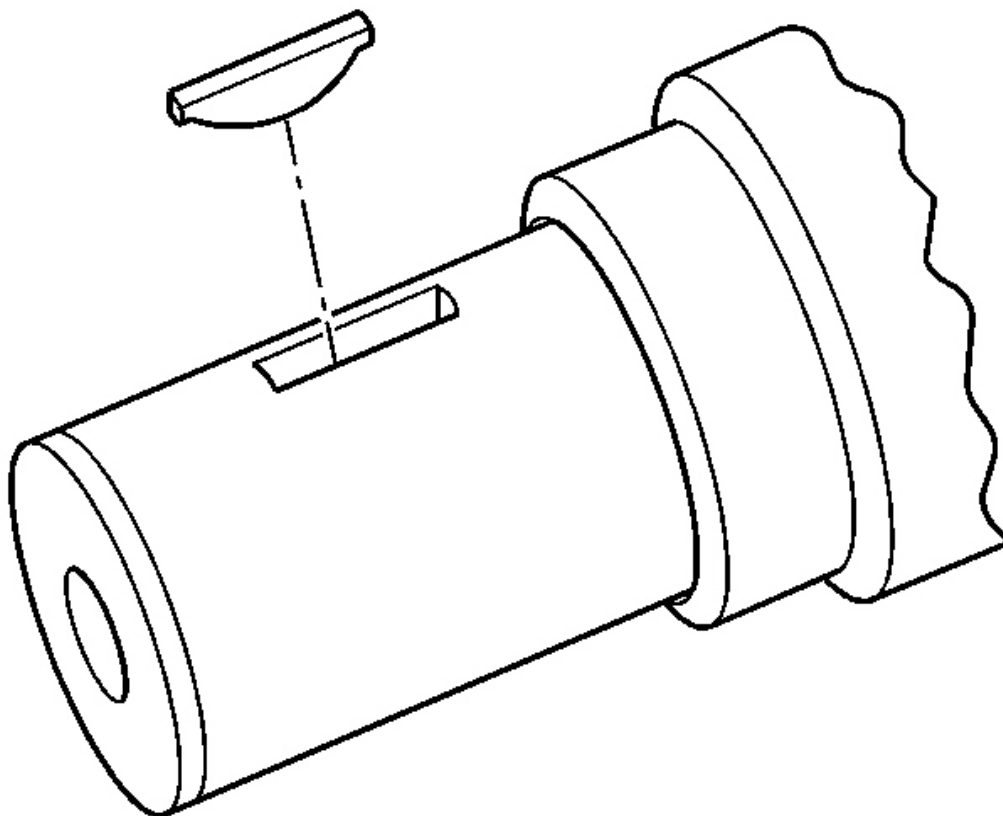
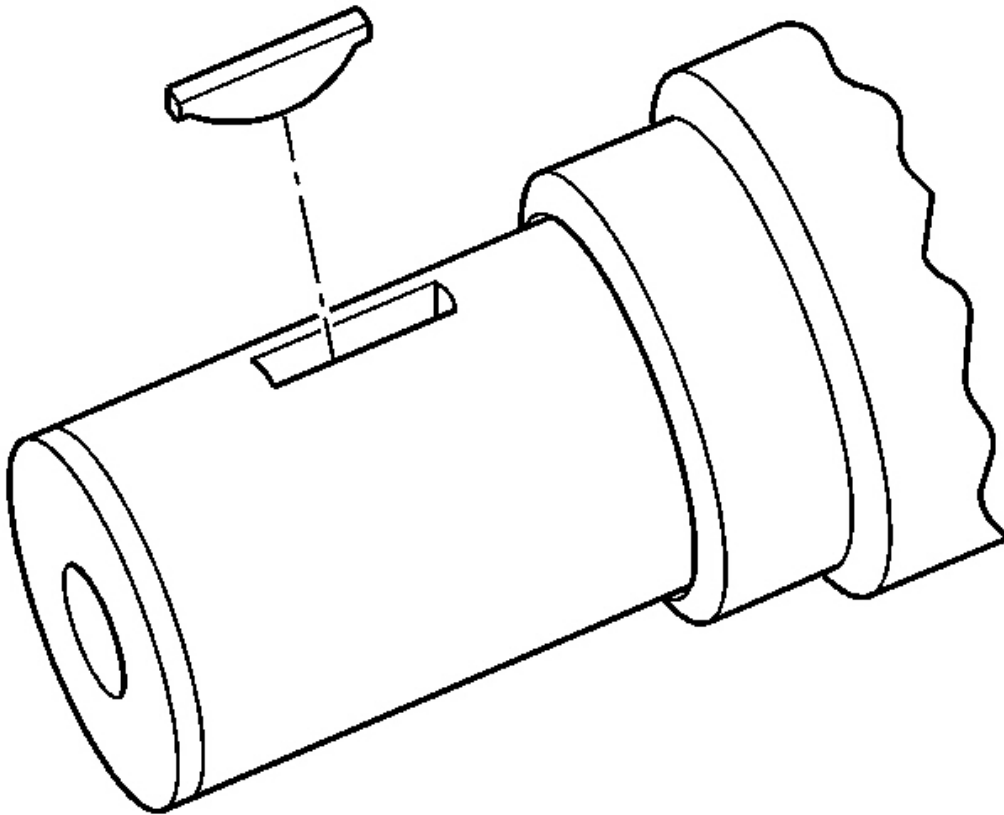
Fig. 246: View Of Crankshaft Key & Keyway
Courtesy of GENERAL MOTORS CORP.

7. Remove the crankshaft sprocket key, if required.
8. Clean and inspect the timing chain and sprockets. Refer to **Timing Chain and Sprockets Cleaning and Inspection**.

1. Install the key into the crankshaft keyway, if previously removed.

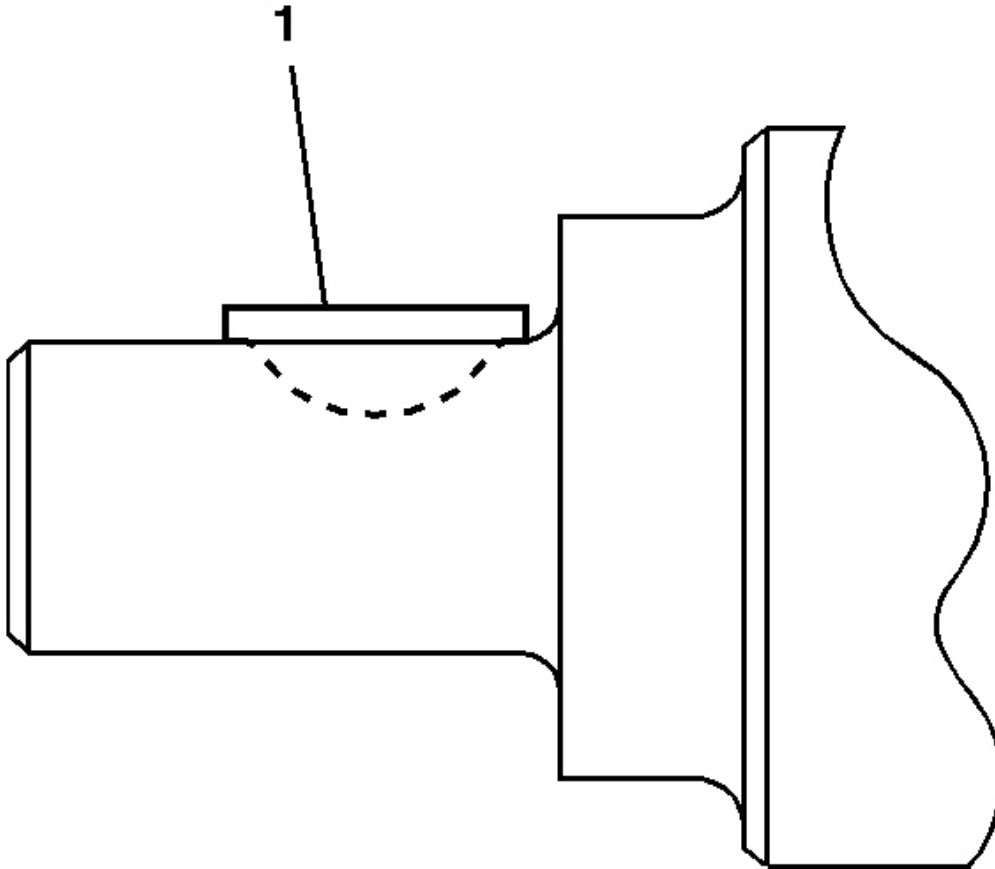
Fig. 248: View Of Crankshaft Sprocket Key Installation Position
Courtesy of GENERAL MOTORS CORP.

2. Tap the key (1) into the keyway until both ends of the key bottom onto the crankshaft.

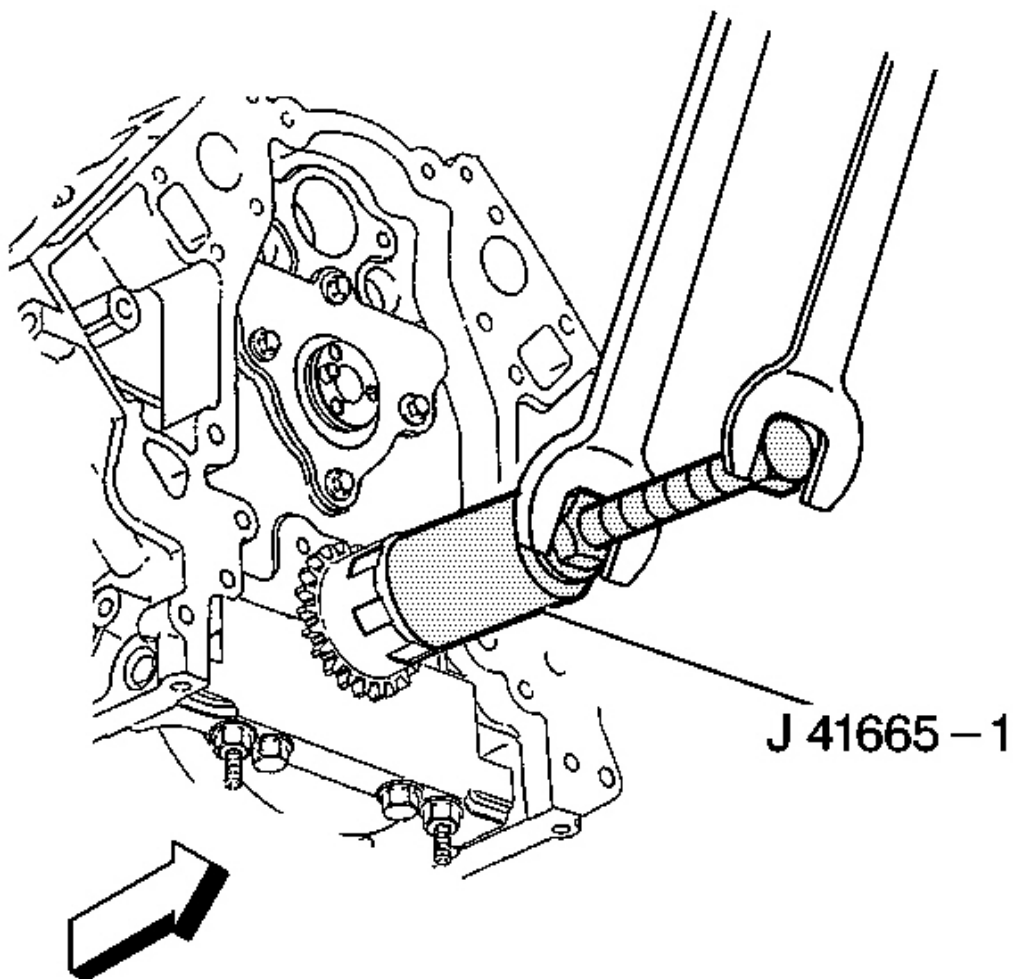
Fig. 250: Using J 41665 To Install Crankshaft Sprocket
Courtesy of GENERAL MOTORS CORP.

4. Use the **J 41665** in order to install the crankshaft sprocket. See **Special Tools and Equipment**.

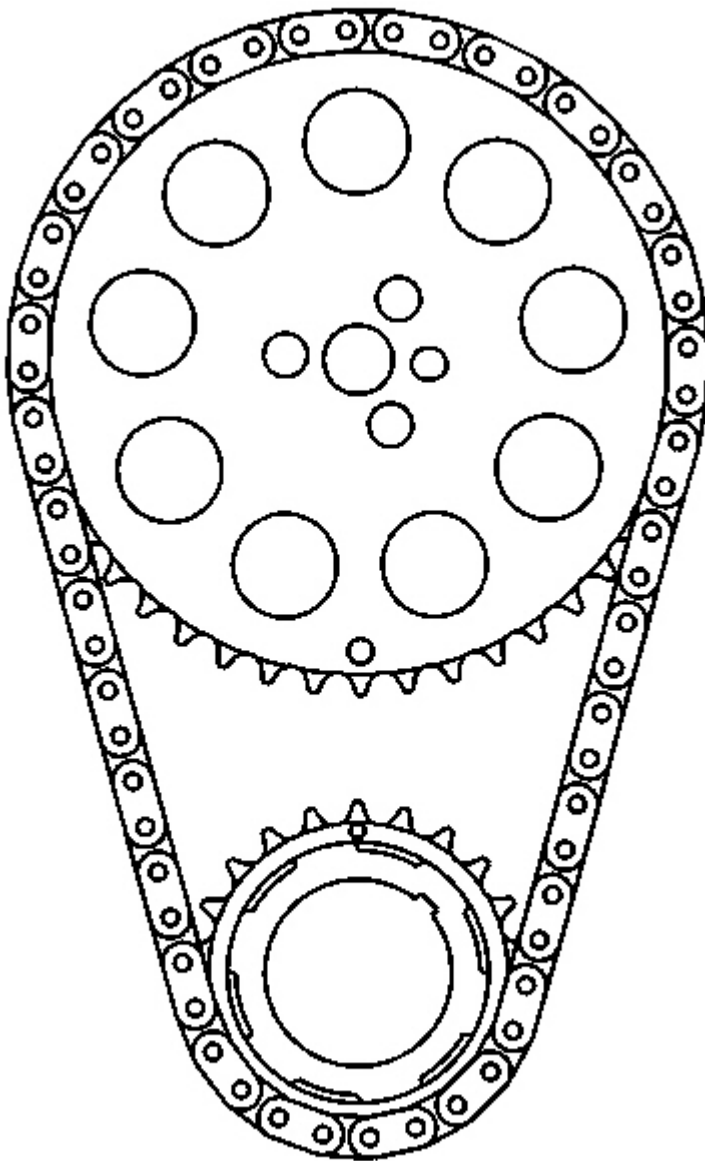
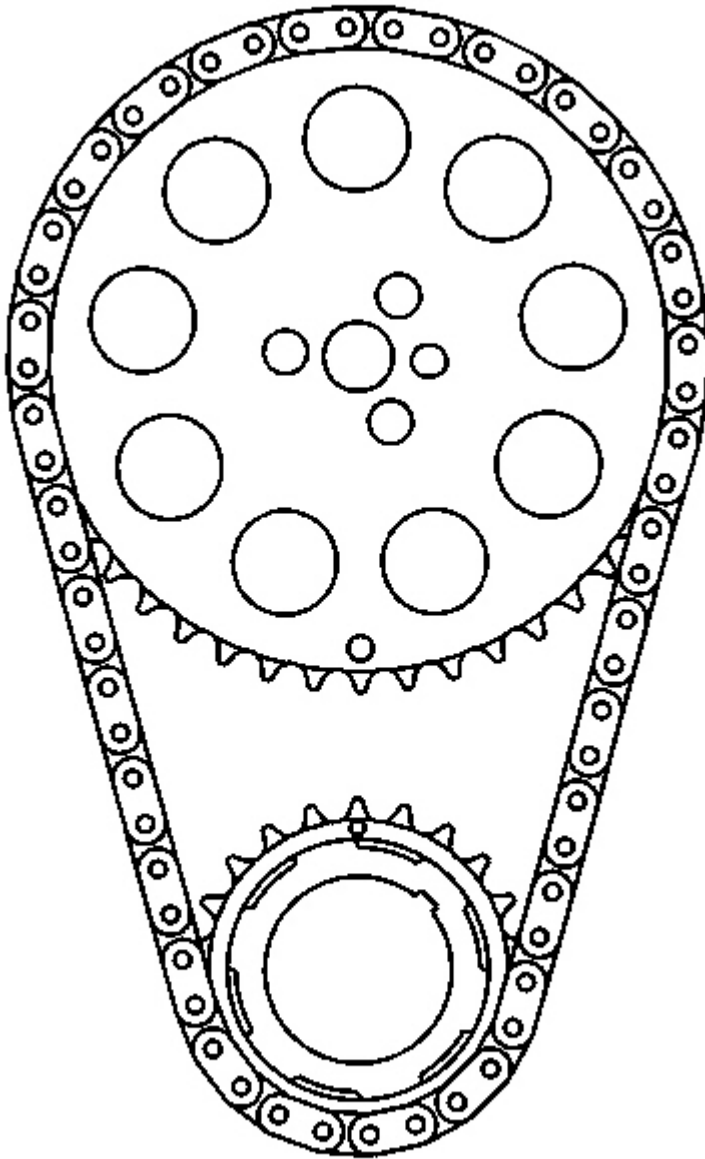
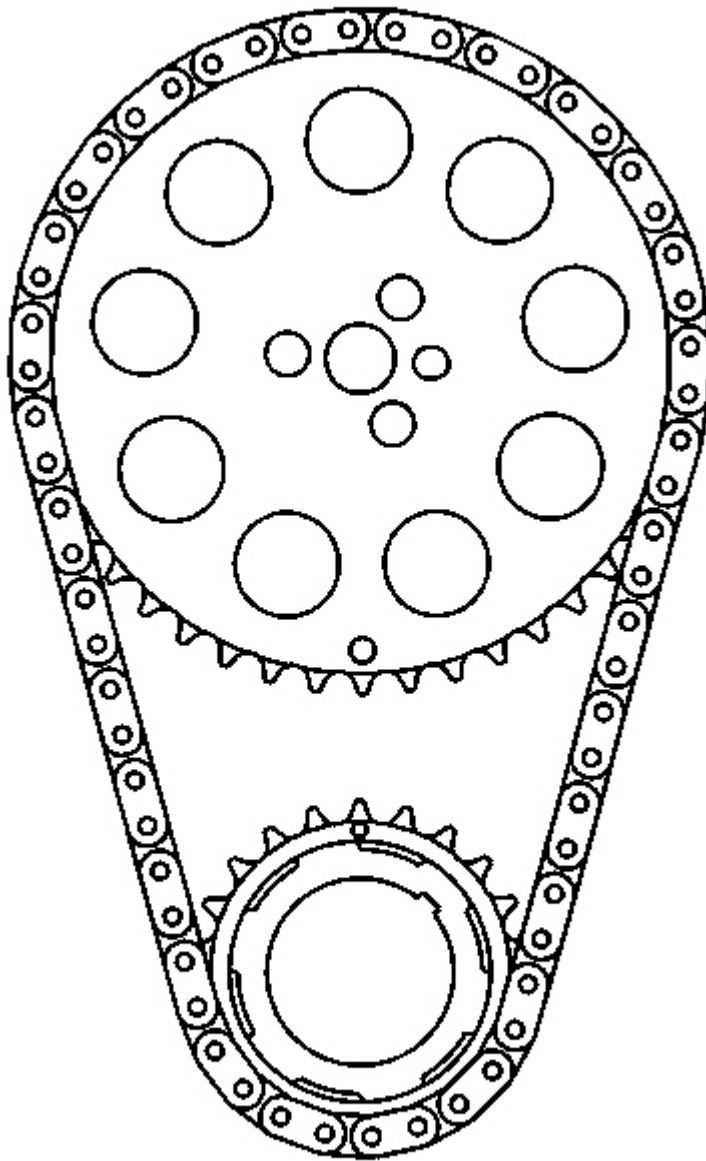
Fig. 252: View Of Camshaft & Crankshaft Sprockets Timing Marks Aligned
Courtesy of GENERAL MOTORS CORP.

4. Rotate the crankshaft until the timing marks on the crankshaft and camshaft sprockets are aligned.

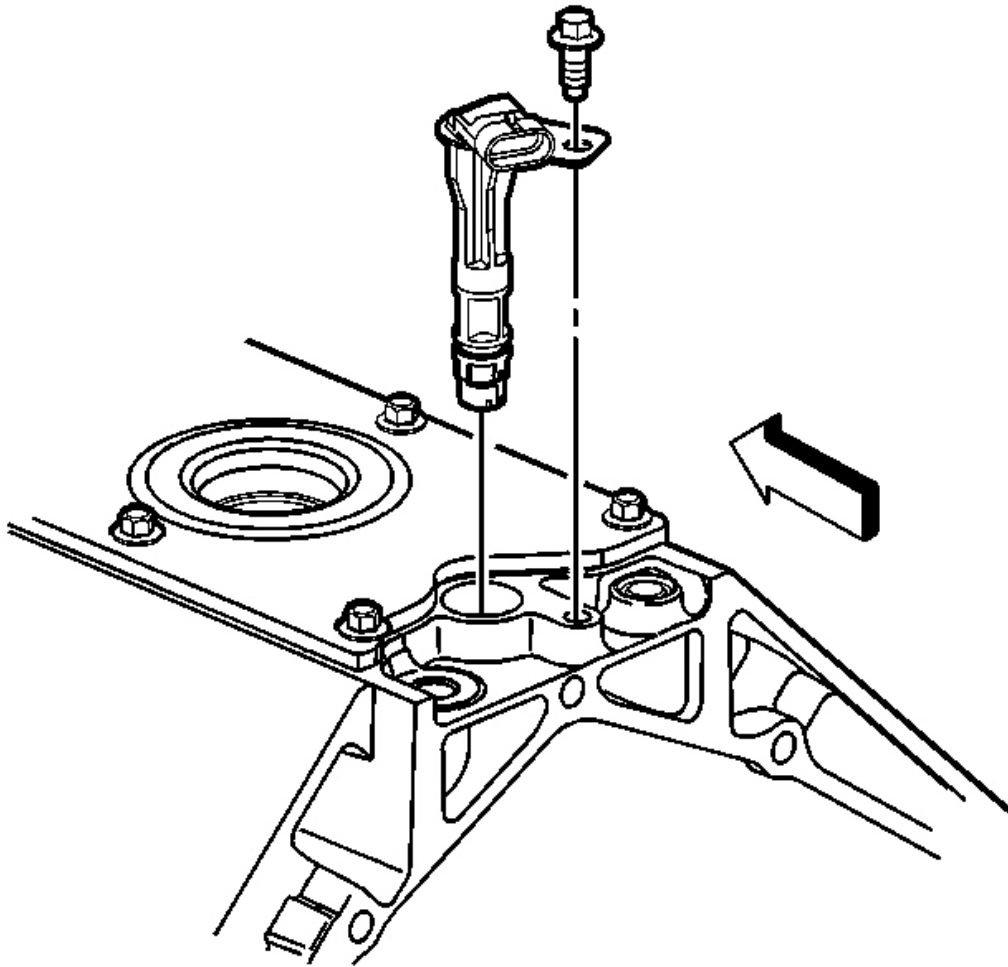
Fig. 253: View Of Camshaft Position (CMP) Sensor & Bolt
Courtesy of GENERAL MOTORS CORP.

3. Remove the camshaft sensor bolt and sensor.

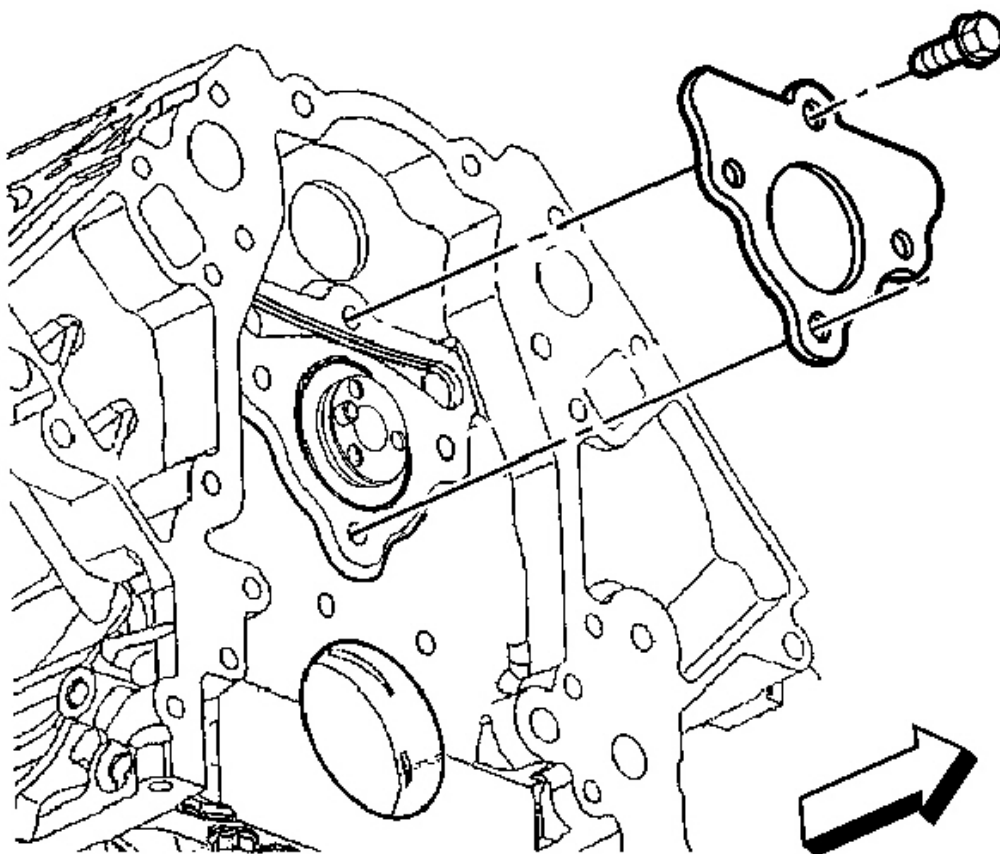
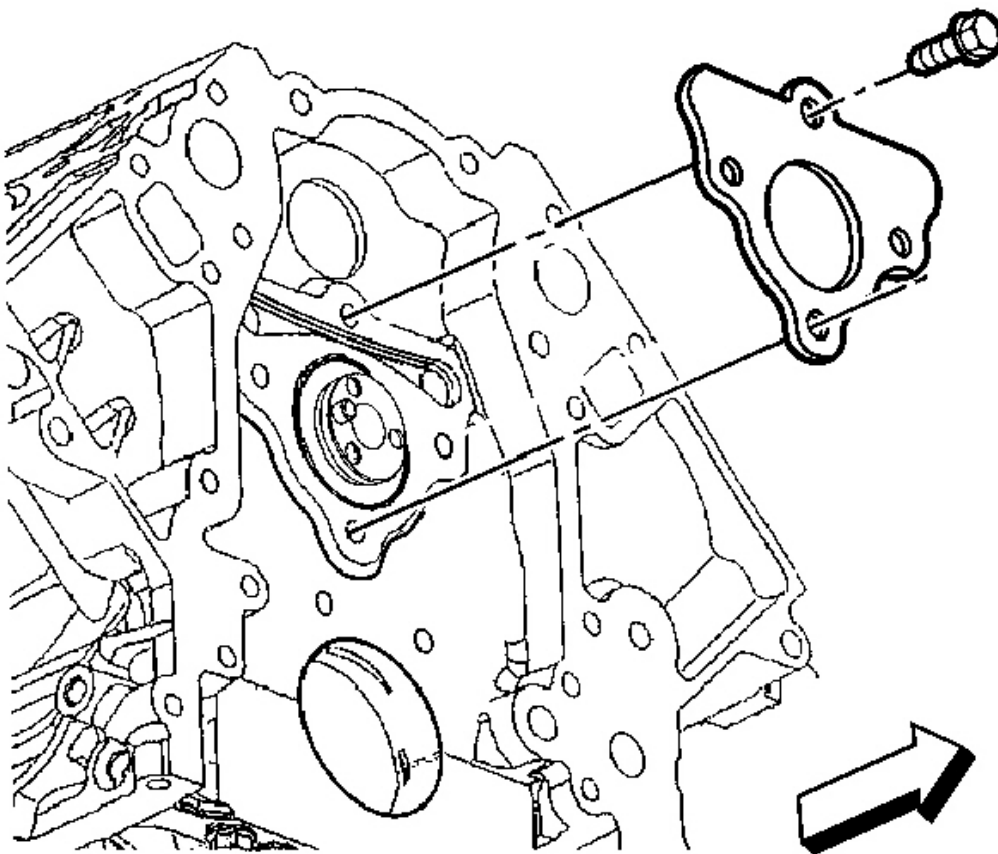
Fig. 256: View Of Camshaft Retainer Plate
Courtesy of GENERAL MOTORS CORP.

7. Remove the camshaft retainer bolts and retainer.

IMPORTANT: Install the retainer plate with the sealing gasket facing the engine block. The gasket surface on the engine block should be clean and free of dirt and/or debris.

5. Install the camshaft retainer and bolts.

Tighten: Tighten the bolts to 25 N.m (18 lb ft).

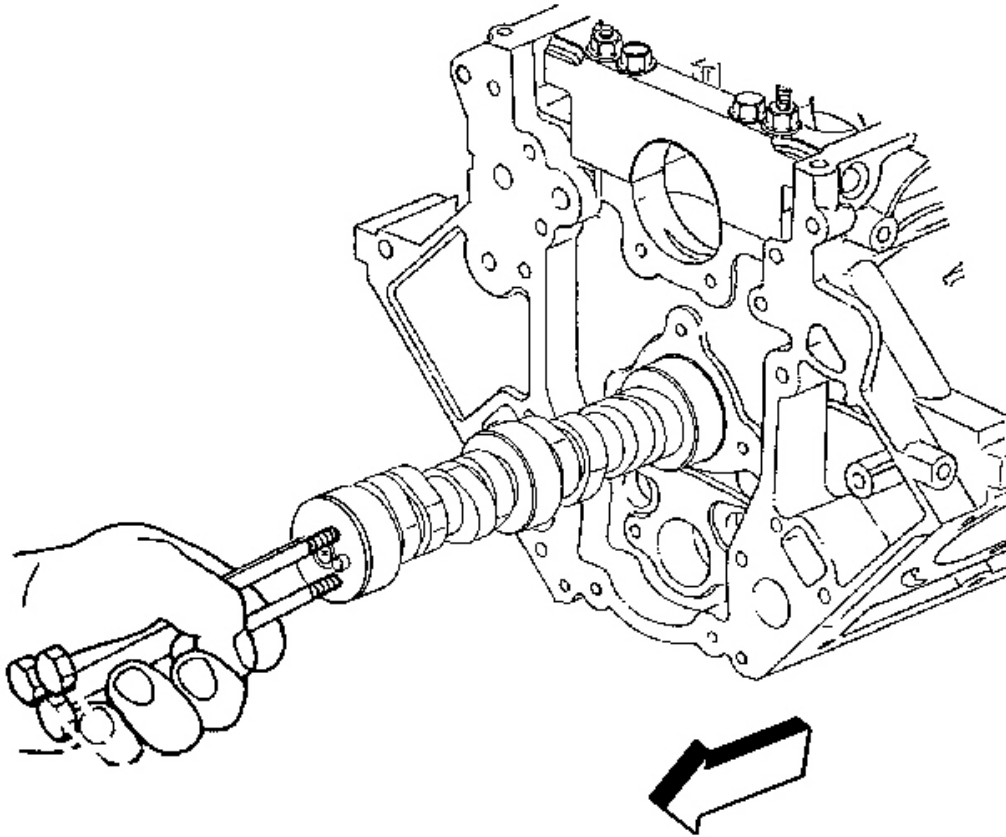
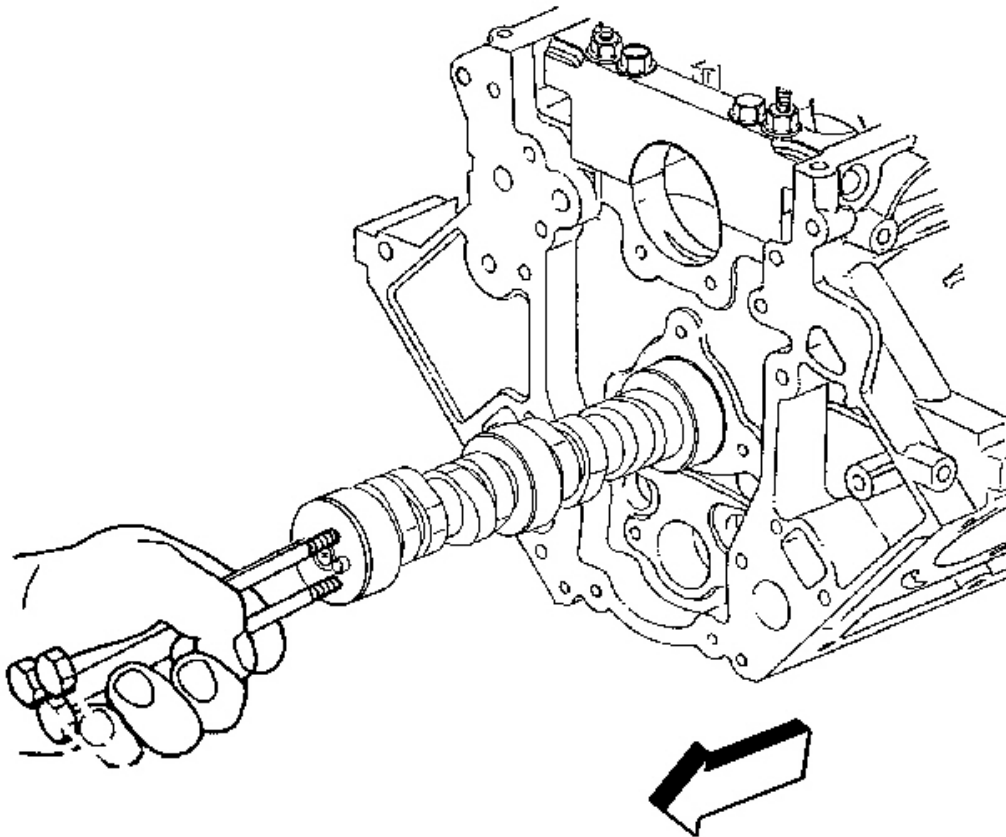
Fig. 257: View Of Bolts installed In Camshaft Front Bolt Holes
Courtesy of GENERAL MOTORS CORP.

8. Remove the camshaft.
 1. Install three M8-1.25 x 100 mm (M8-1.25 x 4.0 in) bolts to the bolt holes in the front of the camshaft.
 2. Using the bolts as a handle, carefully rotate and pull the camshaft out of the engine block.
 3. Remove the three bolts from the camshaft.
9. Clean and inspect the camshaft and bearings. Refer to **Camshaft and Bearings Cleaning and Inspection**.

1. Lubricate the camshaft journals and the bearings with clean engine oil.
2. Install three M8-1.25 x 100 mm (M8-1.25 x 4.0 in) bolts to the bolt holes in the front of the camshaft.

3. Using the bolts as a handle, carefully install the camshaft into the engine block.
4. Remove the three bolts from the front of the camshaft.

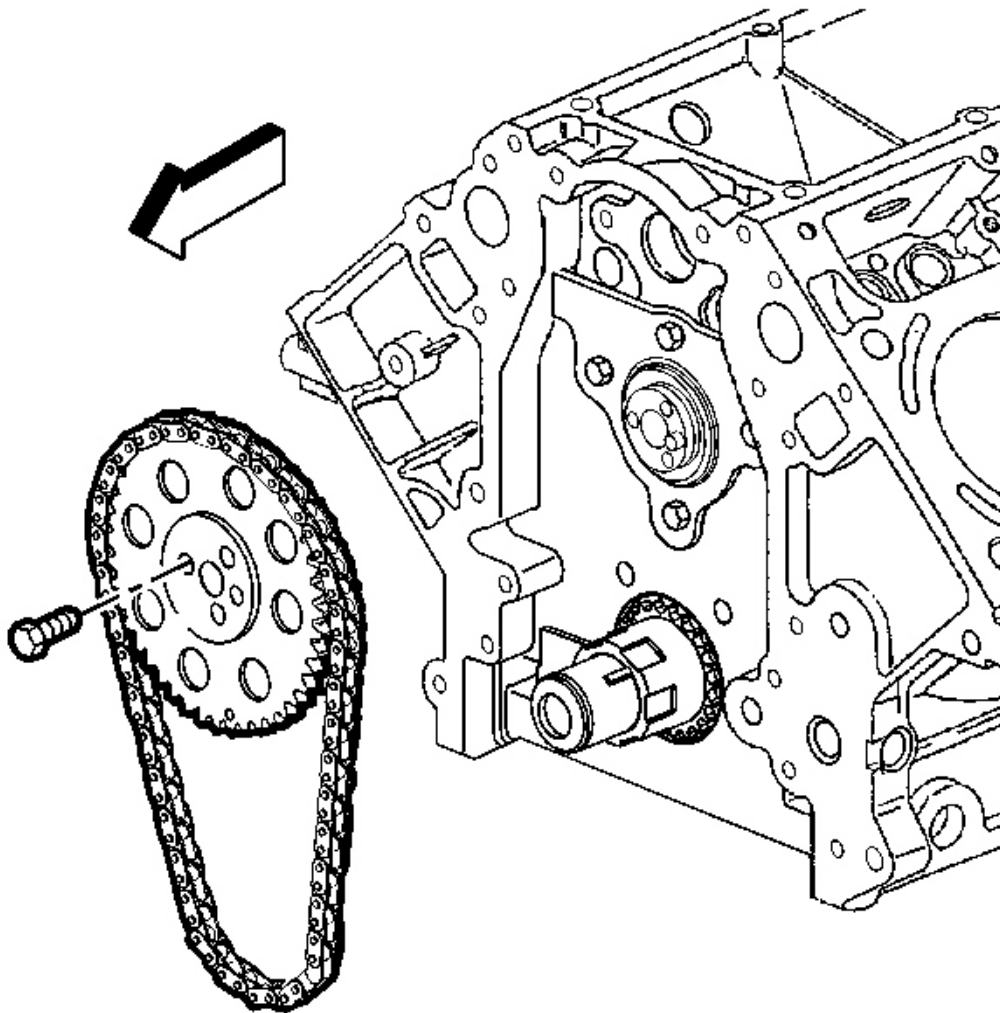
Fig. 261: Camshaft Sprocket, Bolt & Timing Chain
Courtesy of GENERAL MOTORS CORP.

- The camshaft and the crankshaft sprocket alignment marks **MUST** be aligned properly. Locate the camshaft sprocket alignment mark in the 6 o'clock position.

6. If necessary, rotate the camshaft or crankshaft sprockets in order to align the timing marks.

7. Install the camshaft sprocket and the timing chain.
8. Install the camshaft sprocket bolts.

Tighten: Tighten the bolts to 35 N.m (26 lb ft).

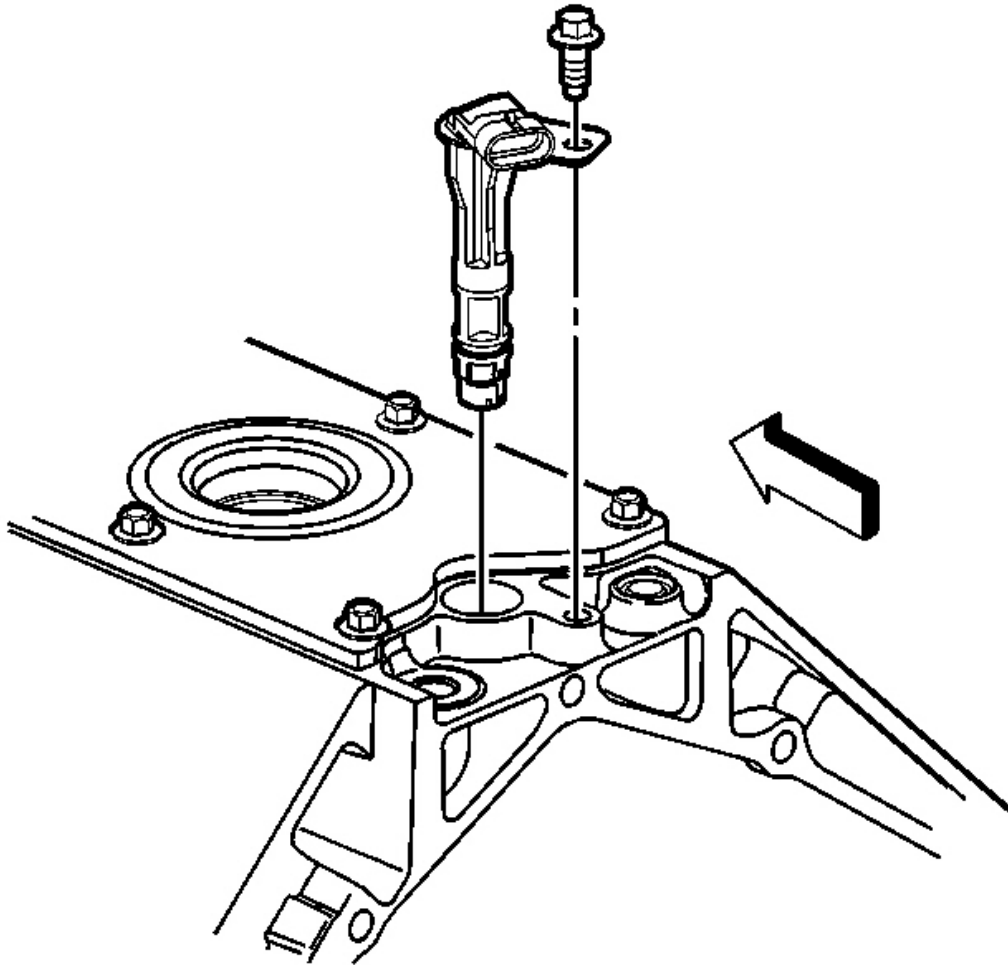
Fig. 262: View Of Camshaft Position (CMP) Sensor & Bolt
Courtesy of GENERAL MOTORS CORP.

9. Inspect the camshaft sensor O-ring seal. If the O-ring seal is not cut or damaged, it may be reused.
10. Lubricate the O-ring seal with clean engine oil.
11. Install the camshaft sensor and bolt.

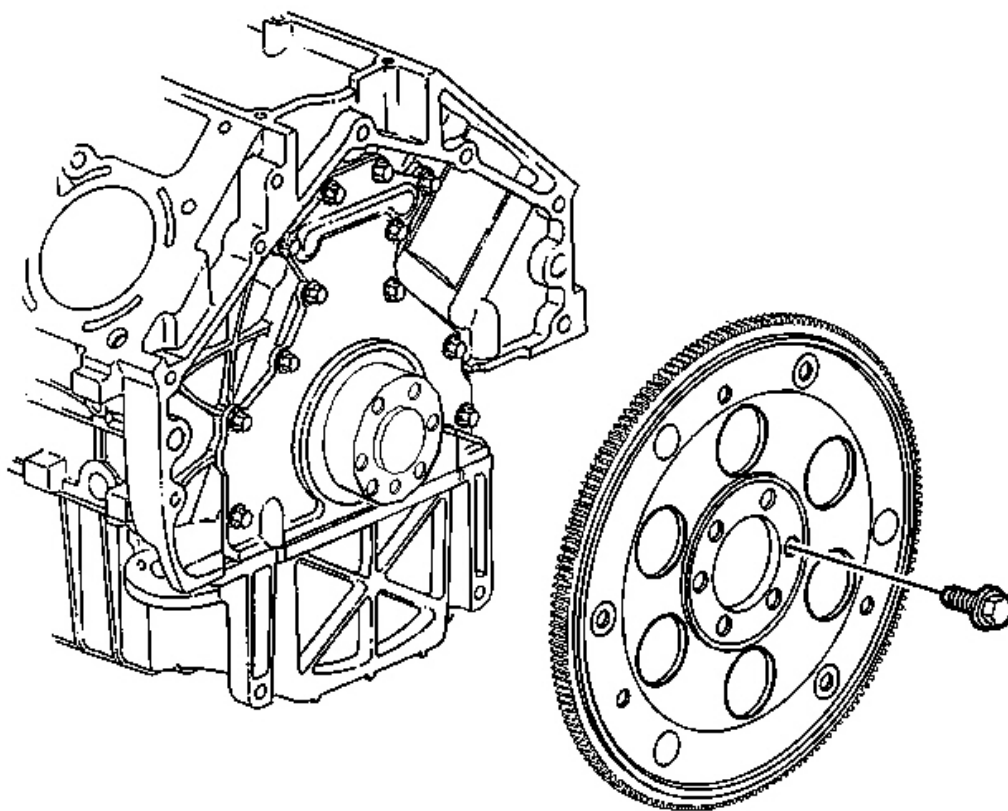
Fig. 263: View Of Engine Flywheel & Bolt
Courtesy of GENERAL MOTORS CORP.

IMPORTANT: Note the position and direction of the engine flywheel before removal.

1. Remove the transmission. Refer to **Transmission Replacement (LM4)** or **Transmission Replacement (LL8)** in Automatic Transmission - 4L60-E.
2. Remove the engine flywheel bolts.
3. Remove the engine flywheel.
4. Clean and inspect the engine flywheel. Refer to **Engine Flywheel Cleaning and Inspection**.

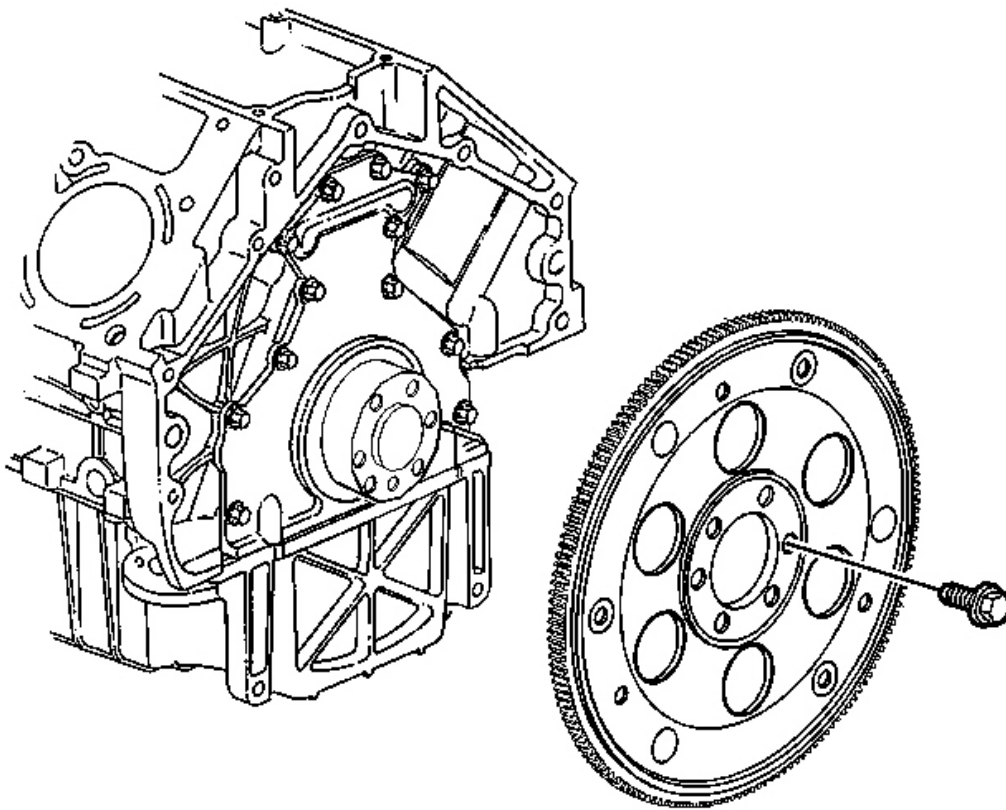
Fig. 264: View Of Engine Flywheel & Bolt
Courtesy of GENERAL MOTORS CORP.

IMPORTANT: The flywheel does not use a locating pin for alignment and will not initially seat against the crankshaft flange, but will be pulled onto the crankshaft by the engine flywheel bolts. This procedure requires a three stage tightening process.

1. Install the engine flywheel to the crankshaft.
2. Apply threadlock GM P/N 12345382 (Canadian P/N 10953489) or equivalent to the threads of the flywheel bolts.
