2004 Isuzu Ascender LS

2004 ENGINE Engine Mechanical - 4.8L, 5.3L, and 6.0L - Ascender

Engine Mechanical - 4.8L, 5.3L, and 6.0L - Ascender

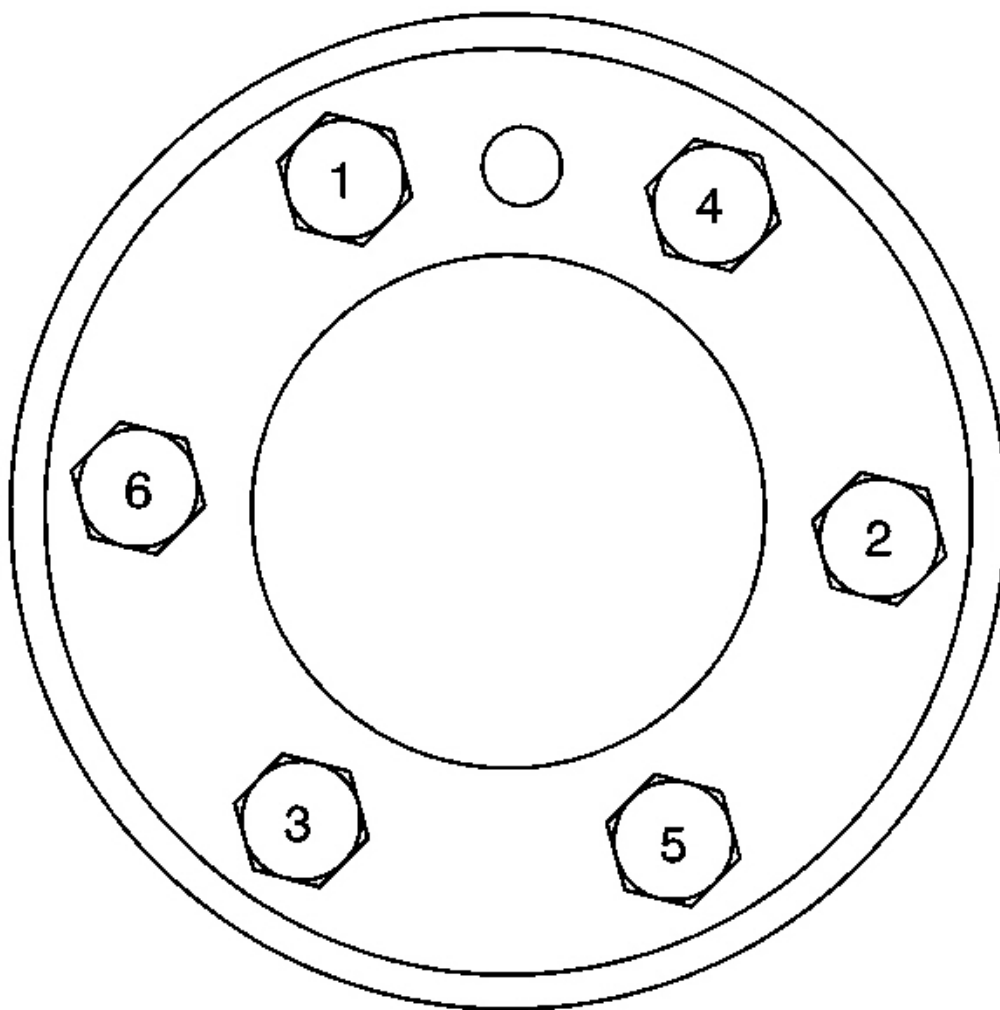
Fig. 265: Identifying Flywheel Bolt Tightening Sequence
Courtesy of GENERAL MOTORS CORP.

NOTE: Refer to Fastener Notice in Cautions and Notices.

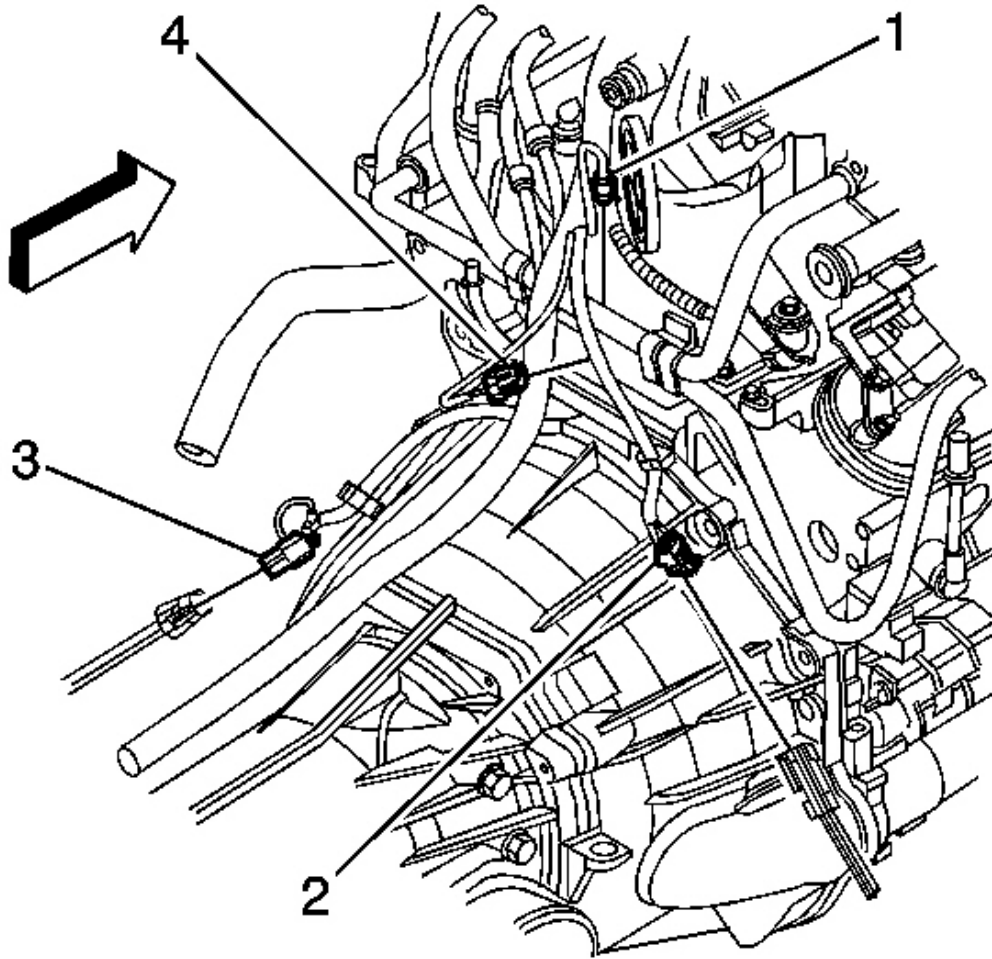
Fig. 266: Locating Components Connectors At Rear Of Engine
Courtesy of GENERAL MOTORS CORP.

6. Remove the radiator support brace. Refer to **Brace Replacement - Radiator Support Diagonal** in Body Front End.
7. Remove the front differential drive axle, if equipped with 4-wheel drive (4WD). Refer to **Differential Carrier Assembly Replacement (4.8L, 5.3L, 6.0L V-8)** in Front Drive Axle.
8. Remove the wheel drive shafts. Refer to **Wheel Drive Shaft Replacement** in Wheel Drive Shafts.
9. Remove the intake manifold. Refer to **Intake Manifold Replacement**.
10. Disconnect the following electrical connectors:
 - Oil pressure sensor (1)
 - Oxygen sensors (2, 3)
 - Camshaft position (CMP) sensor (4)

45. Connect the following electrical connectors:
 - Oil pressure sensor (1)
 - Oxygen sensors (2, 3)
 - Camshaft position (CMP) sensor (4)
46. Install the intake manifold. Refer to **Intake Manifold Replacement**.
47. Install the wheel drive shafts. Refer to **Wheel Drive Shaft Replacement** in Wheel Drive Shafts.
48. Install the front differential drive axle, if equipped with 4WD. Refer to **Differential Carrier Assembly Replacement (4.8L, 5.3L, 6.0L V-8)** in Front Drive Axle.

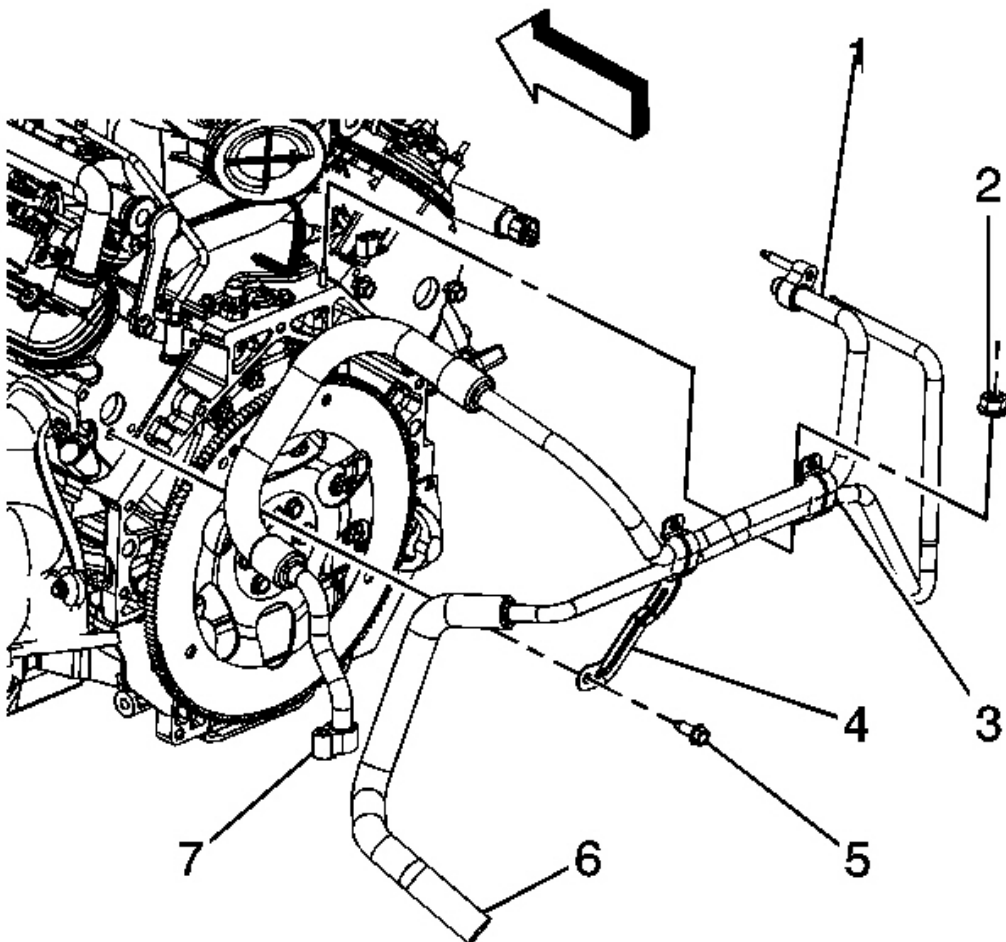
Fig. 267: View Of Rear A/C Lines

11. Remove the air conditioning (A/C) compressor hose. Refer to **Compressor Hose Assembly Replacement (Short Wheel Base)** or **Compressor Hose Assembly Replacement (Long Wheel Base)** in Heating, Ventilation, and Air Conditioning.
12. Disconnect the rear auxiliary A/C compressor pipe fitting (7).
13. Remove the rear auxiliary A/C compressor pipe nut and bolt (2, 5).
14. Tie the pipe assembly out of the way.

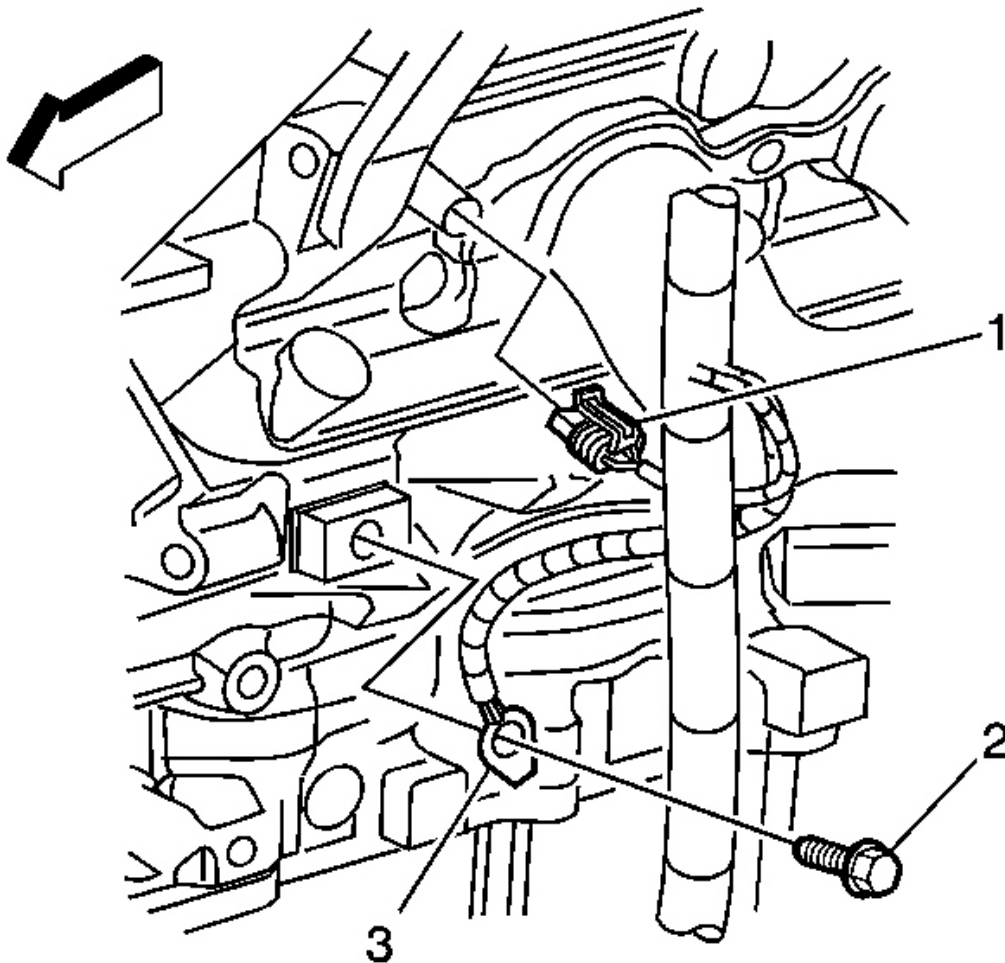
Fig. 268: View Of ECT Sensor Electrical Connector And Ground
Courtesy of GENERAL MOTORS CORP.

15. Disconnect the engine coolant temperature (ECT) sensor (1).
16. Remove the ground terminal bolt (2).
17. Remove the retaining clips from the brackets.

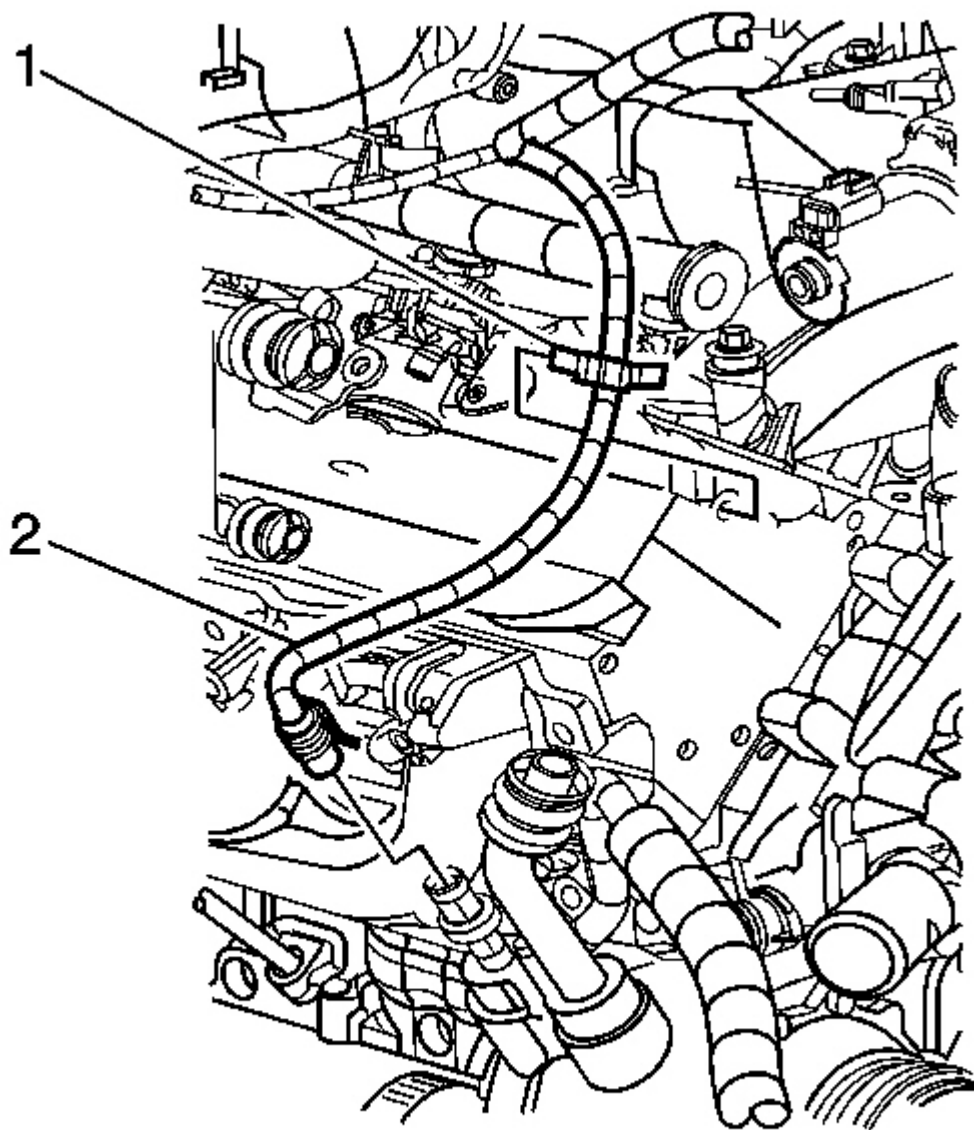
Fig. 269: View Of A/C Compressor Pressure Switch Electrical Connector & Retaining Clip
Courtesy of GENERAL MOTORS CORP.

18. Disconnect the A/C pressure switch electrical connector (2).
19. Remove the retaining clip (1) from the cylinder head.
20. Raise and suitably support the vehicle. Refer to **Lifting and Jacking the Vehicle** in General Information.

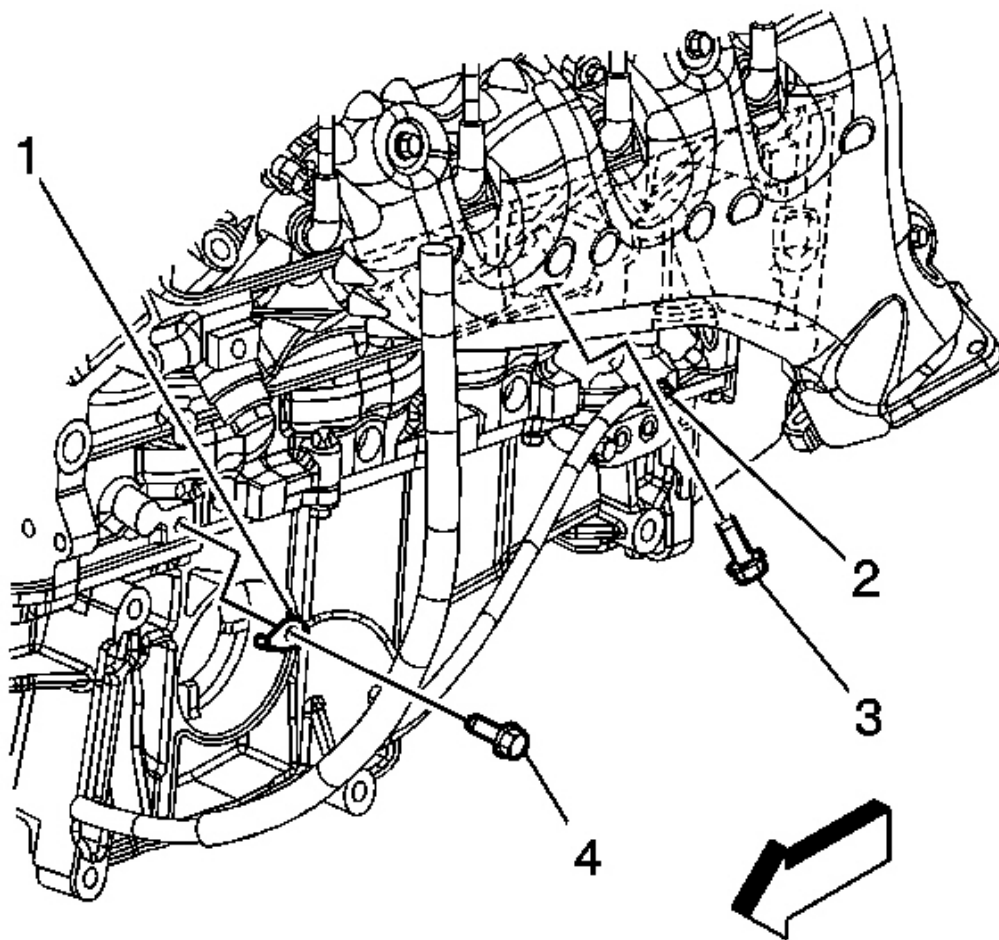
Fig. 270: View Of Ground Terminal Bolts
Courtesy of GENERAL MOTORS CORP.

21. Remove the ground terminal bolts (2, 4).
22. Remove the starter. Refer to **Starter Motor Replacement (4.2L Engine)** or **Starter Motor Replacement (5.3L Engine)** in Engine Electrical.

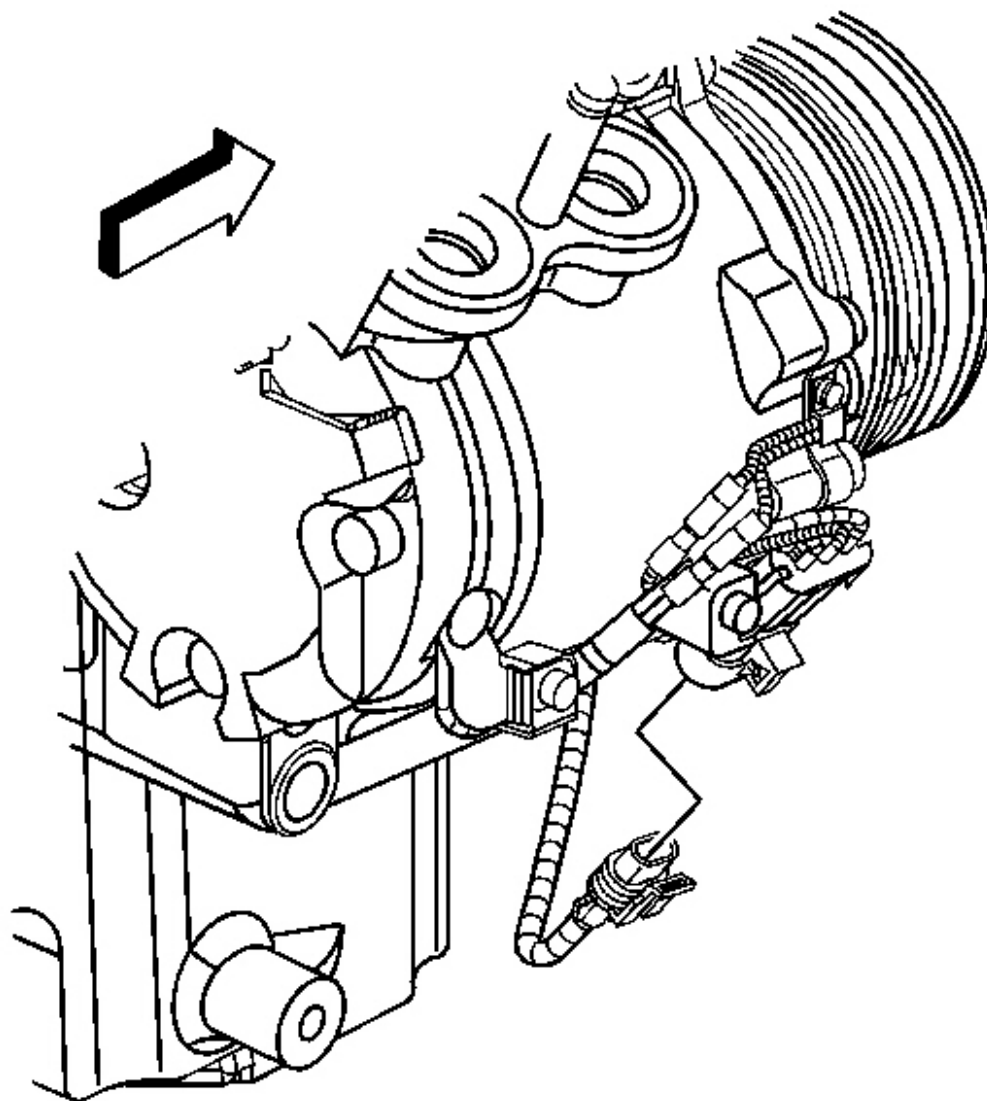
Fig. 272: View Of A/C Compressor Electrical Connector
Courtesy of GENERAL MOTORS CORP.

25. Disconnect the A/C compressor electrical connector.
26. Lower the vehicle.
27. Gather all branches of the engine wiring harness and reposition the harness off to the side.

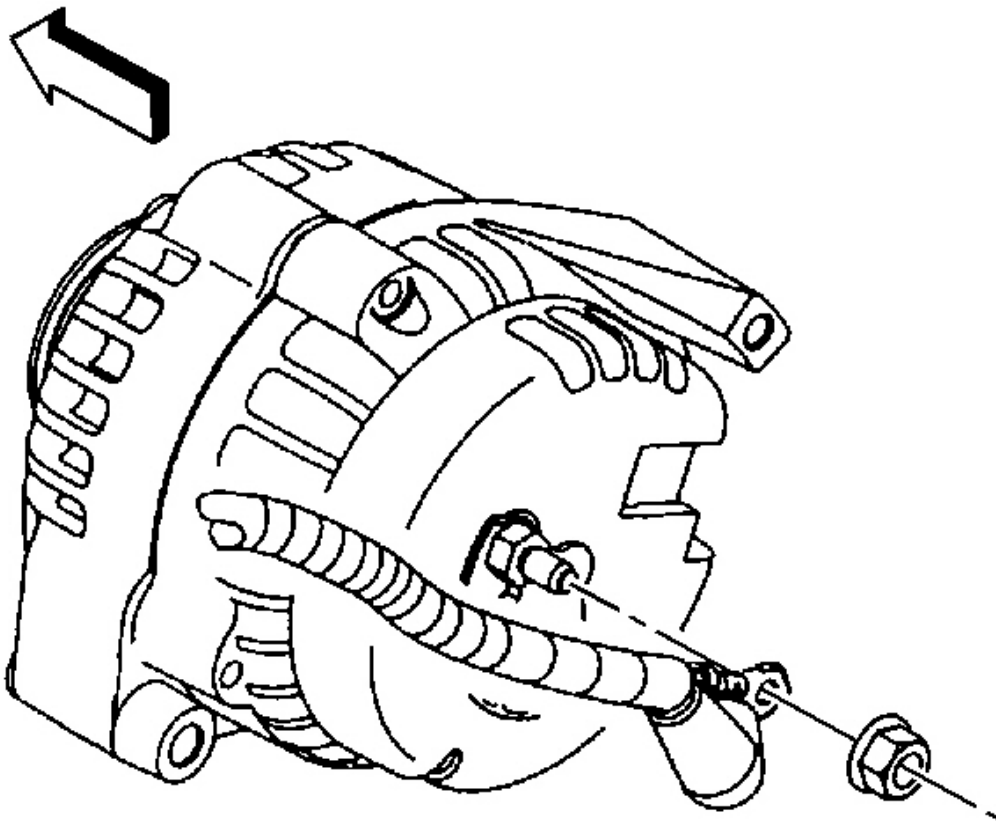
Fig. 273: View Of Generator Cable & Nut
Courtesy of GENERAL MOTORS CORP.

28. Remove the generator cable from the generator, perform the following:
- Slide the boot down revealing the terminal stud.
 - Remove the generator cable nut from the terminal stud.
 - Remove the generator cable.

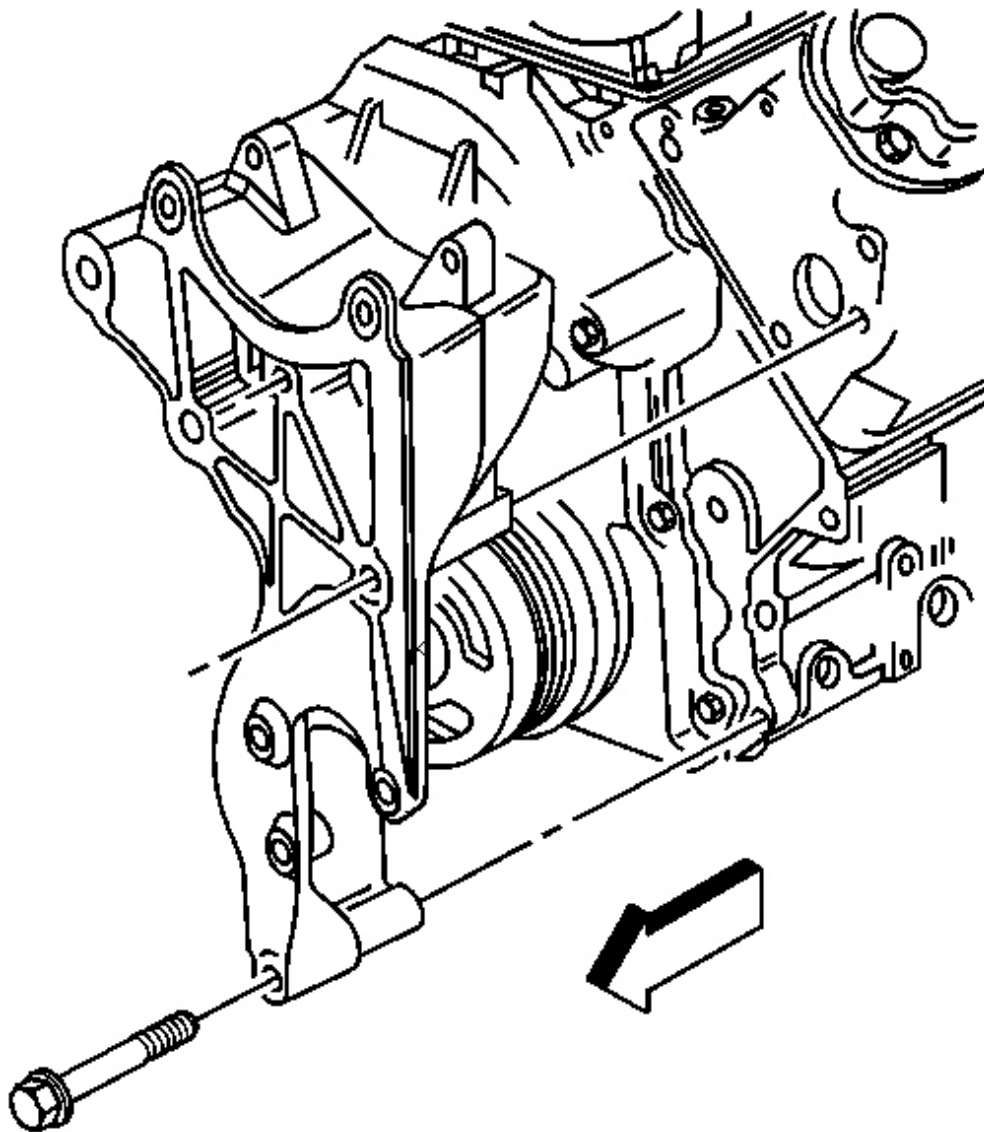
Fig. 274: View Of Generator Bracket & Bolts
Courtesy of GENERAL MOTORS CORP.

29. Remove the generator bracket bolts.
30. Position the bracket with generator aside.

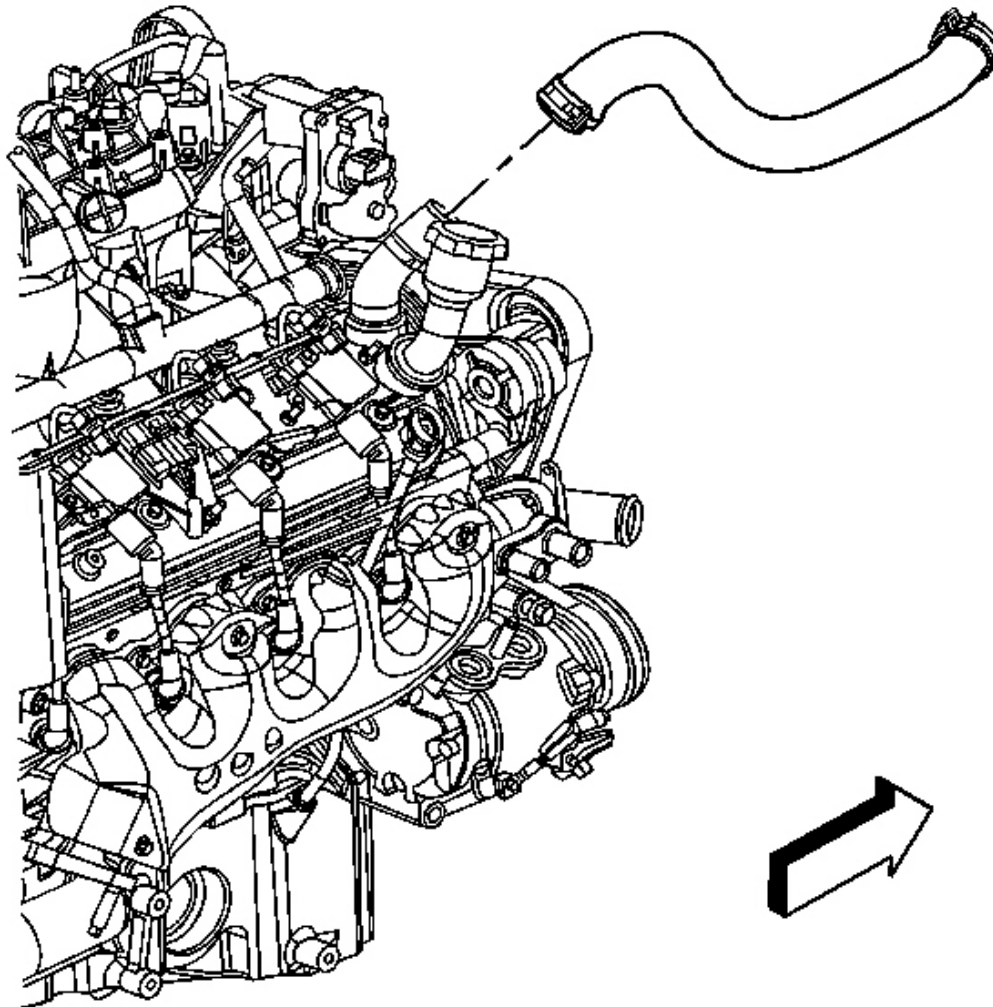
Fig. 275: View Of Inlet Hose
Courtesy of GENERAL MOTORS CORP.

31. Using **J 38185** , reposition the inlet hose clamp. See **Special Tools and Equipment**.
32. Remove the inlet hose from the water outlet.

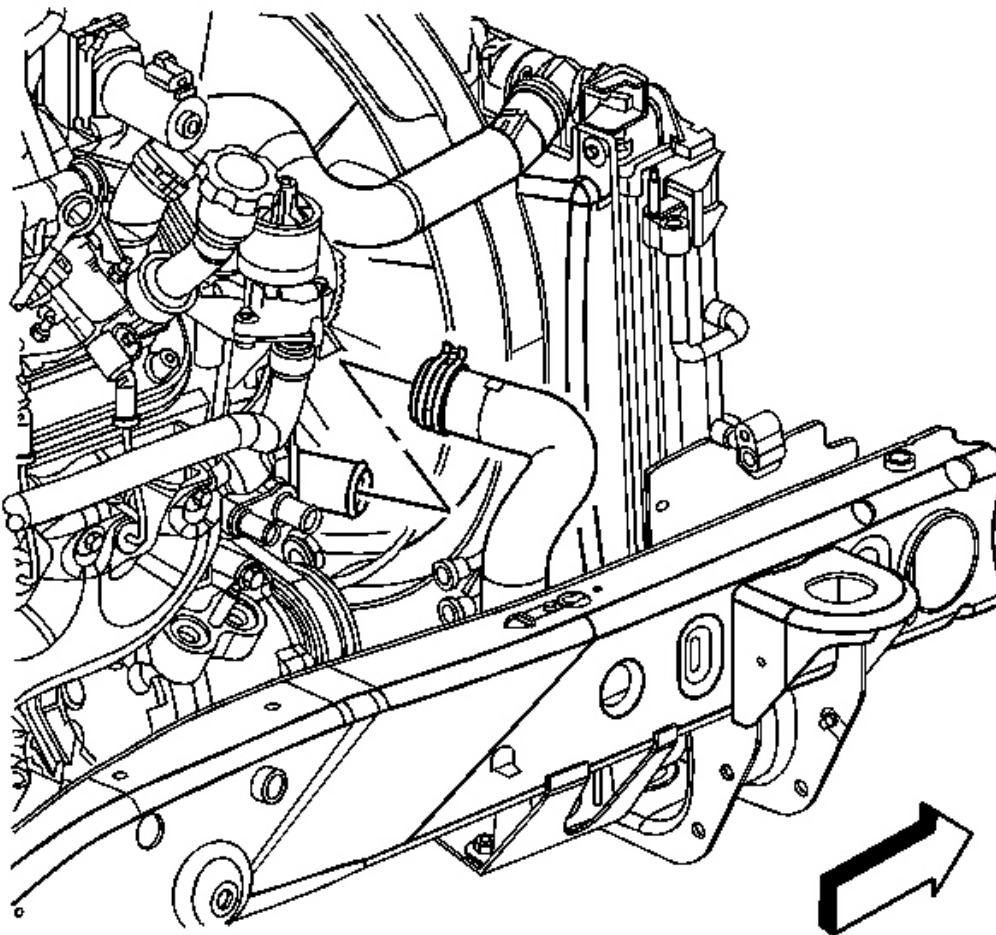
Fig. 276: View Of Outlet Hose
Courtesy of GENERAL MOTORS CORP.

33. Using **J 38185** , reposition the inlet hose clamp. See **Special Tools and Equipment**.
34. Remove the outlet hose from the water outlet.

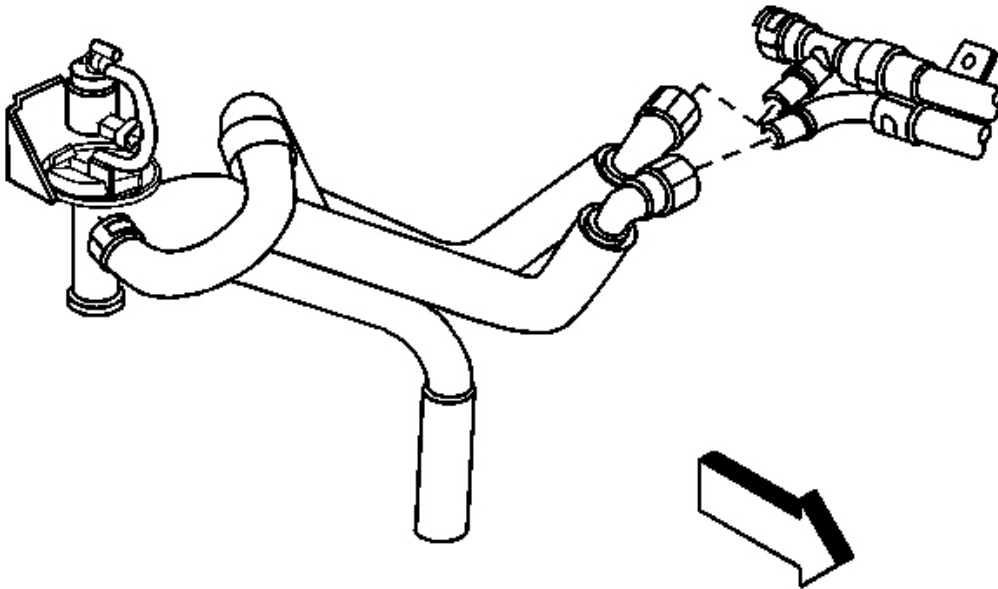
Fig. 277: View Of Auxiliary Heater Inlet & Outlet Hose/Pipe Assembly
Courtesy of GENERAL MOTORS CORP.

35. Disconnect the auxiliary heater inlet and outlet hose/pipe assembly from the heater water shutoff valve pipes.

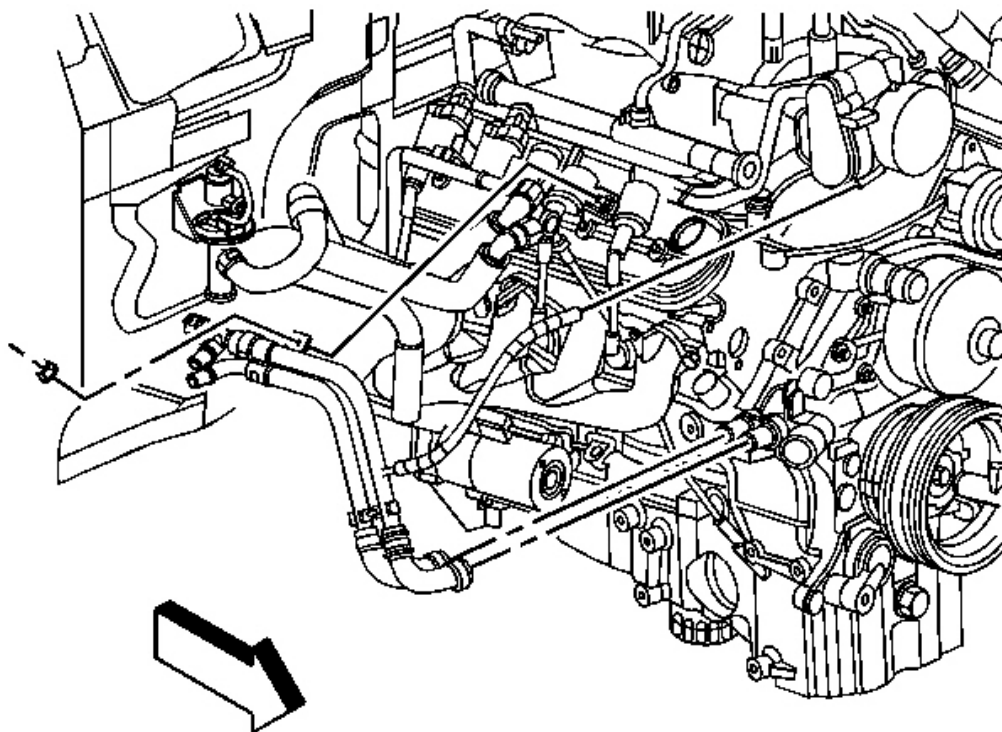
Fig. 278: View Of Auxiliary Heater Inlet & Outlet Hoses/Pipes
Courtesy of GENERAL MOTORS CORP.

36. Using **J 38185** , reposition the auxiliary heater inlet and outlet hose clamps. See **Special Tools and Equipment**.
37. Remove the auxiliary heater inlet and outlet hoses/pipes from the water pump.

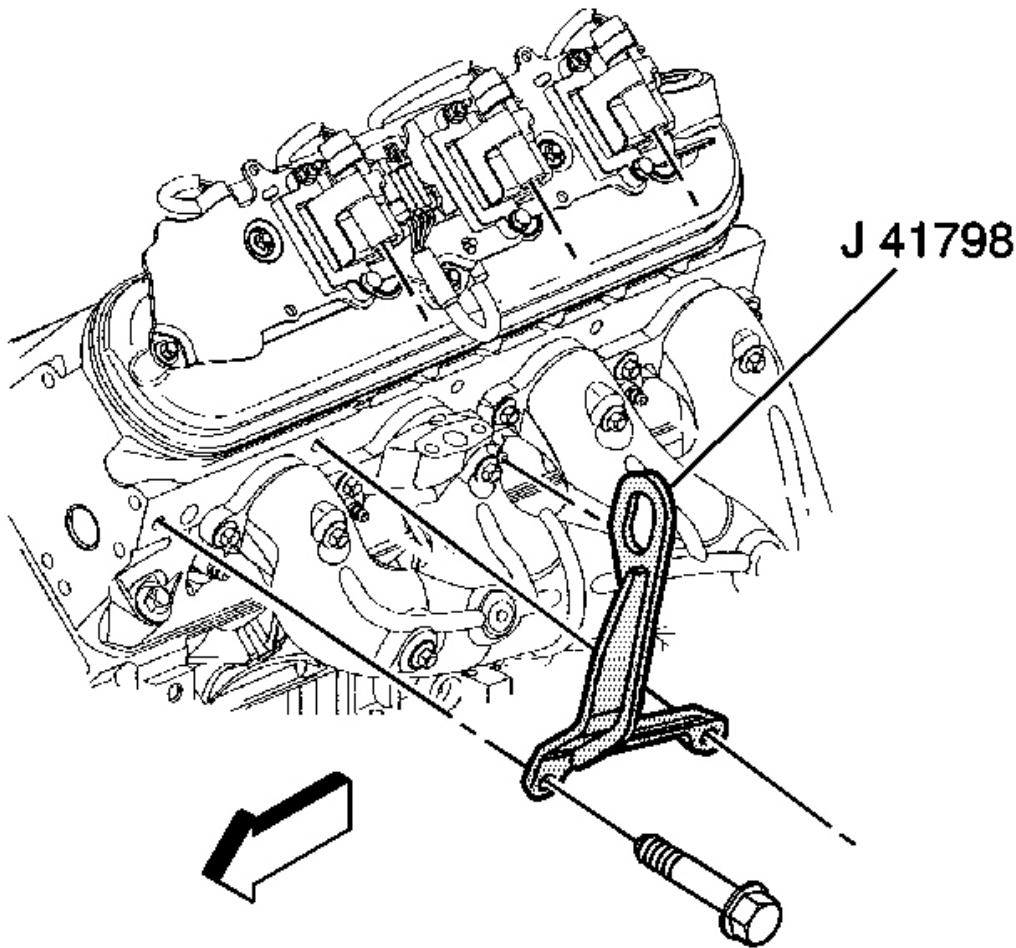
Fig. 279: View Of J 41798

38. Remove the ignition coil(s) (as required) for the proper fit of the **J 41798** before lifting the engine. Refer to Ignition Coil(s) Replacement in Engine Controls - 4.8L, 5.3L, and 6.0L. See Special Tools and Equipment.
39. Install the **J 41798** to the cylinder heads. See Special Tools and Equipment.

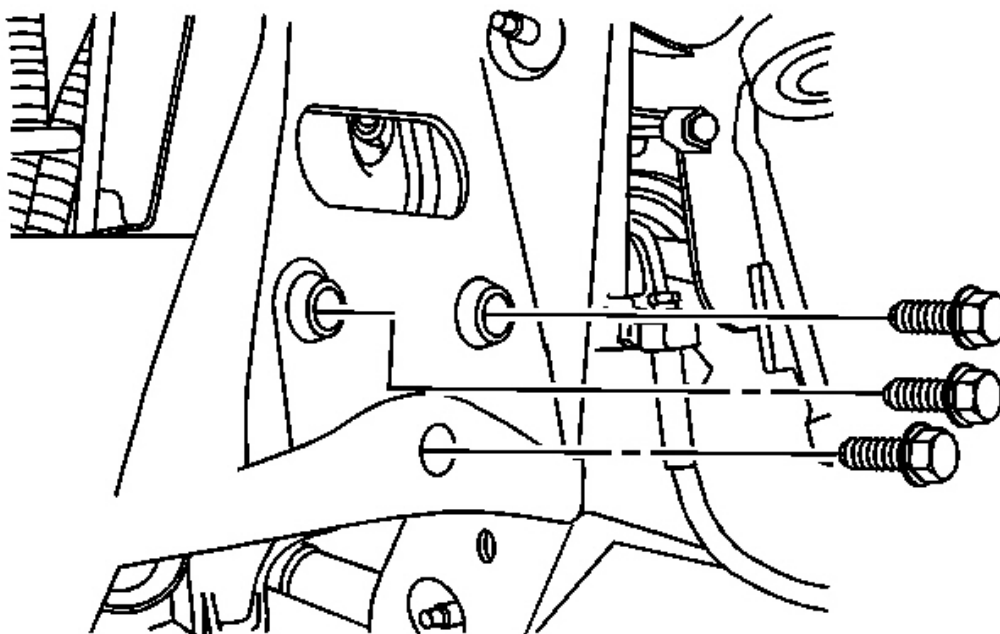
Fig. 280: View Of Frame Engine Mount Bracket Bolt Locations
Courtesy of GENERAL MOTORS CORP.

42. Remove the 3 frame engine mount bracket bolts from both the right and left sides.

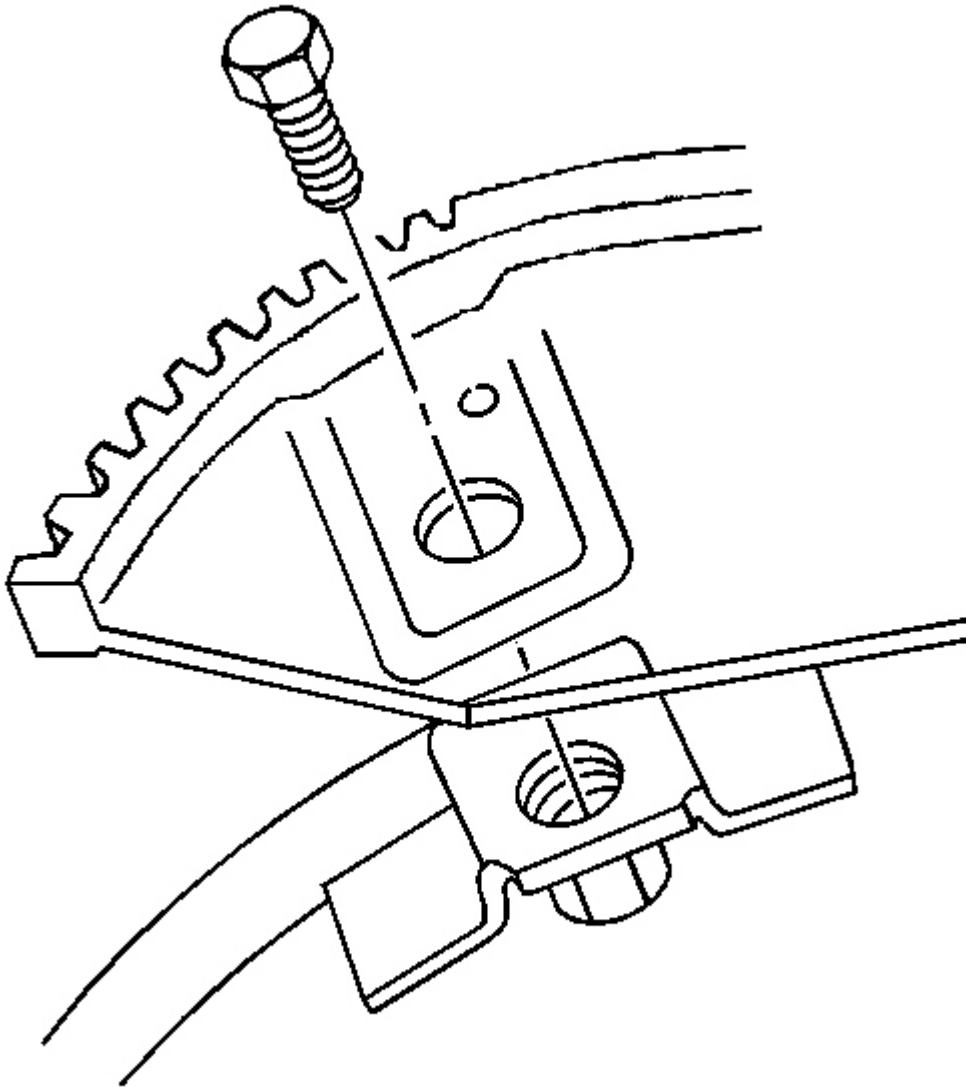
Fig. 281: Flywheel-To-Torque Converter Bolts
Courtesy of GENERAL MOTORS CORP.

43. Remove the torque converter bolts.

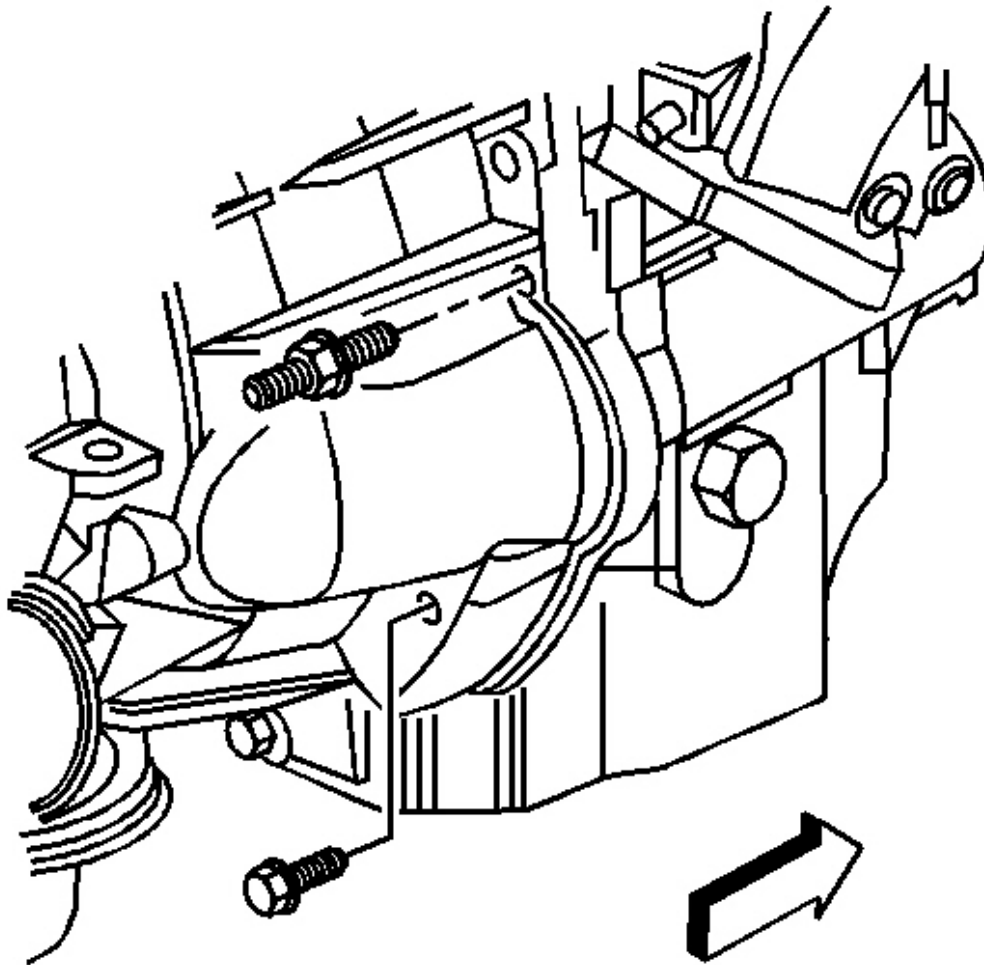
Fig. 284: View Of Right Side Transmission Bolt & Stud
Courtesy of GENERAL MOTORS CORP.

46. Remove the transmission bolt and stud on the right side.

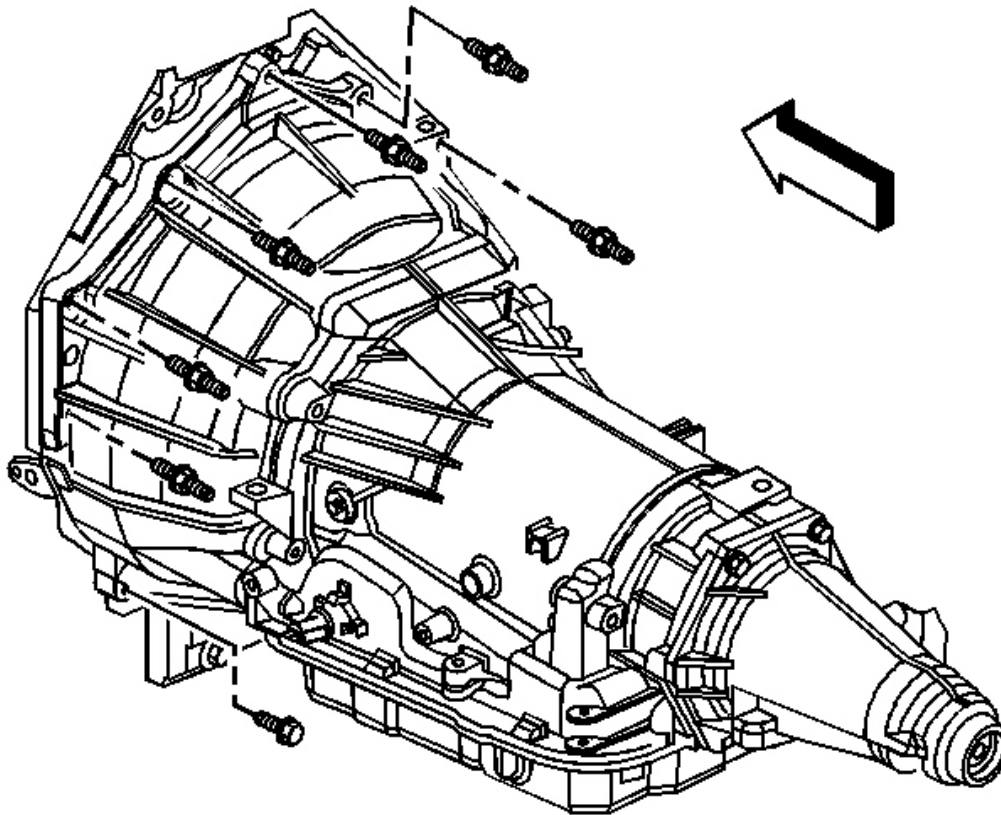
Fig. 285: View Of Automatic Transmission Bolt/Studs
Courtesy of GENERAL MOTORS CORP.

47. Remove the lower transmission bolt/studs.
48. Lower the vehicle.
49. Remove the 3 upper transmission bolts/studs.
50. Install an engine hoist to the **J 41798** . See **Special Tools and Equipment**.
51. Install a floor jack under the transmission for support.
52. Separate the engine from the transmission.
53. Remove the engine.
54. Install the engine to an engine stand.
55. Install **J 21366** to the transmission in order to hold the torque converter. See **Special Tools and Equipment**.

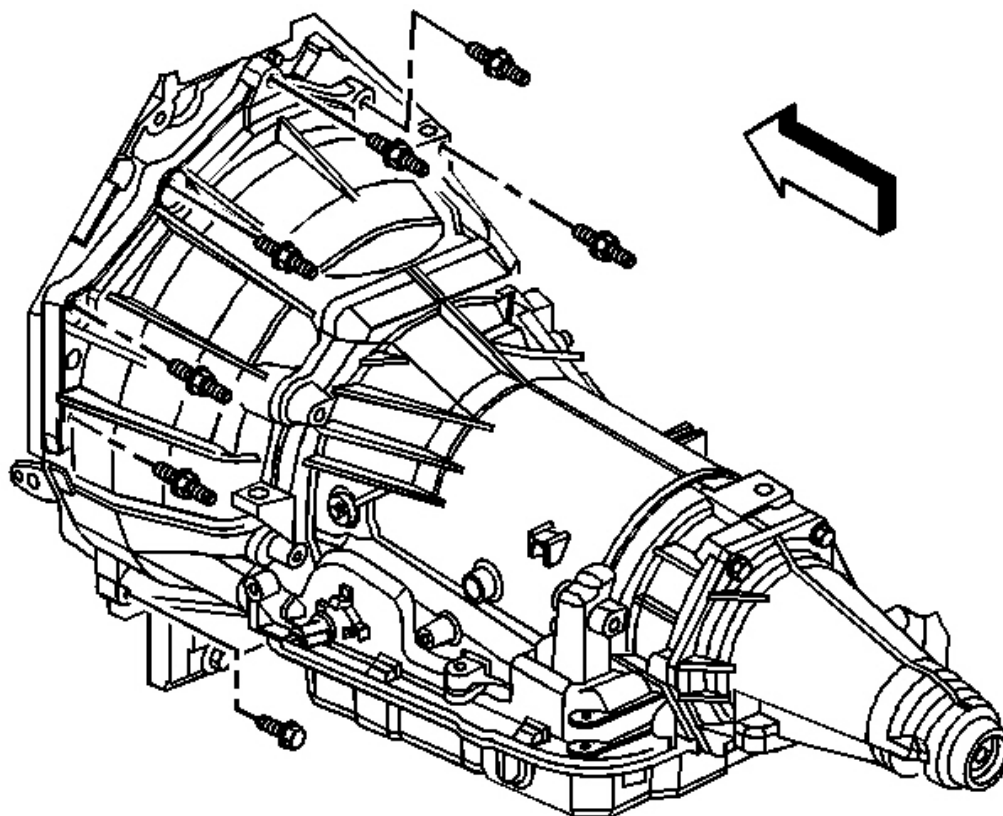
Fig. 286: View Of Automatic Transmission Bolt/Studs
Courtesy of GENERAL MOTORS CORP.

1. Remove the **J 21366** from the transmission. See Special Tools and Equipment.
2. Install an engine hoist to the **J 41798** . See Special Tools and Equipment.
3. Remove the engine from the engine stand.
4. Install the engine.
5. Mate the engine to the transmission.
6. Remove the floor jack from under the transmission for support.

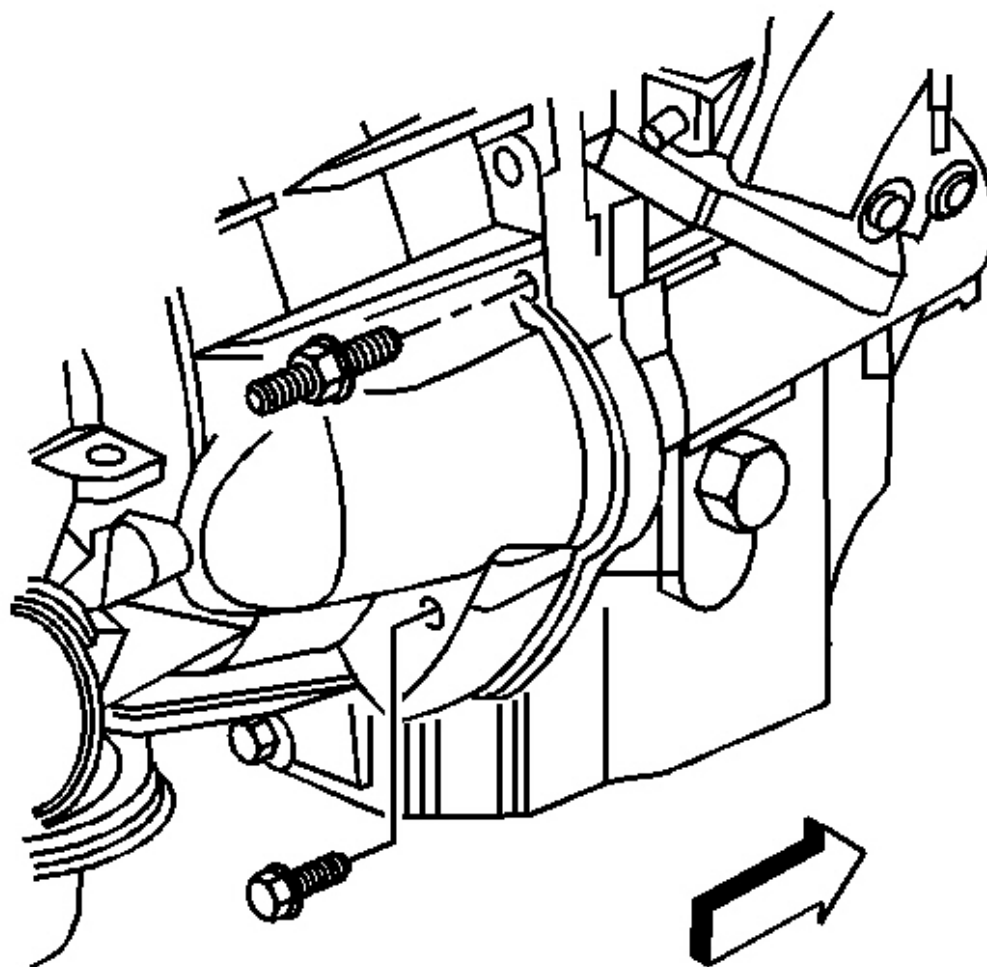
Fig. 287: View Of Right Side Transmission Bolt & Stud
Courtesy of GENERAL MOTORS CORP.

10. Install the transmission bolt and stud on the right side.

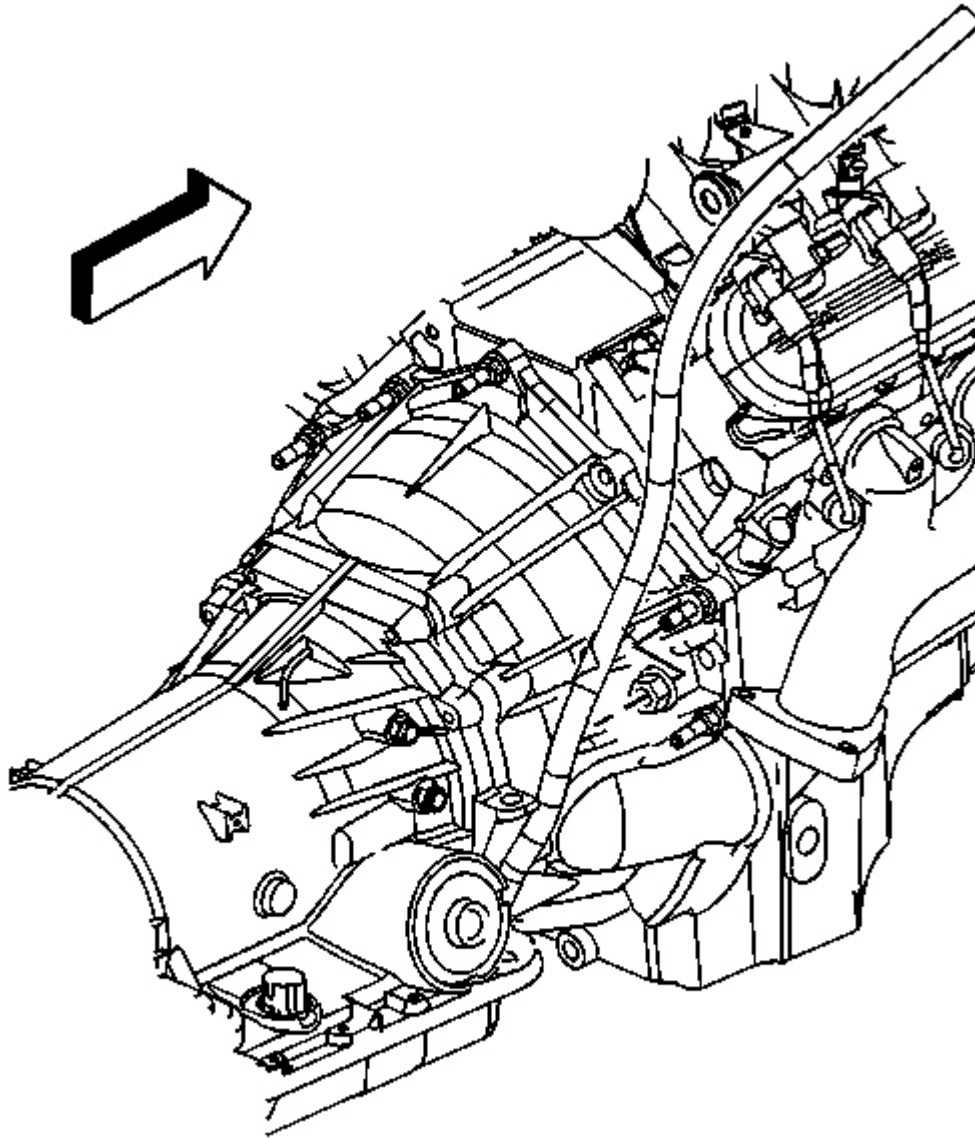
Fig. 289: View Of Oil Level Indicator Tube Nut
Courtesy of GENERAL MOTORS CORP.

12. Install the transmission oil level indicator tube nut.

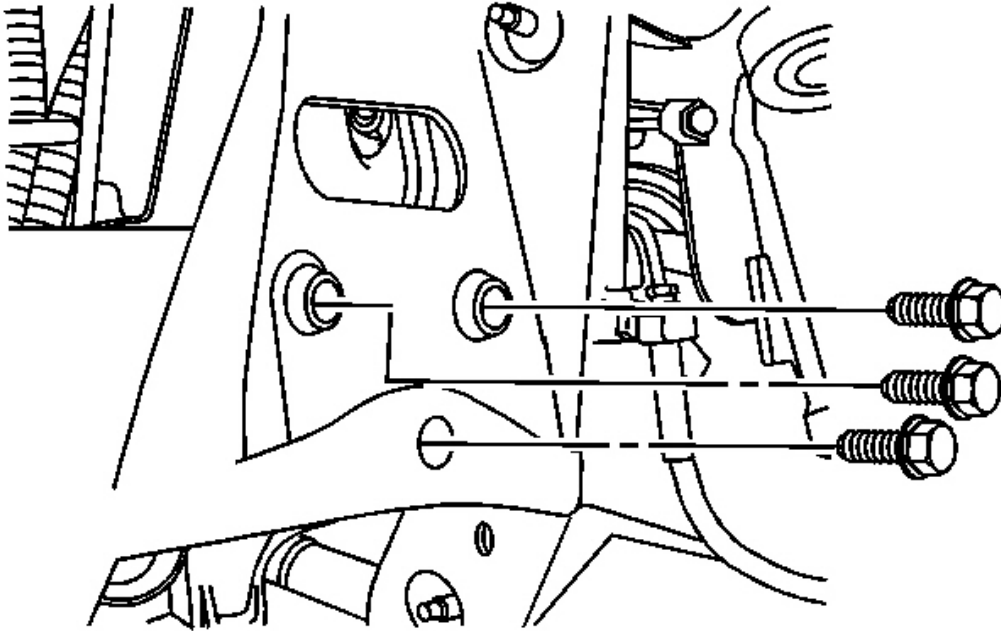
Fig. 291: View Of Frame Engine Mount Bracket Bolt Locations
Courtesy of GENERAL MOTORS CORP.

14. Install the 3 frame engine mount bracket bolts to both the right and left sides.

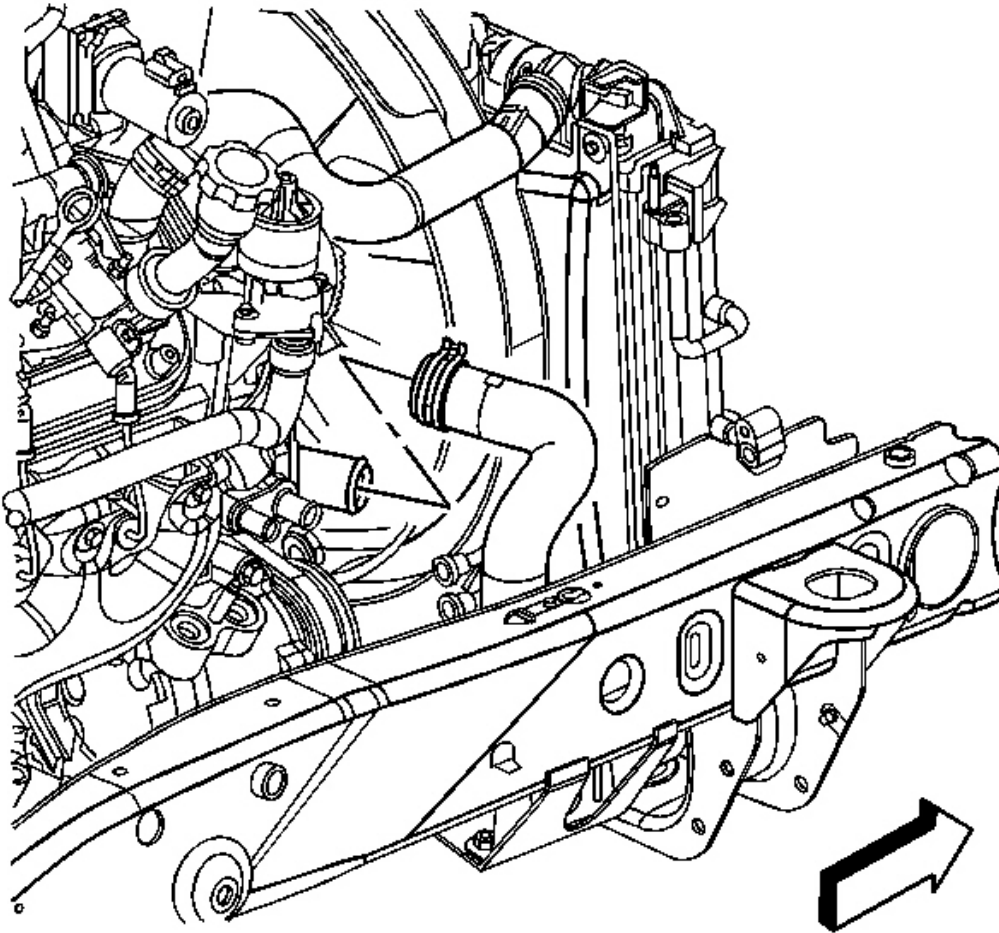
Fig. 295: View Of Outlet Hose
Courtesy of GENERAL MOTORS CORP.

22. Install the outlet hose to the water outlet.
23. Using **J 38185** , reposition the inlet hose clamp. See **Special Tools and Equipment**.
