2004 Isuzu Ascender LS

2004 ENGINE Engine Mechanical - 4.8L, 5.3L, and 6.0L - Ascender

Engine Mechanical - 4.8L, 5.3L, and 6.0L - Ascender

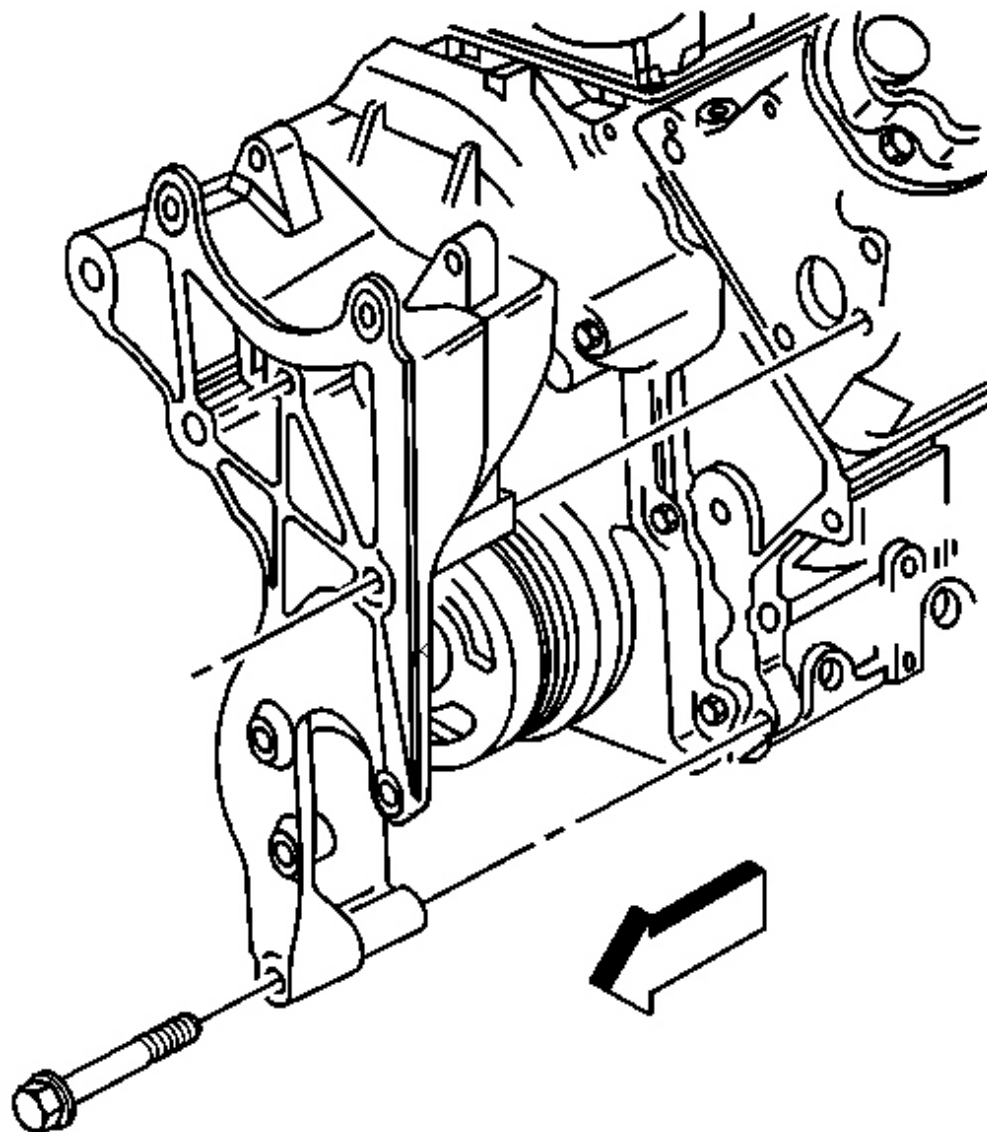
Fig. 297: View Of Generator Bracket & Bolts
Courtesy of GENERAL MOTORS CORP.

26. Position the bracket with generator to the engine.
27. Install the generator bracket bolts.

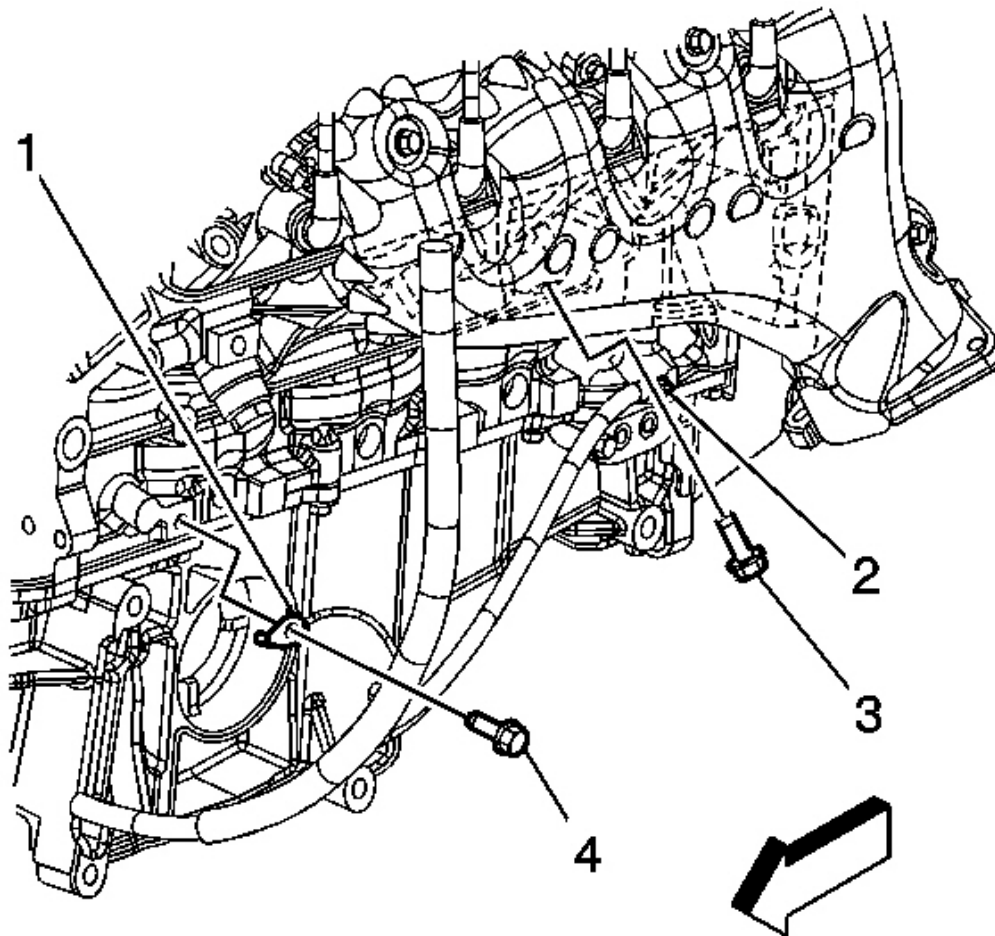
Fig. 301: View Of Ground Terminal Bolts
Courtesy of GENERAL MOTORS CORP.

34. Install the starter. Refer to **Starter Motor Replacement (4.2L Engine)** or **Starter Motor Replacement (5.3L Engine)** in Engine Electrical.
35. Install the ground terminal bolts (2, 4).

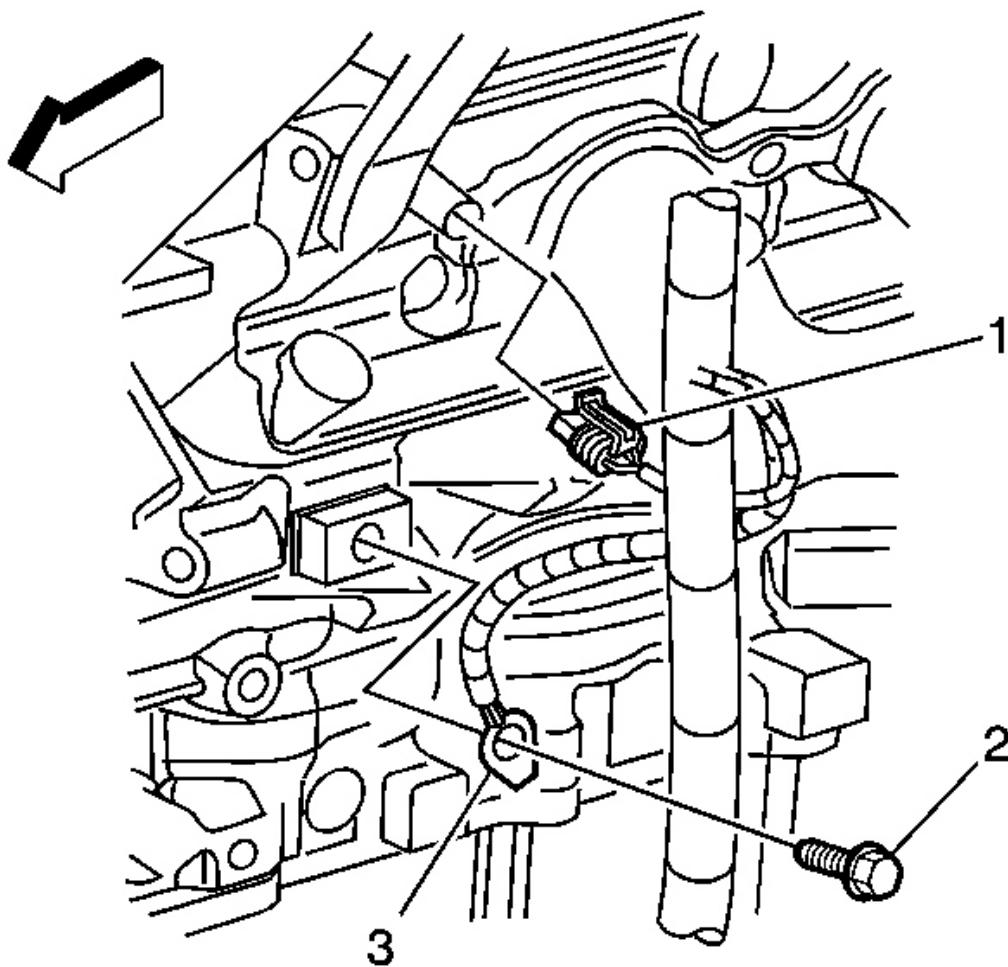
Fig. 303: View Of ECT Sensor Electrical Connector And Ground
Courtesy of GENERAL MOTORS CORP.

39. Install the retaining clips to the brackets.
40. Install the ground terminal bolt (2).

Tighten: Tighten the bolt to 25 N.m (18 lb ft).

41. Connect the ECT sensor (1).

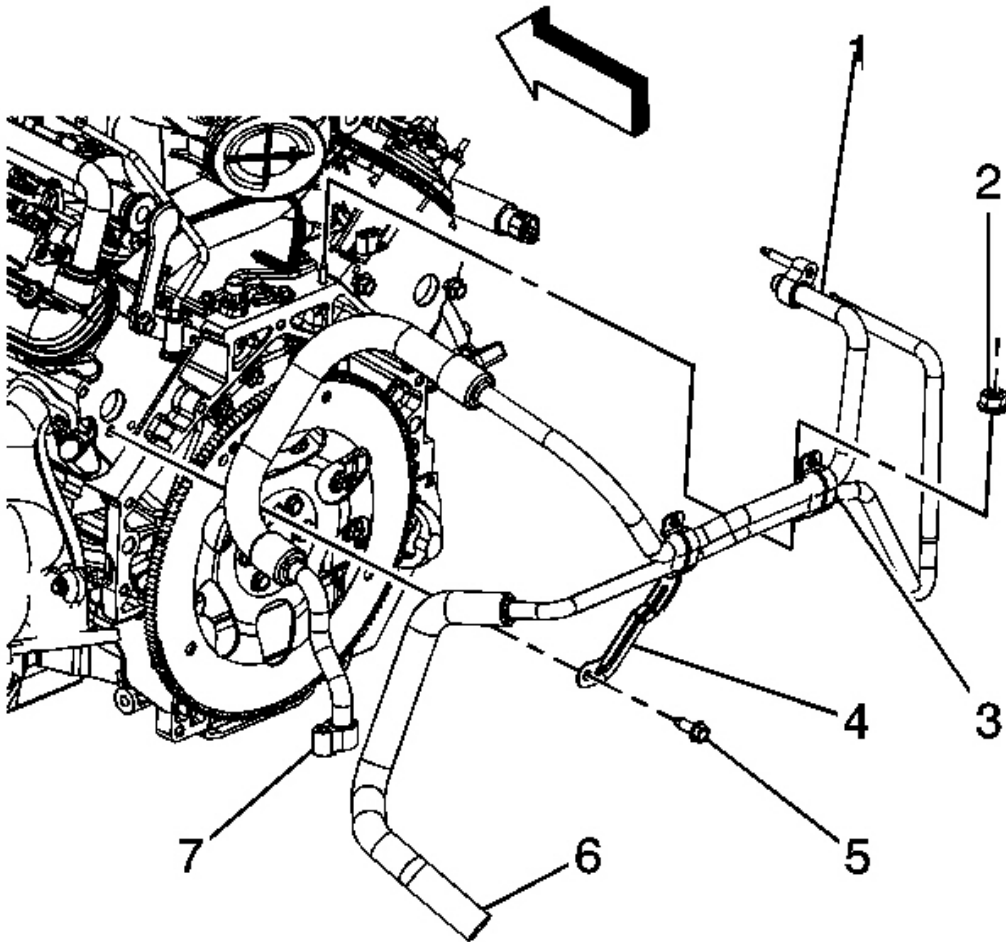
Fig. 304: View Of Rear A/C Lines
Courtesy of GENERAL MOTORS CORP.

42. Install the rear auxiliary A/C compressor pipe nut and bolt (2, 5).

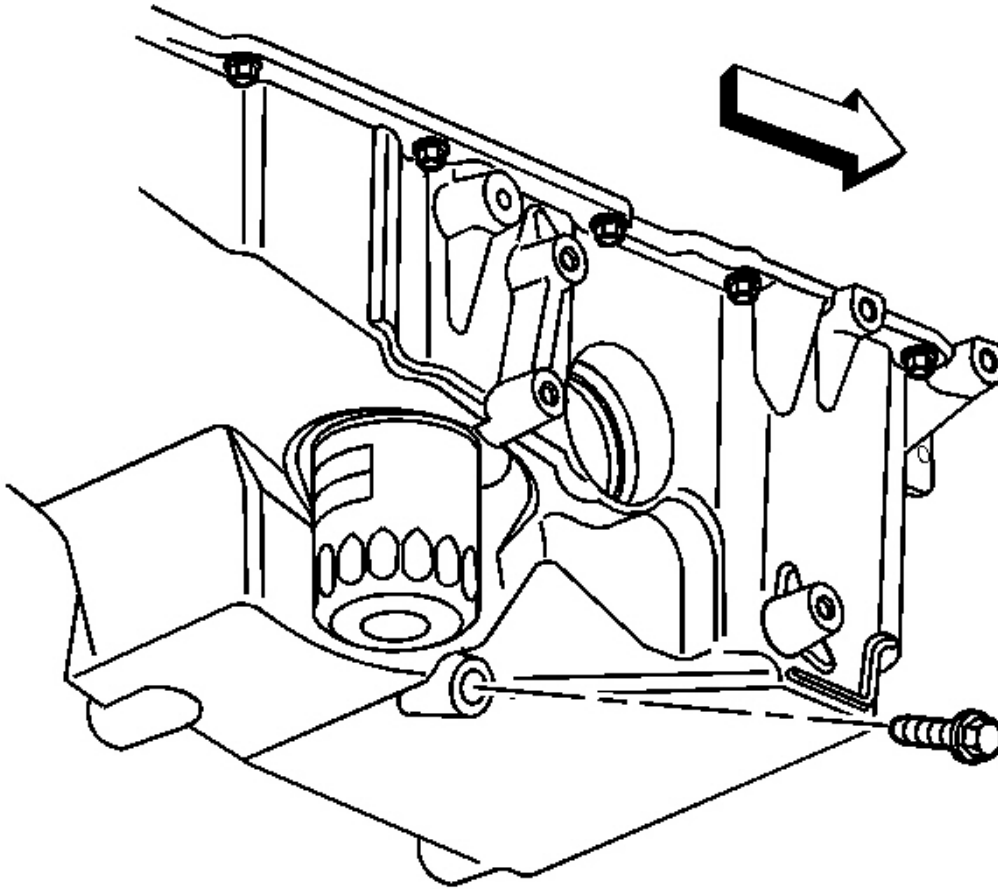
Fig. 306: View Of Oil Pan Drain Plug
Courtesy of GENERAL MOTORS CORP.

IMPORTANT: In order to completely drain the oil from the oil pan internal baffling, the bottom of the oil pan must be level during the oil drain procedure.

1. Open the hood.
2. Remove the oil fill cap.
3. Raise and suitably support the vehicle. Refer to **Lifting and Jacking the Vehicle** in General Information.
4. Place a oil drain pan under the oil pan drain plug.
5. Remove the oil pan drain plug.
6. Drain the engine oil.

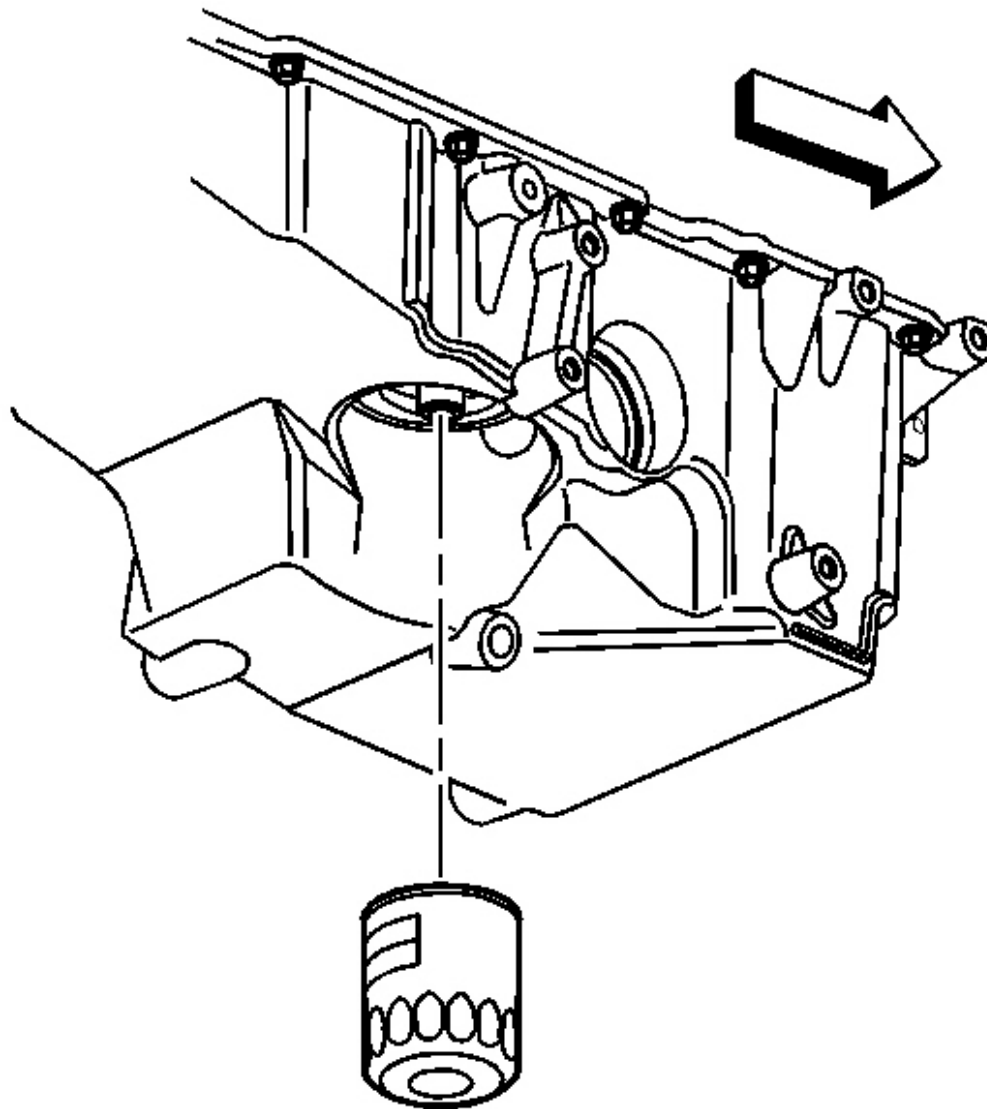
Fig. 308: Locating Oil Filter

Tighten: Tighten the filter to 30 N.m (22 lb ft).

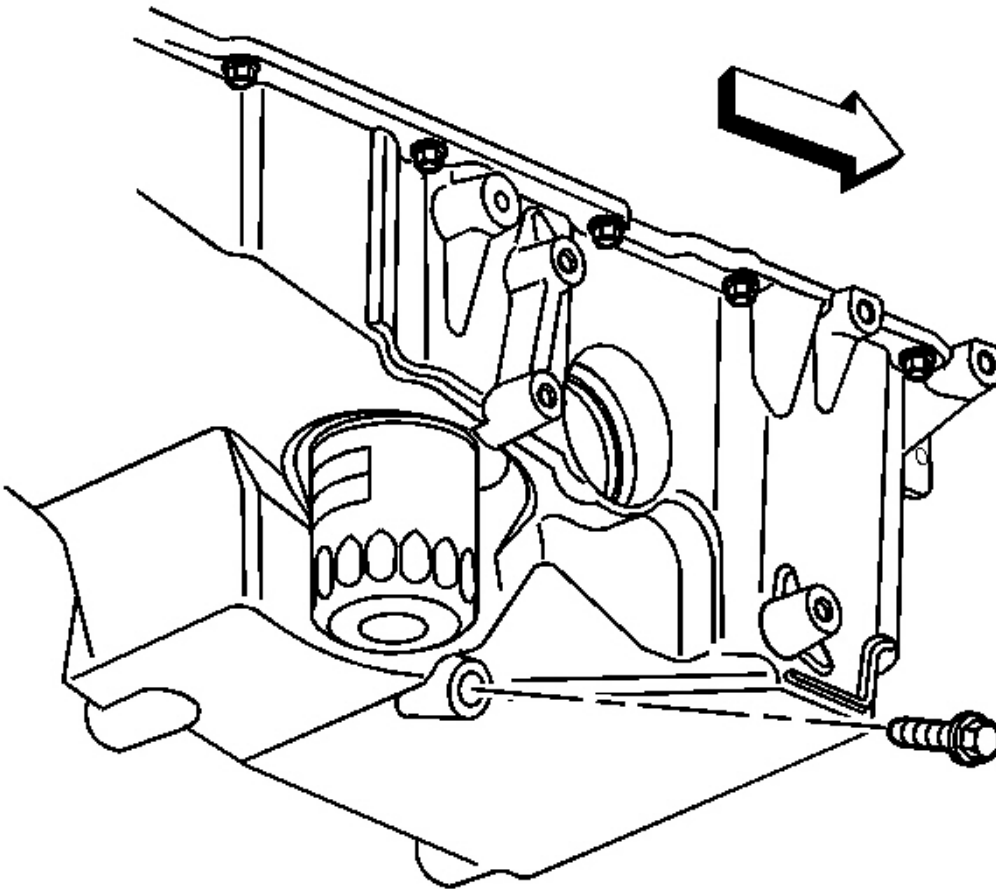
Fig. 309: View Of Oil Pan Drain Plug
Courtesy of GENERAL MOTORS CORP.

5. Install the oil drain plug to the oil pan.

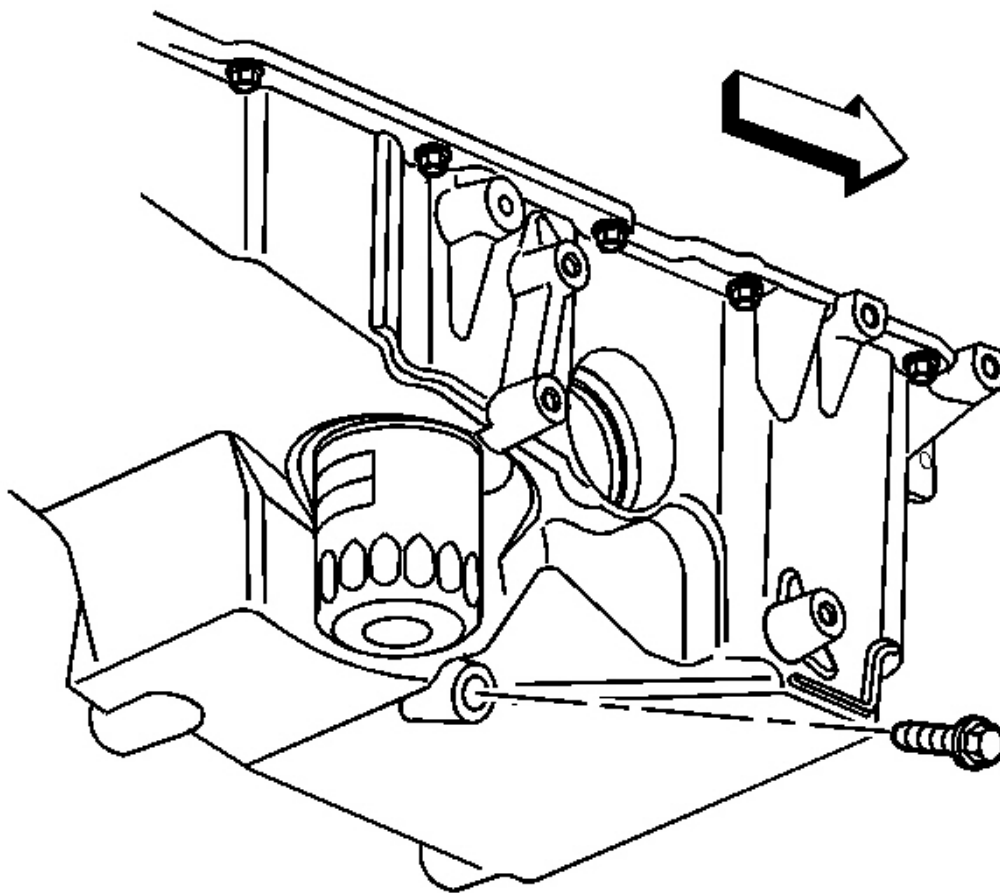
Fig. 310: View Of Oil Pan Drain Plug
Courtesy of GENERAL MOTORS CORP.

IMPORTANT: In order to completely drain the oil, the bottom of the oil pan must be level during the oil drain procedure.

1. Remove the oil pan drain plug and allow the oil to drain.

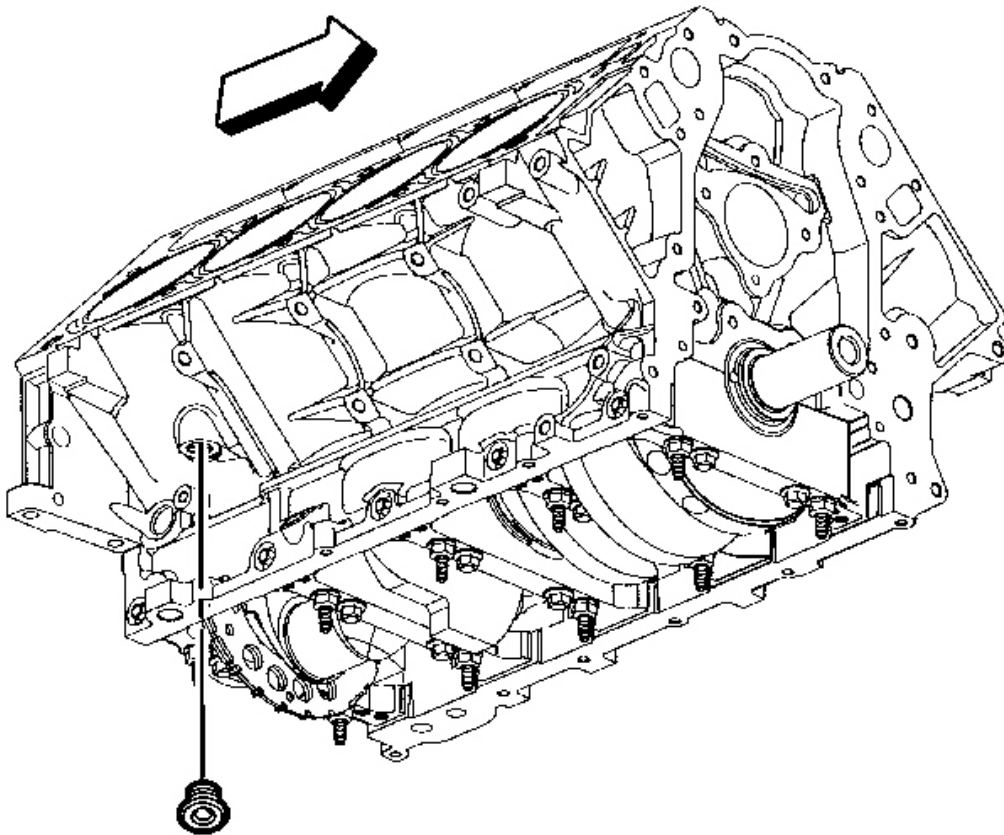
Fig. 312: Identifying Plug Location On Underside Of Block
Courtesy of GENERAL MOTORS CORP.

3. Remove the right rear engine block coolant drain plug and allow the coolant to drain.

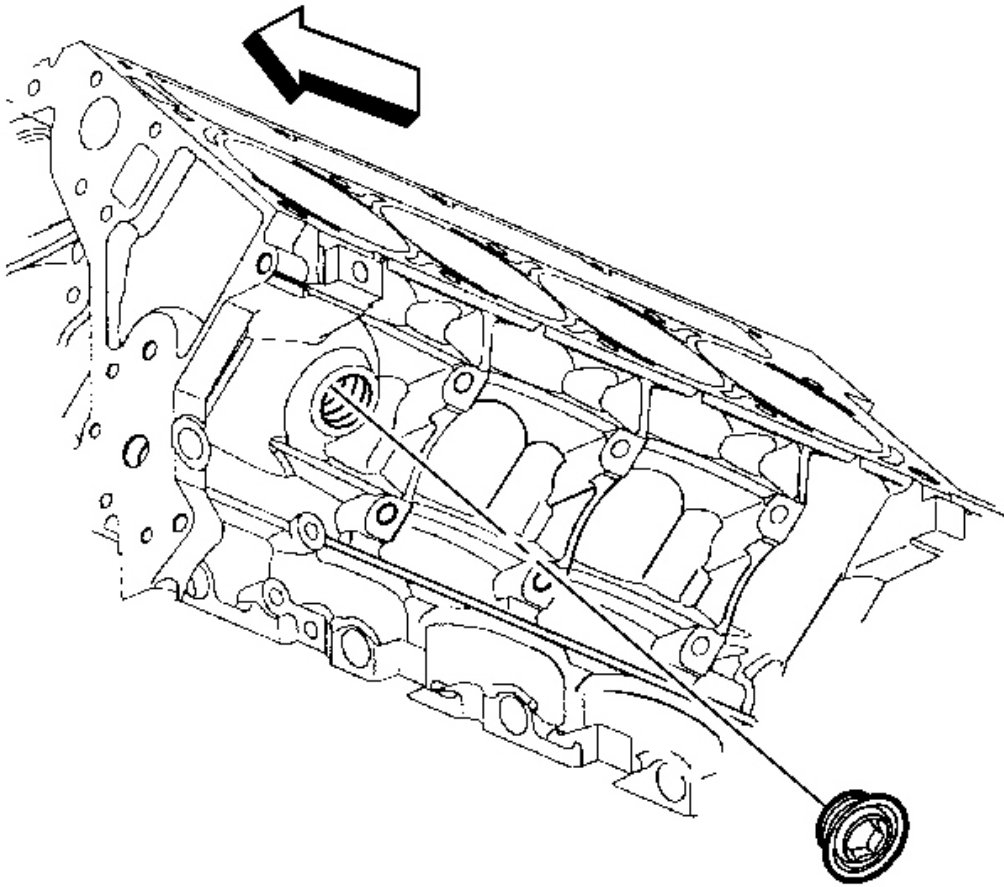
Fig. 313: View Of Engine Block Left Front Coolant Drain Hole Plug
Courtesy of GENERAL MOTORS CORP.

4. Remove the left front engine block coolant drain plug and allow the coolant to drain.

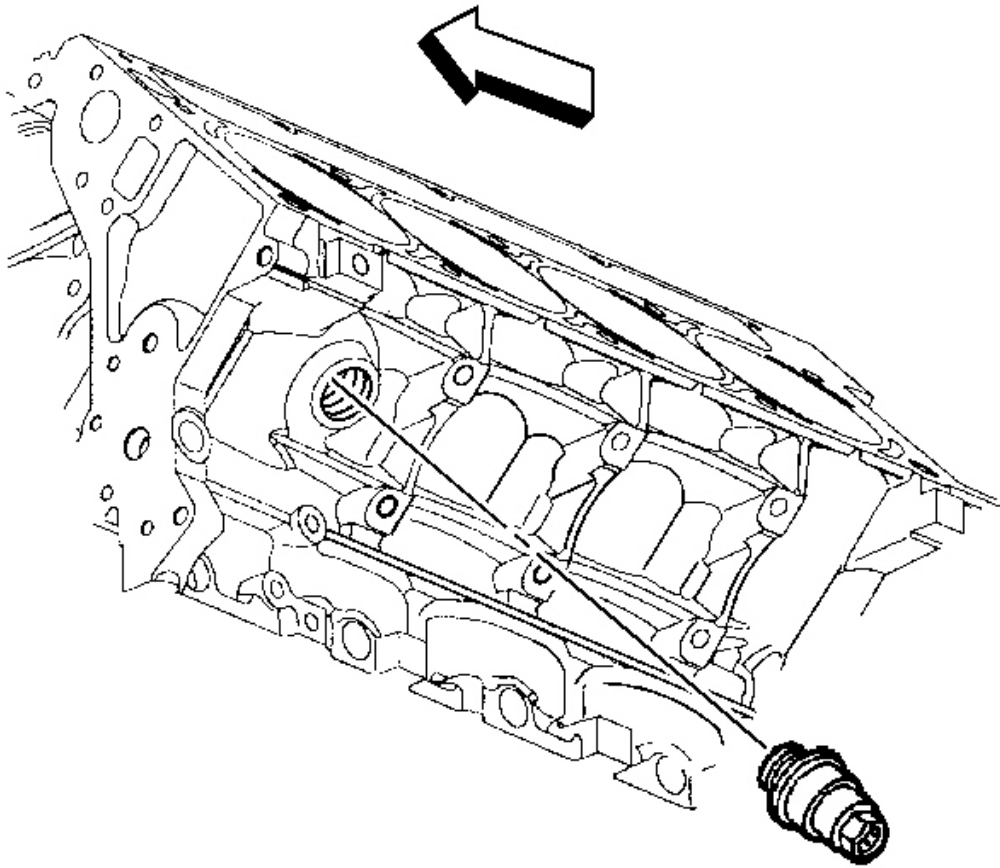
Fig. 314: View Of Engine Block Coolant Heater
Courtesy of GENERAL MOTORS CORP.

5. Remove the engine block coolant heater, if applicable, and allow the coolant to drain.

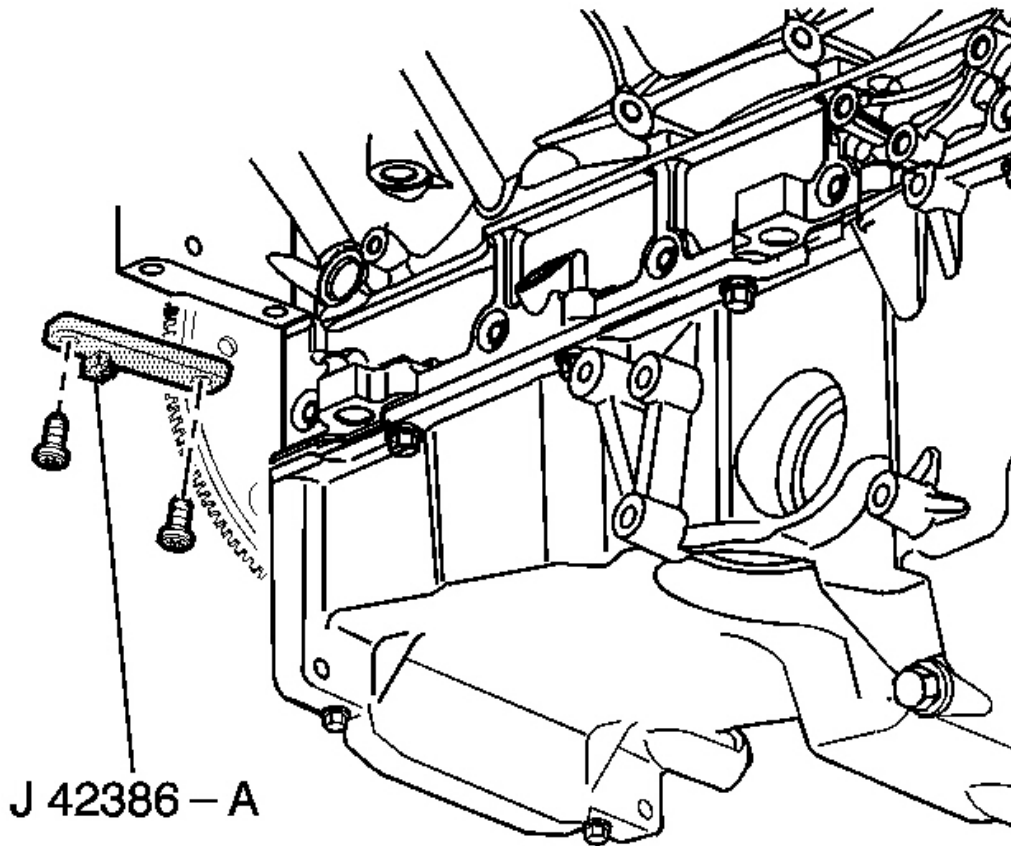
Fig. 316: View Of J 42386-A Flywheel Tool
Courtesy of GENERAL MOTORS CORP.

Use one M10 - 1.5 x 120 mm and one M10 - 1.5 x 45 mm bolt for proper tool operation.

Tighten: Tighten the **J 42386-A** bolts to 50 N.m (37 lb ft). See **Special Tools and Equipment**.

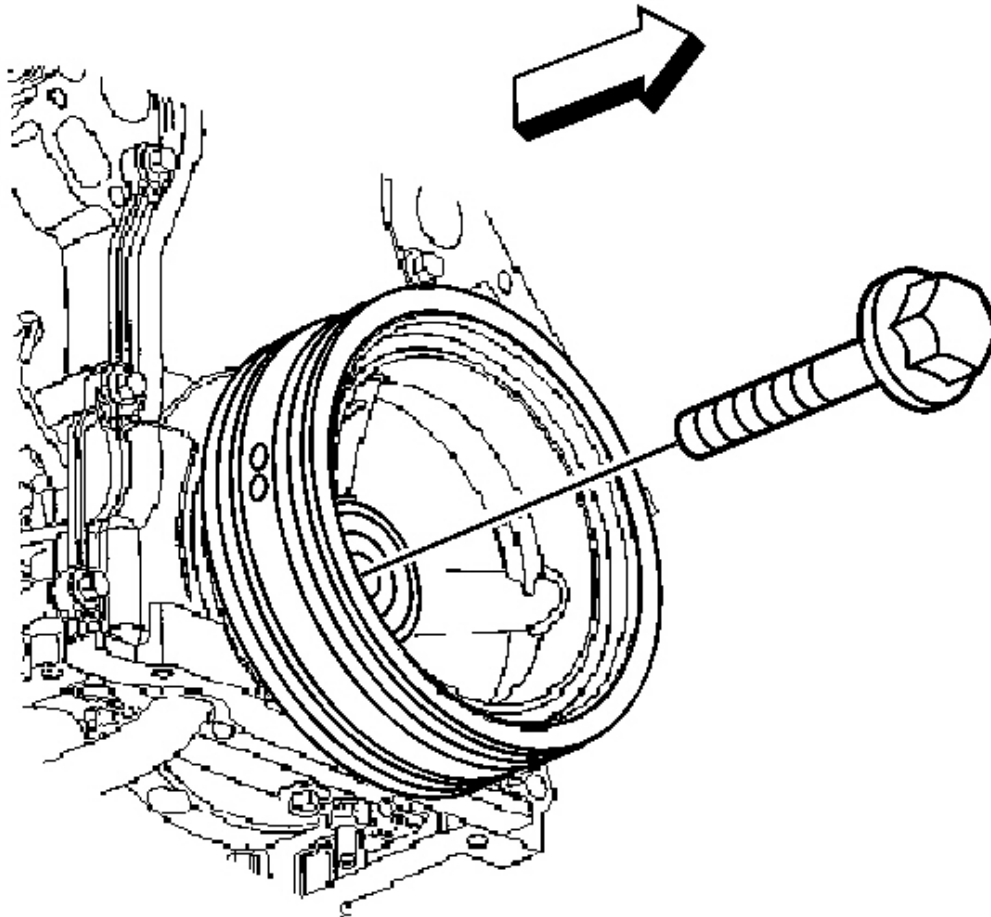
Fig. 317: Crankshaft Balancer And Retaining Bolt
Courtesy of GENERAL MOTORS CORP.

2. Remove the crankshaft balancer bolt.

Do not discard the crankshaft balancer bolt. The balancer bolt will be used during the balancer installation procedure.

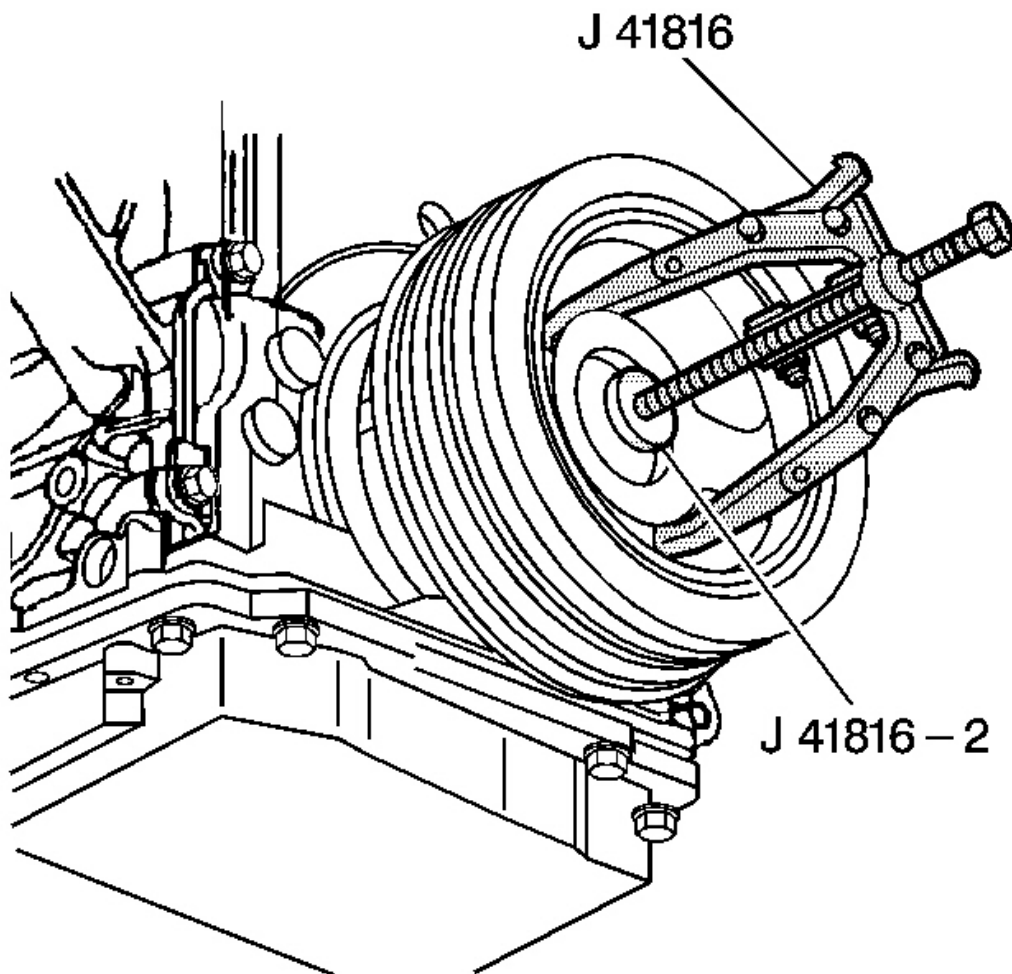
Fig. 318: Removing The Crankshaft Balancer
Courtesy of GENERAL MOTORS CORP.

3. Use the **J 41816** and the **J 41816-2** in order to remove the crankshaft balancer. See **Special Tools and Equipment**.
4. Remove the **J 42386-A** and bolts. See **Special Tools and Equipment**.

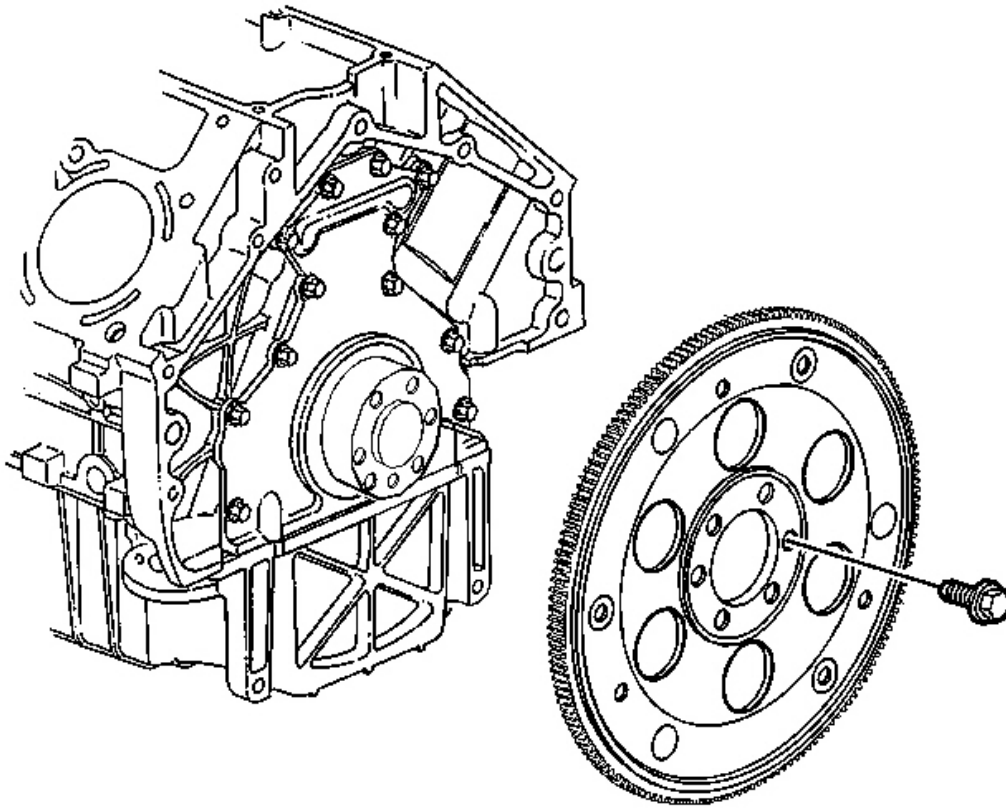
Fig. 319: View Of Engine Flywheel & Bolt
Courtesy of GENERAL MOTORS CORP.

IMPORTANT: The flywheel does not use a locating pin for alignment and will not initially seat against the crankshaft flange or spacer, if applicable, but will be pulled onto the crankshaft by the engine flywheel bolts. This procedure requires a three stage tightening process.

1. Remove the engine flywheel bolts.
2. Remove the automatic transmission engine flywheel.

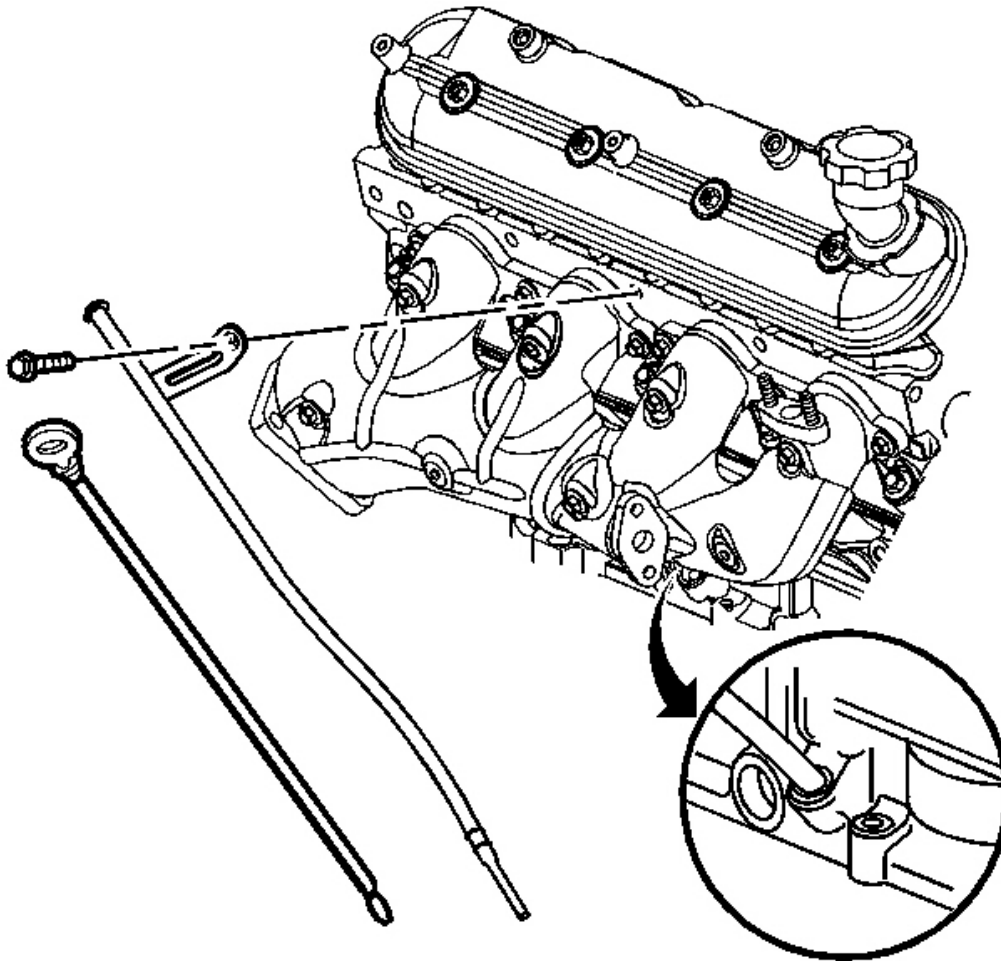
Fig. 320: View Of Oil Level Indicator, Tube & Bolt
Courtesy of GENERAL MOTORS CORP.

1. Remove the oil level indicator from the tube.
2. Remove the oil level indicator tube bolt.
3. Remove the oil level indicator tube from the engine block.

IMPORTANT: Inspect the O-ring seal for cuts or damage. The O-ring seal may be used again if it is not cut or damaged.

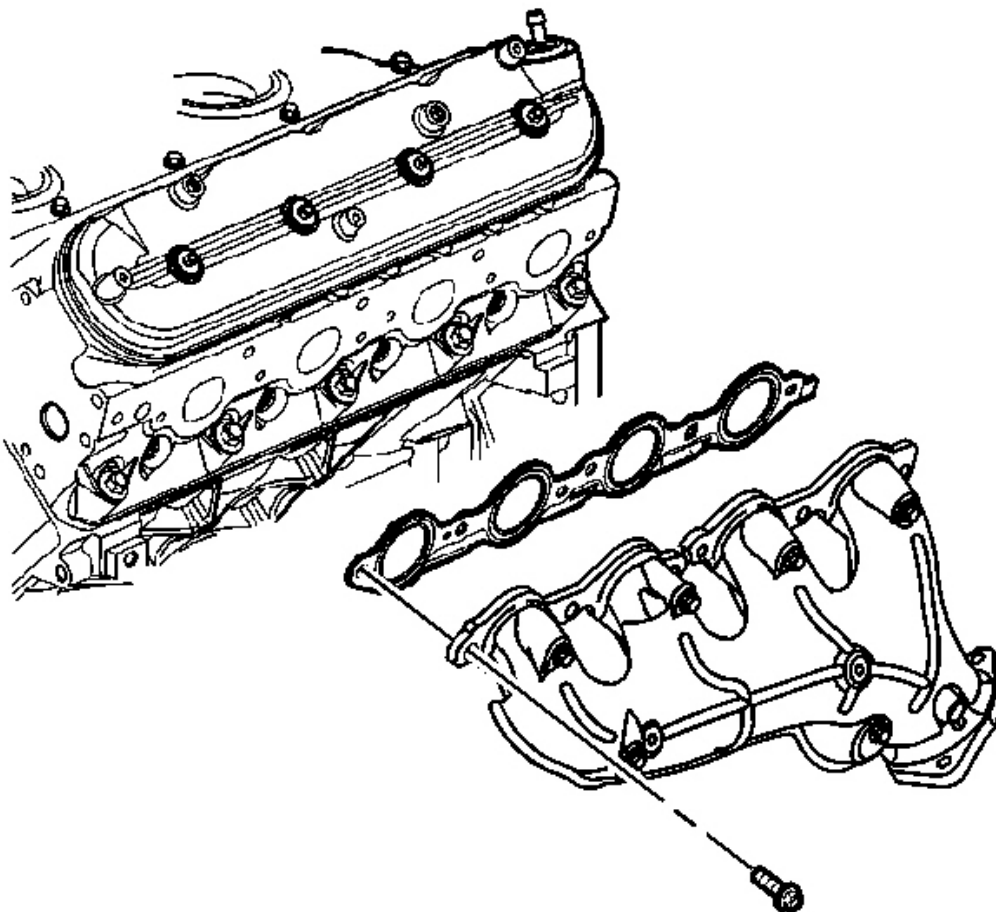
Fig. 321: View Of Exhaust Manifold, Bolts & Gasket (Left)
Courtesy of GENERAL MOTORS CORP.

2. Remove the exhaust manifold, bolts, and gasket.
3. Discard the gasket.

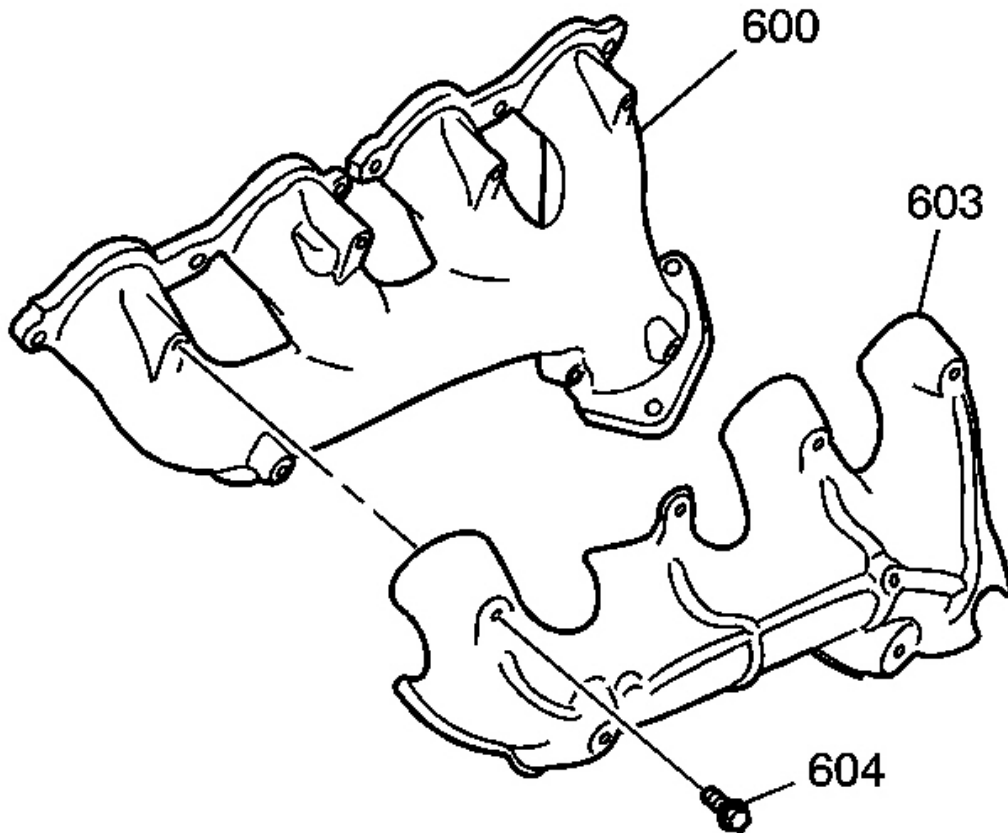
Fig. 322: View Of Manifold, Heat Shield & Bolts
Courtesy of GENERAL MOTORS CORP.

4. Remove the heat shield (603) and bolts (604) from the manifold (600), if required.

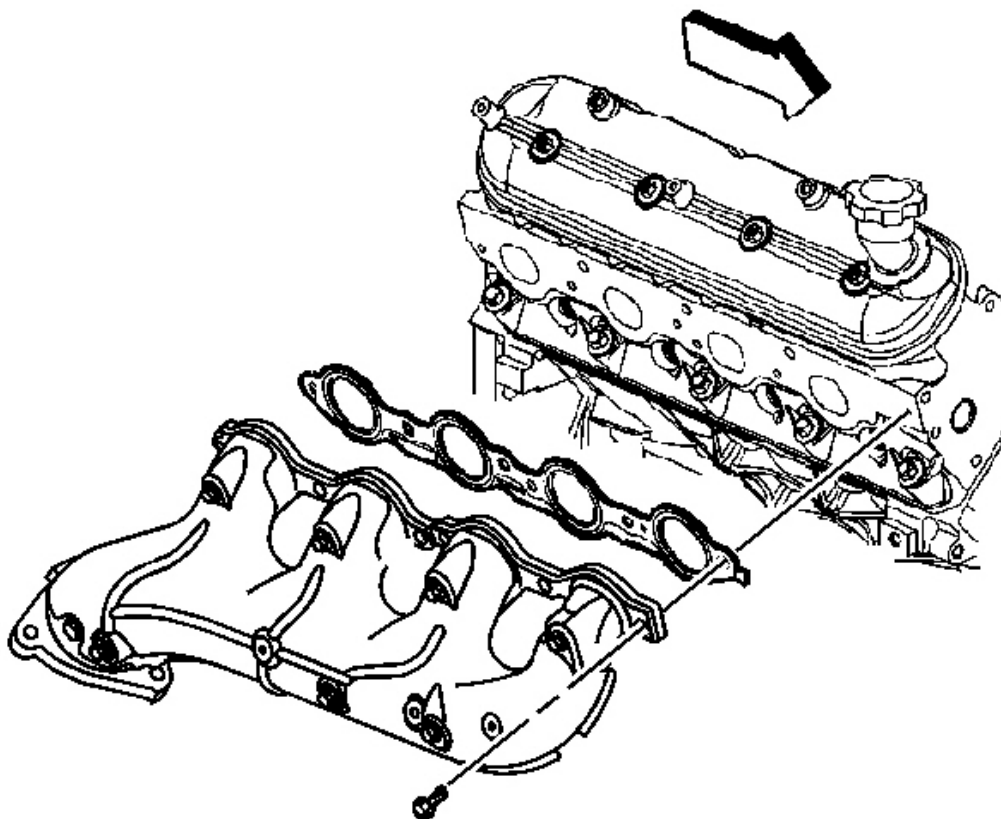
Fig. 323: View Of Exhaust Manifold & Gasket (Right)
Courtesy of GENERAL MOTORS CORP.

2. Remove the exhaust manifold, bolts, and gasket.
3. Discard the gasket.

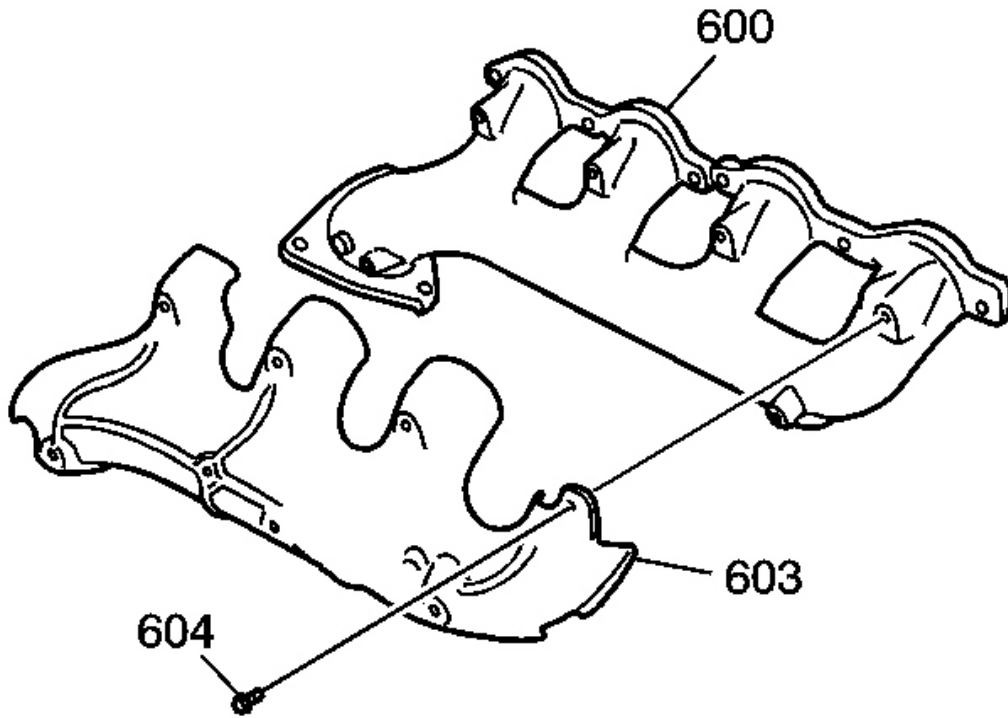
Fig. 324: View Of Exhaust Manifold Heat Shield & Bolts (Right)
Courtesy of GENERAL MOTORS CORP.

4. Remove the heat shield (603) and bolts (604) from the manifold (600), if required.

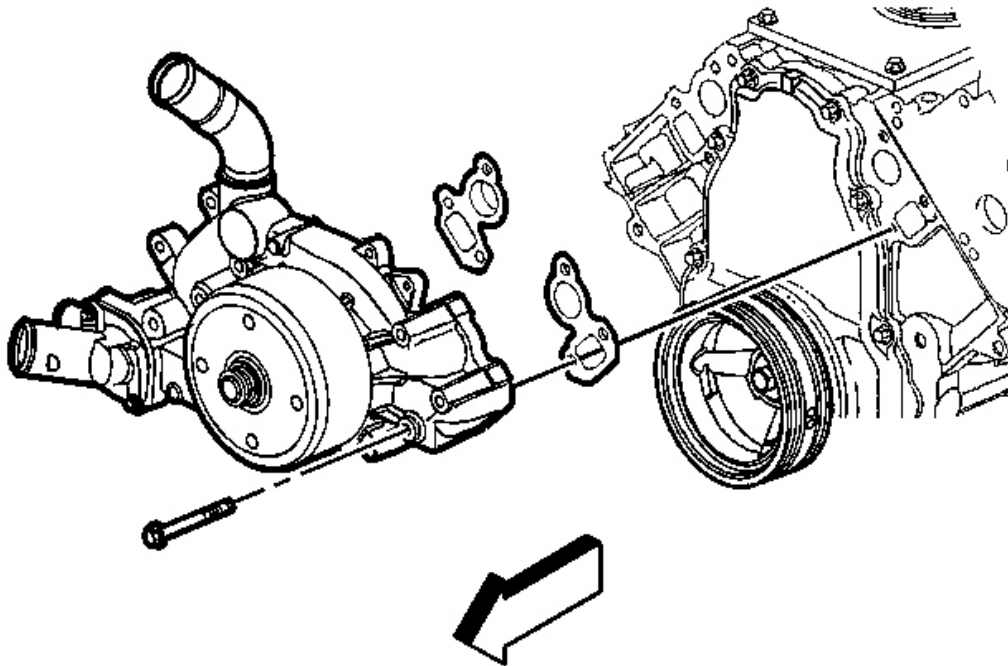
Fig. 325: View Of Water Pump, Gaskets & Bolts
Courtesy of GENERAL MOTORS CORP.

1. Remove the water pump bolts.
2. Remove the water pump and gaskets.
3. Discard the water pump gaskets.

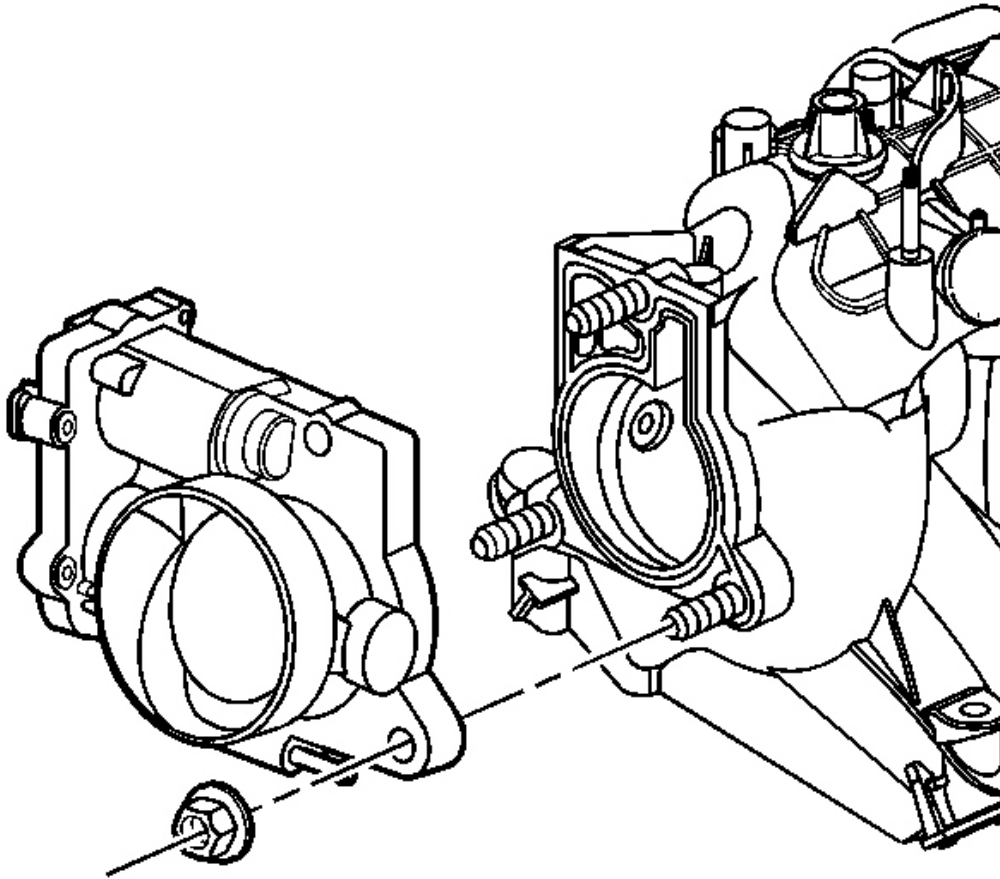
Fig. 326: View Of Throttle Body & Nuts
Courtesy of GENERAL MOTORS CORP.

IMPORTANT: The intake manifold, throttle body, fuel injection rail, and fuel injectors may be removed as an assembly. If not servicing the individual components, remove the manifold as a complete assembly.

1. Remove the electrical wire harness connectors from the throttle body.
2. Remove the engine coolant air bleed hose and clamp.
3. Remove the throttle body nuts.
4. Remove the throttle body.

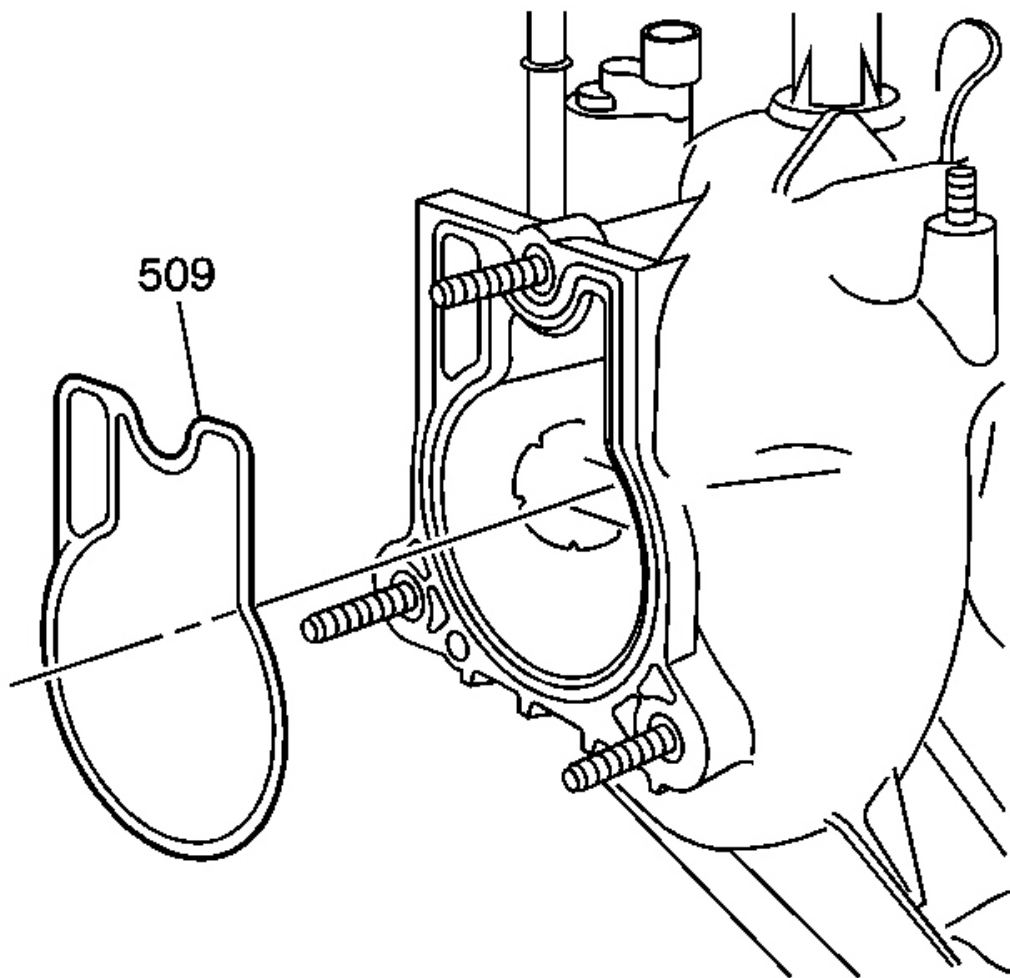
Fig. 327: View Of Throttle Body Gasket
Courtesy of GENERAL MOTORS CORP.

5. Remove the throttle body gasket (509).
6. Discard the gasket.
7. Remove the throttle body studs, if required.

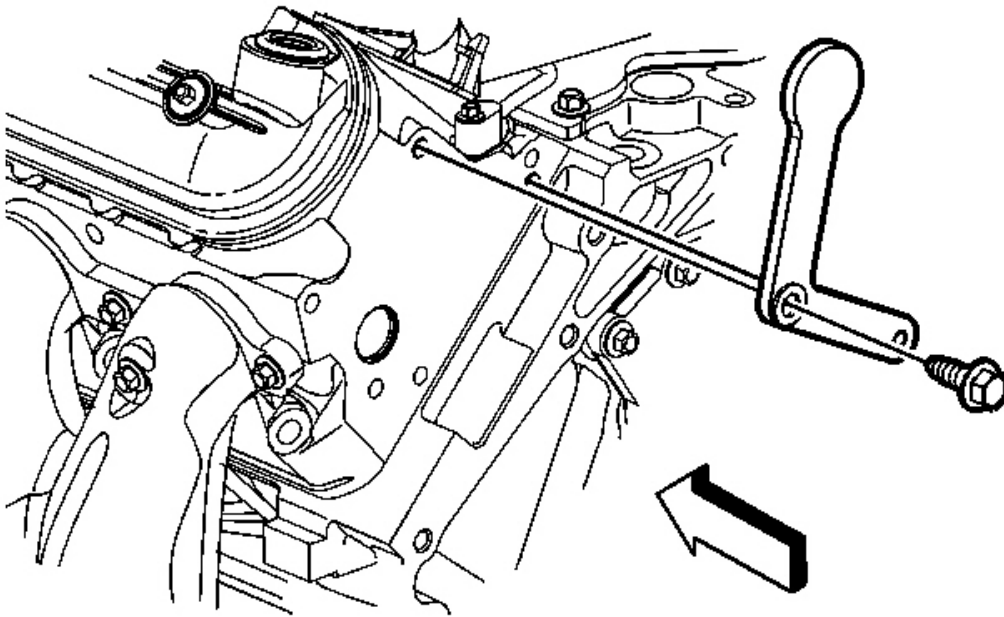
Fig. 328: View Of Fuel Rail Stop Bracket & Bolt
Courtesy of GENERAL MOTORS CORP.

CAUTION: The fuel rail stop bracket must be installed onto the engine assembly. The stop bracket serves as a protective shield for the fuel rail in the event of a vehicle frontal crash. If the fuel rail stop bracket is not installed and the vehicle is involved in a frontal crash, fuel could be sprayed possibly causing a fire and personal injury from burns.

1. Remove the fuel rail stop bracket and bolt, if required.
2. Remove the vacuum hose from the fuel pressure regulator.
3. Loosen the crossover tube-to-right fuel rail retaining bolt.
4. Remove the fuel rail bolts.
