2004 Isuzu Ascender LS

2004 ENGINE Engine Mechanical - 4.8L, 5.3L, and 6.0L - Ascender

Engine Mechanical - 4.8L, 5.3L, and 6.0L - Ascender

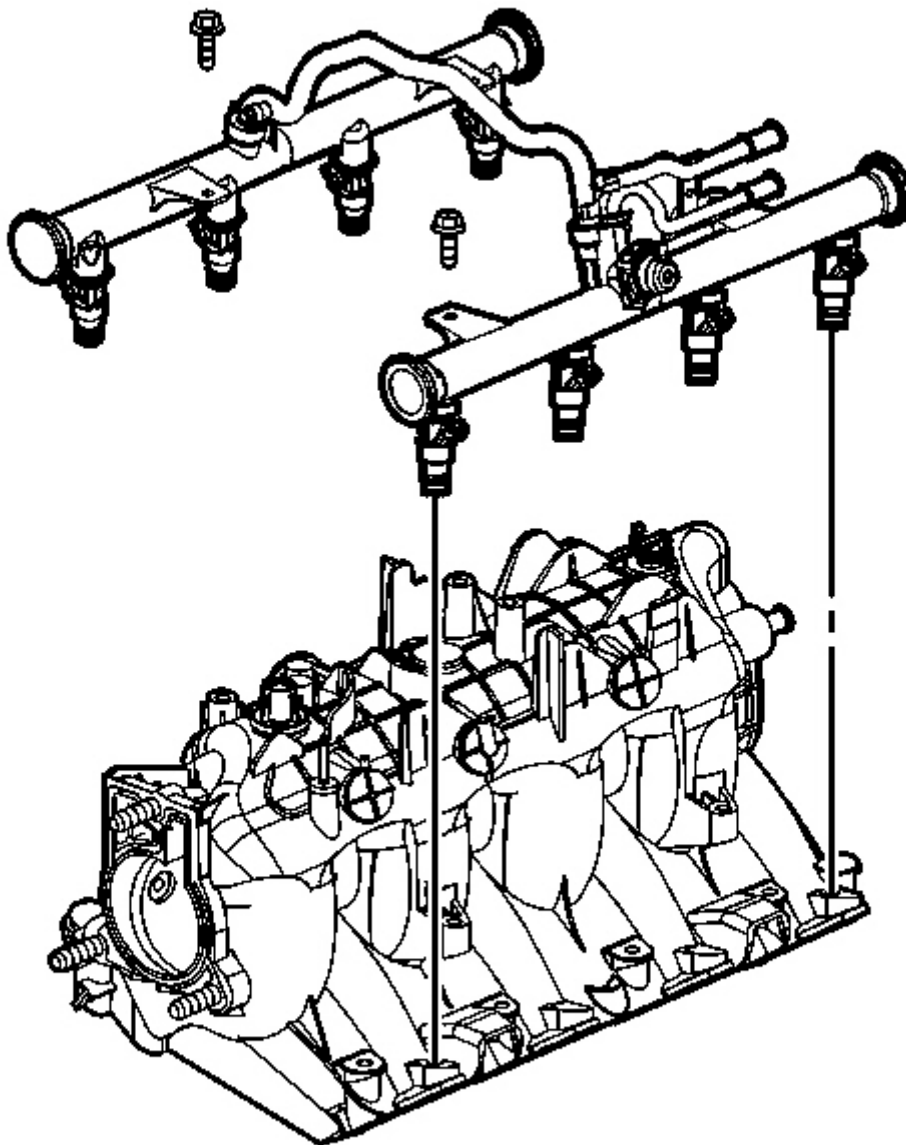
Fig. 329: View Of Fuel Injector Rail

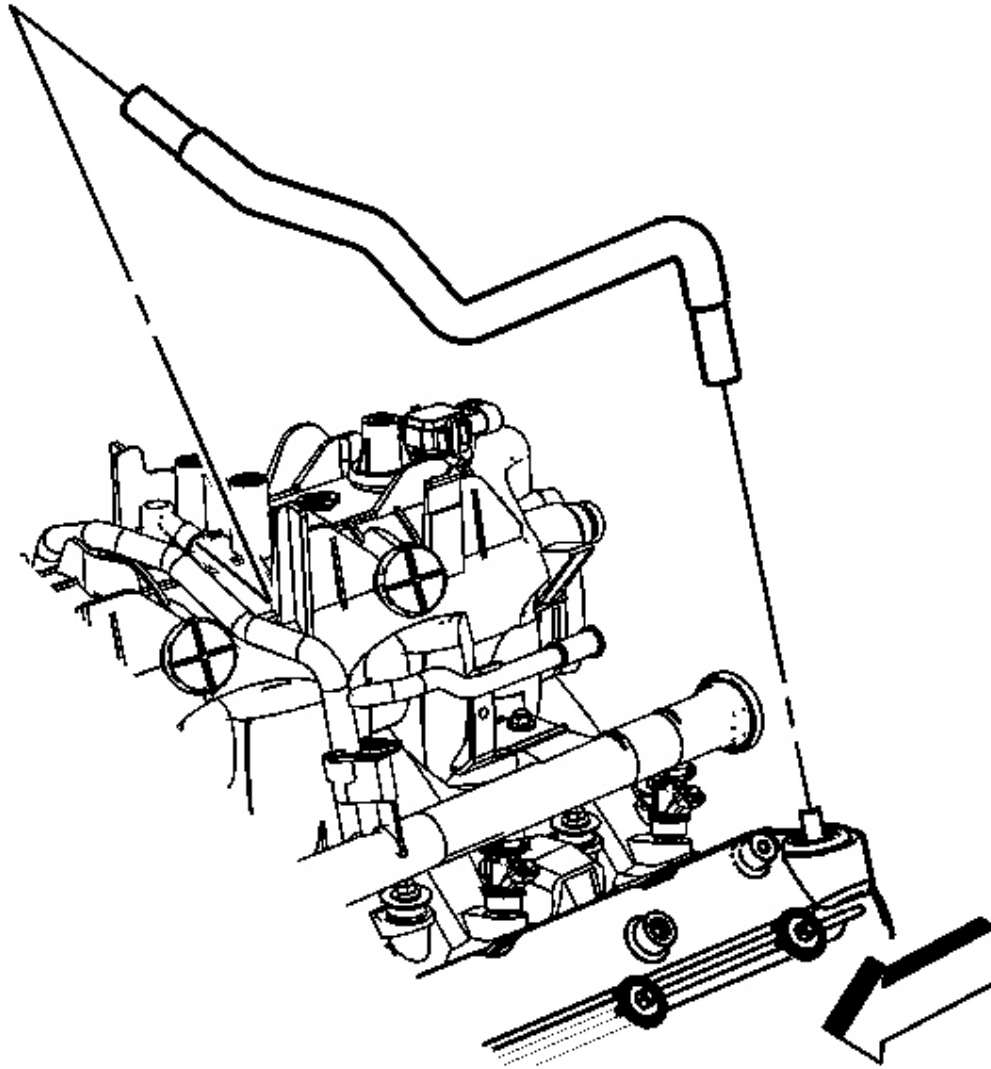
Fig. 330: View Of PCV Hose

1. Remove the positive crankcase ventilation (PCV) hose.

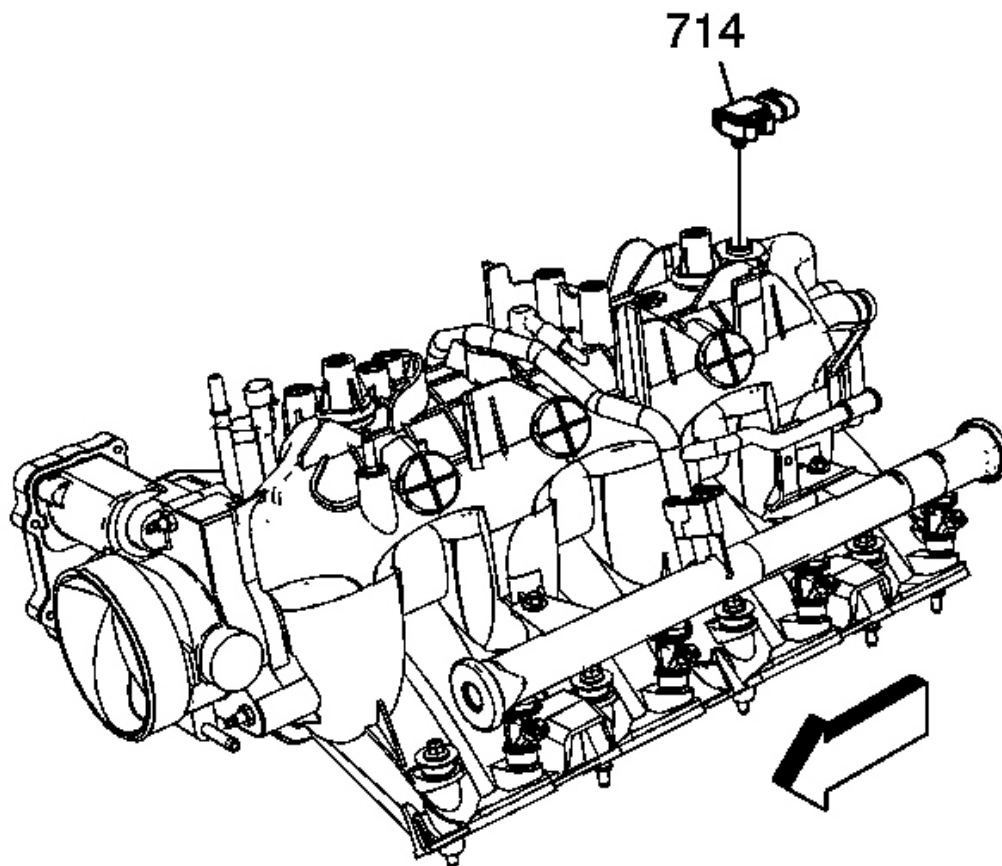
Fig. 331: View Of MAP Sensor
Courtesy of GENERAL MOTORS CORP.

2. Remove the manifold absolute pressure (MAP) sensor (714), if required.
3. Remove the engine coolant air bleed clamp and hose from the throttle body.

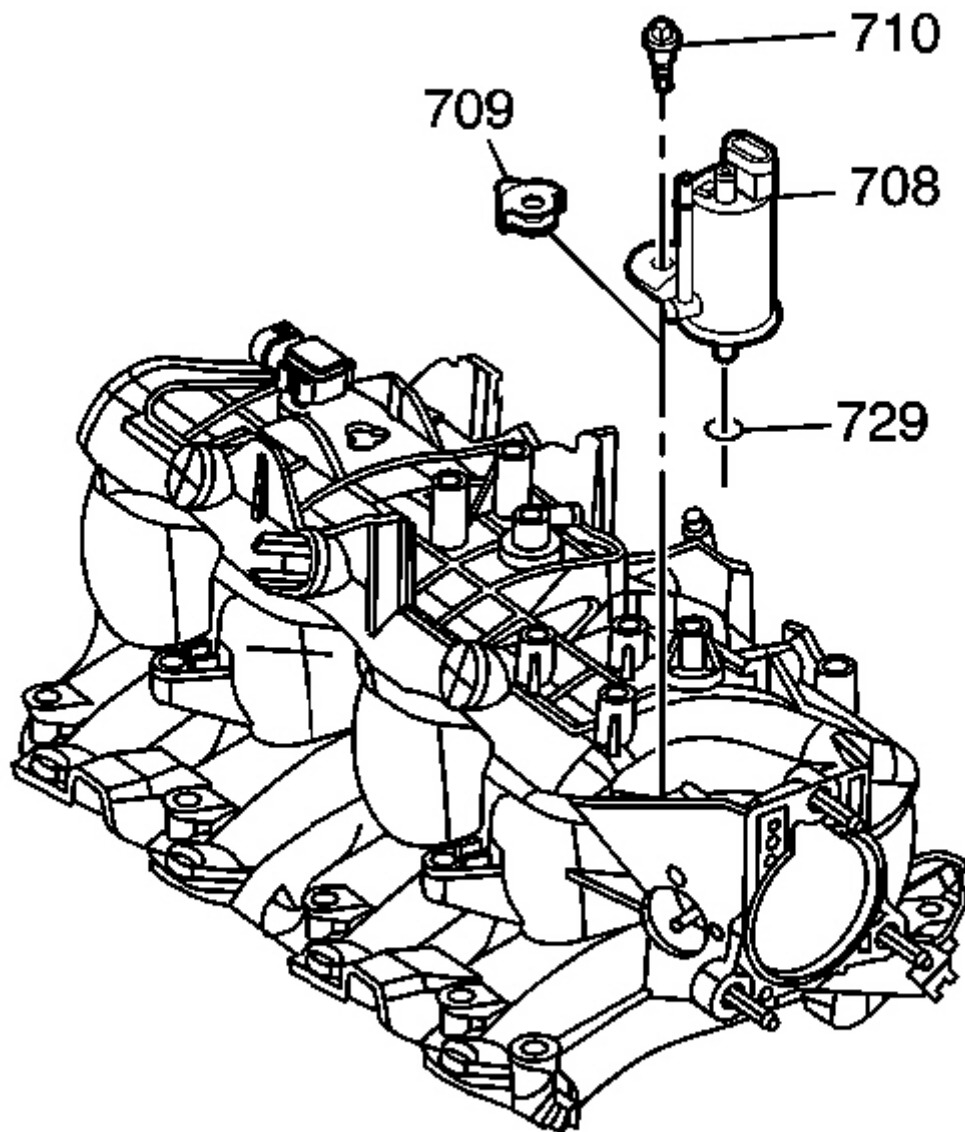
Fig. 332: View Of EVAP Purge Solenoid, Bolt & Isolator
Courtesy of GENERAL MOTORS CORP.

4. Remove the evaporative emission (EVAP) solenoid (708), bolt (710), and isolator (709), if required.

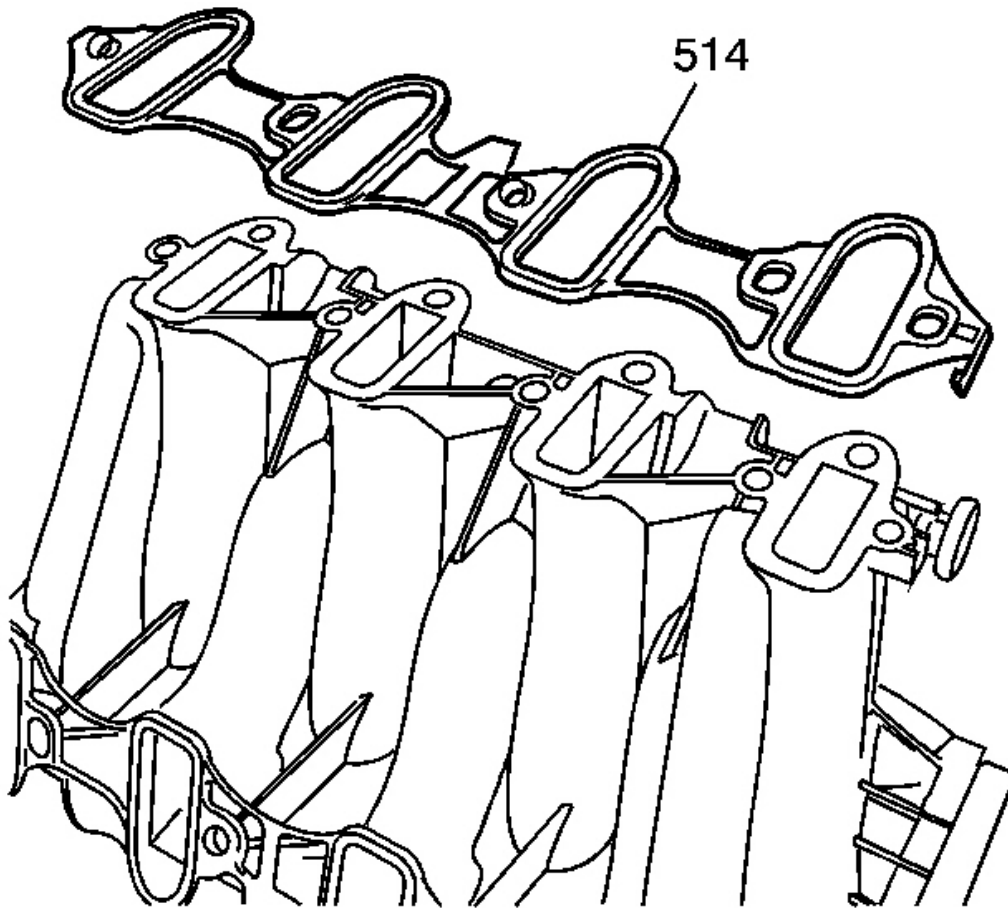
Fig. 334: View Of Intake Manifold-To-Cylinder Head Gasket
Courtesy of GENERAL MOTORS CORP.

7. Separate the intake manifold-to-cylinder head gaskets (514) from the manifold.
8. Discard the intake manifold gaskets.

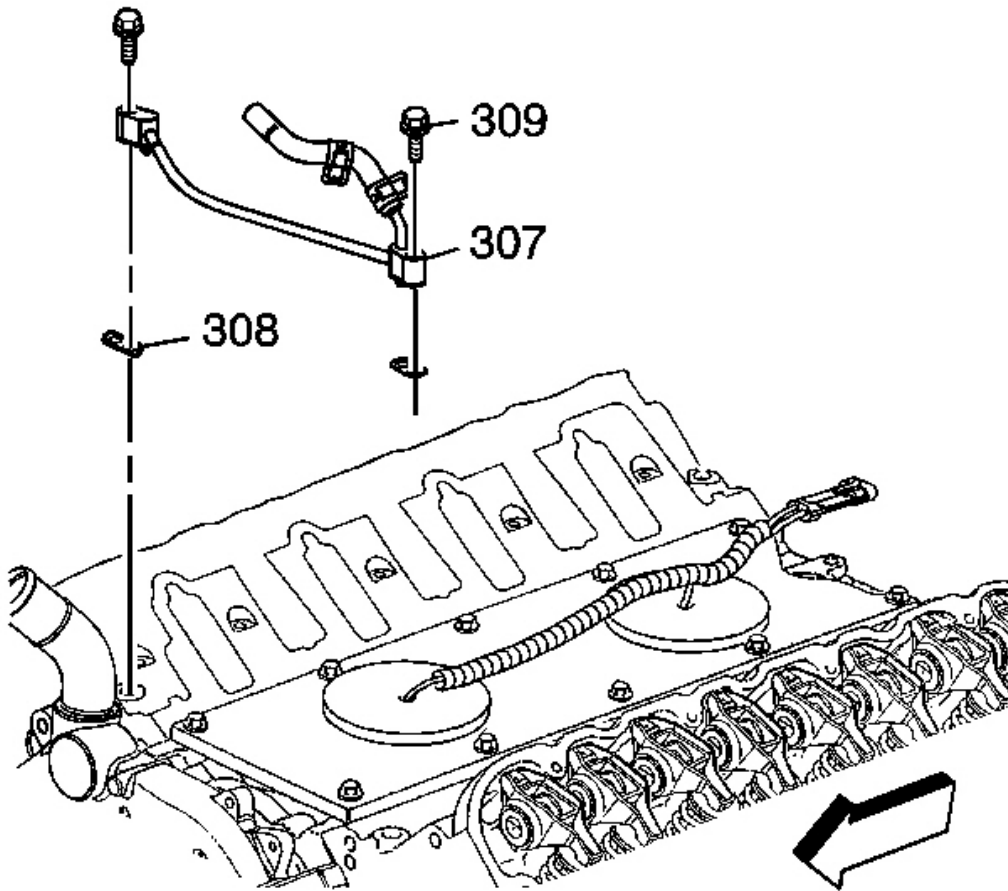
Fig. 335: View Of Engine Coolant Air Bleed Pipe, Bolt & Gasket
Courtesy of GENERAL MOTORS CORP.

1. Remove the engine coolant air bleed pipe bolts (309).
2. Remove the pipe (307) with hose and gaskets (308).

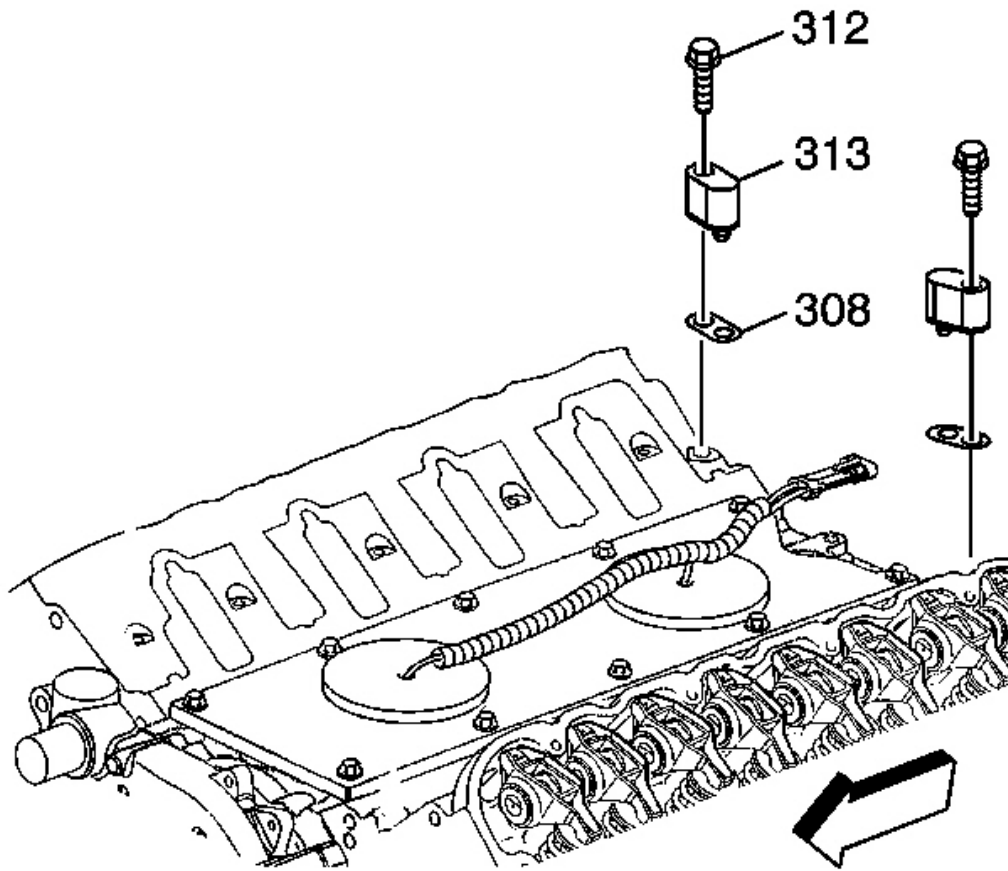
Fig. 336: View Of Engine Coolant Air Bleed Cover, Gasket & Bolts
Courtesy of GENERAL MOTORS CORP.

3. Remove the engine coolant air bleed cover bolts (312), covers (313), and gaskets (308).

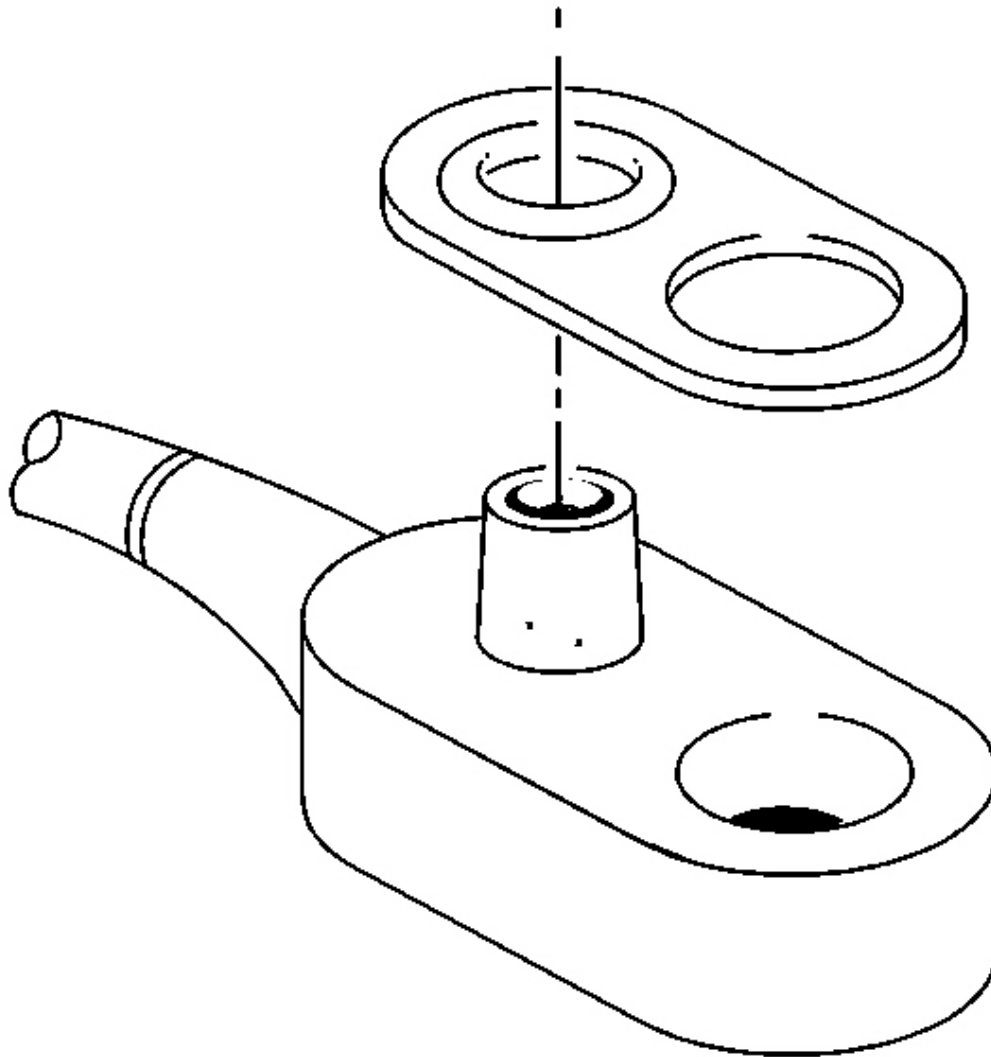
Fig. 337: View Of Air Bleed Pipe Sealing Gasket
Courtesy of GENERAL MOTORS CORP.

4. Remove the gaskets from the pipe and covers.
5. Discard the gaskets.

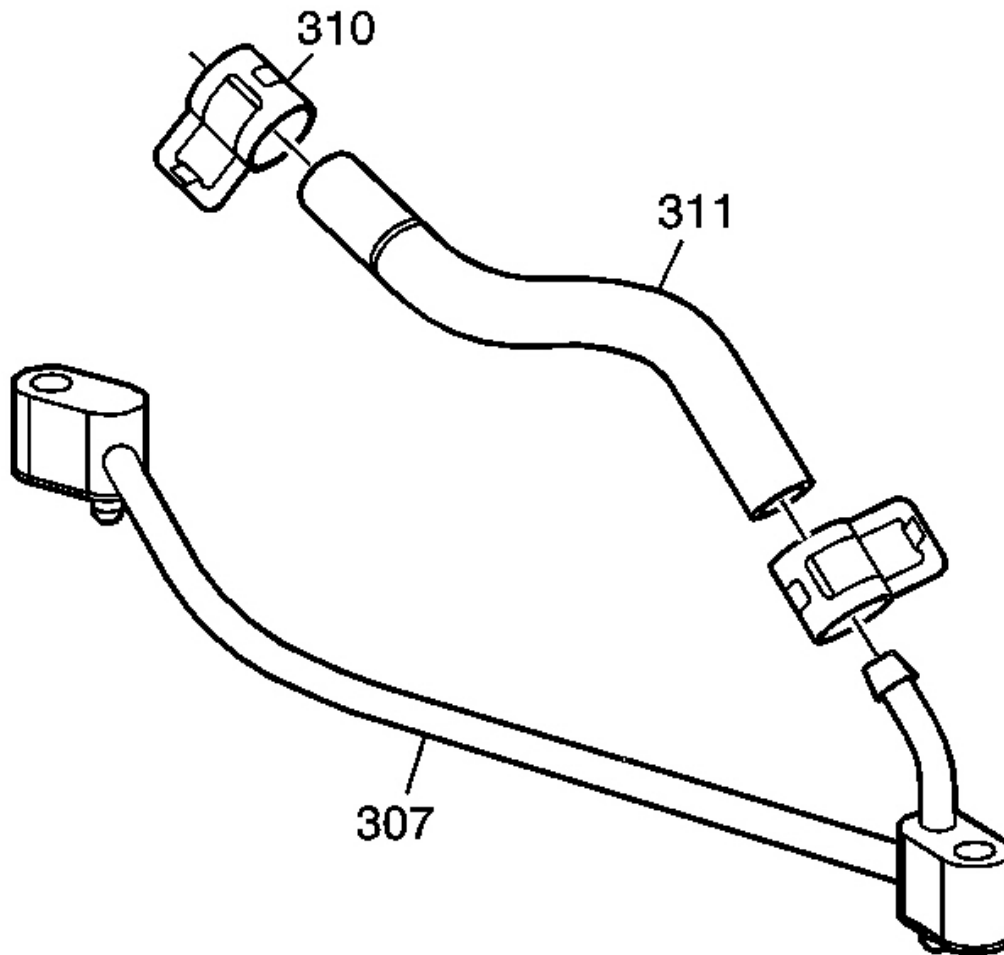
Fig. 338: View Of Engine Coolant Air Bleed Pipe, Hose & Clamps
Courtesy of GENERAL MOTORS CORP.

6. Remove the hose (311) and clamps (310) from the pipe (307).

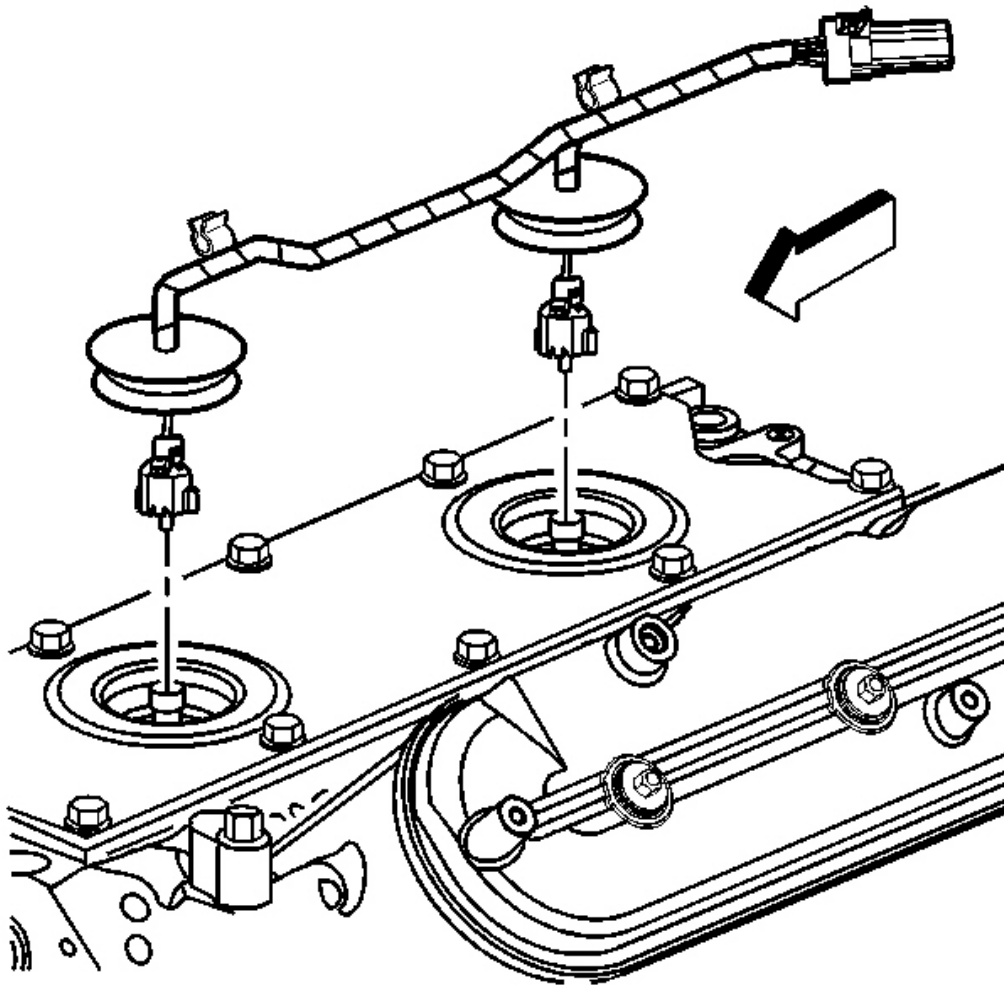
Fig. 339: View Of Knock Sensor Wire Harness
Courtesy of GENERAL MOTORS CORP.

1. Remove the knock sensor wire harness.

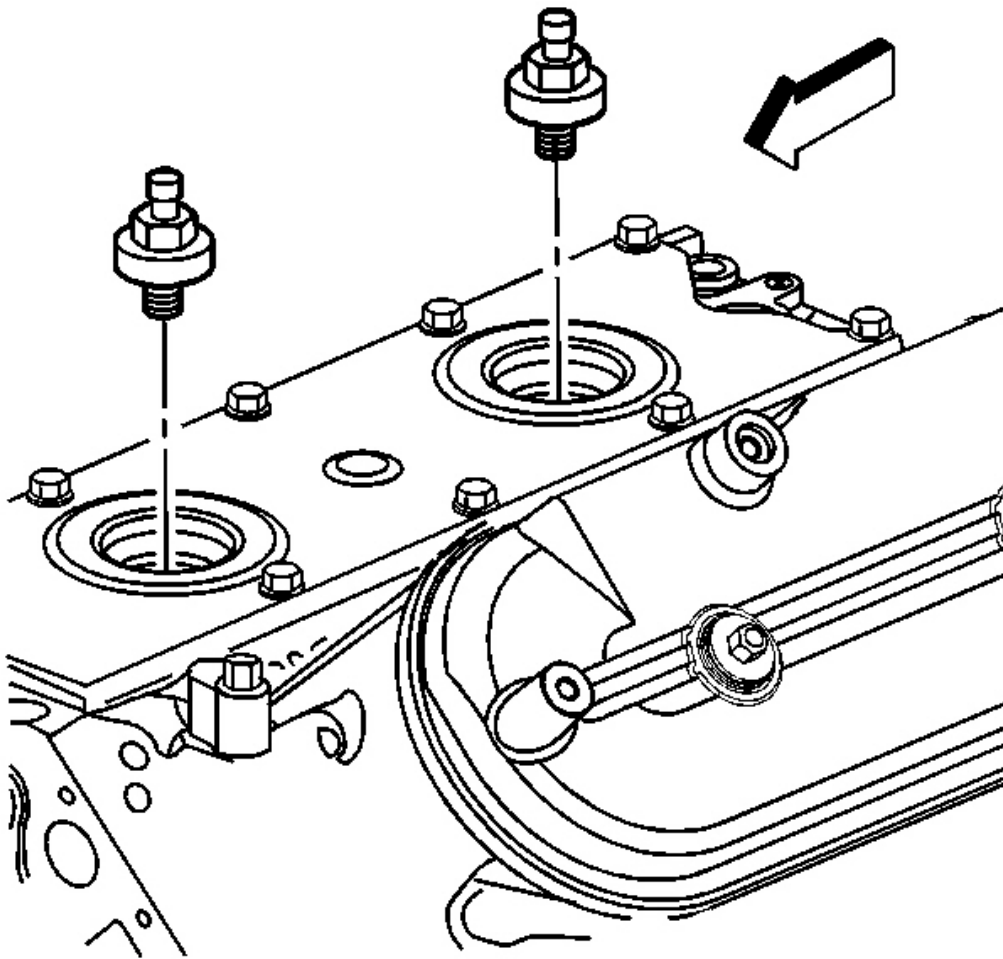
Fig. 340: View Of Knock Sensors
Courtesy of GENERAL MOTORS CORP.

2. Remove the knock sensors.

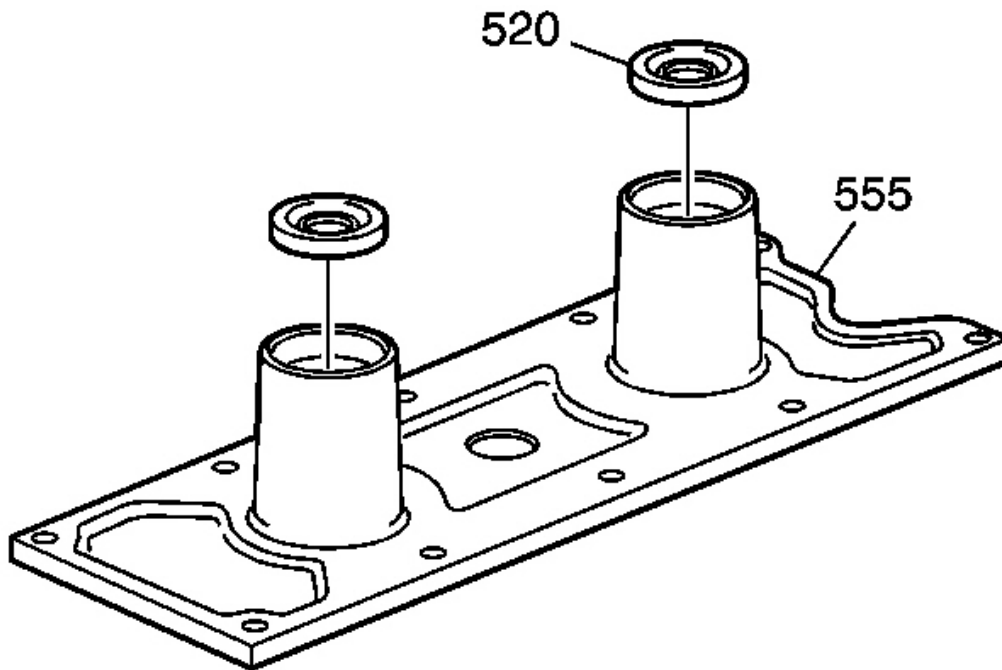
Fig. 342: View Of Knock Sensor Oil Seals & Valley Cover
Courtesy of GENERAL MOTORS CORP.

6. Remove the knock sensor oil seals (520) from the cover (555).

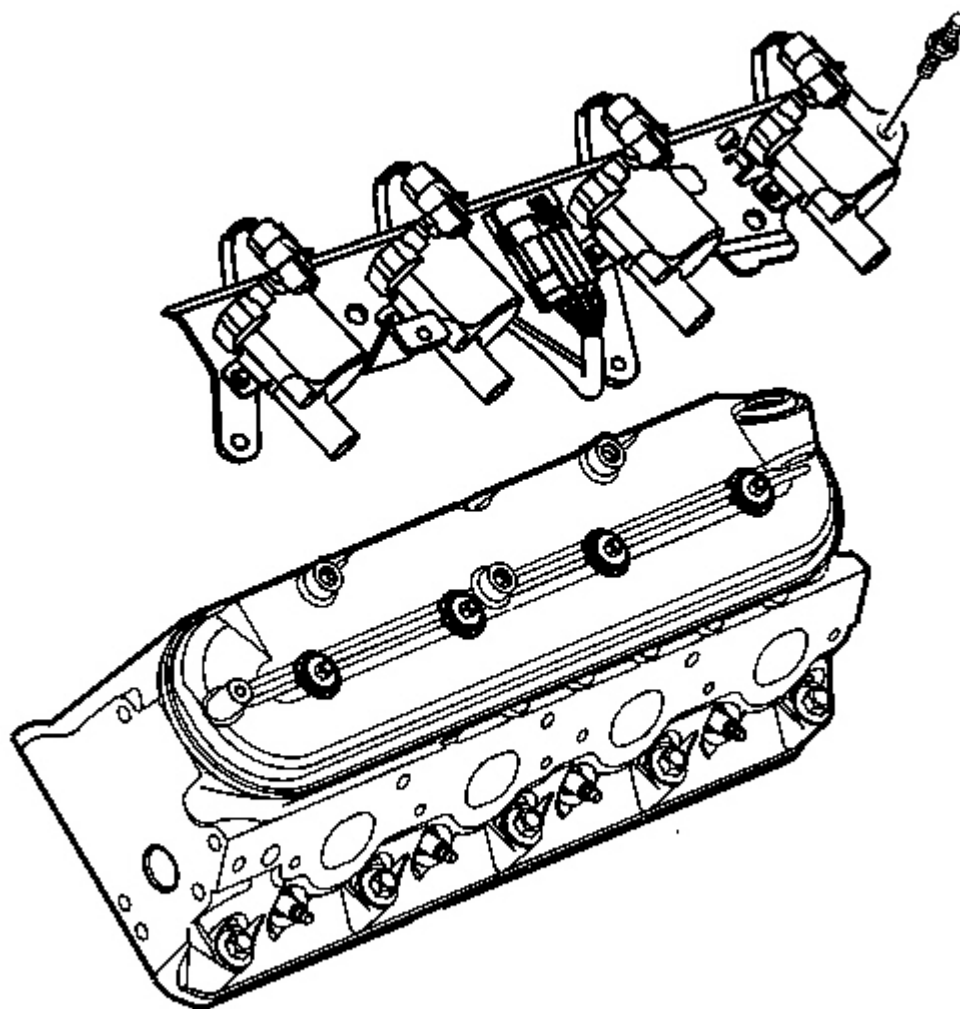
Fig. 343: Identifying Ignition Coils

IMPORTANT: Do not remove the ignition coils and bracket from the valve rocker arm cover unless required.

1. Remove the ignition coil bracket bolts from the rocker arm cover, if required.
2. Remove the ignition coil and bracket assembly from the cover.

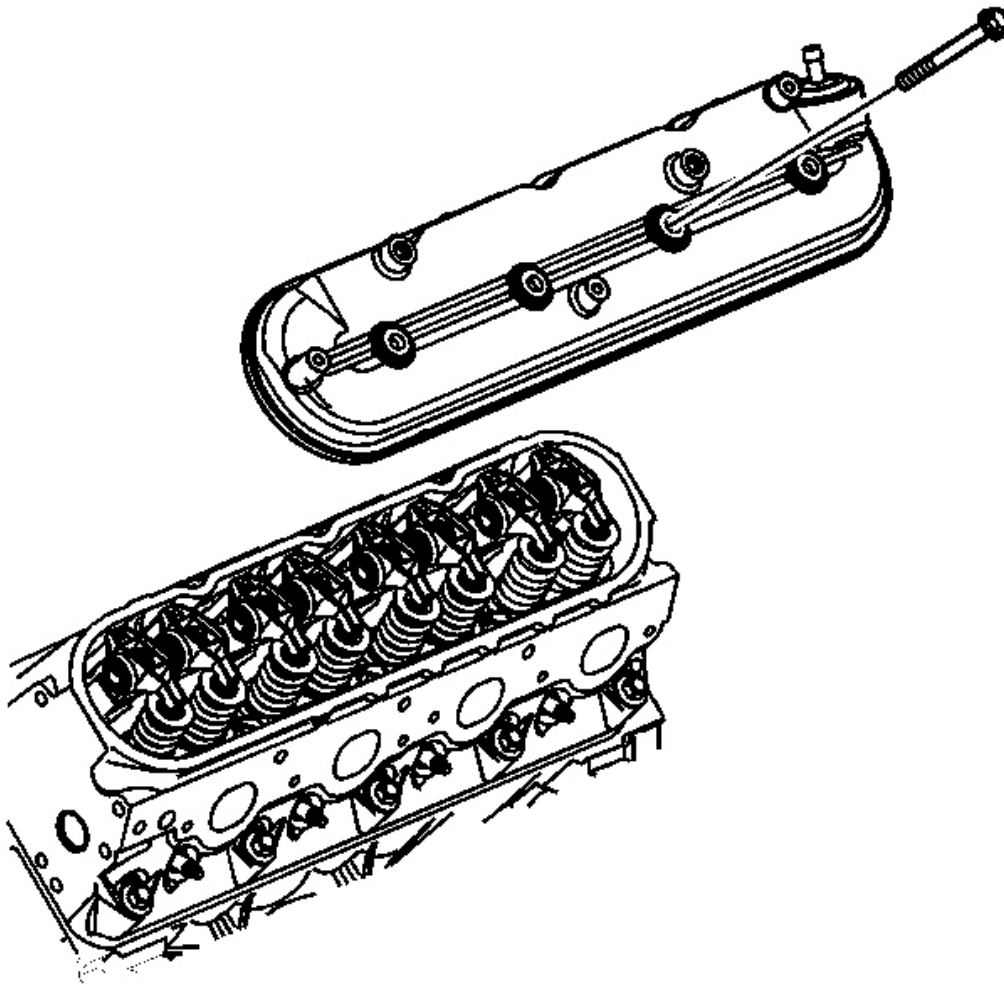
Fig. 344: View Of Valve Rocker Arm Cover
Courtesy of GENERAL MOTORS CORP.

3. Remove the valve rocker arm cover bolts.
4. Remove the valve rocker arm cover.

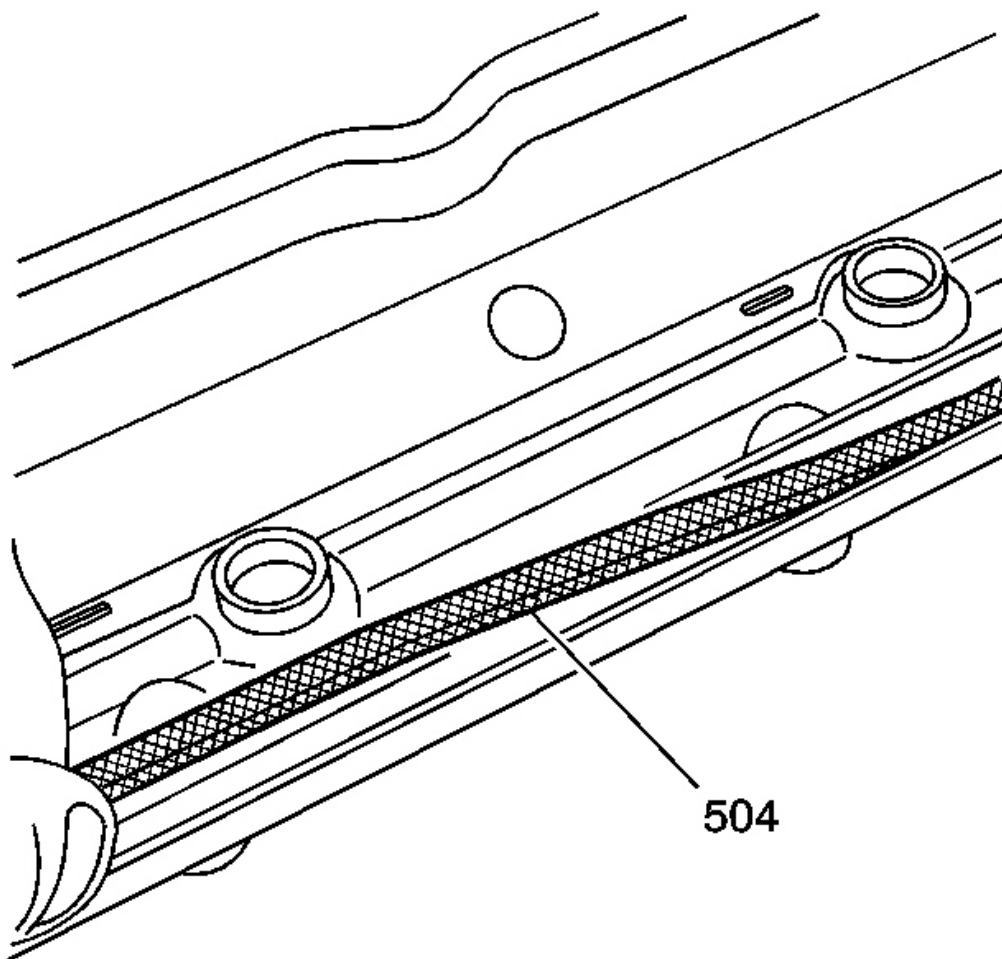
Fig. 345: View Of Valve Rocker Arm Cover Gasket
Courtesy of GENERAL MOTORS CORP.

5. Remove the gasket (504) from the cover.
6. Discard the gasket.

The bolt grommets may be used again if not damaged.

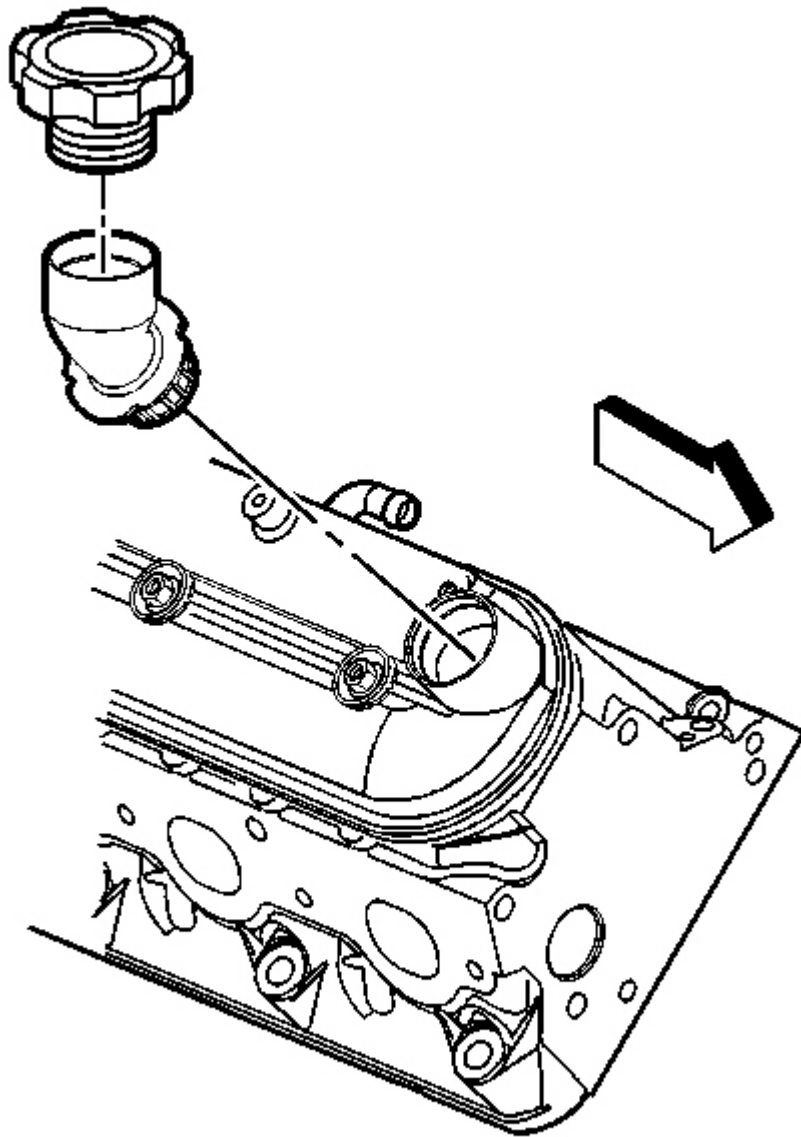
Fig. 349: View Of Oil Fill Cap & Tube
Courtesy of GENERAL MOTORS CORP.

7. Remove the oil fill cap from the oil fill tube.
8. Remove the oil fill tube, if required.
9. Discard the oil fill tube.

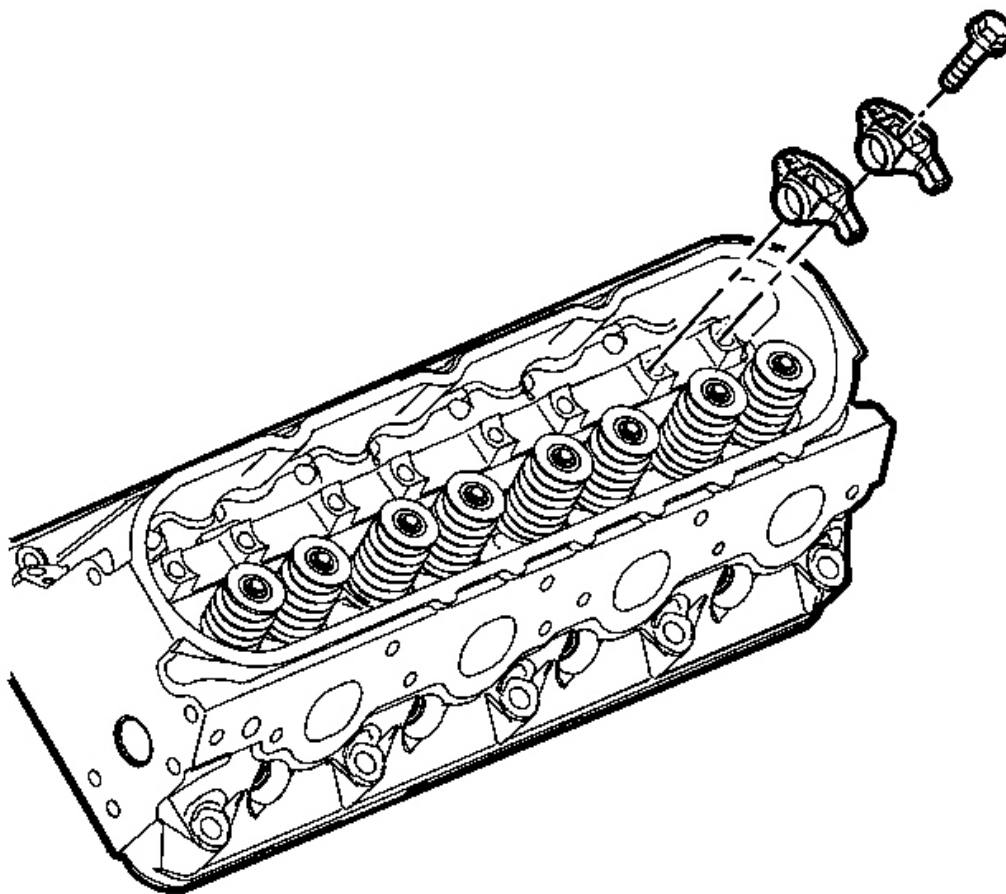
Fig. 350: View Of Rocker Arms & Bolts
Courtesy of GENERAL MOTORS CORP.

1. Remove the valve rocker arm bolts.
2. Remove the valve rocker arms.

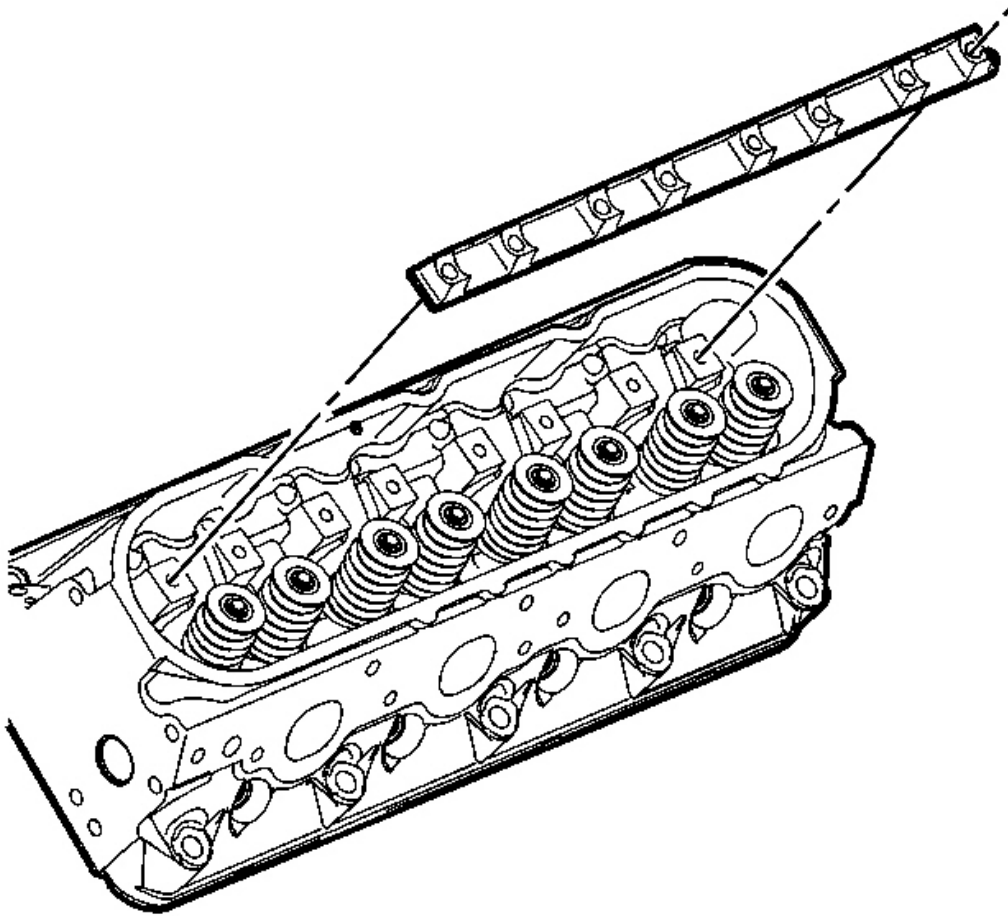
Fig. 351: View Of Valve Rocker Arm Pivot Support
Courtesy of GENERAL MOTORS CORP.

3. Remove the valve rocker arm pivot support.

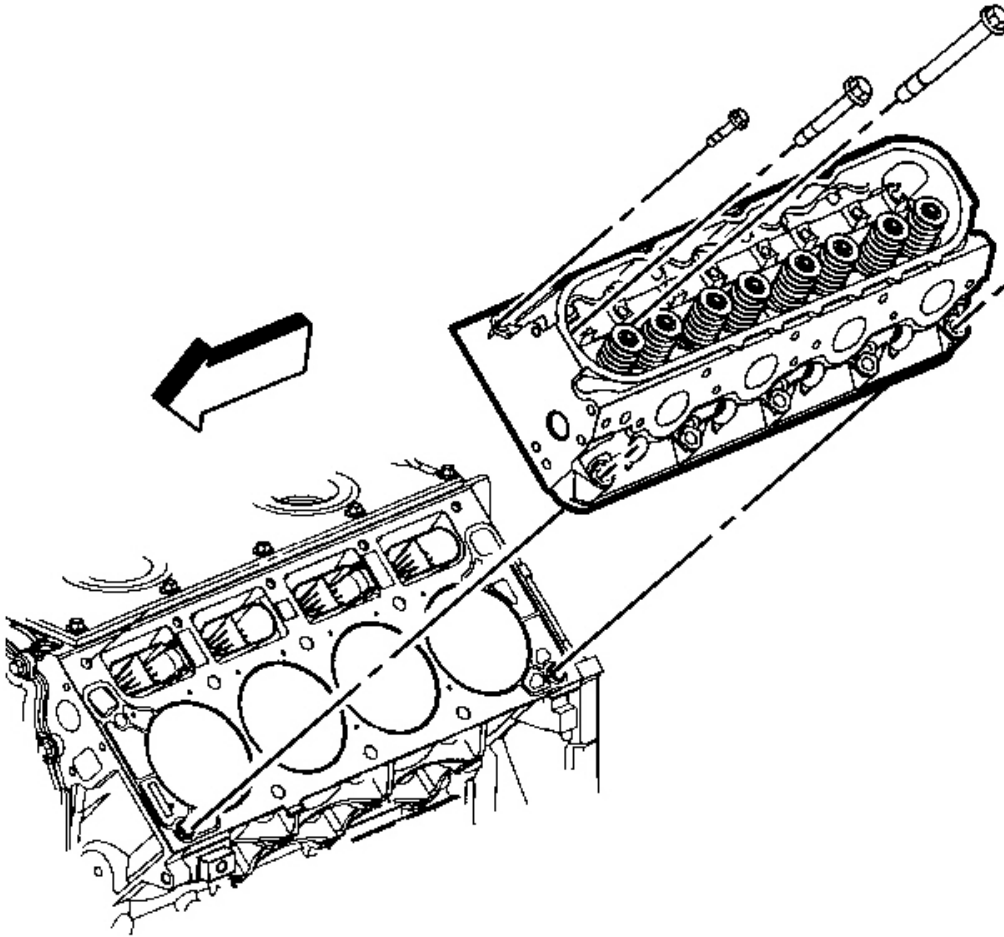
Fig. 353: View Of Cylinder Head & Bolts (Left)
Courtesy of GENERAL MOTORS CORP.

1. Remove the spark plugs from the cylinder head.

NOTE: After removal, place the cylinder head on two wood blocks to prevent damage to the sealing surfaces.

3. Remove the cylinder head.

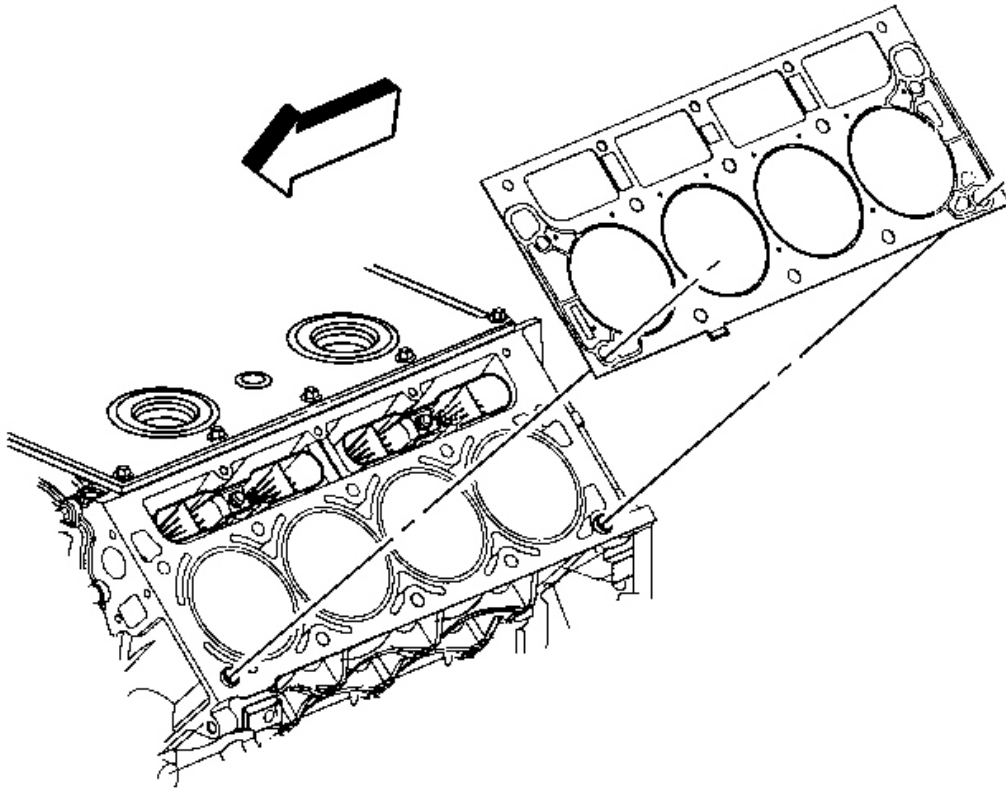
Fig. 354: View Of Left Cylinder Head Gasket & Locator Pins
Courtesy of GENERAL MOTORS CORP.

4. Remove the gasket.
5. Discard the gasket.
6. Discard the cylinder head bolts.

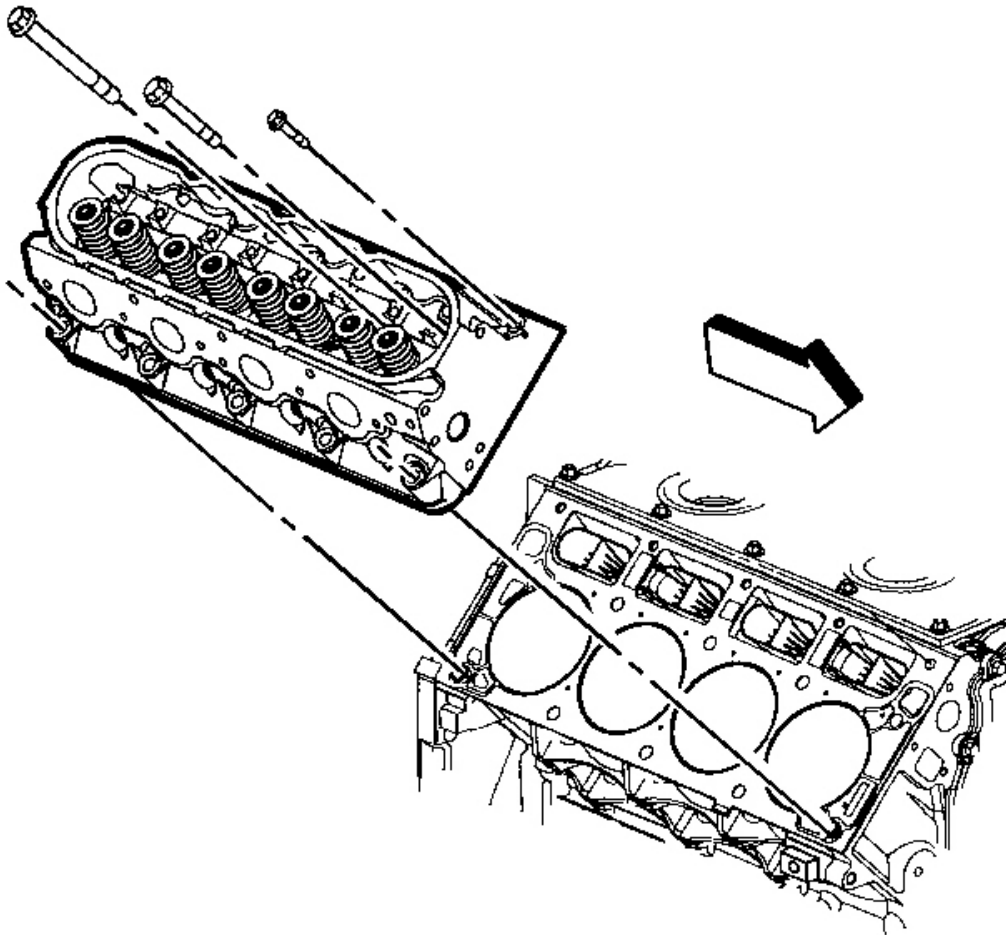
Fig. 355: View Of Cylinder Head & Bolts
Courtesy of GENERAL MOTORS CORP.

1. Remove the spark plugs from the cylinder head.

NOTE: After removal, place the cylinder head on two wood blocks to prevent damage to the sealing surfaces.

3. Remove the cylinder head.

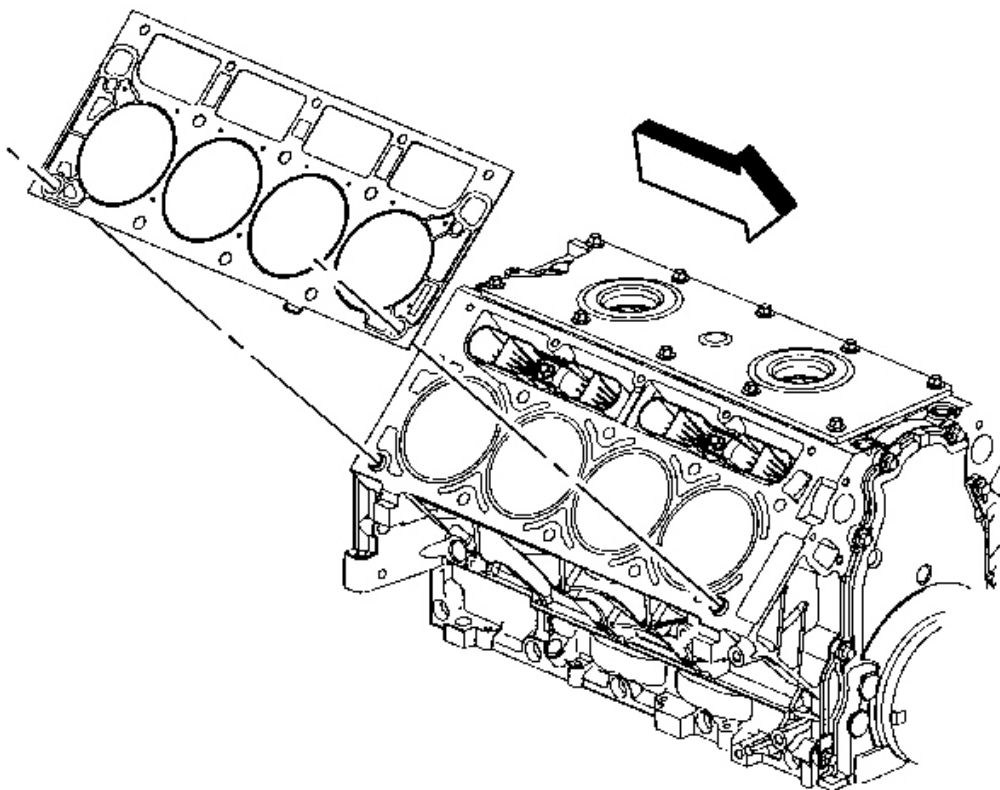
Fig. 356: View Of Right Cylinder Head Gasket And Alignment Pins
Courtesy of GENERAL MOTORS CORP.

4. Remove the gasket.
5. Discard the gasket.
6. Discard the cylinder head bolts.

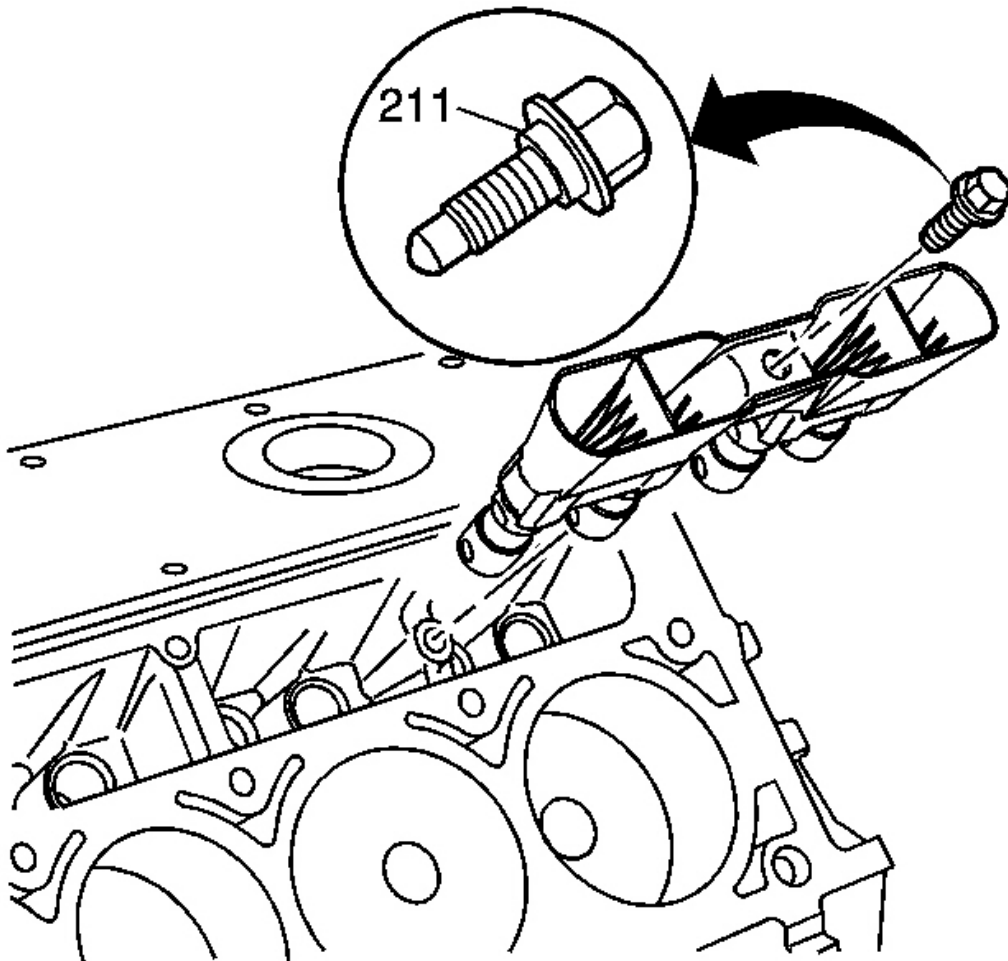
Fig. 357: View Of Valve Lifters, Guide & Guide Bolts
Courtesy of GENERAL MOTORS CORP.

1. Remove the valve lifter guide bolts (211).
2. Remove the valve lifters and guide.
