2004 Isuzu Ascender LS

2004 ENGINE Engine Mechanical - 4.8L, 5.3L, and 6.0L - Ascender

Engine Mechanical - 4.8L, 5.3L, and 6.0L - Ascender

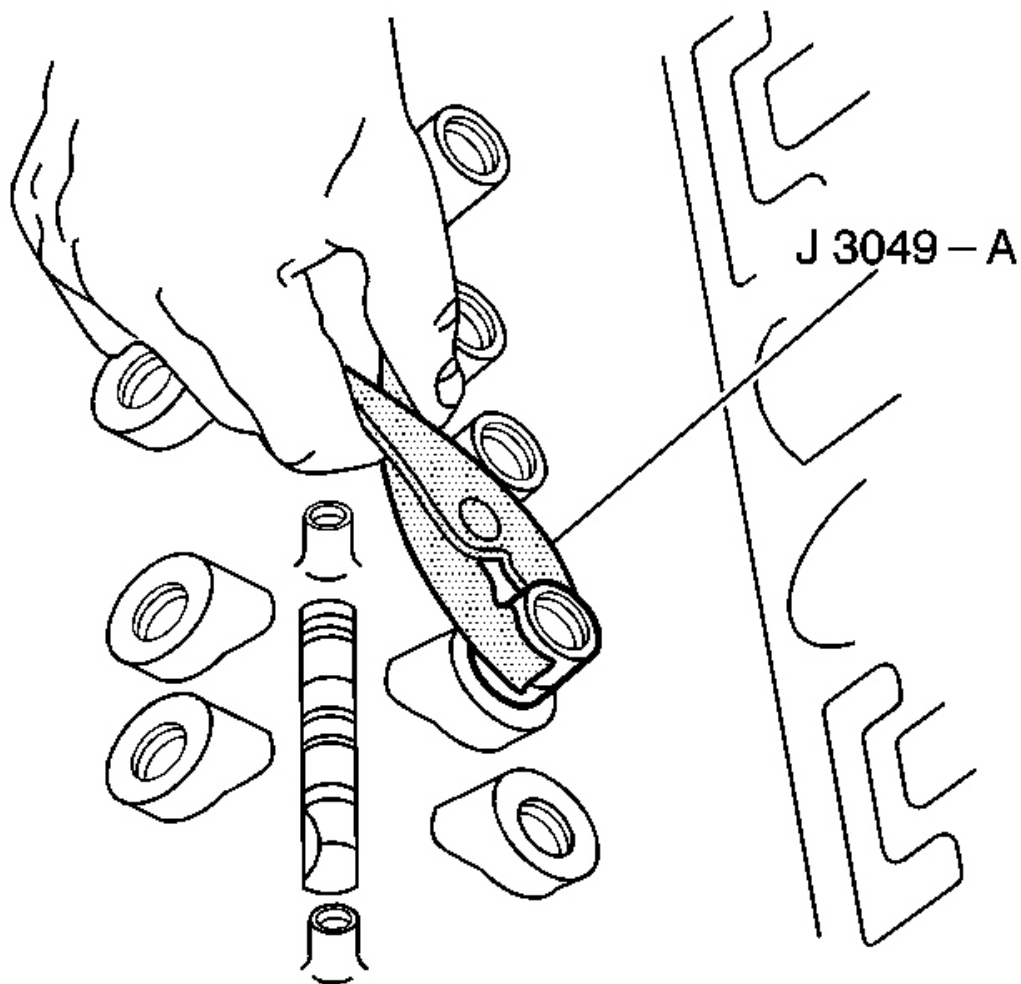
Fig. 358: Using J 3049-A To Remove The Stuck Valve Lifters
Courtesy of GENERAL MOTORS CORP.

IMPORTANT: Some valve lifters may be stuck in their bores because of gum or varnish deposits.

3. Use the **J 3049-A** or equivalent in order to remove the valve lifters, if required. See **Special Tools and Equipment**.

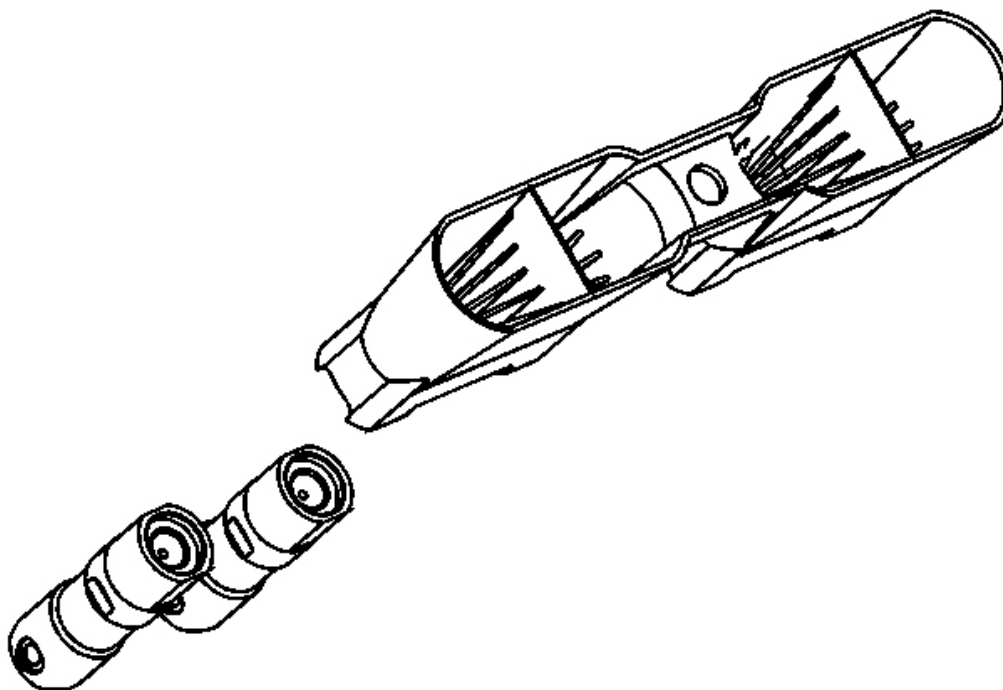
Fig. 359: View Of Valve Lifters & Lifter Guides
Courtesy of GENERAL MOTORS CORP.

4. Remove the valve lifters from the guide.
5. Organize or mark the components so that they can be installed in the same location from which they were removed. Refer to **Separating Parts**.

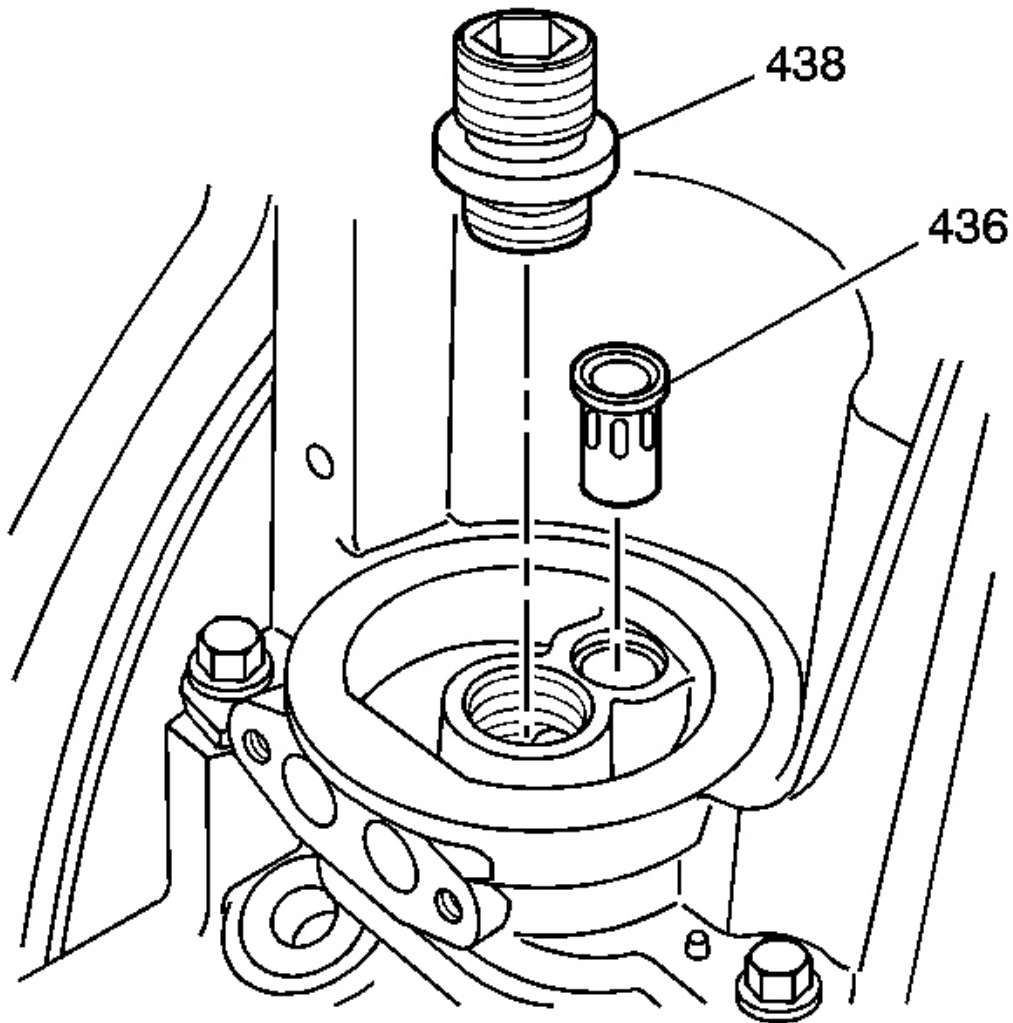
Fig. 361: View Of Oil Filter Fitting & Bypass Valve
Courtesy of GENERAL MOTORS CORP.

2. Remove the oil filter fitting (438) and bypass valve (436), if required.

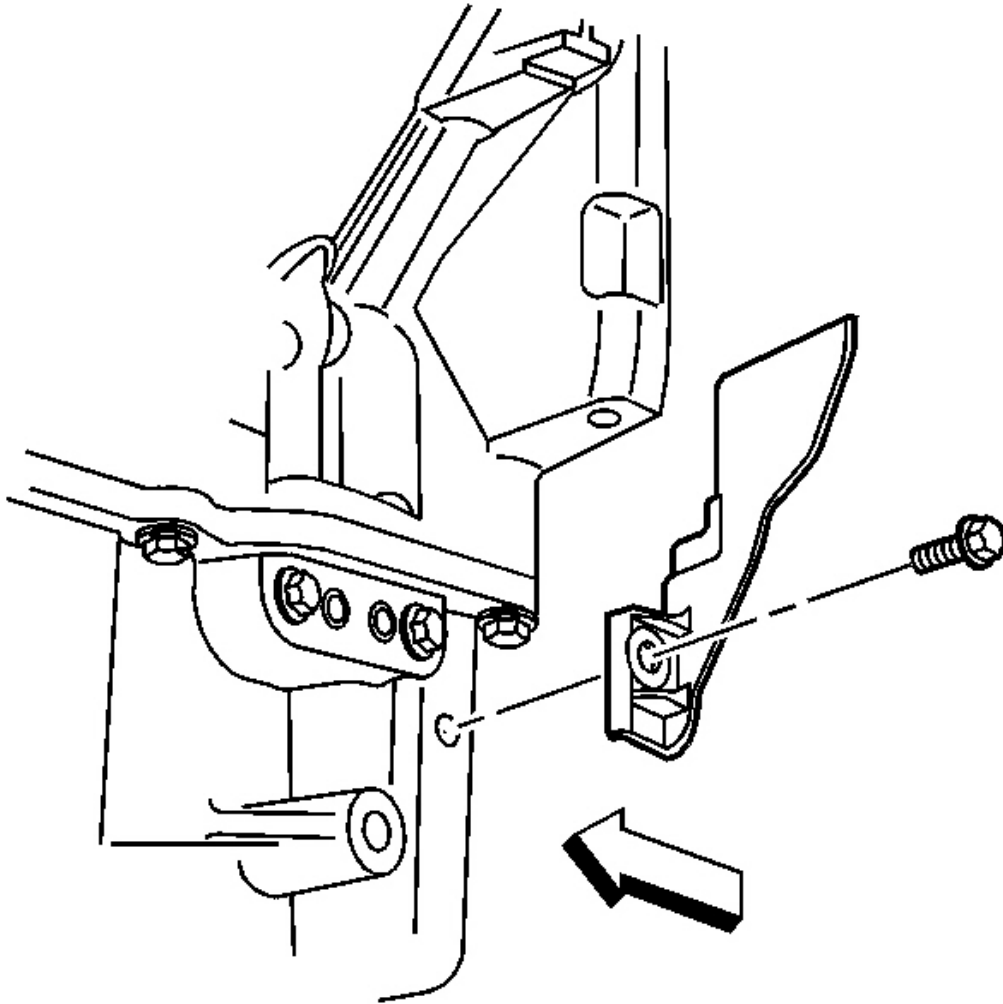
Fig. 362: View Of Left Closeout Cover & Bolt
Courtesy of GENERAL MOTORS CORP.

1. Remove the left closeout cover and bolt.

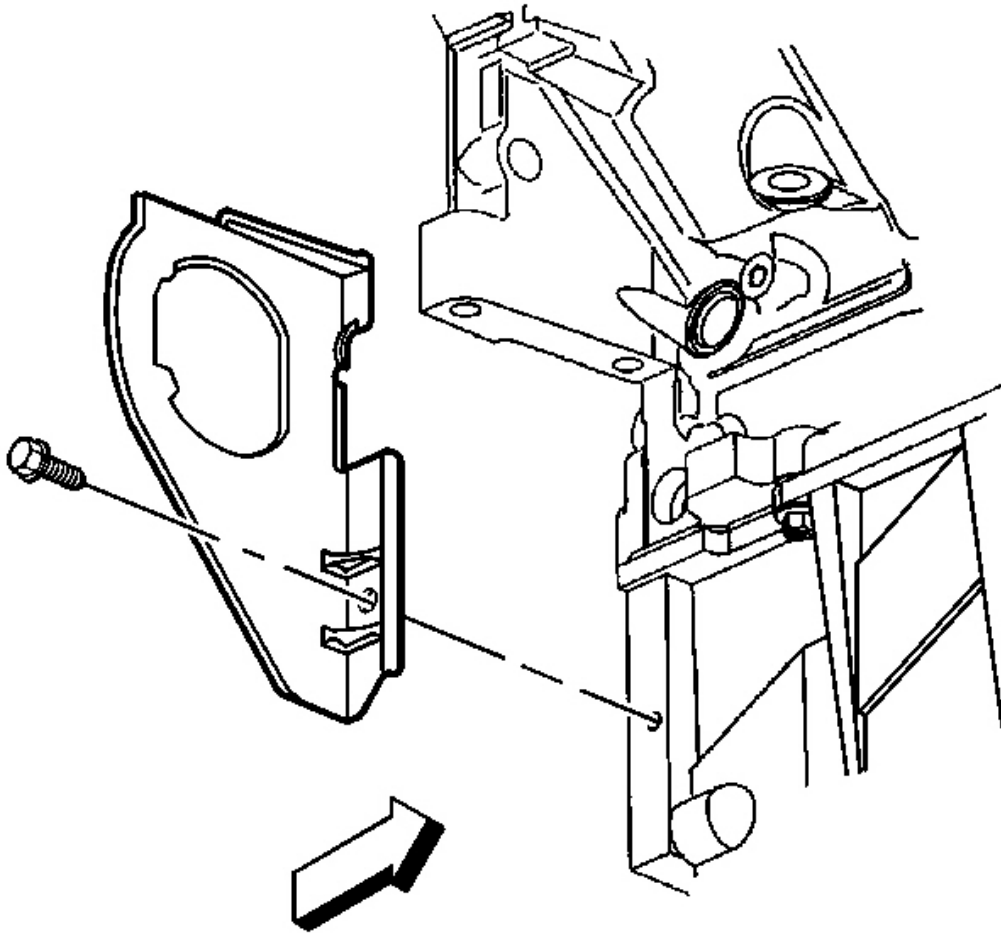
Fig. 363: View Of Right Transmission Closeout Cover & Bolt
Courtesy of GENERAL MOTORS CORP.

2. Remove the right closeout cover and bolt.

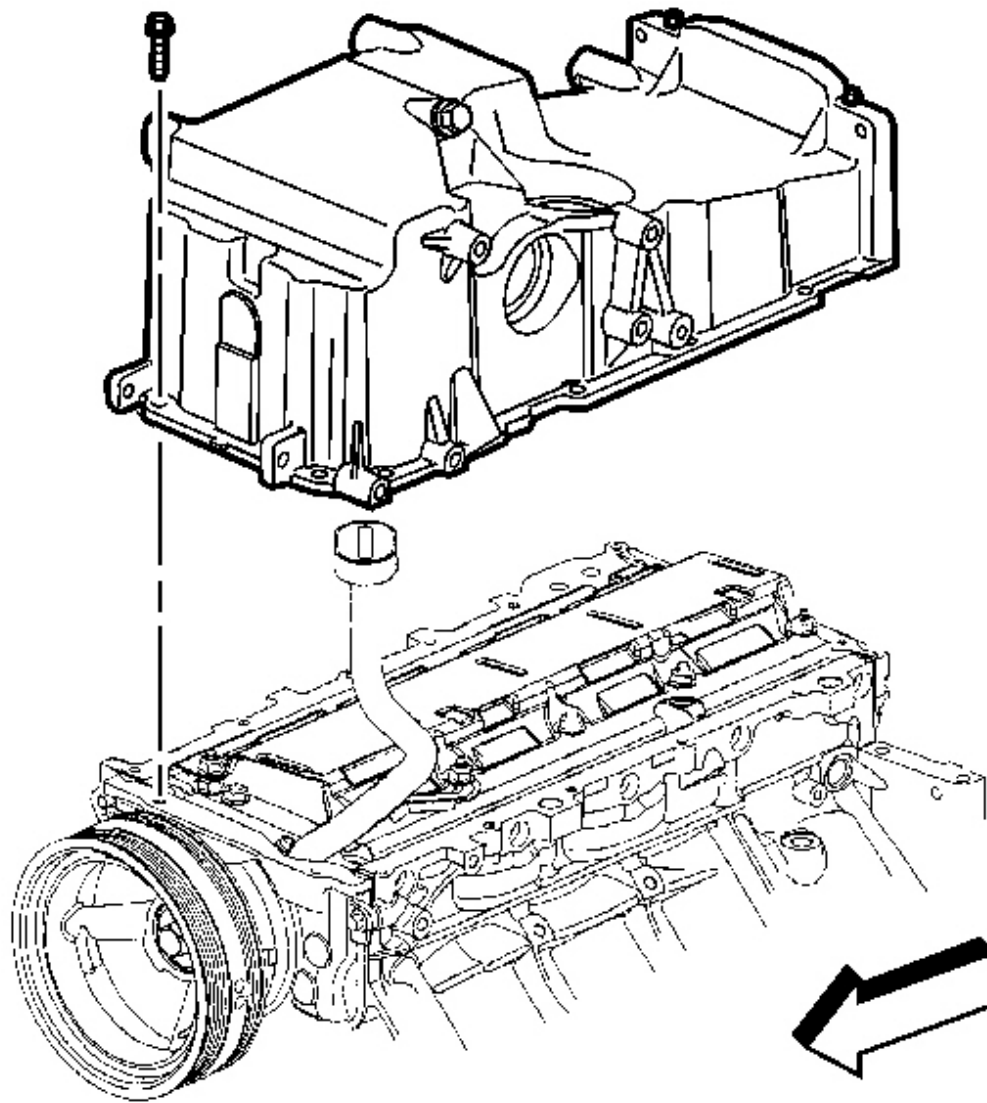
Fig. 364: View Of Oil Pan & Bolts
Courtesy of GENERAL MOTORS CORP.

3. Remove the oil pan bolts.
4. Remove the oil pan.

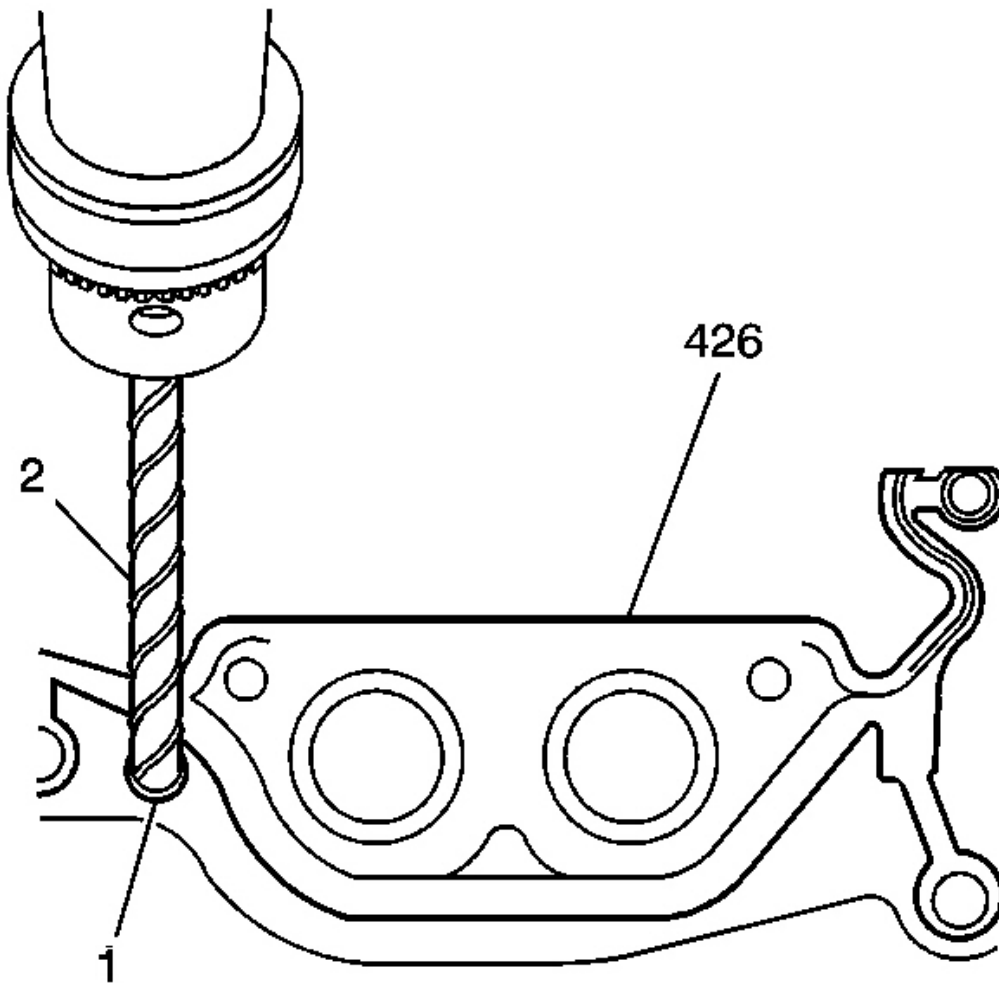
Fig. 365: Drilling Out Oil Pan Gasket Retaining Rivets
Courtesy of GENERAL MOTORS CORP.

5. Drill (2) out the oil pan gasket retaining rivets (1), if required.
6. Remove the gasket (426) from the pan.
7. Discard the gasket and rivets.

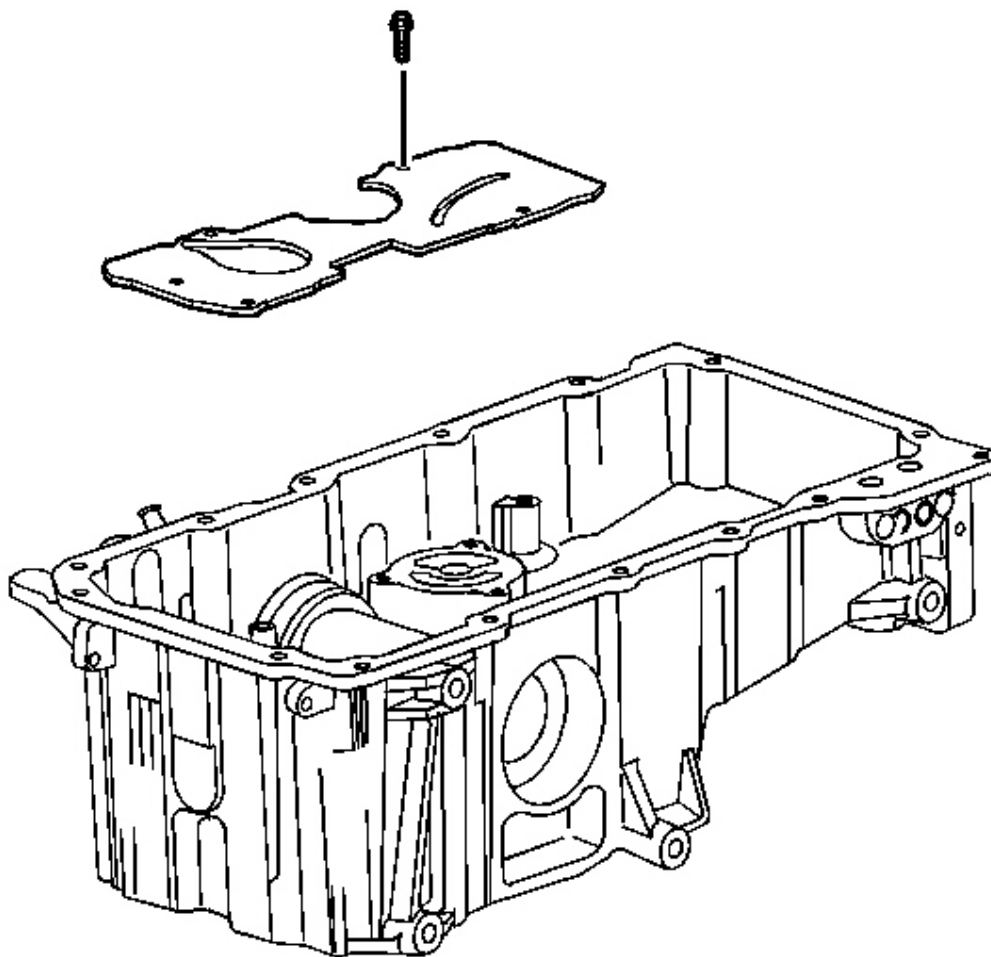
Fig. 366: View Of Oil Baffle & Bolts
Courtesy of GENERAL MOTORS CORP.

8. Remove the transfer tube, baffle and other components, if required. Refer to **Oil Pan Cleaning and Inspection.**

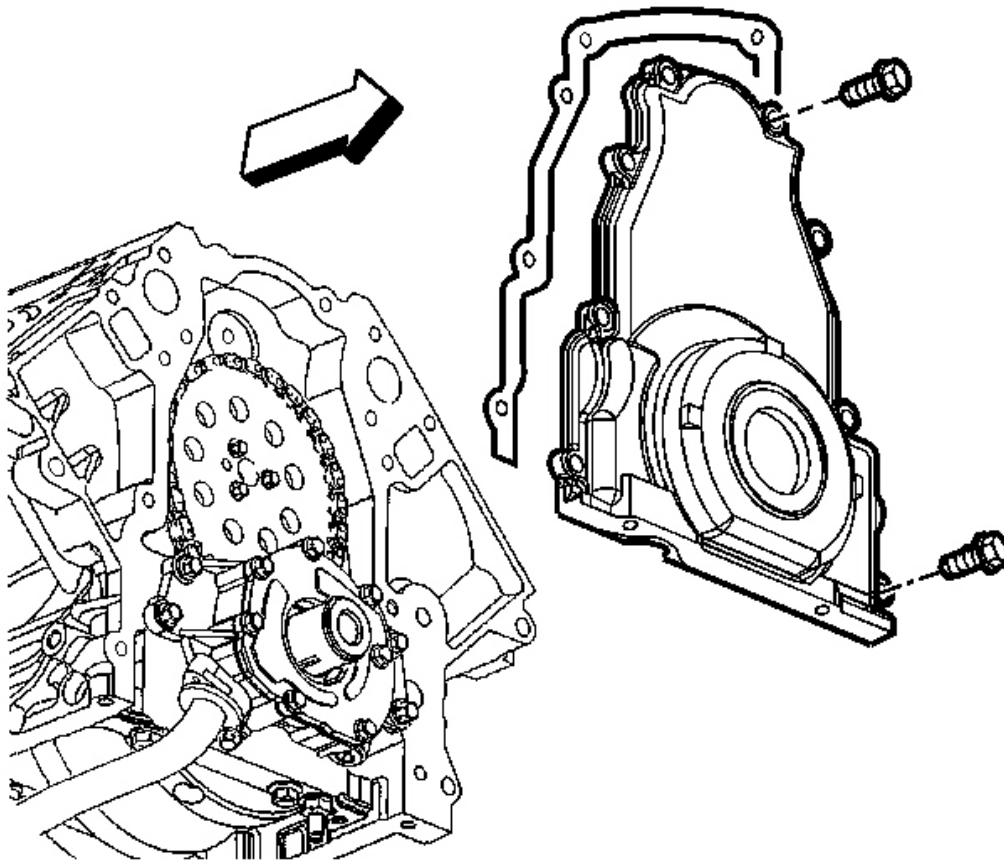
Fig. 367: View Of Front Cover & Gasket
Courtesy of GENERAL MOTORS CORP.

1. Remove the front cover bolts.
2. Remove the front cover and gasket.
3. Discard the front cover gasket.

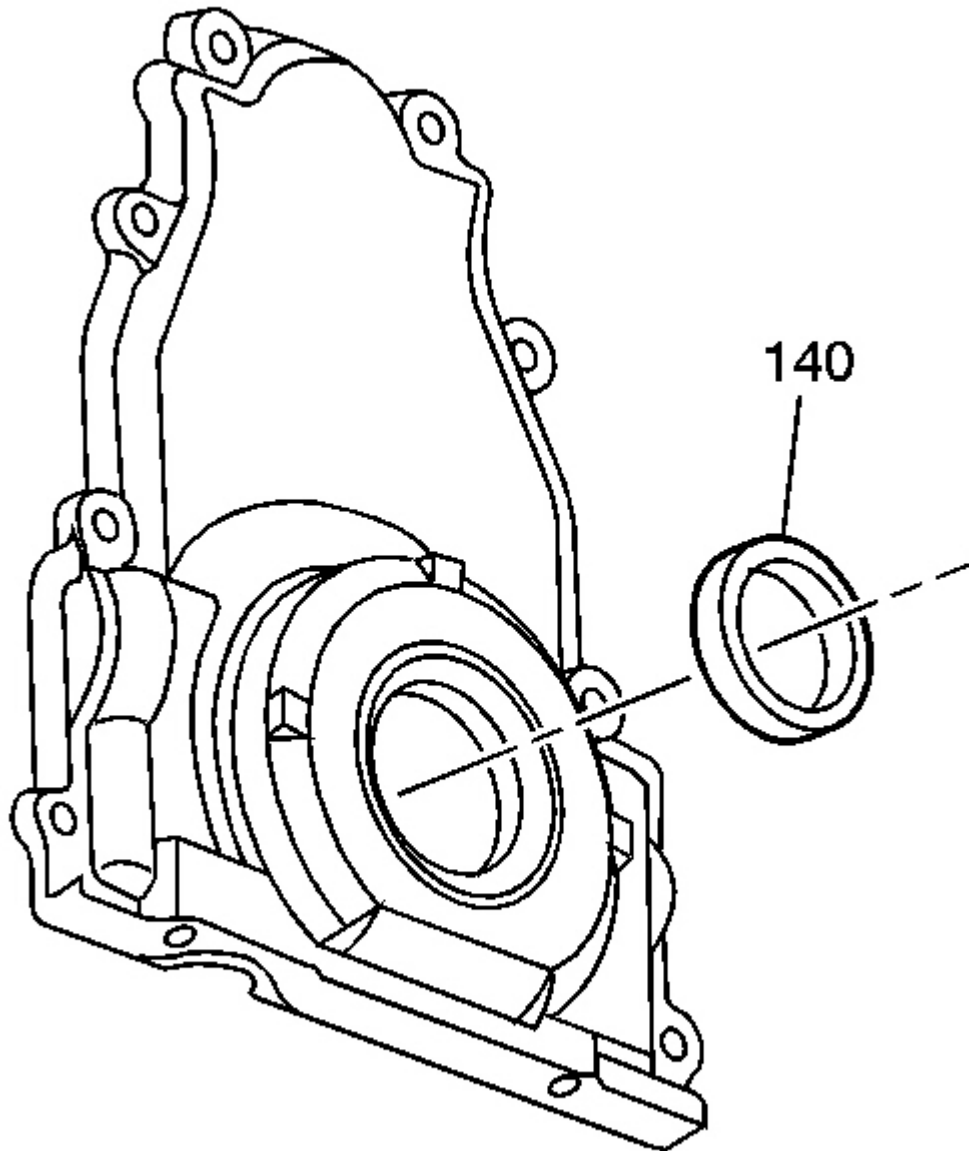
Fig. 368: View Of Crankshaft Front Oil Seal
Courtesy of GENERAL MOTORS CORP.

4. Remove the crankshaft front oil seal (140) from the cover.

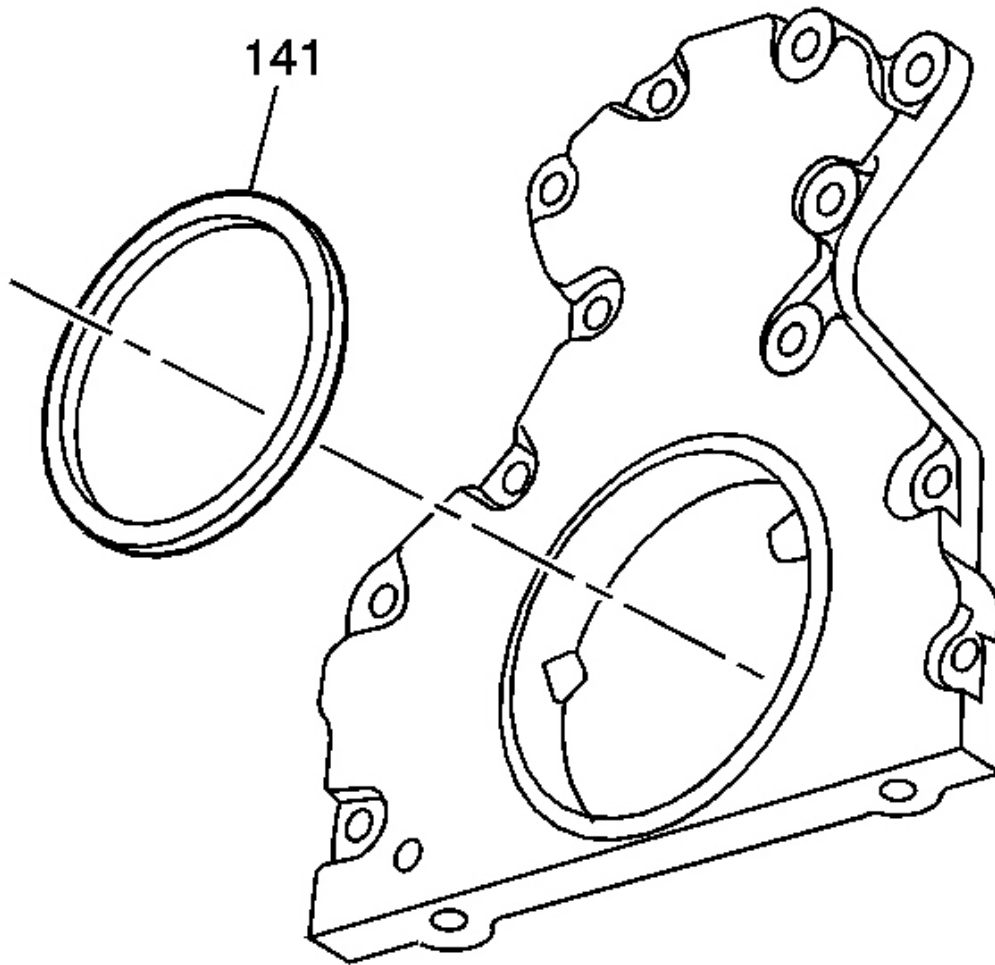
Fig. 370: View Of Crankshaft Rear Oil Seal
Courtesy of GENERAL MOTORS CORP.

4. Remove the crankshaft rear oil seal (141) from the cover.

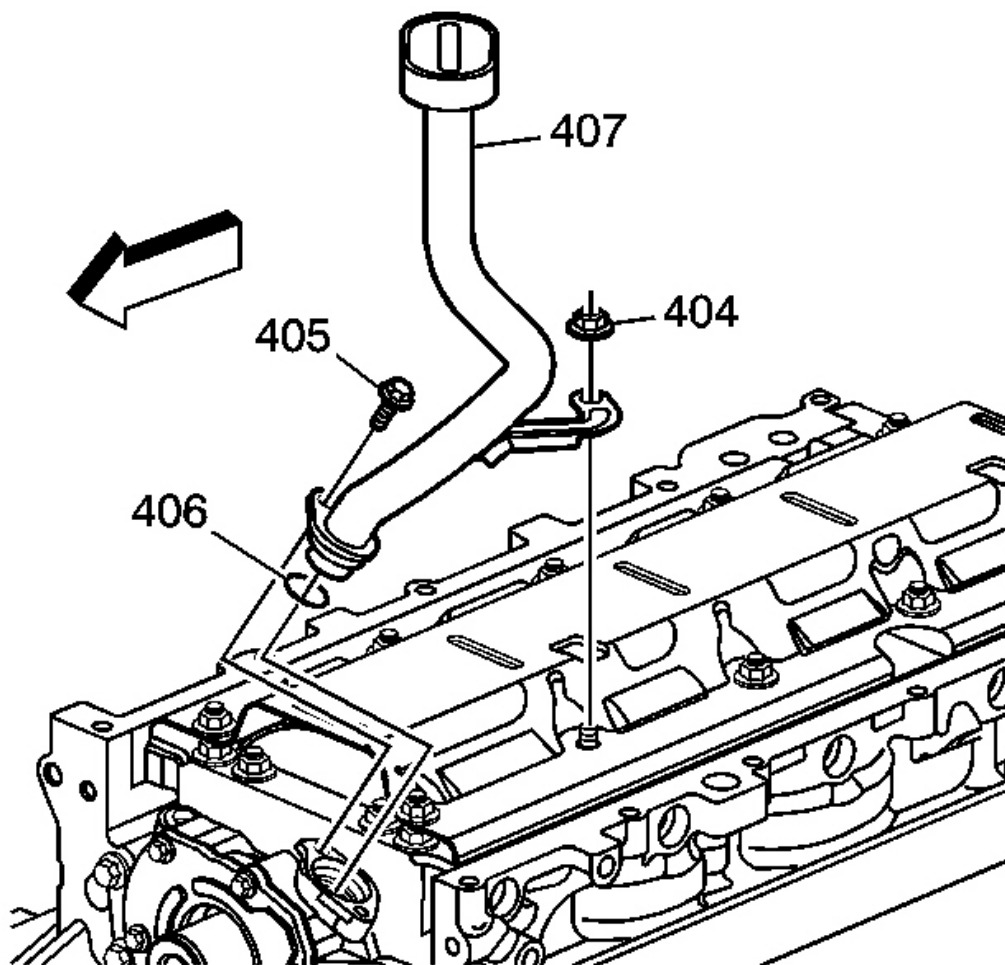
Fig. 371: View Of Oil Pump Screen, Bolt, Nuts & O-Ring Seal
Courtesy of GENERAL MOTORS CORP.

1. Remove the oil pump screen bolt (405) and nuts (404).
2. Remove the oil pump screen (407) with O-ring seal.
3. Remove the O-ring seal (406) from the pump screen.
4. Discard the O-ring seal.

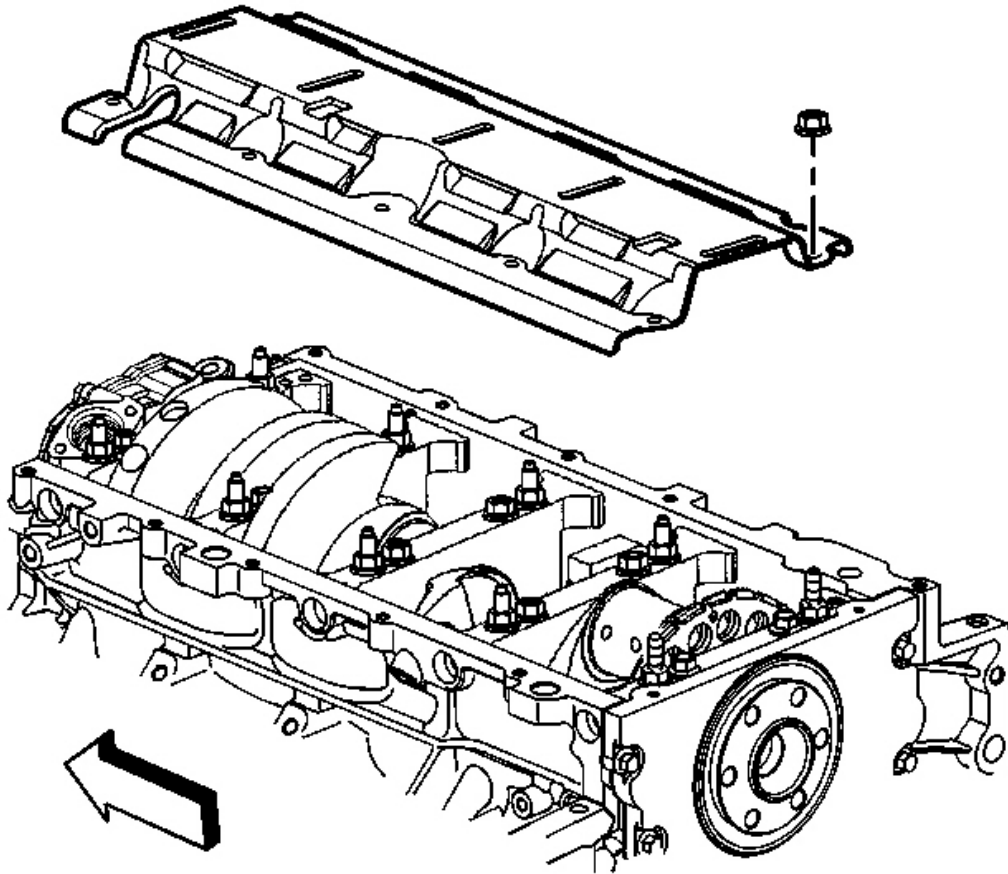
Fig. 372: View Of Crankshaft Oil Deflector
Courtesy of GENERAL MOTORS CORP.

5. Remove the remaining crankshaft oil deflector nuts.
6. Remove the crankshaft oil deflector.

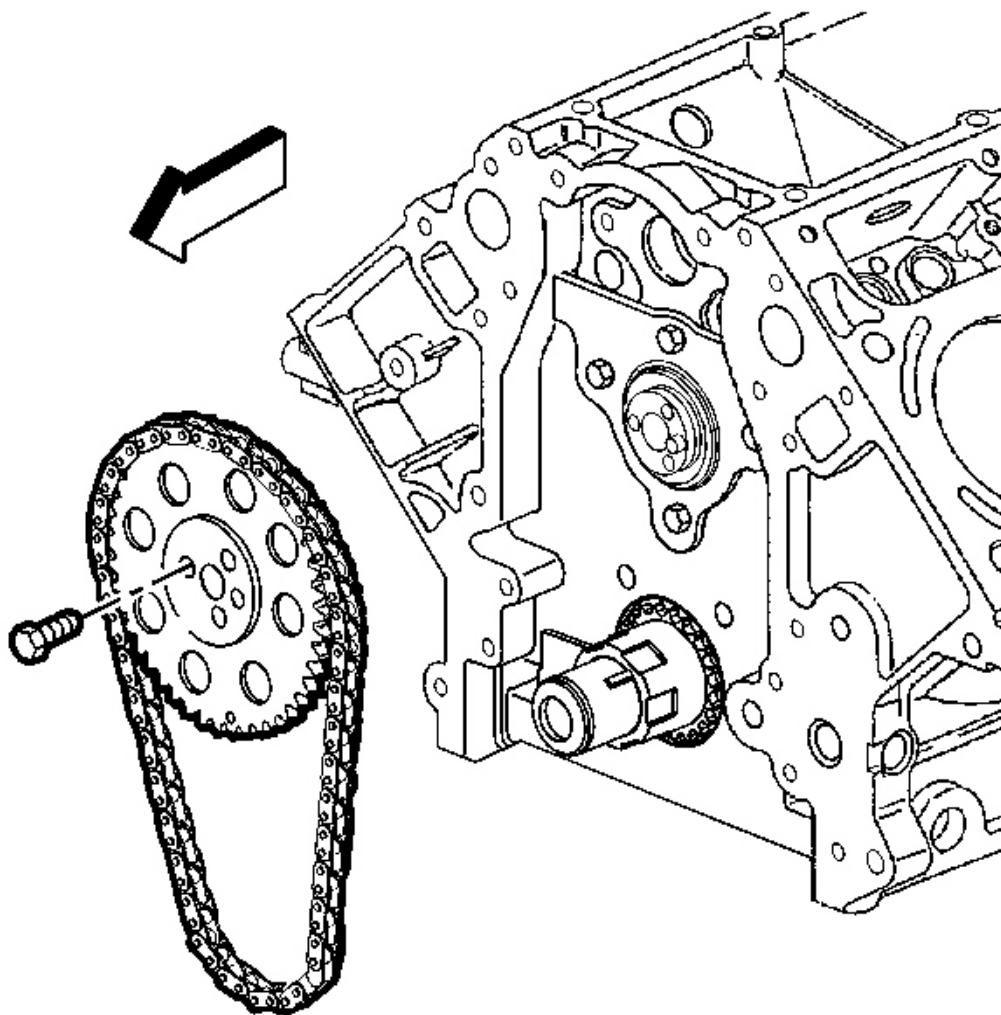
Fig. 374: Camshaft Sprocket, Bolt & Timing Chain
Courtesy of GENERAL MOTORS CORP.

1. Remove the camshaft sprocket bolts.
2. Remove the camshaft sprocket and timing chain.

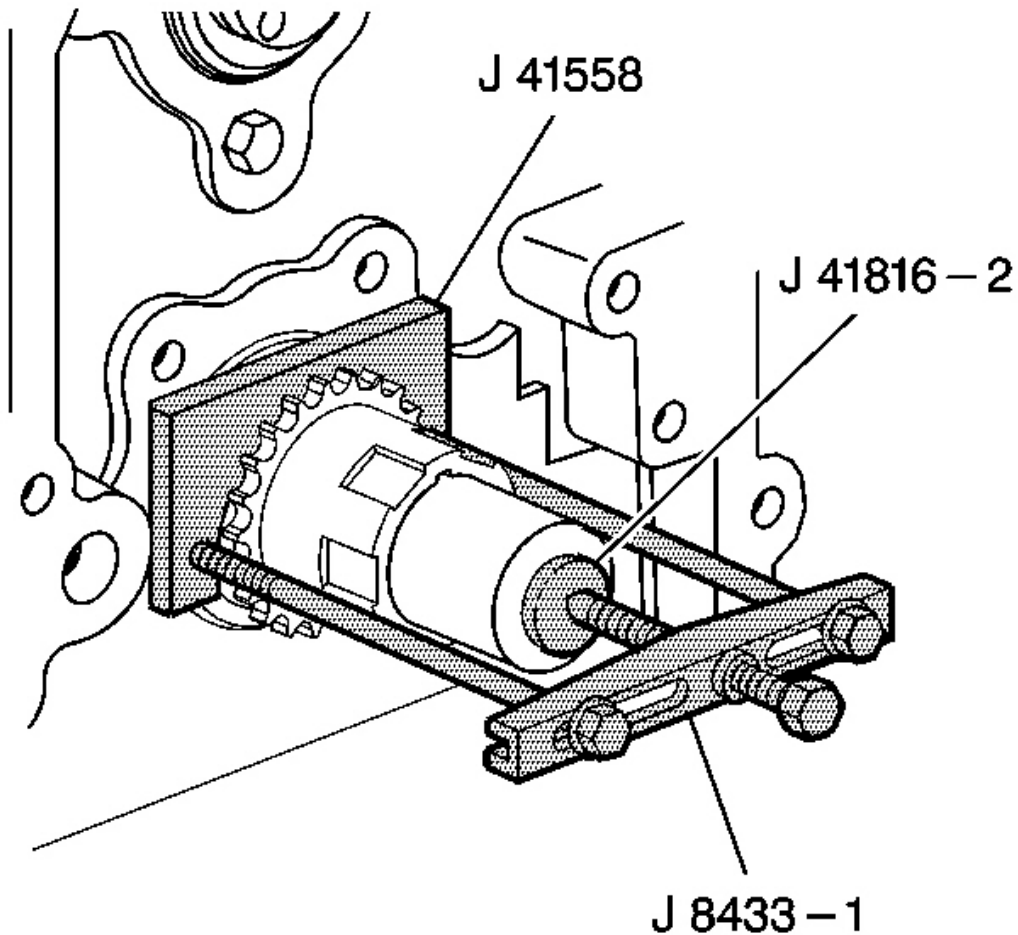
Fig. 375: Removing The Crankshaft Sprocket Using J 8433-1, J 41816-2 & J 41558
Courtesy of GENERAL MOTORS CORP.

3. Use the J 8433-1 , the **J 41816-2** , and the **J 41558** in order to remove the crankshaft sprocket. See **Special Tools and Equipment.**

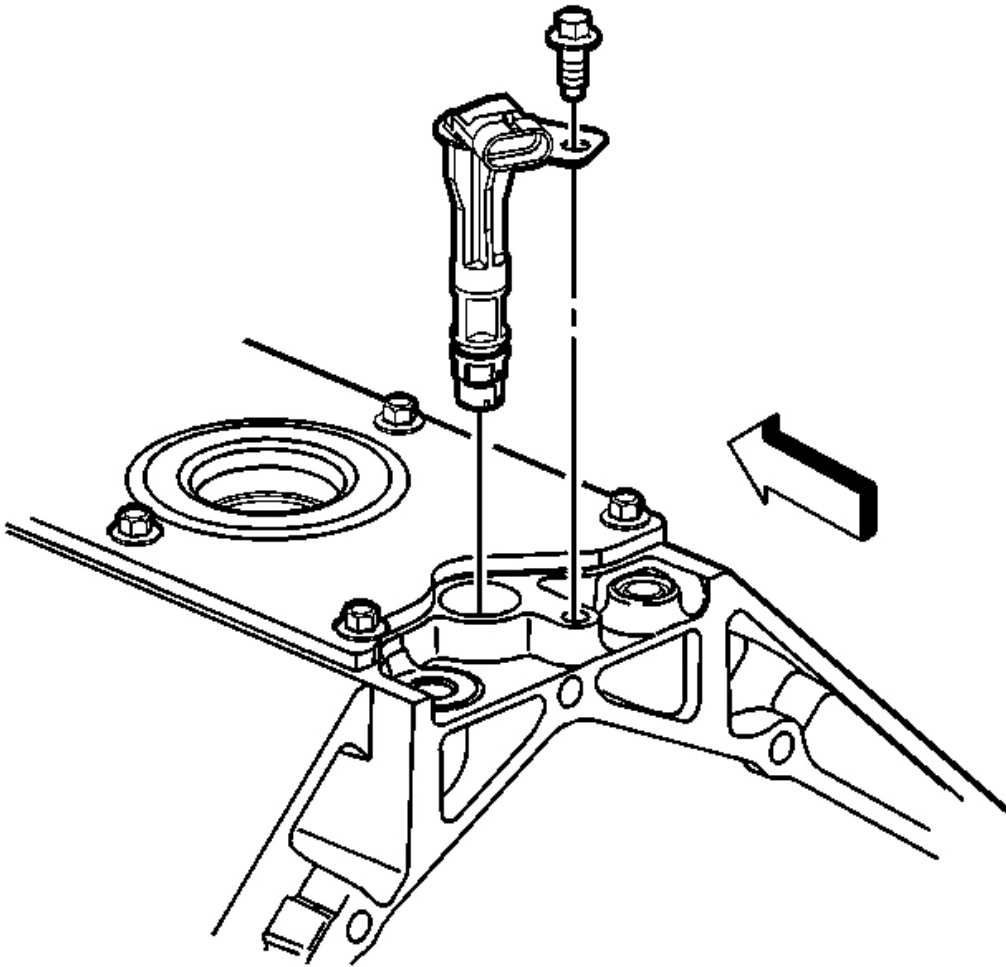
Fig. 378: View Of Camshaft Position (CMP) Sensor & Bolt
Courtesy of GENERAL MOTORS CORP.

1. Remove the camshaft position (CMP) sensor bolt and the sensor.

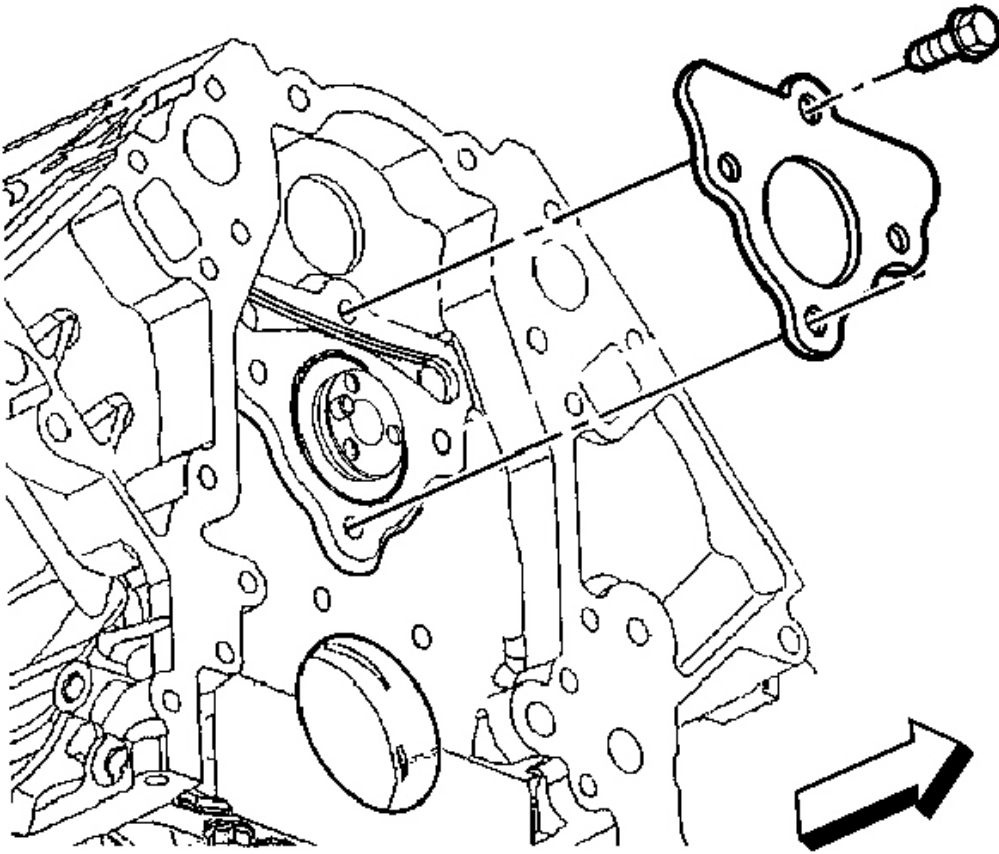
Fig. 379: View Of Camshaft Retainer Plate
Courtesy of GENERAL MOTORS CORP.

2. Remove the camshaft retainer bolts and the retainer.

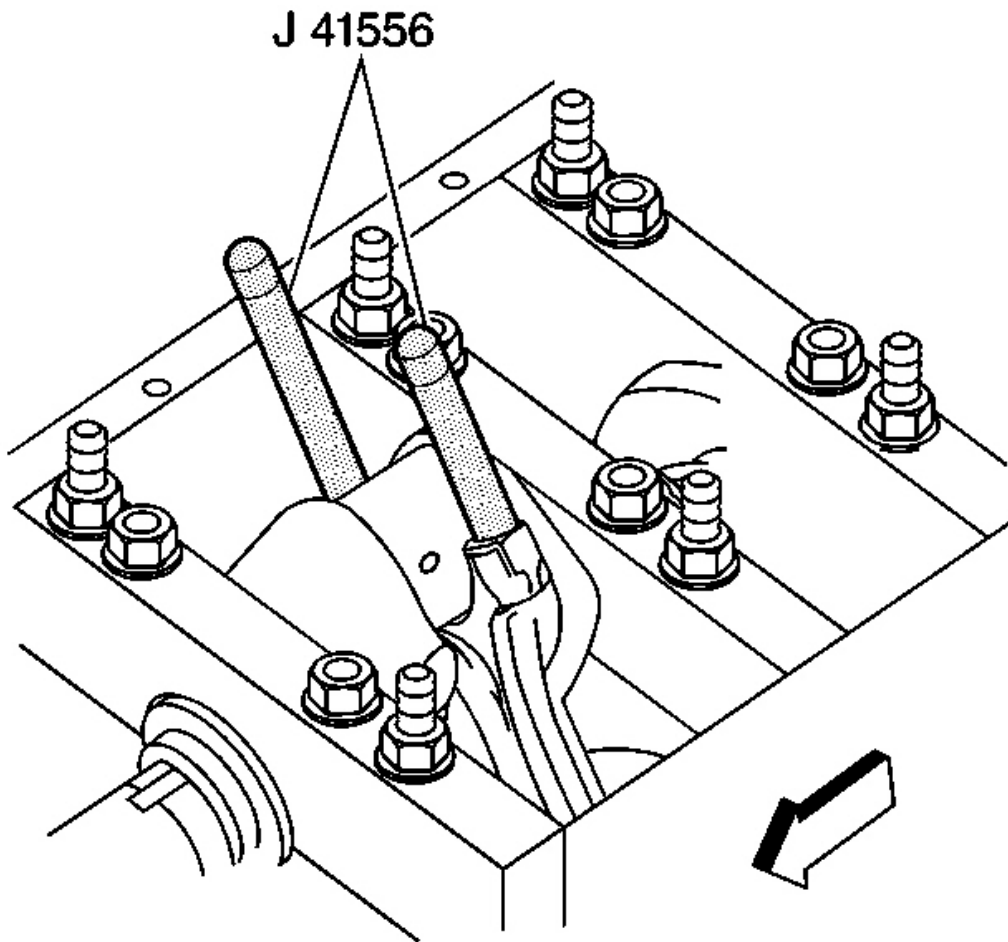
Fig. 383: View Of J 41556 & Connecting Rod
Courtesy of GENERAL MOTORS CORP.

4. Install the **J 41556** to the connecting rod.

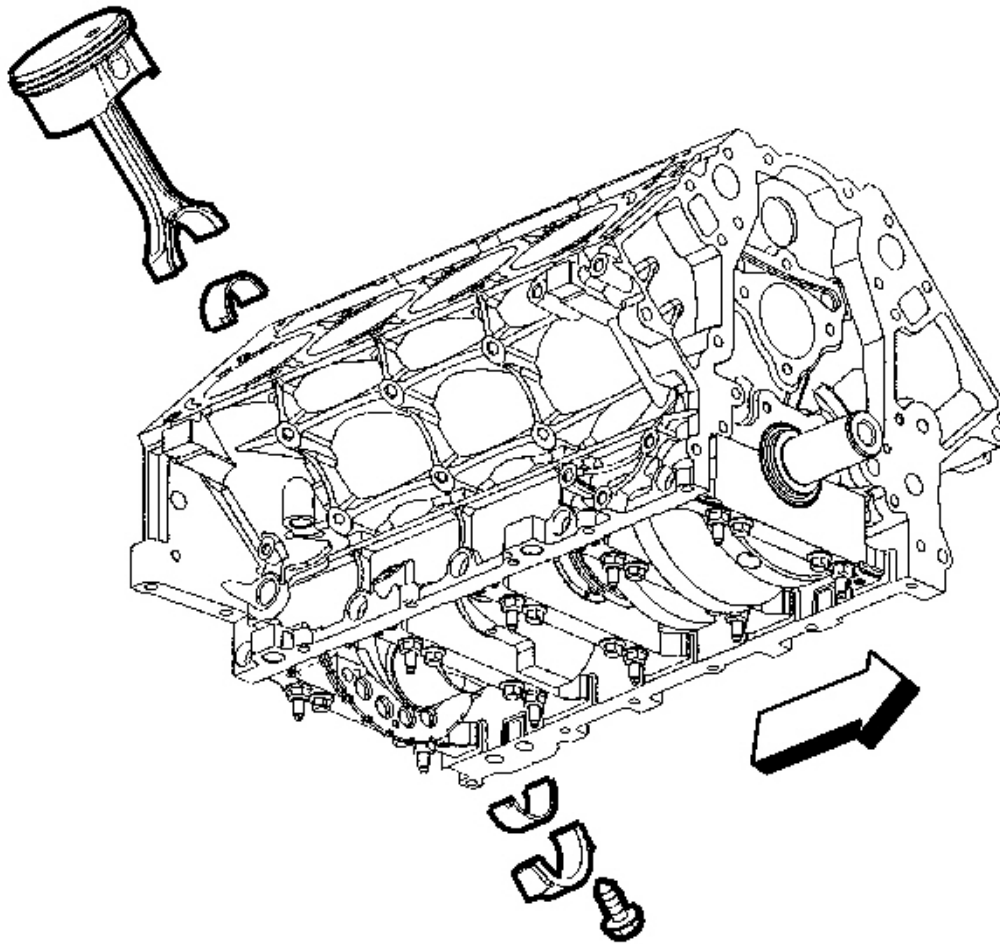
Fig. 384: View Of Piston & Connecting Rod Assembly
Courtesy of GENERAL MOTORS CORP.

5. Use a hammer and tap lightly on the end of the **J 41556** in order to remove the piston and connecting rod assembly from the cylinder bore.

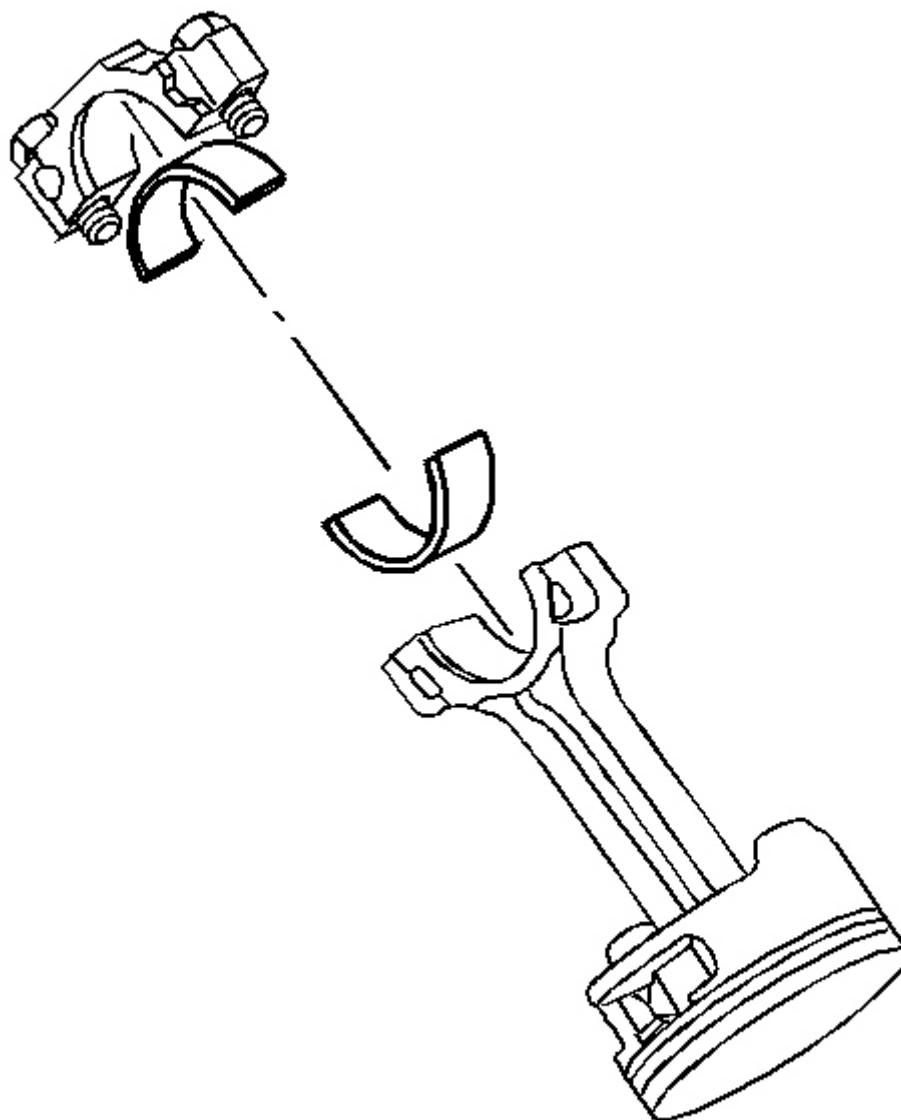
Fig. 385: View Of Piston, Connecting Rod, Bearing Cap, Bearing Halves & Bolts
Courtesy of GENERAL MOTORS CORP.

6. Upon removal of the piston and connecting rod assembly, assemble the connecting rod cap and bolts onto the matching connecting rod.

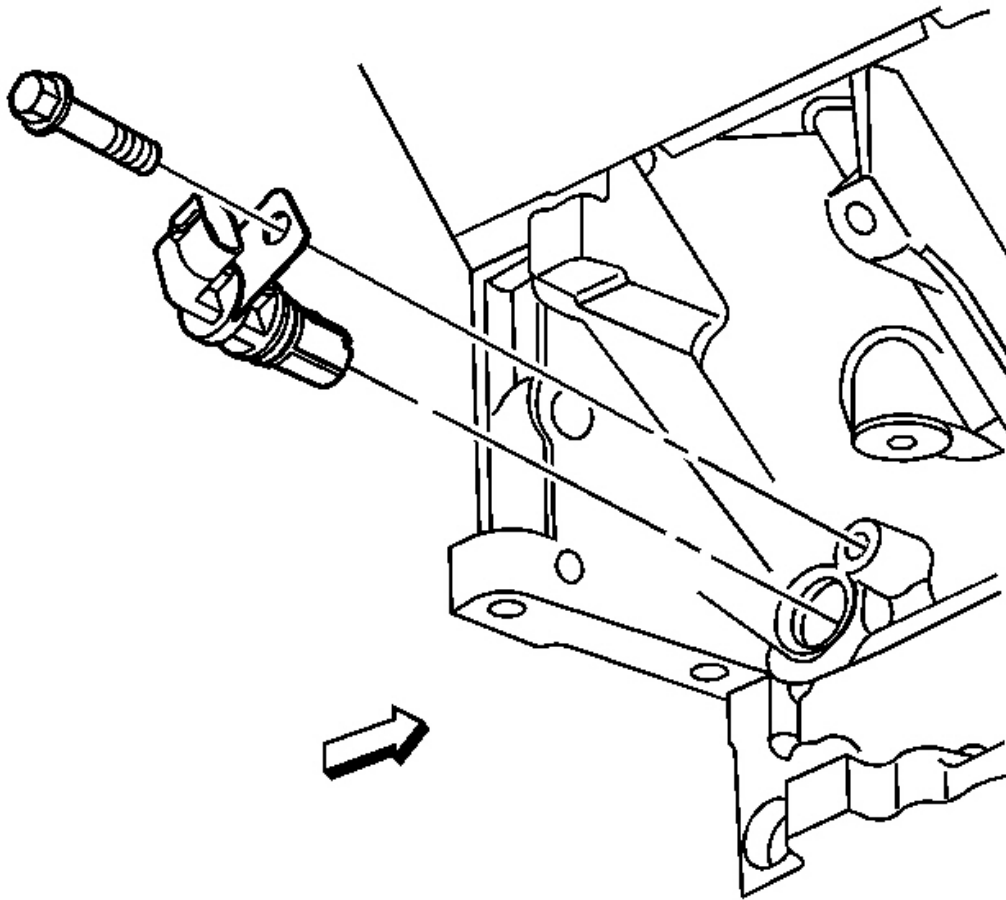
Fig. 386: View Of CKP Sensor & Bolt
Courtesy of GENERAL MOTORS CORP.

1. Remove the crankshaft position (CKP) sensor bolt.
2. Remove the CKP sensor.

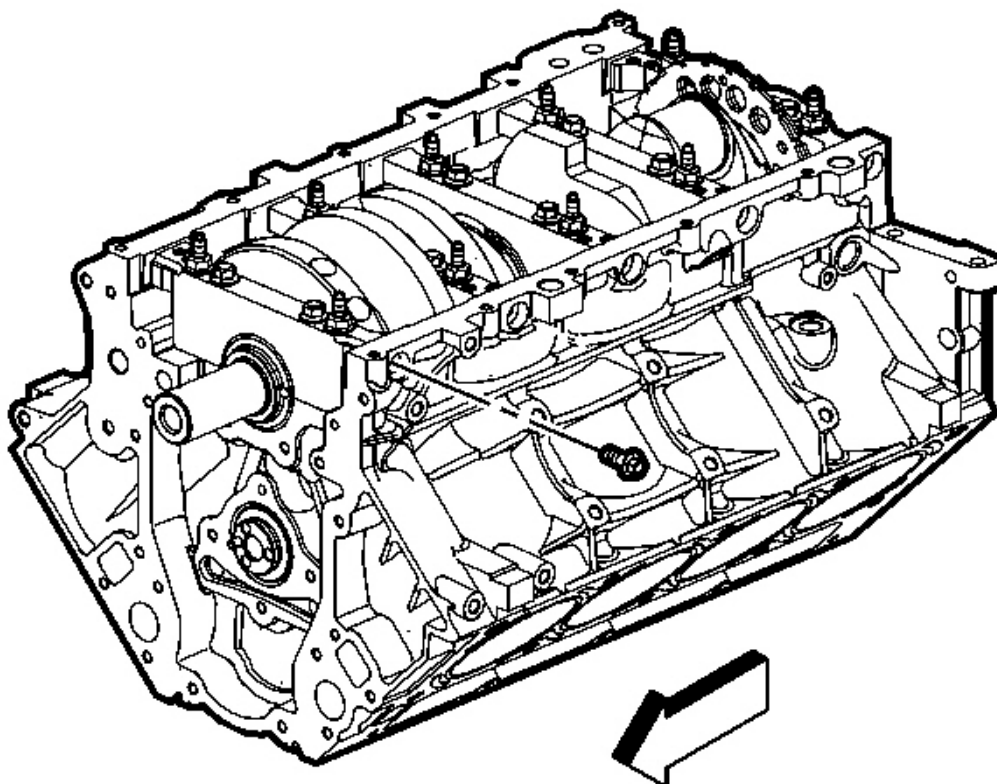
Fig. 387: View Of Bearing Cap Bolts & Studs
Courtesy of GENERAL MOTORS CORP.

3. Remove the bearing cap M8 bolts.
4. Remove the bearing cap M10 bolts and studs.

Note the M10 bolt/stud locations.

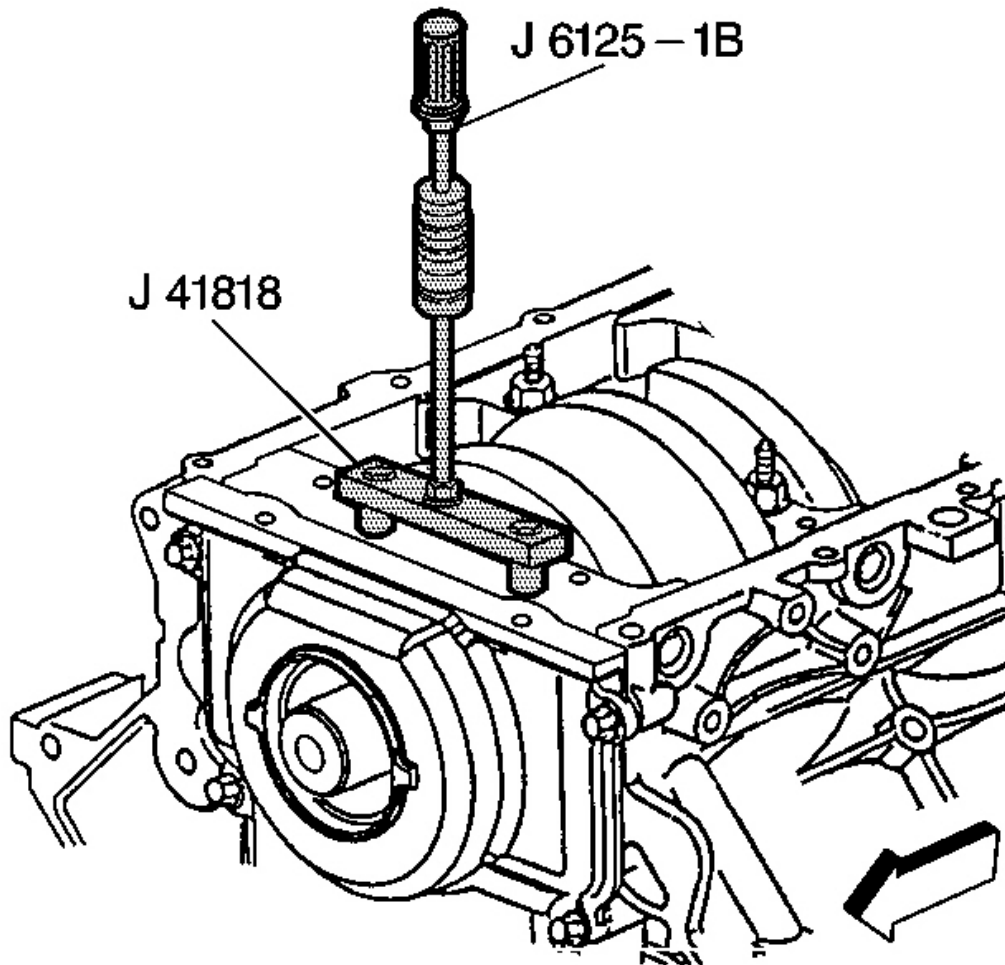
Fig. 388: View Of J 6125-1B & J 41818 Removing Main Bearing Cap
Courtesy of GENERAL MOTORS CORP.

Tighten: Tighten the **J 41818** bolts to 11 N.m (100 lb in). See Special Tools and Equipment.

6. Install the J 6125-1B to the **J 41818** in order to remove the crankshaft bearing caps. See Special Tools and Equipment.
