2004 Isuzu Ascender LS

2004 ENGINE Engine Mechanical - 4.8L, 5.3L, and 6.0L - Ascender

Engine Mechanical - 4.8L, 5.3L, and 6.0L - Ascender

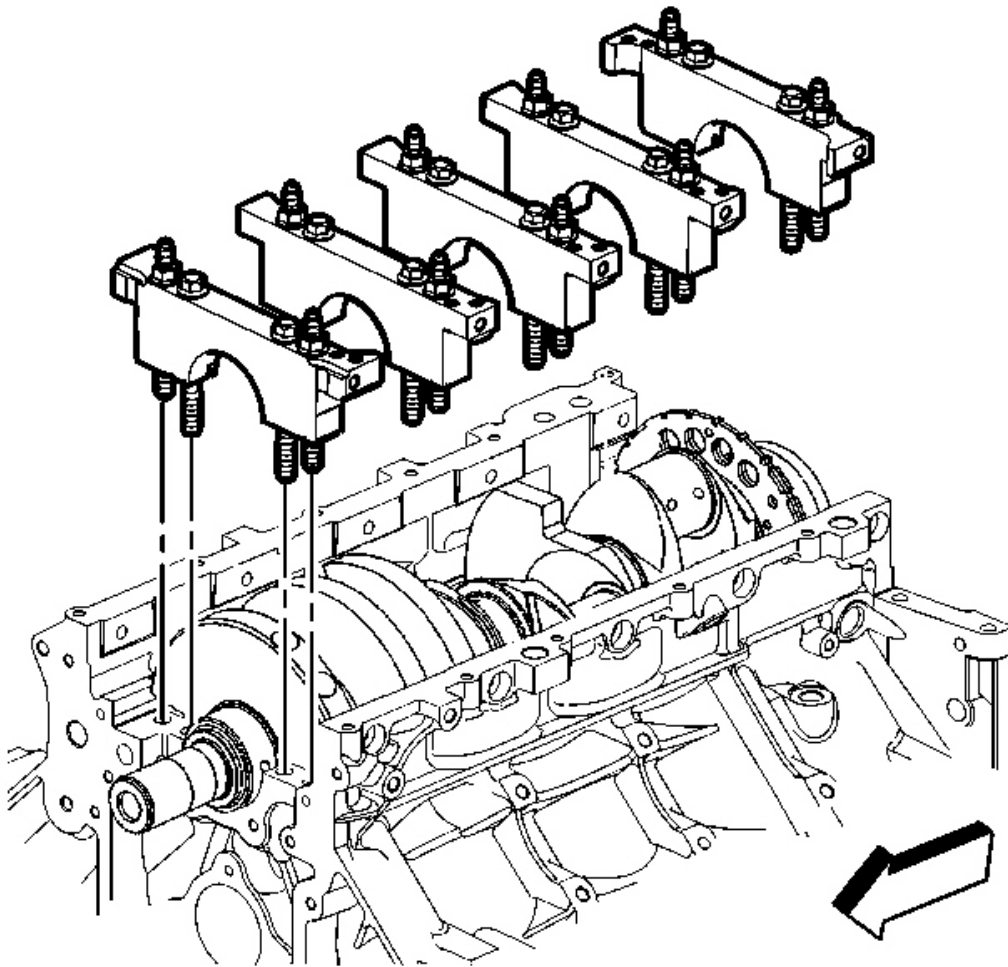
Fig. 389: View Of Crankshaft Main Bearing Caps
Courtesy of GENERAL MOTORS CORP.

7. Remove the bearing caps.

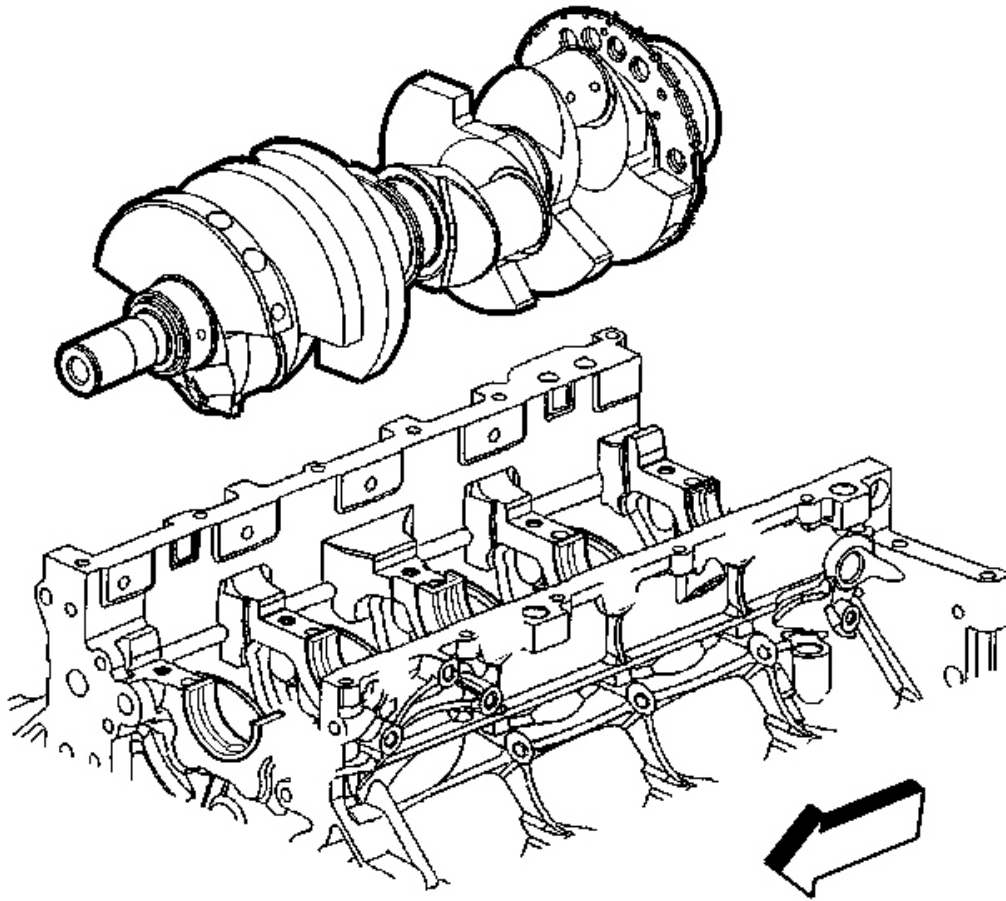
Fig. 390: View Of Crankshaft & Engine Block
Courtesy of GENERAL MOTORS CORP.

8. Remove the crankshaft.

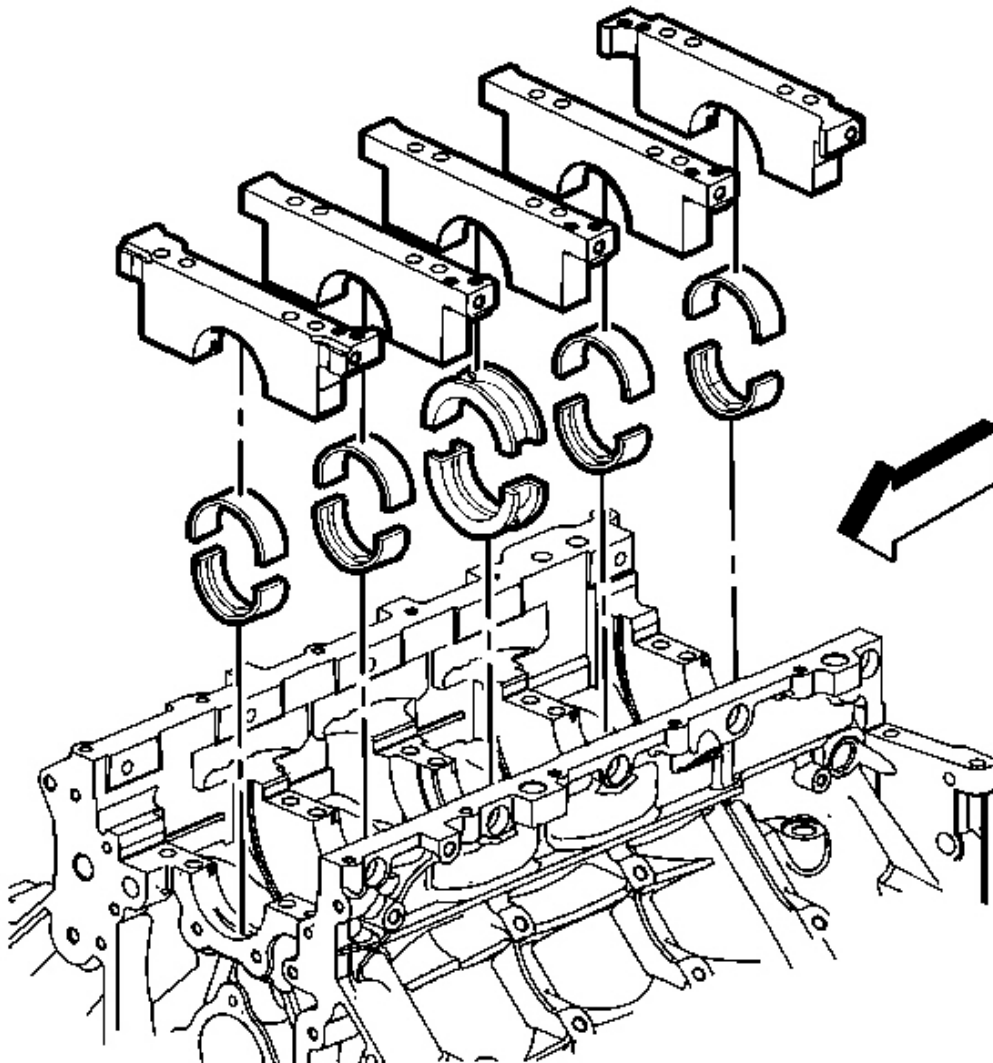
Fig. 392: View Of Crankshaft Bearings & Bearing Caps
Courtesy of GENERAL MOTORS CORP.

10. Remove the crankshaft bearings from the bearing caps and the engine block.
11. Mark, sort, or organize the crankshaft bearings so they may be installed to their original position and location. Refer to **Separating Parts**.

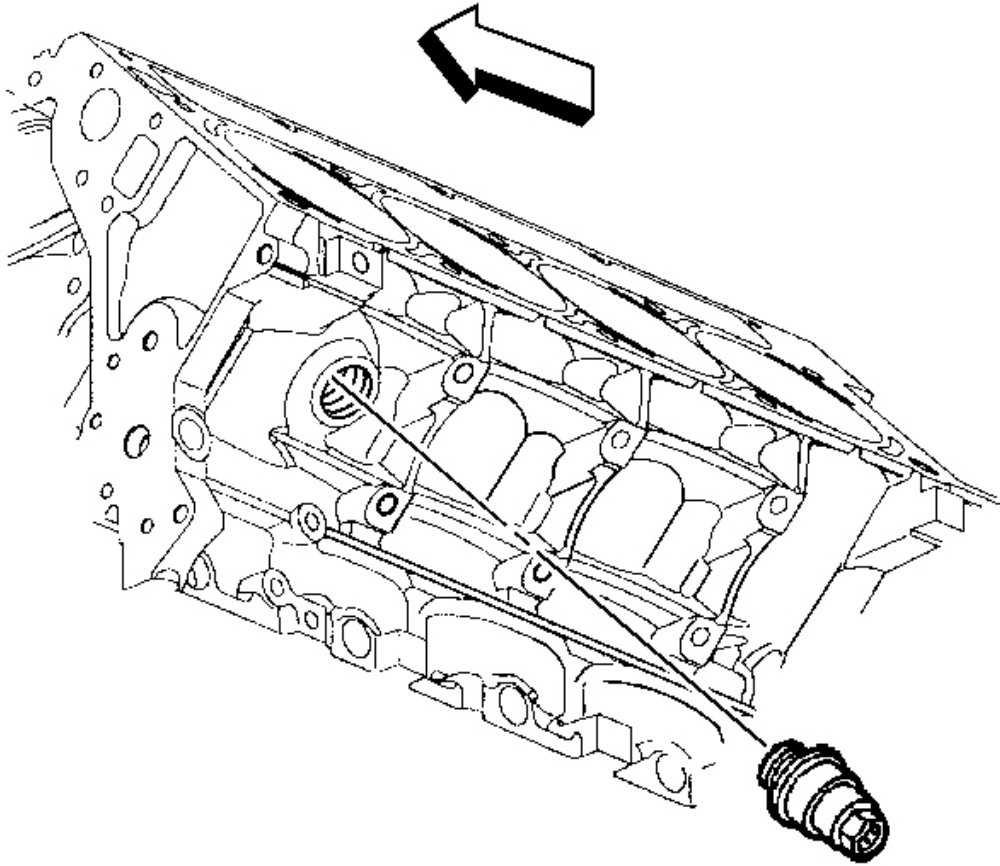
Fig. 395: View Of Engine Block Coolant Heater
Courtesy of GENERAL MOTORS CORP.

3. Remove the engine block coolant heater, if applicable.

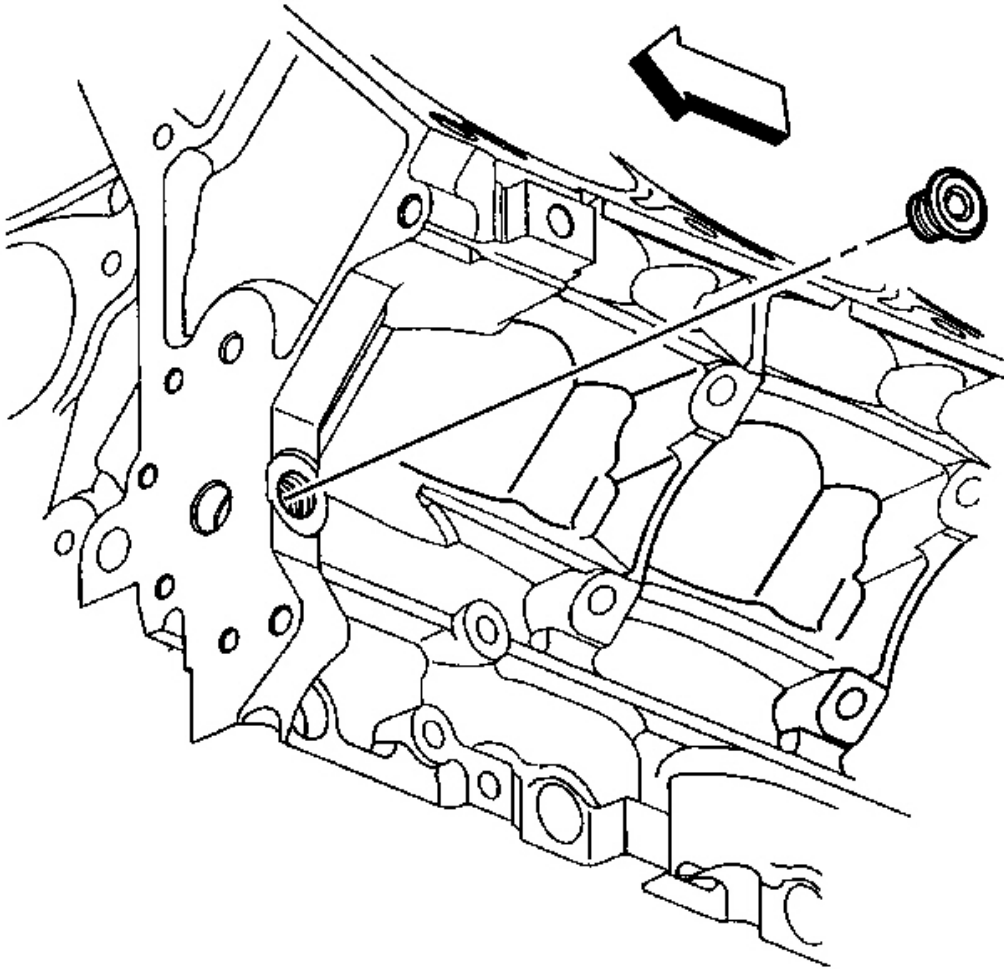
Fig. 397: View Of Engine Block Left Front Oil Gallery Plug
Courtesy of GENERAL MOTORS CORP.

5. Remove the engine block left front oil gallery plug.

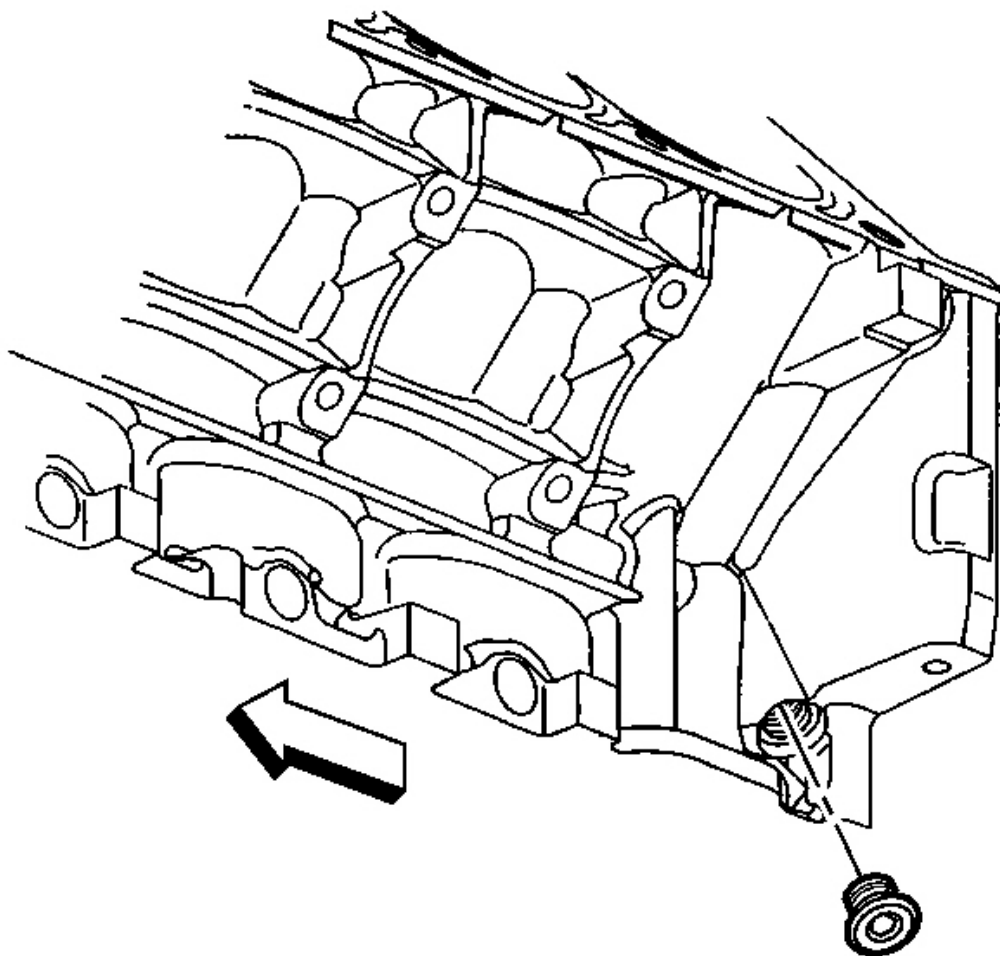
Fig. 398: View Of Engine Block Left Rear Oil Gallery Plug
Courtesy of GENERAL MOTORS CORP.

6. Remove the engine block left rear oil gallery plug.
7. Inspect the block plug sealing washers.

If the block plug and heater sealing washers are not damaged, they may be used during assembly.

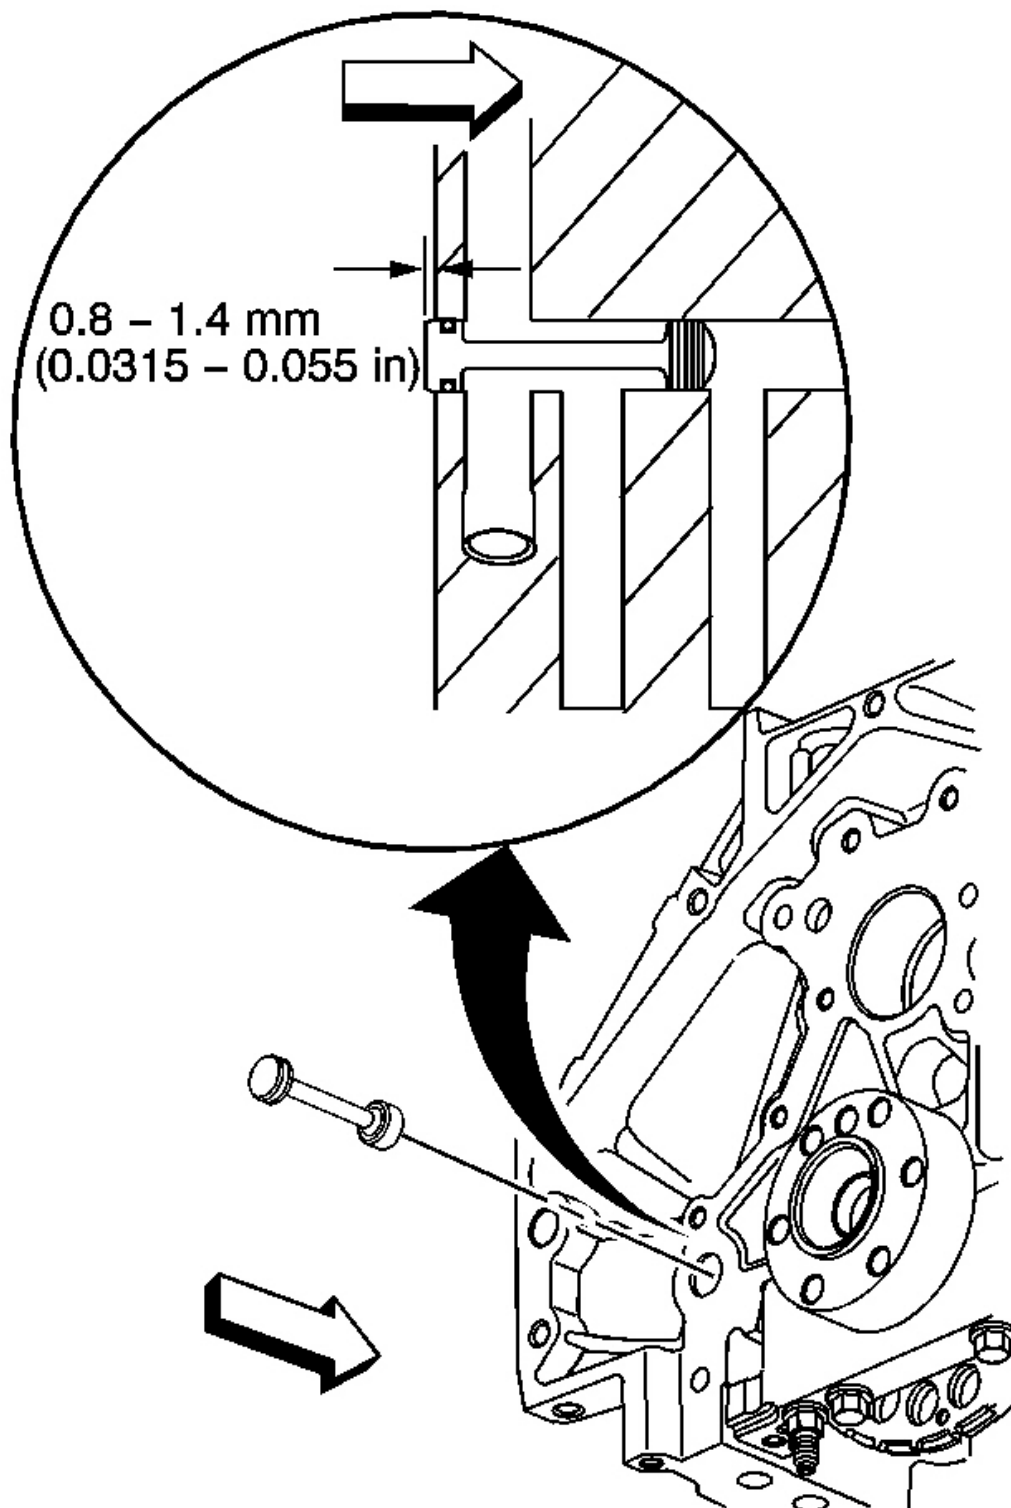
Fig. 399: View Of Engine Block Rear Oil Gallery Plug
Courtesy of GENERAL MOTORS CORP.

8. Remove the engine block rear oil gallery plug.
9. Inspect the O-ring seal of the rear oil gallery plug.

If the O-ring seal is not cut or damaged, the plug and O-ring seal may be used during assembly.

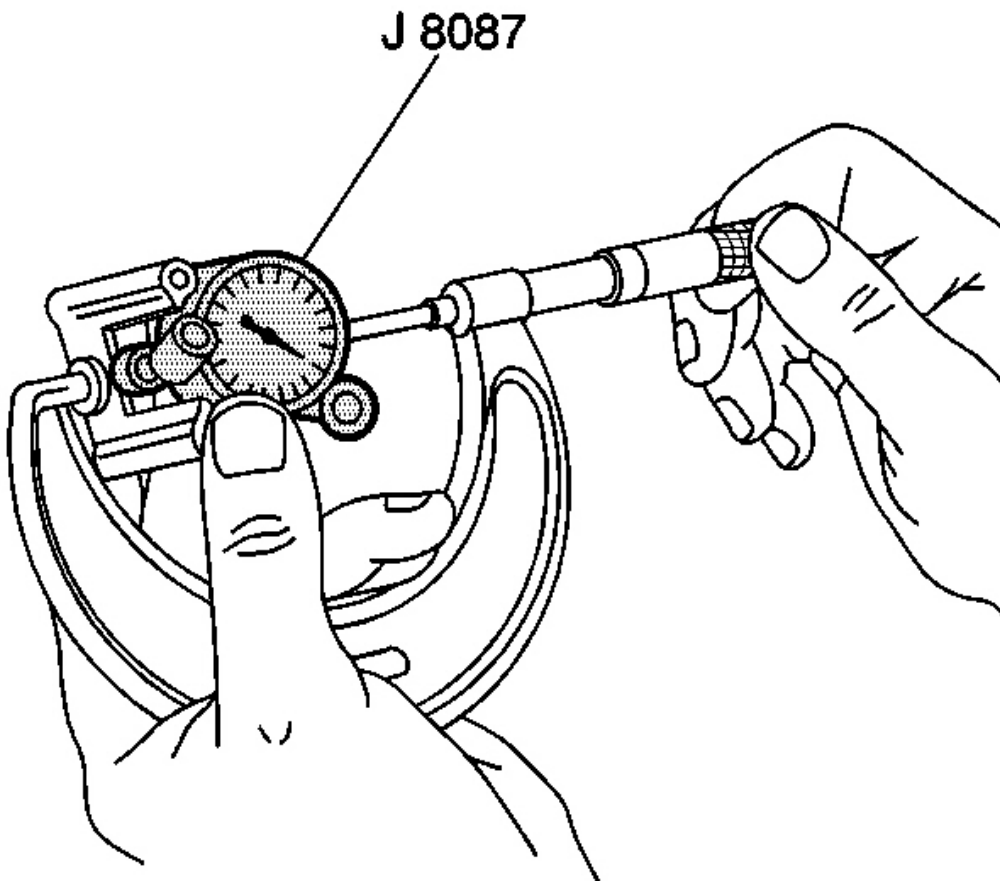
Fig. 401: Measuring Bore Gauge With Micrometer

1. Adjust the micrometer to a dimension slightly smaller than the bore size.

Adjust the micrometer to 96.0 mm (3.78 in) for 5.3 liter engines.

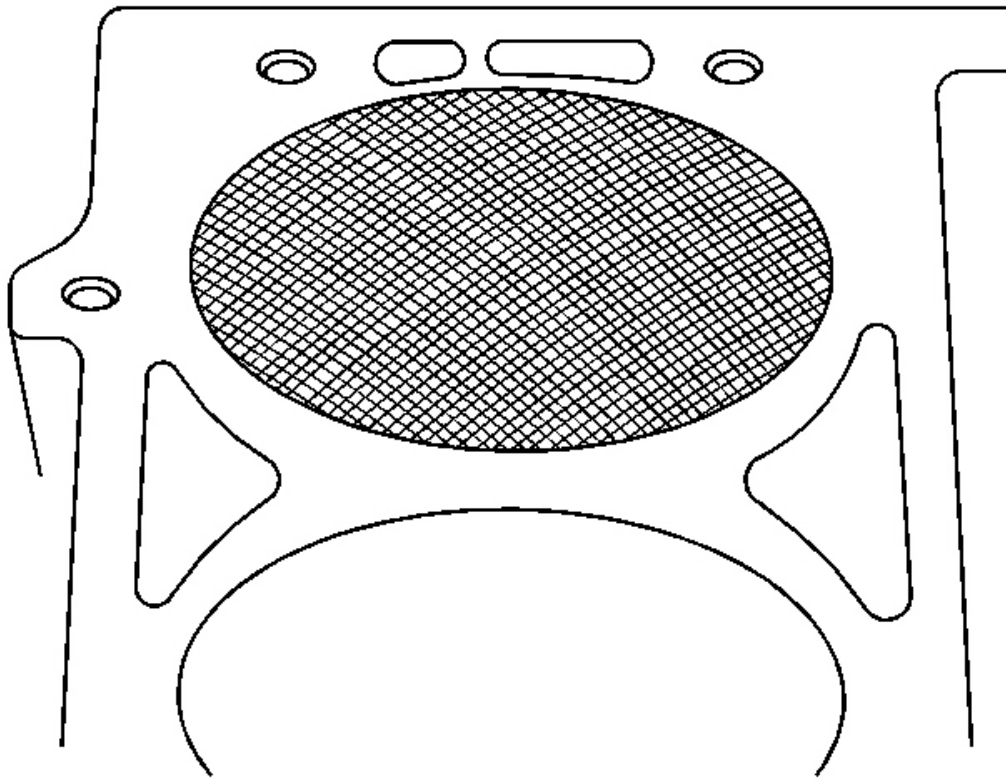
Fig. 403: Identifying Cylinder Bore Cross Hatch Pattern
Courtesy of GENERAL MOTORS CORP.

1. When honing the cylinders, follow the manufacturer's recommendations for equipment use, cleaning, and lubrication. Use only clean, sharp stones of the proper grade for the amount of material you remove. Dull, dirty stones cut unevenly and generate excessive heat. Do not hone to final clearance with a coarse or medium-grade stone. Leave sufficient metal so that all stone marks may be removed with fine-grade stones. Perform final honing with a fine-grade stone, honing the cylinder to the proper clearance.
2. During the honing operation, thoroughly clean the cylinder bore. Repeatedly check the cylinder bore for fit with the selected piston.

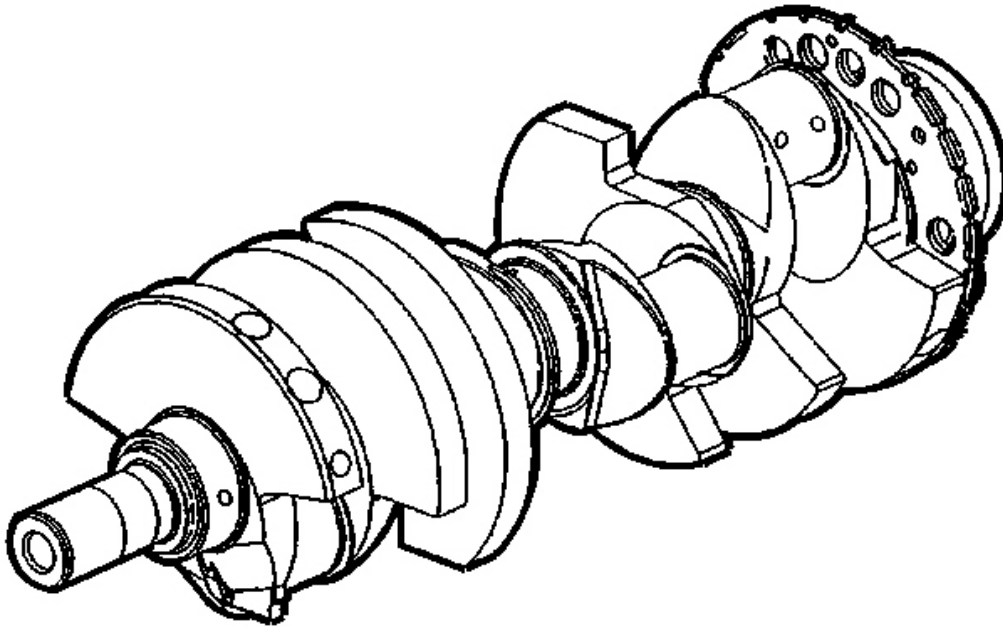
IMPORTANT: The reluctor ring teeth should not have imperfections on the rising or falling edges.
Imperfections of the reluctor ring teeth may effect OBD II system performance.

1. Perform a visual inspection of the crankshaft for damage.
2. Inspect the crankshaft position (CKP) reluctor ring lobes for damage.

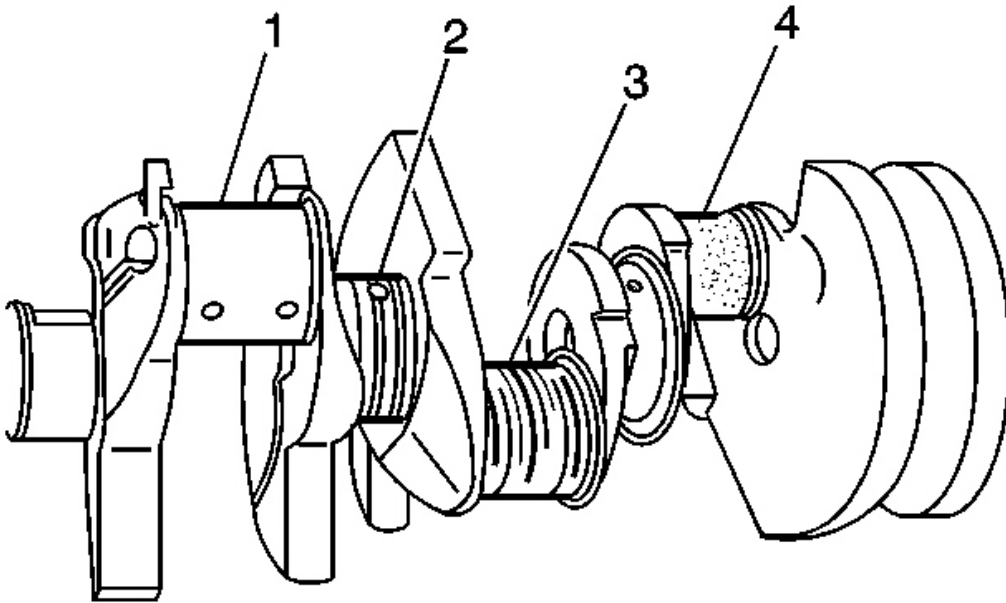
Fig. 407: Identifying Different Crankshaft Journal Wear Patterns
Courtesy of GENERAL MOTORS CORP.

3. Inspect the crankshaft journals for wear (1).

Journals should be smooth with no signs of scoring, wear, or damage.

4. Inspect the crankshaft journals for grooves or scoring (2).
5. Inspect the crankshaft journals for scratches or wear (3).
6. Inspect the crankshaft journals for pitting or imbedded bearing material (4).

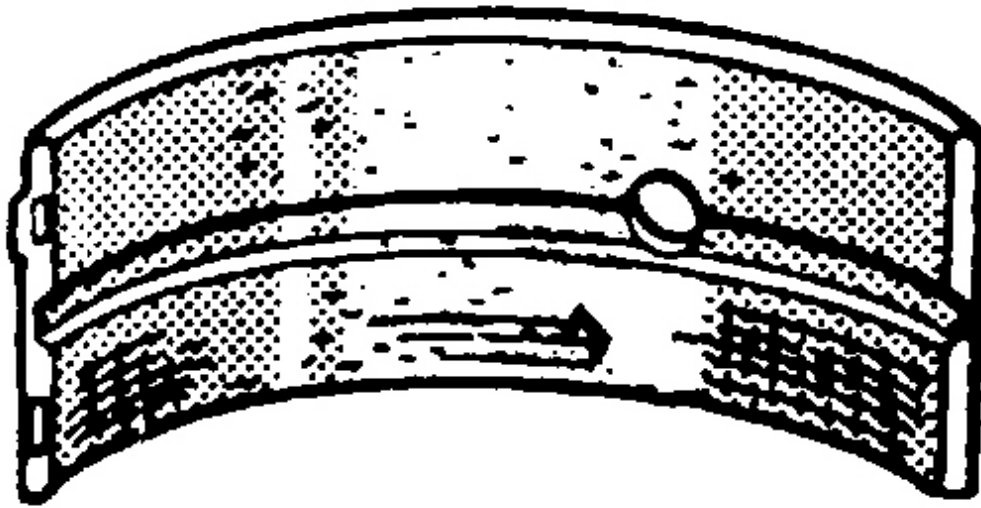
Fig. 412: Identifying Crankshaft Bearing Craters Or Pockets
Courtesy of GENERAL MOTORS CORP.

15. Inspect crankshaft bearings for craters or pockets. Flattened sections on the bearing halves also indicate fatigue.

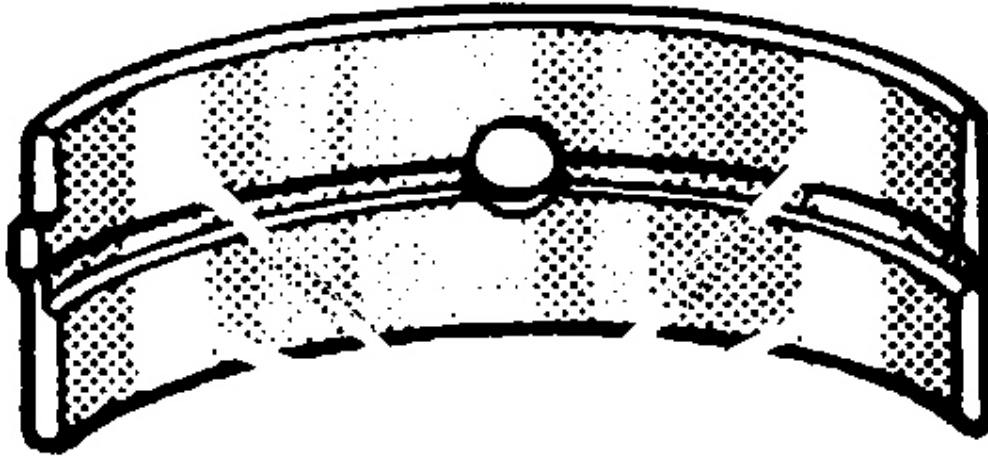
Fig. 413: Identifying Connecting Rod Bearing Scoring Or Discoloration
Courtesy of GENERAL MOTORS CORP.

16. Inspect the crankshaft bearings for excessive scoring or discoloration.
17. Inspect the crankshaft bearings for dirt or debris imbedded into the bearing material.

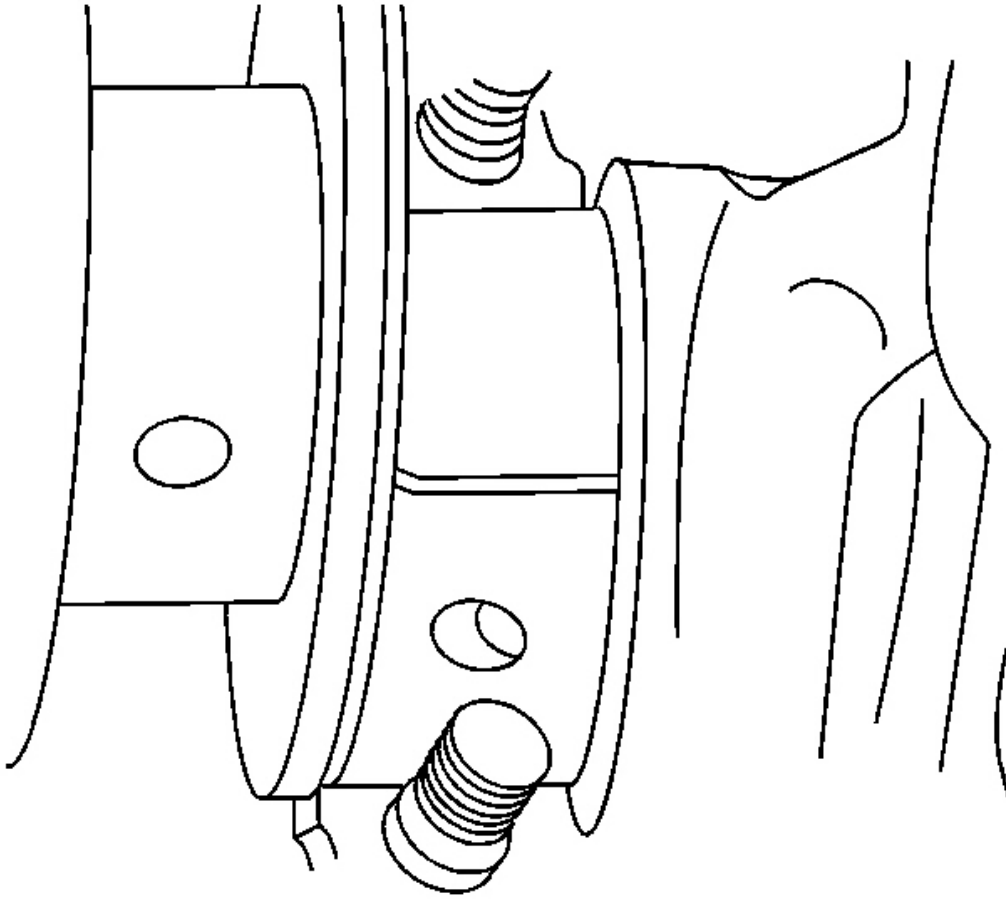
Fig. 418: View Of Crankshaft Bearings & Bearing Caps
Courtesy of GENERAL MOTORS CORP.

5. Remove the bearing cap and lower bearing.

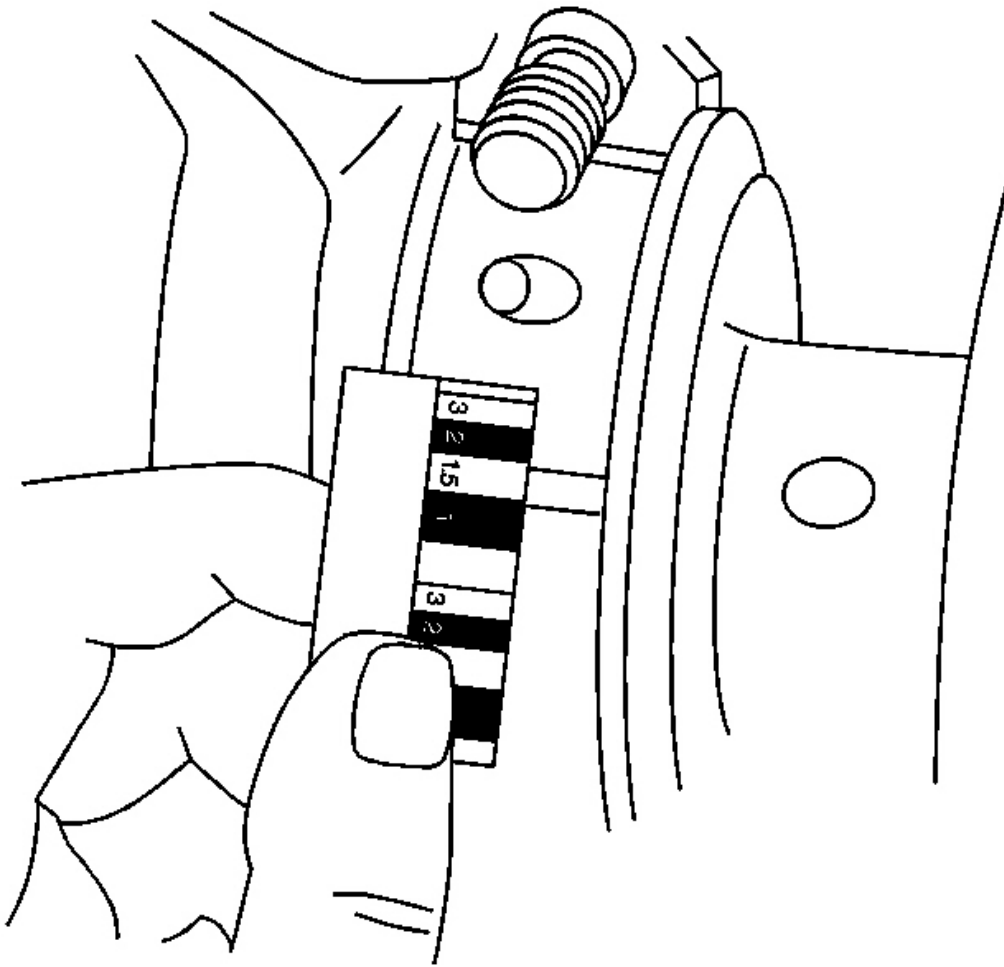
Fig. 424: Measuring Gaging Plastic
Courtesy of GENERAL MOTORS CORP.

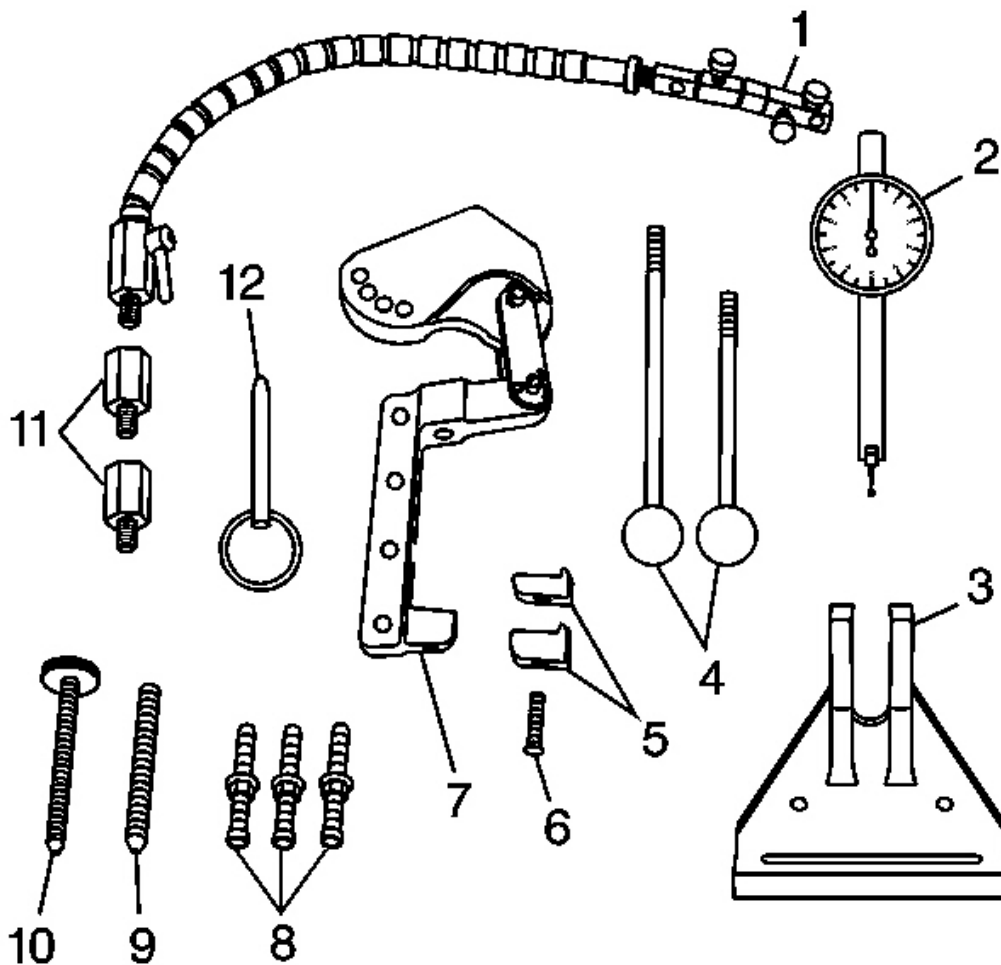
Fig. 429: Measuring Gaging Plastic
Courtesy of GENERAL MOTORS CORP.

5. Measure the gaging plastic at its widest area using the scale supplied with the plastic gaging kit.

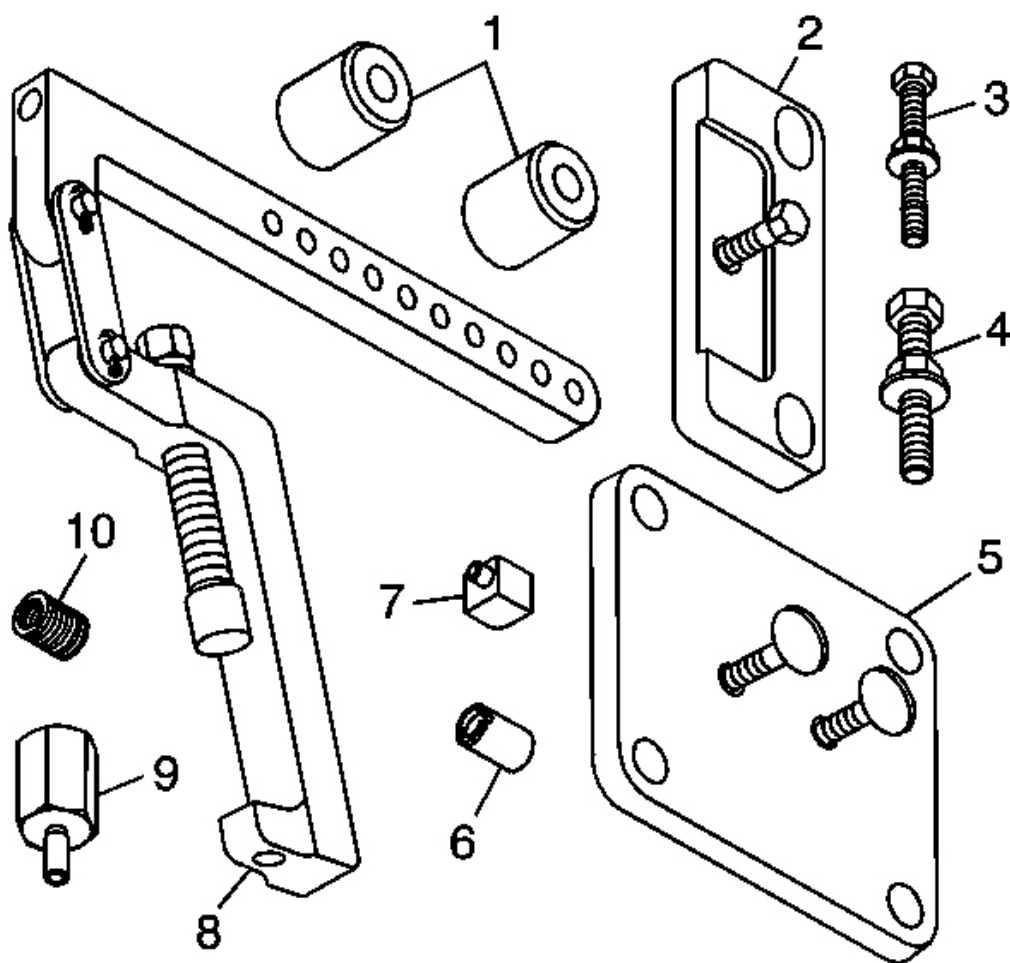
Fig. 430: Identifying Rod Bearing Clearance Checking Tool
 Courtesy of GENERAL MOTORS CORP.

Rod Bearing Checking Tool. See **Special Tools and Equipment**.

- J 43690-2 Base (3)
- J 43690-5, -6 Handle (4)
- J 43690-10, -11 Foot (5)
- 280307 Screw (6)
- J 43690-1 Pivot Arm Assembly (7)
- J 43690-3, -7, -8 Screws (8)
- 280319 Screw (9)
- 280311 Screw (10)
- J 43690-17, -18 Adapter (11)
- 280310 Pin (12)

J 43690 and **J 43690-100** have been developed as a more accurate method to measure connecting rod bearing clearances. The instructions below provide an overview of tool set-up and usage. For more detailed information, refer to the tool instruction sheets as supplied by the tool manufacturer. See **Special Tools and Equipment**.

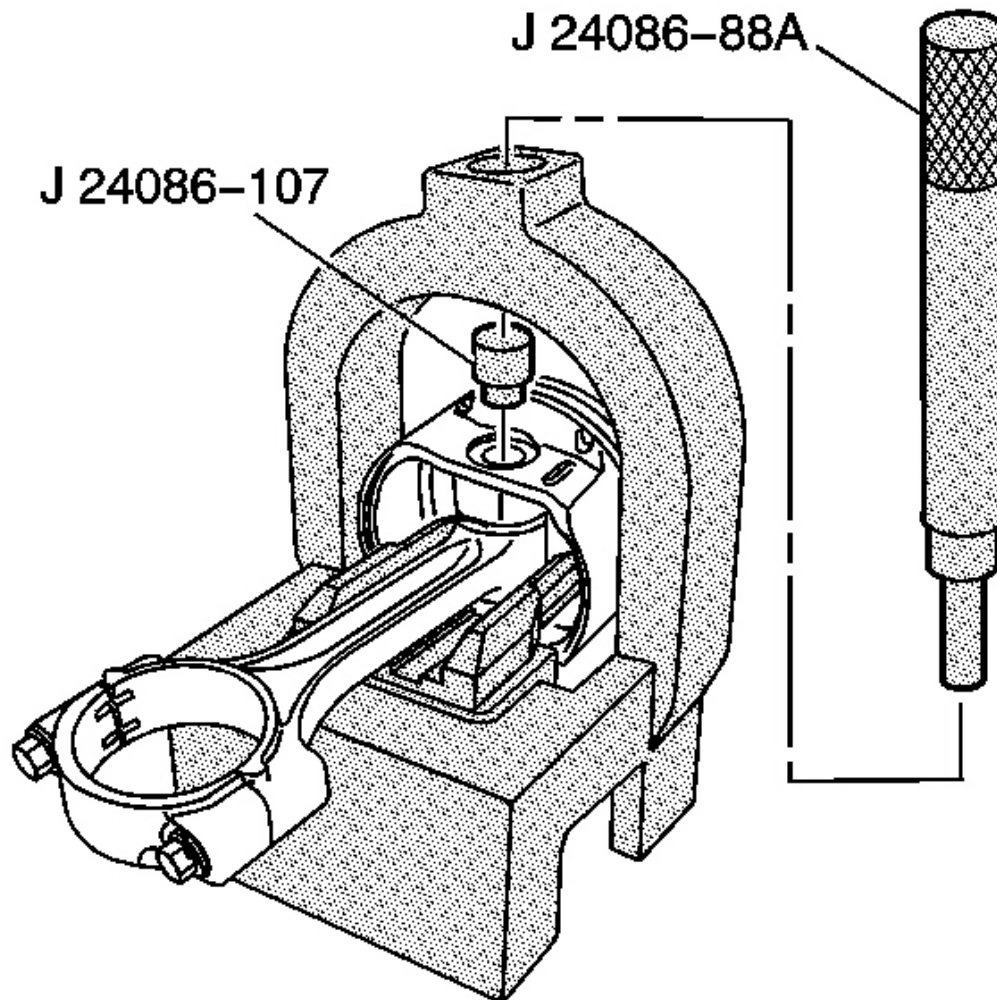
Fig. 439: View Of J 24086-920A & J 24086-10
Courtesy of GENERAL MOTORS CORP.

3. Install fork insert J 24086-920A into J 24086-10 .

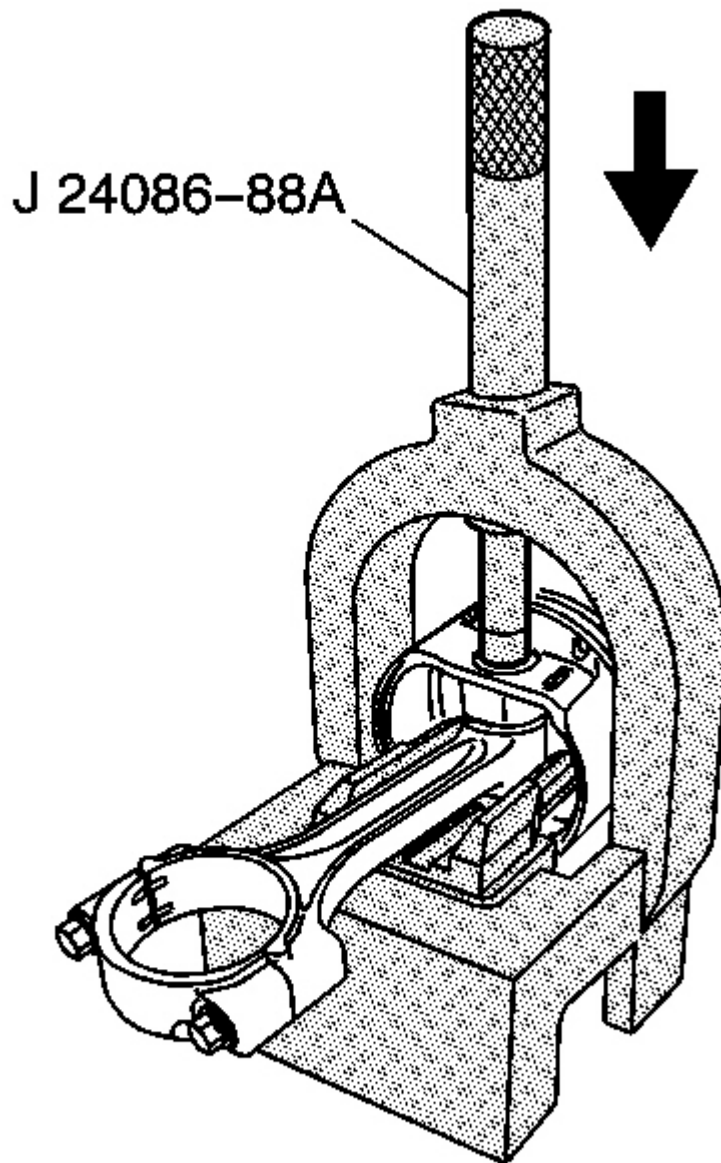
Fig. 440: View Of J 24086-107 & J 24086-88A
Courtesy of GENERAL MOTORS CORP.

4. Install the piston and connecting rod assembly onto J 24086-10 .
5. Install J 24086-107 to the piston pin.
6. Install J 24086-88A through the fixture and to the J 24086-107.

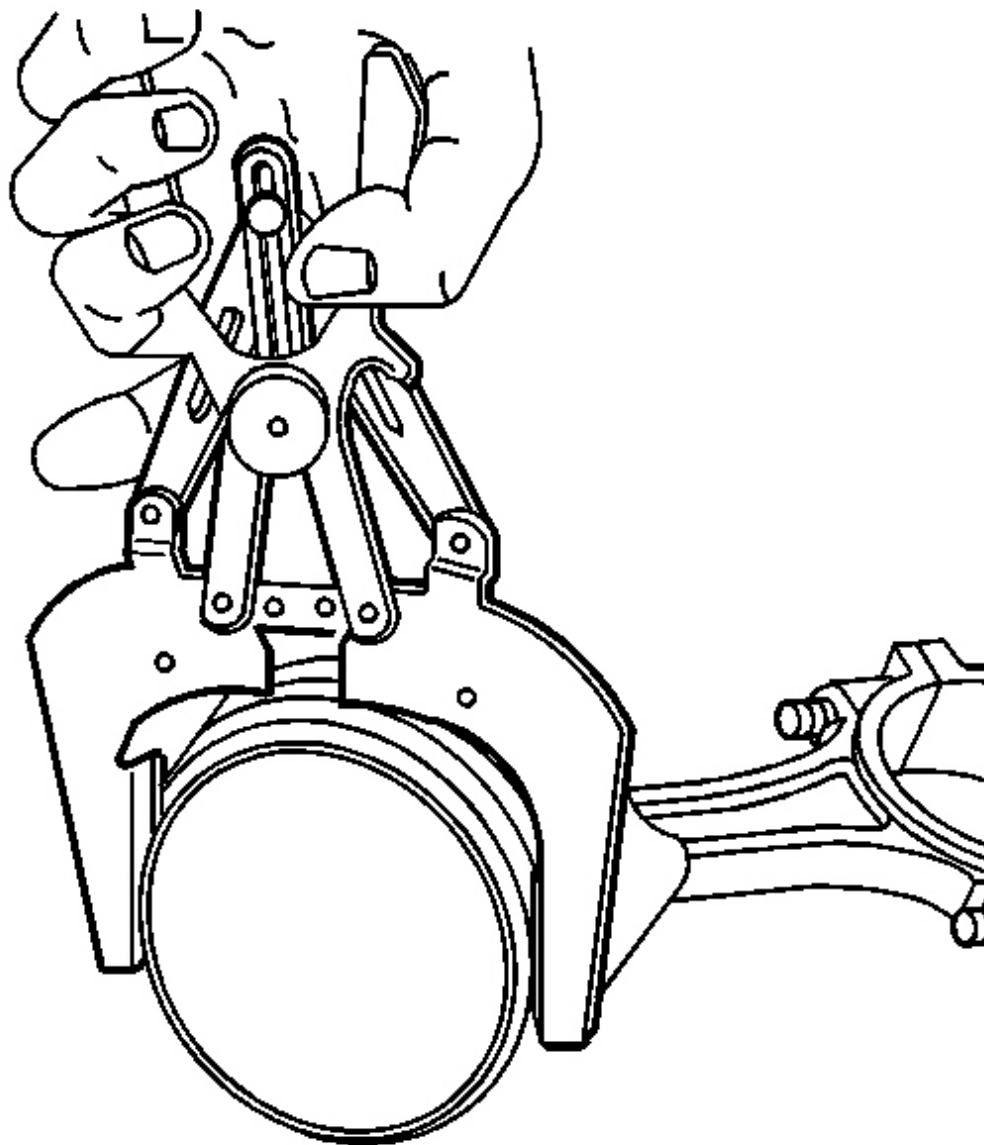
Fig. 443: Cleaning The Piston Ring Grooves With Suitable Ring Groove Cleaning Tool
Courtesy of GENERAL MOTORS CORP.

3. Clean the piston ring grooves with a suitable ring groove cleaning tool.
4. Clean the oil lubrication holes and slots.

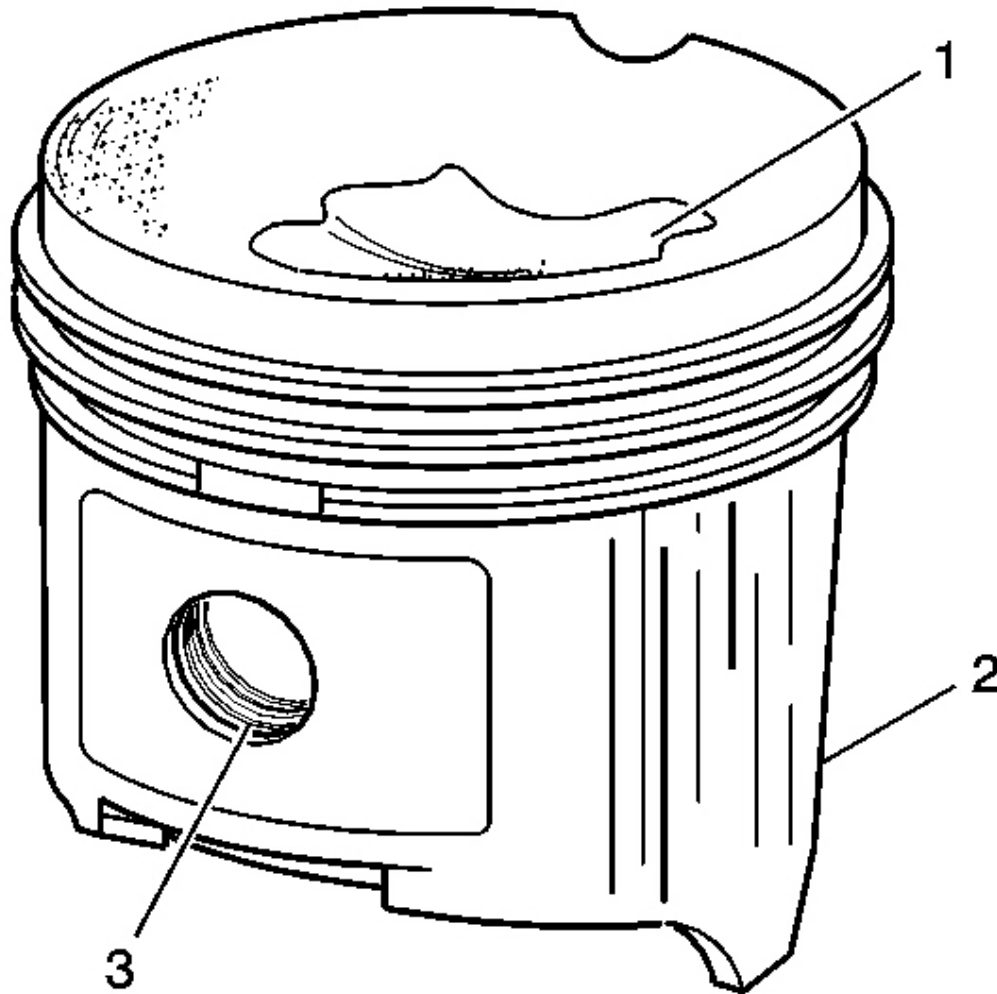
Fig. 444: Identifying Piston Damage Inspection Areas
Courtesy of GENERAL MOTORS CORP.

- Scoring to the full-floating design piston pin bore (3) or piston pin

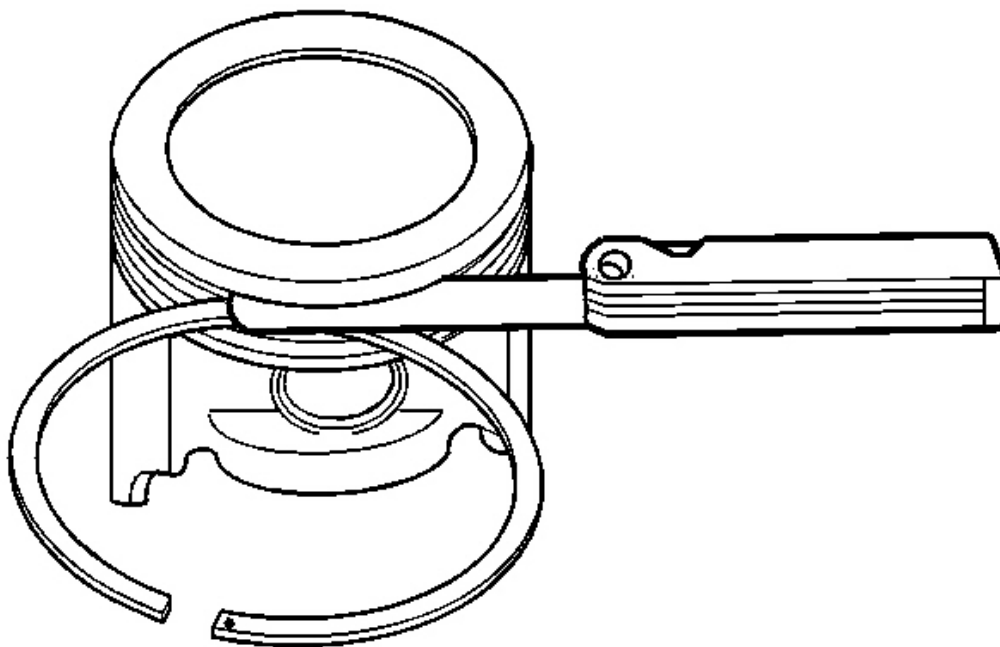
Fig. 446: Inserting Piston Ring Into Ring Groove
Courtesy of GENERAL MOTORS CORP.

7. Insert the edge of the piston ring into the piston ring groove.

Roll the piston ring completely around the piston. If binding is caused by distorted ring groove, MINOR imperfections may be removed with a fine file. If binding is caused by a distorted piston ring, replace the rings as required.

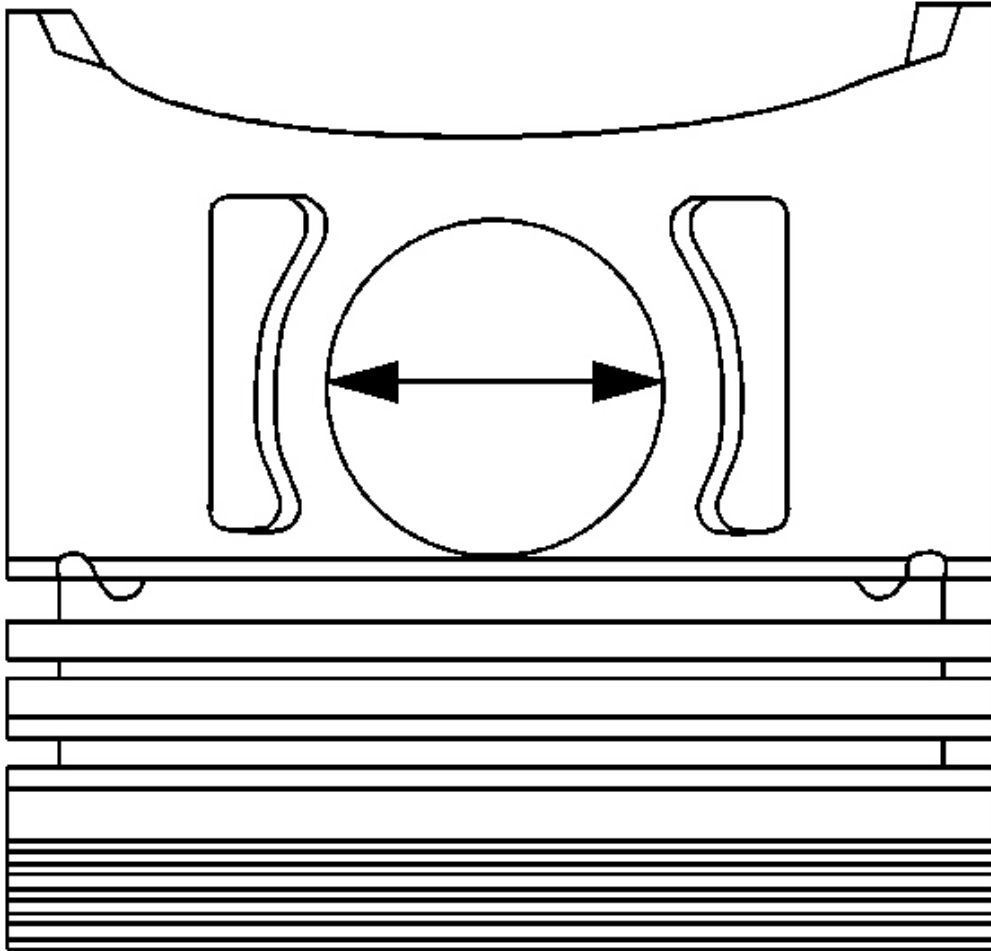
Fig. 448: Measuring Piston Pin Diameter
Courtesy of GENERAL MOTORS CORP.

9. To determine piston pin-to-bore clearance, use a micrometer and measure the piston pin outside diameter (OD).
