2004 Isuzu Ascender LS

2004 ENGINE Engine Mechanical - 4.8L, 5.3L, and 6.0L - Ascender

Engine Mechanical - 4.8L, 5.3L, and 6.0L - Ascender

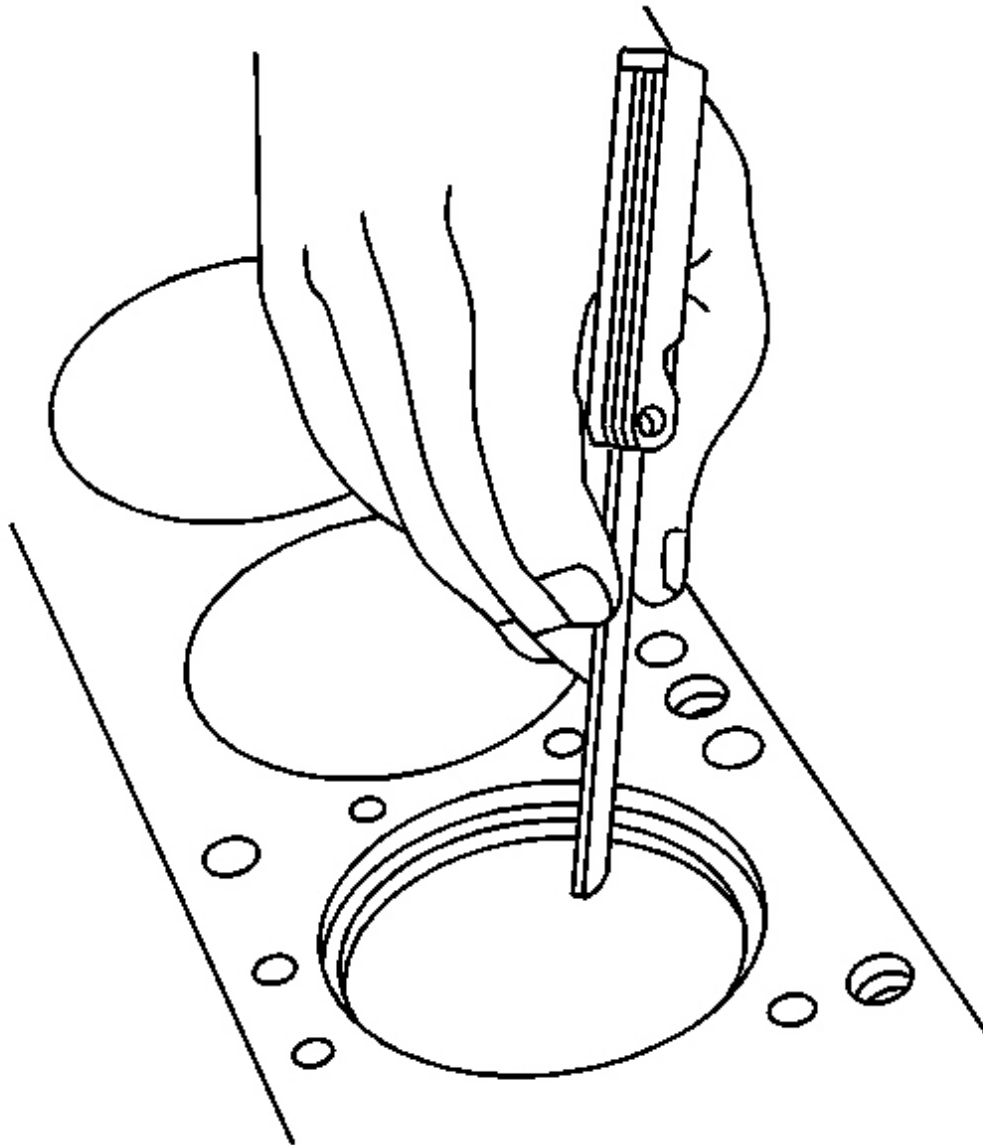
Fig. 451: Measuring Piston Ring End Gap
Courtesy of GENERAL MOTORS CORP.

2. Place the piston ring into the cylinder bore 6.5 mm (0.25 in) below the top of the ring travel area.
3. Insert a feeler gage and measure the piston ring end gap. Refer to **Engine Mechanical Specifications**.

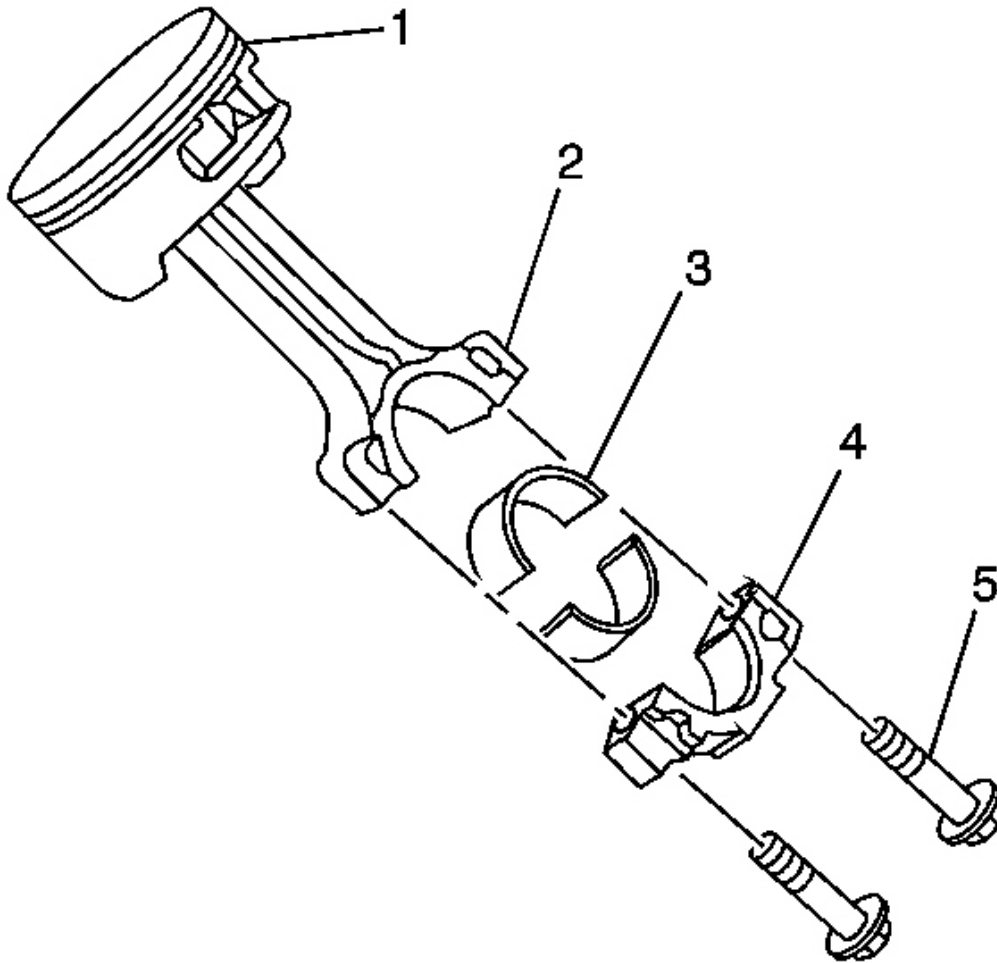
Fig. 452: View Of Piston & Connecting Rod Components
Courtesy of GENERAL MOTORS CORP.

- The powdered metal connecting rod and cap are machined for proper clearances. The connecting rod and cap must be used as an assembly with no repair or modifications to either mating surface. Do not attempt to repair the rod or cap. If service is required, replace the first design press-fit piston, pin, and connecting rod as an assembly.
- Do not attempt to repair the bolt hole threads of the connecting rod.

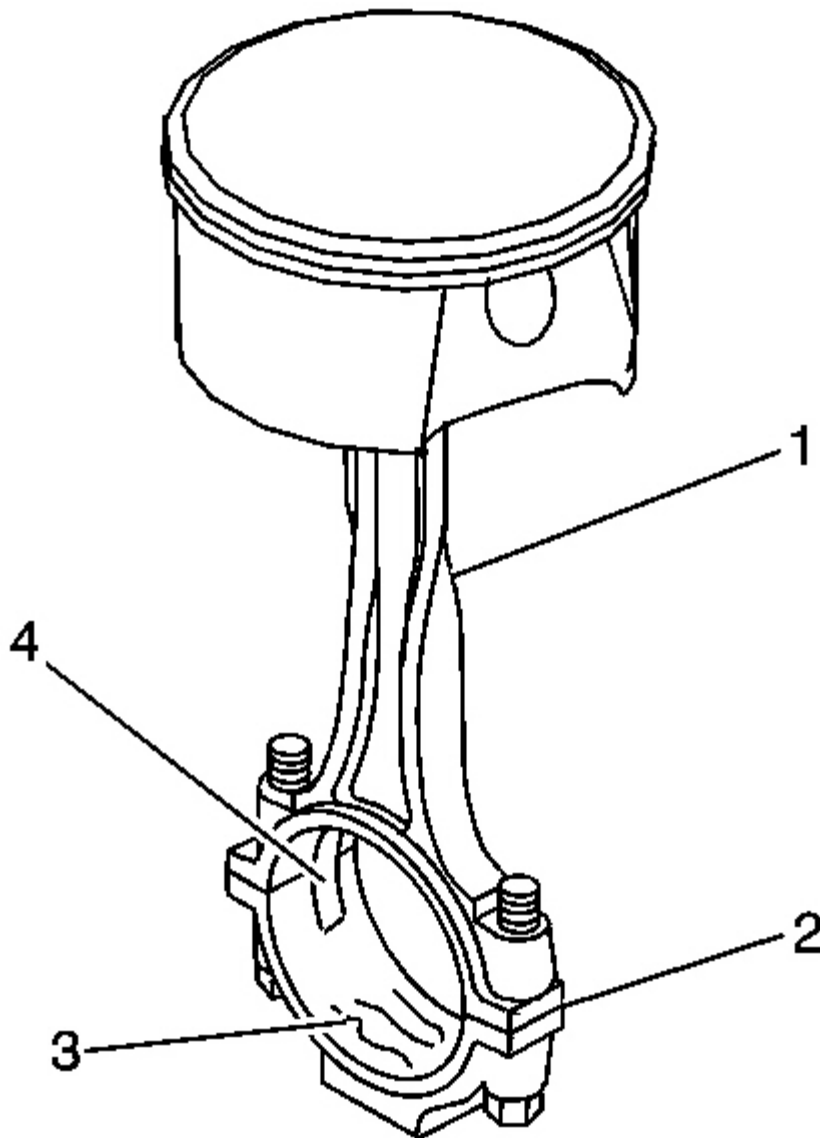
Fig. 453: Identifying Connecting Rod Inspection Areas

3. Inspect the connecting rod for the following conditions:
 - Twisting (1)
 - Proper fit of the connecting rod and cap mating surfaces (2)
 - Nicks or gouges in the bearing bore (3)
 - Damage to the bearing locating slots (4)

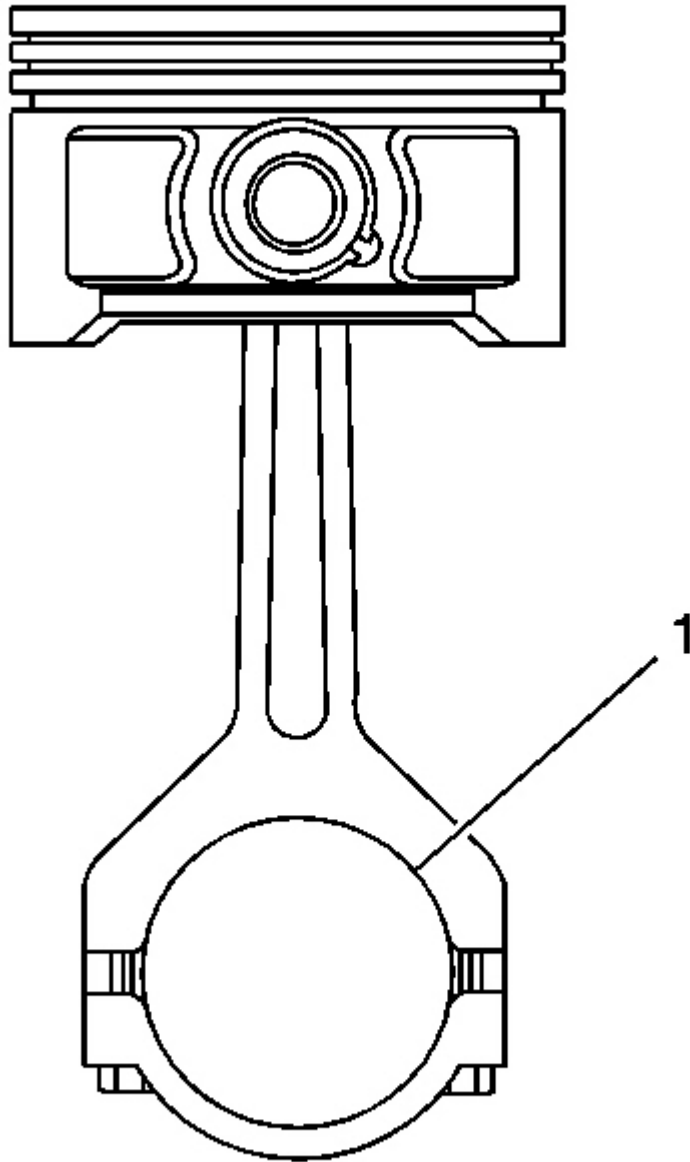
Fig. 454: View Of Connecting Rod Bearing Bore
Courtesy of GENERAL MOTORS CORP.

4. Measure the connecting rod bearing bore (1) for an out-of-round condition. Refer to **Engine Mechanical Specifications**.

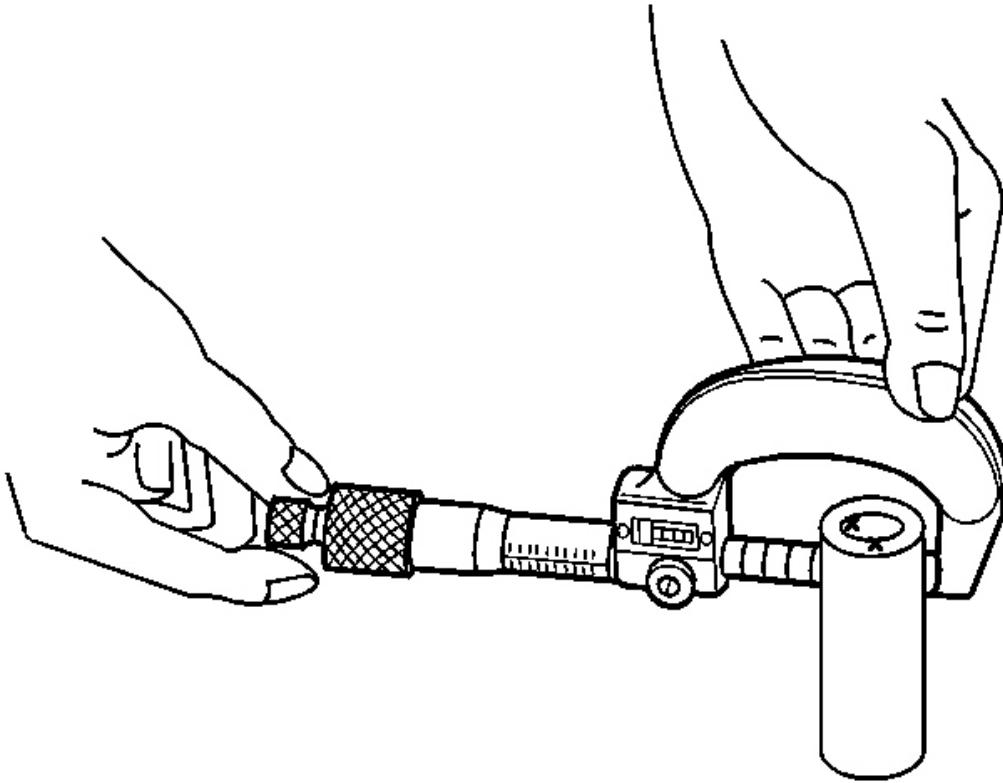
Fig. 455: Measuring Piston Pin Diameter
Courtesy of GENERAL MOTORS CORP.

5. To determine full-floating piston pin-to-connecting rod bore clearance, use a micrometer and measure the piston pin outside diameter (OD).

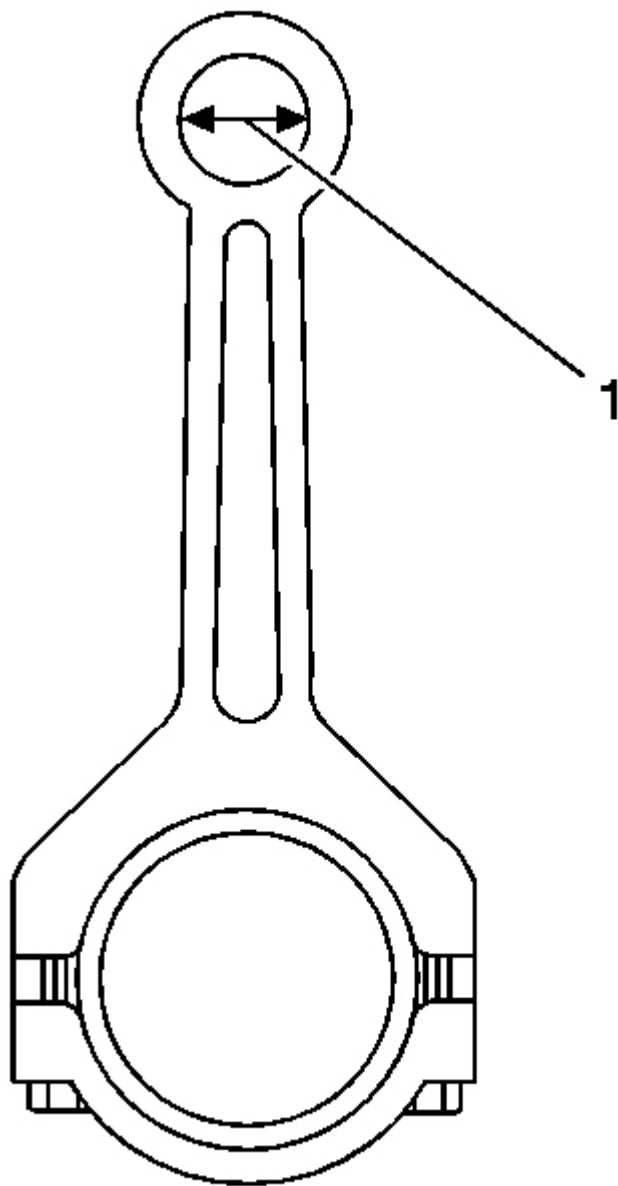
Fig. 456: Measuring Connecting Rod Pin Bore Inside Diameter
Courtesy of GENERAL MOTORS CORP.

6. To determine the full-floating piston pin-to-connecting rod bore clearance, use a micrometer and measure the connecting rod pin bore (1) inside diameter (ID).
7. Subtract the piston pin OD measurement from the connecting rod pin bore ID measurement to determine

pin-to-bore clearance. Refer to **Engine Mechanical Specifications**.

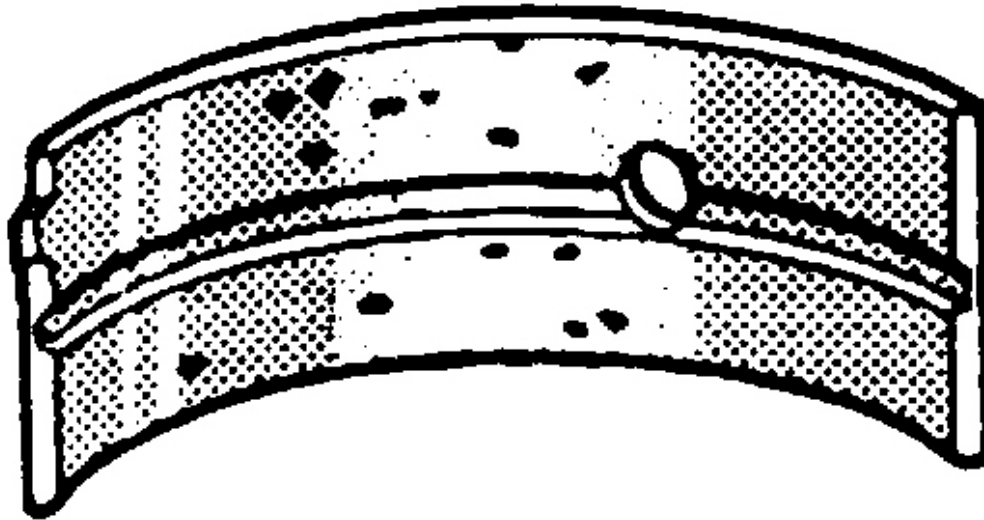
Fig. 457: Identifying Crankshaft Bearing Craters Or Pockets
Courtesy of GENERAL MOTORS CORP.

8. Inspect the connecting rod bearings for craters or pockets. Flattened sections on the bearing halves indicate fatigue.

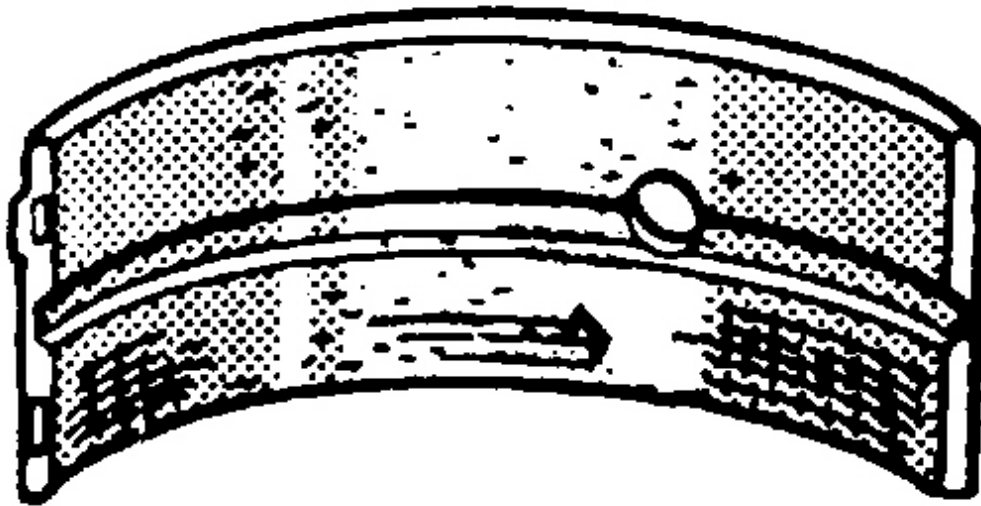
Fig. 458: Identifying Connecting Rod Bearing Scoring Or Discoloration
Courtesy of GENERAL MOTORS CORP.

9. Inspect the connecting rod bearings for excessive scoring or discoloration.
10. Inspect the connecting rod bearings for dirt or debris imbedded into the bearing material.

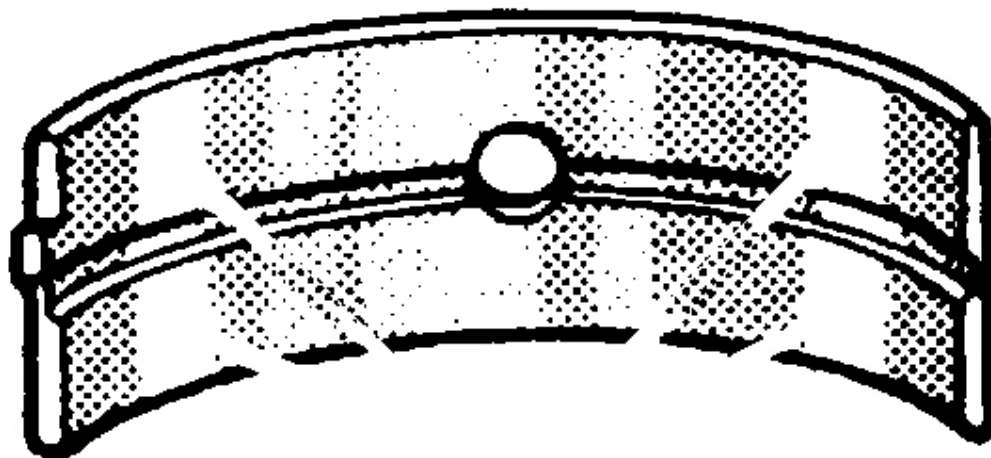
Fig. 459: Crankshaft Bearing Polished Sections (Improper Seating)
Courtesy of GENERAL MOTORS CORP.

11. Inspect the connecting rod bearings for improper seating indicated by bright, polished sections of the bearing surface.

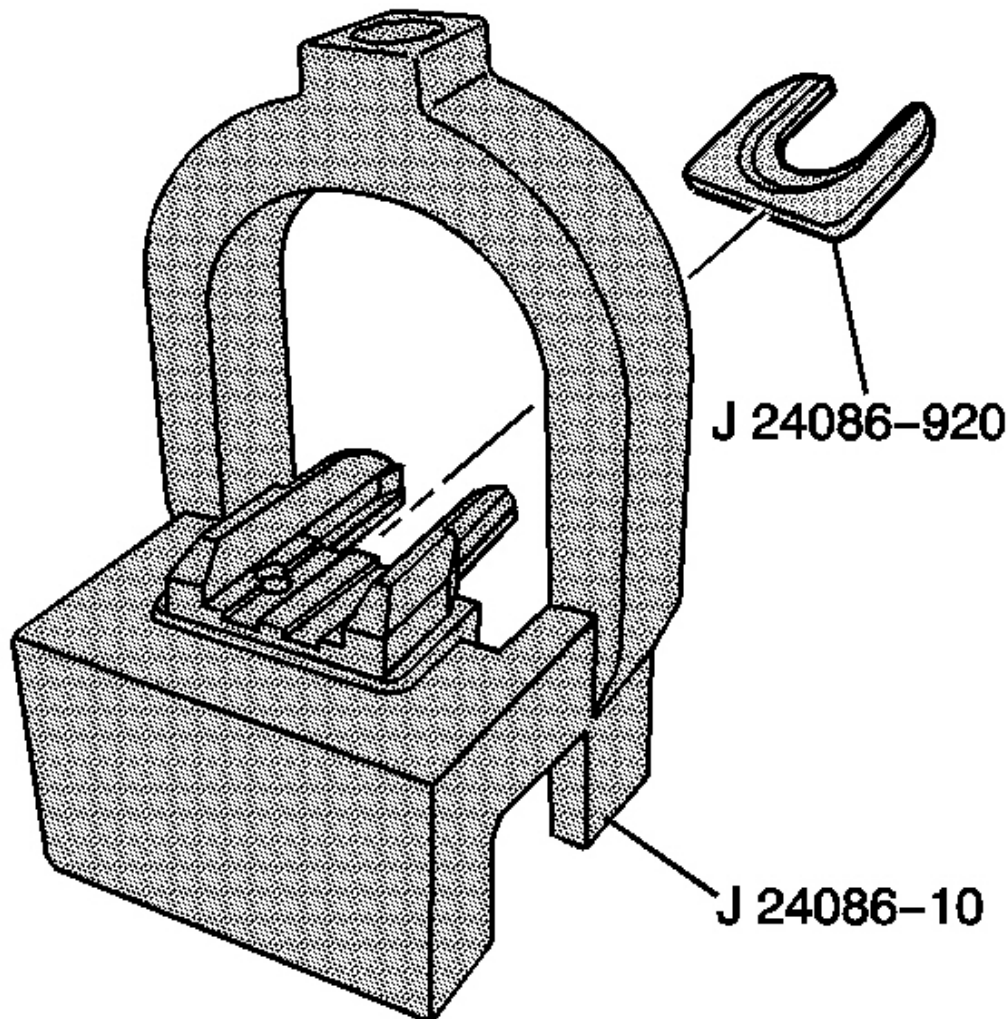
Fig. 460: View Of J 24086-920 & J 24086-10
Courtesy of GENERAL MOTORS CORP.

1. Install fork insert J 24086-920 into J 24086-10 .

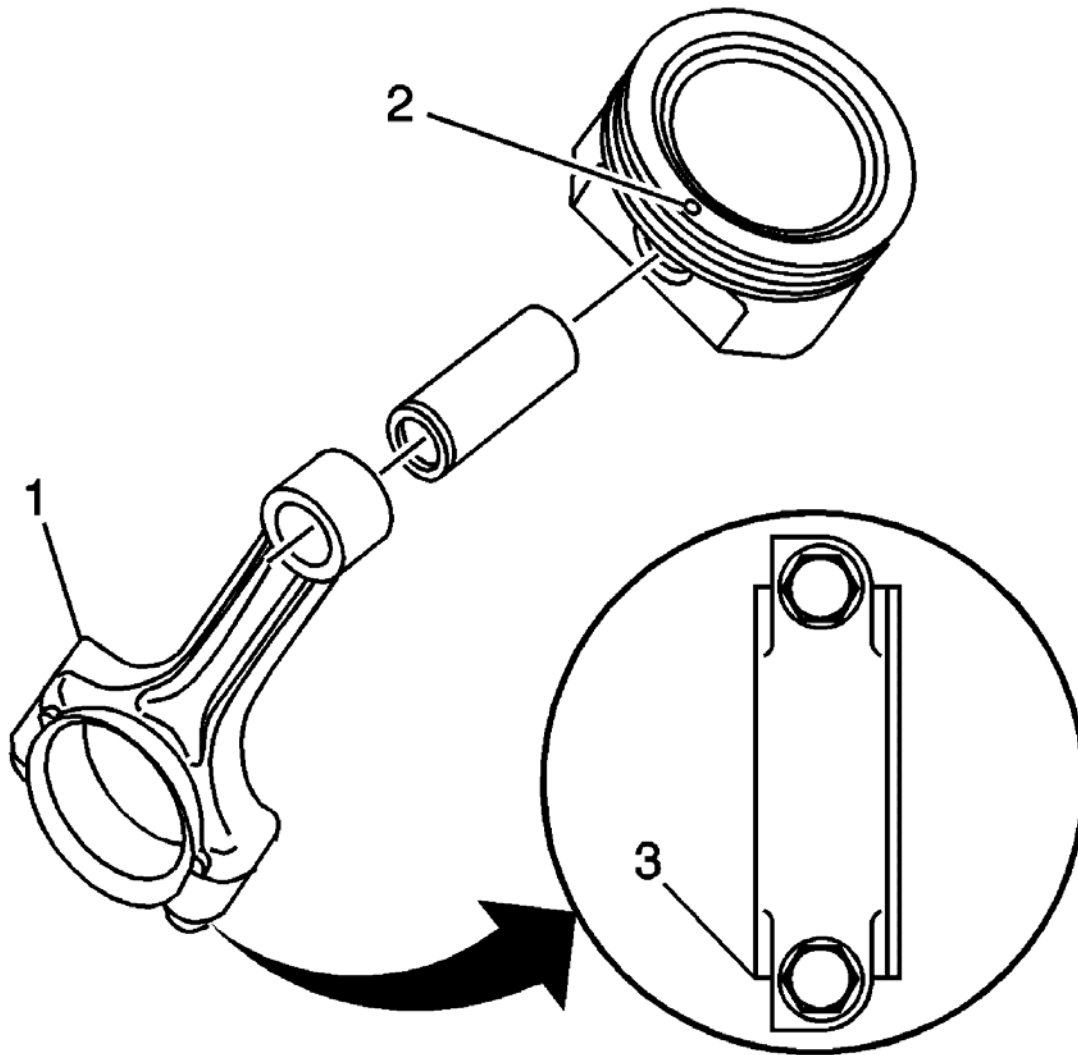
Fig. 461: View Of Connecting Rod Positioning Tab, Flat Flange & Mark On Top Of Piston
Courtesy of GENERAL MOTORS CORP.

2. Use a torch and apply MILD heat to the pin end of the connecting rod. Mild heating of the connecting rod will ease in piston and pin assembly.
3. Identify the positioning tab (1) or flat flange (3) of the connecting rod. When properly assembled, the positioning tab or flat flange of the rod and the mark (2) on the top of the piston should both be facing the front of the engine.

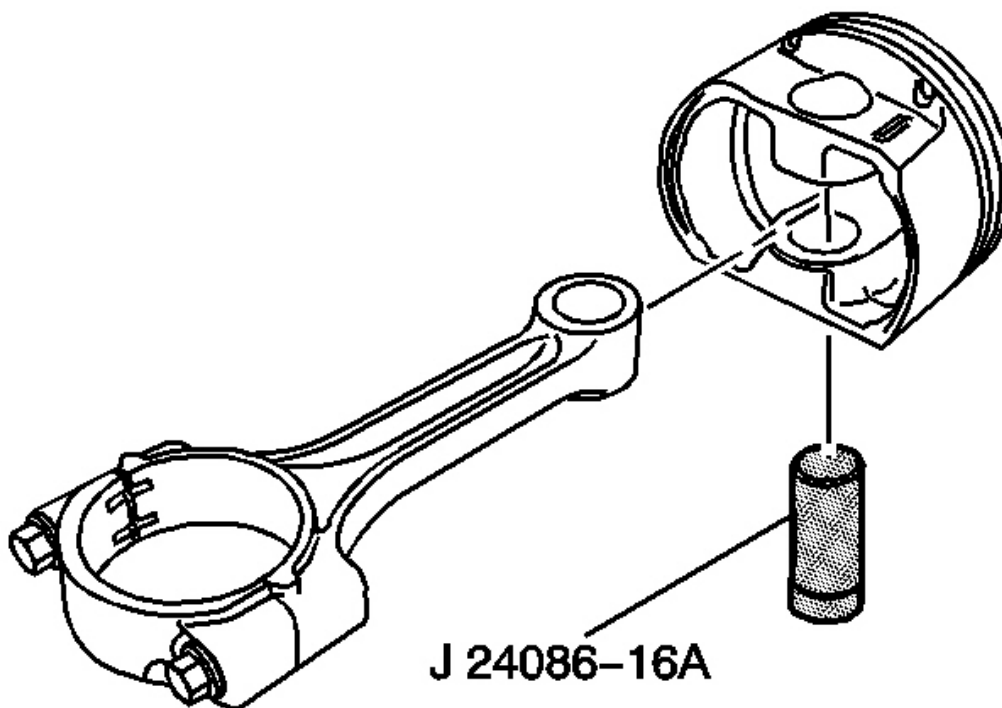
Fig. 462: View Of Piston, Connecting Rod & J 24086-16A
Courtesy of GENERAL MOTORS CORP.

4. Assemble the piston, the connecting rod, and the J 24086-16A.

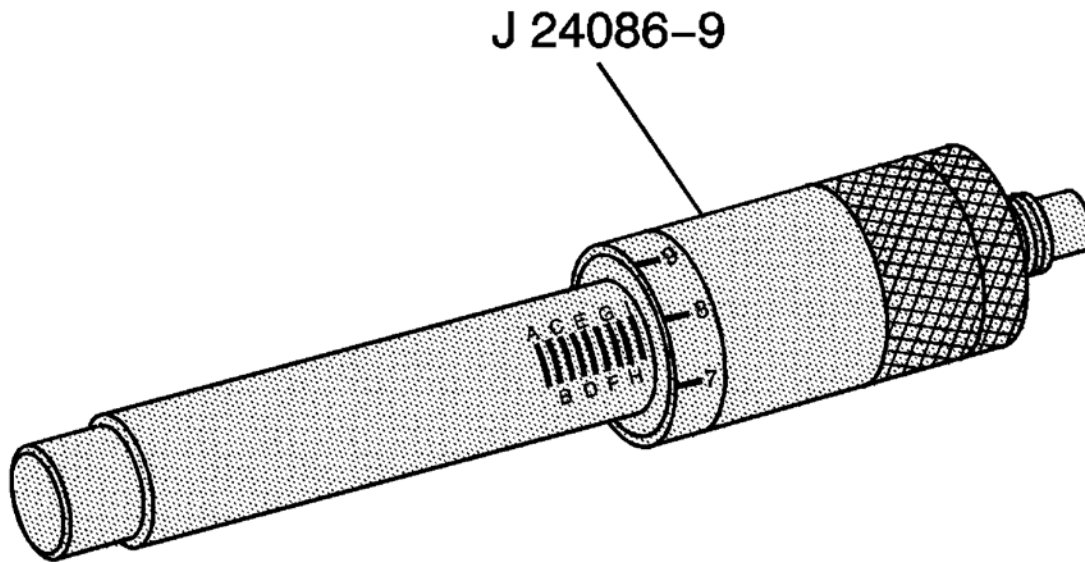
Fig. 463: Closeup View Of J 24086-9
Courtesy of GENERAL MOTORS CORP.

5. Adjust the J 24086-9 to I 8.

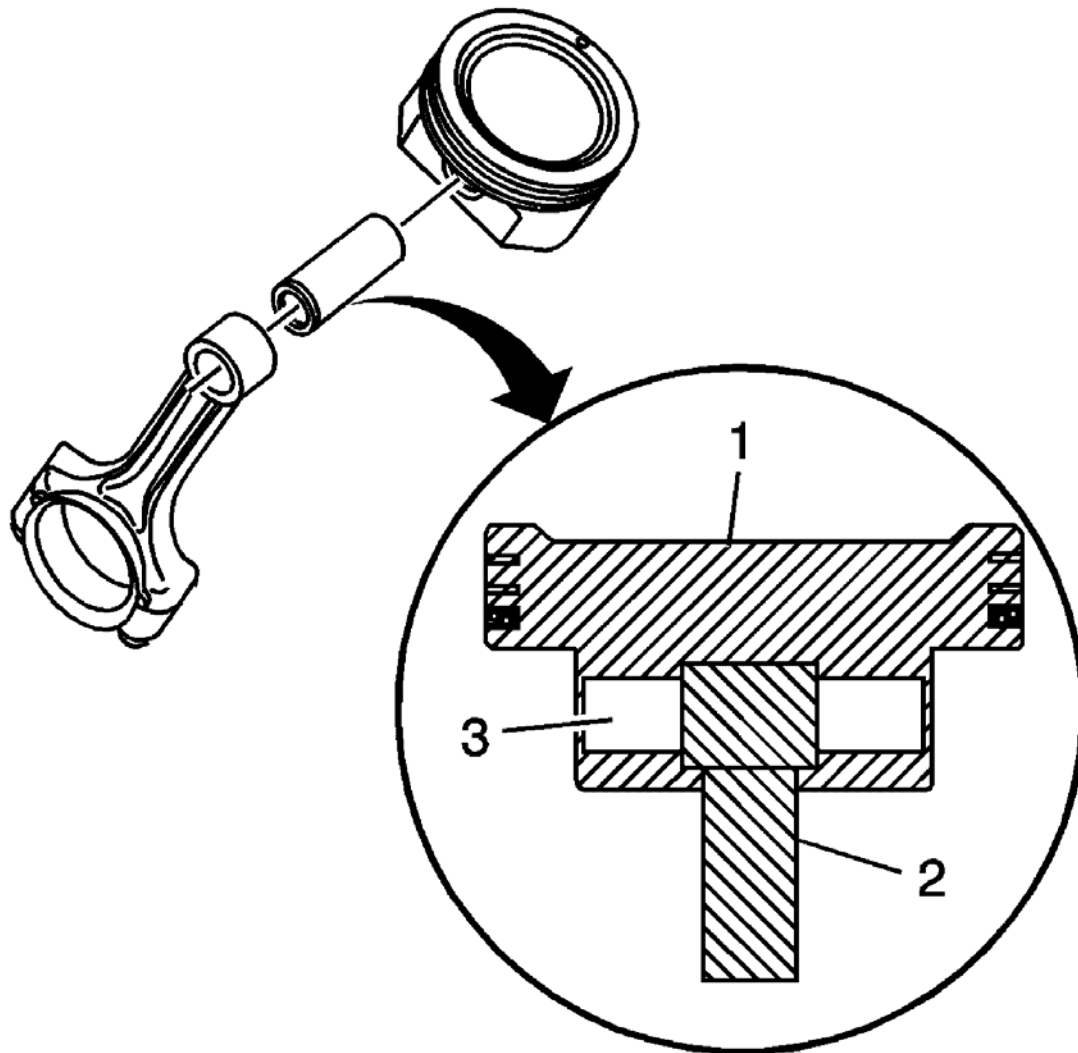
6. Install the piston, connecting rod, piston pin, and J 24086-16A to the J 24086-10 .

Fig. 465: View Of Piston, Pin & Connecting Rod Proper Assembly
Courtesy of GENERAL MOTORS CORP.

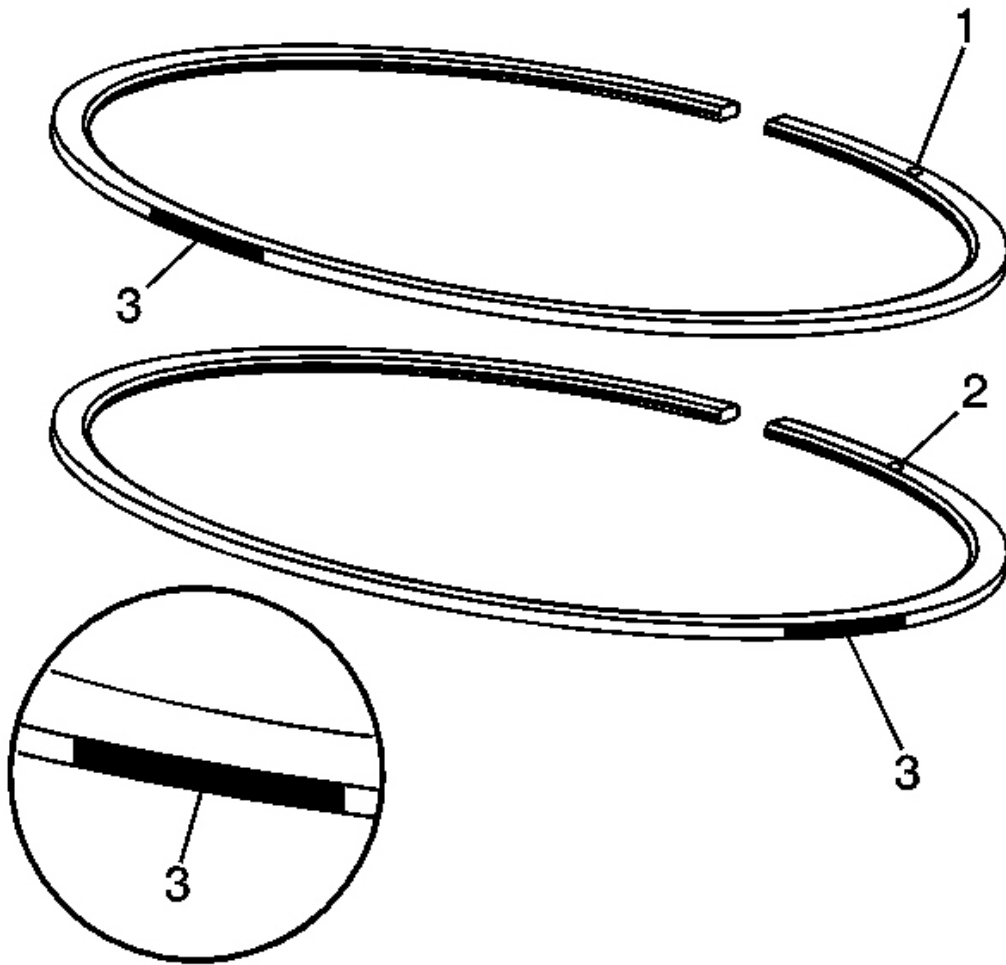
Fig. 466: View Of Upper/Lower Compression Rings & Marks
Courtesy of GENERAL MOTORS CORP.

10. Identify the compression and oil control rings for proper installation. The upper compression ring can be identified by a paint mark (3) located 180 degrees from the end gap. The lower compression ring can be identified by a paint mark (3) located 90 degrees from the end gap. Both rings should be installed with the orientation marks (1, 2) facing the top of the piston.

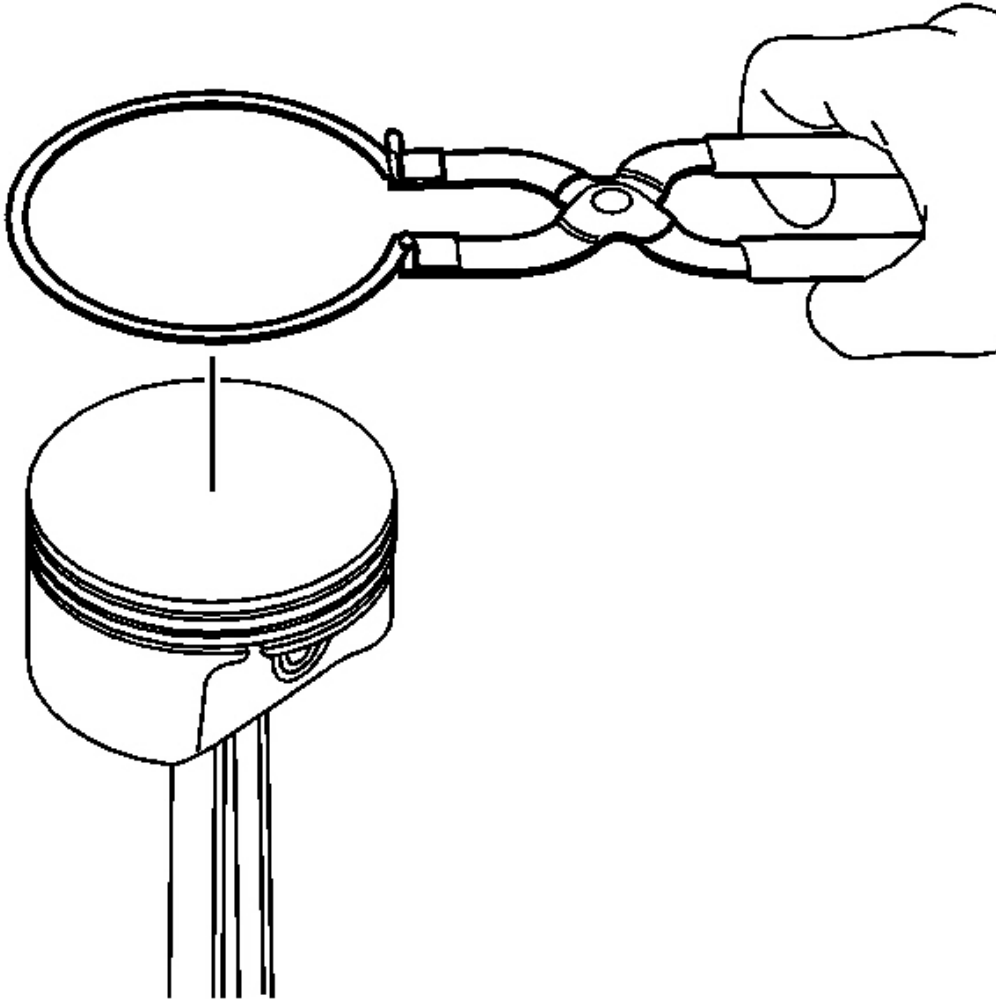
Fig. 467: Removing/Installing Piston Rings
Courtesy of GENERAL MOTORS CORP.

IMPORTANT: When installing piston rings, use a ring expander plier type tool. Do not roll the rings into the grooves of the piston. Use caution and care to expand the rings only slightly larger than the outside diameter (OD) of the piston.

11. Using piston ring pliers, install the piston rings onto the piston.
12. Position the oil control ring end gaps a minimum of 25 mm (1.0 in) from each other.
13. Position the compression ring end gaps 180 degrees opposite each other.

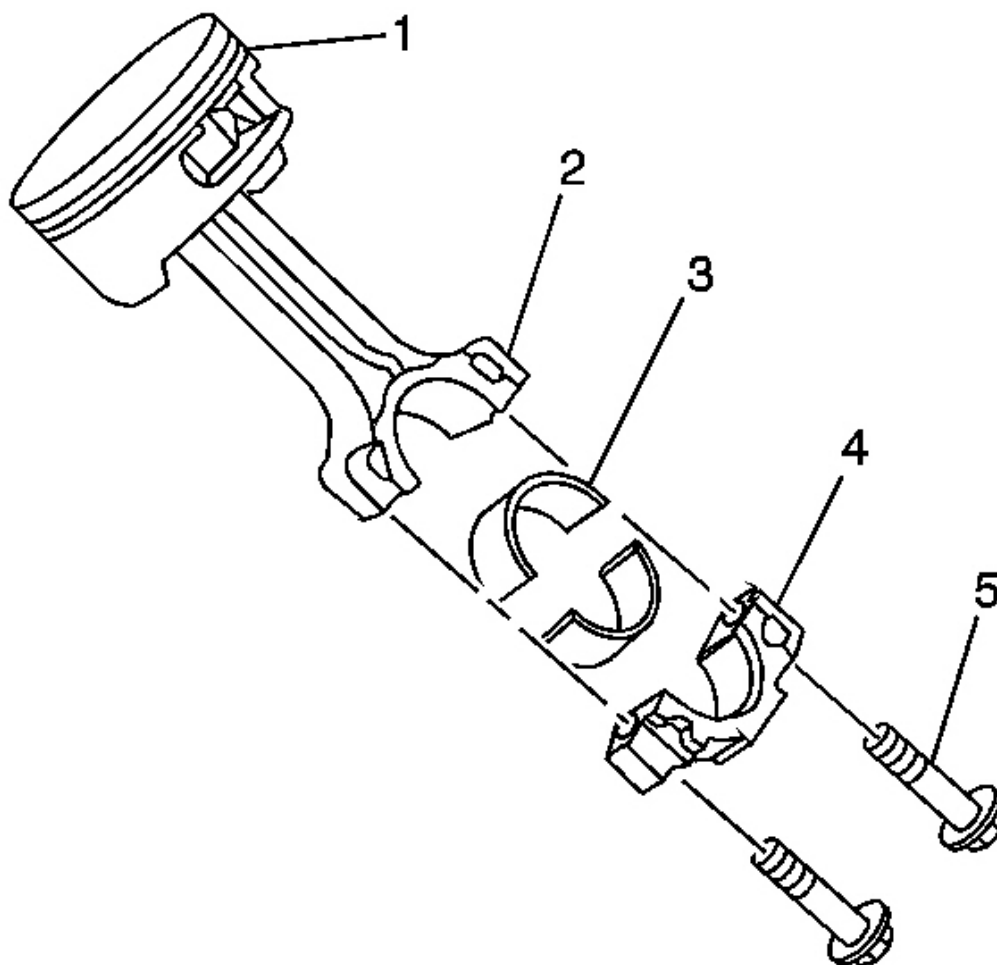
Fig. 468: View Of Piston & Connecting Rod Components
Courtesy of GENERAL MOTORS CORP.

14. Install the connecting rod bearings (3) to the rod (2) and cap (4).

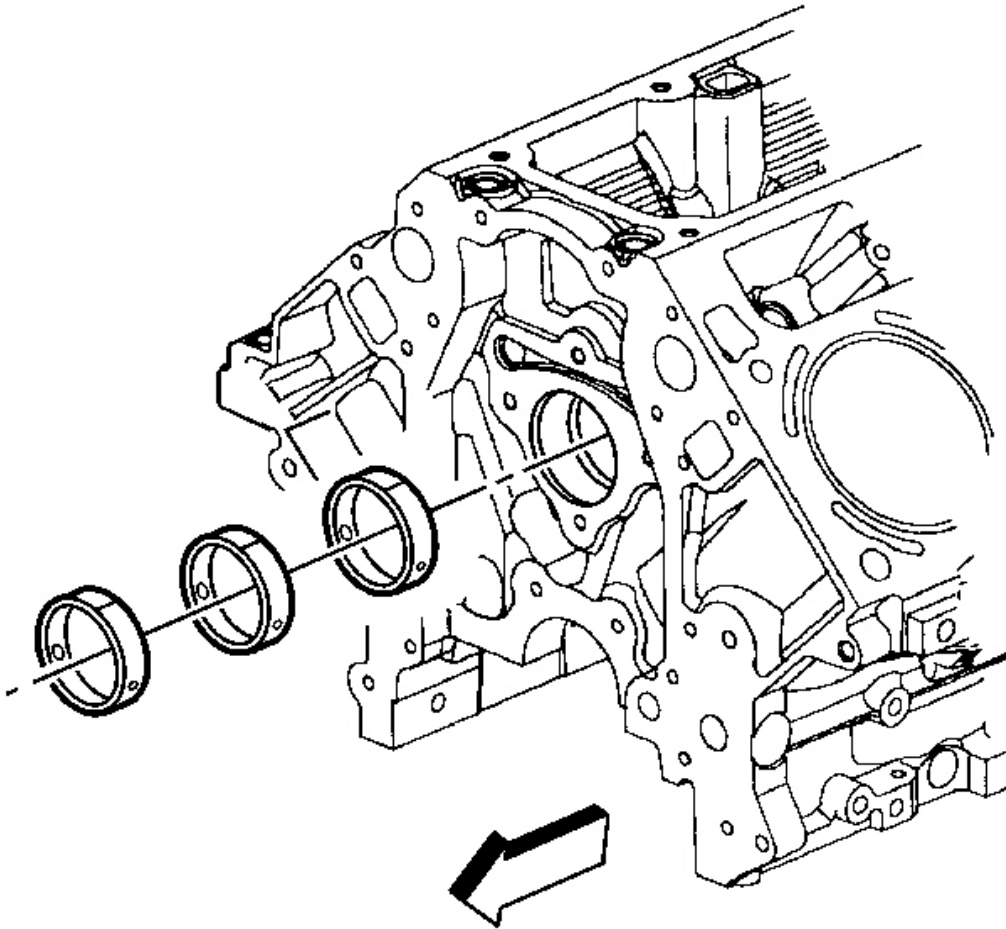
Fig. 469: View Of Camshaft Bearings
Courtesy of GENERAL MOTORS CORP.

IMPORTANT: A loose camshaft bearing may be caused by an enlarged, out of round or damaged engine block bearing bore.

1. Prior to bearing removal, inspect the camshaft bearings for loose fit in the engine block bearing bores.

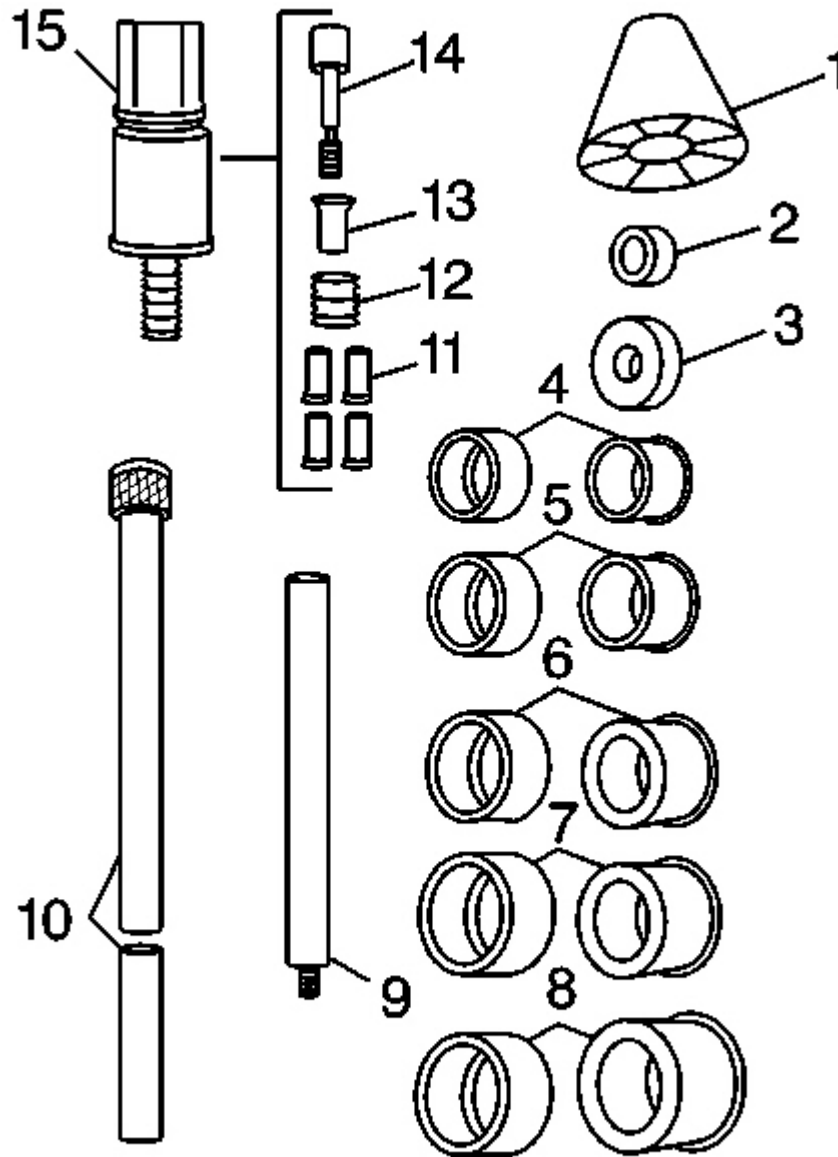
Fig. 470: View Of J 33049 Camshaft Bearing Service Kit Components
Courtesy of GENERAL MOTORS CORP.

3. Select the expanding driver (4-8) and washer (2 or 3) from the **J 33049** . See **Special Tools and Equipment.**
4. Assemble the tool.

5. Insert the tool through the front of the engine block and into the bearing.
6. Tighten the expander assembly (15) nut until snug.
7. Push the guide cone (1) into the front camshaft bearing to align the tool.

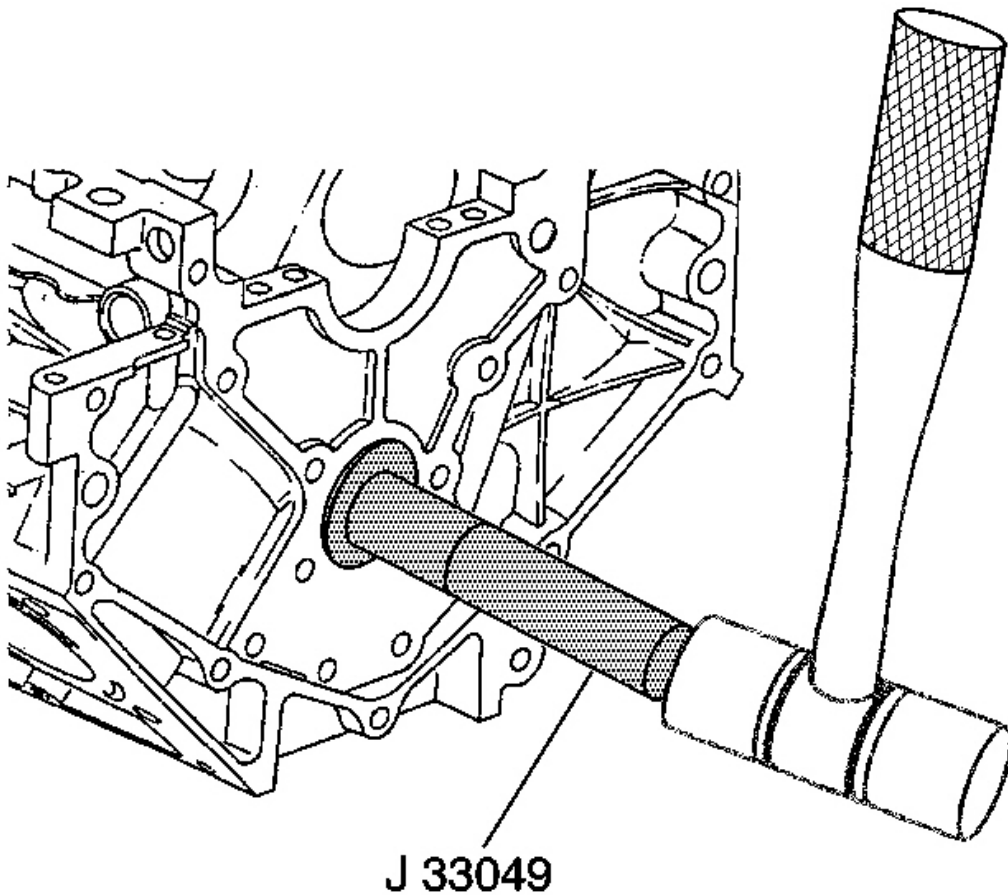
Fig. 471: Driving Bearing From/Into Block Bore
Courtesy of GENERAL MOTORS CORP.

8. Drive the bearing from the block bore.

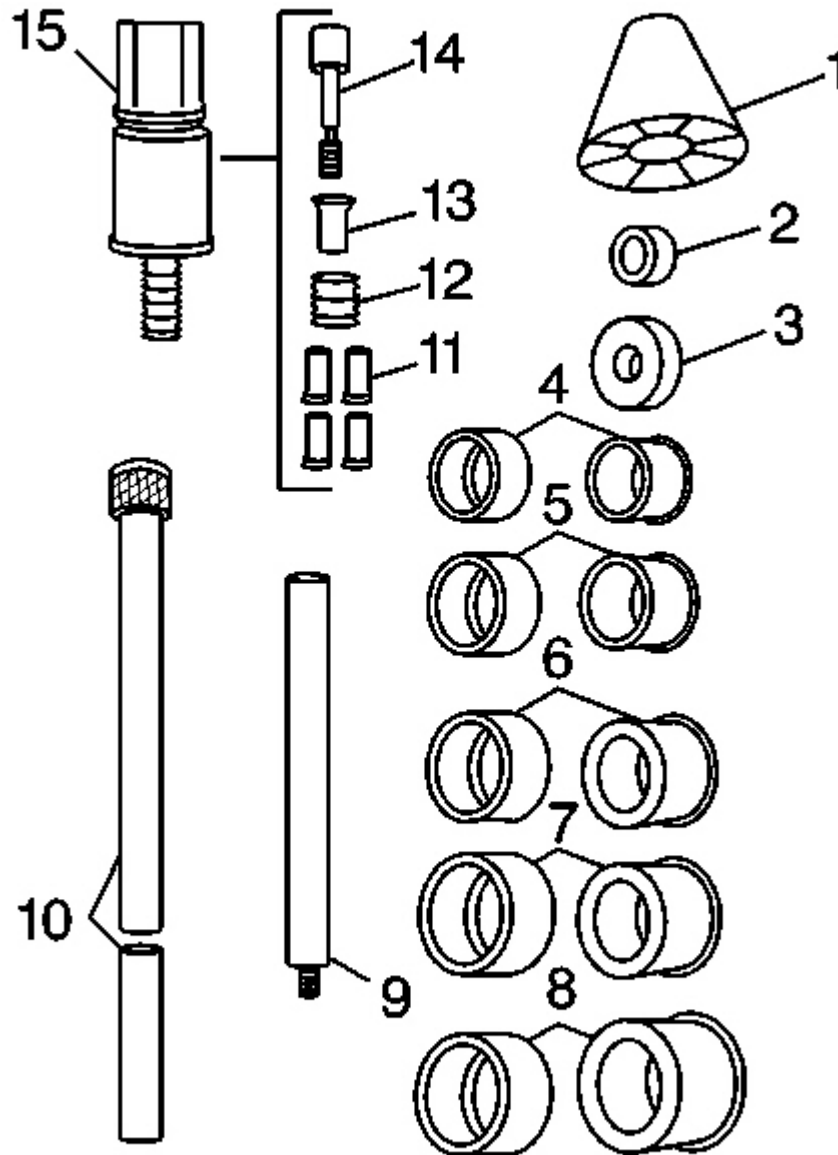
Fig. 472: View Of J 33049 Camshaft Bearing Service Kit Components
Courtesy of GENERAL MOTORS CORP.

2. Place the expanding driver onto the expander assembly.
3. Check to insure that the separation lines between the segments of the expanding driver align with the separation lines of the expander assembly.
4. Place the guide cone over the driving bar, with the small end of the cone facing the driver assembly.
5. Place the driving washer over the threaded portion of the expander assembly.
6. Screw the expander assembly, with driving washer, onto the driving bar.

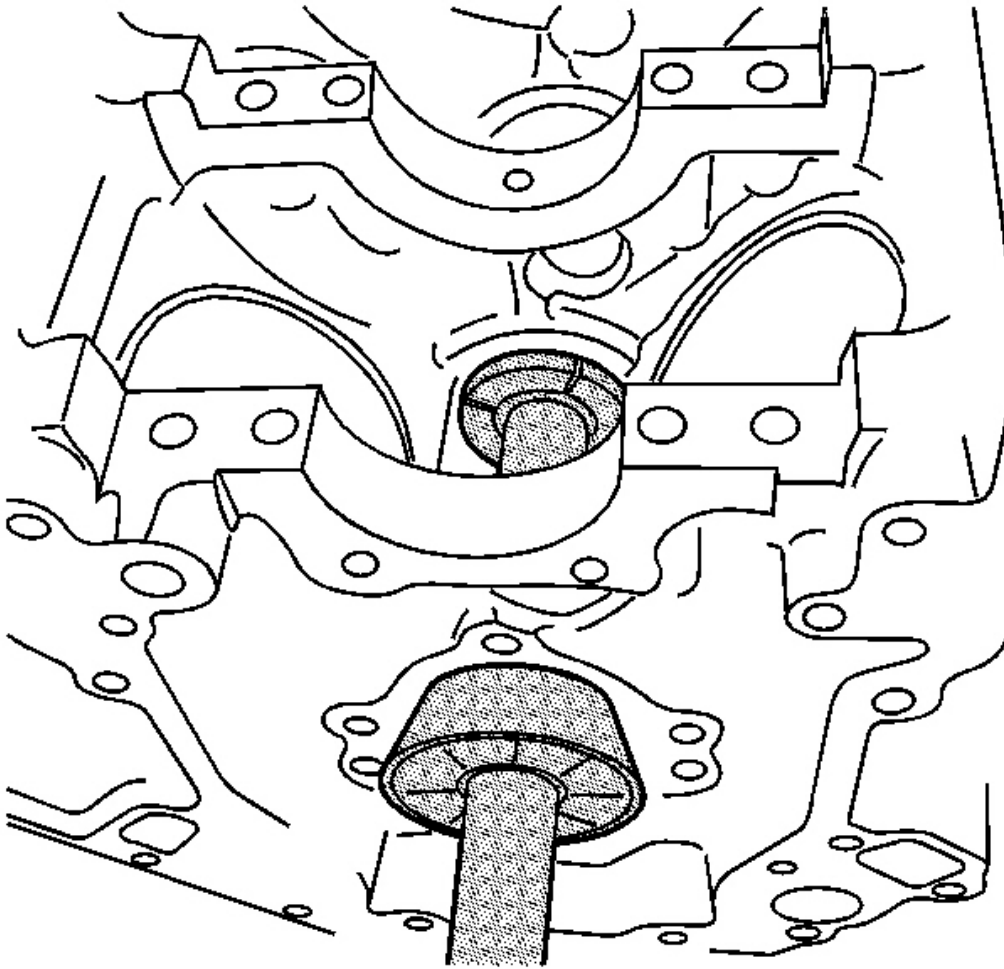
Fig. 473: View Of J 33049 Camshaft Bearing Tool & Nylon Cone
Courtesy of GENERAL MOTORS CORP.

7. Insert the tool into a inner camshaft bearing and tighten until snug.

8. Slide the nylon cone into the front or rear camshaft bearing. This will properly align the tool.
9. Drive the bearing out of or into the engine block.
10. Repeat the procedure for the additional inner bearings.

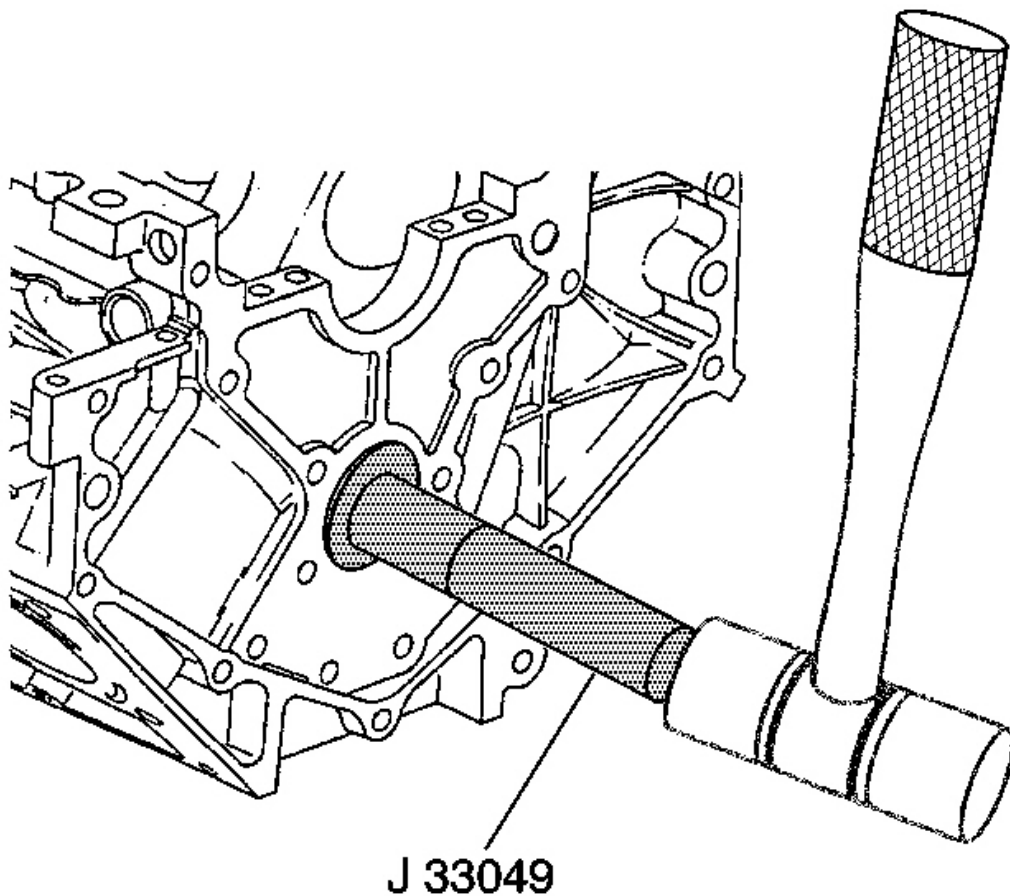
Fig. 474: Driving Bearing From/Into Block Bore
Courtesy of GENERAL MOTORS CORP.

11. For the two end bearings, front and rear, remove the nylon cone and driver bar extension.
12. Drive the bearings out of or into the engine block.

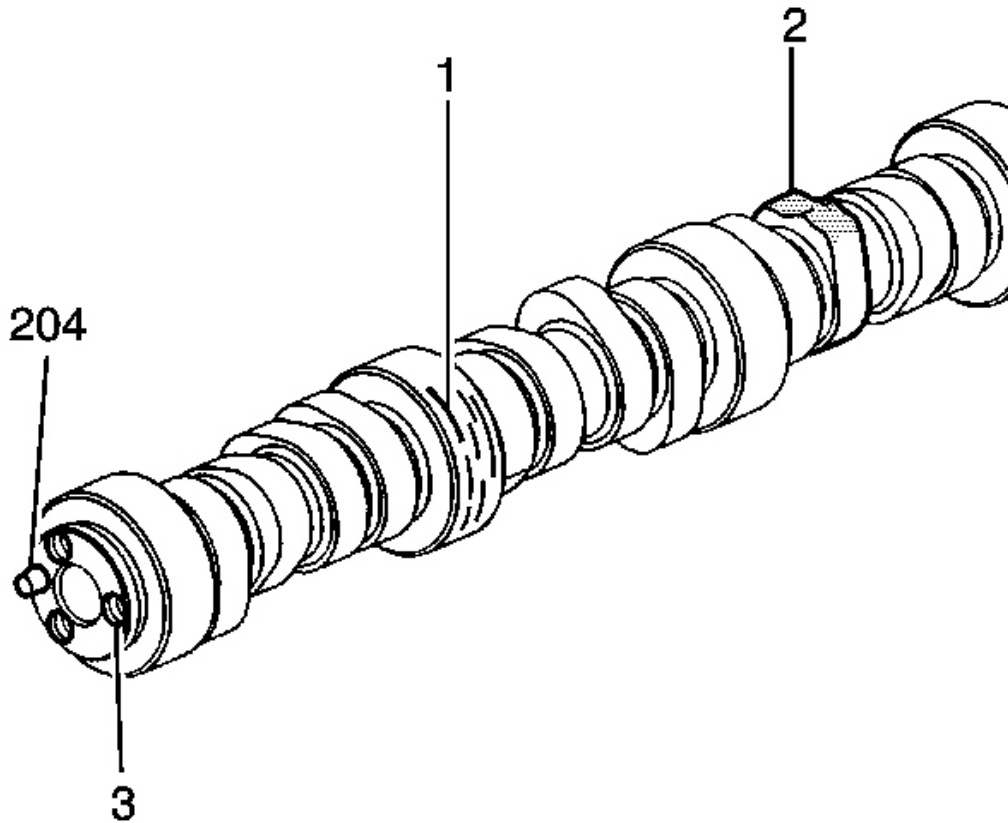
Fig. 475: Identifying Camshaft & Bearing Inspection Areas
Courtesy of GENERAL MOTORS CORP.

2. Dry the components with compressed air.
3. Inspect the camshaft bearing journals (1) for scoring or excessive wear.
4. Inspect the camshaft valve lifter lobes (2) for scoring or excessive wear.
5. Inspect the threaded bolt holes (3) in the front of the camshaft for damaged threads or debris.
6. Inspect the camshaft sprocket pin (204) for damage.
7. Inspect the camshaft position reluctor ring for nicks or damage.
