2004 Isuzu Ascender LS

2004 ENGINE Engine Mechanical - 4.8L, 5.3L, and 6.0L - Ascender

Engine Mechanical - 4.8L, 5.3L, and 6.0L - Ascender

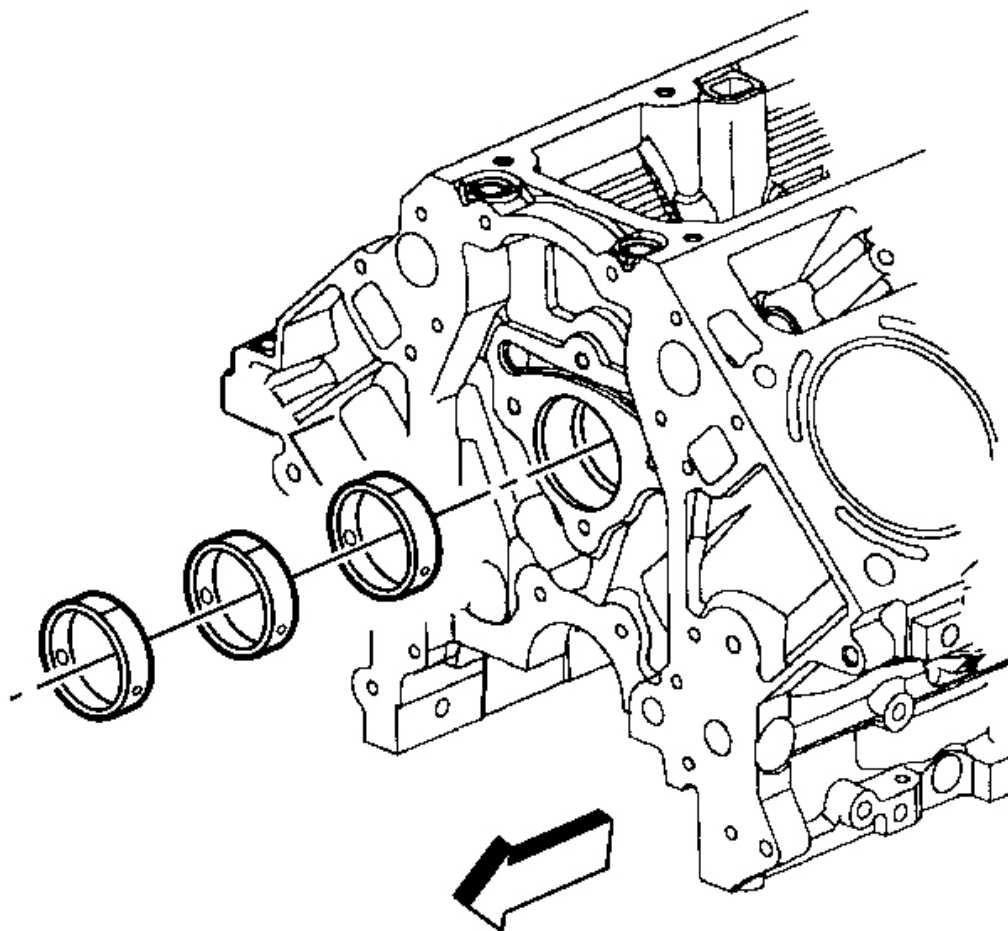
Fig. 477: View Of Camshaft Bearings
Courtesy of GENERAL MOTORS CORP.

9. Inspect the camshaft bearings for proper fit in the engine block. Camshaft bearings have an interference fit to the engine block and should not be loose in their engine block bearing bores.
10. Inspect the camshaft bearings for excessive wear or scoring.

Bearings with excessive scoring or wear must be replaced.

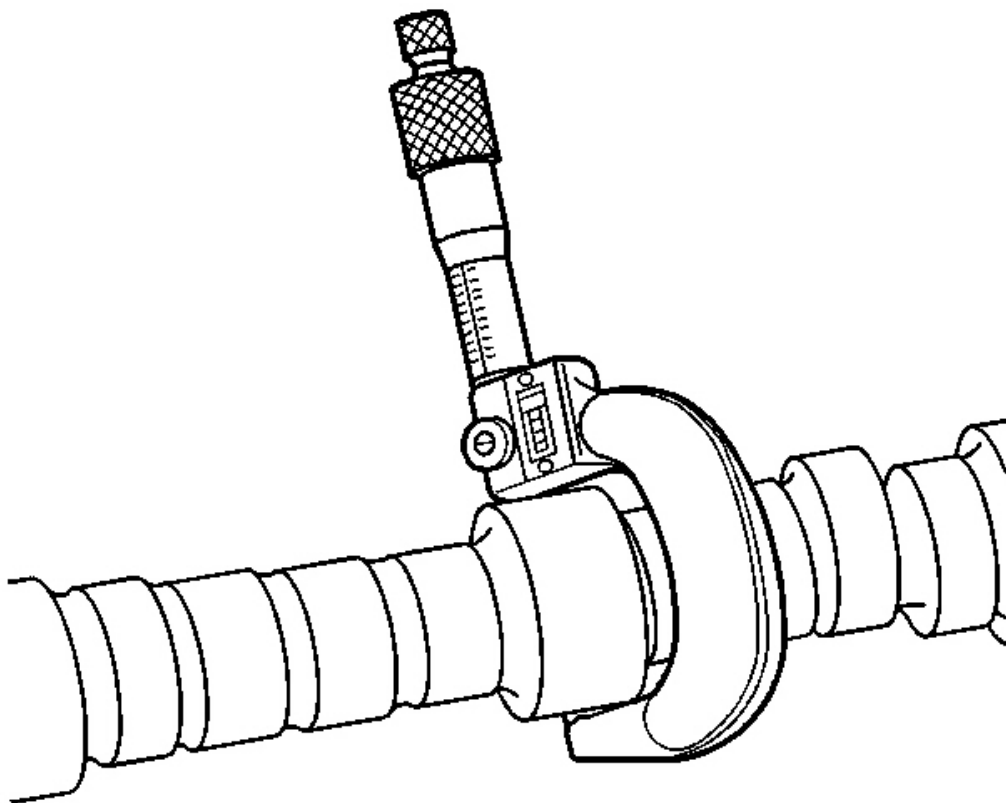
Fig. 478: Measure Camshaft Journals With Micrometer
Courtesy of GENERAL MOTORS CORP.

11. Measure the camshaft journals for wear and out-of-round with a micrometer.
 - If the camshaft bearing journals are more than 0.025 mm (0.001 in) out-of-round, replace the camshaft.
 - If the camshaft bearing journal diameter is less than 54.99 mm (2.164 in), replace the camshaft.

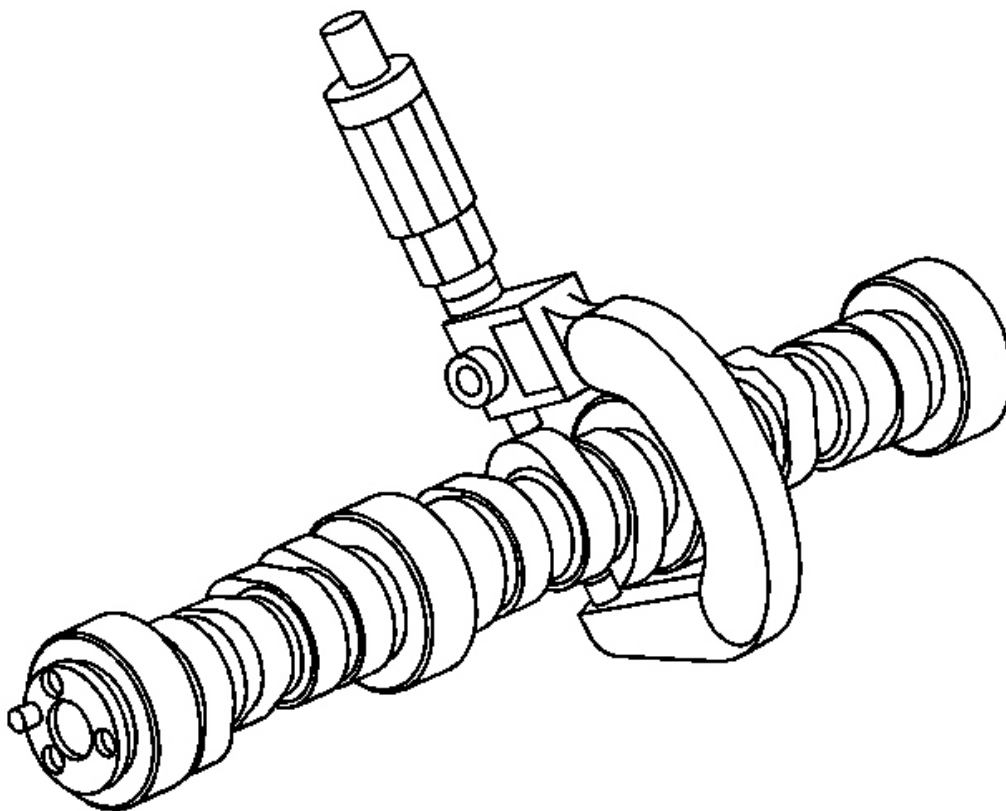
Fig. 479: Measuring Camshaft Lobes
Courtesy of GENERAL MOTORS CORP.

12. Measure the camshaft lobes for wear with a micrometer.
 - A 5.3L camshaft with an intake lobe that measures 46.169 mm (1.817 in) or less must be replaced.
 - A 5.3L camshaft with an exhaust lobe that measures 46.199 mm (1.818 in) or less must be replaced.

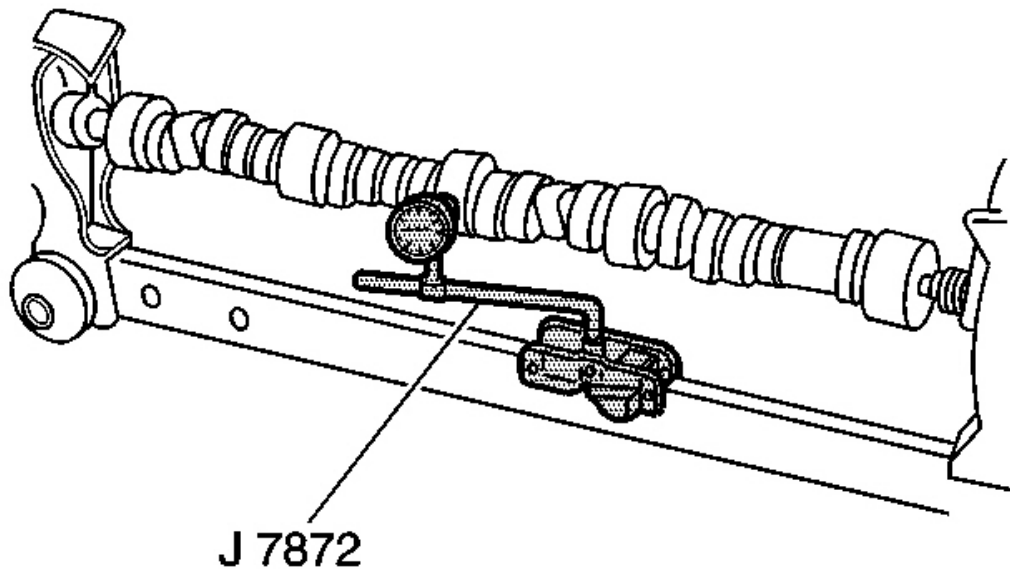
Fig. 480: Measuring Camshaft Runout
Courtesy of GENERAL MOTORS CORP.

13. Measure the camshaft runout.
 1. Mount the camshaft in wooden V blocks or between centers on a fixture.
 2. Check the runout of the intermediate camshaft bearing journals using the **J 7872**.
 3. If camshaft runout exceeds 0.05 mm (0.002 in), the camshaft is bent and should be replaced.

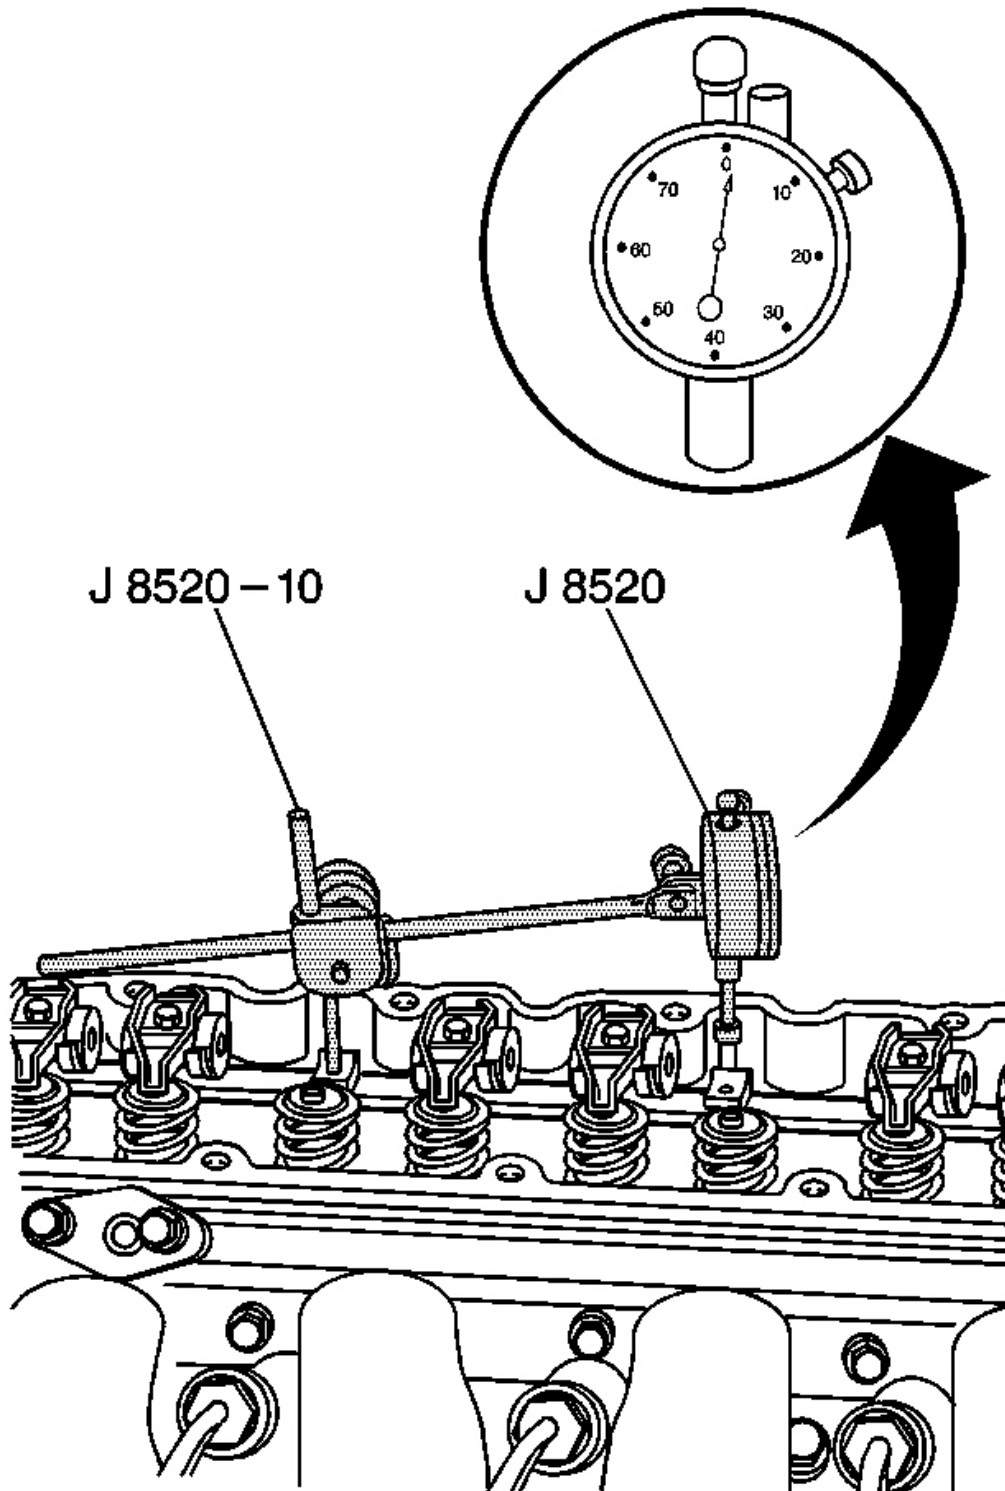
Fig. 481: Measuring Camshaft Lobe Lift
Courtesy of GENERAL MOTORS CORP.

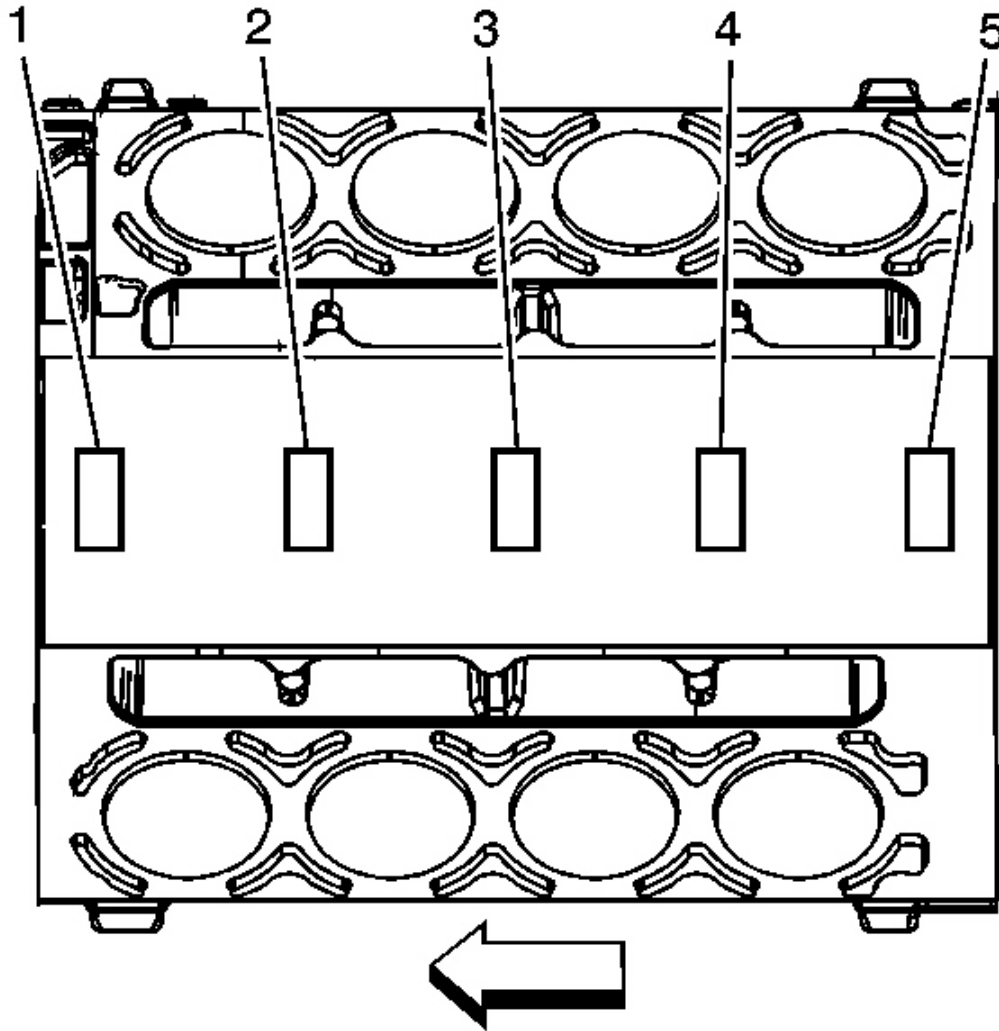
Fig. 482: Identifying Engine Block Camshaft Bearing Bores
Courtesy of GENERAL MOTORS CORP.

IMPORTANT: The engine block camshaft bearing bores are machined for 3 different outside diameter (OD) size bearings. Positions 1 and 5 are the largest diameter bores. Position 3 is the smallest diameter bore. Positions 2 and 4 are the intermediate size bores. The inside diameter (ID) for all camshaft bearings is the same size.

1. Measure the engine block camshaft bearing bores (1-5) to identify the correct OD size bearing for each position. Refer to **Engine Mechanical Specifications**

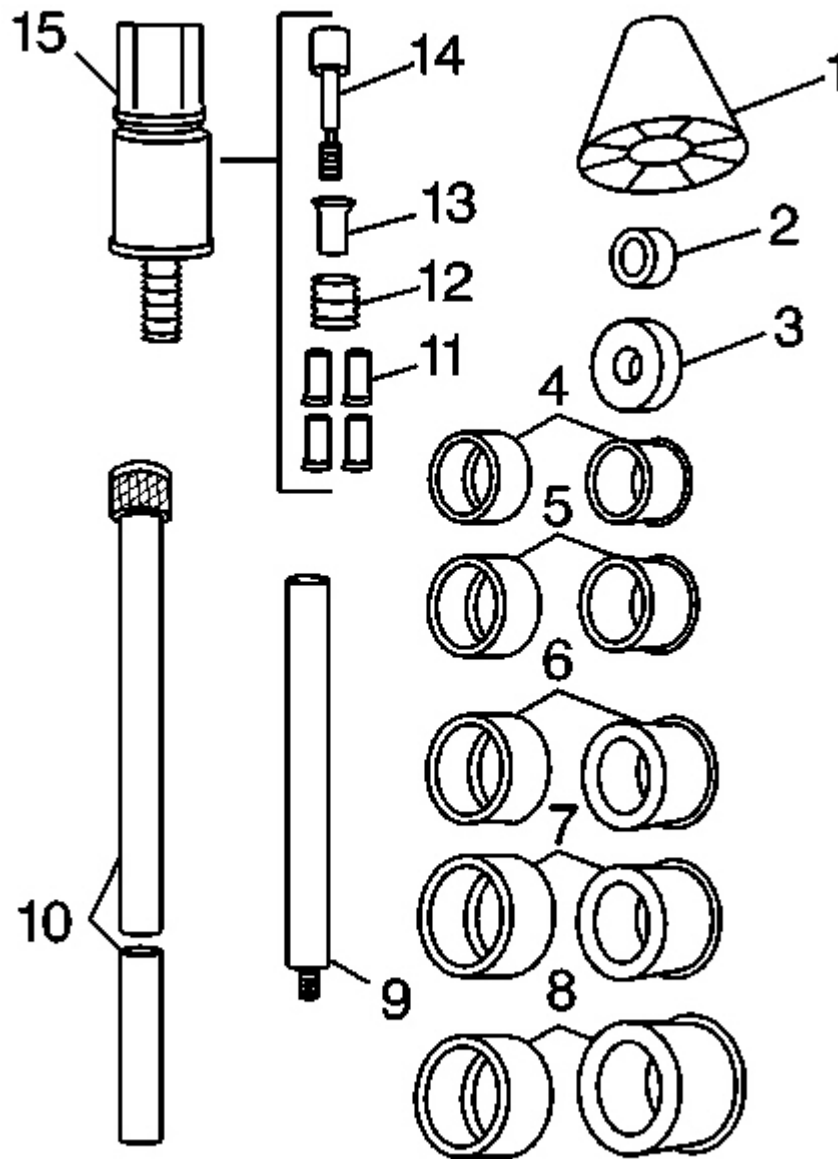
Fig. 483: View Of J 33049 Camshaft Bearing Service Kit Components
Courtesy of GENERAL MOTORS CORP.

2. Select the expanding driver (4-8) and washer (2 or 3) from the **J 33049** . Refer to **Camshaft Bearing Removal**. See **Special Tools and Equipment**.
3. Assemble the tool.

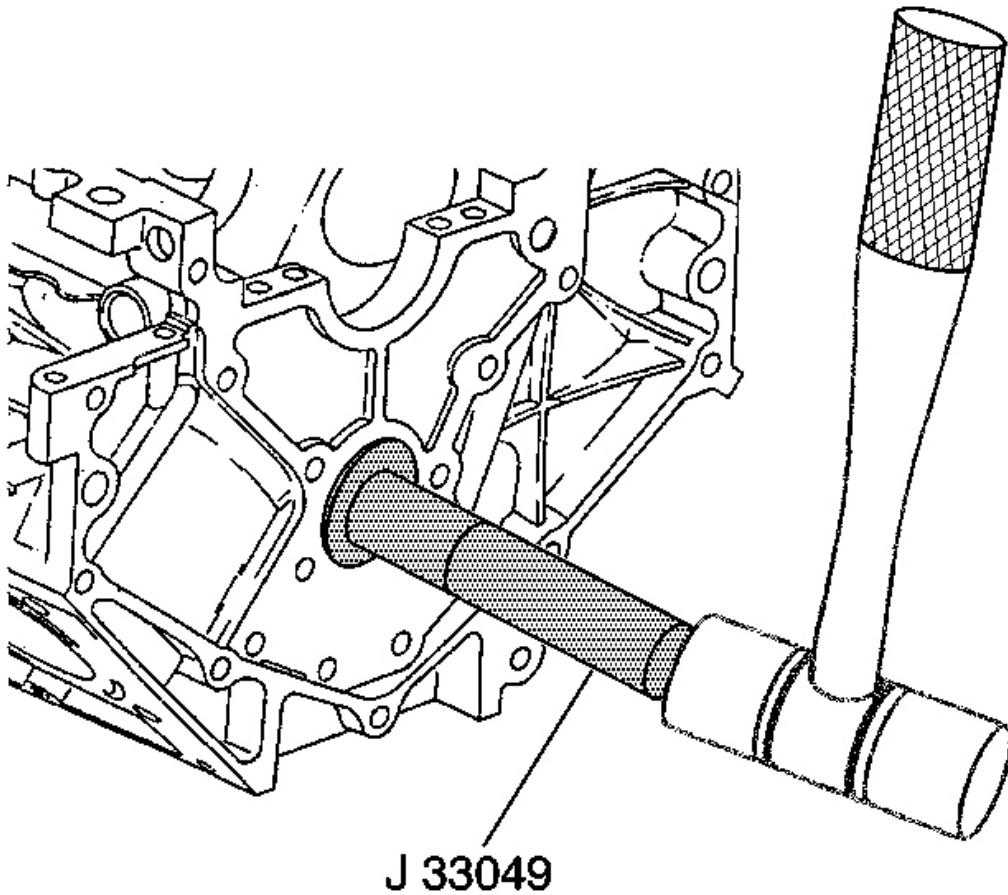
Fig. 484: Driving Bearing From/Into Block Bore
Courtesy of GENERAL MOTORS CORP.

4. Insert the tool through the front of the engine block and into the bearing.
5. Tighten the expander assembly nut until snug.
6. Push the guide cone into the front camshaft bearing to align the tool.
7. Drive the bearing into the block bore.
8. Repeat the above procedures to install the remaining bearings.

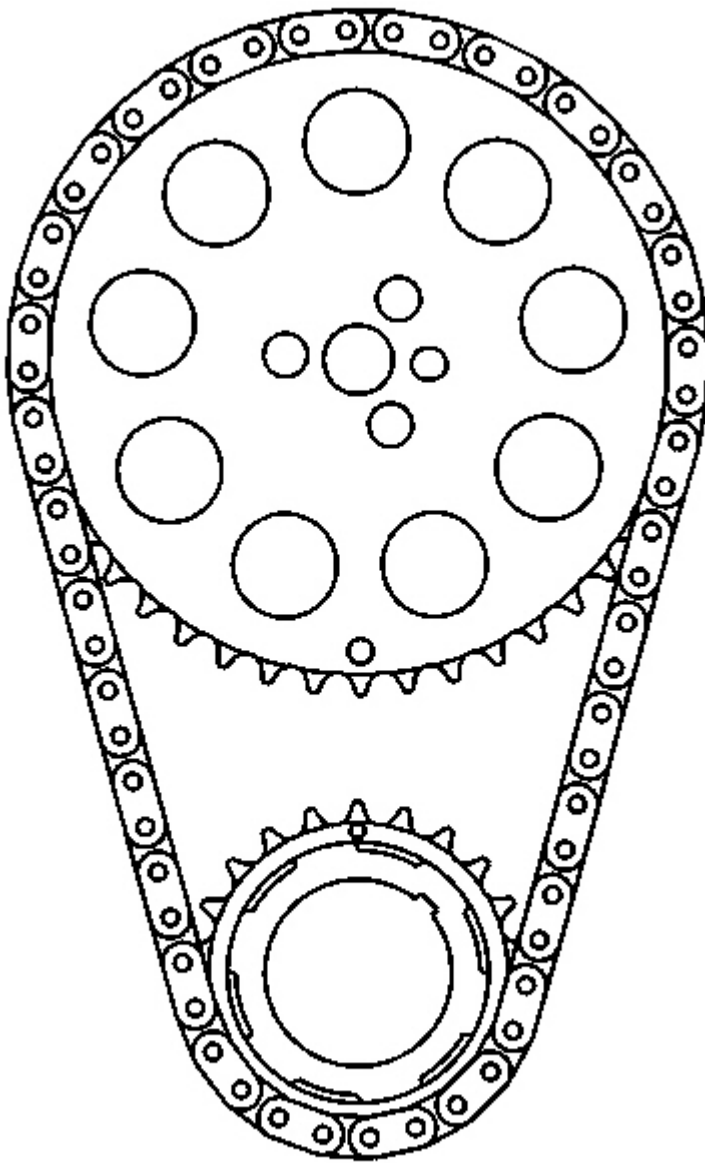
Fig. 485: View Of Camshaft & Crankshaft Sprockets Timing Marks Aligned
Courtesy of GENERAL MOTORS CORP.

3. Inspect the timing chain for binding or wear.

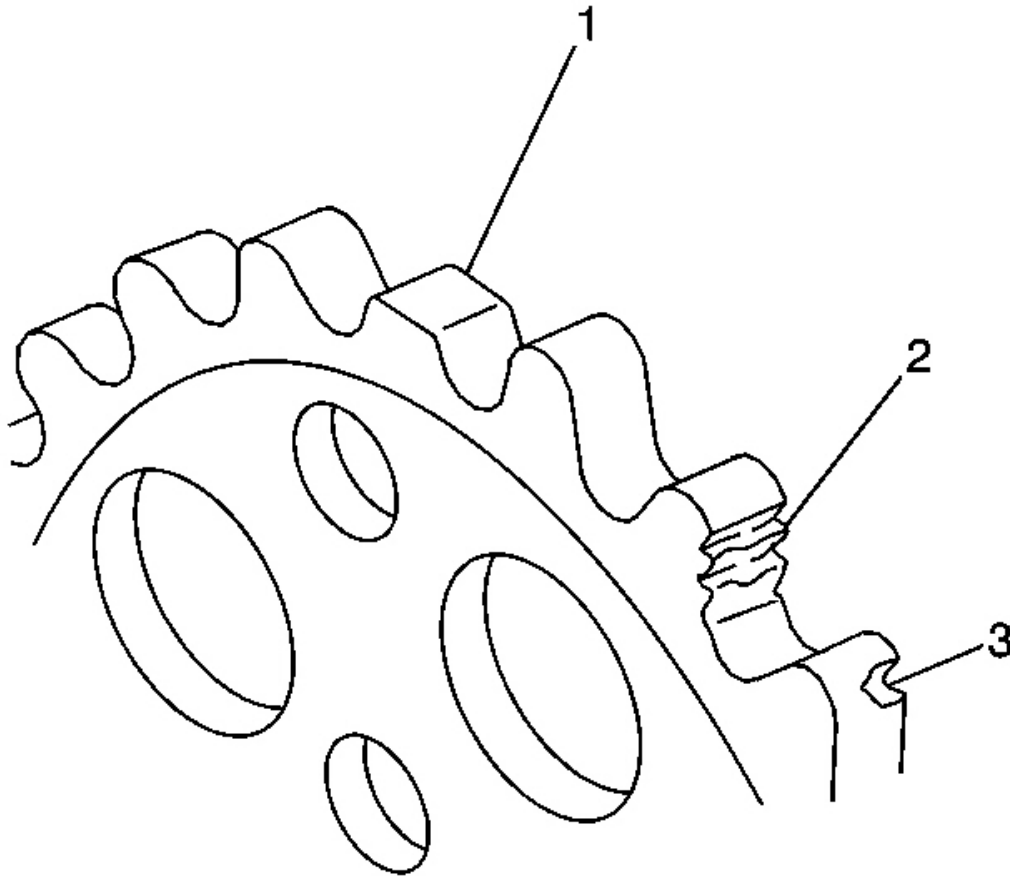
Fig. 486: Identifying Damaged Sprocket Teeth
Courtesy of GENERAL MOTORS CORP.

4. Inspect the camshaft and crankshaft sprockets for:
- Worn teeth (1)
 - Damaged teeth (2)
 - Chipped teeth (3)
 - Worn valleys between the sprocket teeth

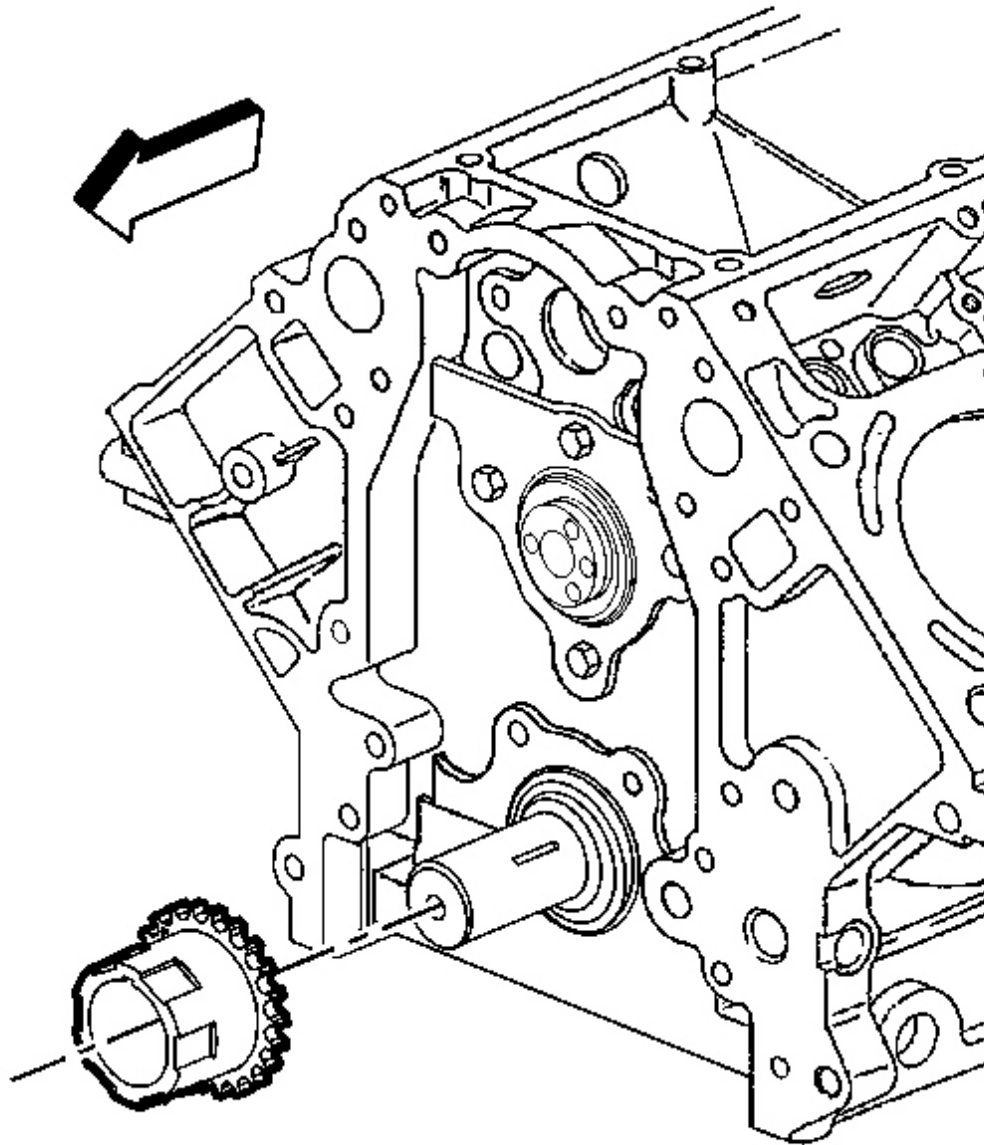
Fig. 487: View Of Crankshaft Sprocket
Courtesy of GENERAL MOTORS CORP.

5. Inspect the crankshaft sprocket keyway for wear.
6. Inspect the crankshaft sprocket oil pump drive splines for wear.

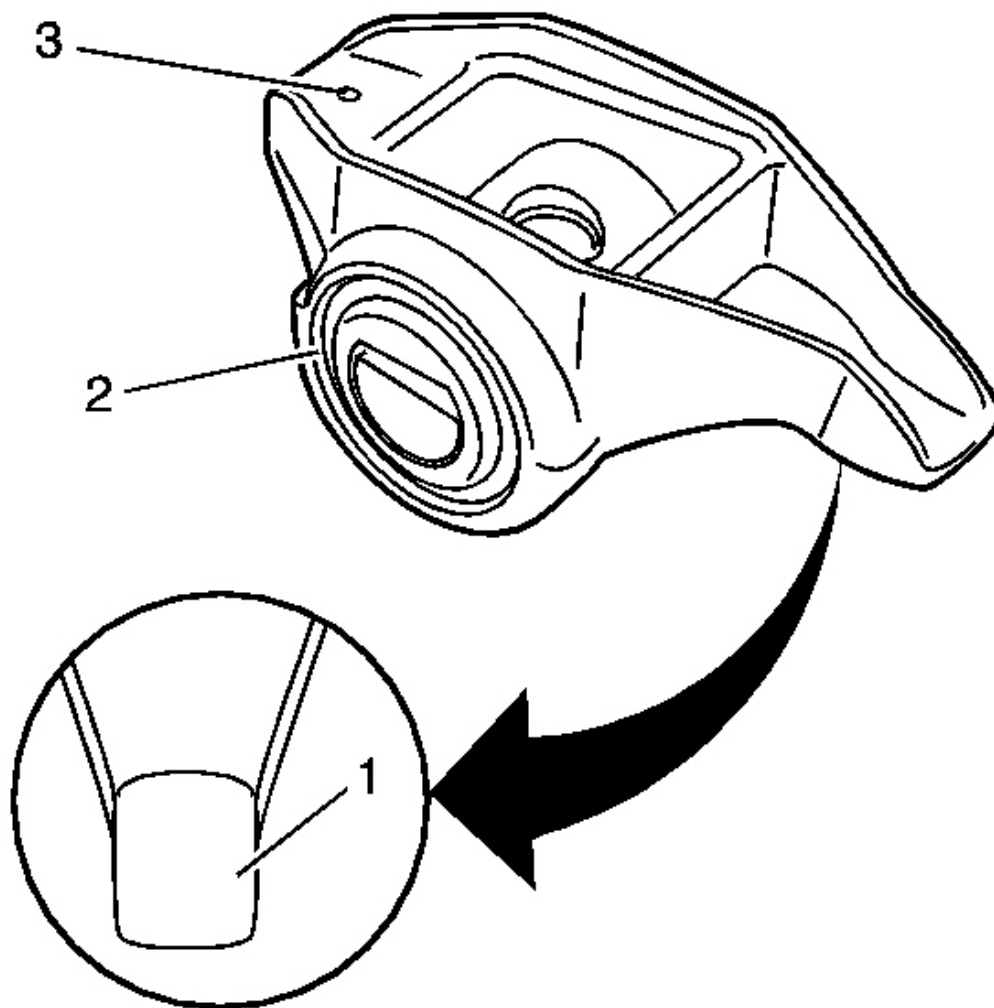
Fig. 488: Identifying Valve Rocker Arm Components
Courtesy of GENERAL MOTORS CORP.

3. Dry the components with compressed air.
4. Inspect the valve rocker arms bearings (2) for binding or roughness.
5. Inspect the valve rocker arm pushrod sockets (3) and valve stem mating surfaces (1). These surfaces should be smooth with no scoring or exceptional wear.

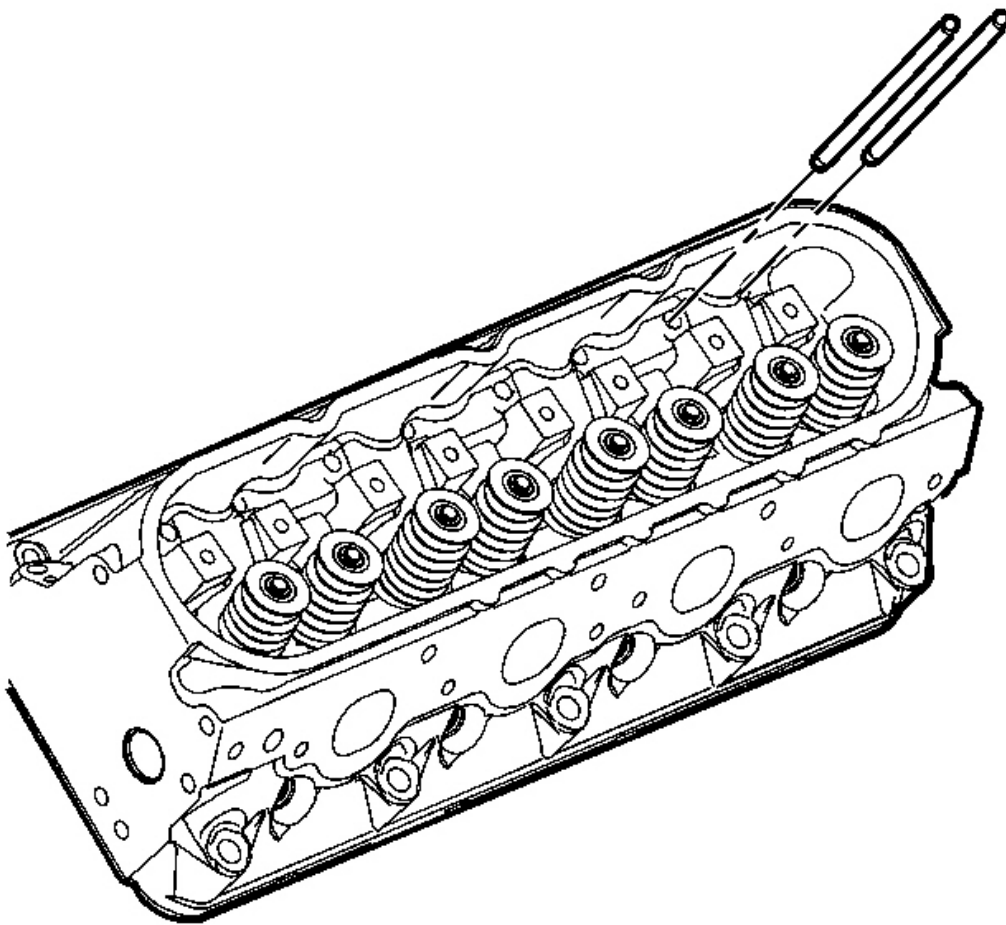
Fig. 489: View Of Pushrods

6. Inspect the pushrods for worn or scored ends. These surfaces should be smooth with no scoring or exceptional wear.
7. Inspect the pushrods for bends. Roll the pushrod on a flat surface to determine if the pushrod is bent.
8. Inspect the pushrod oil passages for restrictions.

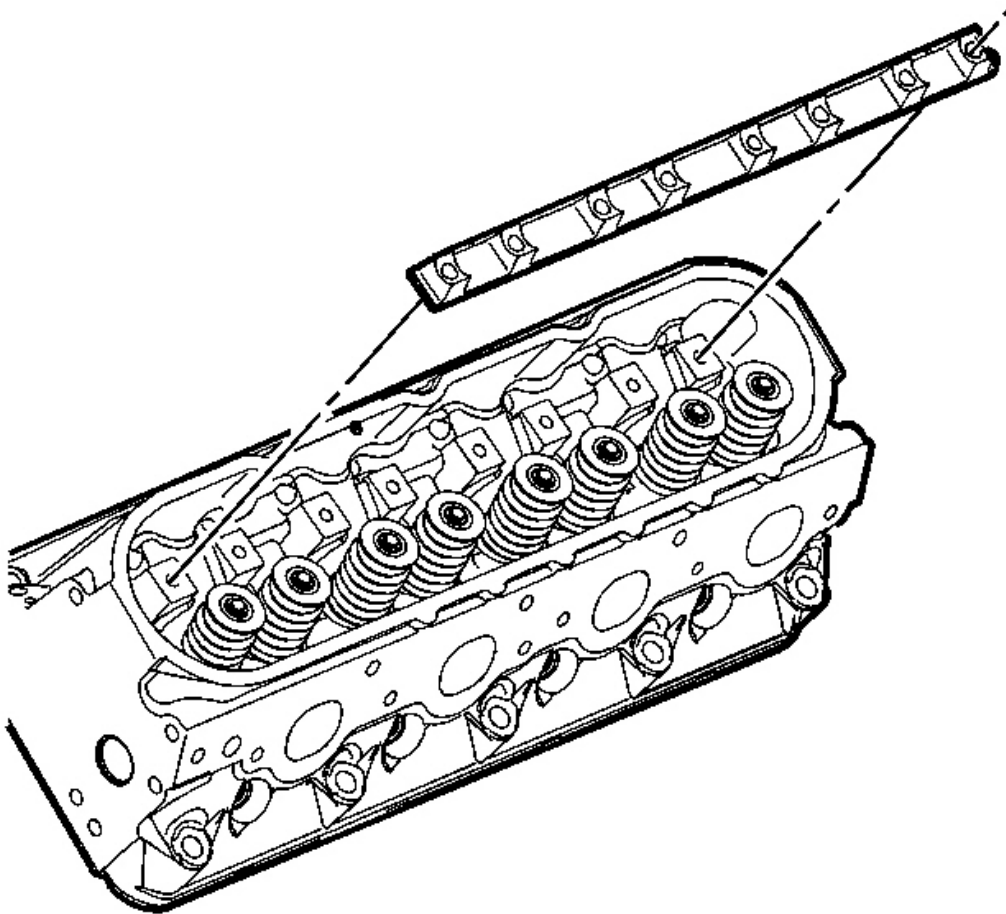
Fig. 490: View Of Valve Rocker Arm Pivot Support
Courtesy of GENERAL MOTORS CORP.

9. Inspect the pivot supports for cracks, wear, or other damage.

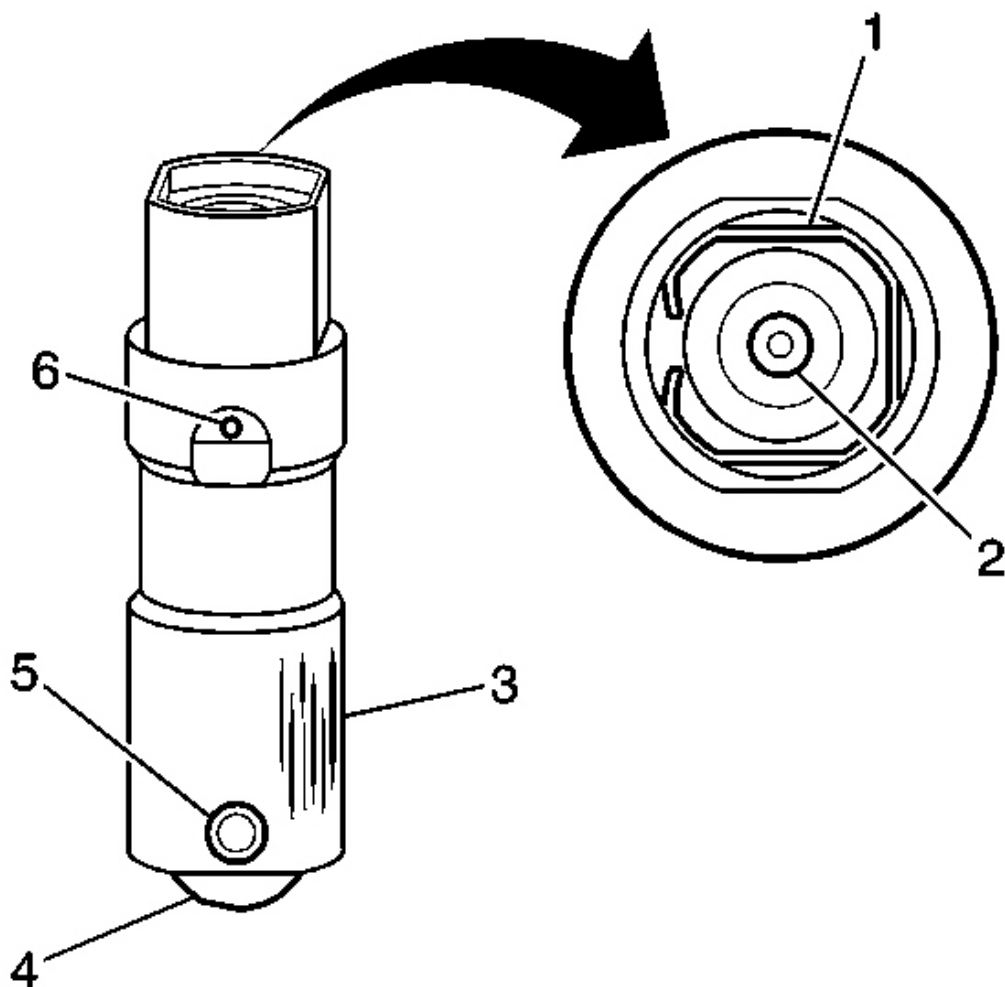
Fig. 491: Inspecting Areas Of Valve Lifters
Courtesy of GENERAL MOTORS CORP.

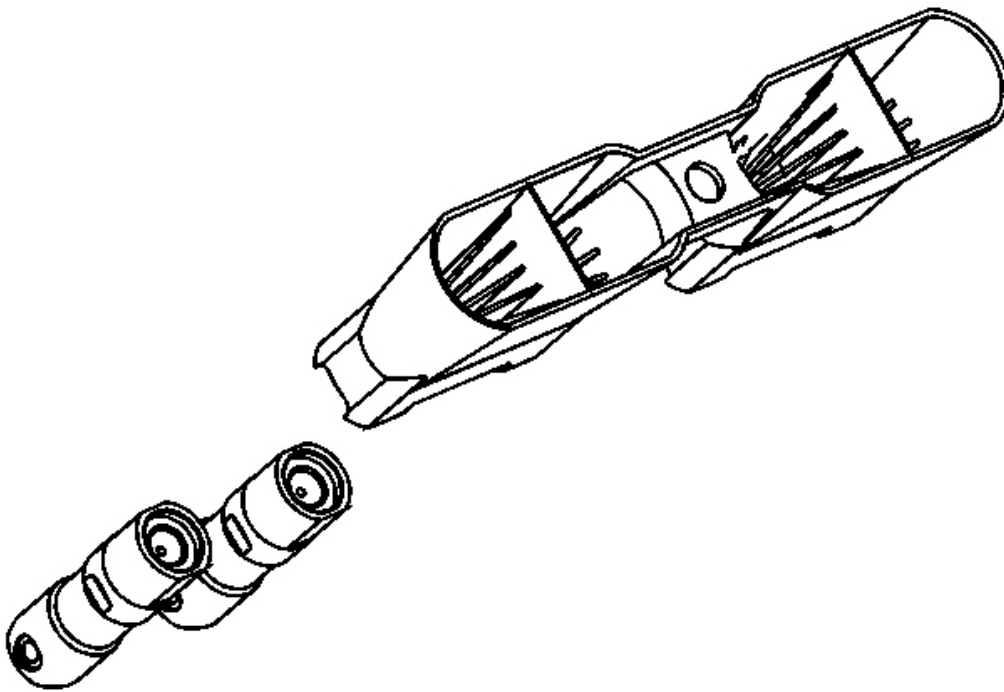
Fig. 492: View Of Valve Lifters & Lifter Guides
Courtesy of GENERAL MOTORS CORP.

5. Inspect the valve lifter guides for the following conditions:
 - For cracks or damage
 - Excessive wear in the lifter mounting bores

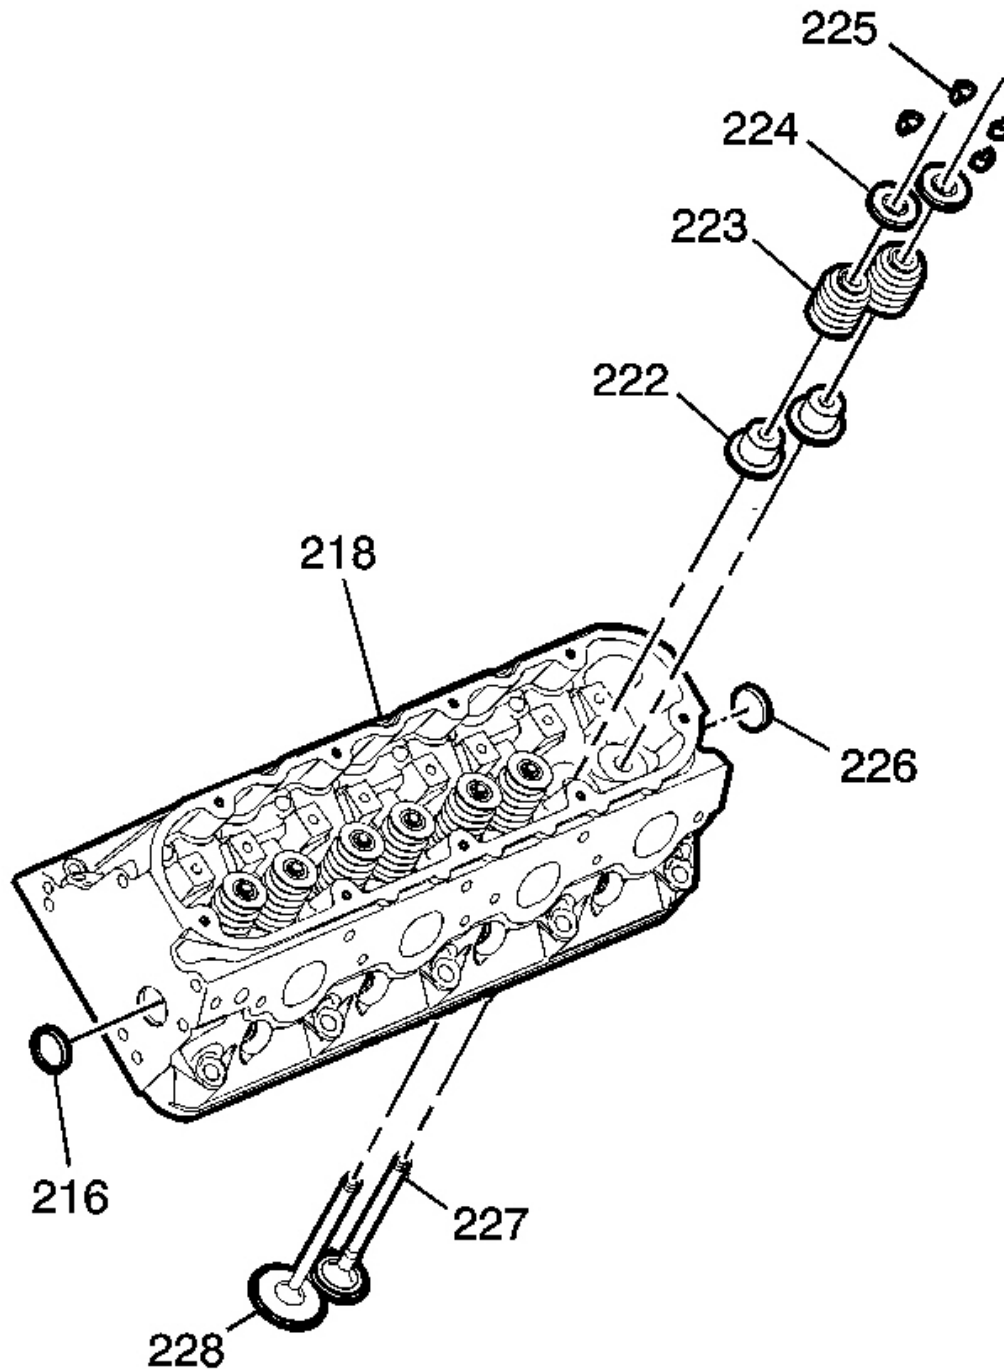
Fig. 493: View Of Cylinder Head Components

- Remove the spark plugs from the cylinder head with the components at room temperature.
- Mark, organize, or sort the cylinder head components for assembly. Return the components to their original location during assembly.
- Do not remove the cylinder head expansion plugs (226) unless service is required.

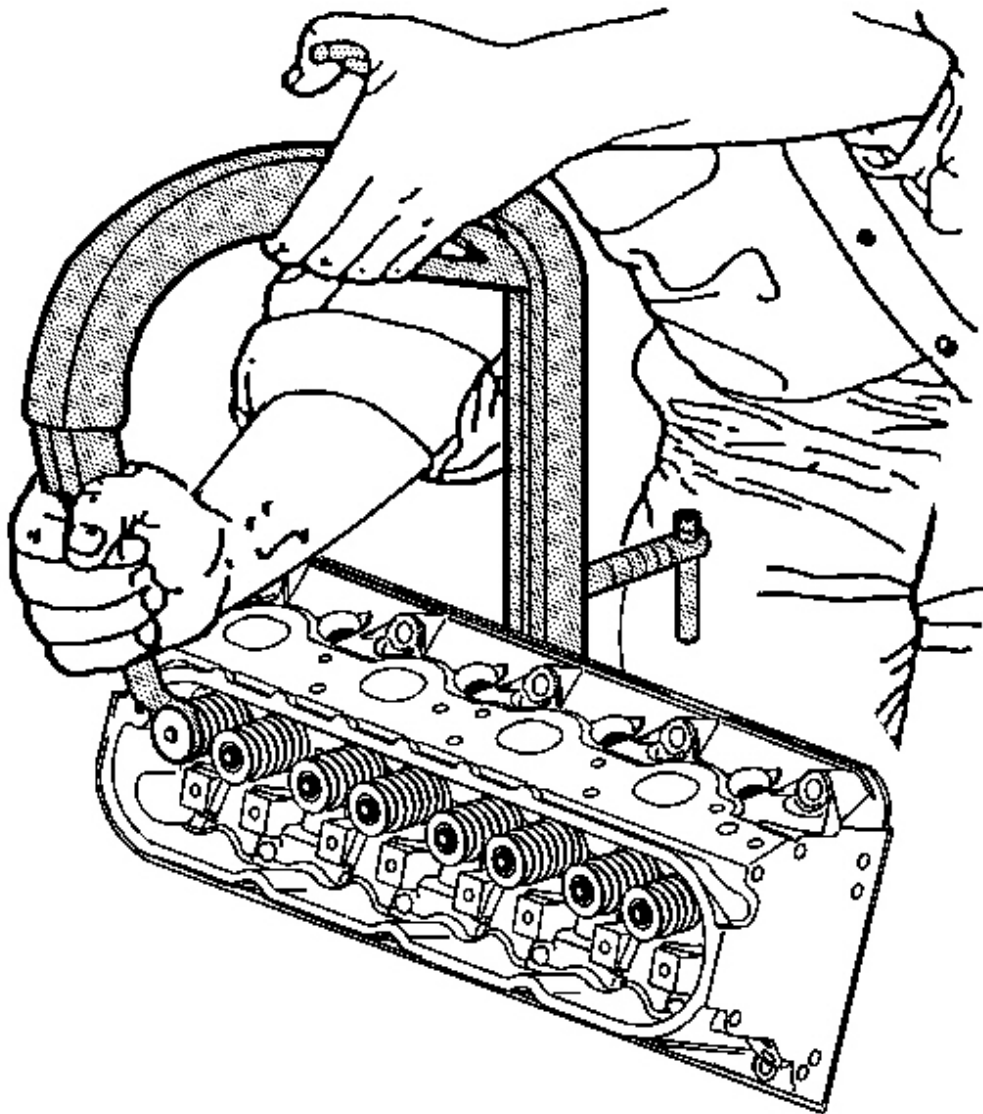
Fig. 494: Compressing Valve Spring Using
Courtesy of GENERAL MOTORS CORP.

2. Use the **J 8062** in order to compress the valve spring.

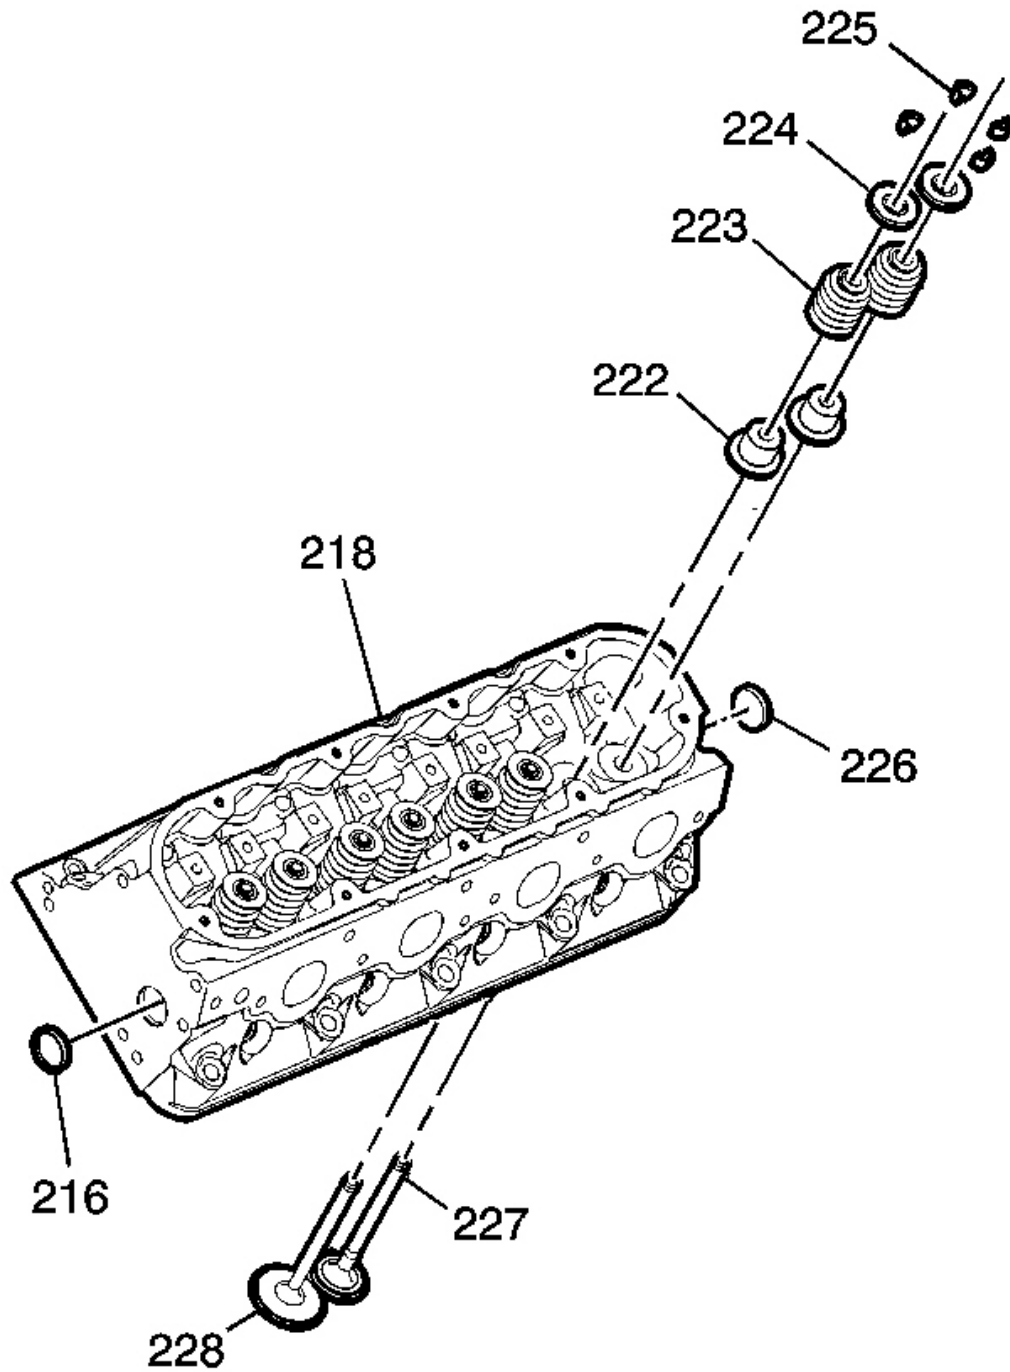
Fig. 495: View Of Cylinder Head Components
Courtesy of GENERAL MOTORS CORP.

3. Remove the valve stem keys (225).
4. Remove the valve spring cap (224).
5. Remove the valve spring (223).
6. Remove the valves (227 and 228).
7. Remove the valve stem oil seal (222). Refer to **Separating Parts**.

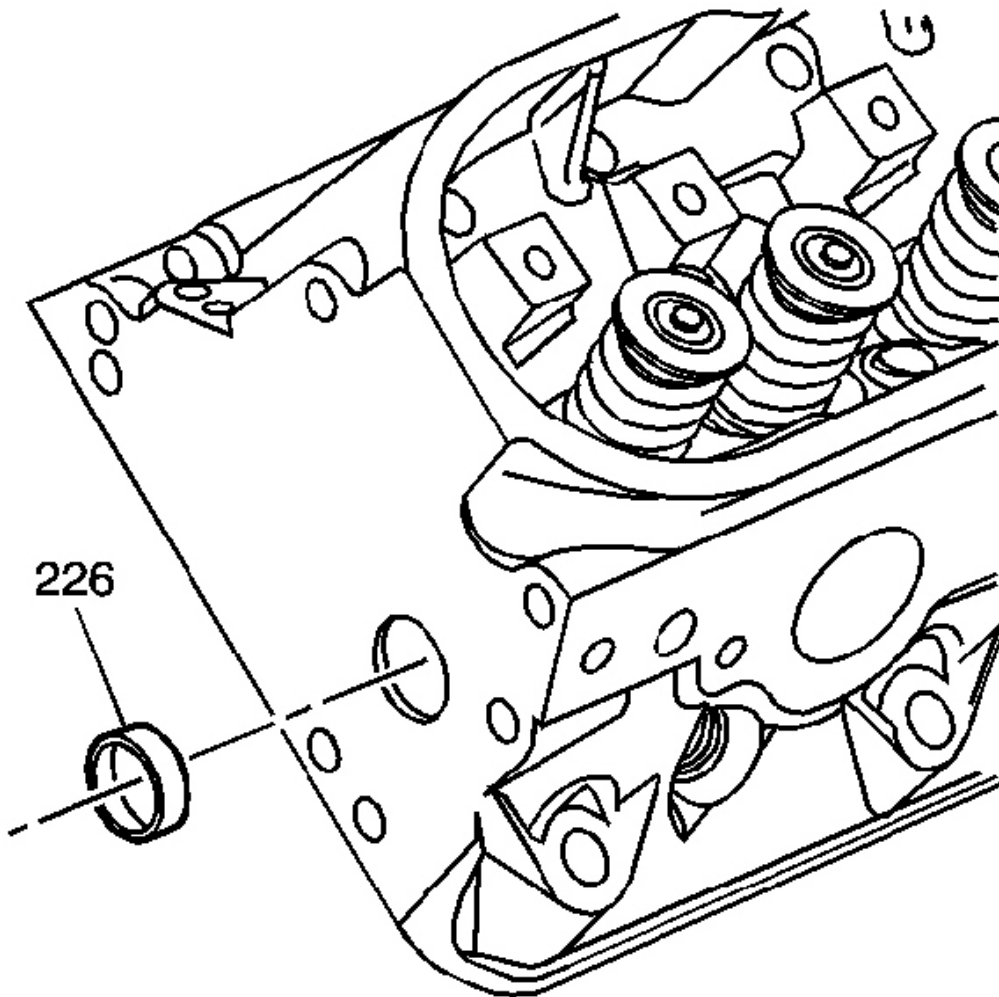
Fig. 496: View Of Cylinder Head Expansion Plugs
Courtesy of GENERAL MOTORS CORP.

8. Remove the cylinder head expansion plugs (226), if required.

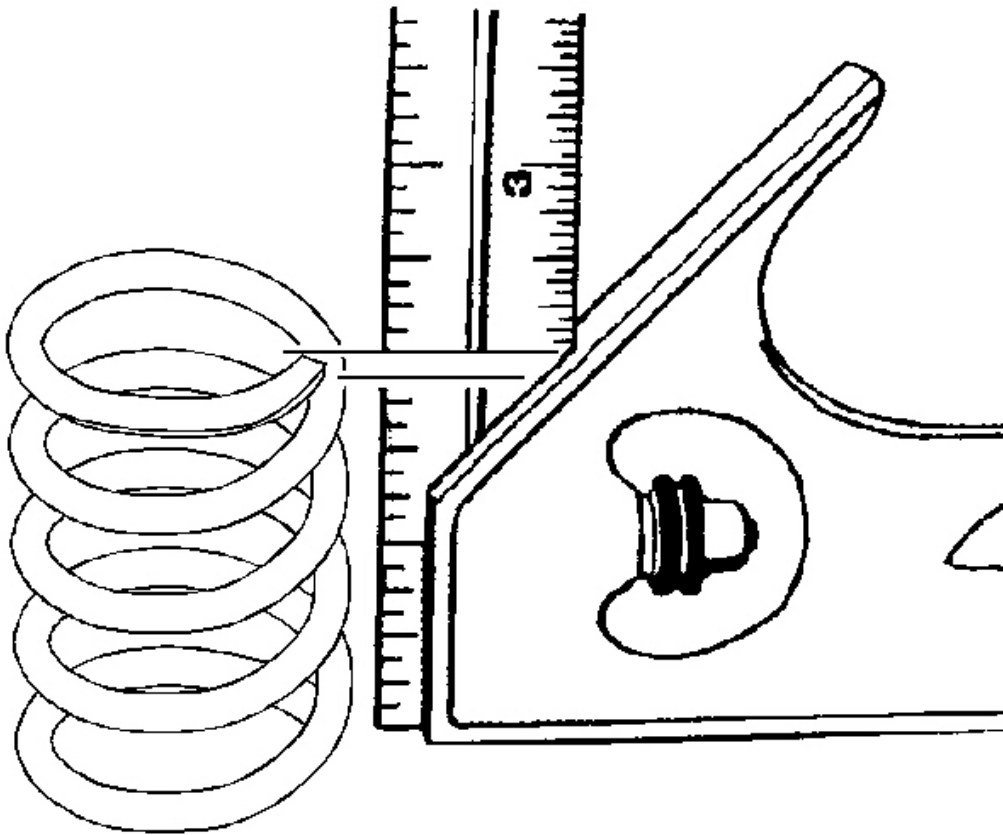
Fig. 502: Inspecting Valve Spring For Squareness
Courtesy of GENERAL MOTORS CORP.

4. Inspect the valve springs for squareness.

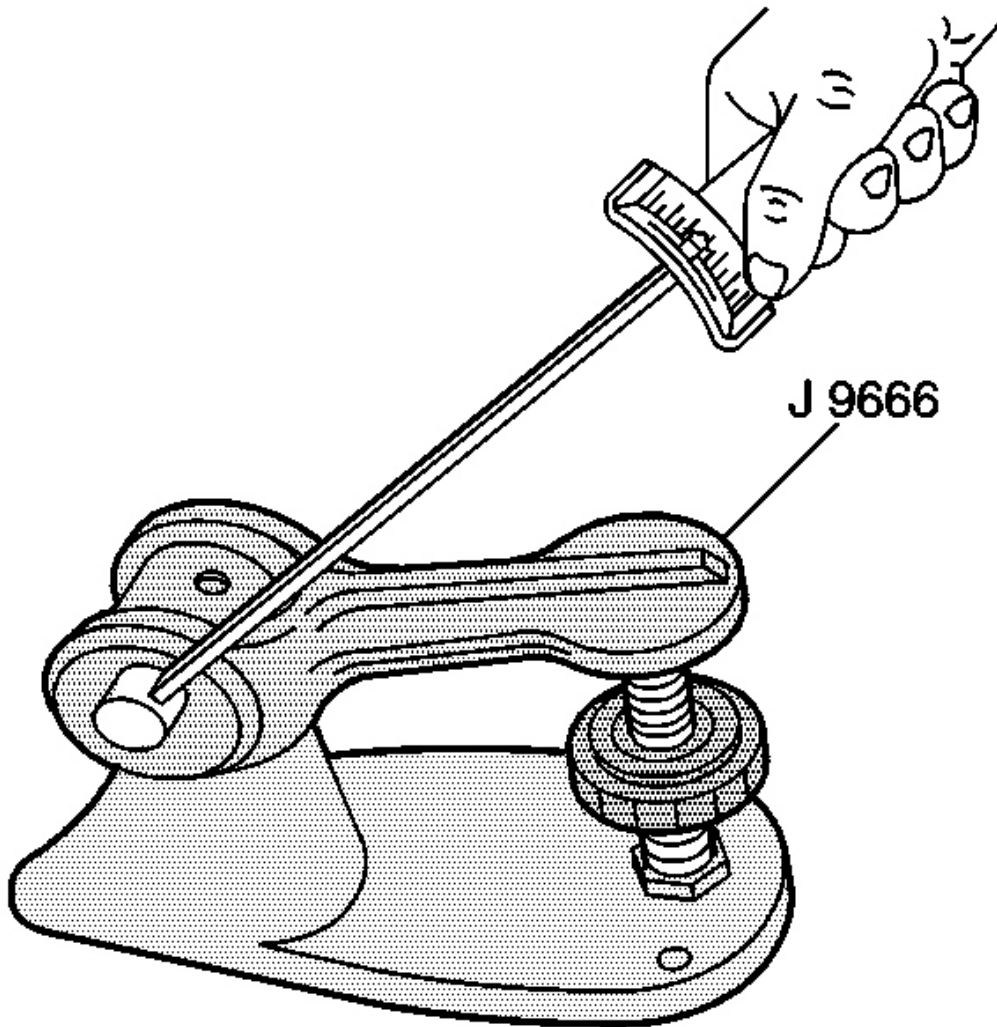
Fig. 503: Measuring Valve Spring Tension
Courtesy of GENERAL MOTORS CORP.

5. Use the **J 9666** in order to measure the valve spring tension. See **Special Tools and Equipment**.

Replace the spring if the spring tension is less than 310 N (70 lb) at 45.75 mm (1.80 in).
