2004 Isuzu Ascender LS

2004 ENGINE Engine Mechanical - 4.8L, 5.3L, and 6.0L - Ascender

Engine Mechanical - 4.8L, 5.3L, and 6.0L - Ascender

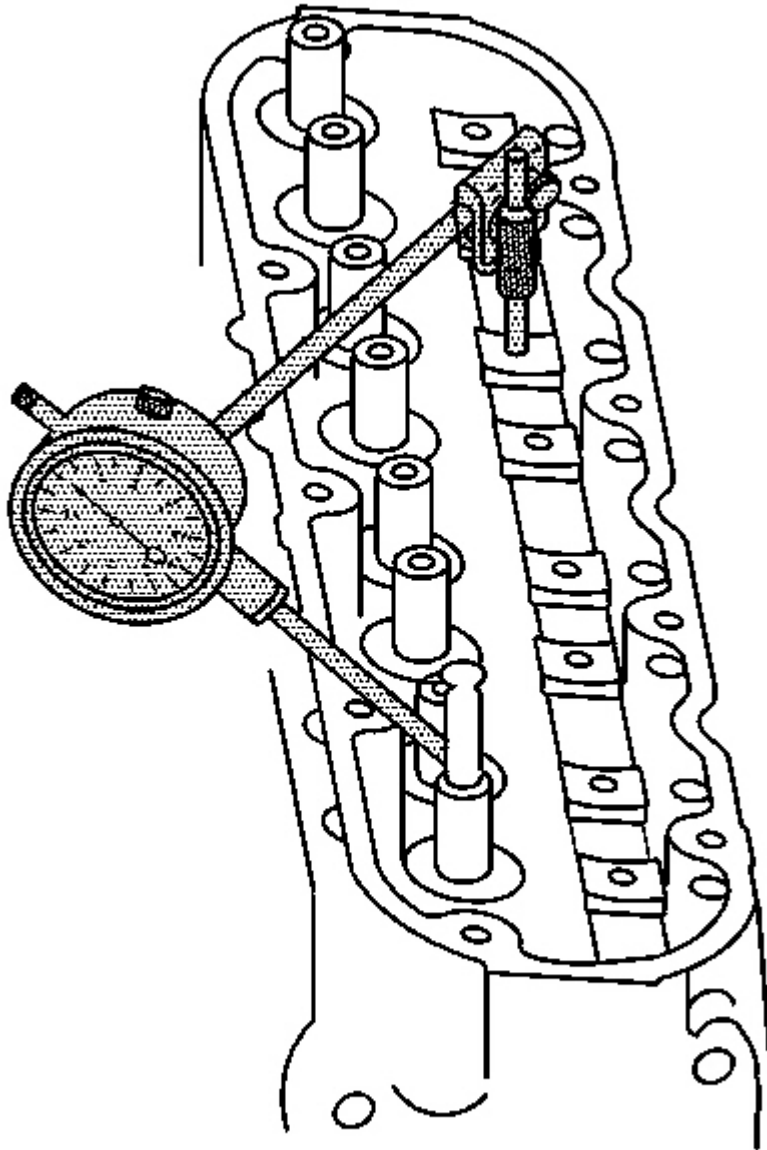
Fig. 504: Measuring Valve Stem-To-Guide Clearance
Courtesy of GENERAL MOTORS CORP.

- **Excessive valve stem-to-guide clearance may cause a noisy valve train, premature valve stem oil seal wear, component damage, and/or excessive engine oil consumption.**
- **Insufficient valve stem-to-guide clearance will result in noisy or sticking valves. Valves that are too tight may disturb engine smoothness or lead to component damage.**

2. A valve stem (1) and guide (2) with excessive clearance must be replaced or the components replaced.

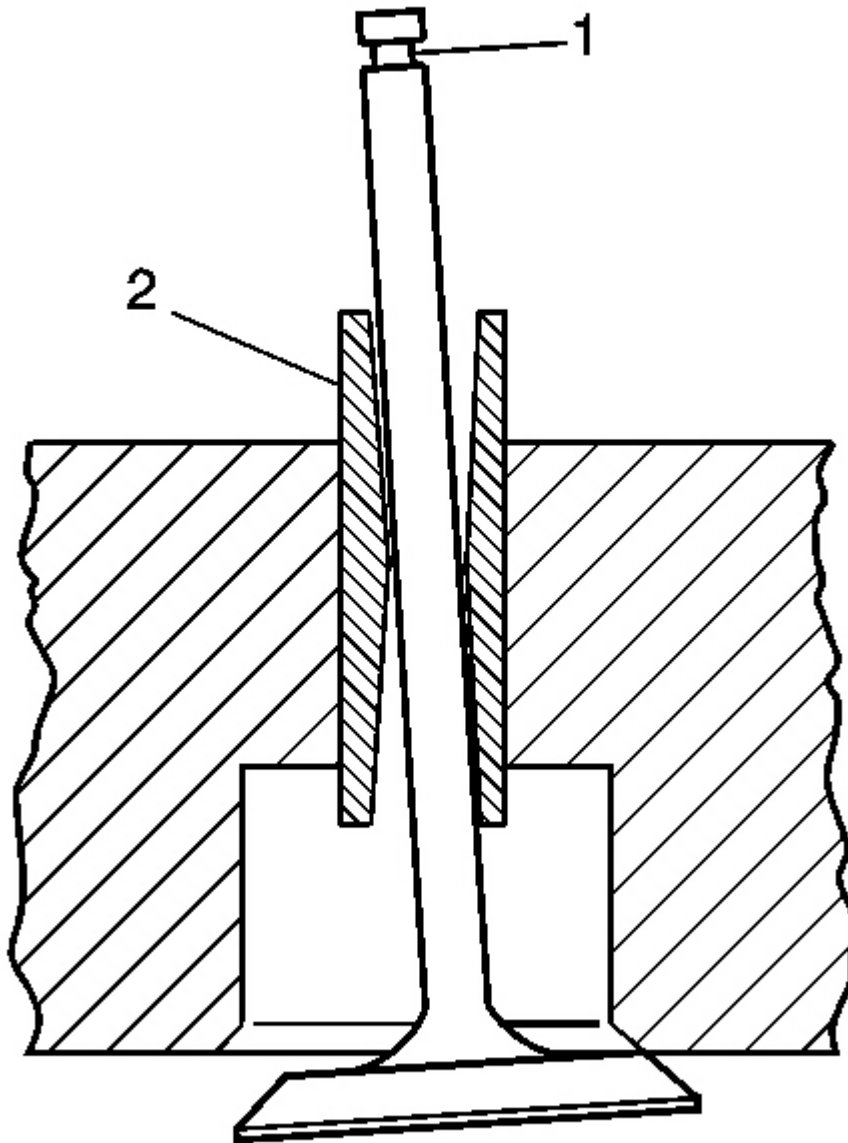
Valve stem-to-guide clearance may also be obtained by using a micrometer to measure the valve stem diameter and a ball type measuring gage to measure the guide bore.

Fig. 505: Inspecting For Excessive Valve Stem To Guide Clearance
Courtesy of GENERAL MOTORS CORP.

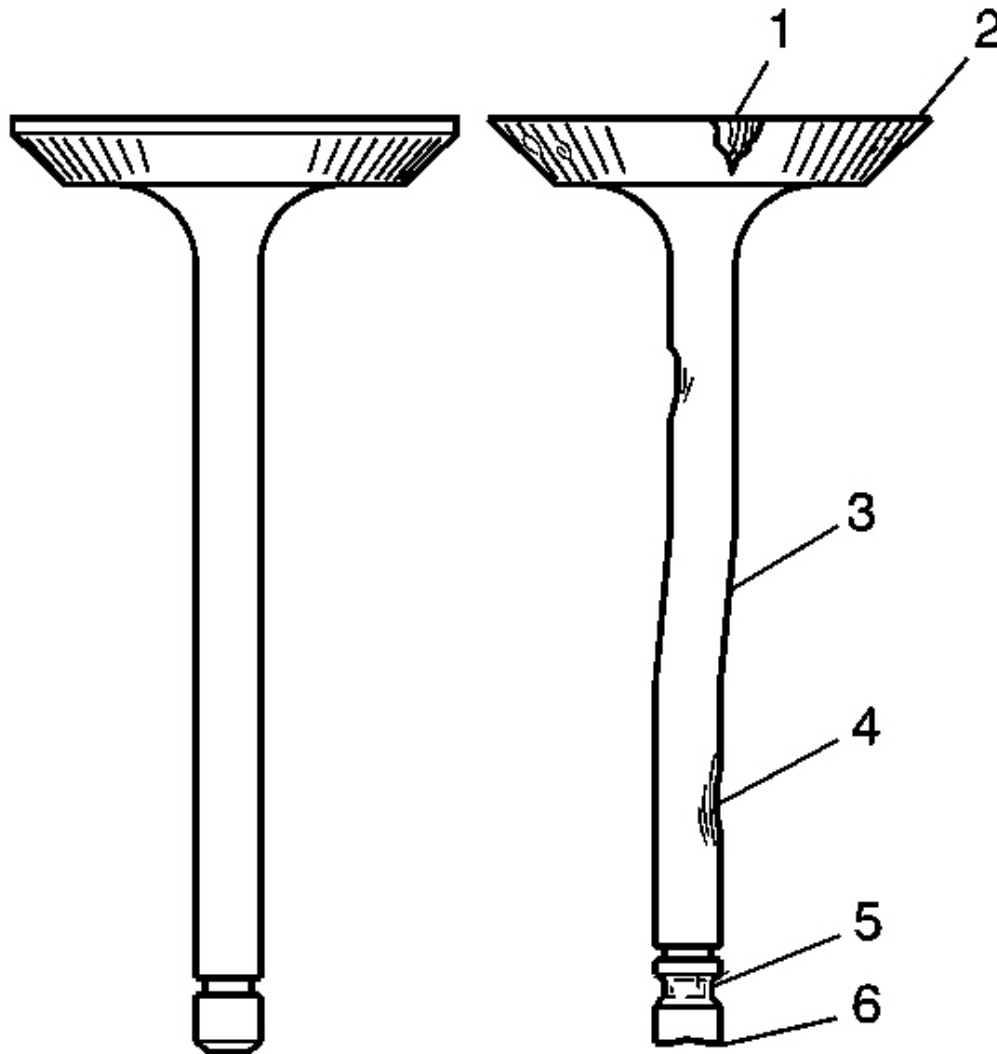
Fig. 506: Identifying Inspection Points For Valves Damage
Courtesy of GENERAL MOTORS CORP.

3. Inspect the valve stems for excessive scoring, wear, or warpage.
 - A valve stem that has excessive scoring (3 or 4) or wear (4 or 6) must be replaced.
 - A valve guide that is worn and has excessive stem-to-guide clearance should be reamed and valves with oversize stems installed.
4. Measure the valve stem diameter. A valve stem with a diameter less than 7.95 mm (0.313 in) must be replaced.

If the valve stem diameter is within specifications, and the stem-to-guide clearance is excessive, the valve guide must be reamed oversize and a valve with oversize stem installed.

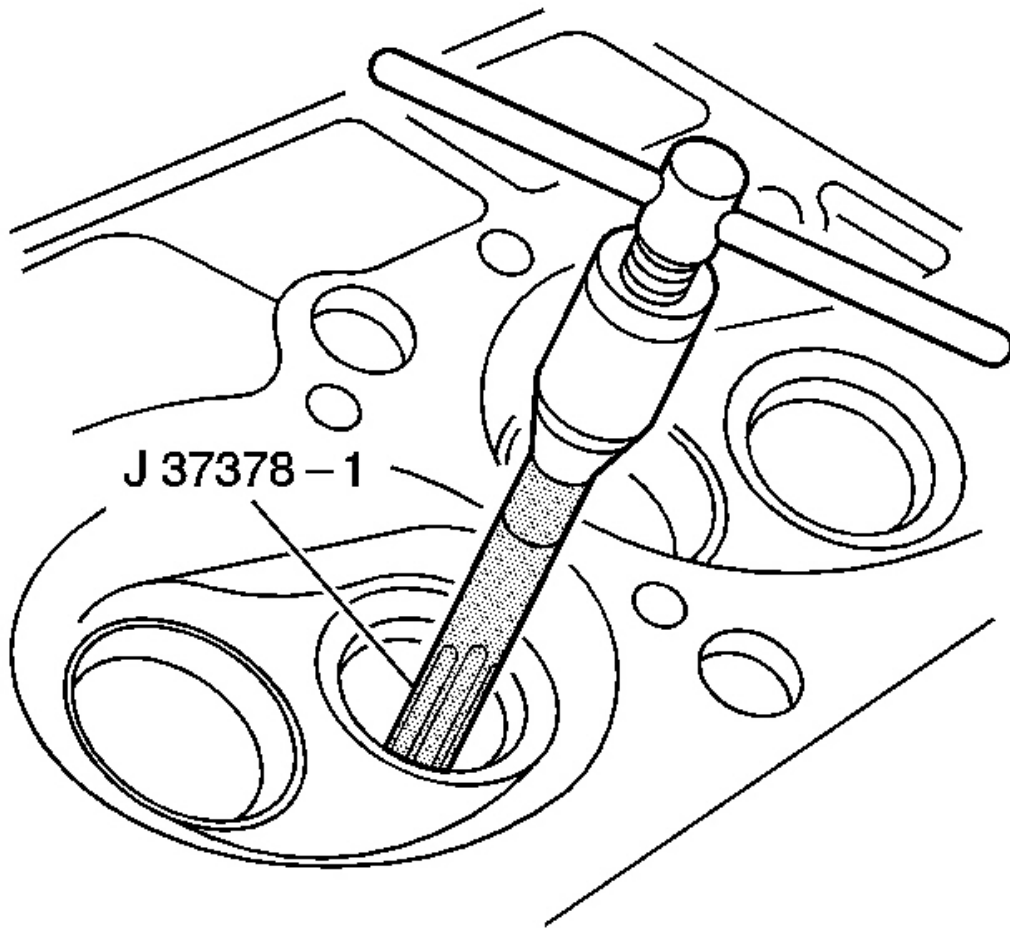
Fig. 507: Reaming Valve Guide Using J 37378-1
Courtesy of GENERAL MOTORS CORP.

5. Ream the valve guide using the **J 37378-1** . See **Special Tools and Equipment**.
6. Clean the guide bore of all metal shavings and debris.

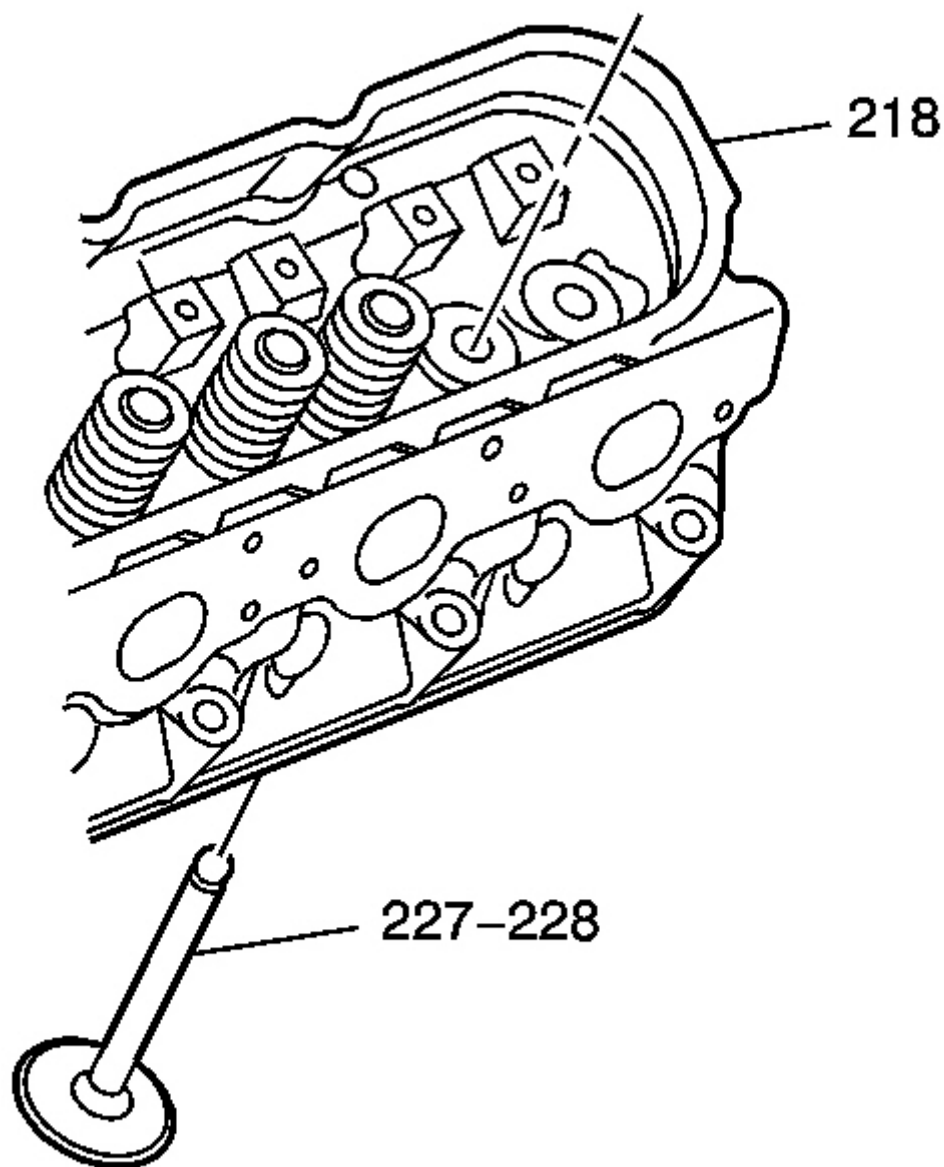
Fig. 508: View Of Valve & Cylinder Head
Courtesy of GENERAL MOTORS CORP.

7. Install the valve (227-228), with oversize stem, into the cylinder head (218).
8. Inspect the valve for the proper fit.

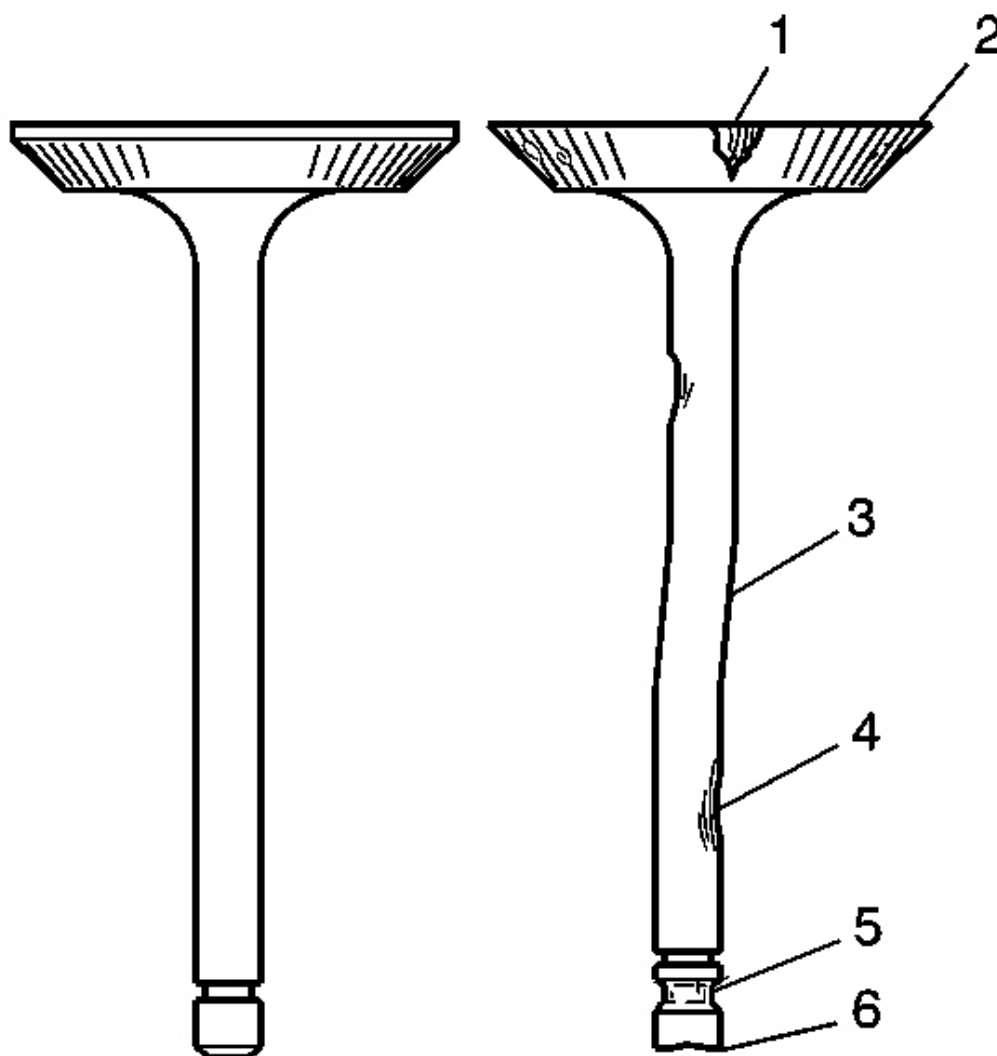
Fig. 509: Identifying Inspection Points For Valves Damage
Courtesy of GENERAL MOTORS CORP.

- Burnt or eroded areas (1)
- A worn margin (2)
- A bent stem (3)
- A worn or scored stem (4)
- A worn key groove (5)
- A worn stem tip (6)

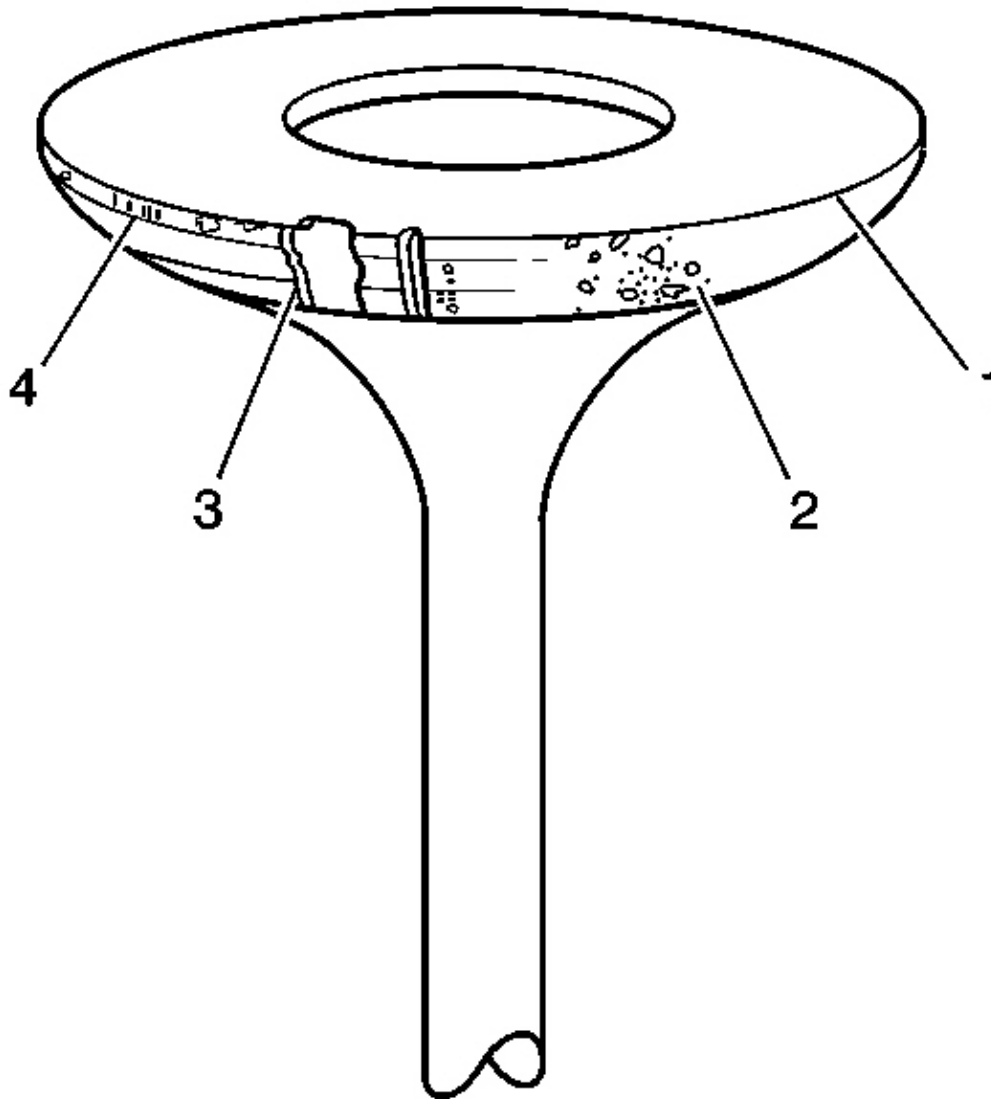
Fig. 510: Inspecting Valve Face For Burning, Pitting & Cracking
Courtesy of GENERAL MOTORS CORP.

2. Inspect the valve face for the following conditions:
 - Worn or no margin (1 or 4)
 - Pitted surfaces (2)
 - Burnt or eroded areas (3)

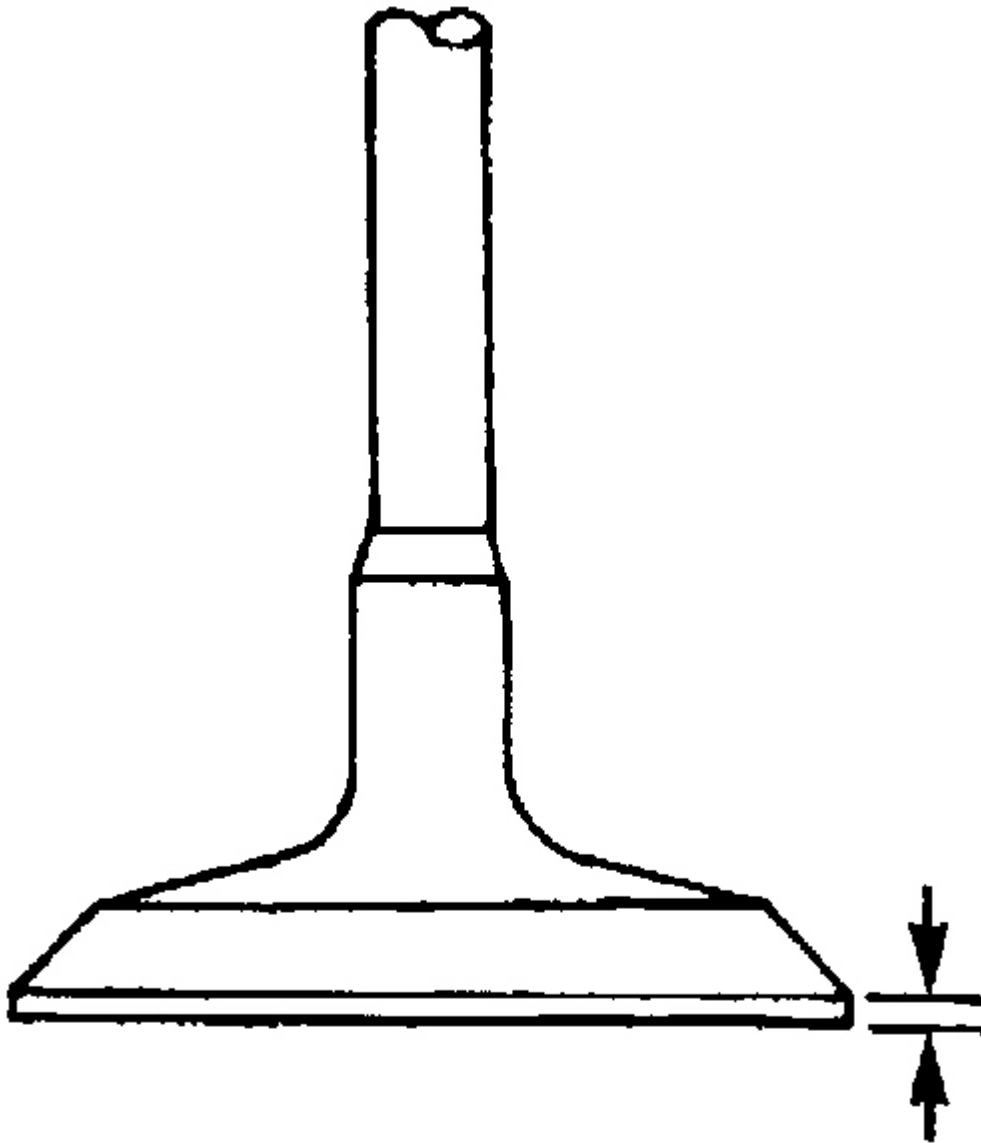
Fig. 511: Inspecting Valve Margin
Courtesy of GENERAL MOTORS CORP.

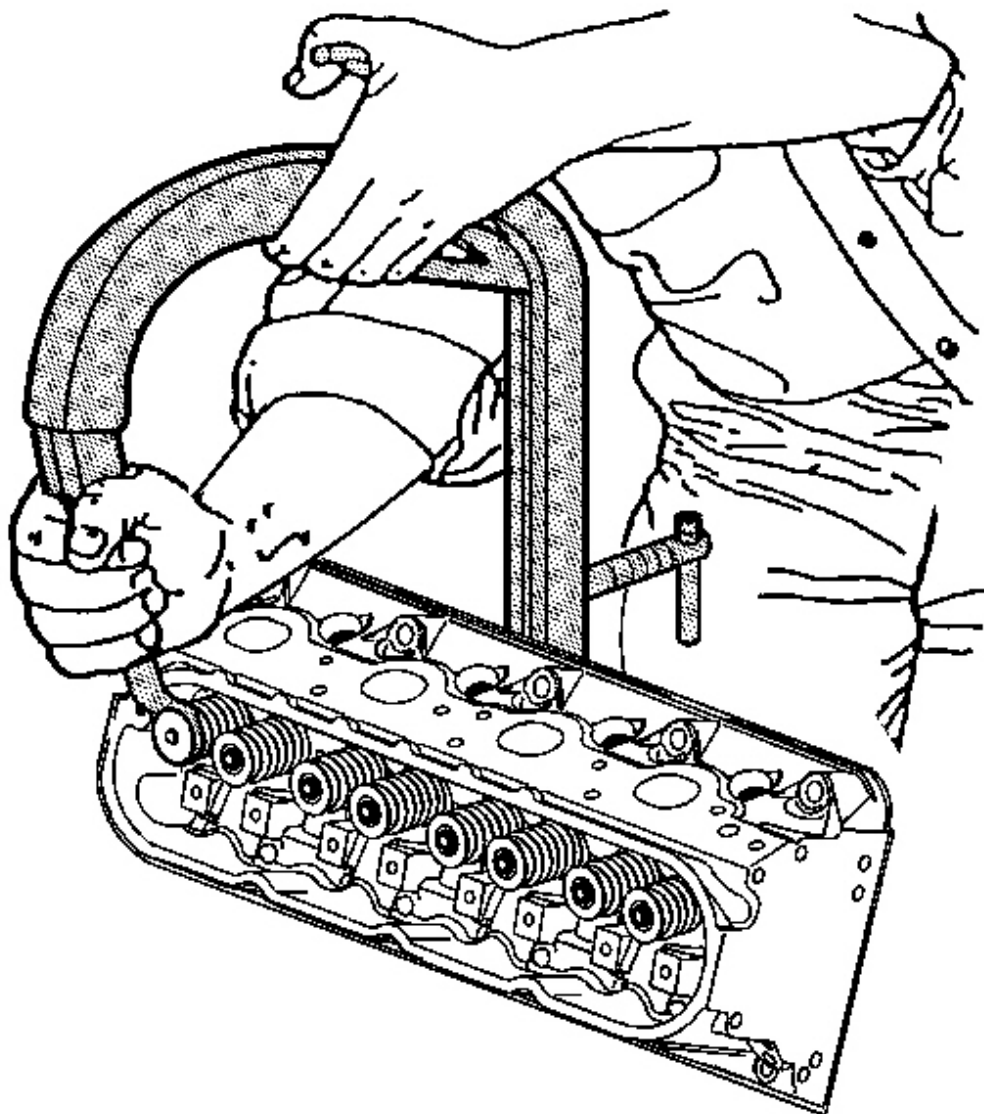
Fig. 514: Compressing Valve Spring Using
Courtesy of GENERAL MOTORS CORP.

6. Compress the valve spring using the **J 8062**.
7. Install the valve stem keys.
 1. Use grease to hold the keys in place and remove the **J 8062**.
 2. Ensure the keys seat properly in the groove of the valve stem.

3. Tap the end to the valve stem with a plastic faced hammer to seat the keys, if necessary.

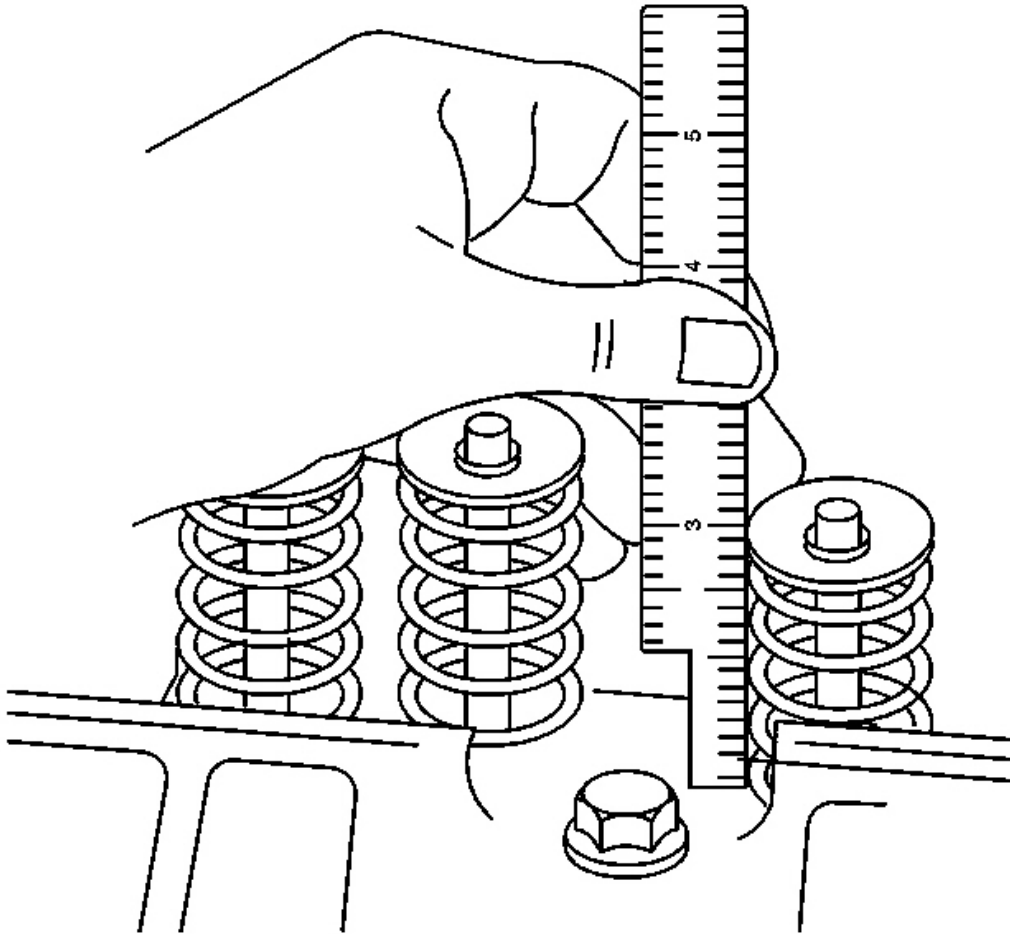
Fig. 515: Measuring Valve Spring Installed Height
Courtesy of GENERAL MOTORS CORP.

8. Measure the valve spring installed height using a ruler.

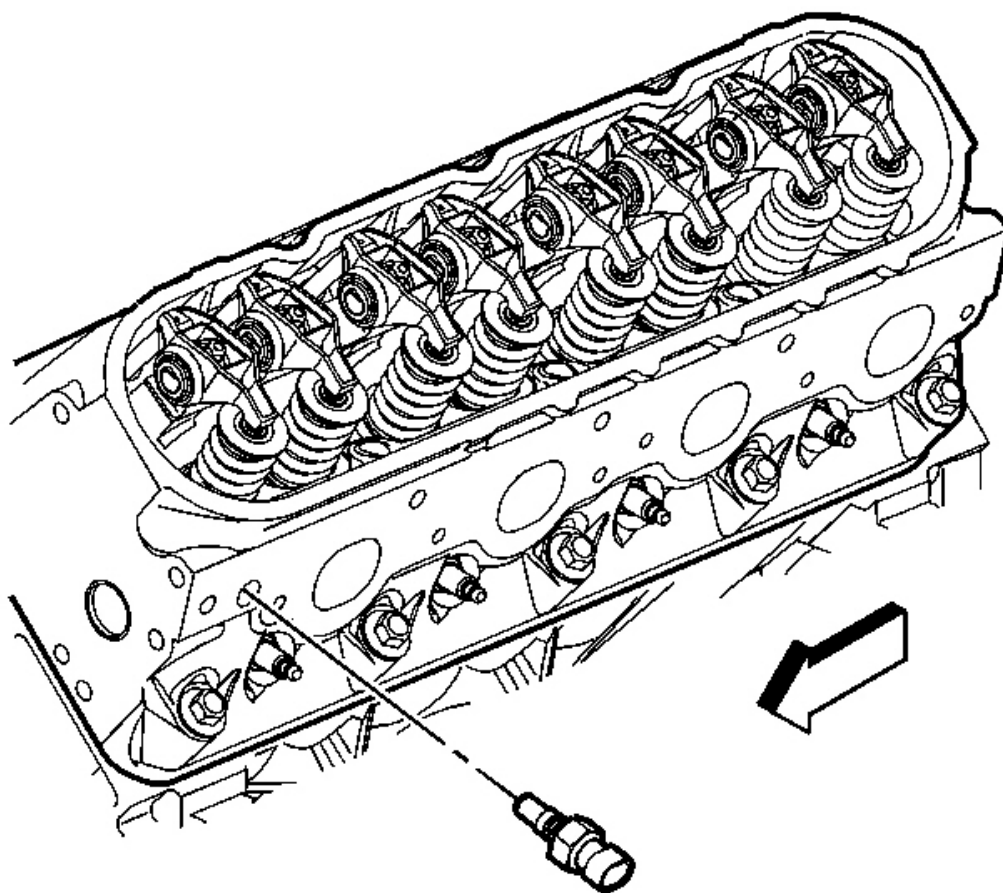
Fig. 516: View Of Coolant Temperature Sensor (Left Cylinder Head)
Courtesy of GENERAL MOTORS CORP.

10. Install sealant GM P/N 12346004 (Canadian P/N 10953480) or equivalent to the threads of the coolant sensor.

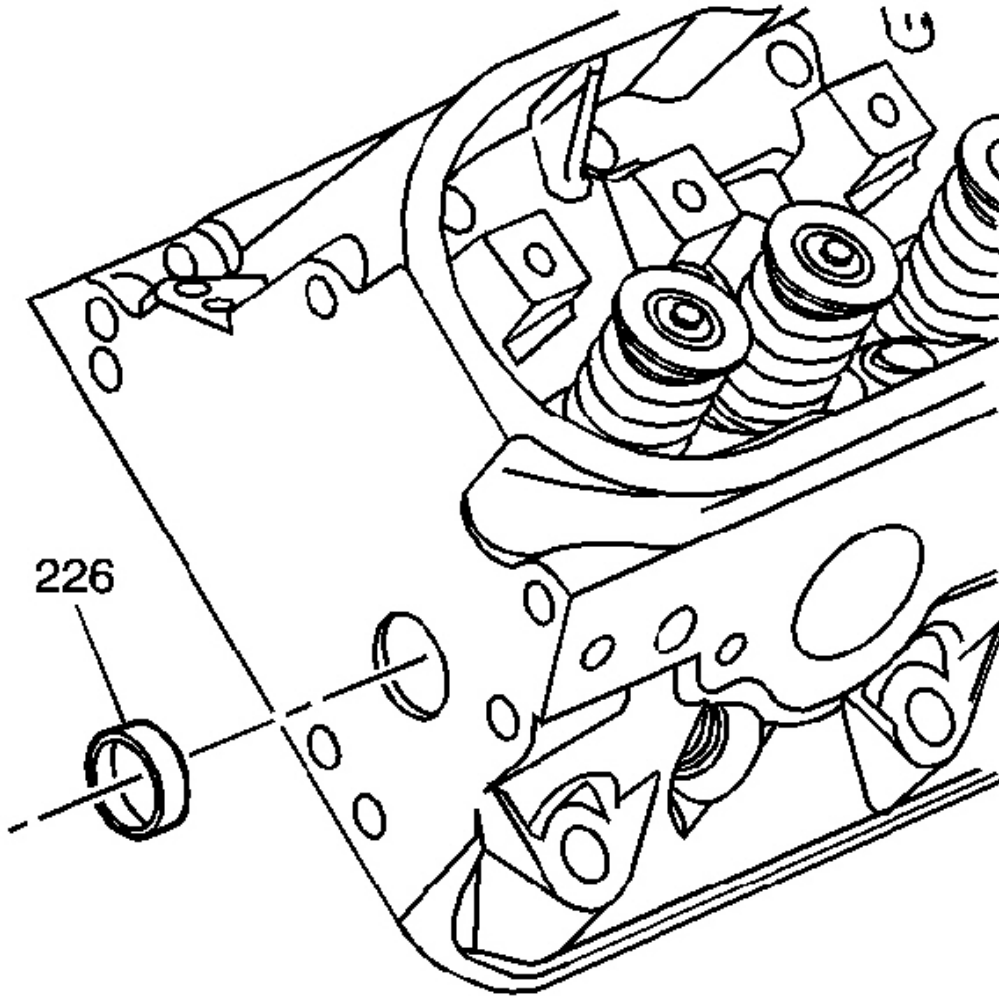
Fig. 518: View Of Cylinder Head Expansion Plugs
Courtesy of GENERAL MOTORS CORP.

14. Apply threadlock GM P/N 12345382 (Canadian P/N 10953489) or equivalent to the sides of the cylinder head expansion plugs (226).
15. Install the expansion plugs into the cylinder head.

A properly installed plug should be installed 2.5 mm (0.1 in) below the end face of the head.

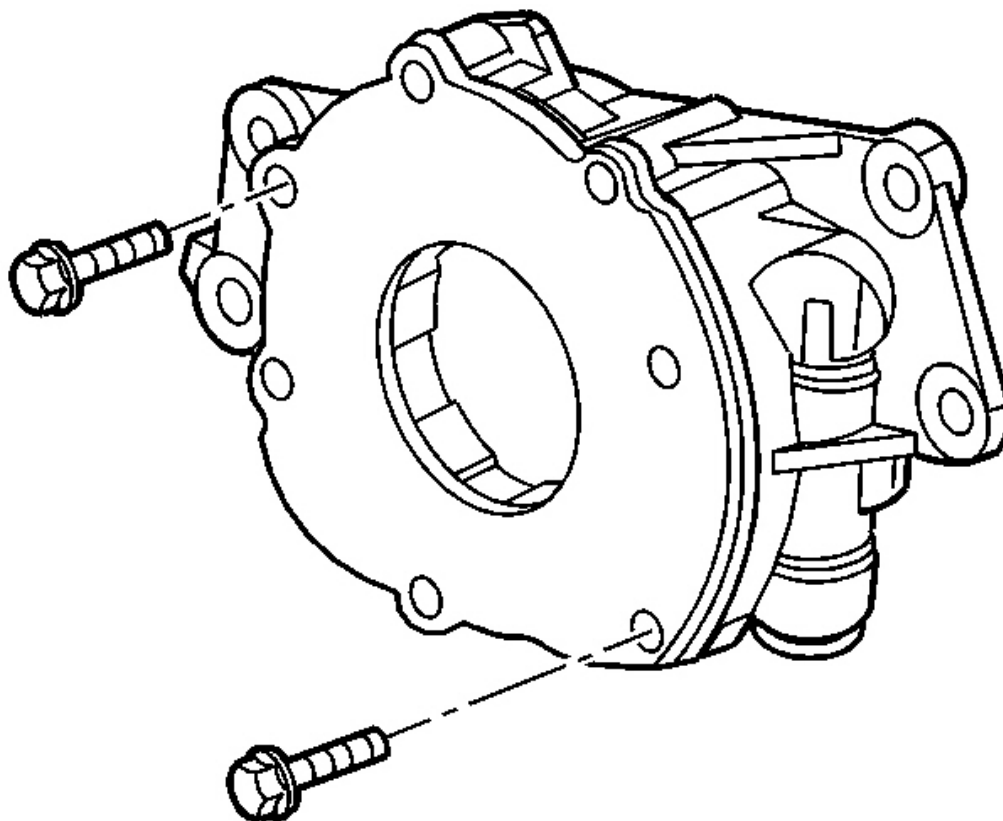
Fig. 535: View Of Oil Pump Cover Bolts
Courtesy of GENERAL MOTORS CORP.

4. Install the pump cover bolts.

Tighten: Tighten the oil pump cover bolts to 12 N.m (106 lb in).

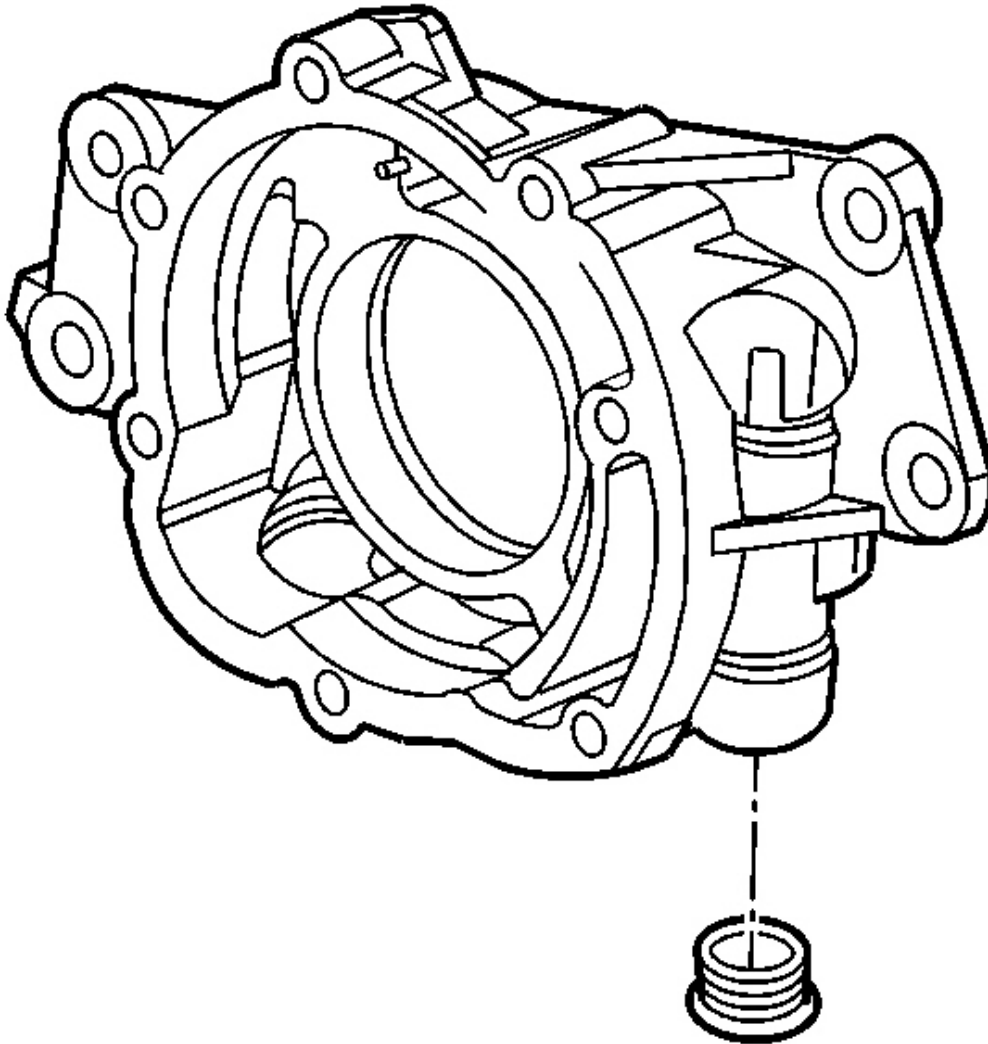
Fig. 538: View Of Oil Pump Pressure Relief Valve Plug
Courtesy of GENERAL MOTORS CORP.

7. Install the pressure relief valve plug.

Tighten: Tighten the pressure relief valve plug to 12 N.m (106 lb in).

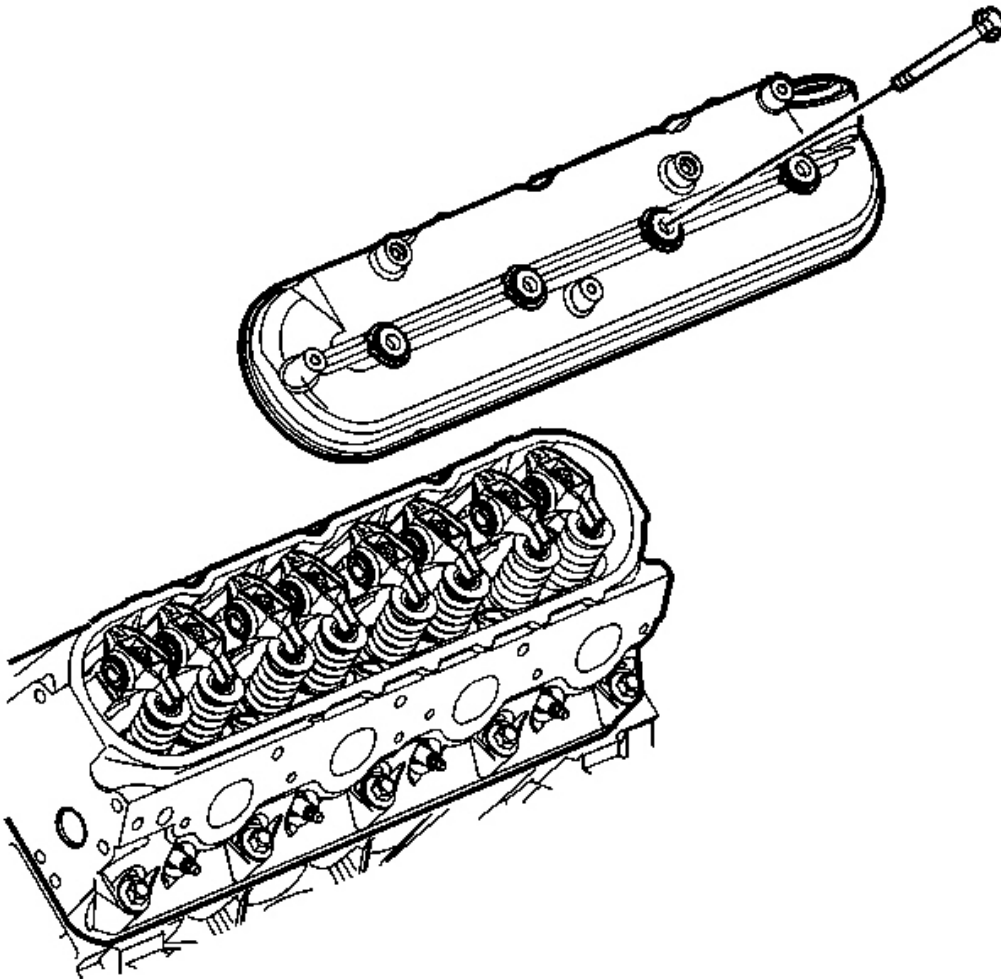
Fig. 546: Valve Cover To Cylinder Head View
Courtesy of GENERAL MOTORS CORP.

8. Dry the covers with compressed air.
9. Inspect the ventilation system passages for restrictions.
10. Inspect the gasket grooves for damage.
11. Inspect the coil bracket threaded bolt holes for damage or debris.

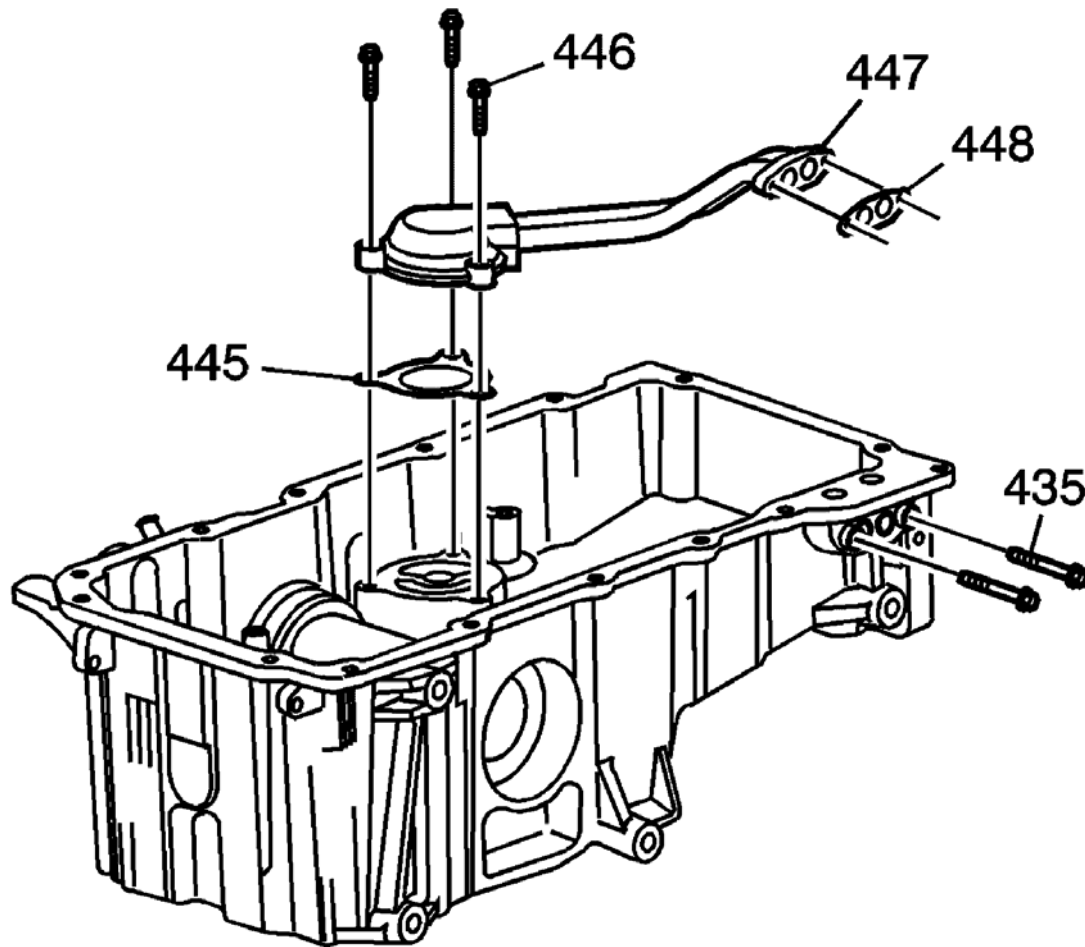
Fig. 547: View Of Oil Transfer Tube, Bolts & Gaskets
Courtesy of GENERAL MOTORS CORP.

1. Remove the oil transfer tube bolts (435, 446) and gaskets (445, 448).
2. Remove the oil transfer tube (447).
3. Inspect the tube for damage or restrictions.

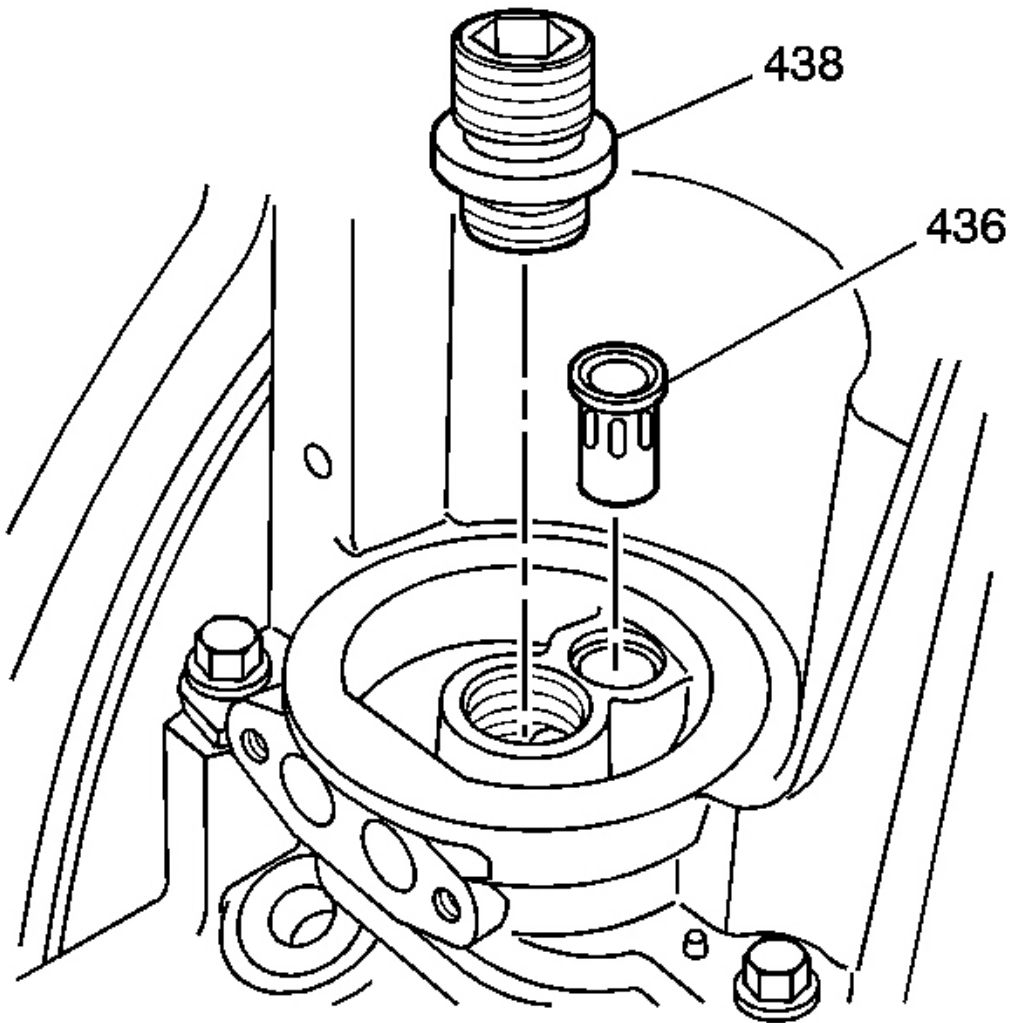
Fig. 551: View Of Oil Filter Fitting & Bypass Valve
Courtesy of GENERAL MOTORS CORP.

12. Inspect the oil filter sealing surface for scratches or gouging.
13. Inspect the oil filter fitting (438) for a loose fit or damaged threads.
14. Inspect the oil passages for restrictions.

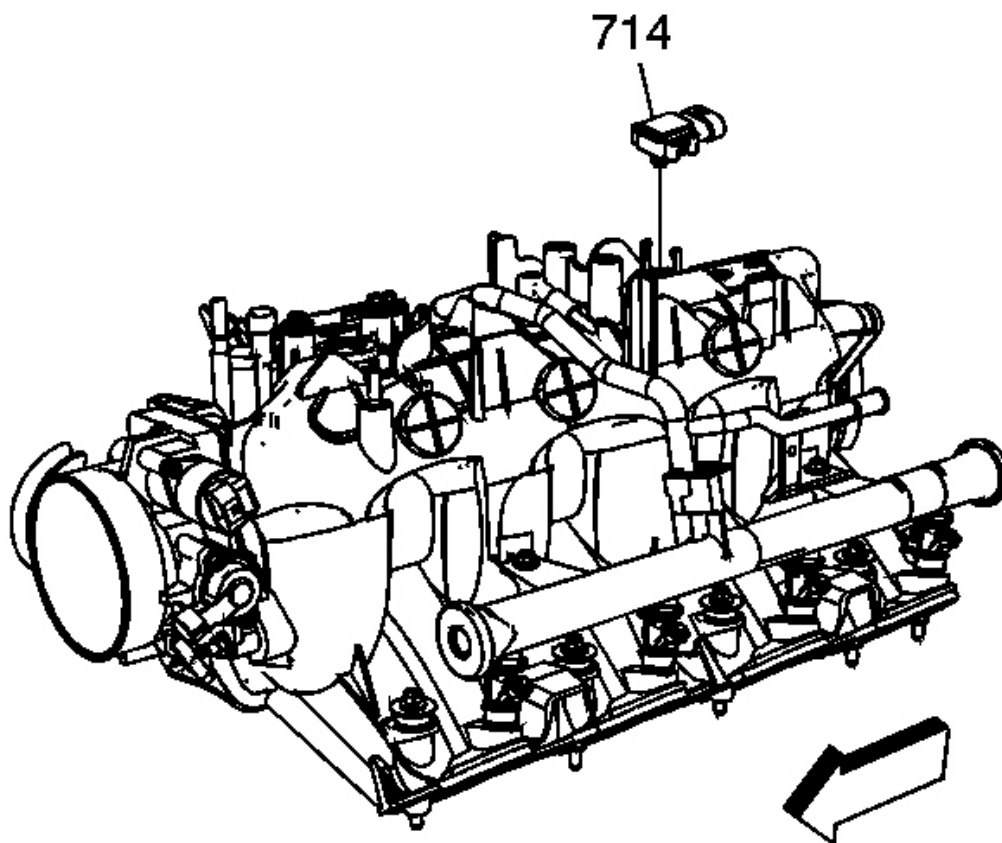
Fig. 552: View Of MAP Sensor
Courtesy of GENERAL MOTORS CORP.

1. Remove the manifold absolute pressure (MAP) sensor (714) from the rear of the intake. The MAP sensor is to be installed upon completion of the cleaning and inspection procedures.
2. Inspect the sealing grommet on the MAP sensor. The grommet should not be torn or damaged.

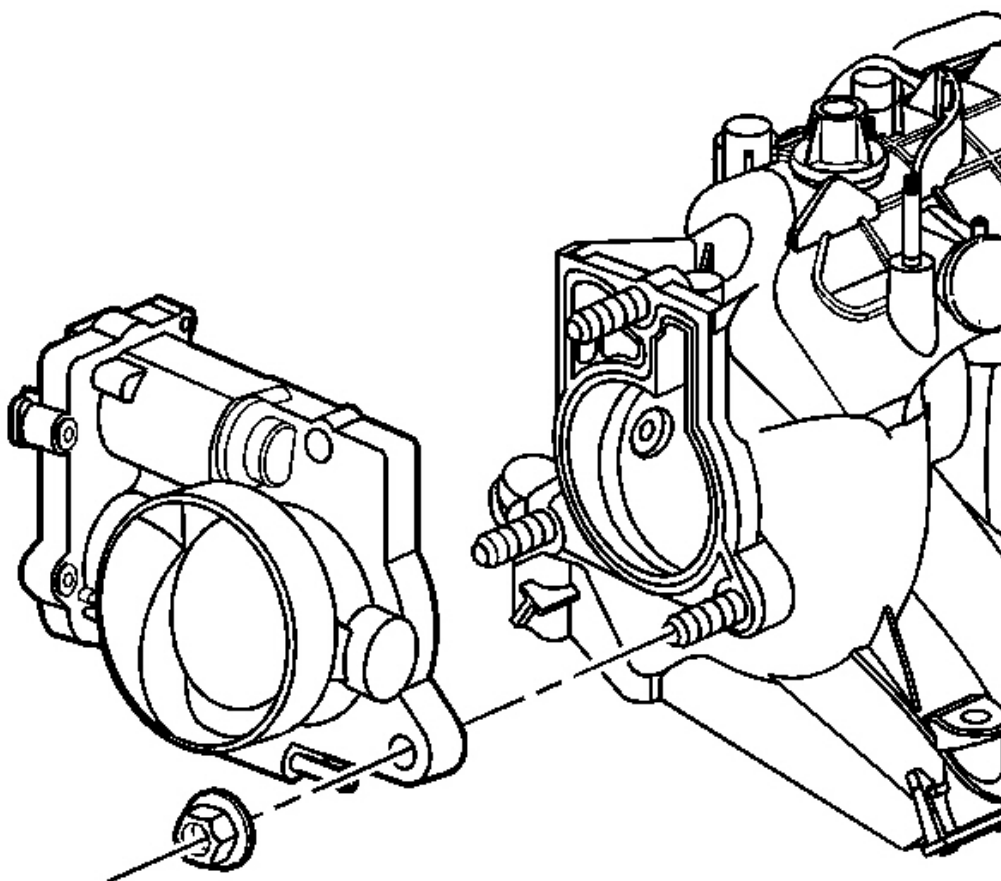
Fig. 557: View Of Throttle Body & Nuts
Courtesy of GENERAL MOTORS CORP.

1. Inspect the throttle body studs and threaded inserts for looseness or damaged threads.
2. Inspect the wire harness stud and threaded insert for looseness or damaged threads.

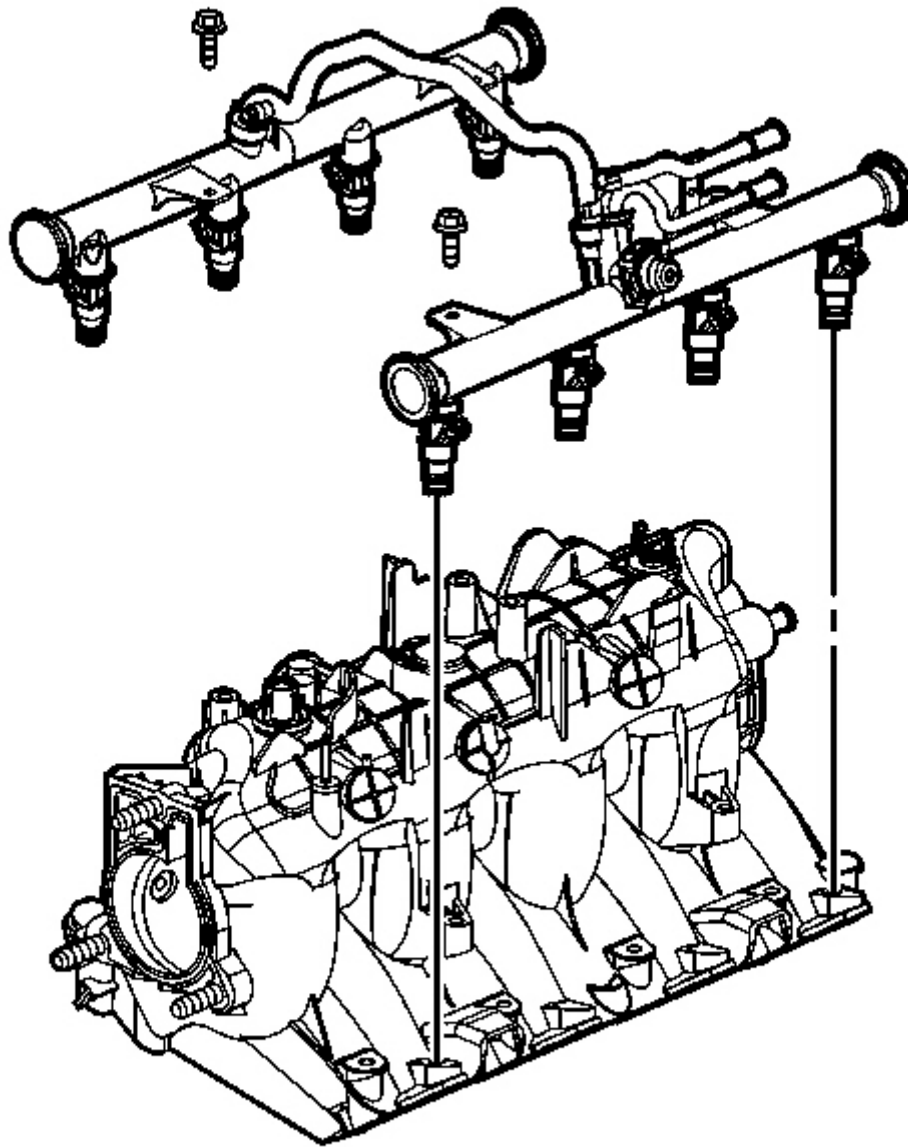
Fig. 558: View Of Fuel Injector Rail
Courtesy of GENERAL MOTORS CORP.

3. Inspect the fuel rail bolt inserts for looseness or damaged threads.
4. Inspect the intake manifold vacuum passages for debris or restrictions.

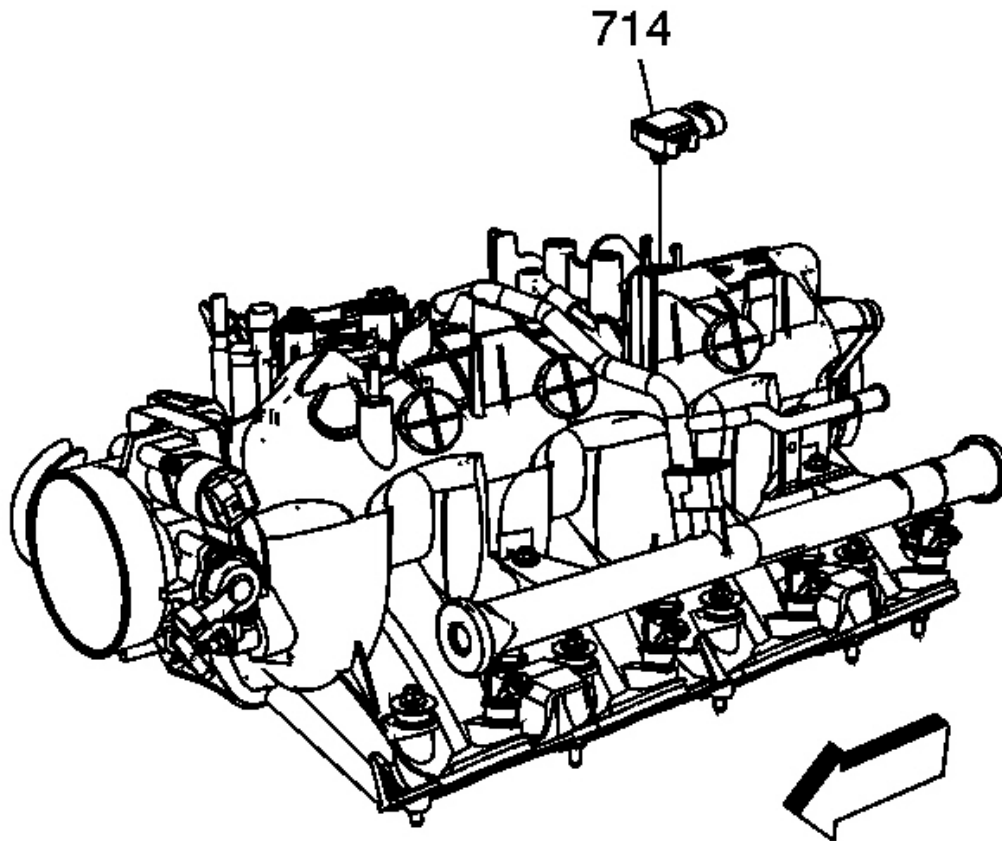
Fig. 559: View Of MAP Sensor
Courtesy of GENERAL MOTORS CORP.

5. Inspect for damaged or broken vacuum fittings, damaged MAP sensor (714) mounting bore, or broken MAP sensor retaining tabs.
6. Inspect the composite intake manifold assembly for cracks or other damage.
7. Inspect the areas between the intake runners.
8. Inspect all the gasket sealing surfaces for damage.
9. Install the MAP sensor.
