2004 Isuzu Ascender LS

2004 ENGINE Engine Mechanical - 4.8L, 5.3L, and 6.0L - Ascender

Engine Mechanical - 4.8L, 5.3L, and 6.0L - Ascender

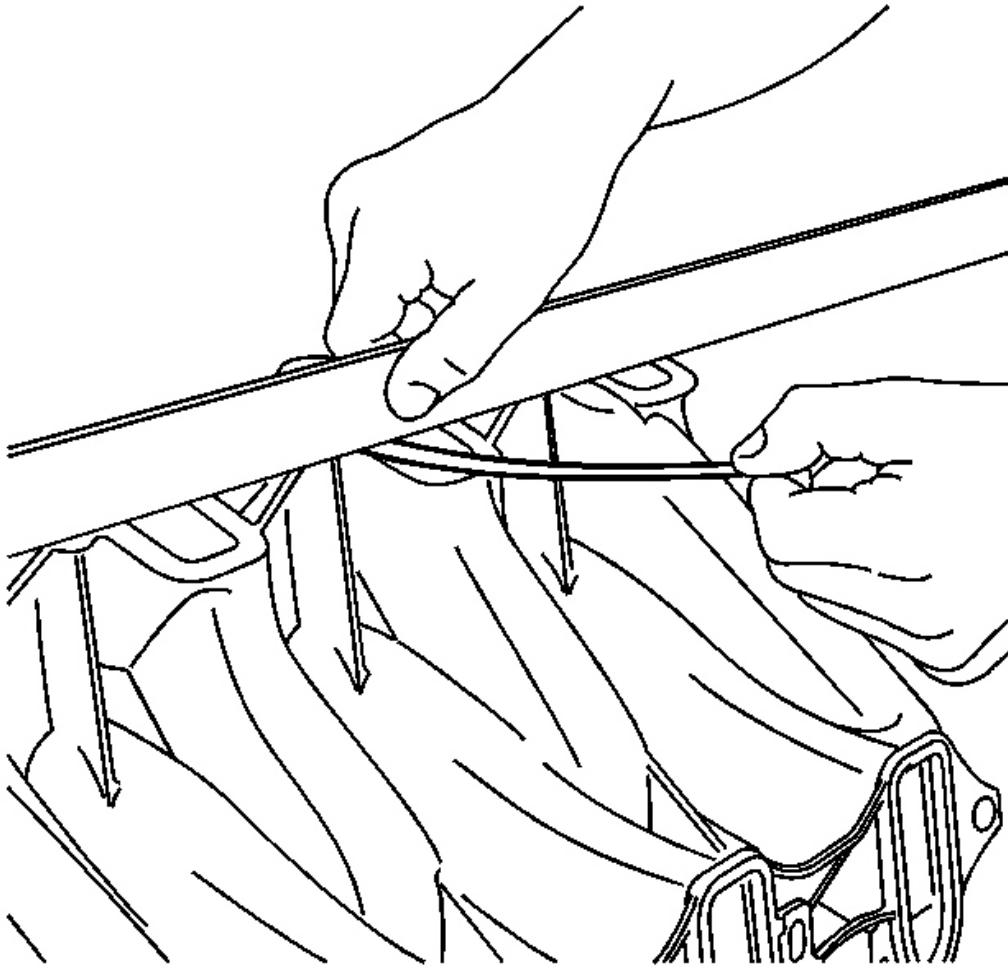
Fig. 560: Inspecting Intake Manifold Cylinder Head Deck For Warpage
Courtesy of GENERAL MOTORS CORP.

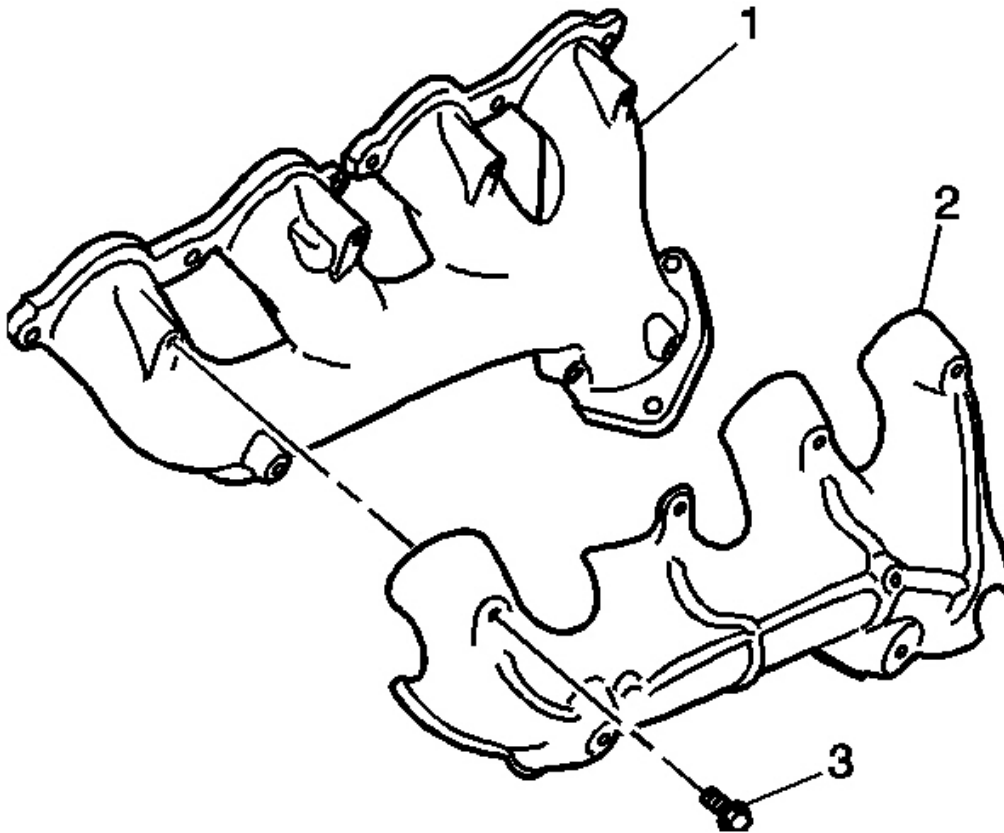
Fig. 562: View Of Left Exhaust Manifold Heat Shield & Bolts
Courtesy of GENERAL MOTORS CORP.

1. Clean the exhaust manifold (1) and heat shield (2) in solvent.
2. Dry the exhaust manifold with compressed air.
3. Inspect the exhaust manifold-to-cylinder head gasket surface for excessive scratches or gouging.
4. Inspect for a loose or damaged heat shield (2).

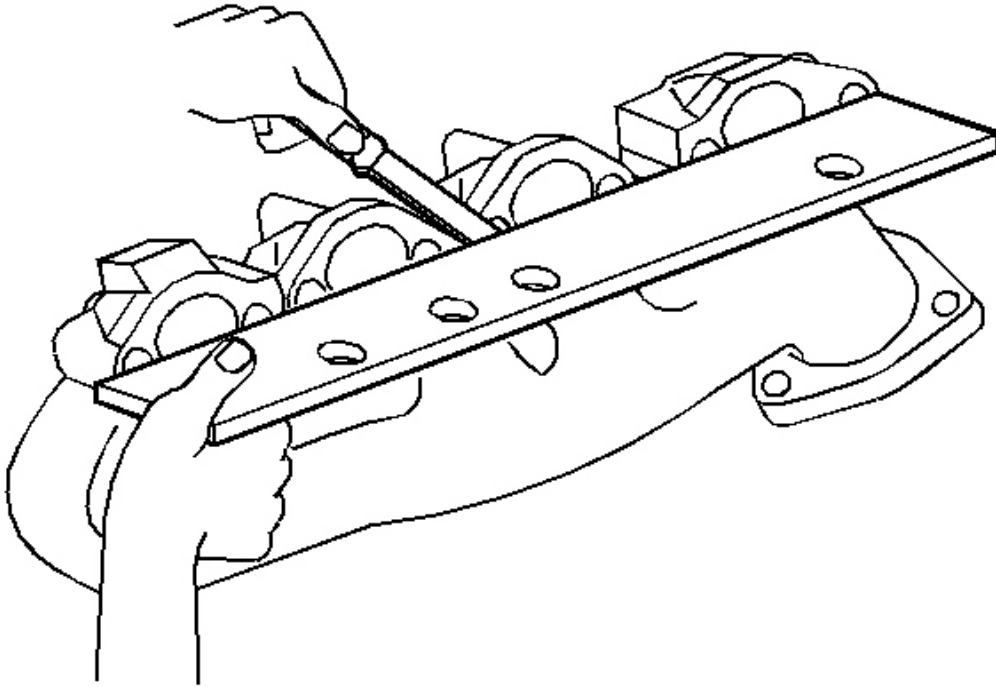
Fig. 563: Measuring Exhaust Manifold To Cylinder Head Surface For Warpage
Courtesy of GENERAL MOTORS CORP.

6. Use a straight edge and a feeler gage and measure the exhaust manifold cylinder head deck for warpage.

An exhaust manifold deck with warpage in excess of 0.25 mm (0.01 in) within the two front or two rear runners or 0.5 mm (0.02 in) overall, may cause an exhaust leak and may effect OBD II system performance. Exhaust manifolds not within specifications must be replaced.

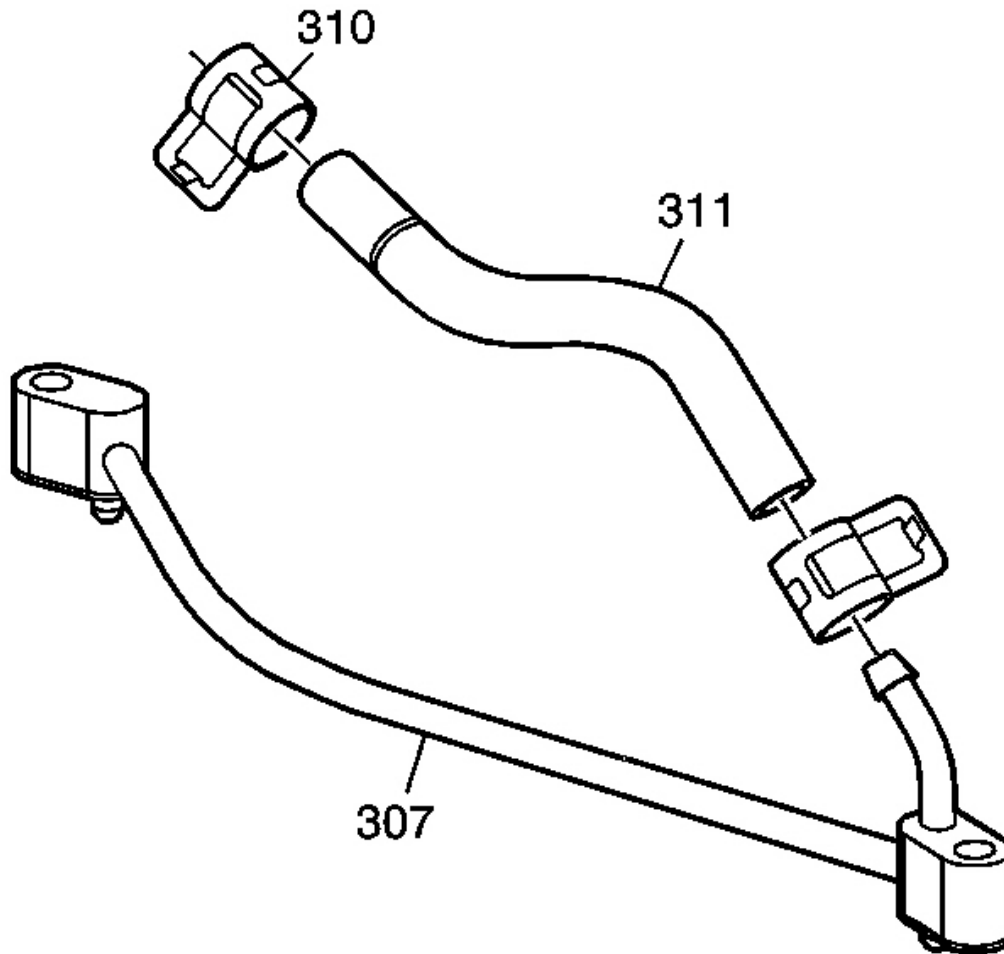
Fig. 565: View Of Engine Coolant Air Bleed Pipe, Hose & Clamps
Courtesy of GENERAL MOTORS CORP.

3. Clean the pipe (307), hose (311), and covers in solvent.

4. Dry the pipe and covers with compressed air.
5. Inspect the pipe and covers for damage or restrictions.
6. Inspect the gasket and hose sealing surfaces for damage.
7. Inspect the hose (311) for restrictions, cracking or wear.

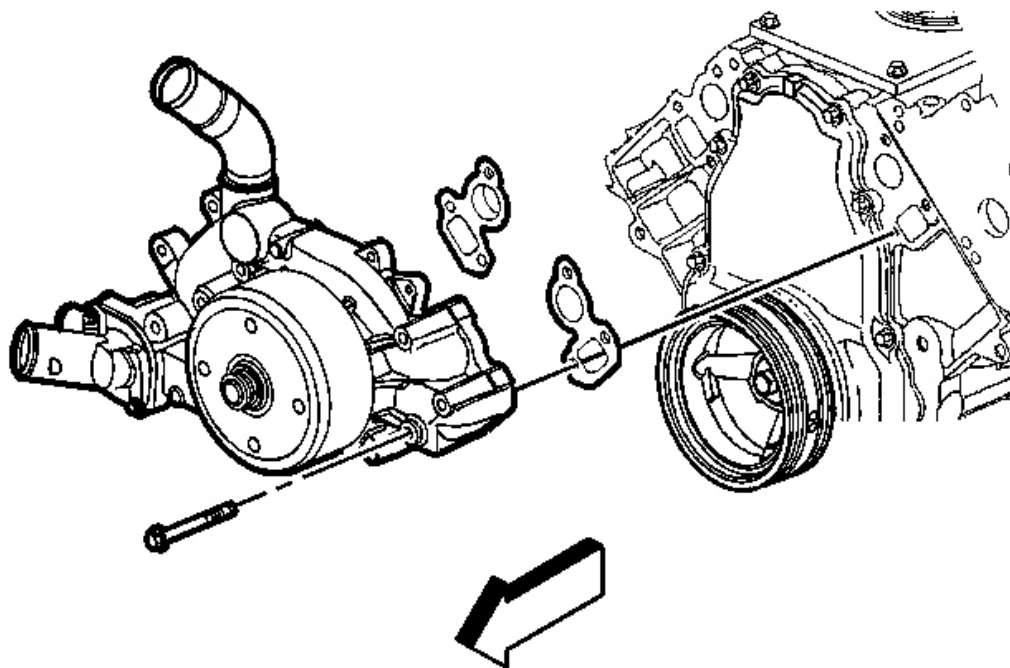
Fig. 566: View Of Water Pump, Gaskets & Bolts
Courtesy of GENERAL MOTORS CORP.

1. Remove the old gasket from the water pump sealing surfaces. Refer to **Replacing Engine Gaskets**.
2. Clean all excess dirt and debris from the water pump housing.
3. Inspect the water pump for the following:
 - Gasket and hose sealing surfaces for excessive scratches or gouging
 - Restrictions within the internal coolant passages
 - Excessive side-to-side play in the pulley shaft
 - Leakage at the water outlet housing or rear cover gasket
 - Leakage at the water pump vent hole

A stain around the vent hole is acceptable. If leakage, dripping, occurs with the engine running and the cooling system pressurized, replace the water pump.

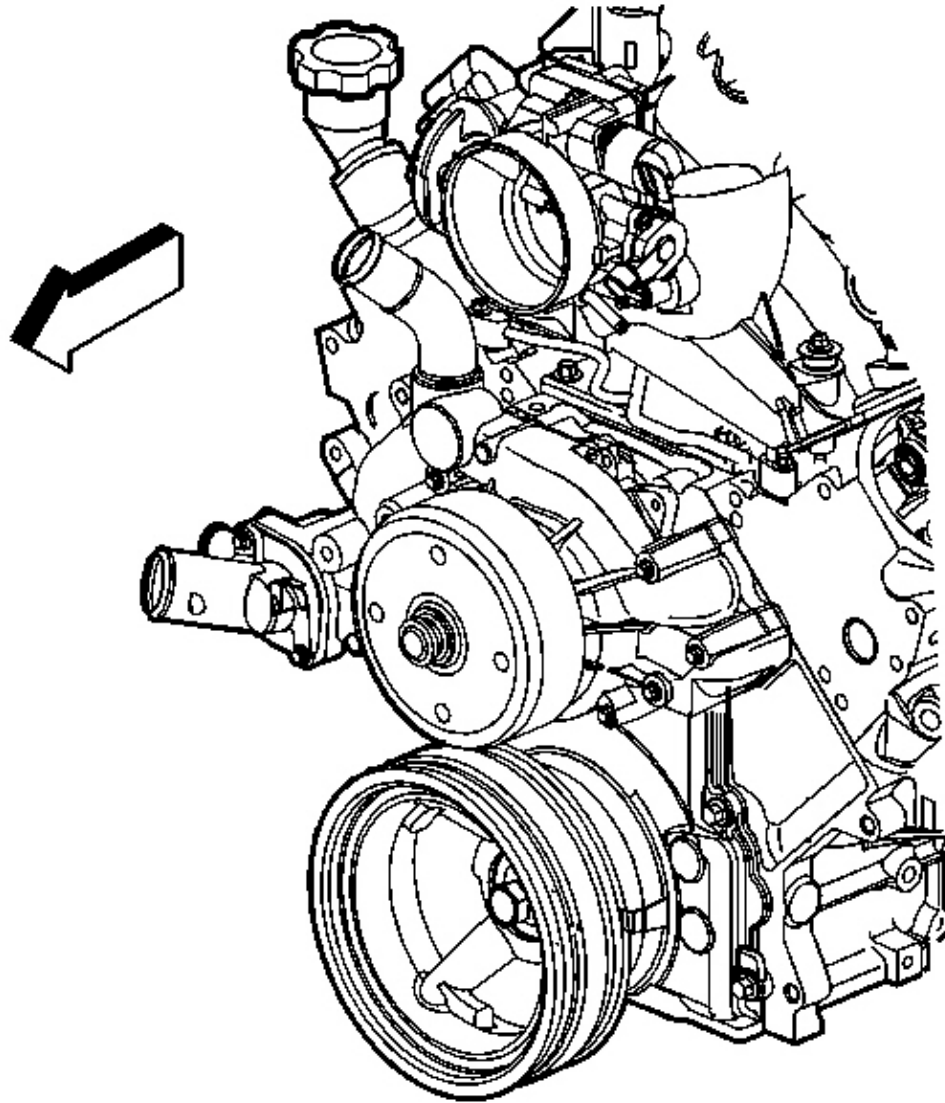
Fig. 567: View Of Water Pump Pulley In Belt Tracking Area
Courtesy of GENERAL MOTORS CORP.

4. Inspect the water pump pulley for wear or damage in the belt tracking area.

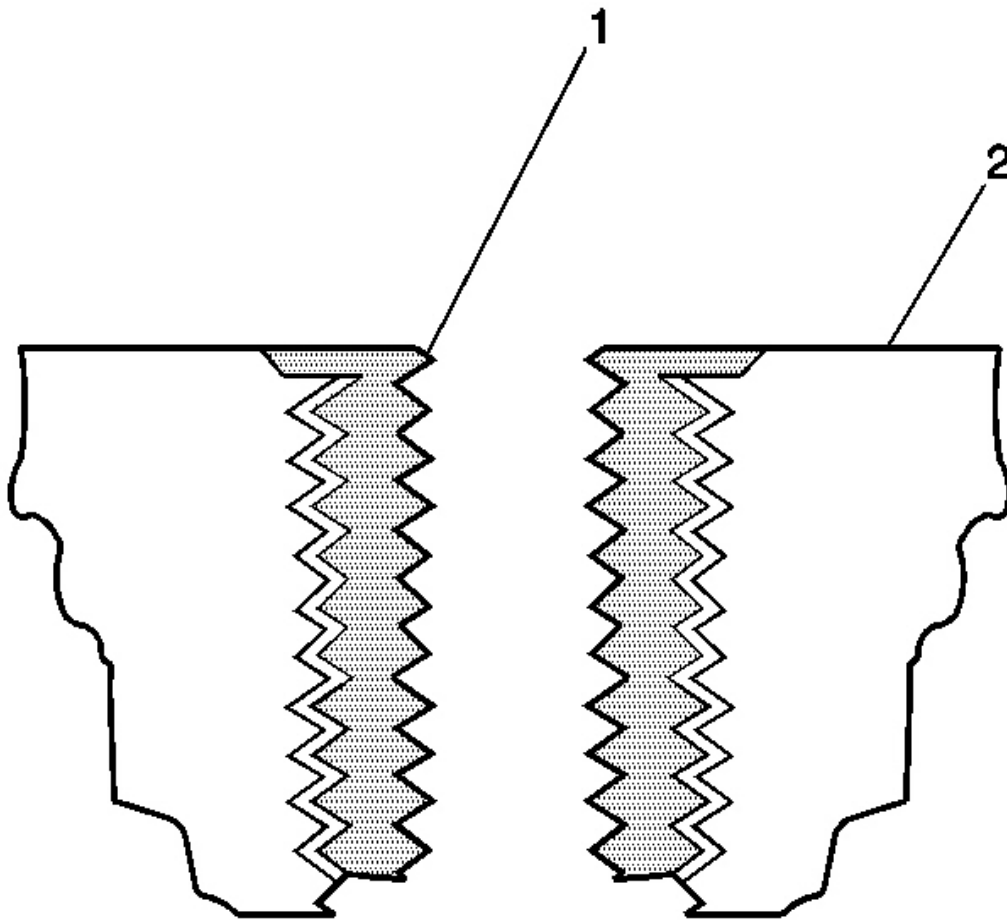
Fig. 568: View Of Bushing Type Insert & Base Material
Courtesy of GENERAL MOTORS CORP.

The thread repair process involves a solid, thin walled, self-locking, carbon steel, bushing type insert (1). During the bushing installation process, the driver tool expands the bottom external threads of the insert into the base material (2). This action mechanically locks the insert in place. Also, when installed to the proper depth, the flange of the insert will be seated against the counterbore of the repaired hole.

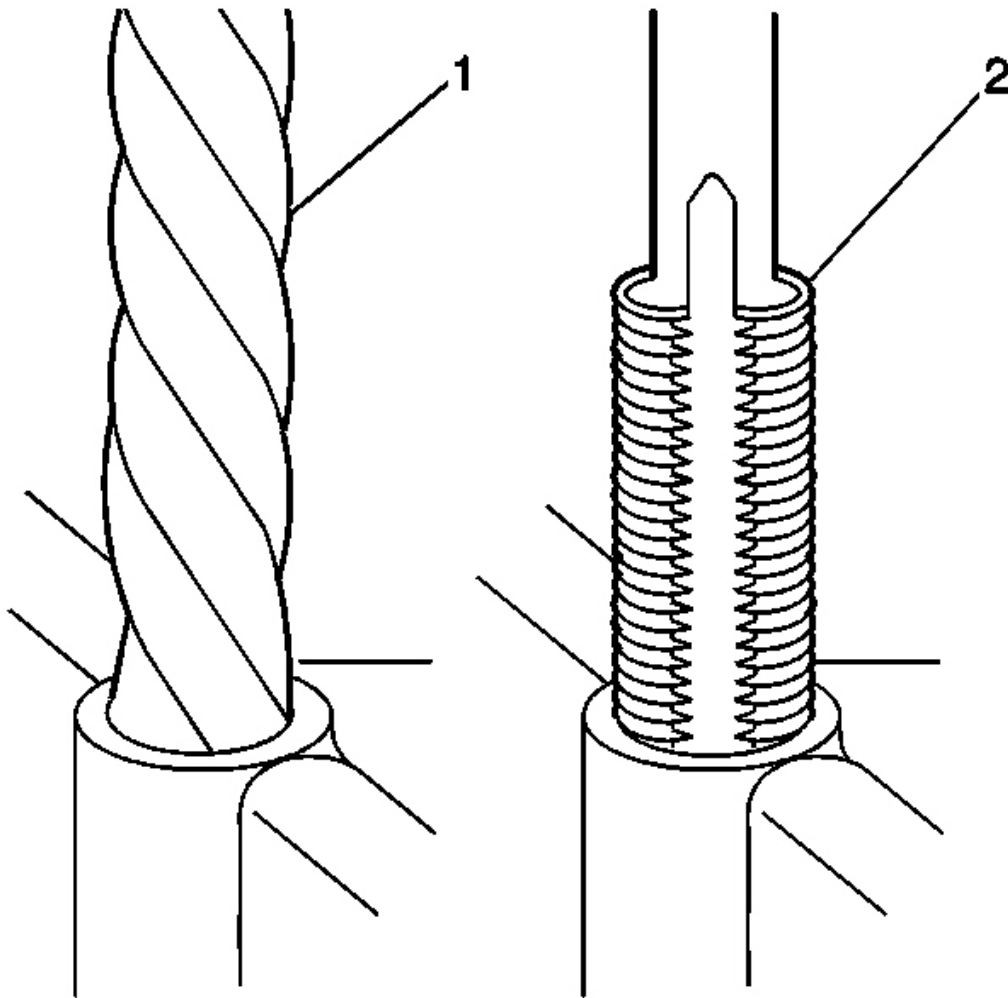
Fig. 571: Drilling & Tapping Threads
Courtesy of GENERAL MOTORS CORP.

5. Using a tap wrench (2), tap the threads of the drilled hole.
 - M6 inserts require a minimum tap depth of 15 mm (0.59 in).
 - M8 inserts require a minimum tap depth of 20 mm (0.79 in).
 - M10 inserts require a minimum tap depth of 23.5 mm (0.93 in).
6. Using compressed air, clean out any chips.
7. Spray cleaner GM P/N 12346139 (Canadian P/N 10953463), GM P/N 12377981 (Canadian P/N 10953463) or equivalent into the hole.
8. Using compressed air, clean any cutting oil and chips out of the hole.

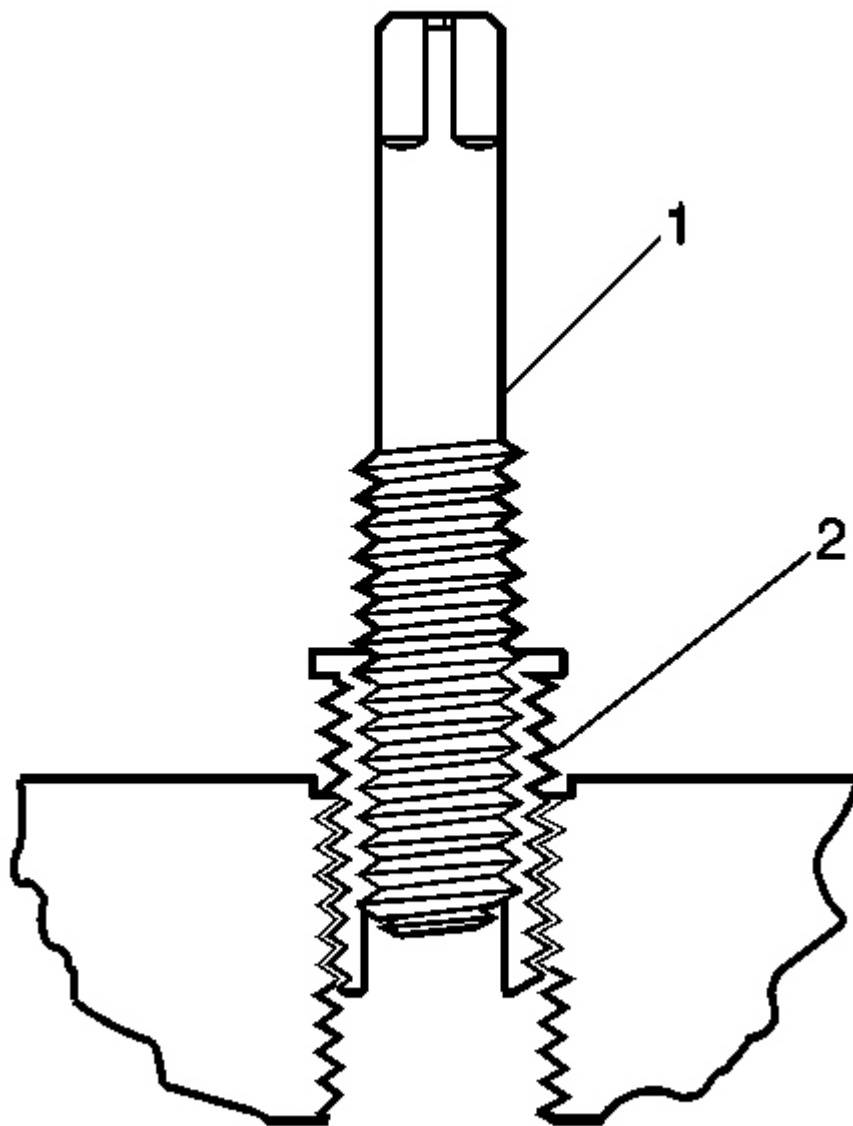
Fig. 575: Installing Insert Into Tapped Bolt Hole
Courtesy of GENERAL MOTORS CORP.

12. Install the insert (2) into the hole.

Install the insert until the flange of the insert contacts the counterbored surface. Continue to rotate the installer tool (1) through the insert.

The installer tool will tighten up before screwing completely through the insert. This is acceptable. You are forming the bottom threads of the insert and mechanically locking the insert to the base material threads.

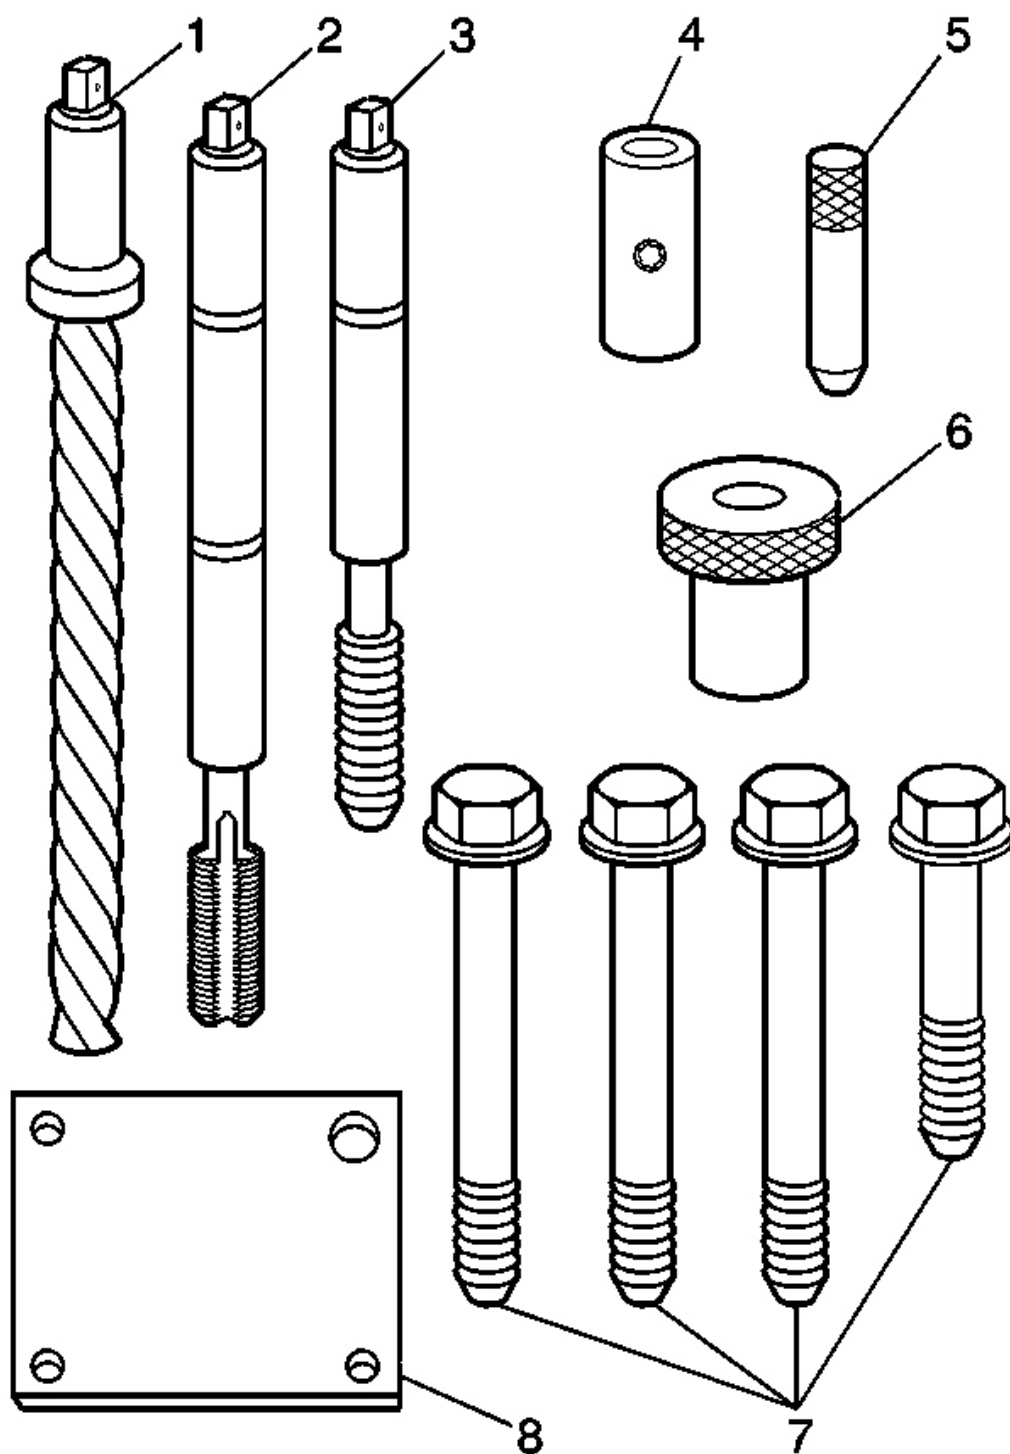
Fig. 577: Identifying Thread Repair Kit Components
Courtesy of GENERAL MOTORS CORP.

1. The cylinder head bolt hole thread repair kit consists of the following items:
 - The drill (1)
 - The tap (2)
 - The installer (3)
 - The sleeve (4)
 - The alignment pin (5)
 - The bushing (6)
 - The bolts (7)
 - The fixture plate (8)

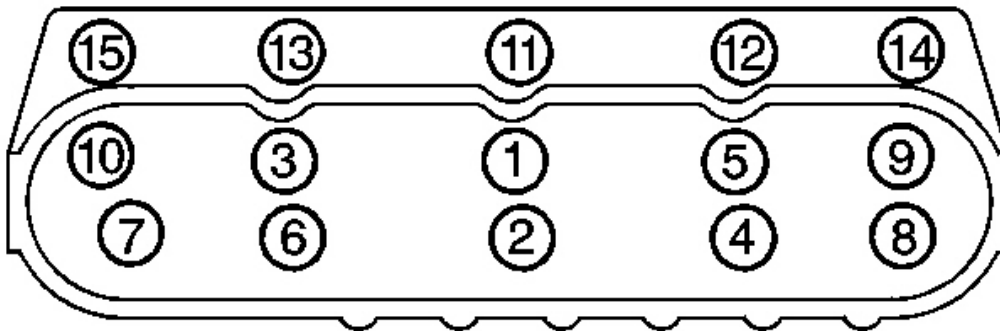
Fig. 578: Cylinder Head Bolt Tightening Sequence
Courtesy of GENERAL MOTORS CORP.

IMPORTANT: First design engine blocks have different drill and tap depths using both medium length 100 mm (3.94 in) and long 155 mm (6.1 in) M11 cylinder head bolts. Second design engine blocks use only the medium length 100 mm (3.94 in) bolt with a common drill and tap depth.

2. Measure the depth of the cylinder head bolt holes (1-10) to determine the proper drill and tap depths. Refer to **Thread Repair Specifications**.

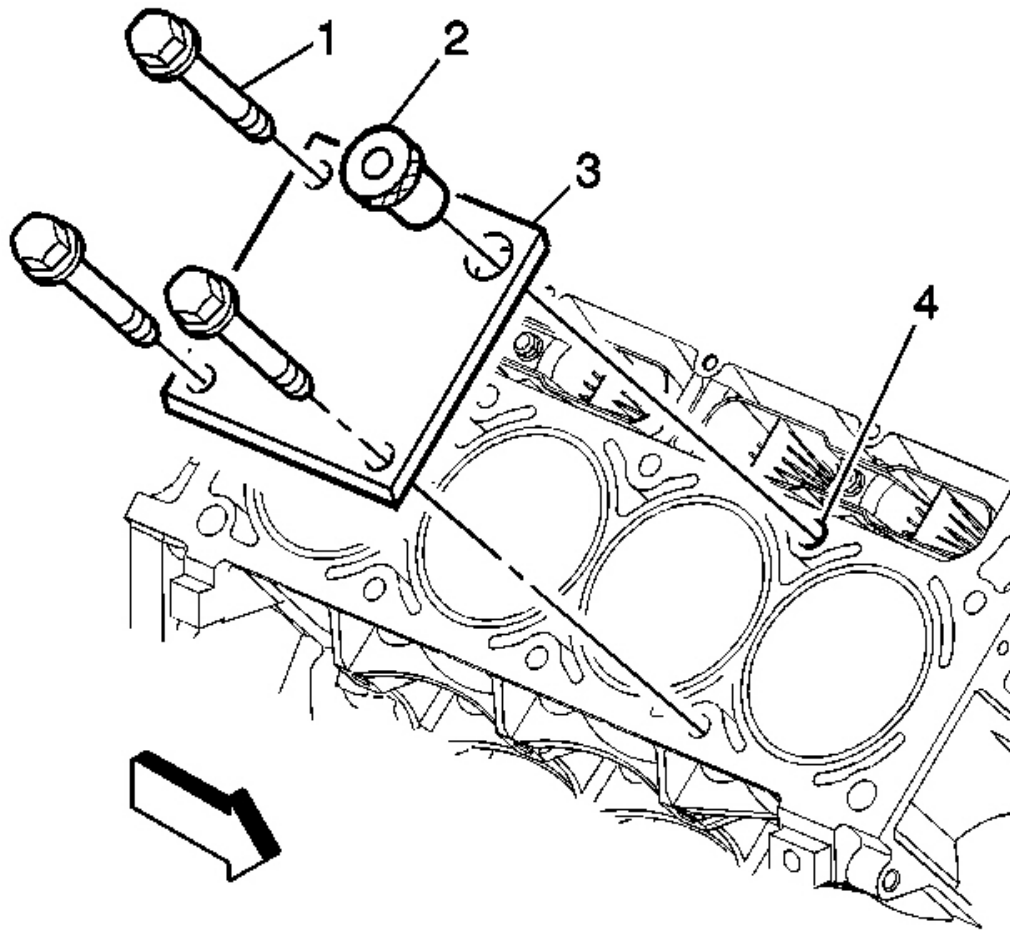
Fig. 579: View Of Fixture Plate, Bolts, Bushing & Cylinder Hole
Courtesy of GENERAL MOTORS CORP.

3. Install the fixture plate (3), bolts (1), and bushing (2) onto the engine block deck.

Position the fixture plate and bushing over the hole that is to be repaired (4).

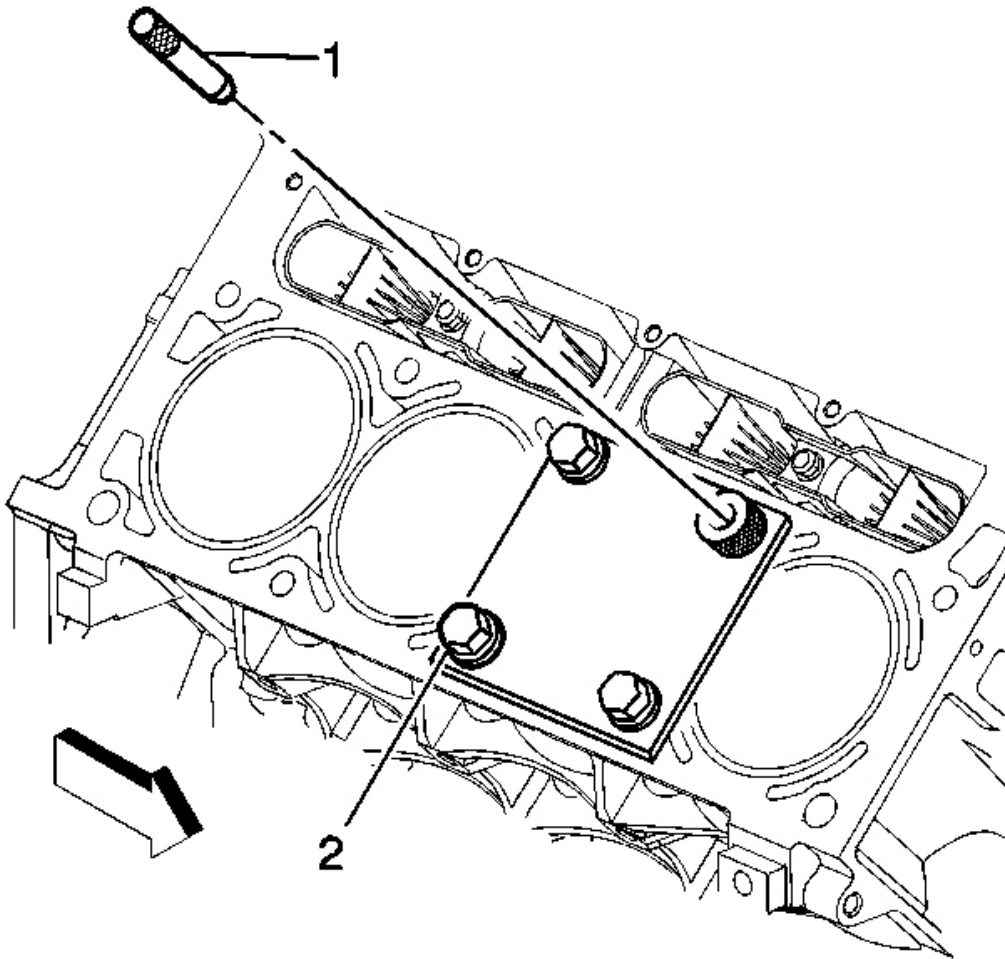
Fig. 580: View Of Alignment Pin & Fixture Retaining Bolts
Courtesy of GENERAL MOTORS CORP.

4. Position the alignment pin (1) through the bushing and into the hole.
5. With the alignment pin in the desired hole, tighten the fixture retaining bolts (2).
6. Remove the alignment pin from the hole.

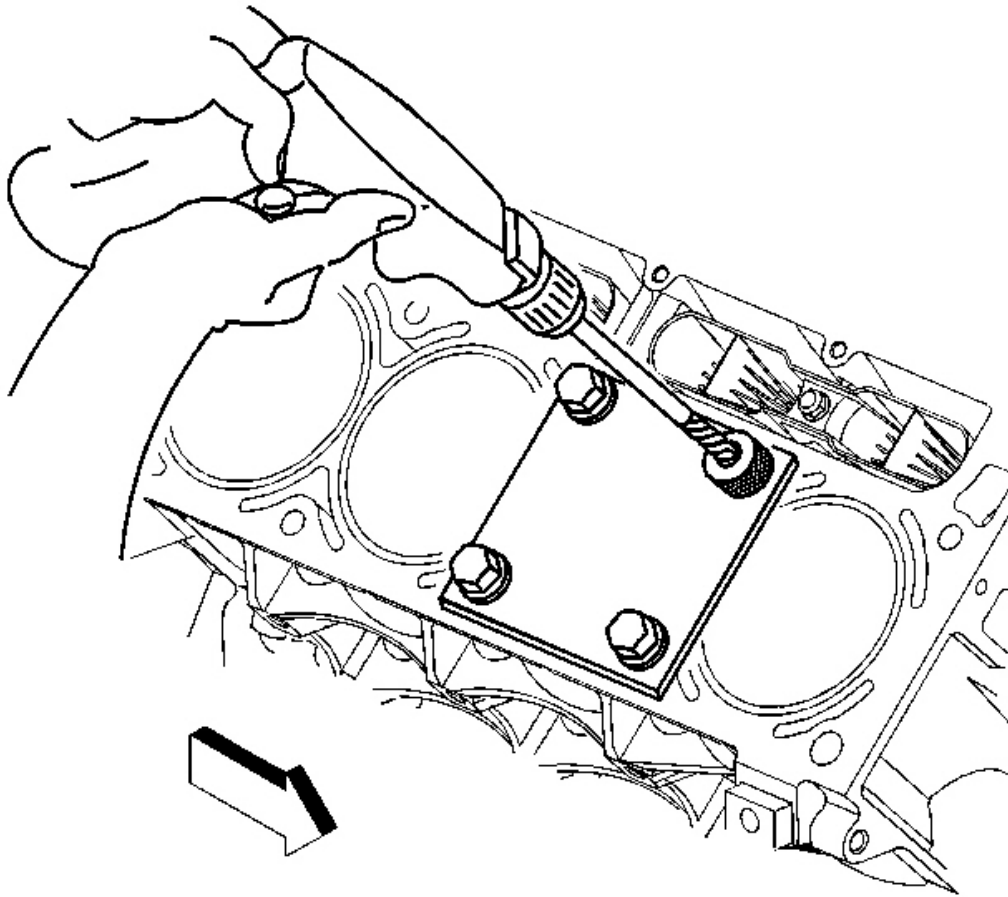
Fig. 582: Drilling Cylinder Head Bolt Hole
Courtesy of GENERAL MOTORS CORP.

IMPORTANT: During the reaming process, it is necessary to repeatedly remove the drill and clean the chips from the hole.

8. Drill out the threads of the damaged hole.

Drill the hole until the stop collar of the drill bit or the sleeve contacts the bushing.

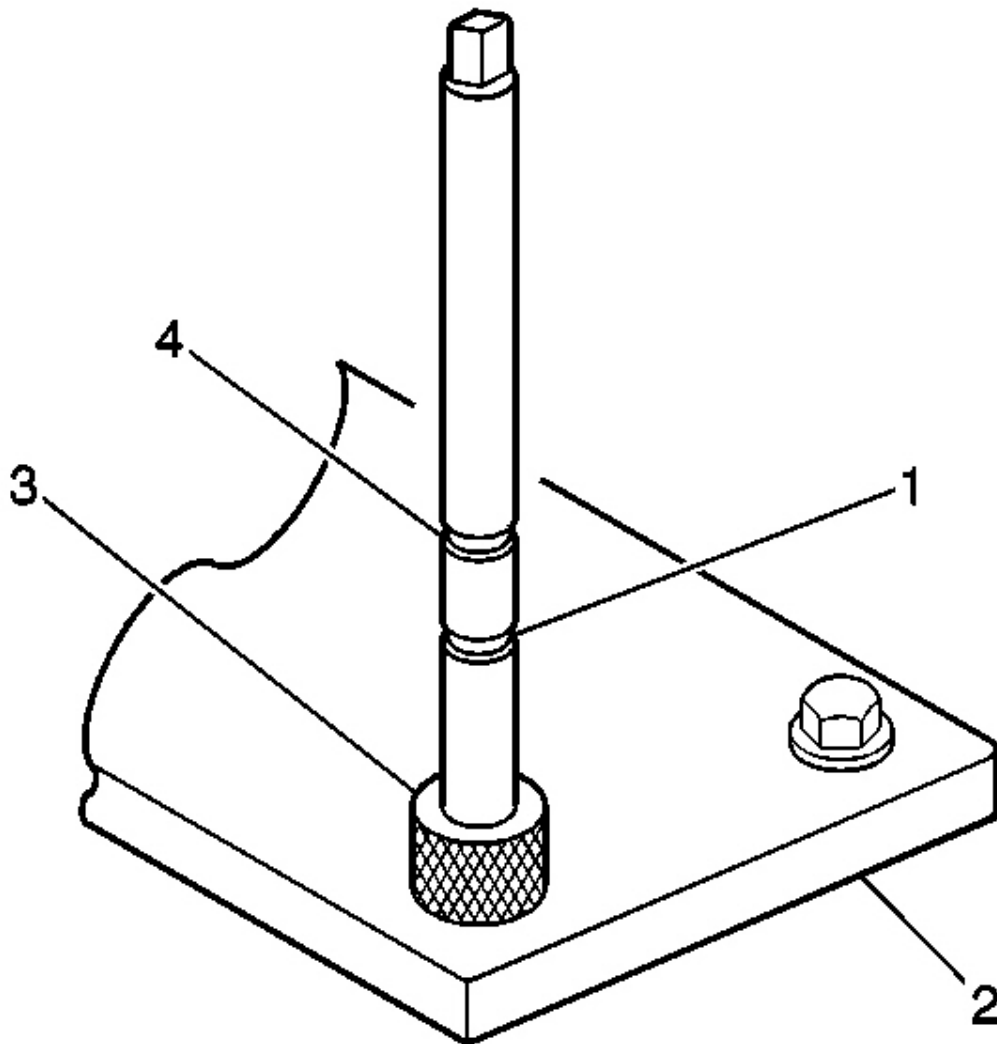
Fig. 584: View Of Tap Upper & Lower Marks, Fixture Plate & Bushing
Courtesy of GENERAL MOTORS CORP.

11. In order to tap the new threads to the proper depth, rotate the tap into the hole until the marks (1 or 4) on the tap align with the top of the drill bushing (3).

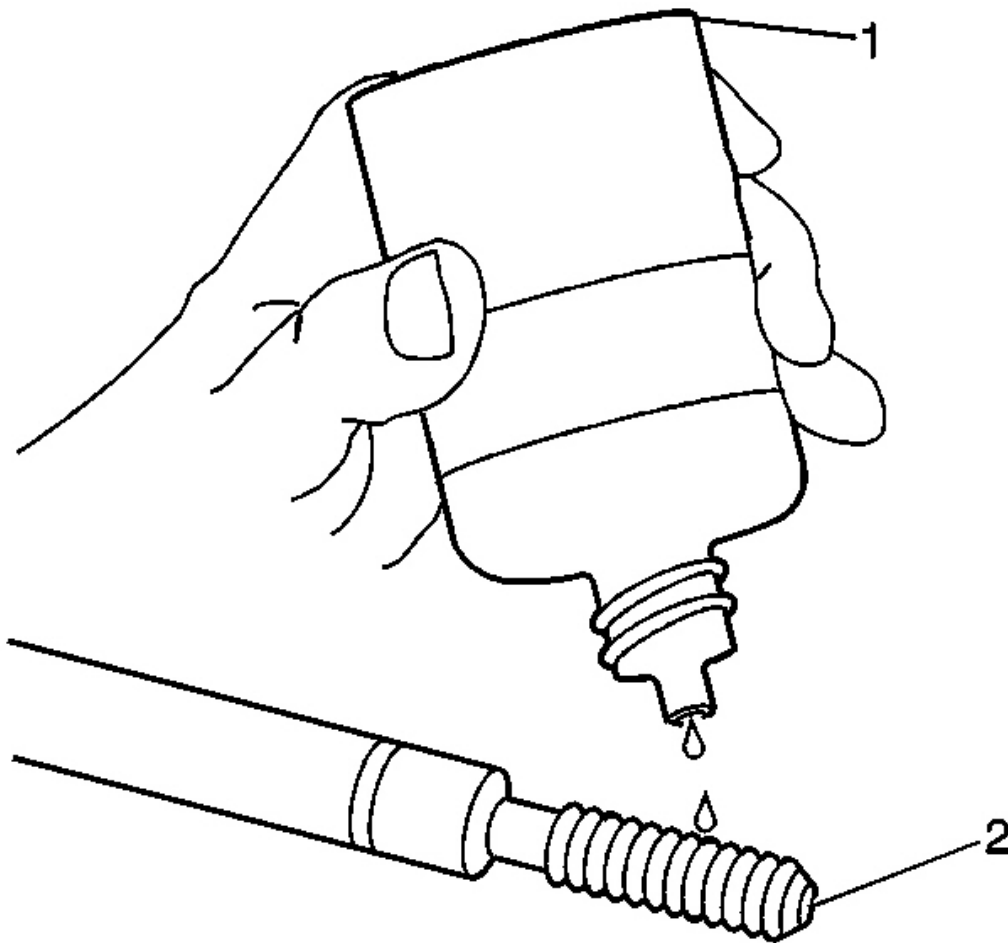
Fig. 585: Lubricating Installer Tool Using Driver Oil
Courtesy of GENERAL MOTORS CORP.

IMPORTANT: Do not allow oil or other foreign material to contact the outside diameter (OD) of the insert.

16. Lubricate the threads of the installer tool (2) with the driver oil (1).

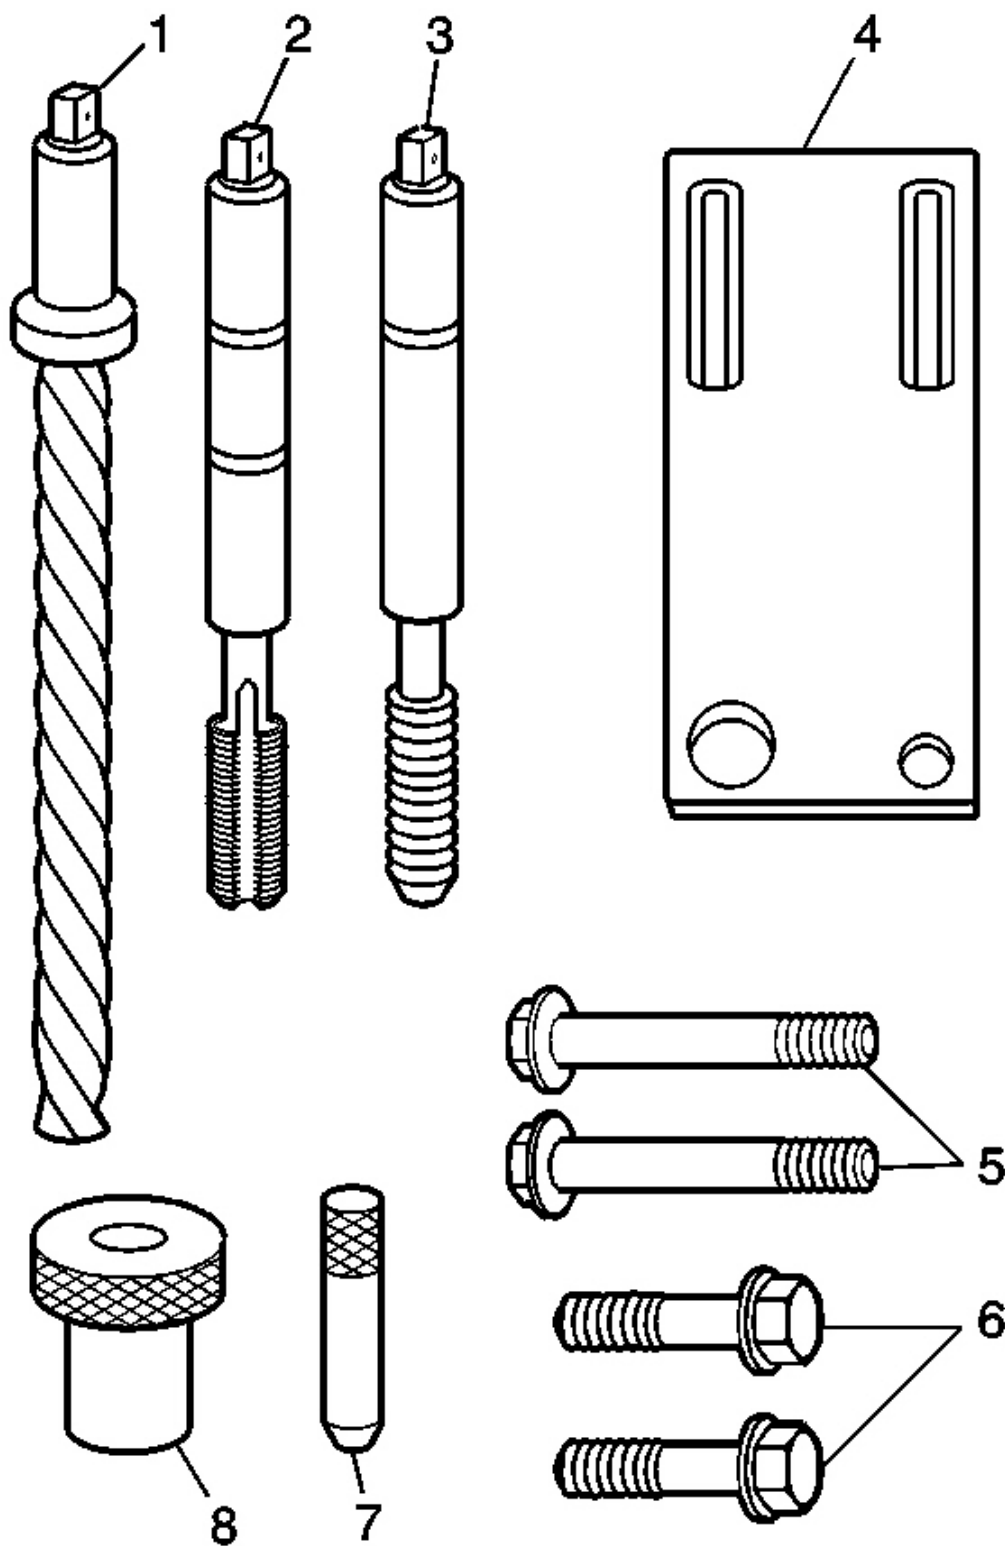
Fig. 589: Identifying Thread Repair Kit Components
Courtesy of GENERAL MOTORS CORP.

1. The main cap bolt hole thread repair kit consists of the following items:
 - The drill (1)
 - The tap (2)
 - The installer (3)
 - The fixture plate (4)
 - The long bolts (5)
 - The short bolts (6)
 - The alignment pin (7)
 - The bushing (8)

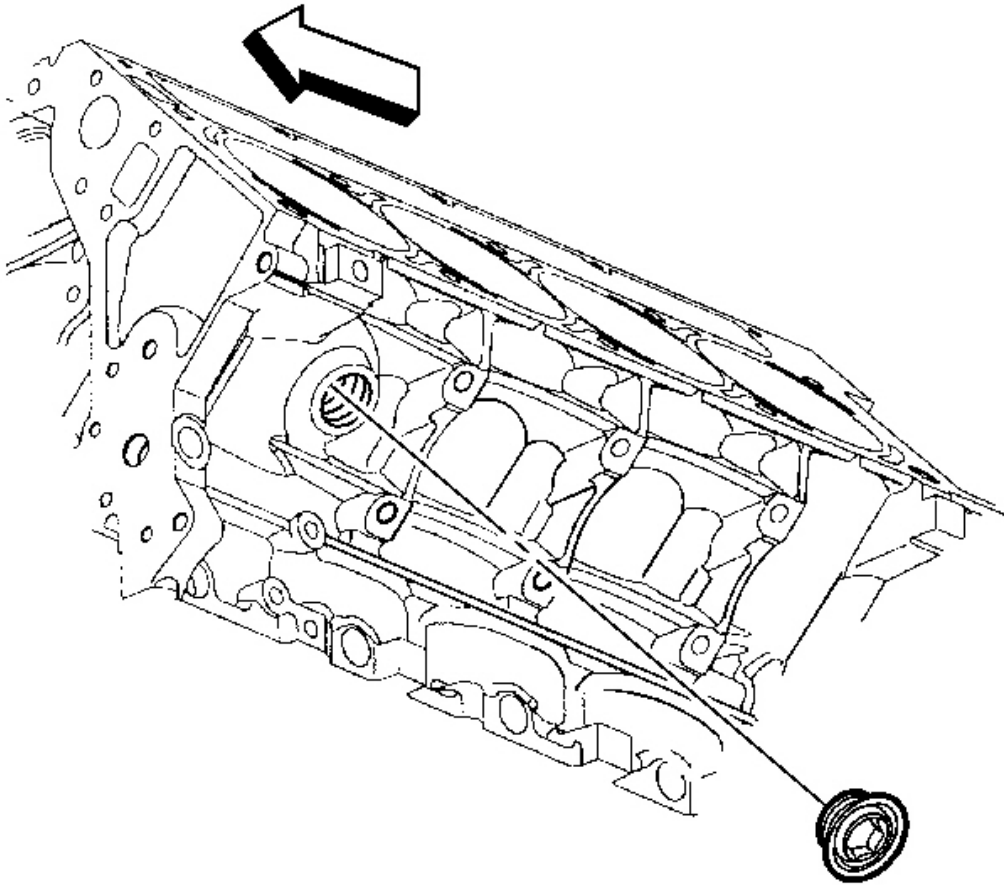
Fig. 599: View Of Engine Block Coolant Heater
Courtesy of GENERAL MOTORS CORP.

2. Install the engine block coolant heater to the engine block, if applicable.

Tighten: Tighten the block coolant heater to 40 N.m (30 lb ft).

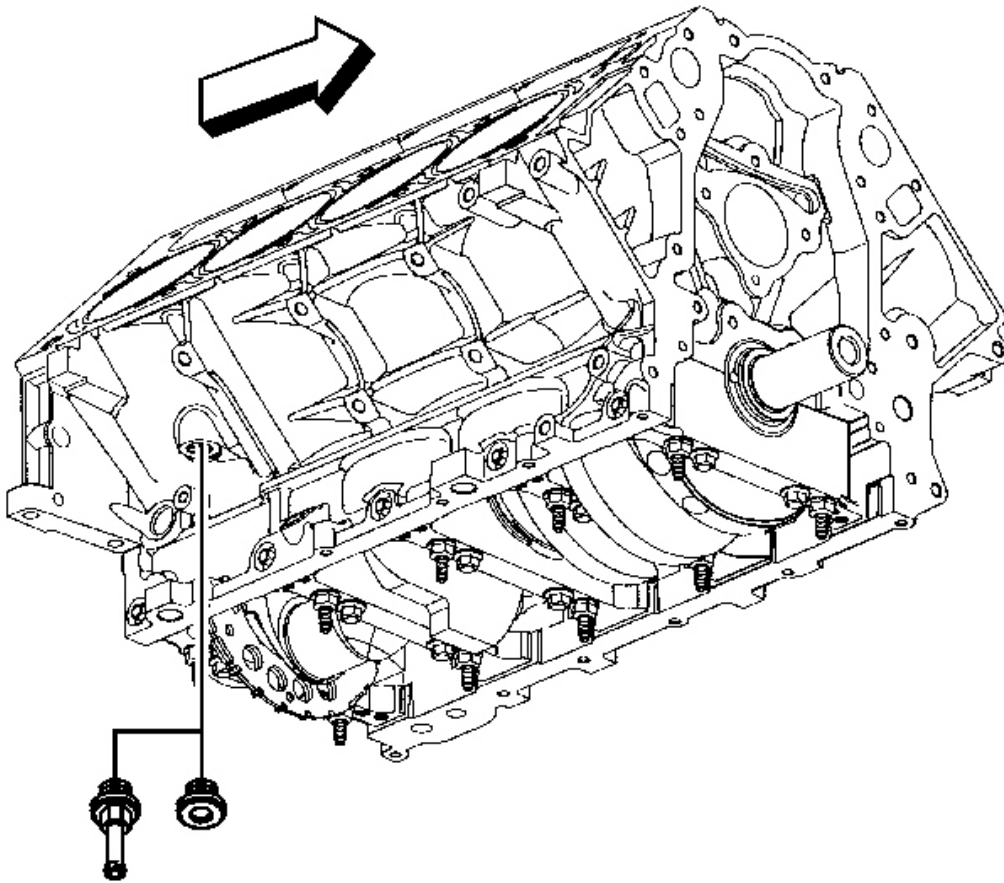
Fig. 600: View Of Engine Block Left Front Coolant Drain Hole Plug
Courtesy of GENERAL MOTORS CORP.

3. Apply a 3.175 mm (0.125 in) bead of sealant to the engine block left rear coolant drain plug sealing washer, if applicable.
4. Install the engine block left front coolant drain plug, if applicable.

Tighten: Tighten the block left front coolant drain plug to 60 N.m (44 lb ft).

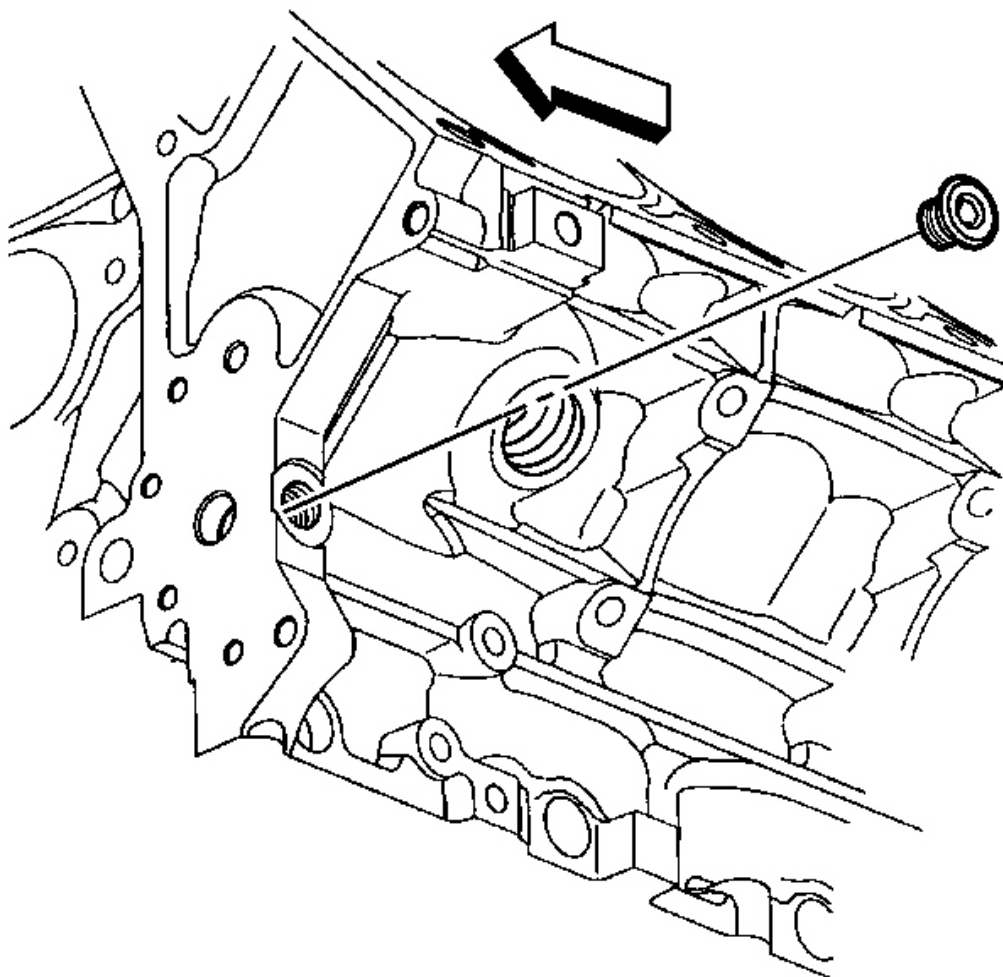
Fig. 601: View Of Engine Block Right Rear Coolant Drain Plug
Courtesy of GENERAL MOTORS CORP.

5. Apply a 3.175 mm (0.125 in) bead of sealant to the engine block right rear coolant drain plug sealing washer, or for RPO HP2 equipped vehicles, to the threads of the coolant fitting.
6. Install the engine block right rear coolant drain plug.

7. On vehicles equipped with RPO HP2, install the coolant fitting.

Tighten: Tighten the coolant fitting to 35 N.m (26 lb ft).

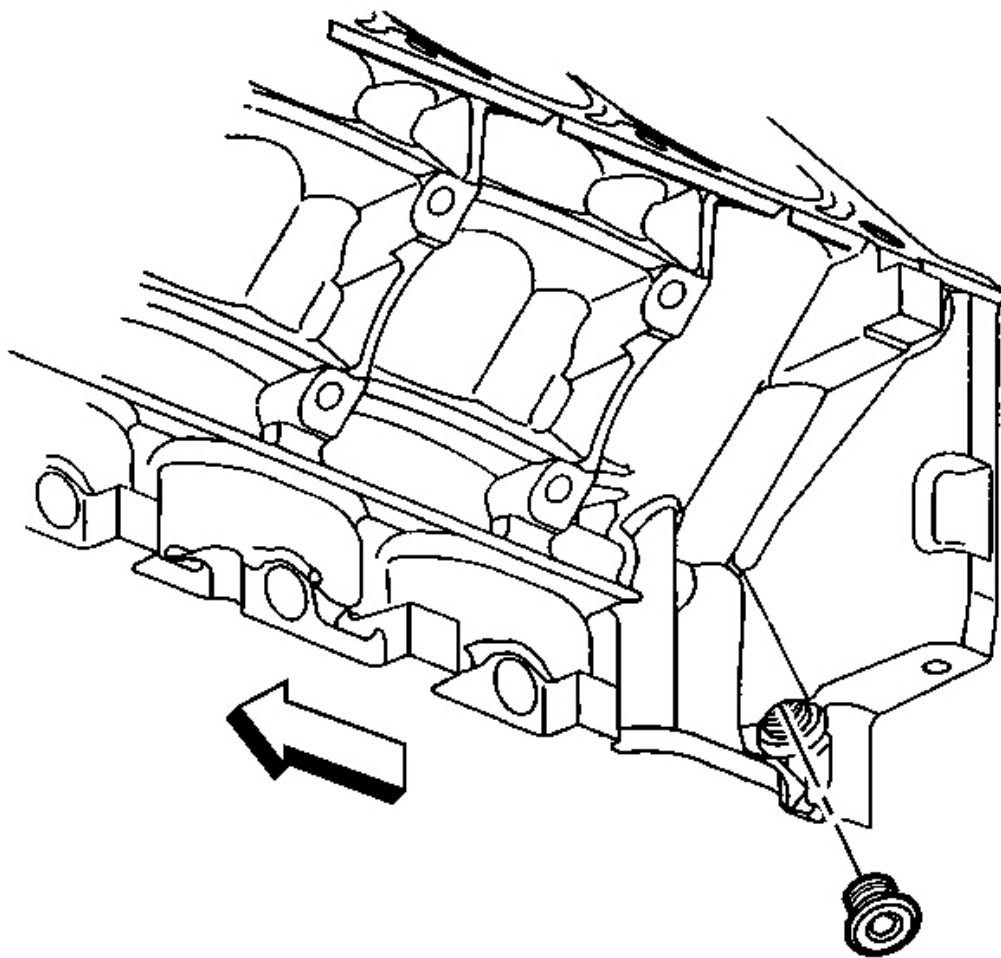
Fig. 602: View Of Engine Block Left Front Oil Gallery Plug
Courtesy of GENERAL MOTORS CORP.

8. Apply a 3.175 mm (0.125 in) bead of sealant to the engine block left front oil gallery plug sealing washer.
9. Install the engine block left front oil gallery plug.

Tighten: Tighten the block left front oil gallery plug to 60 N.m (44 lb ft).
