2004 Isuzu Ascender LS

2004 ENGINE Engine Mechanical - 4.8L, 5.3L, and 6.0L - Ascender

Engine Mechanical - 4.8L, 5.3L, and 6.0L - Ascender

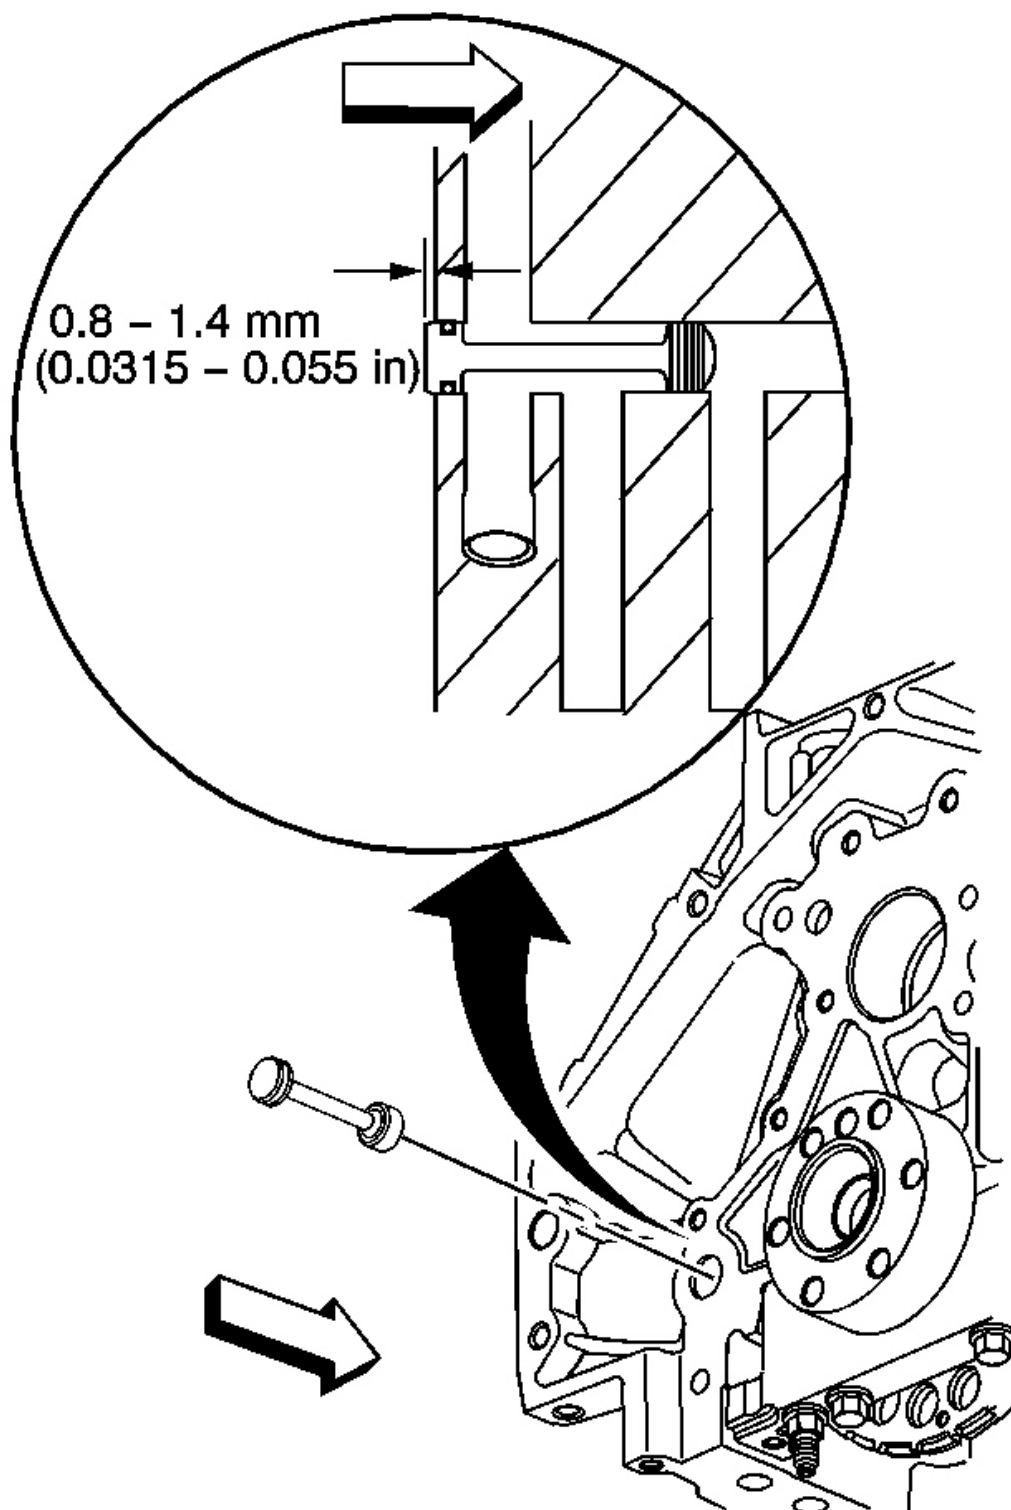
Fig. 603: View Of Engine Block Left Rear Oil Gallery Plug
Courtesy of GENERAL MOTORS CORP.

10. Apply a 3.175 mm (0.125 in) bead of sealant to the engine block left rear oil gallery plug sealing washer.
11. Install the engine block left rear oil gallery plug.

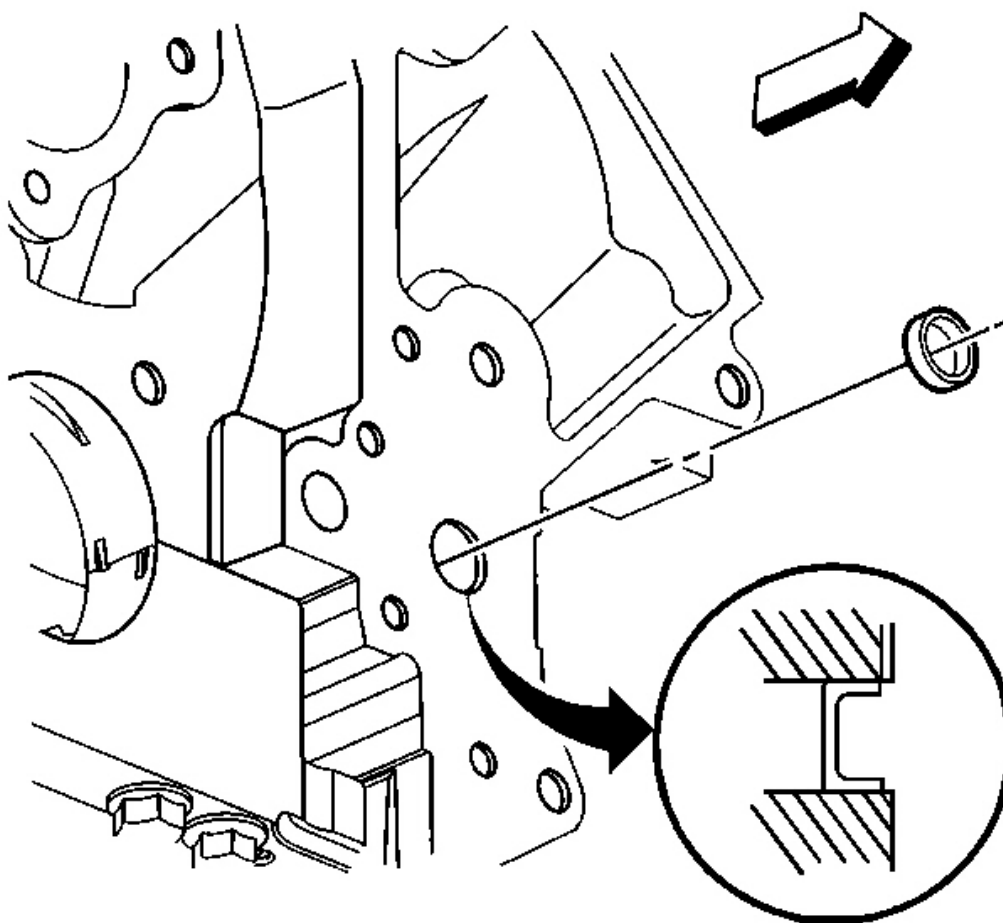
Fig. 604: View Of Engine Block Rear Oil Gallery Plug
Courtesy of GENERAL MOTORS CORP.

12. Inspect the engine block rear oil gallery plug and O-ring seal. If the O-ring seal on the plug is not cut or damaged, the rear oil gallery plug may be used again.
13. Lubricate the O-ring seal with clean engine oil.
14. Install the block rear oil gallery plug into the oil gallery bore. A properly installed block plug will protrude 0.8-1.4 mm (0.0315-0.055 in) beyond the rear face of the block.

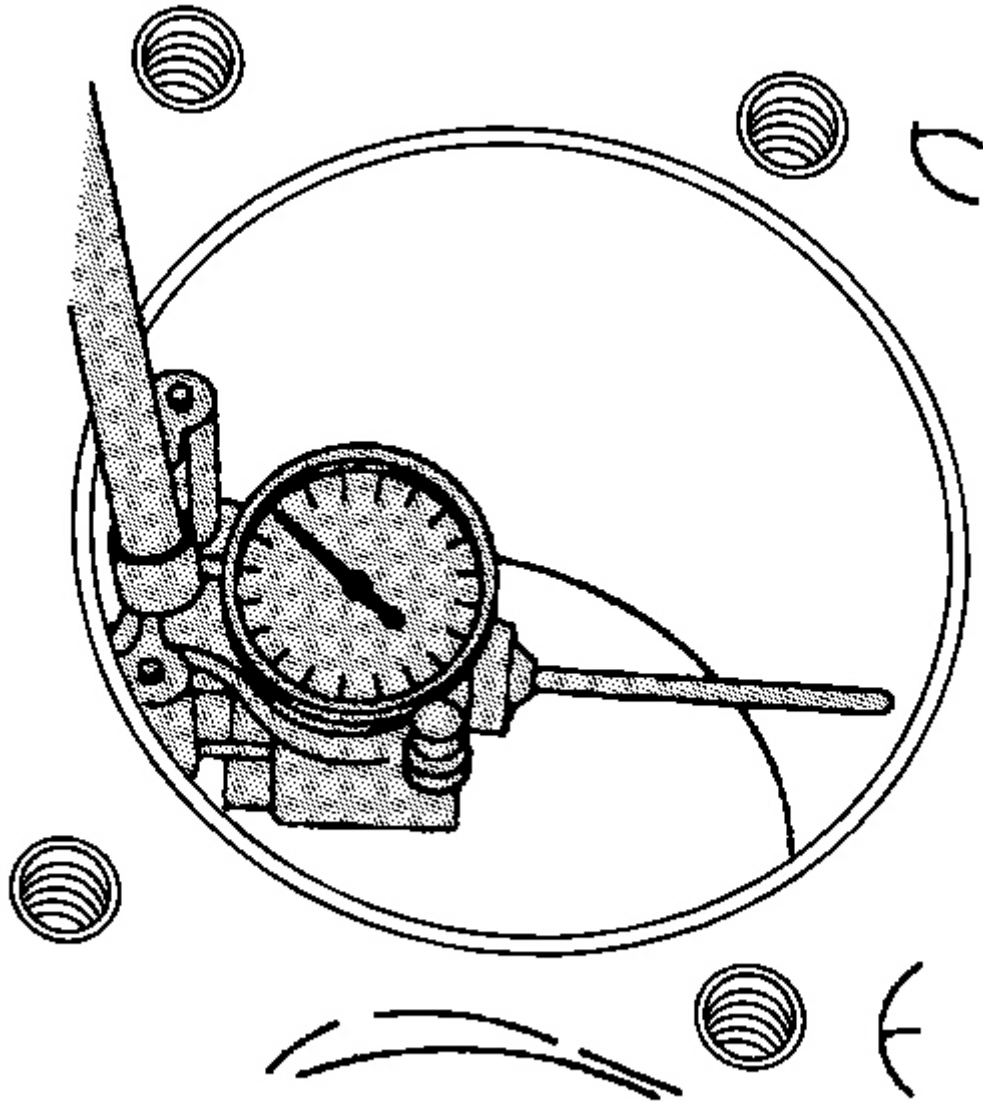
Fig. 615: Measuring Bore Gauge With Micrometer
Courtesy of GENERAL MOTORS CORP.

3. Adjust the micrometer to the recorded piston OD.
4. Insert the **J 8087** into the micrometer and zero the gage dial.

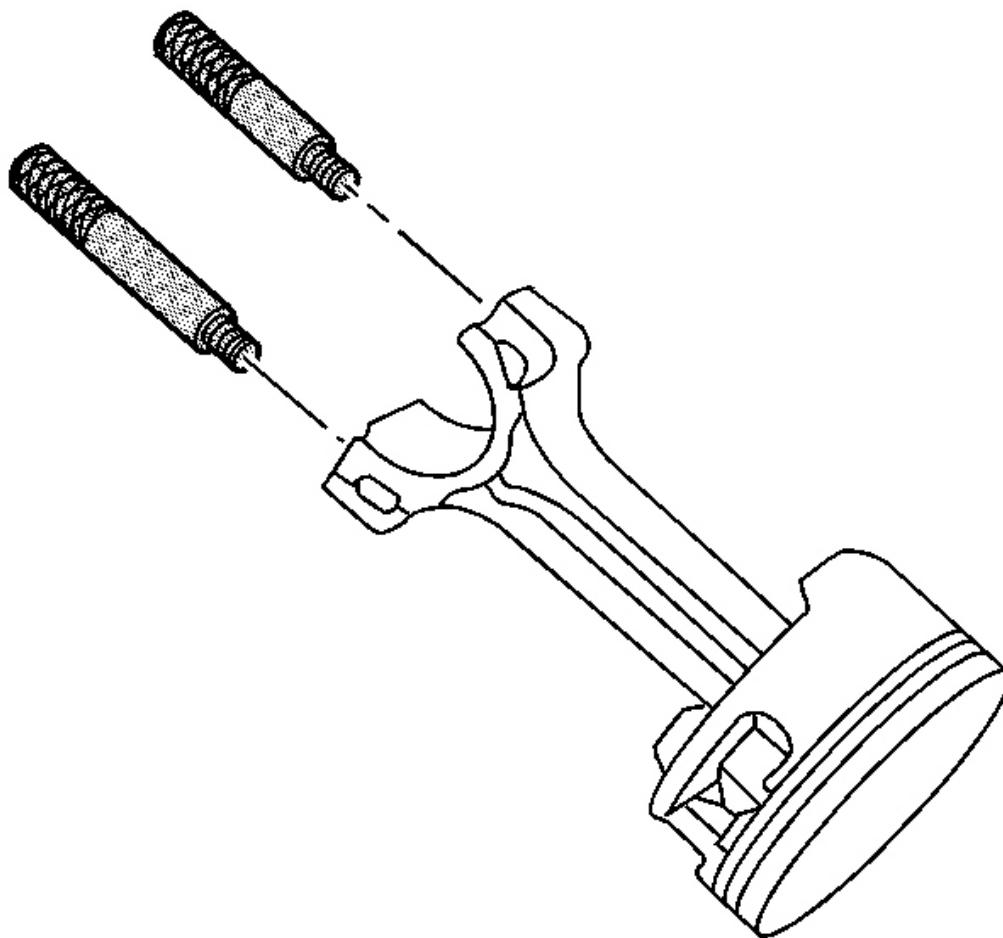
Fig. 617: View Of Piston & Connecting Rod Components
Courtesy of GENERAL MOTORS CORP.

1. Lightly lubricate the following components with clean engine oil:
 - Piston (1)
 - Piston rings

- Cylinder bore
 - Bearings (3) and bearing surfaces
2. Position the oil control ring end gaps a minimum of 25 mm (1.0 in) from each other.
 3. Position the compression ring end gaps 180 degrees opposite each other.

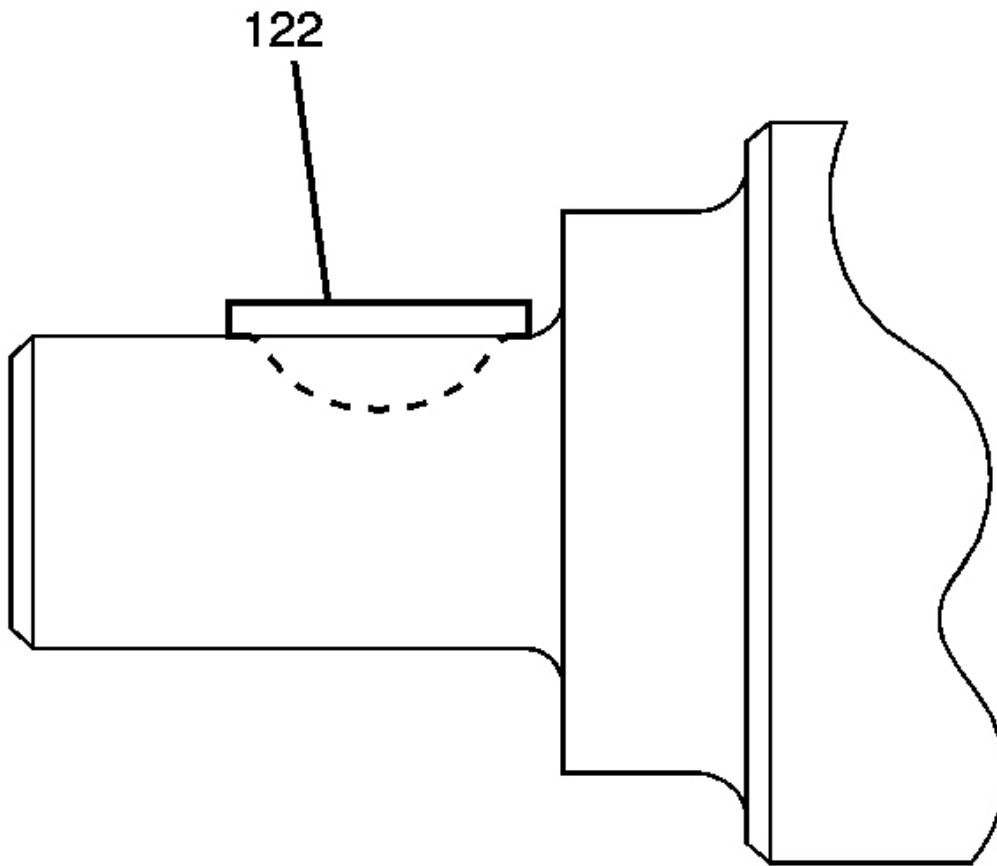
Fig. 626: View Of Crankshaft Key & Keyway
Courtesy of GENERAL MOTORS CORP.

1. Install the key into the crankshaft keyway, if previously removed.

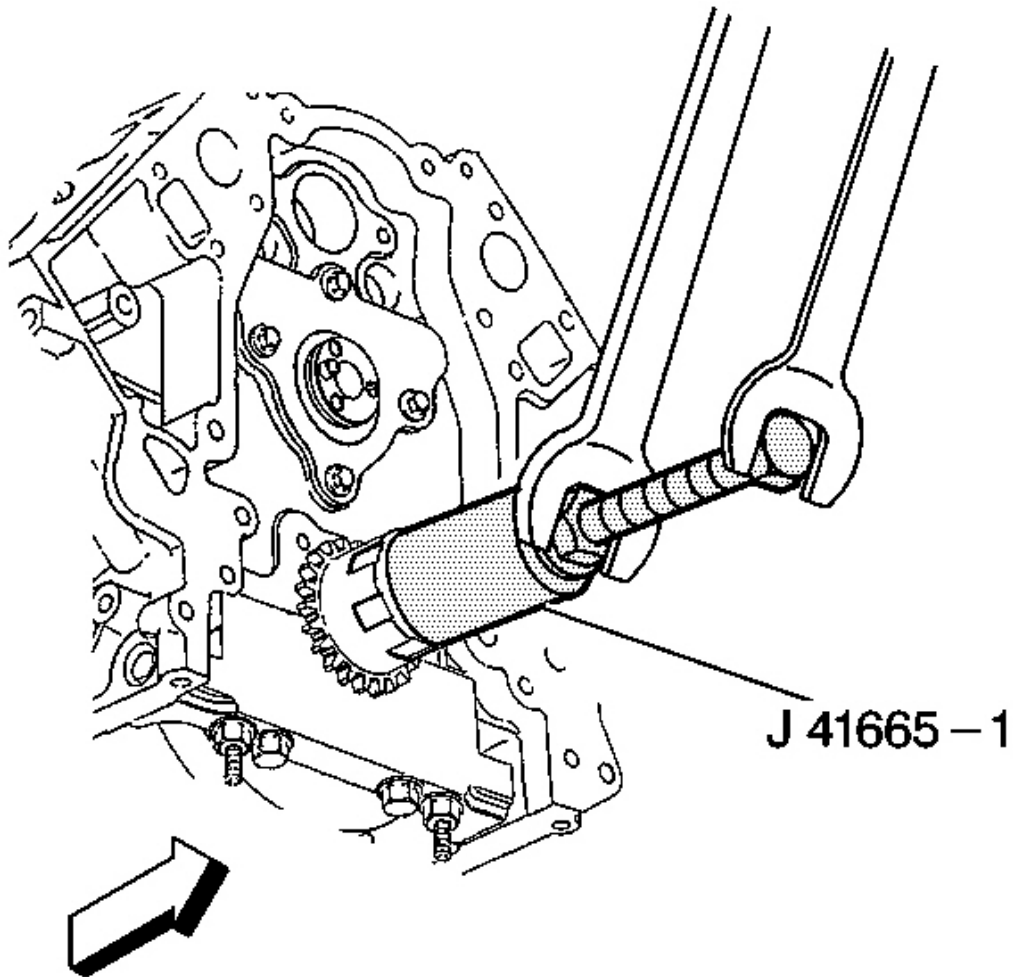
Fig. 628: View Of Crankshaft Sprocket
Courtesy of GENERAL MOTORS CORP.

3. Install the crankshaft sprocket onto the front of the crankshaft. Align the crankshaft key with the crankshaft sprocket keyway.

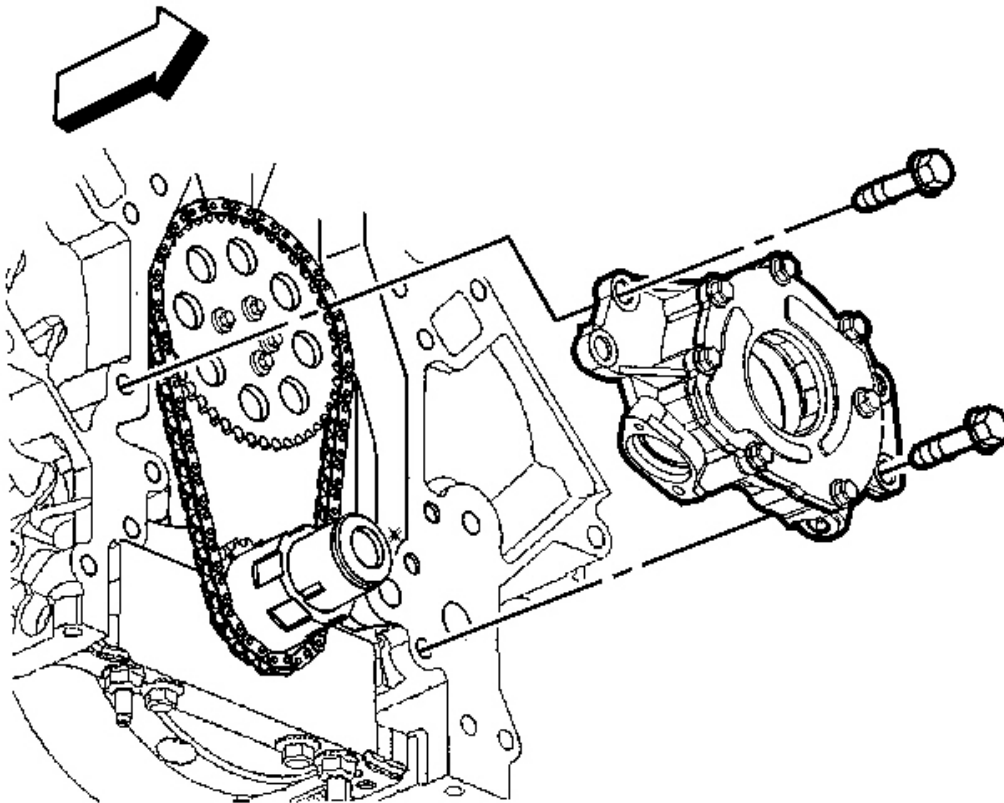
Fig. 632: View Of Oil Pump & Bolt
Courtesy of GENERAL MOTORS CORP.

IMPORTANT: Inspect the oil pump and engine block oil gallery passages. These surfaces must be clear and free of debris or restrictions.

3. Install the oil pump bolts.

Tighten: Tighten the oil pump bolts to 25 N.m (18 lb ft).

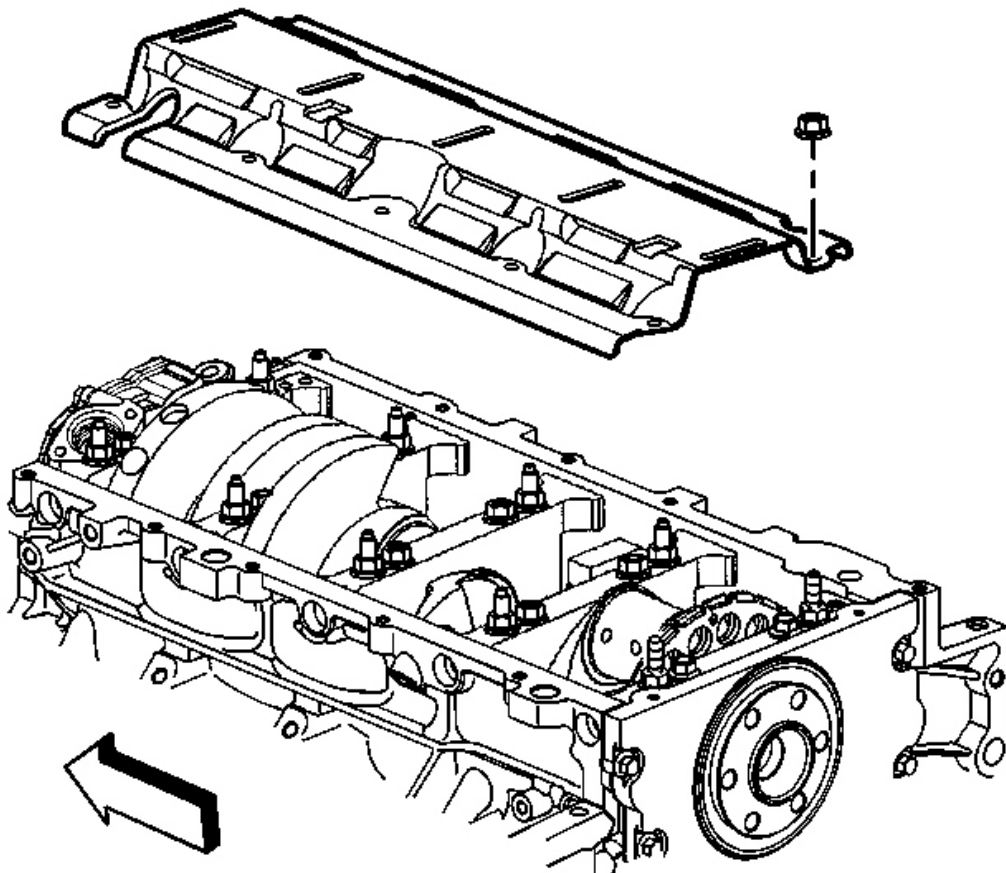
Fig. 633: View Of Crankshaft Oil Deflector
Courtesy of GENERAL MOTORS CORP.

4. Install the crankshaft oil deflector.

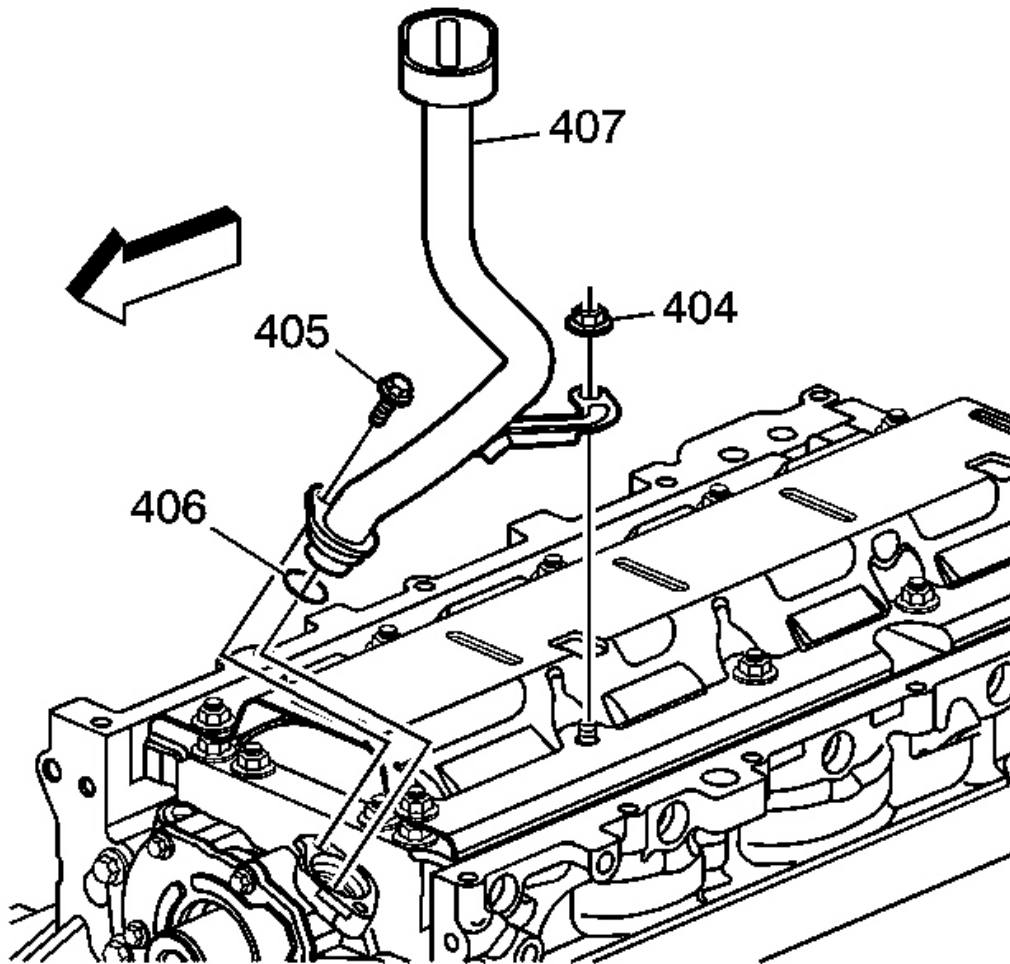
Fig. 634: View Of Oil Pump Screen, Bolt, Nuts & O-Ring Seal
Courtesy of GENERAL MOTORS CORP.

5. Lubricate a NEW oil pump screen O-ring seal (406) with clean engine oil.
6. Install the NEW O-ring seal onto the oil pump screen.

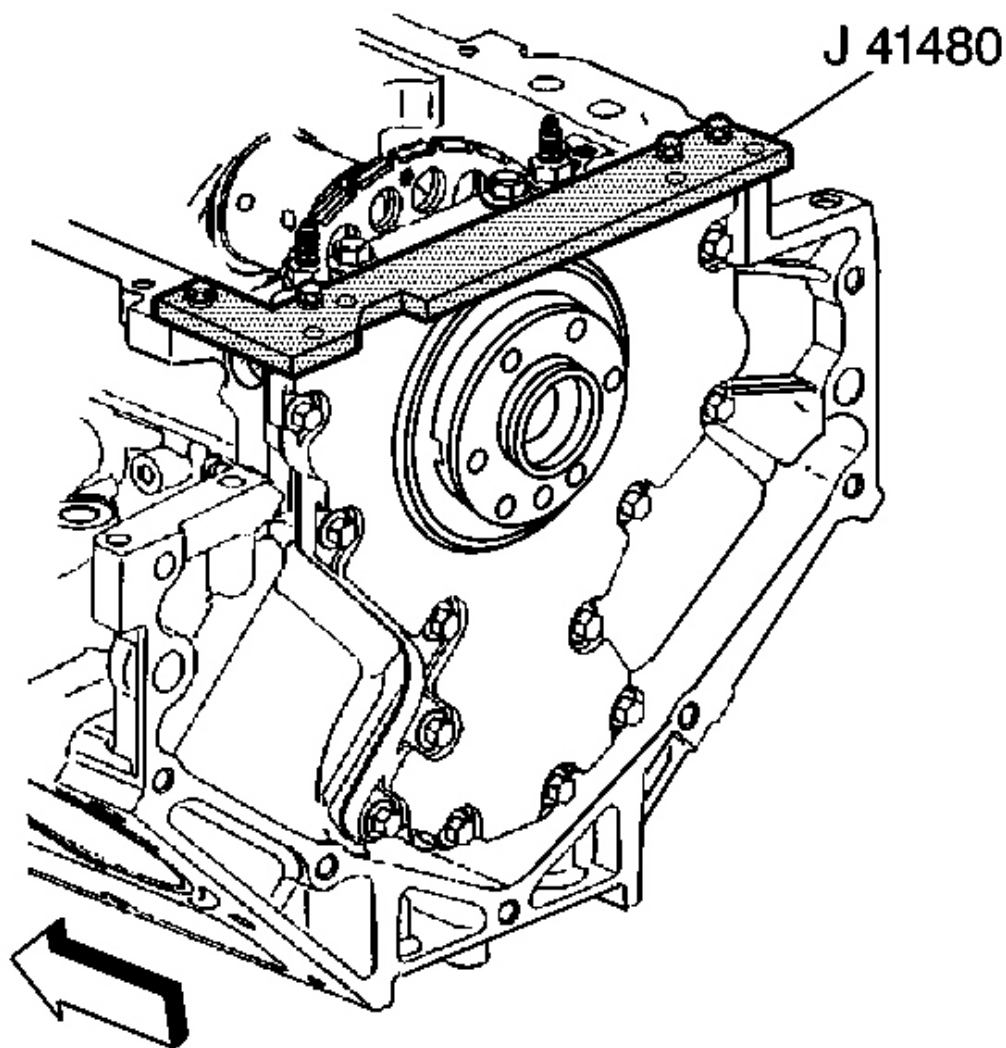
Fig. 637: View Of J 41480 Installed To Engine Block
Courtesy of GENERAL MOTORS CORP.

4. Install the **J 41480** and bolts. See Special Tools and Equipment.

Tighten: Tighten the tool-to-engine block bolts to 25 N.m (18 lb ft).

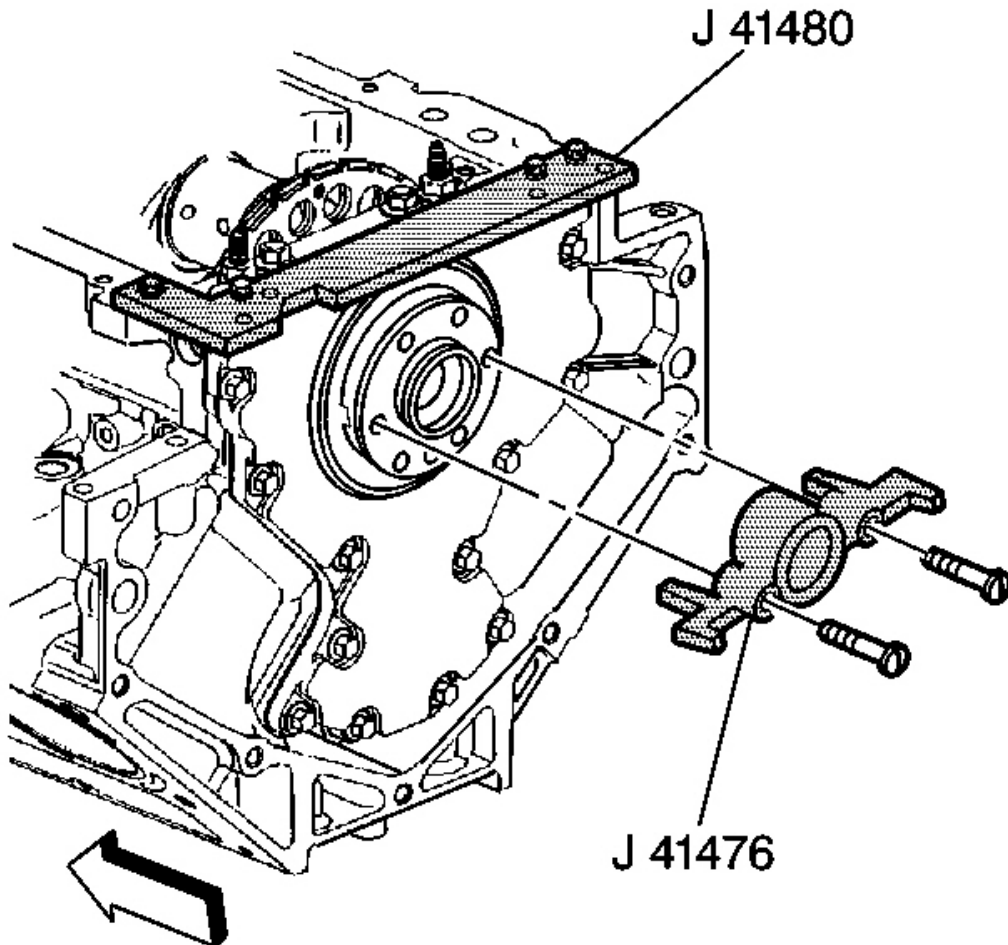
Fig. 638: View Of J 41480 & J 41476
Courtesy of GENERAL MOTORS CORP.

IMPORTANT: To properly align the rear cover, the J 41476 must be installed onto the rear of the crankshaft with the tool mounting bolts parallel to the oil pan surface. See Special Tools and Equipment.

5. Rotate the crankshaft until 2 opposing flywheel bolt holes are parallel to the oil pan surface.

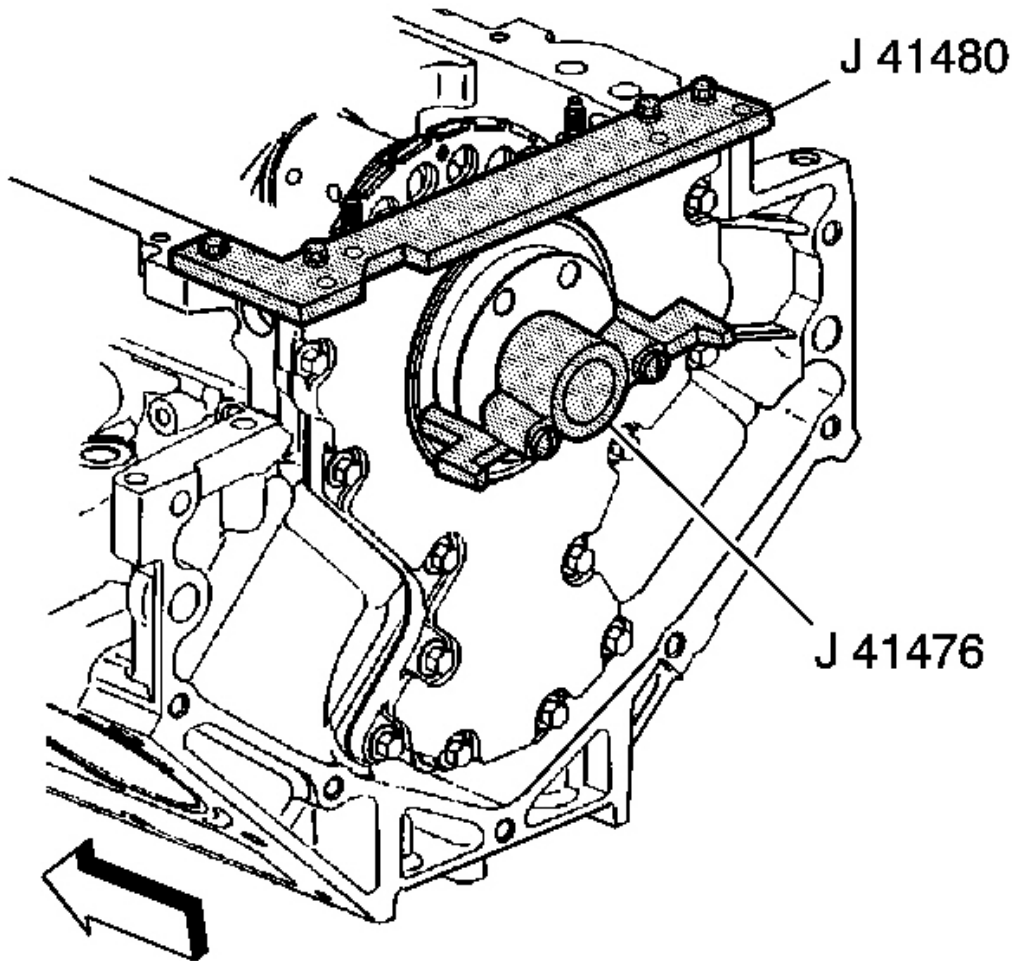
Fig. 639: View Of J 41480 & J 41476 Installed
Courtesy of GENERAL MOTORS CORP.

IMPORTANT: The tapered legs of the alignment tool must enter the rear cover oil seal bore.

3. Tighten the rear cover bolts to 25 N.m (18 lb ft).
7. Remove the tools.

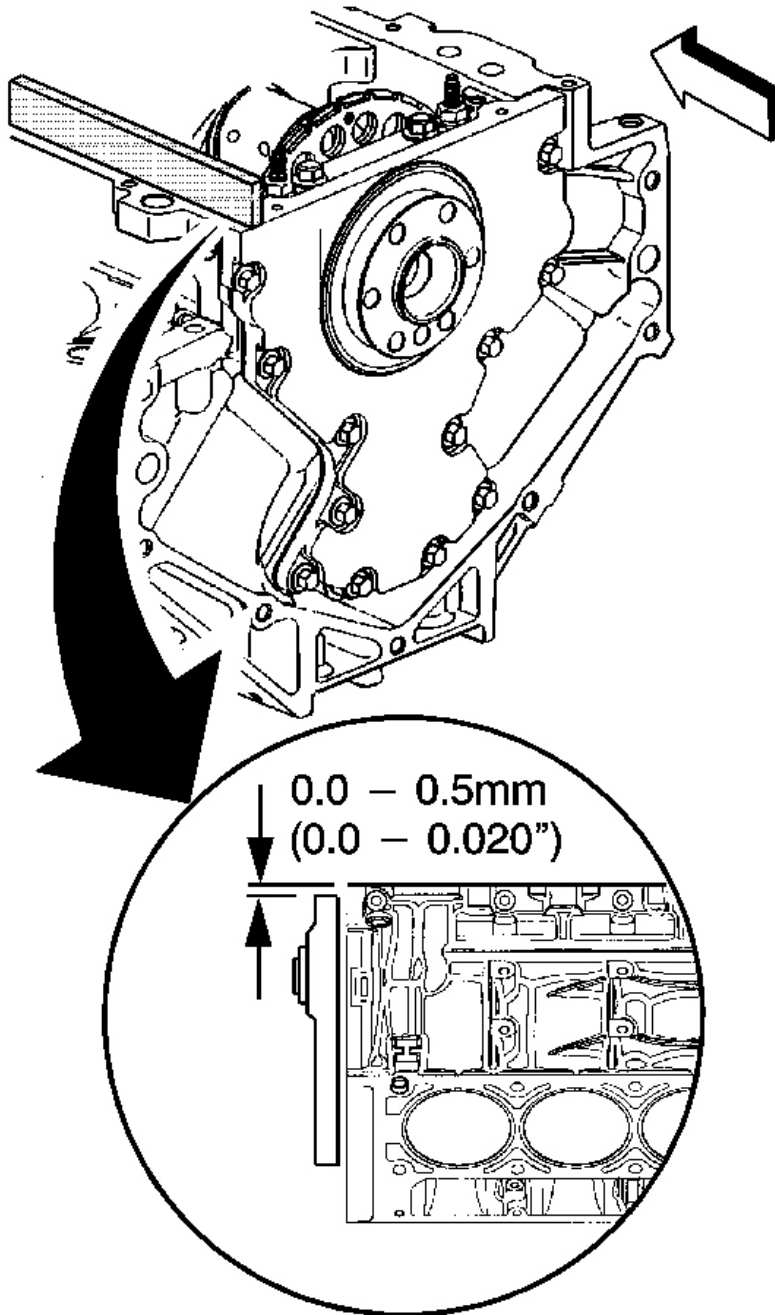
Fig. 640: Checking Rear Cover-To-Engine Block Proper Installation Position
Courtesy of GENERAL MOTORS CORP.

8. Measure the rear cover-to-engine block oil pan surface for flatness.
 1. Place a straight edge onto the engine block and rear cover oil pan sealing surfaces.

Avoid contact with the portion of the gasket that protrudes into the oil pan surface.
 2. Insert a feeler gage between the rear cover and the straight edge. The cover must be flush with the oil pan or no more than 0.5 mm (0.02 in) below flush.
9. If the rear cover-to-engine block oil pan surface alignment is not within specifications, repeat the cover alignment procedure.
10. If the correct rear cover-to-engine block alignment at the oil pan surface cannot be obtained, replace the rear cover.

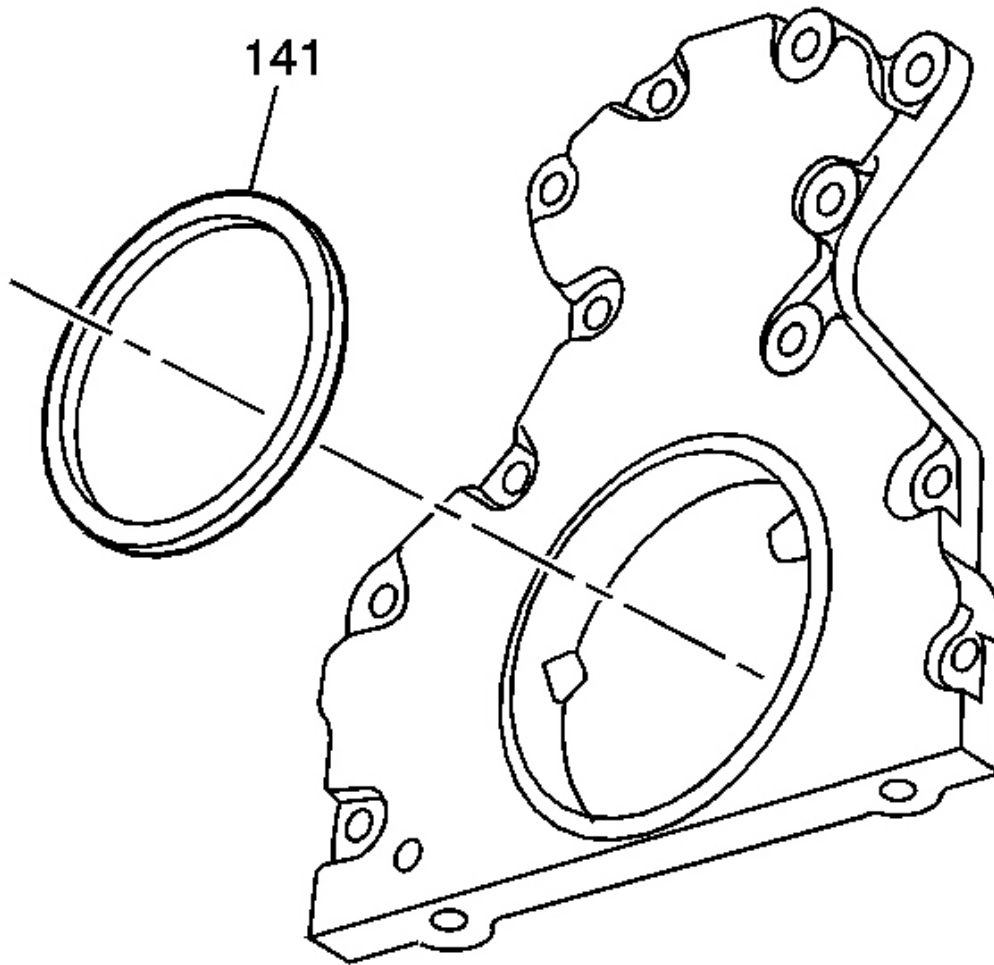
Fig. 641: View Of Crankshaft Rear Oil Seal
Courtesy of GENERAL MOTORS CORP.

2. Lubricate the rear cover oil seal bore with clean engine oil.

DO NOT allow oil or other lubricants to contact the crankshaft surface.

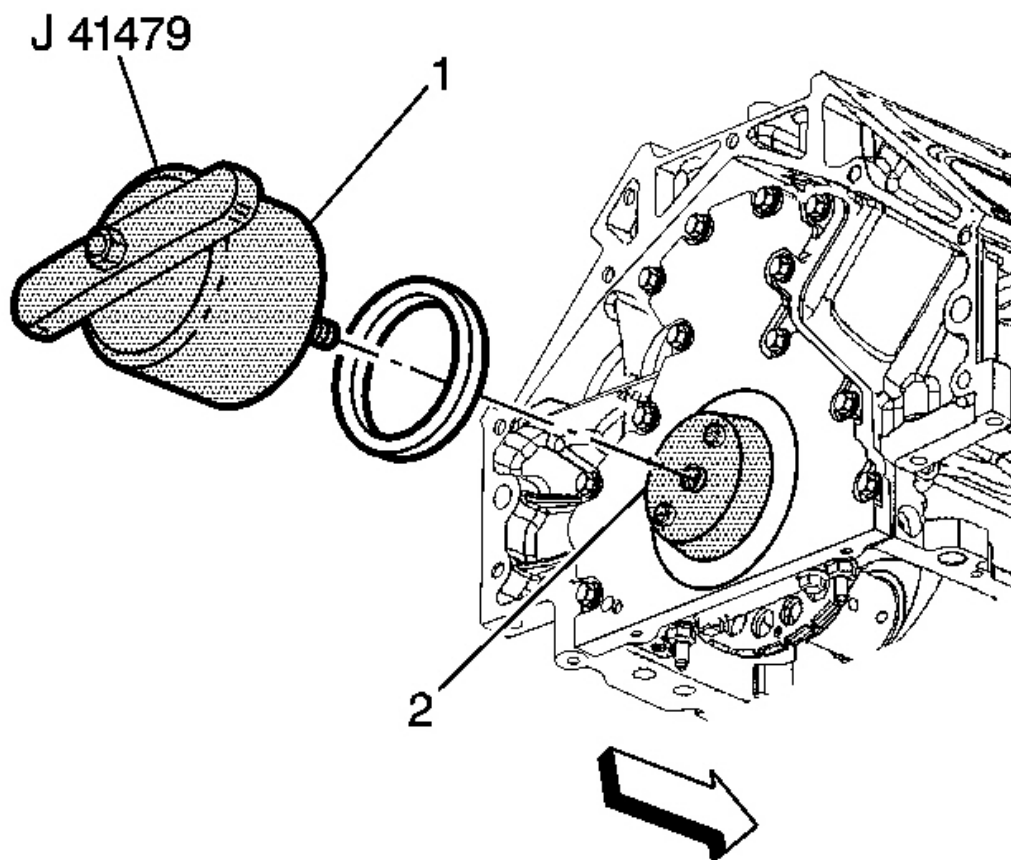
Fig. 642: Installing Crankshaft Rear Oil Seal Using J 41479
 Courtesy of GENERAL MOTORS CORP.

3. Install the **J 41479** cone (2) and bolts onto the rear of the crankshaft. See **Special Tools and Equipment**.
4. Tighten the bolts until snug. Do not overtighten.
5. Install the rear oil seal onto the tapered cone (2) and push the seal to the rear cover bore.
6. Thread the **J 41479** threaded rod into the tapered cone until the tool (1) contacts the oil seal. See **Special Tools and Equipment**.
7. Align the oil seal onto the tool (1).
8. Rotate the handle of the tool (1) clockwise until the seal enters the rear cover and bottoms into the cover bore.
9. Remove the tool.

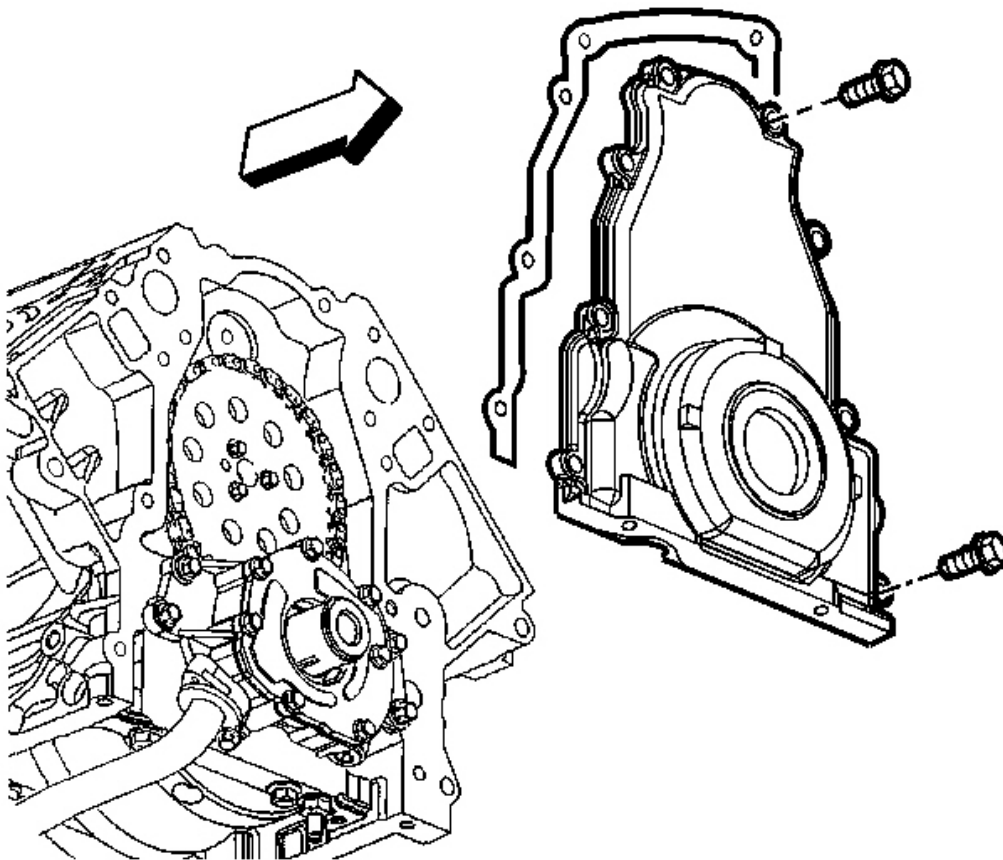
Fig. 643: View Of Front Cover & Gasket
Courtesy of GENERAL MOTORS CORP.

- **The oil pan sealing surface at the front cover and engine block MUST be aligned within specifications.**
- **An improperly aligned front cover may cause premature front oil seal wear and/or engine assembly oil leaks.**

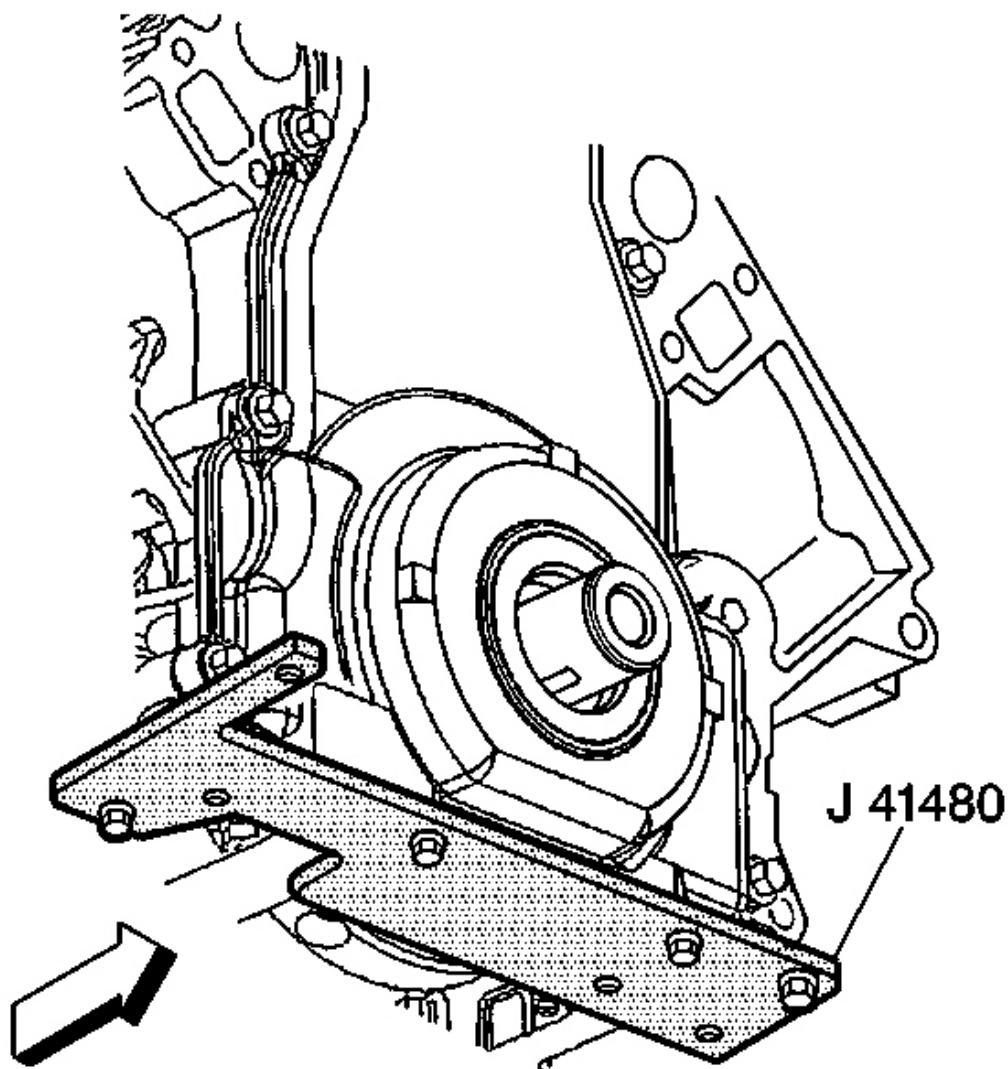
Fig. 644: View Of J 41480 Installed On Engine Block
Courtesy of GENERAL MOTORS CORP.

3. Install the J 41480 . See Special Tools and Equipment.

Tighten: Tighten the tool-to-engine block bolts to 25 N.m (18 lb ft).

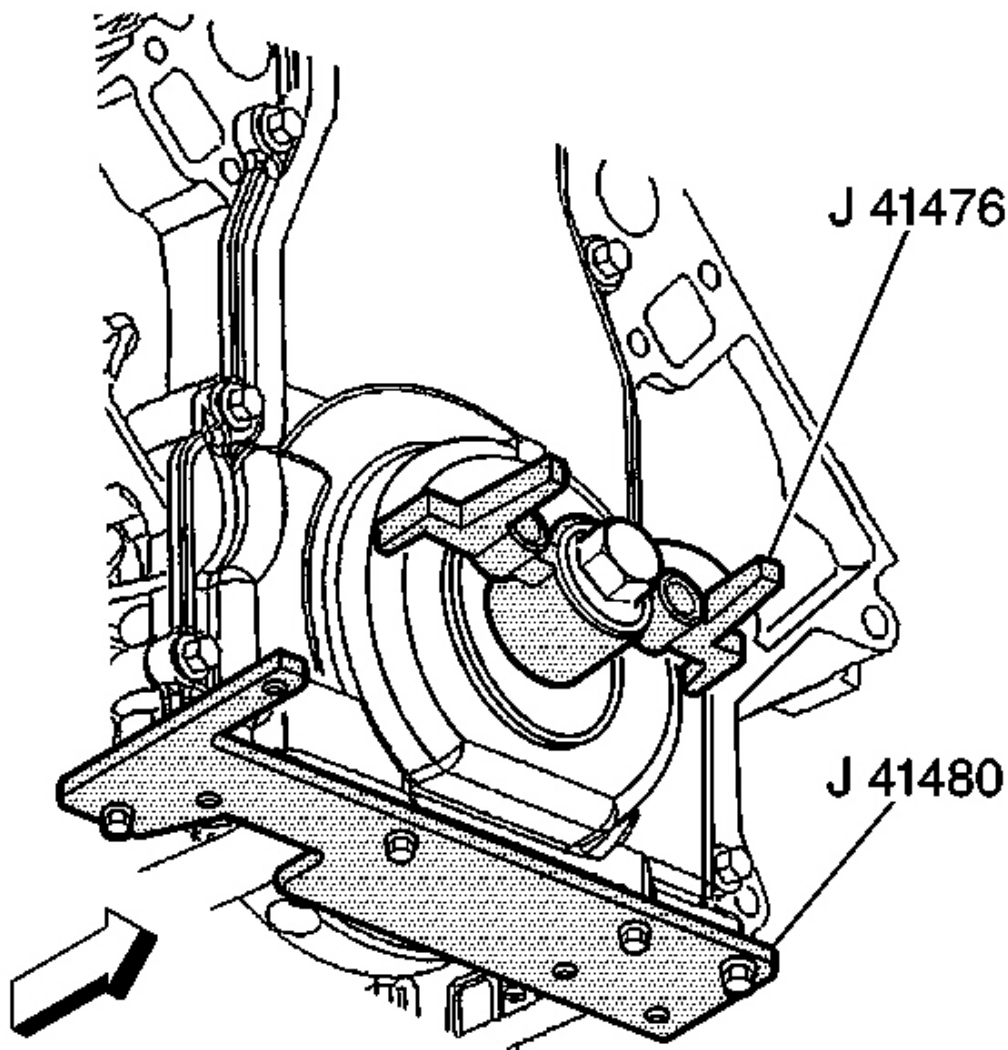
Fig. 645: View Of J 41476 & J 41480 Installed On Engine
Courtesy of GENERAL MOTORS CORP.

IMPORTANT: Align the tapered legs of the tool with the machined alignment surfaces on the front cover.

1. Tighten the crankshaft balancer bolt by hand until snug. Do not overtighten.
 2. Tighten the **J 41480** . See **Special Tools and Equipment**.
 3. Tighten the engine front cover bolts to 25 N.m (18 lb ft).
6. Remove the tools.

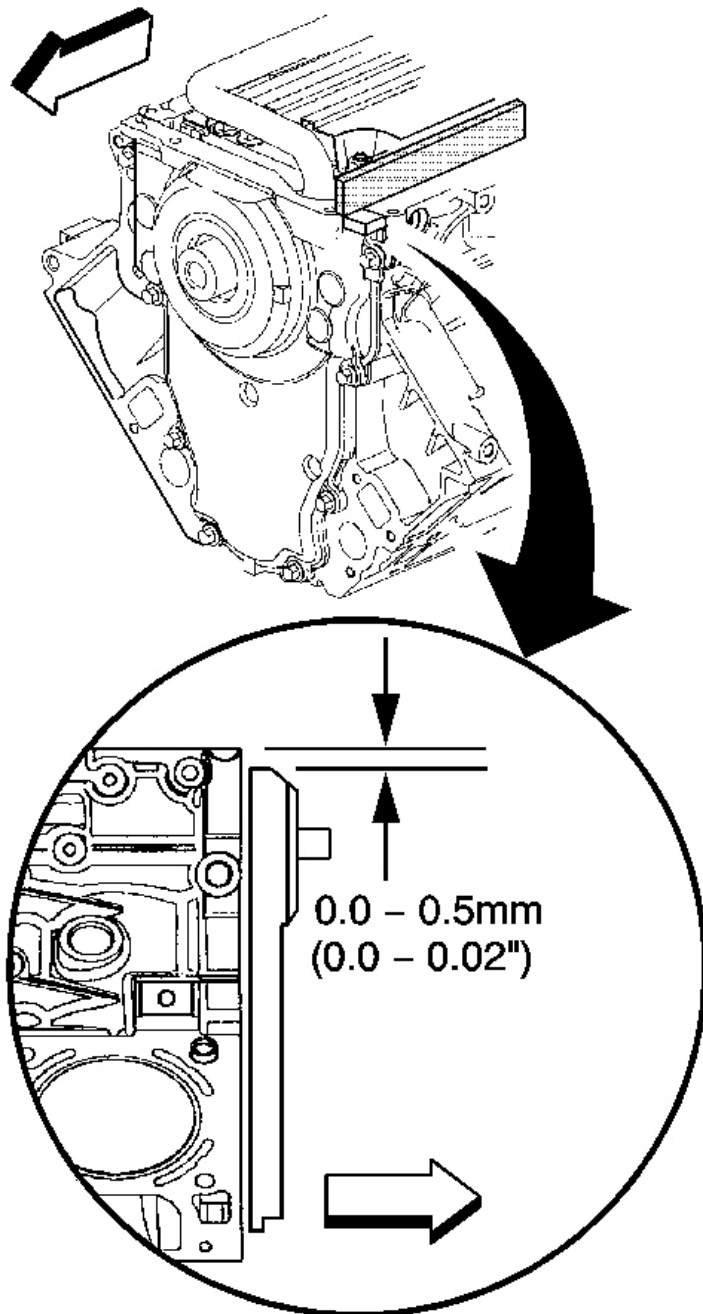
Fig. 646: View Of Front Cover-To-Engine Block Proper Installation Position
Courtesy of GENERAL MOTORS CORP.

7. Measure the oil pan surface flatness, front cover-to-engine block.

2. Insert a feeler gage between the front cover and the straight edge tool. The cover must be flush with the oil pan surface or no more than 0.5 mm (0.02 in) below flush.
8. If the front cover-to-engine block oil pan surface alignment is not within specifications, repeat the cover alignment procedure.
9. If the correct front cover-to-engine block alignment cannot be obtained, replace the front cover.

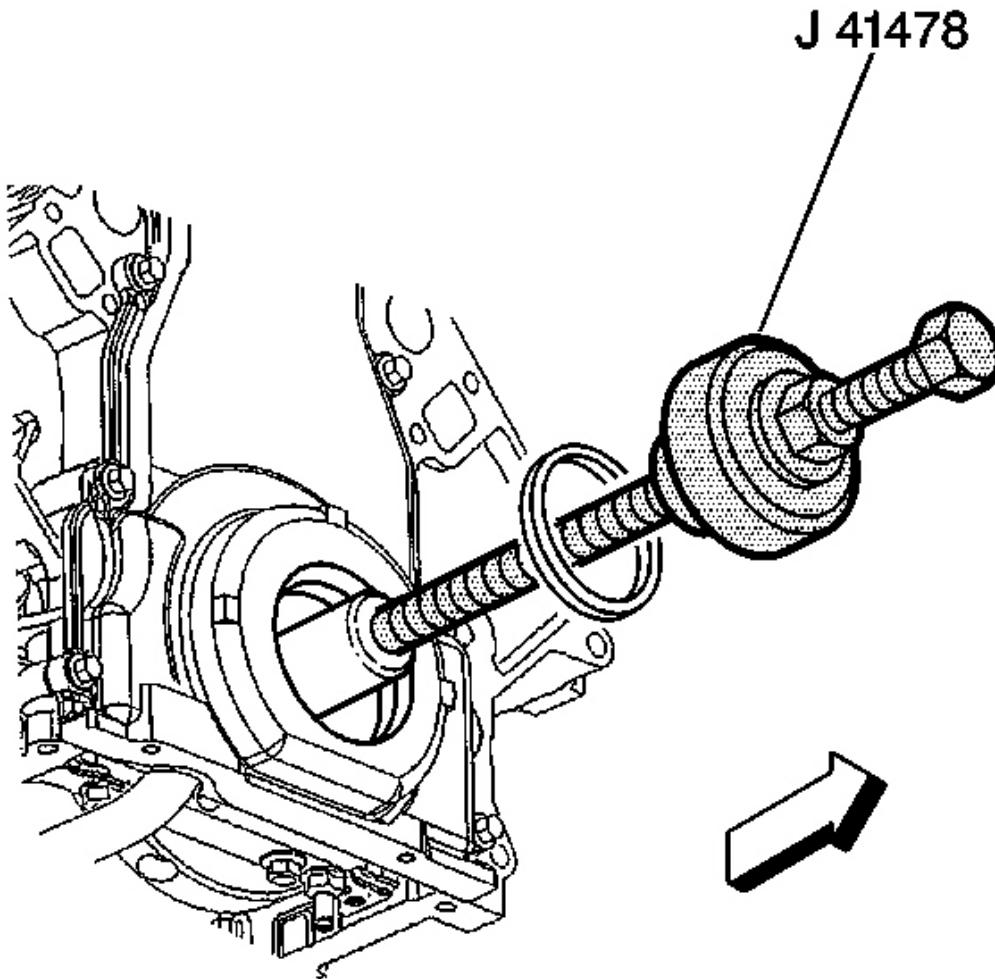
Fig. 648: Installing The Crankshaft Front Oil Seal Using J 41478
Courtesy of GENERAL MOTORS CORP.

3. Install the crankshaft front oil seal onto the **J 41478** guide.
4. Install the **J 41478** threaded rod, with nut, washer, guide, and oil seal, into the end of the crankshaft.
5. Use the **J 41478** in order to install the oil seal into the cover bore.
 1. Use a wrench and hold the hex on the installer bolt.
 2. Use a second wrench and rotate the installer nut clockwise until the seal bottoms in the cover bore.

3. Remove the tool.
4. Inspect the oil seal for proper installation. The oil seal should be installed evenly and completely into the front cover bore.

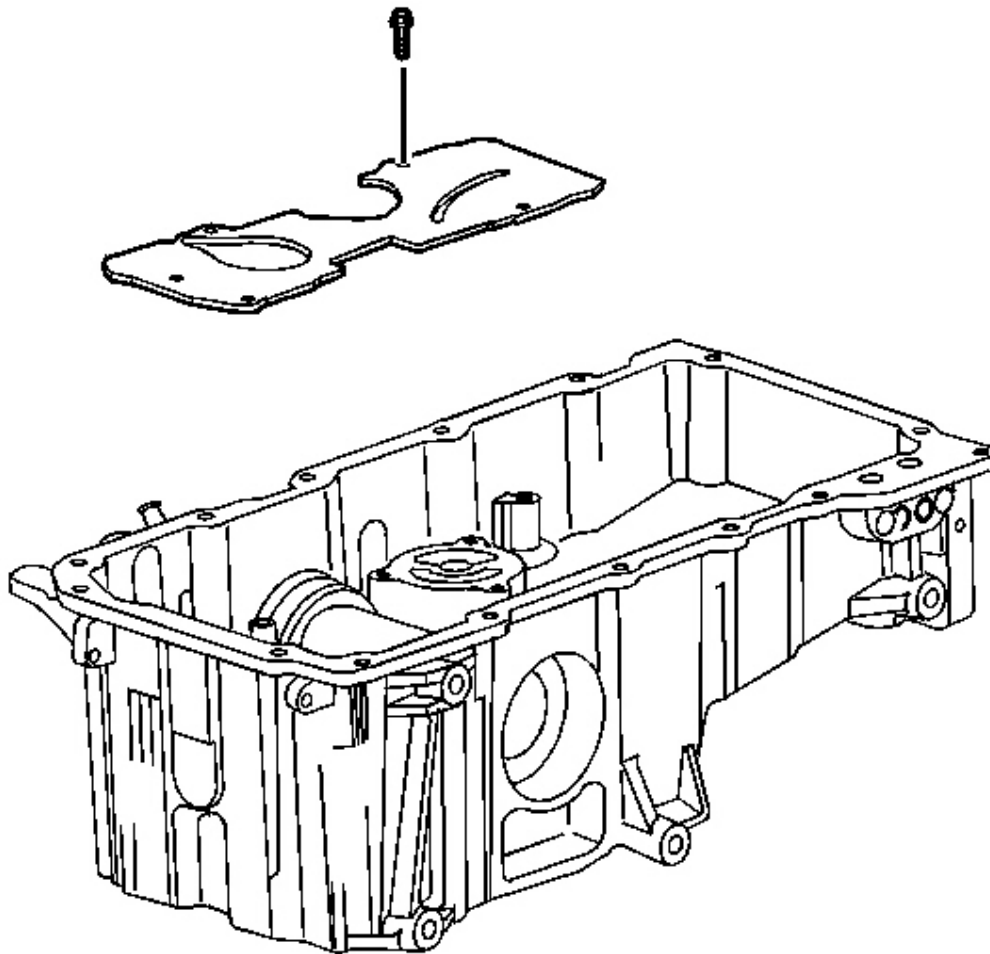
Fig. 649: View Of Oil Baffle & Bolts
Courtesy of GENERAL MOTORS CORP.

1. Install the oil pan baffle and bolts.

Tighten: Tighten the oil pan baffle bolts to 12 N.m (106 lb in).
