2004 Isuzu Ascender LS

2004 ENGINE Engine Mechanical - 4.8L, 5.3L, and 6.0L - Ascender

Engine Mechanical - 4.8L, 5.3L, and 6.0L - Ascender

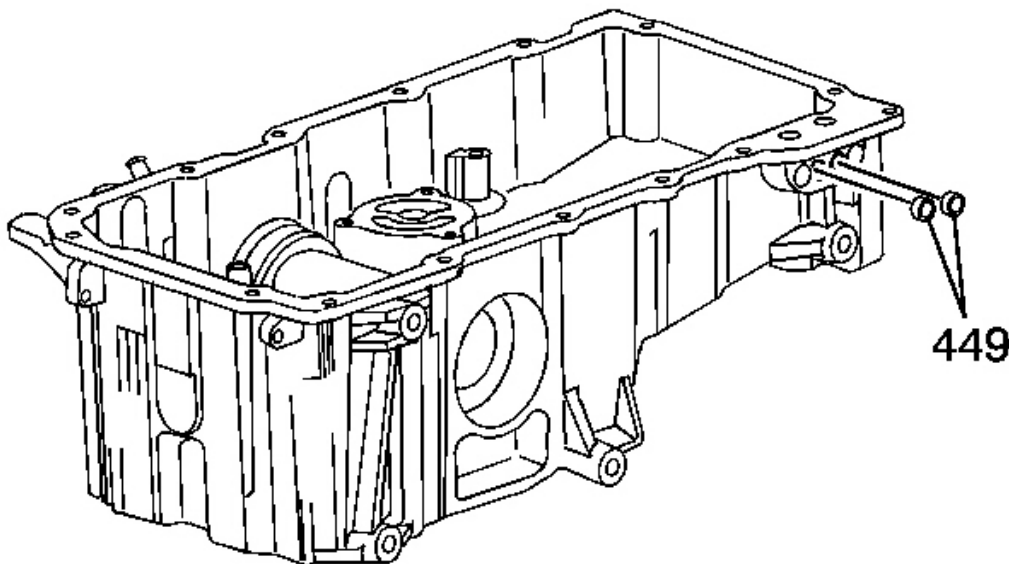
Fig. 650: View Of Oil Gallery Plugs
Courtesy of GENERAL MOTORS CORP.

2. Apply sealant to the threads of the oil pan oil gallery plugs.
3. Install the oil gallery plugs.

Tighten: Tighten the oil gallery plugs to 25N.m (18 lb ft).

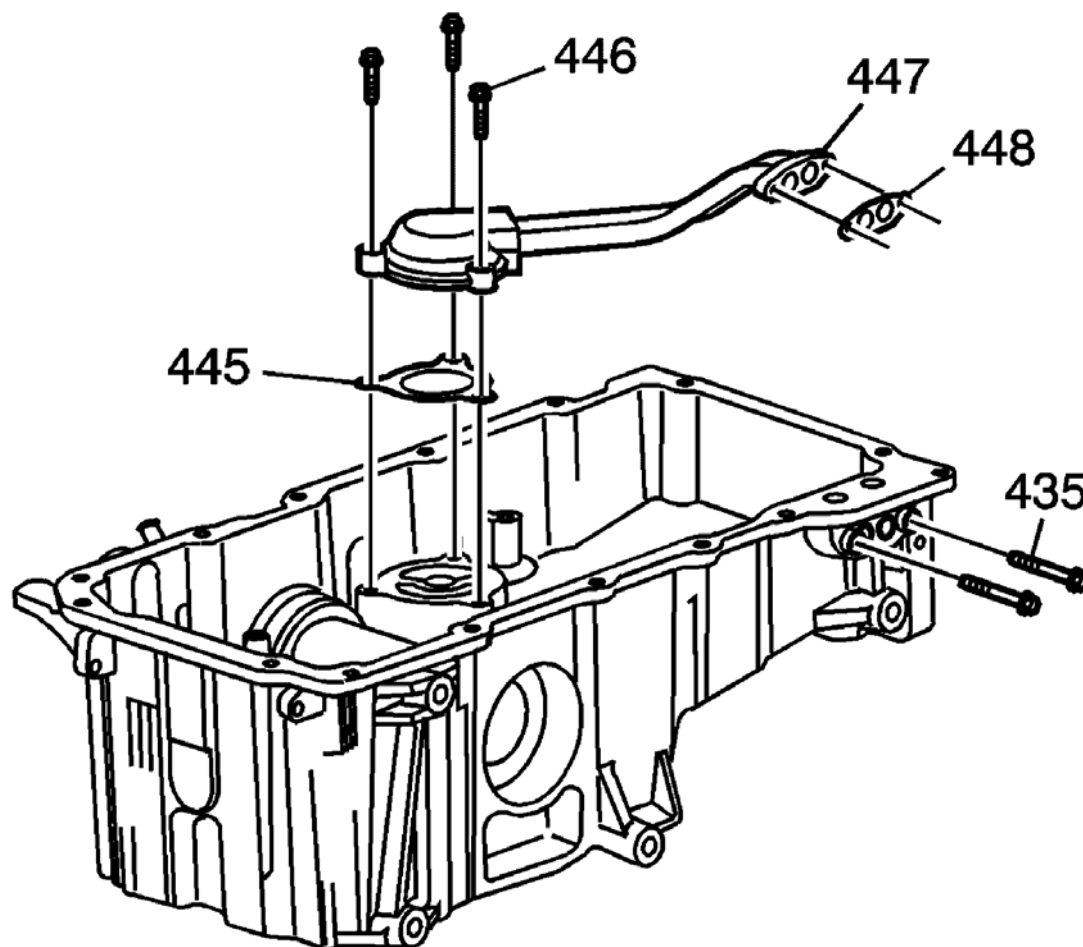
Fig. 651: View Of Oil Transfer Tube, Bolts & Gaskets
Courtesy of GENERAL MOTORS CORP.

4. Install the oil transfer tube (447), gaskets (445, 448) and bolts (435, 446).

Tighten: Tighten the oil transfer tube bolts to 12N.m (106 lb in).

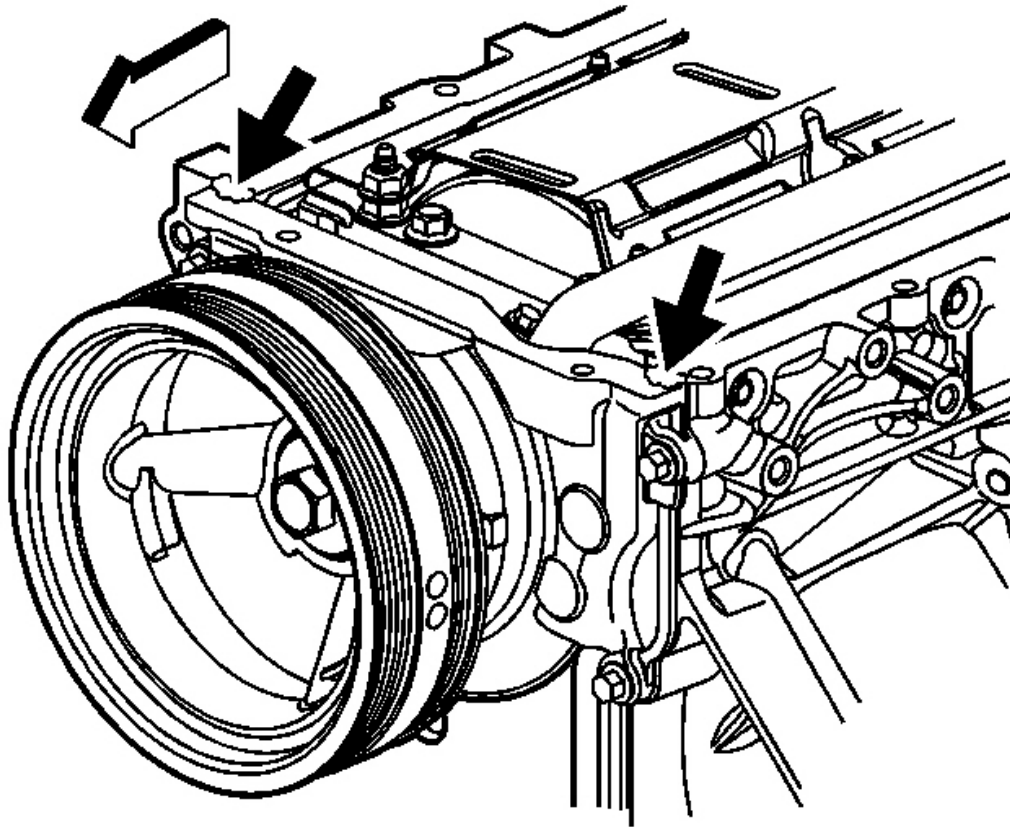
Fig. 652: View Of Sealant On Engine Front Cover Gasket Tabs
Courtesy of GENERAL MOTORS CORP.

5. Apply a 5 mm (0.2 in) bead of sealant 20 mm (0.8 in) long to the engine block. Apply the sealant directly onto the tabs of the front cover gasket that protrude into the oil pan surface. Refer to **Sealers, Adhesives, and Lubricants**.

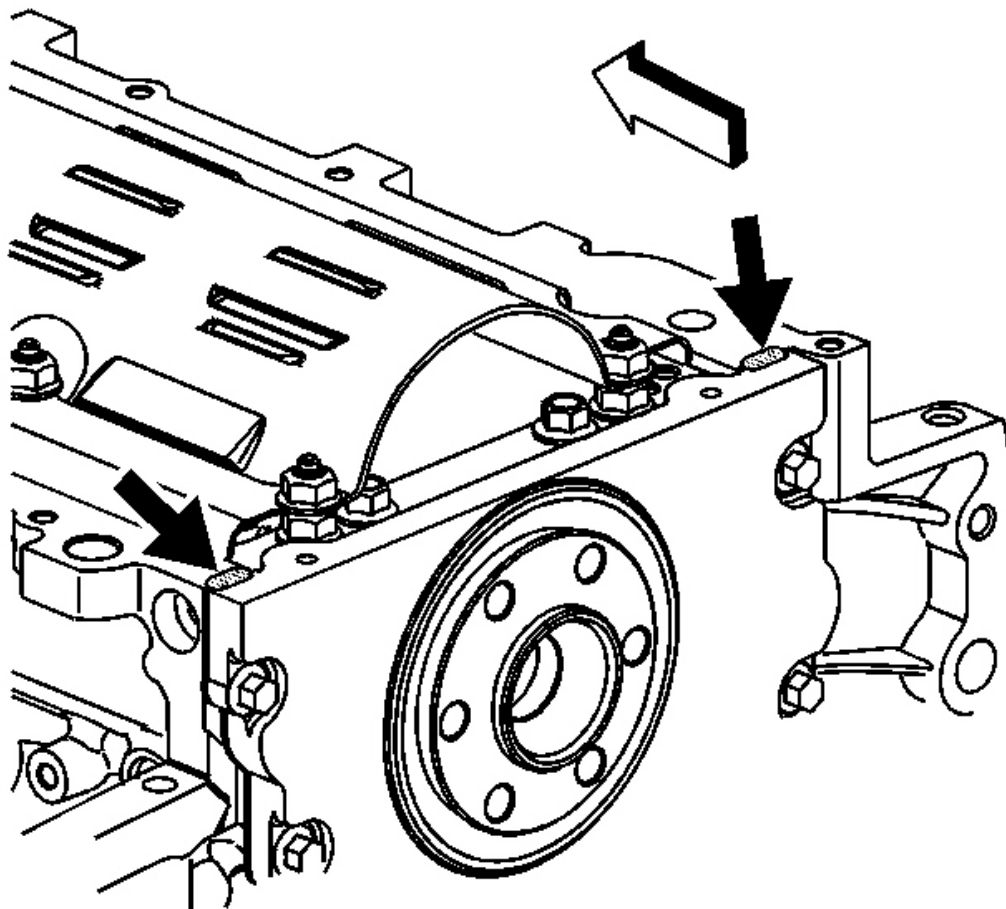
Fig. 653: View Of Sealant On Engine Rear Cover Gasket Tabs
Courtesy of GENERAL MOTORS CORP.

6. Apply a 5 mm (0.2 in) bead of sealant 20 mm (0.8 in) long to the engine block. Apply the sealant directly onto the tabs of the rear cover gasket that protrude into the oil pan surface.

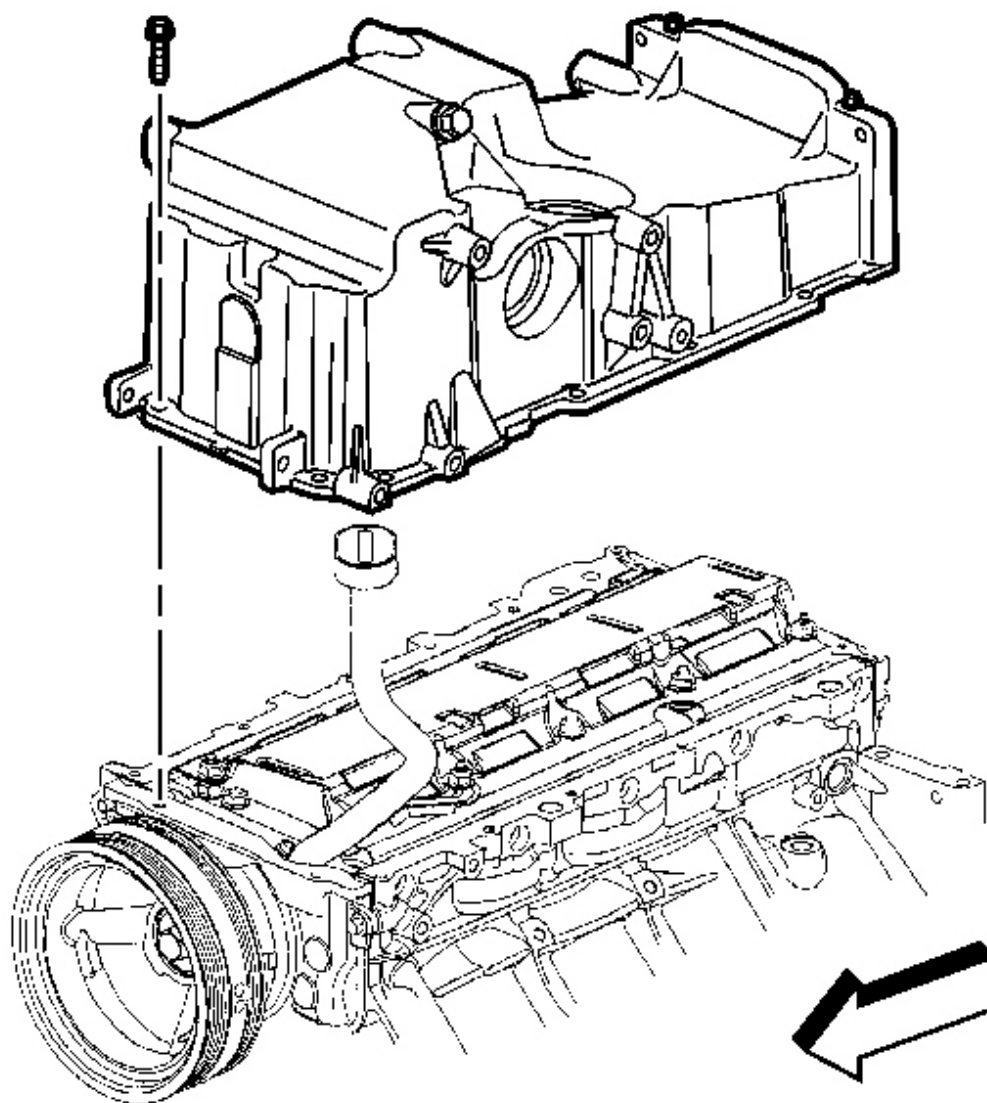
Fig. 654: View Of Oil Pan & Bolts
Courtesy of GENERAL MOTORS CORP.

IMPORTANT: Ensure the oil gallery passages in the oil pan and engine block properly align with the oil pan gasket.

2. Install the oil pan bolts to the pan and through the gasket.
8. Install the oil pan, gasket and bolts to the engine block.
9. Tighten bolts finger tight. Do not overtighten.
10. Place a straight edge across the rear of the engine block and the rear of the oil pan at the transmission housing mounting surfaces.

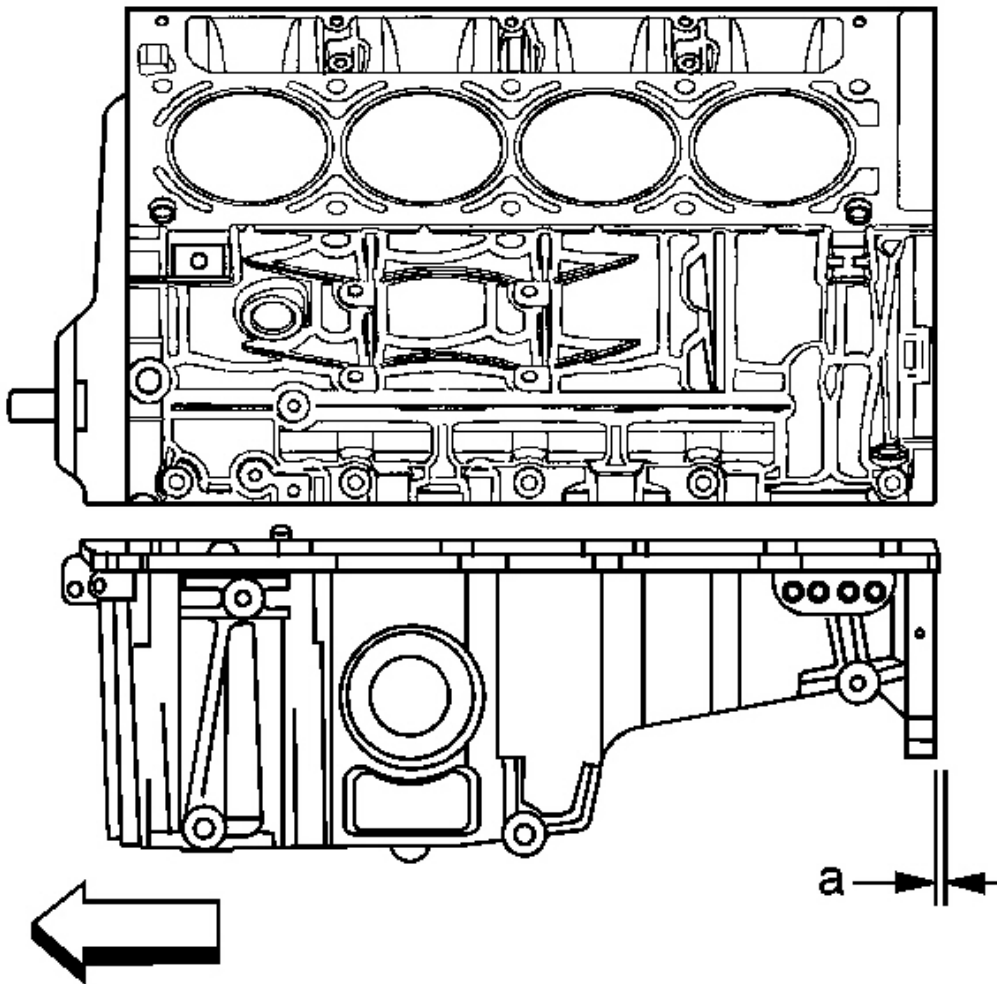
Fig. 655: Aligning Rear Of Oil Pan & Rear Of Engine Block
Courtesy of GENERAL MOTORS CORP.

11. Align the oil pan until the rear of engine block and rear of oil pan are flush or even.

2. Insert a feeler gage between the straight edge and the oil pan transmission housing mounting surface, and inspect to ensure there is no more than a 0.25 mm (0.01 in) gap (a) between the pan and straight edge.
3. If the oil pan alignment is not within specifications, remove the oil pan and repeat the above procedure.

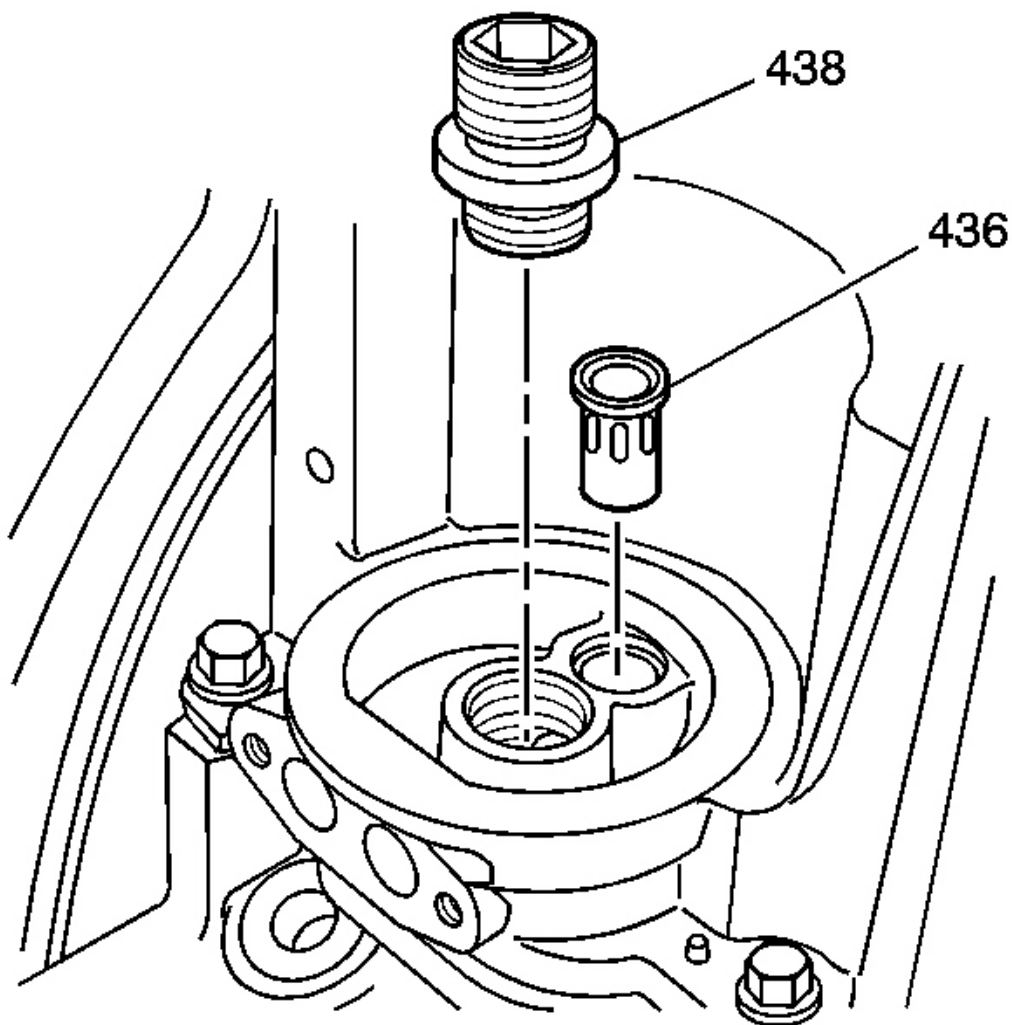
Fig. 656: View Of Oil Filter Fitting & Bypass Valve
Courtesy of GENERAL MOTORS CORP.

1. Install a new oil filter bypass valve (436) into the oil pan, if required.

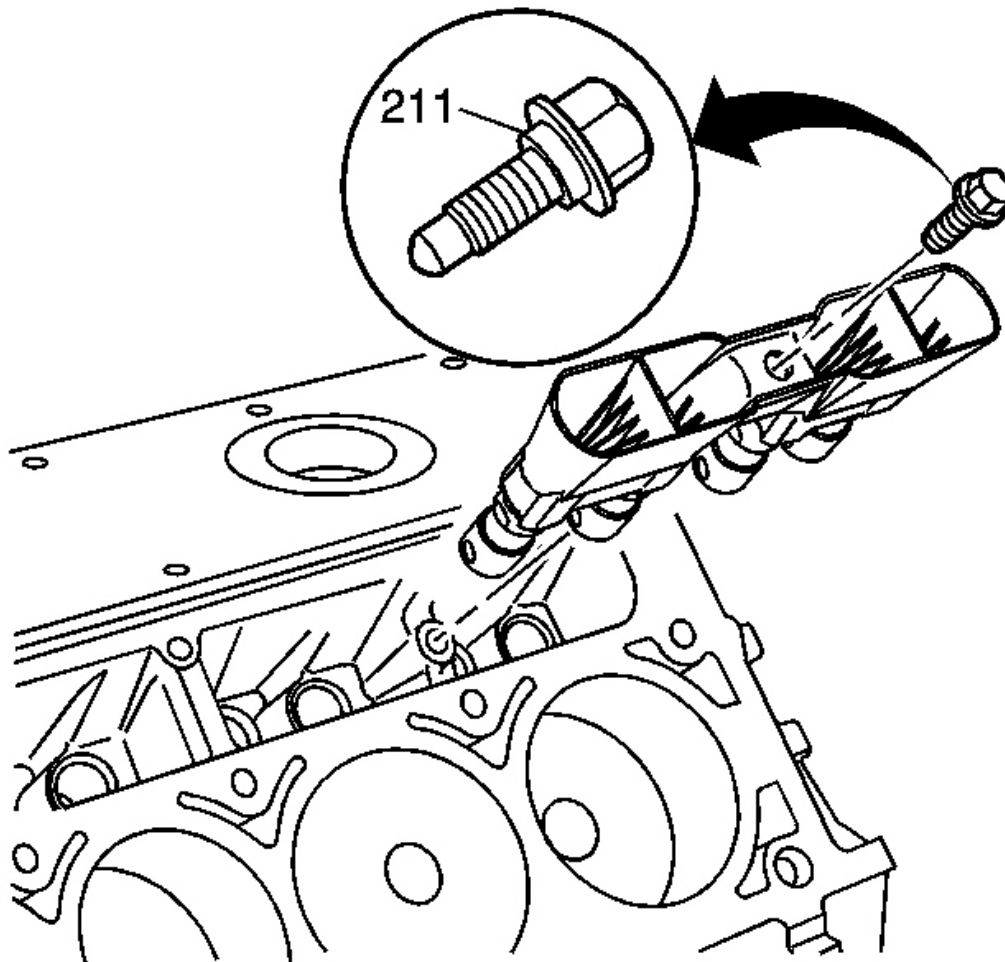
Fig. 660: View Of Valve Lifters, Guide & Guide Bolts
Courtesy of GENERAL MOTORS CORP.

3. Install the valve lifters and guide assembly to the engine block.

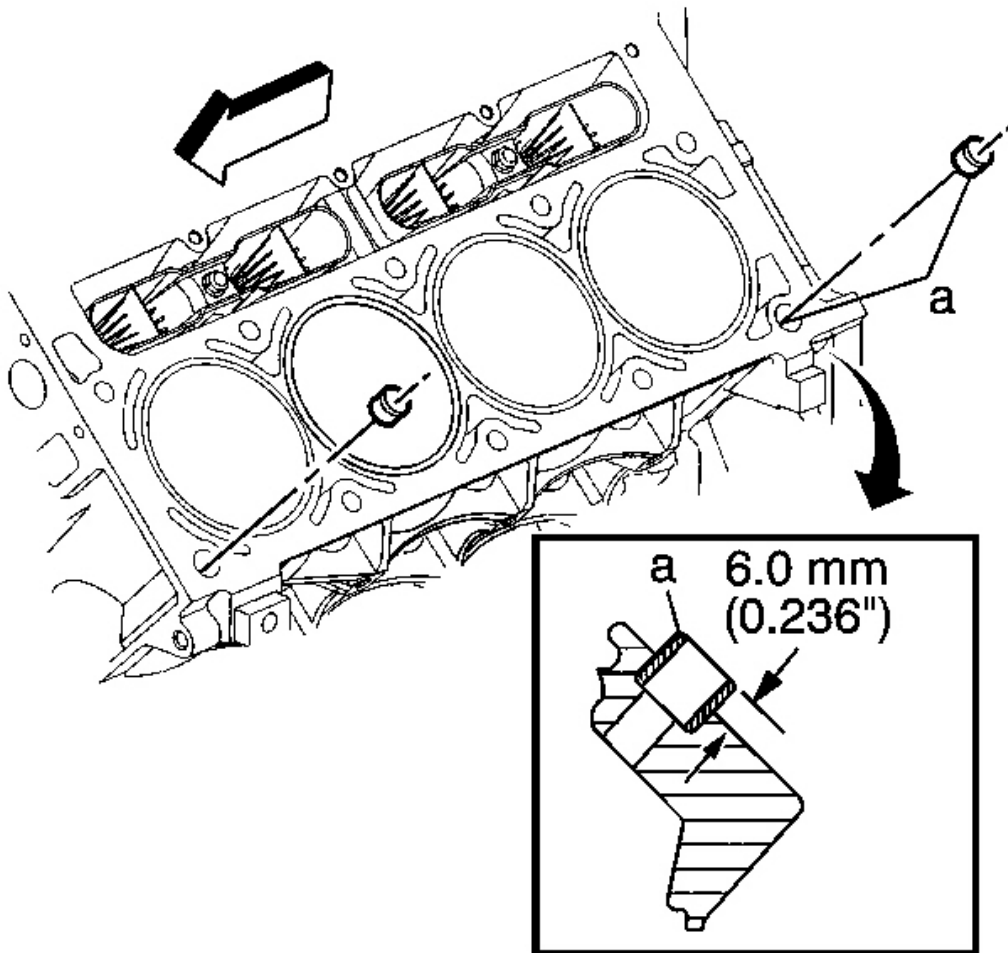
Fig. 661: Identifying Cylinder Head Locating Pins Installation Position
Courtesy of GENERAL MOTORS CORP.

IMPORTANT: First design engine blocks have different drill and tap depths using both medium length 100 mm (3.94 in) and long 155 mm (6.1 in) M11 cylinder head bolts. Second design engine blocks use only the medium length 100 mm (3.94 in) bolt with a common drill and tap depth.

4. Measure the depth of the cylinder head bolt holes (1-10) and select the correct length bolts as required.
5. Check the cylinder head locating pins for proper installation.

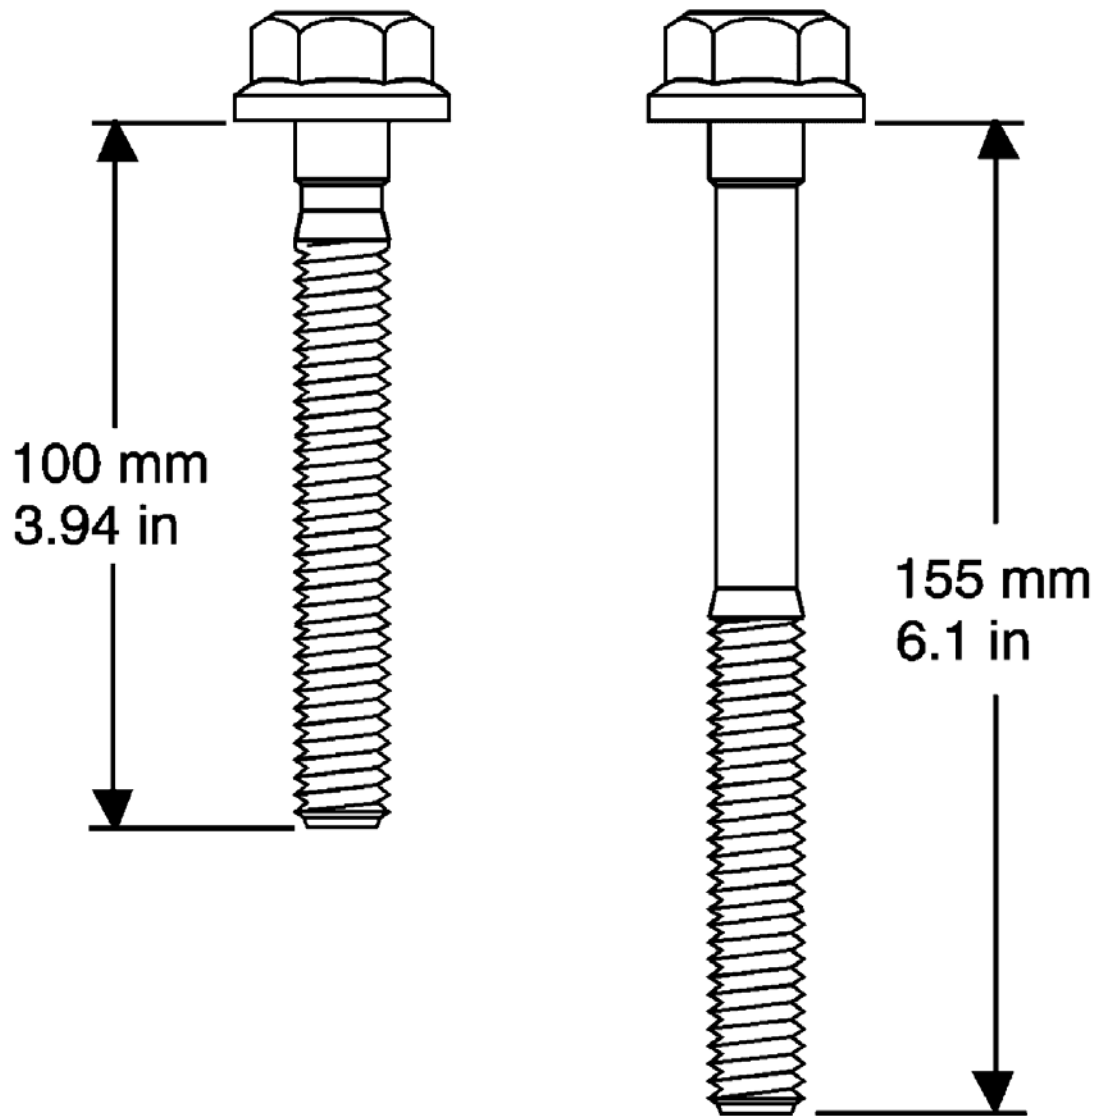
Fig. 662: View Of 100 mm & 155 mm Cylinder Head Bolts
Courtesy of GENERAL MOTORS CORP.

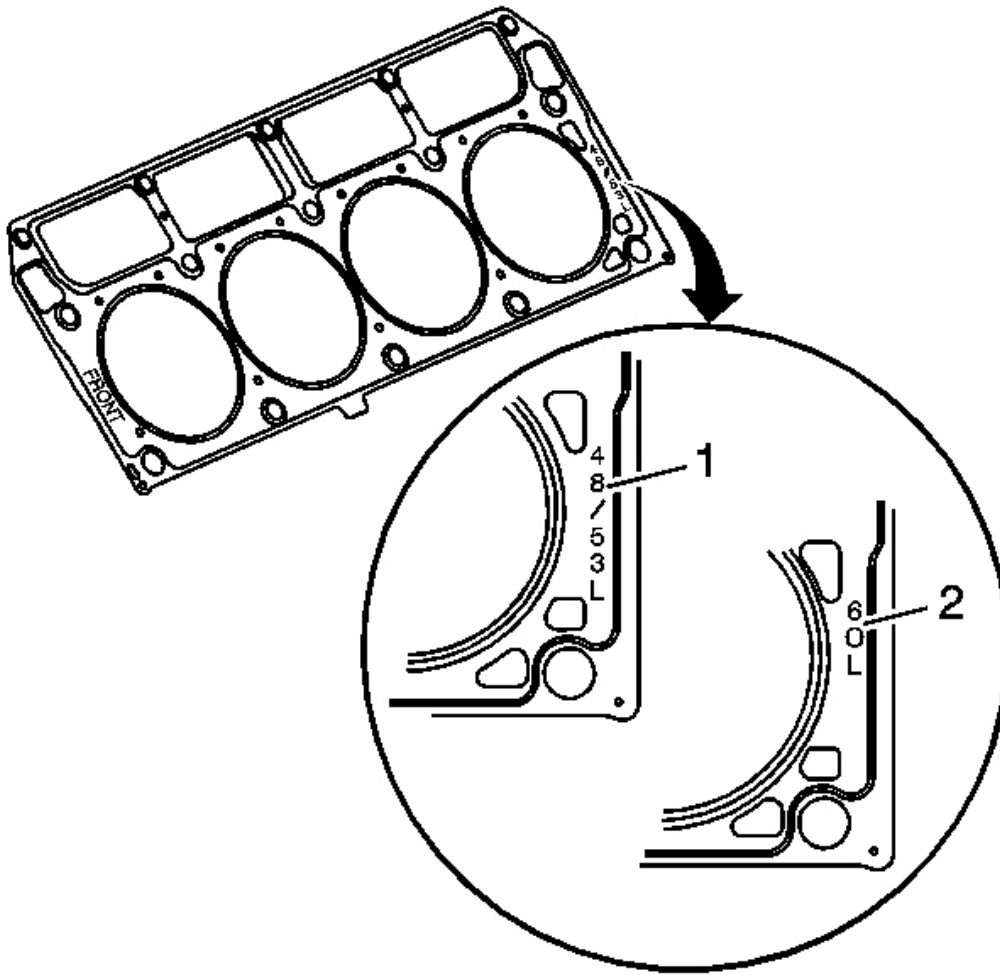
Fig. 663: View Of Cylinder Head Gasket Displacement Markings
Courtesy of GENERAL MOTORS CORP.

6. Inspect the displacement markings (1) on the gasket, for proper usage.

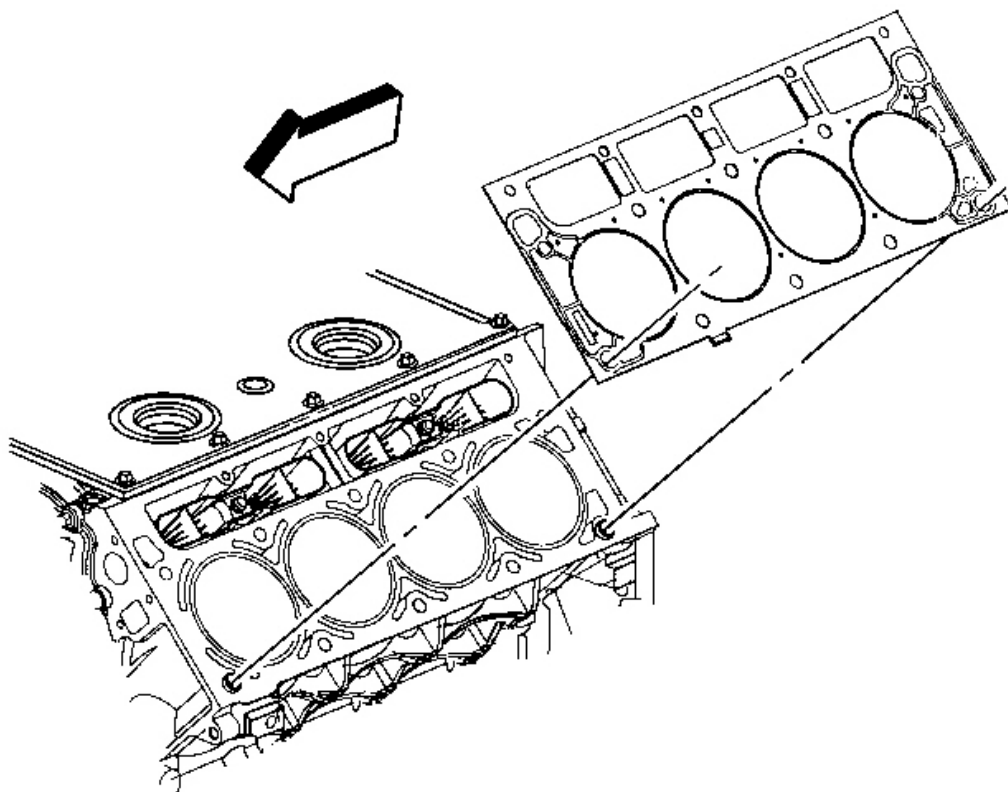
Fig. 664: View Of Left Cylinder Head Gasket & Locator Pins
Courtesy of GENERAL MOTORS CORP.

IMPORTANT: When properly installed, the tab on the left cylinder head gasket will be located left of center, or closer to the front of the engine.

7. Install the NEW left cylinder head gasket onto the locating pins.

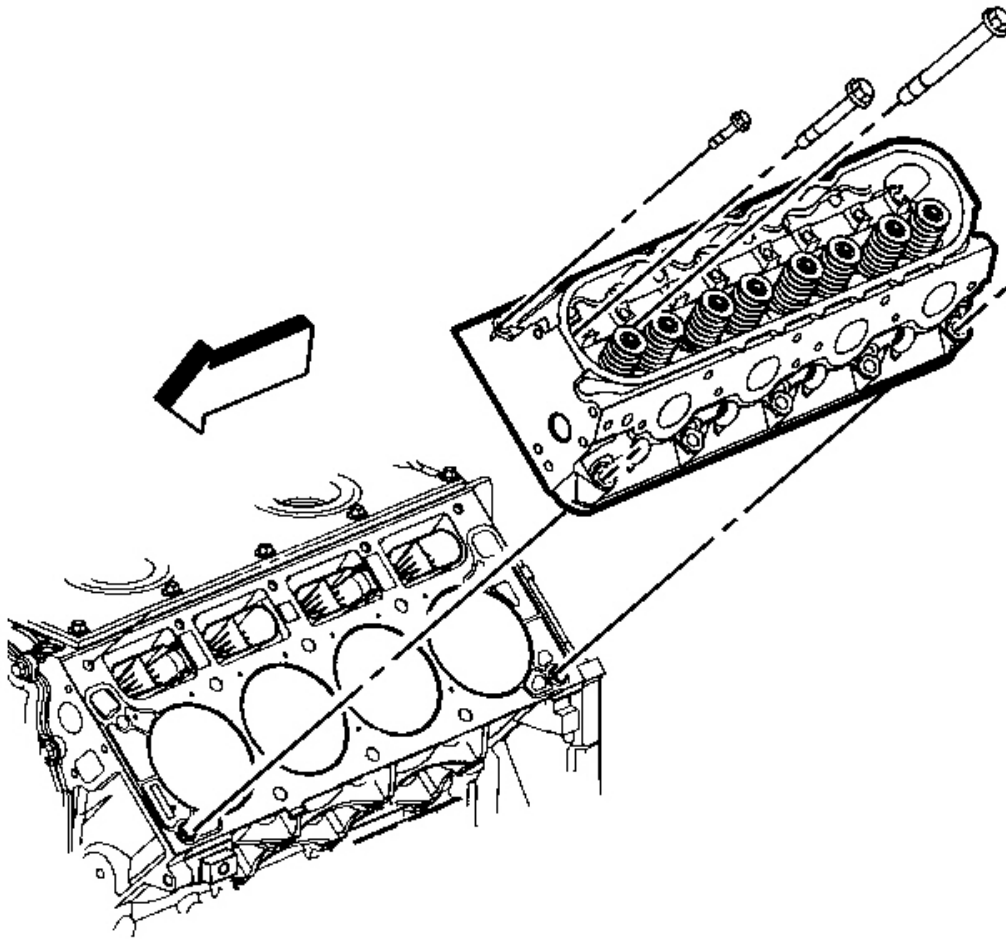
Fig. 665: View Of Cylinder Head & Bolts (Left)
Courtesy of GENERAL MOTORS CORP.

8. Install the cylinder head onto the locating pins and the gasket.
9. Install the NEW cylinder head bolts.

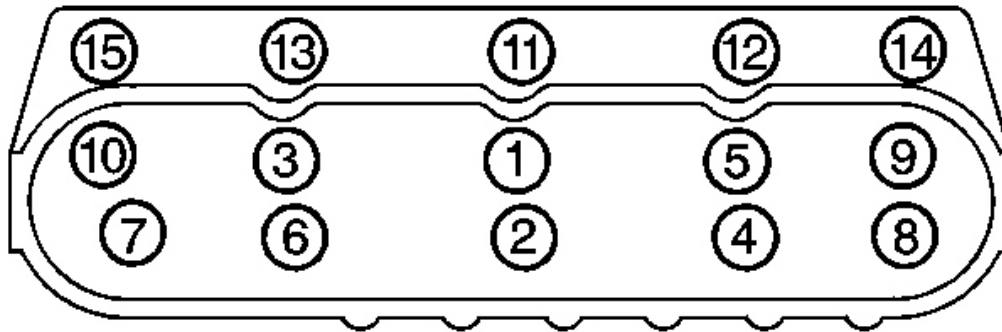
Fig. 666: Cylinder Head Bolt Tightening Sequence
Courtesy of GENERAL MOTORS CORP.

1. Tighten the second design M11 cylinder head bolts (1-10) a first pass in sequence to 30 N.m (22 lb ft).
2. Tighten the second design M11 cylinder head bolts (1-10) a second pass in sequence to 90 degrees using the **J 45059**.
3. Tighten the second design M11 cylinder head bolts (1-10) a final pass in sequence to 70 degrees using the **J 45059**.
4. Tighten the M8 cylinder head bolts (11,12,13,14,15) to 30 N.m (22 lb ft). Begin with the center bolt (11) and alternating side-to-side, work outward tightening all of the bolts.

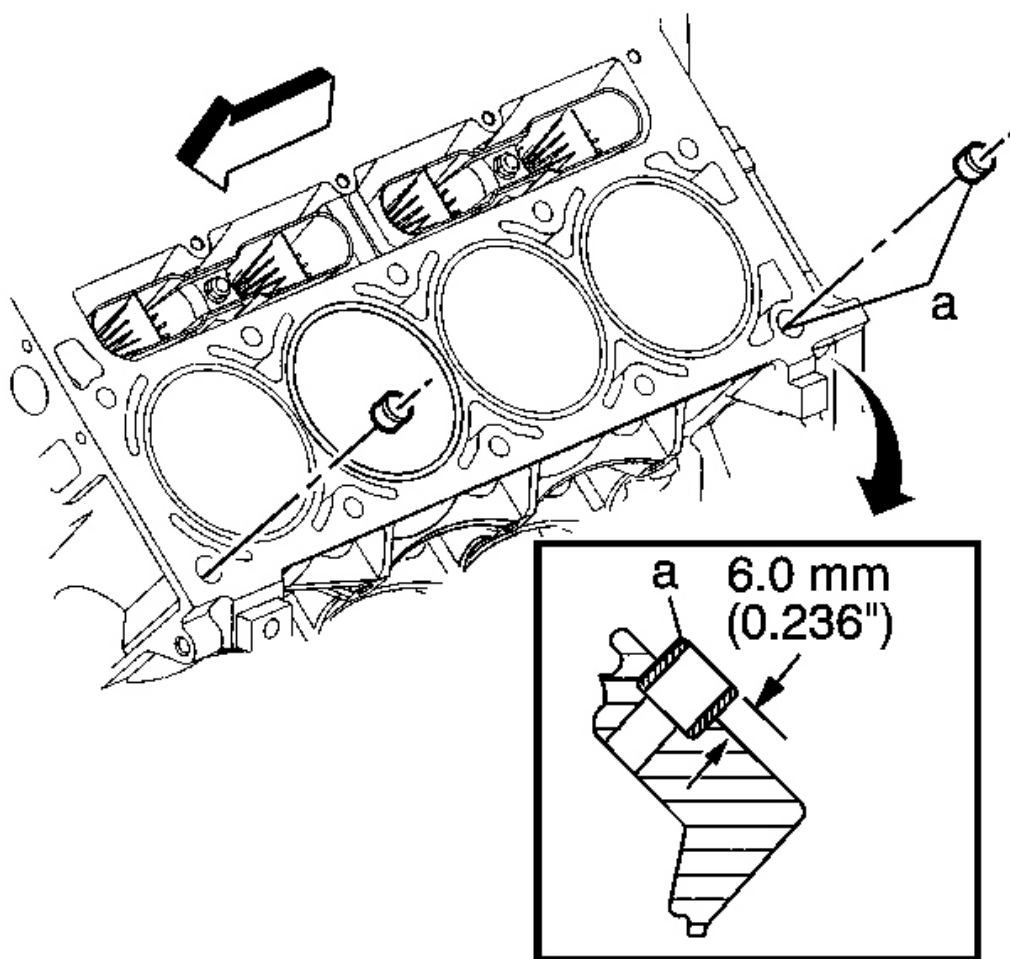
Fig. 667: Identifying Cylinder Head Locating Pins Installation Position
Courtesy of GENERAL MOTORS CORP.

IMPORTANT: First design engine blocks have different drill and tap depths using both medium length 100 mm (3.94 in) and long 155 mm (6.1 in) M11 cylinder head bolts. Second design engine blocks use only the medium length 100 mm (3.94 in) bolt with a common drill and tap depth.

4. Measure the depth of the cylinder head bolt holes (1-10) and select the correct length bolts as required.
5. Check the cylinder head locating pins for proper installation.

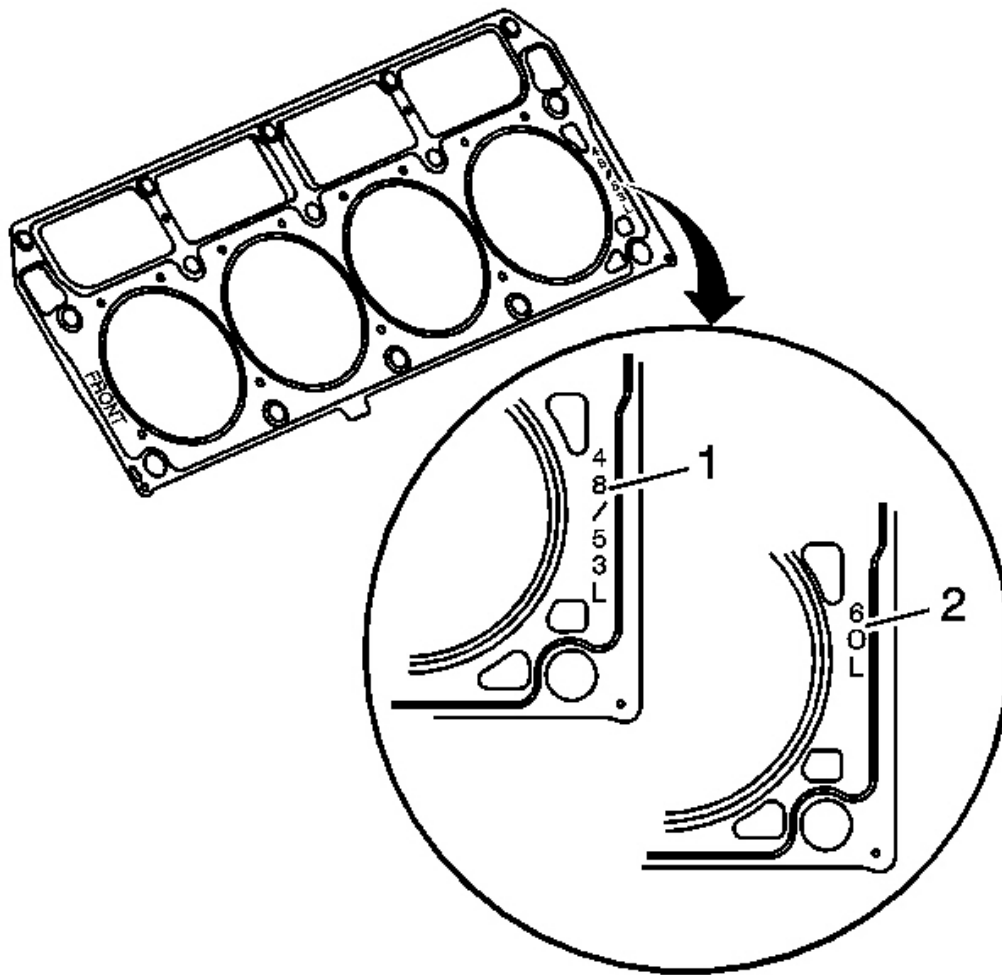
Fig. 669: View Of Cylinder Head Gasket Displacement Markings
Courtesy of GENERAL MOTORS CORP.

6. Inspect the displacement markings (1) on the gasket, for proper usage.

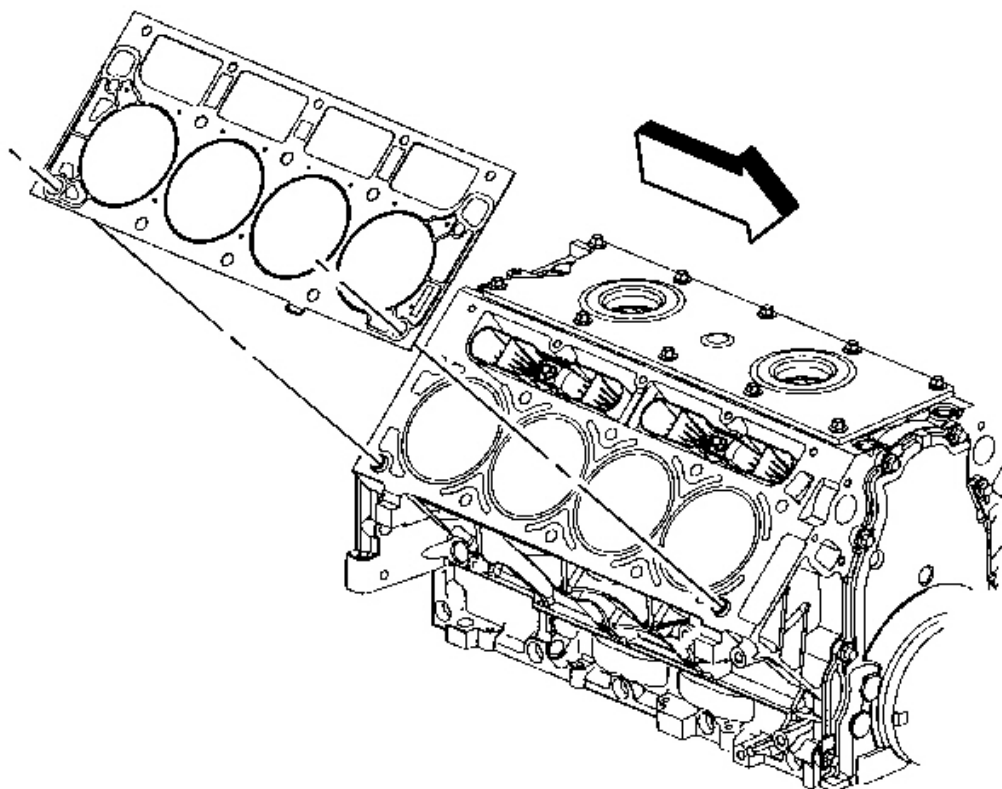
Fig. 670: View Of Right Cylinder Head Gasket And Alignment Pins
Courtesy of GENERAL MOTORS CORP.

IMPORTANT: When properly installed, the tab on the right cylinder head gasket will be located right of center or closer to the front of the engine.

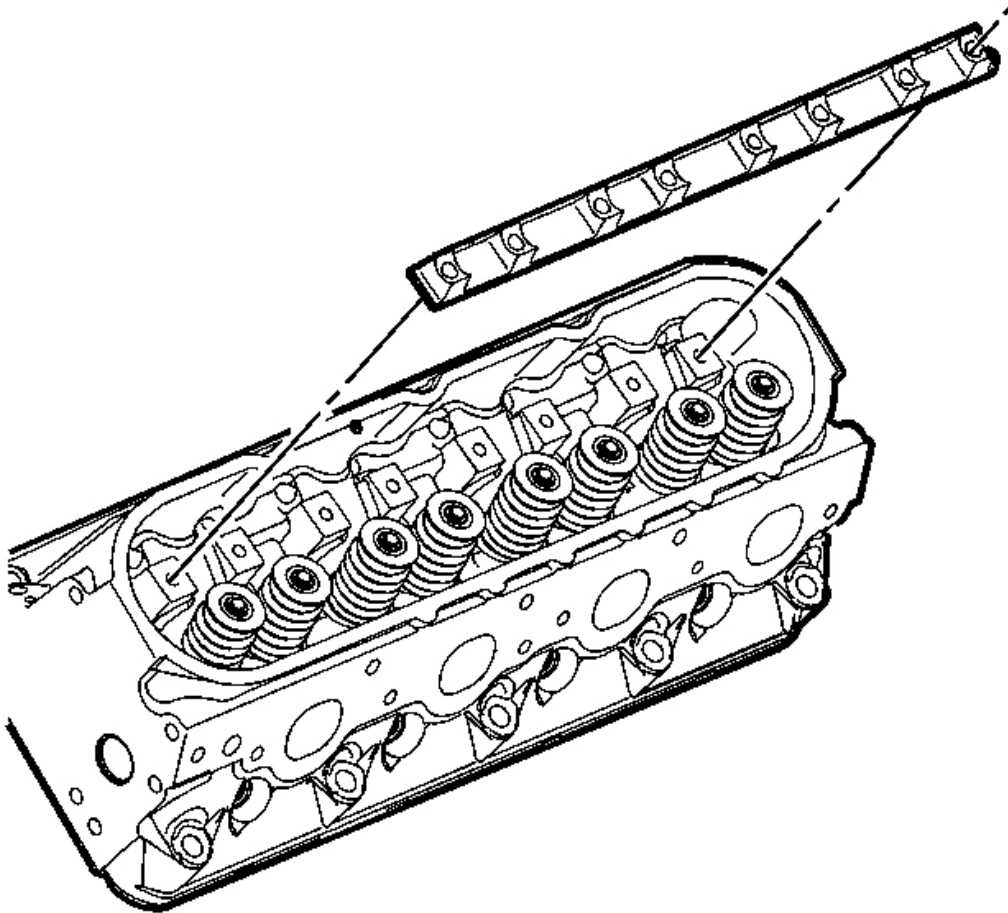
Fig. 673: View Of Valve Rocker Arm Pivot Support
Courtesy of GENERAL MOTORS CORP.

Lubricate the flange or washer surface of the bolt that will contact the valve rocker arm.

3. Install the valve rocker arm pivot support.

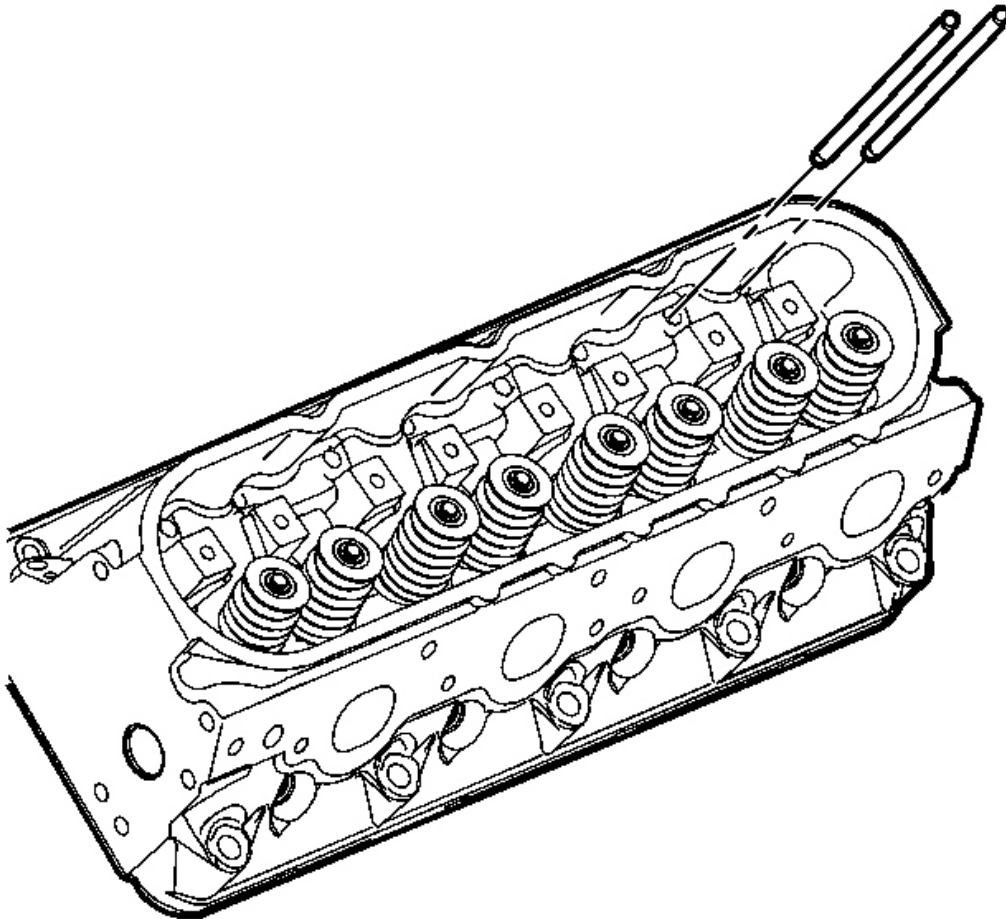
Fig. 674: View Of Pushrods
Courtesy of GENERAL MOTORS CORP.

IMPORTANT: Ensure that the pushrods seat properly to the valve lifter sockets.

4. Install the pushrods.

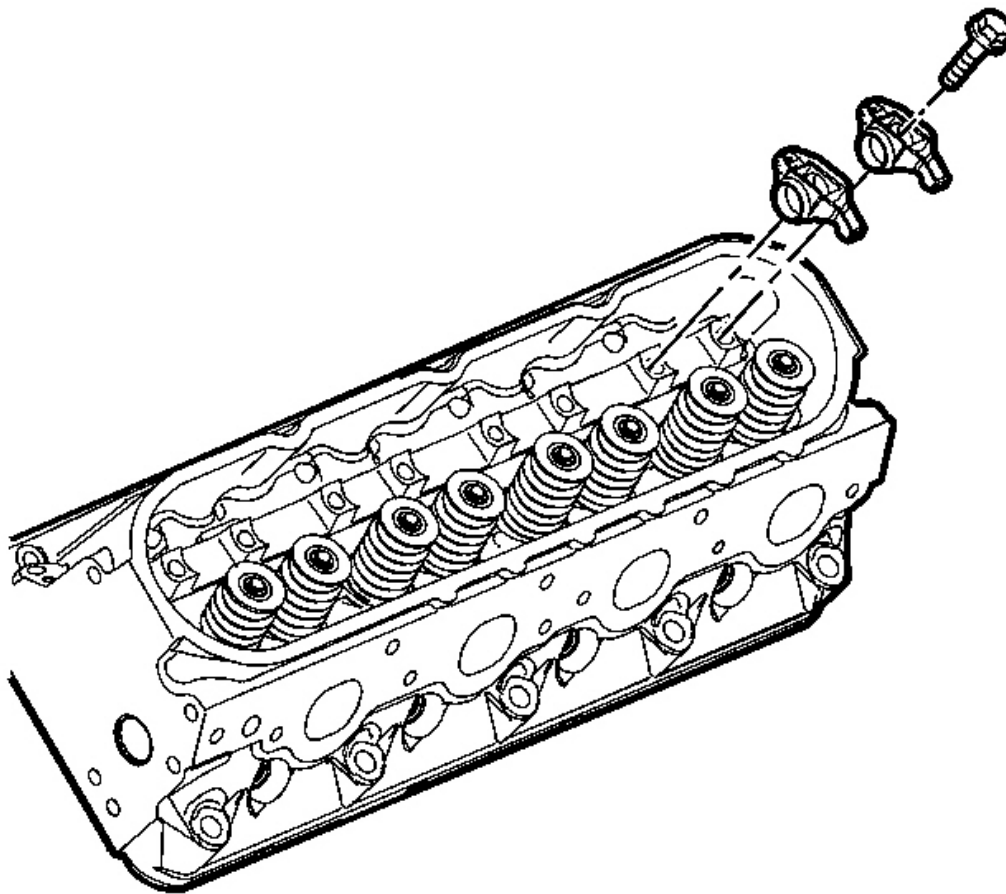
Fig. 675: View Of Rocker Arms & Bolts
Courtesy of GENERAL MOTORS CORP.

- Ensure that the pushrods seat properly to the ends of the rocker arms.
- **DO NOT** tighten the rocker arm bolts at this time.

5. Install the rocker arms and bolts.

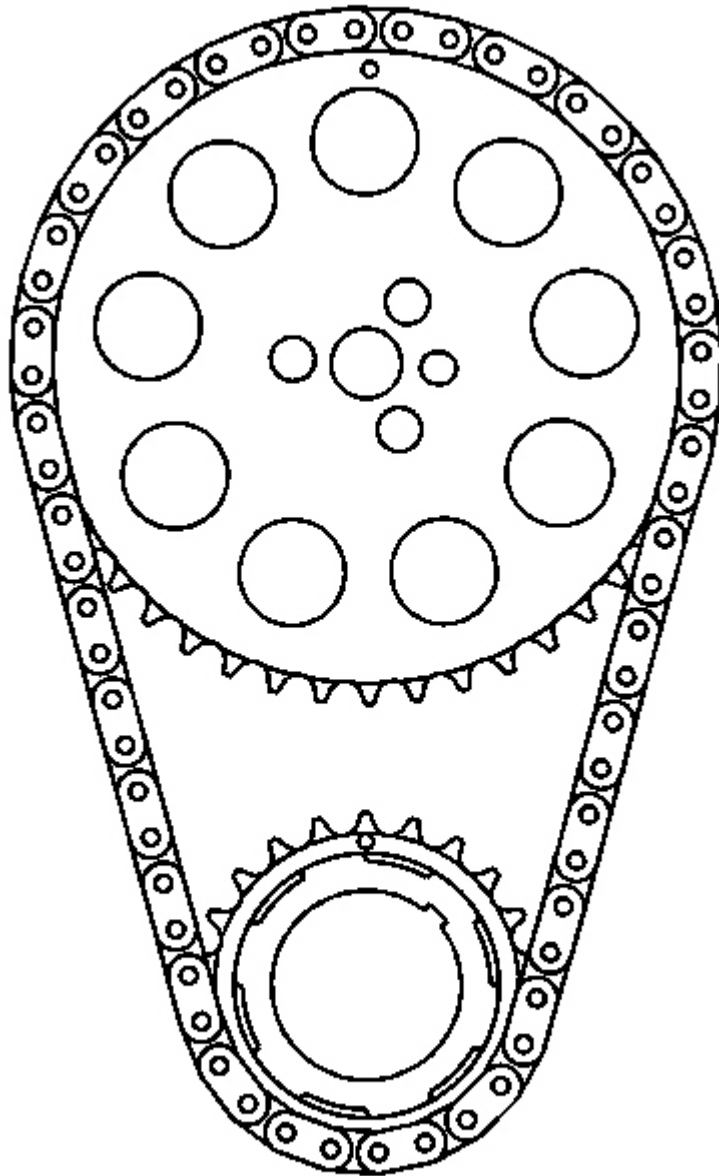
Fig. 676: View of Crankshaft/Camshaft In Position For Number 1 Piston At TDC
Courtesy of GENERAL MOTORS CORP.

6. Rotate the crankshaft until number one piston is at top dead center of compression stroke.

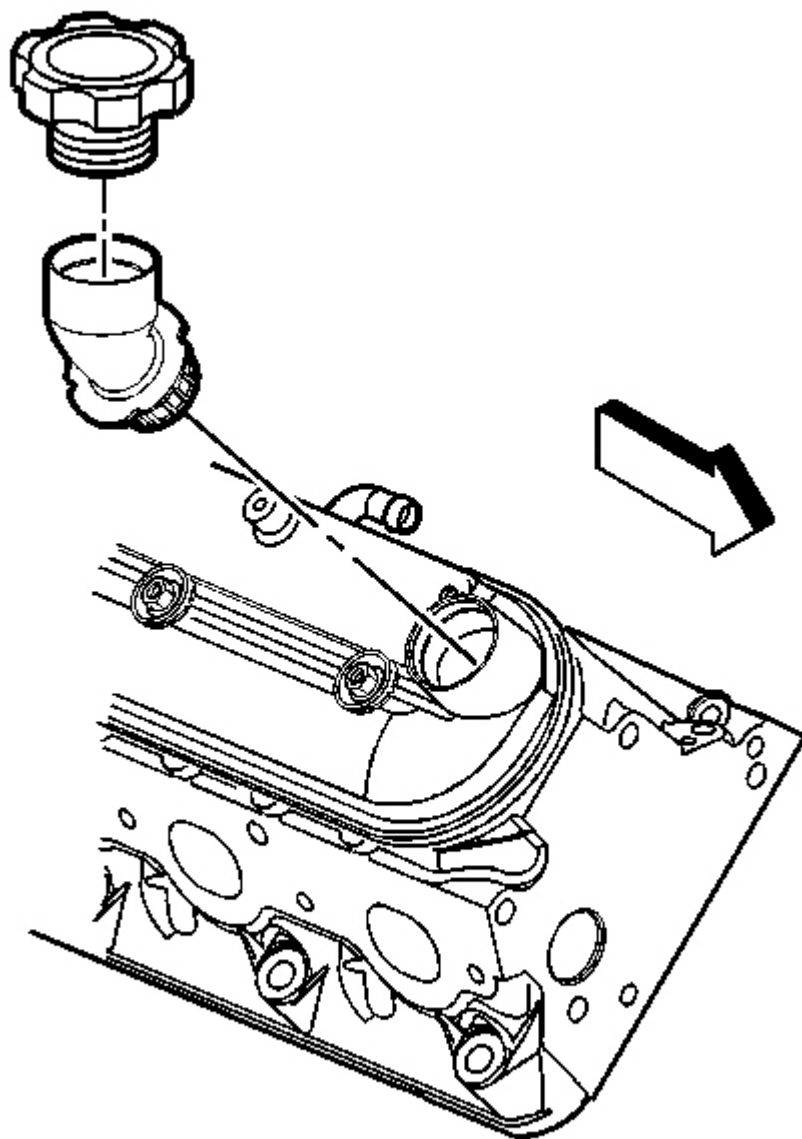
Fig. 680: View Of Oil Fill Cap & Tube
Courtesy of GENERAL MOTORS CORP.

- Do not remove the ignition coils and bracket from the valve rocker arm cover, unless required.
 - The valve rocker arm cover bolt grommets may be used again.
 - If the oil fill tube has been removed from the valve rocker arm cover, install a NEW oil fill tube during assembly.
1. Lubricate the O-ring seal of the NEW oil fill tube with clean engine oil.
 2. Insert the NEW oil fill tube into the rocker arm cover and rotate the tube clockwise until locked in the proper position.
 3. Install the oil fill cap into the tube and rotate clockwise until locked in the proper position.

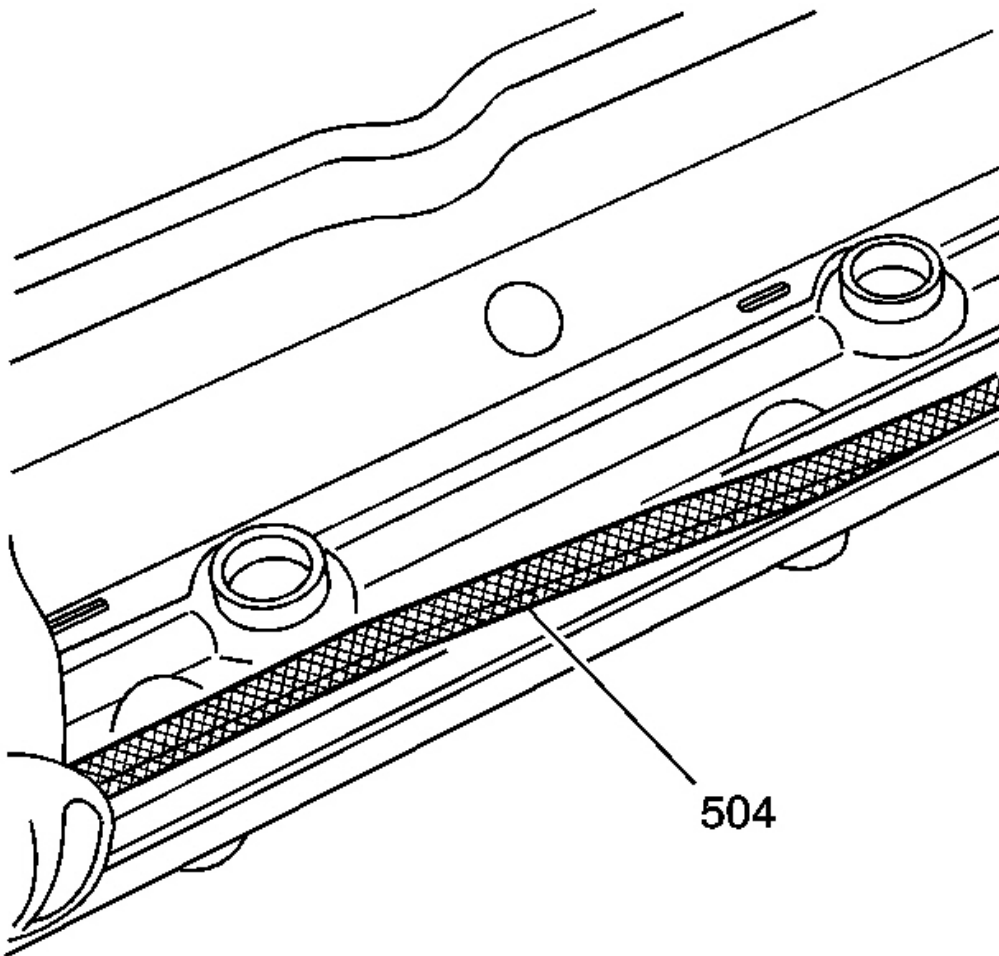
Fig. 681: View Of Valve Rocker Arm Cover Gasket

4. Install a NEW cover gasket (504) into the valve rocker arm cover.
