2004 Isuzu Ascender LS

2004 ENGINE Engine Mechanical - 4.8L, 5.3L, and 6.0L - Ascender

Engine Mechanical - 4.8L, 5.3L, and 6.0L - Ascender

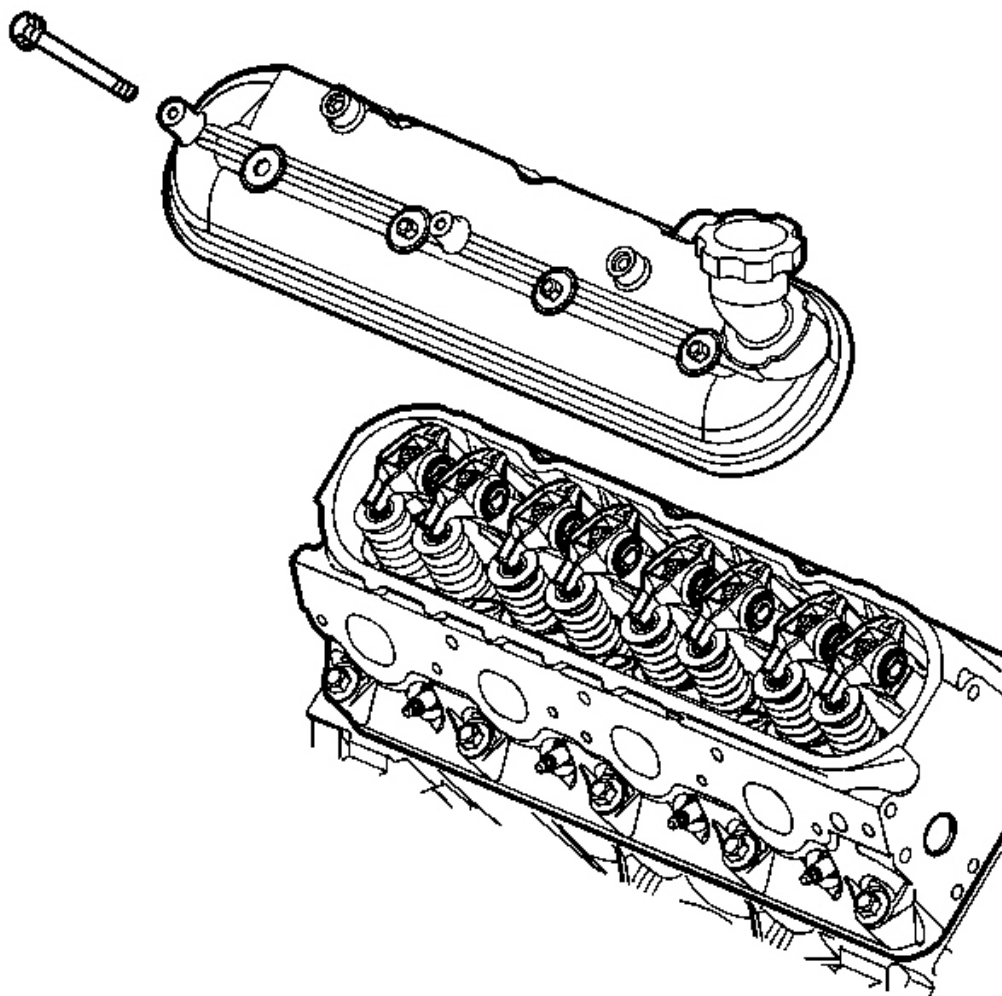
Fig. 682: View Of Valve Rocker Arm Cover & Bolts (Right)
Courtesy of GENERAL MOTORS CORP.

5. Install the valve rocker arm cover onto the cylinder head.

6. Install the cover bolts with grommets.

Tighten: Tighten the valve rocker arm cover bolts to 12 N.m (106 lb in).

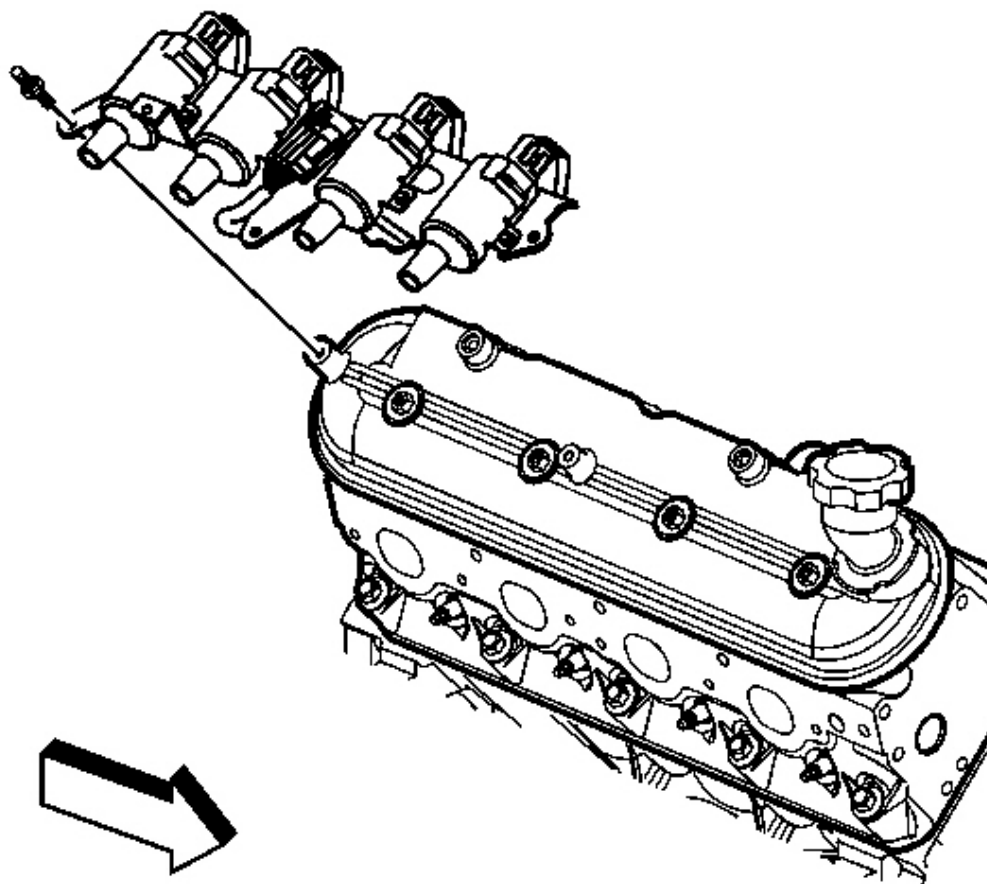
Fig. 683: Ignition Coil View

Tighten: Tighten the ignition coil and bracket assembly studs to 12 N.m (106 lb in).

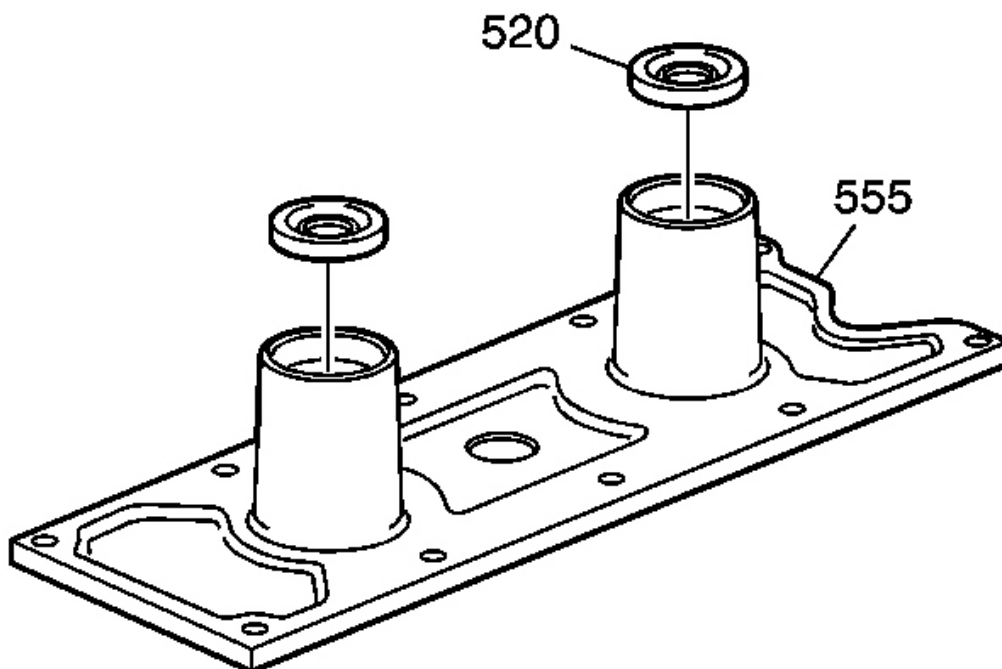
Fig. 684: View Of Knock Sensor Oil Seals & Valley Cover
Courtesy of GENERAL MOTORS CORP.

1. Install NEW knock sensor oil seals (520) into the valley cover (555).

Lubricate the seal surfaces with clean engine oil.

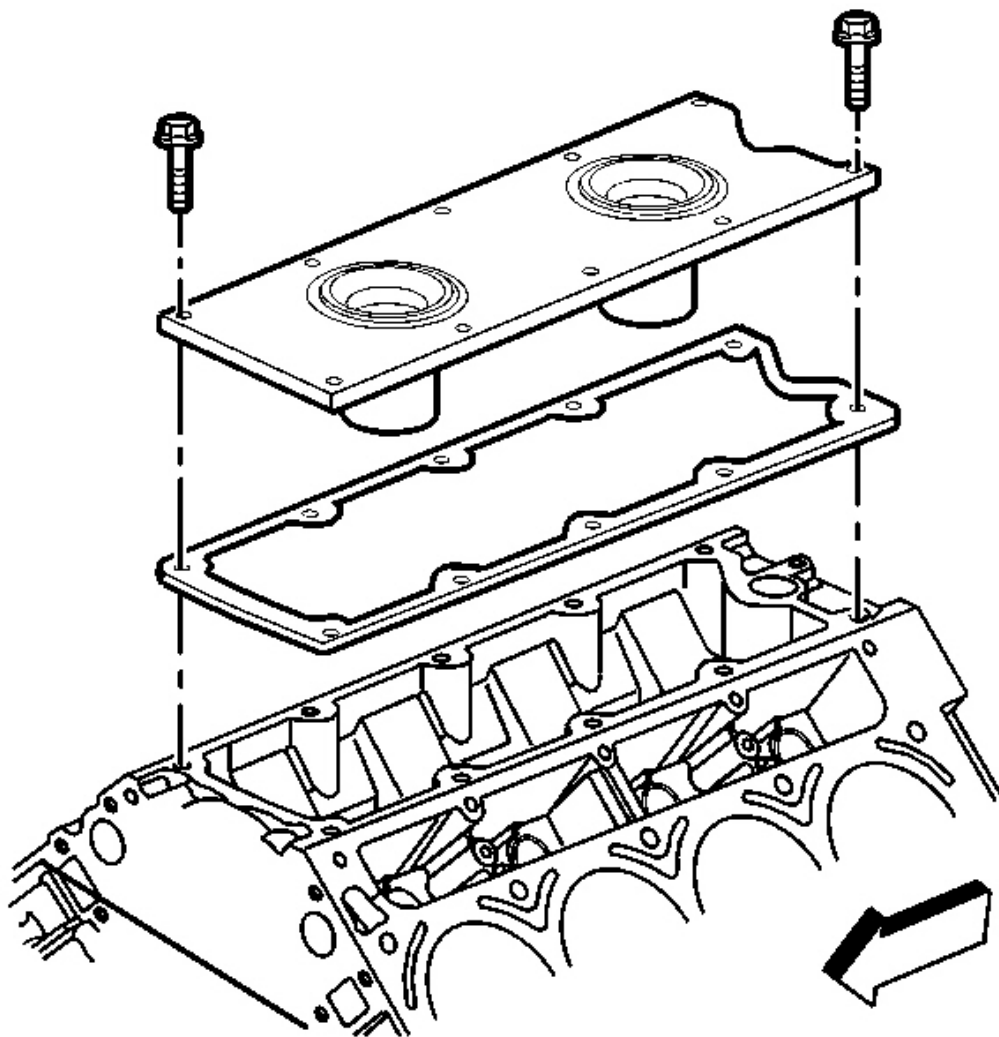
Fig. 685: View Of Engine Valley Cover, Gasket & Bolts
Courtesy of GENERAL MOTORS CORP.

2. Install the valley cover and NEW gasket.

3. Install the valley cover bolts.

Tighten: Tighten the valley cover bolts to 25 N.m (18 lb ft).

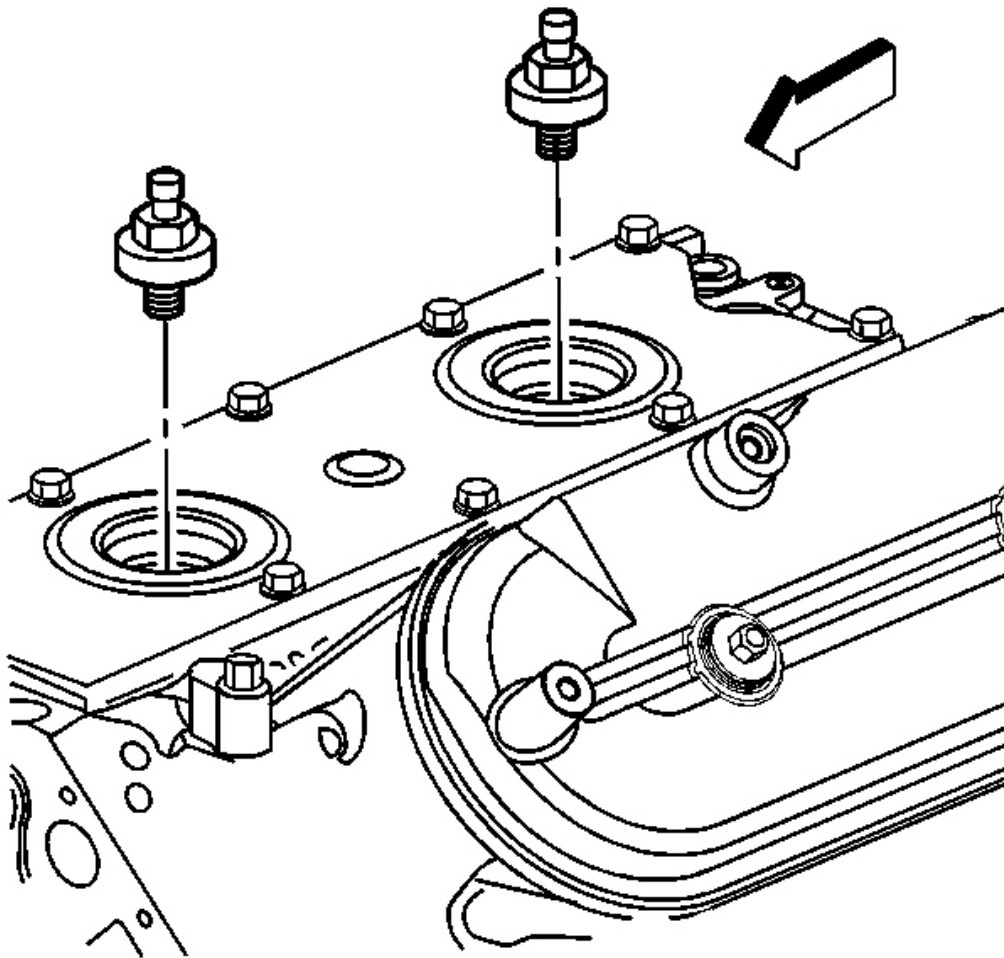
Fig. 686: View Of Knock Sensors
Courtesy of GENERAL MOTORS CORP.

4. Install the knock sensors.

Tighten: Tighten the knock sensors to 20 N.m (15 lb ft).

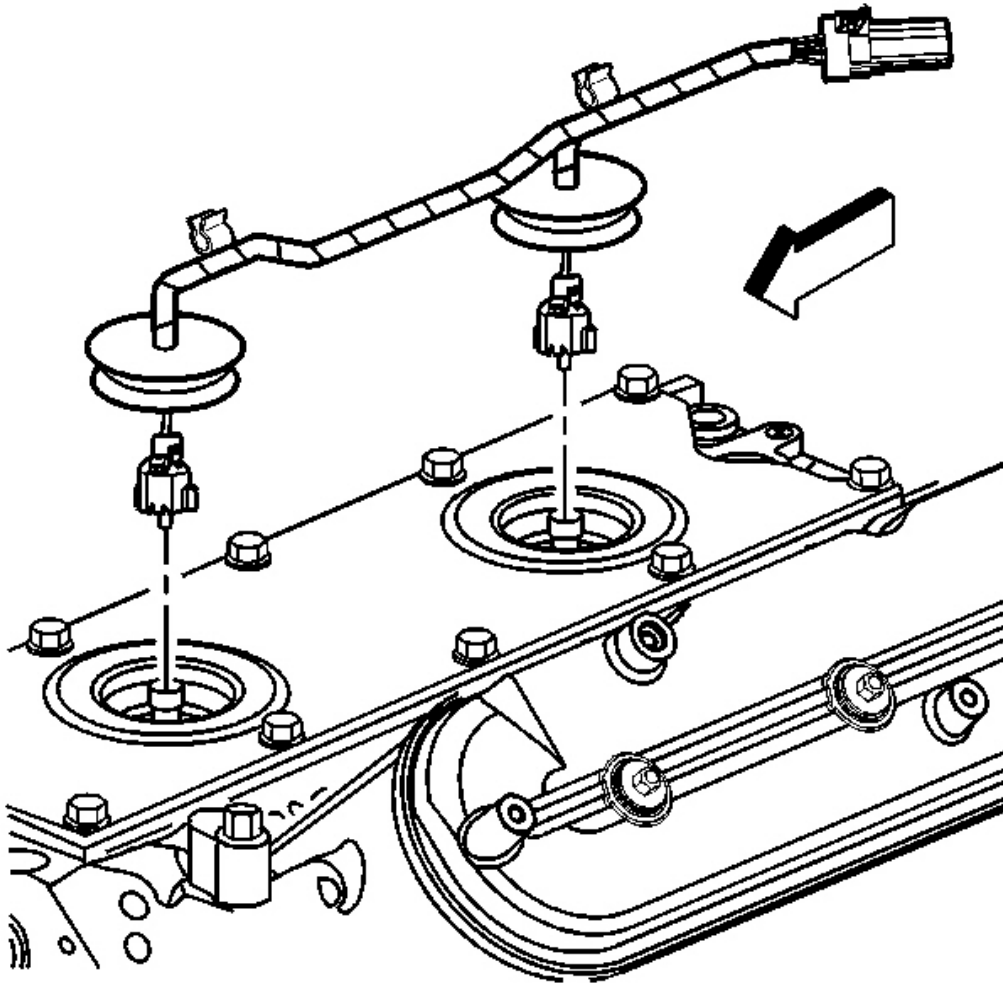
Fig. 687: View Of Knock Sensor Wire Harness
Courtesy of GENERAL MOTORS CORP.

5. Install the knock sensor wire harness.

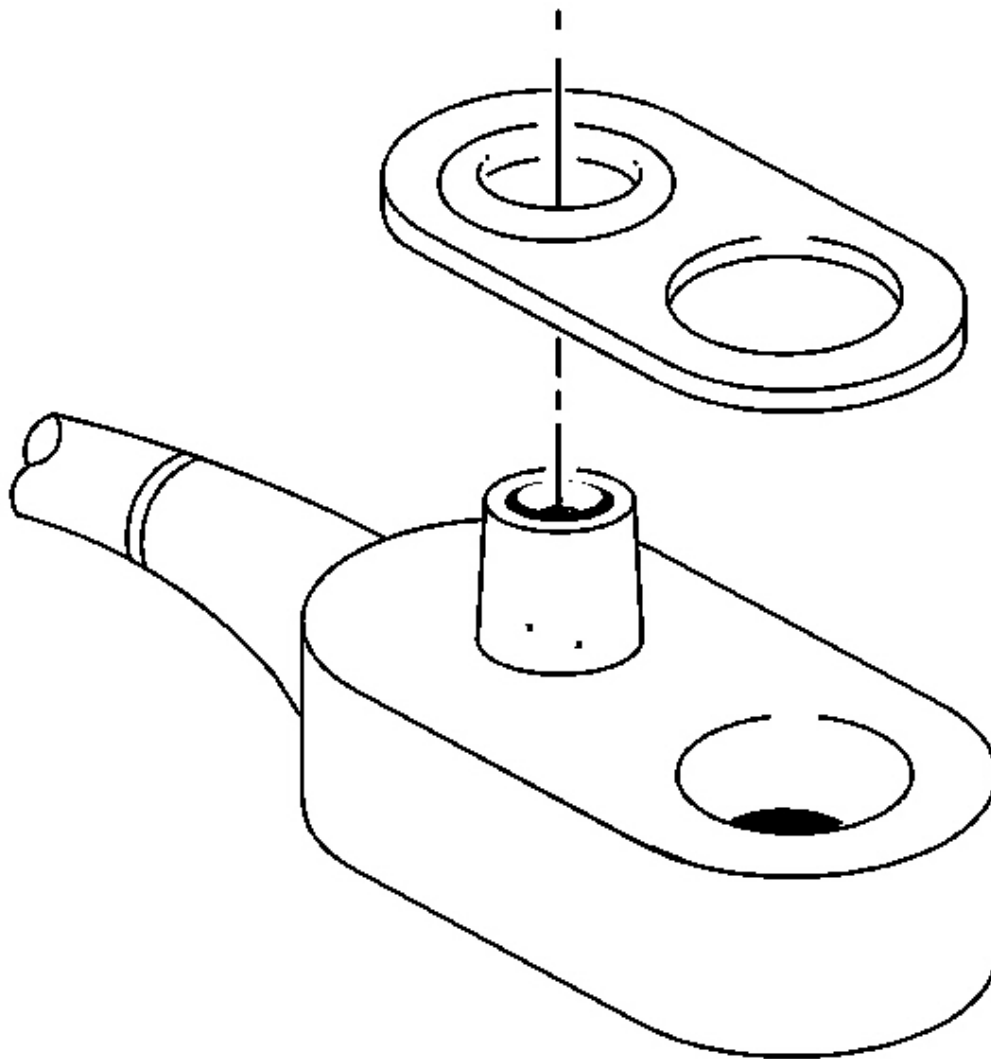
Fig. 688: View Of Air Bleed Pipe Sealing Gasket
Courtesy of GENERAL MOTORS CORP.

- Install the pipe gaskets properly onto the pipe and covers.
- Position the gasket O-ring seal onto the nipple portion of the pipe.

1. Install the gaskets onto the engine coolant air bleed pipe and covers.

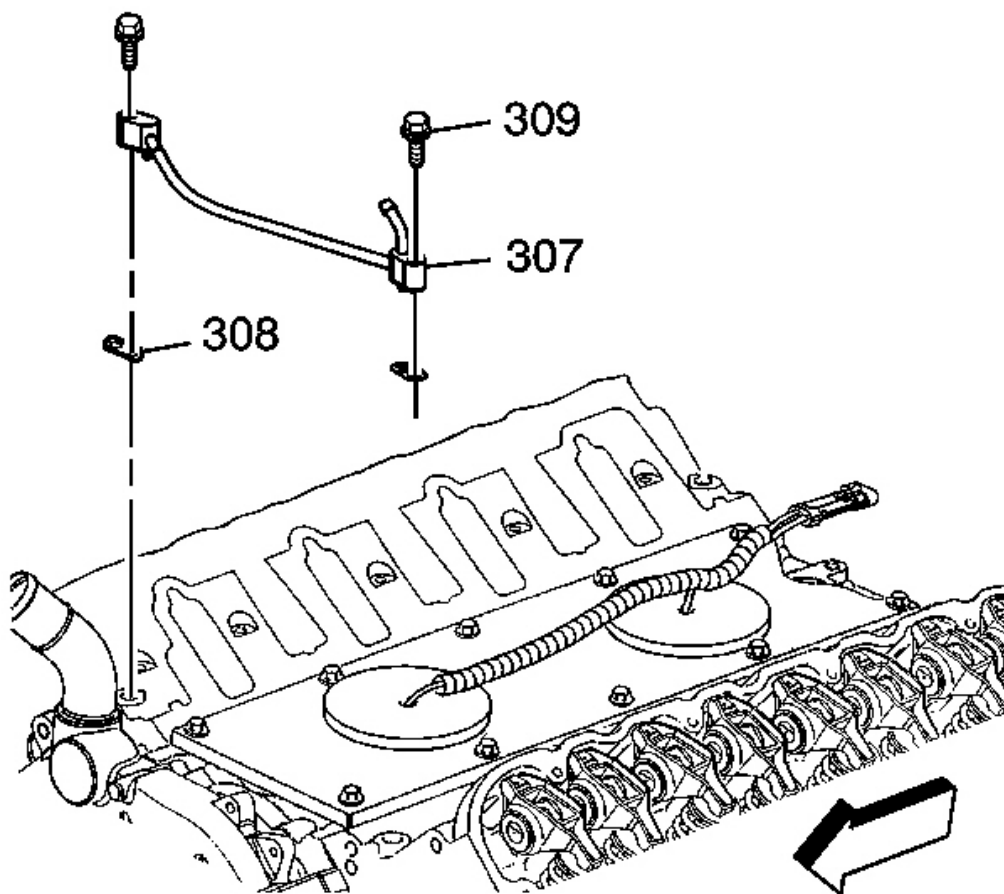
Fig. 689: View Of Air Bleed Pipe, Bolts & Gasket
Courtesy of GENERAL MOTORS CORP.

2. Install the pipe (307) and gaskets (308) onto the cylinder heads.

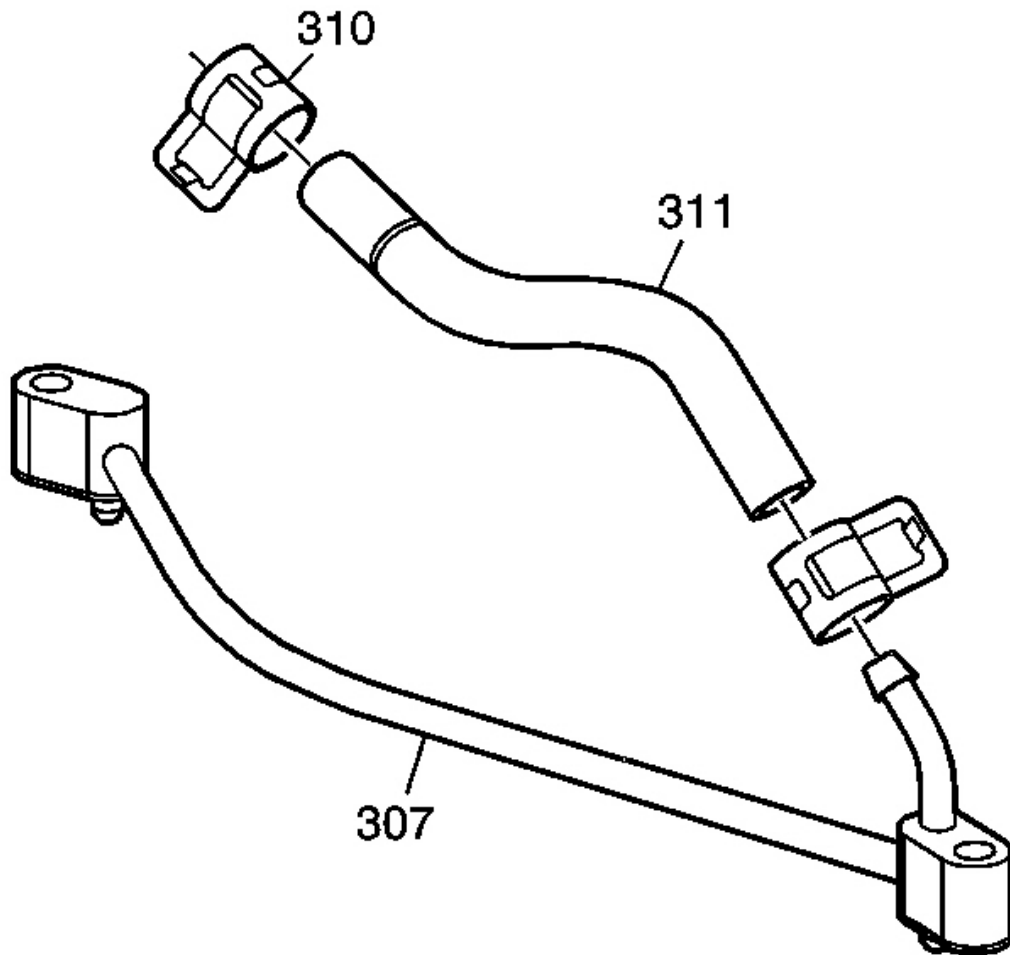
Fig. 691: View Of Engine Coolant Air Bleed Pipe, Hose & Clamps
Courtesy of GENERAL MOTORS CORP.

5. Install the hose (311) and clamps (310) onto the pipe (307).

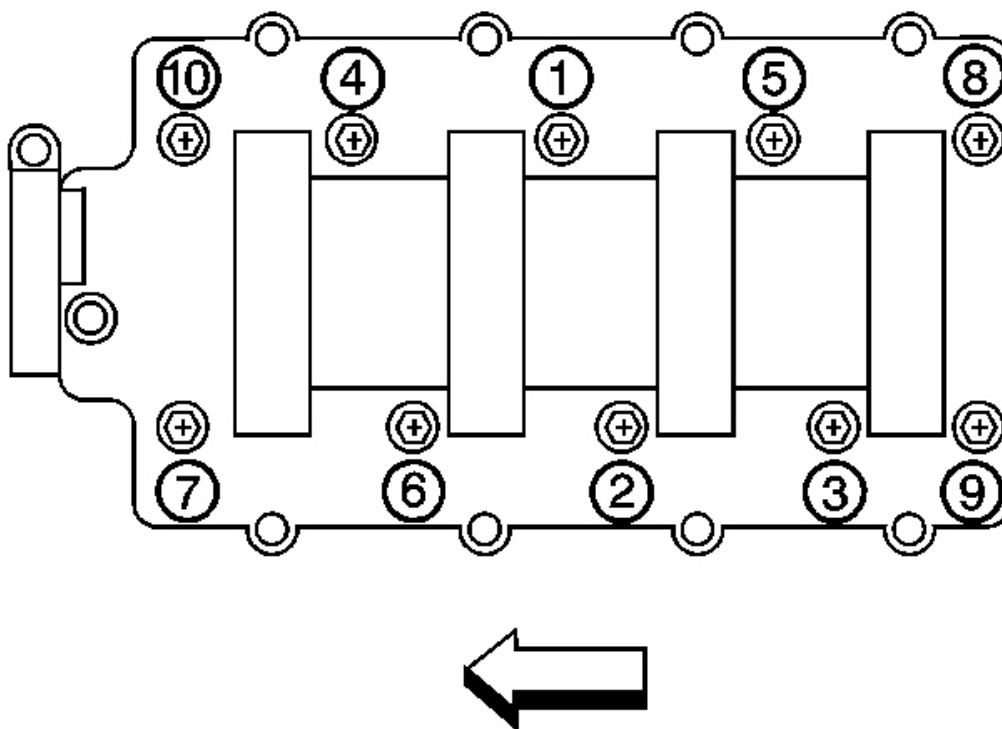
Fig. 694: Identifying Intake Manifold Bolt Tightening Sequence
Courtesy of GENERAL MOTORS CORP.

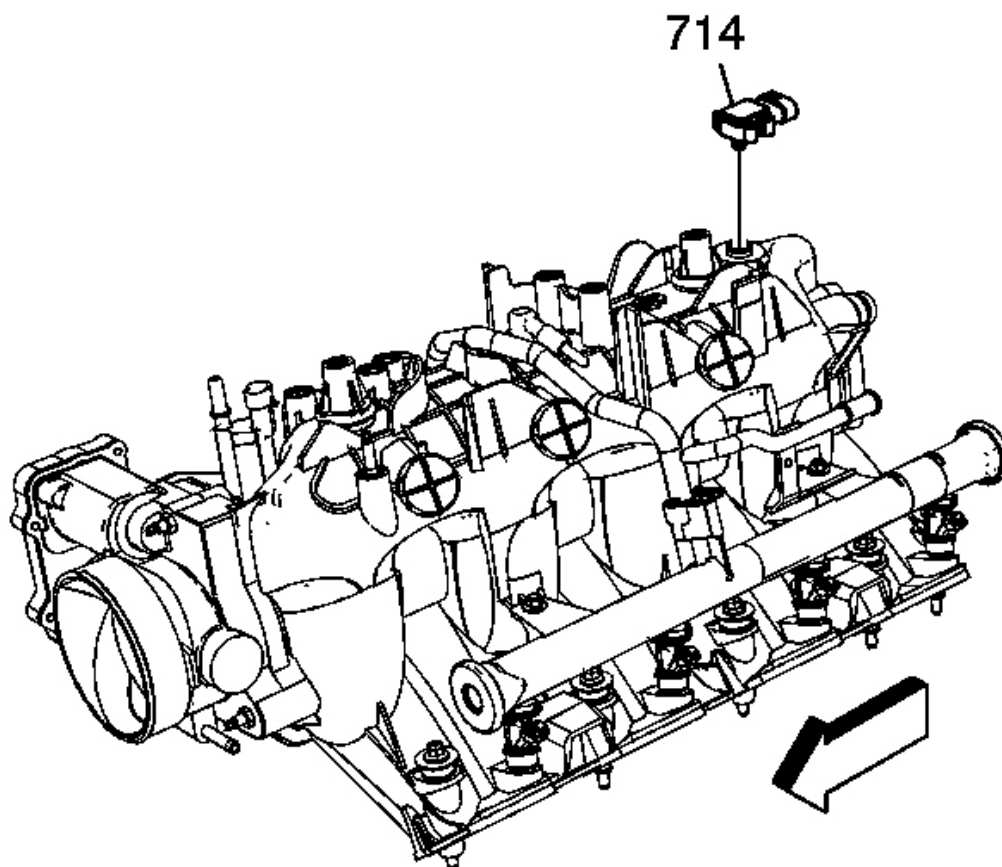
Fig. 695: View Of MAP Sensor
Courtesy of GENERAL MOTORS CORP.

5. Install the manifold absolute pressure (MAP) sensor (714), if previously removed.

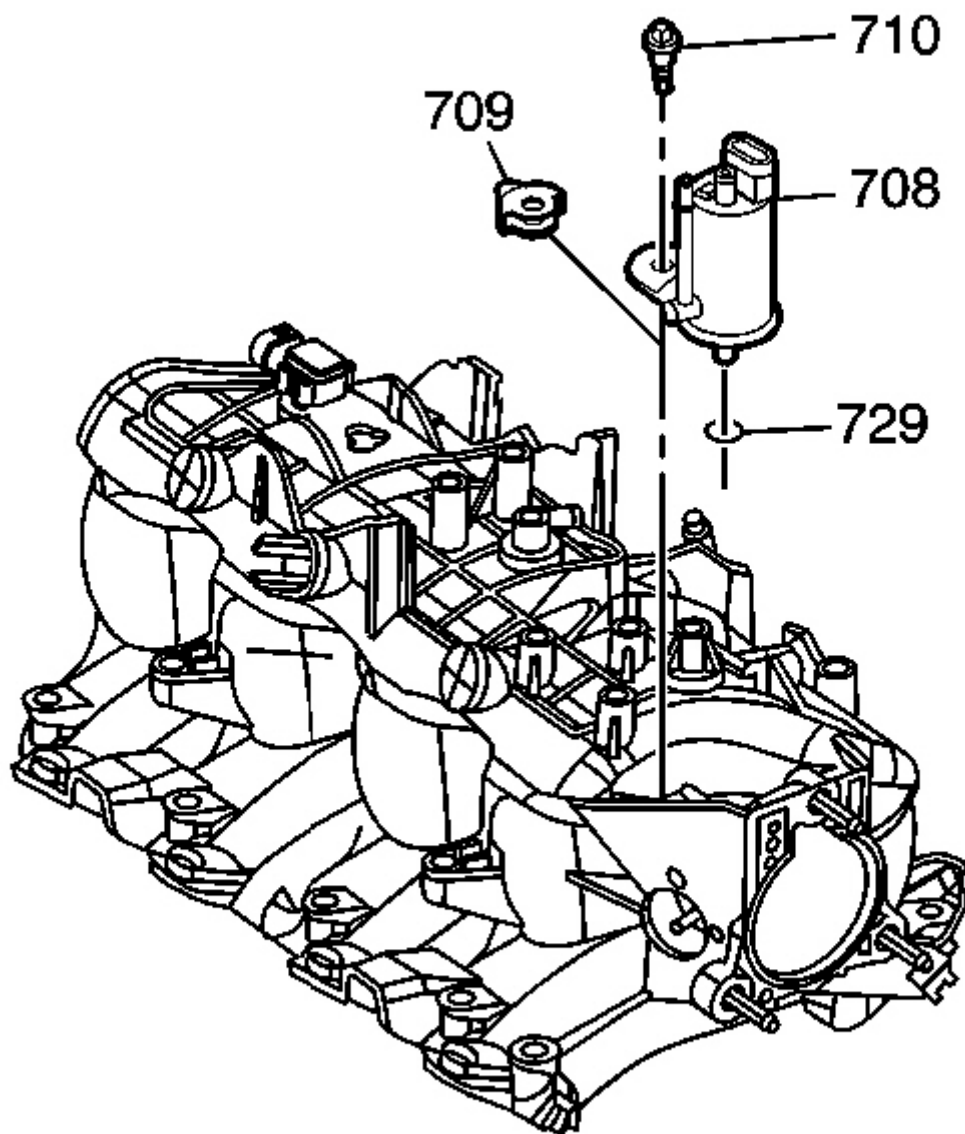
Fig. 697: View Of EVAP Purge Solenoid, Bolt & Isolator
Courtesy of GENERAL MOTORS CORP.

8. Install the evaporative emission (EVAP) purge solenoid (708), bolt (710), and isolator (709).

Tighten: Tighten the solenoid bolt to 10 N.m (89 lb in).

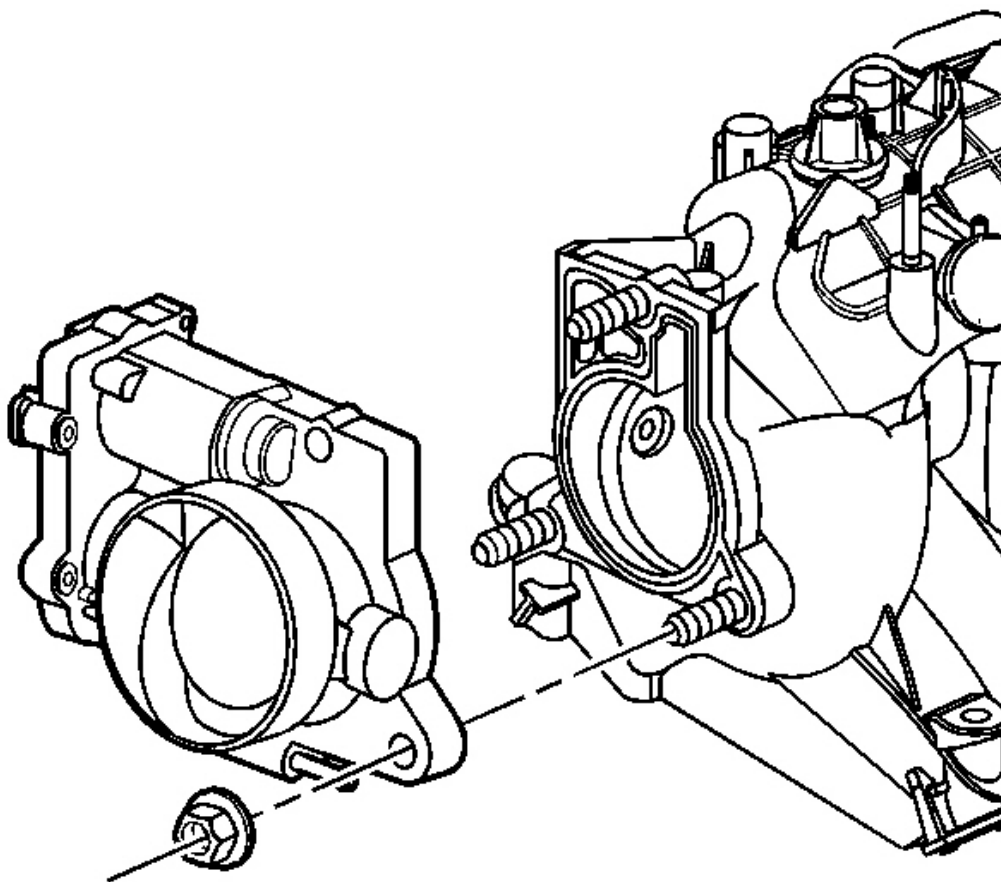
Fig. 701: View Of Throttle Body & Nuts
Courtesy of GENERAL MOTORS CORP.

3. Install the throttle body and nuts.

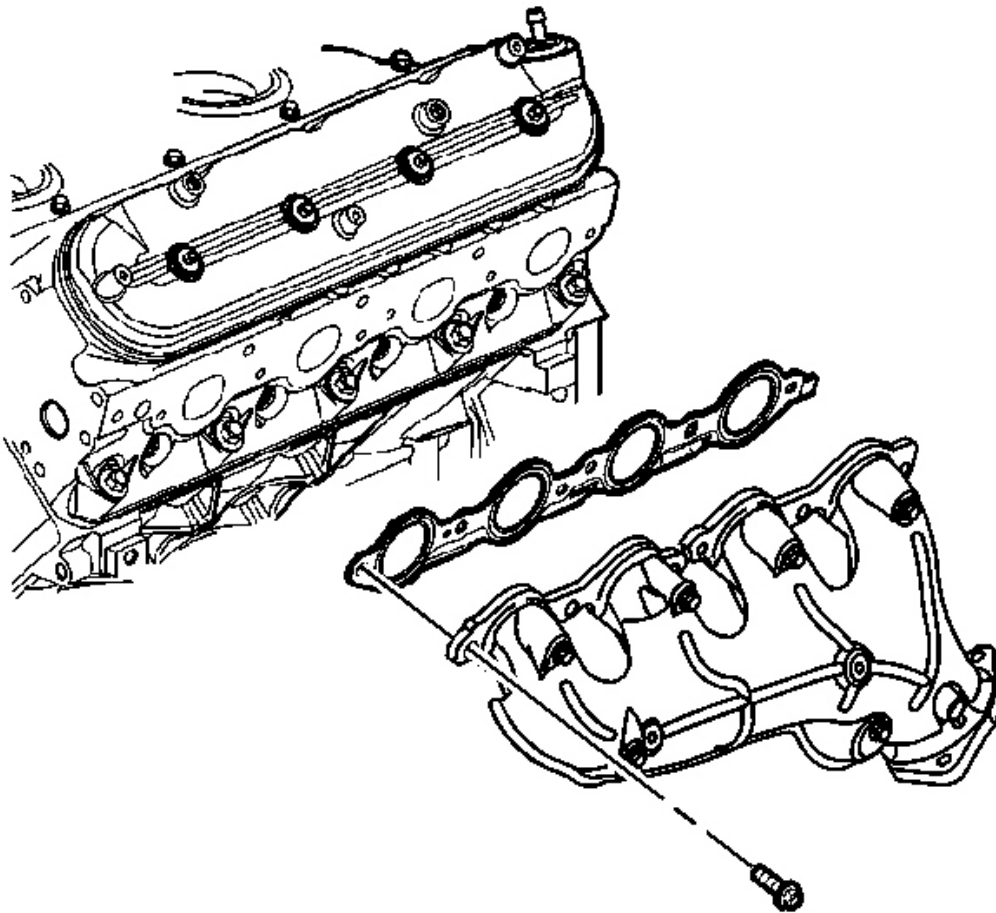
Fig. 703: View Of Exhaust Manifold, Bolts & Gasket (Left)
Courtesy of GENERAL MOTORS CORP.

- Tighten the exhaust manifold bolts as specified in the service procedure. Improperly installed and/or leaking exhaust manifold gaskets may affect vehicle emissions and/or On-Board Diagnostic (OBD) II system performance.
- The cylinder head exhaust manifold bolt hole threads must be clean

1. Tighten the exhaust manifold bolts a first pass to 15 N.m (11 lb ft). Tighten the exhaust manifold bolts beginning with the center two bolts. Alternate from side-to-side, and work toward the outside bolts.
 2. Tighten the exhaust manifold bolts a final pass to 25 N.m (18 lb ft). Tighten the exhaust manifold bolts beginning with the center two bolts. Alternate from side-to-side, and work toward the outside bolts.
4. Using a flat punch, bend over the exposed edge of the exhaust manifold gasket at the rear of the left cylinder head.

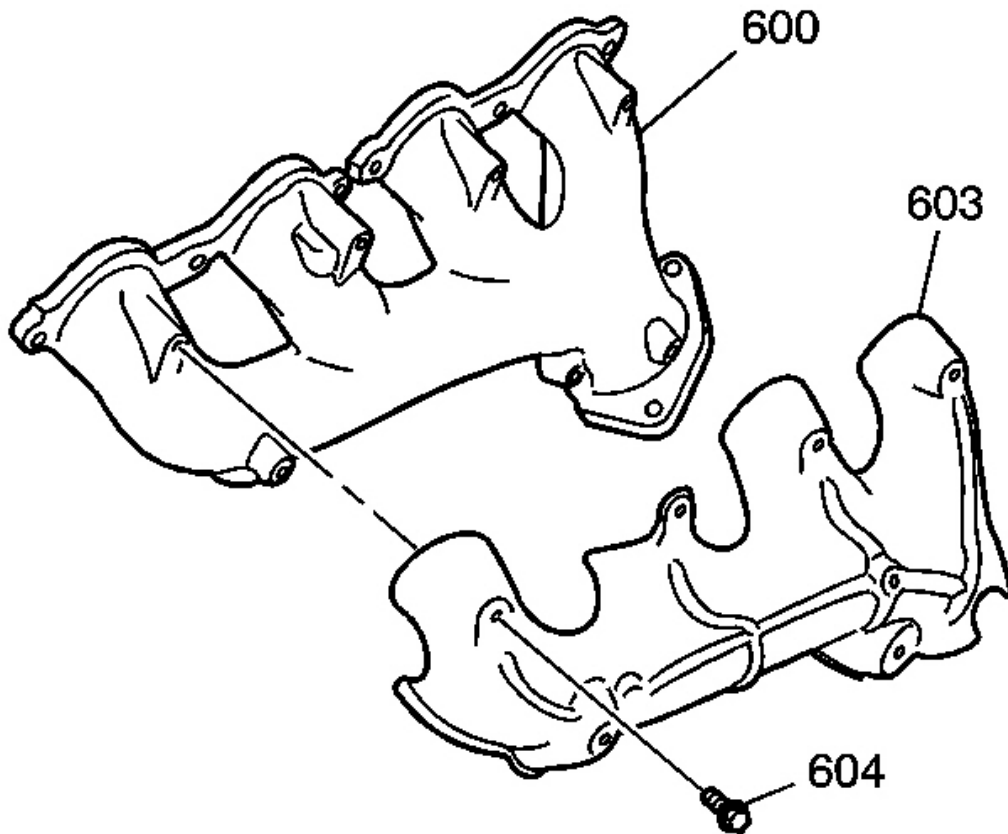
Fig. 704: View Of Manifold, Heat Shield & Bolts
Courtesy of GENERAL MOTORS CORP.

5. Install the heat shield (603) and bolts (604).

Tighten: Tighten the heat shield bolts to 9 N.m (80 lb in).

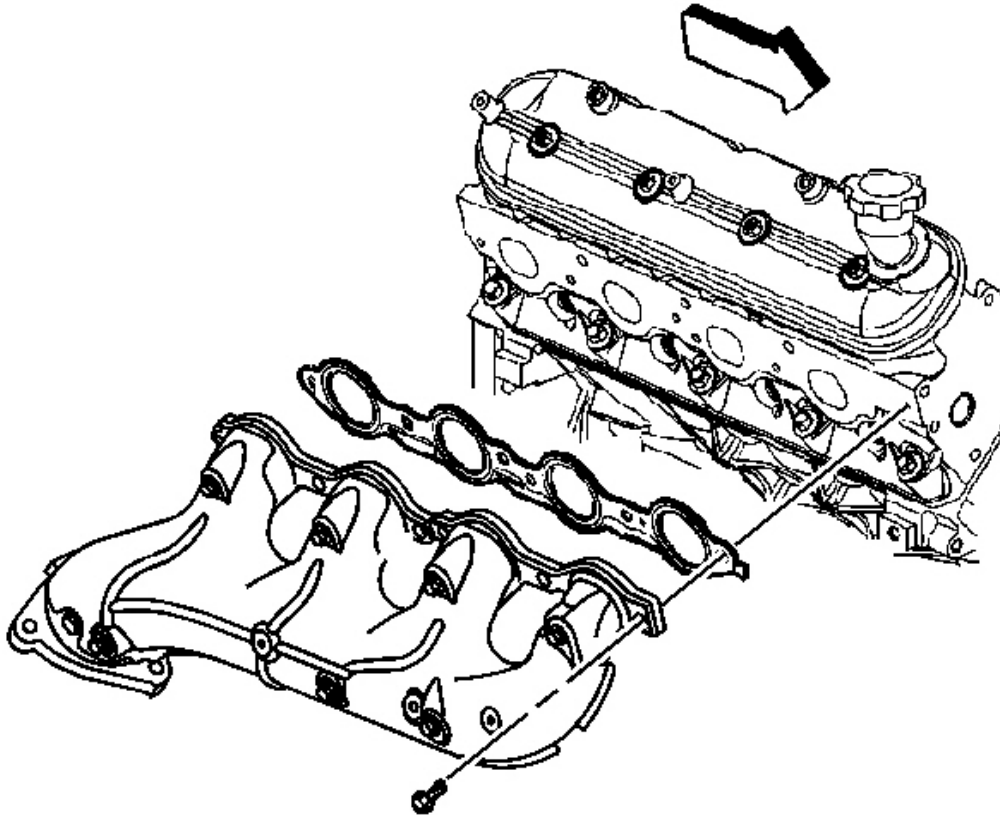
Fig. 705: View Of Exhaust Manifold & Gasket (Right)
Courtesy of GENERAL MOTORS CORP.

- Tighten the exhaust manifold bolts as specified in the service procedure. Improperly installed and/or leaking exhaust manifold gaskets may affect vehicle emissions and/or On-Board Diagnostic (OBD) II system performance.
- The cylinder head exhaust manifold bolt hole threads must be clean and free of debris or threadlocking material.

1. Tighten the exhaust manifold bolts first pass to 15 N.m (11 lb ft). Tighten the exhaust manifold bolts beginning with the center two bolts. Alternate from side-to-side, and work toward the outside bolts.
 2. Tighten the exhaust manifold bolts final pass to 25 N.m (18 lb ft). Tighten the exhaust manifold bolts beginning with the center two bolts. Alternate from side-to-side, and work toward the outside bolts.
4. Using a flat punch, bend over the exposed edge of the exhaust manifold gasket at the front of the right cylinder head.

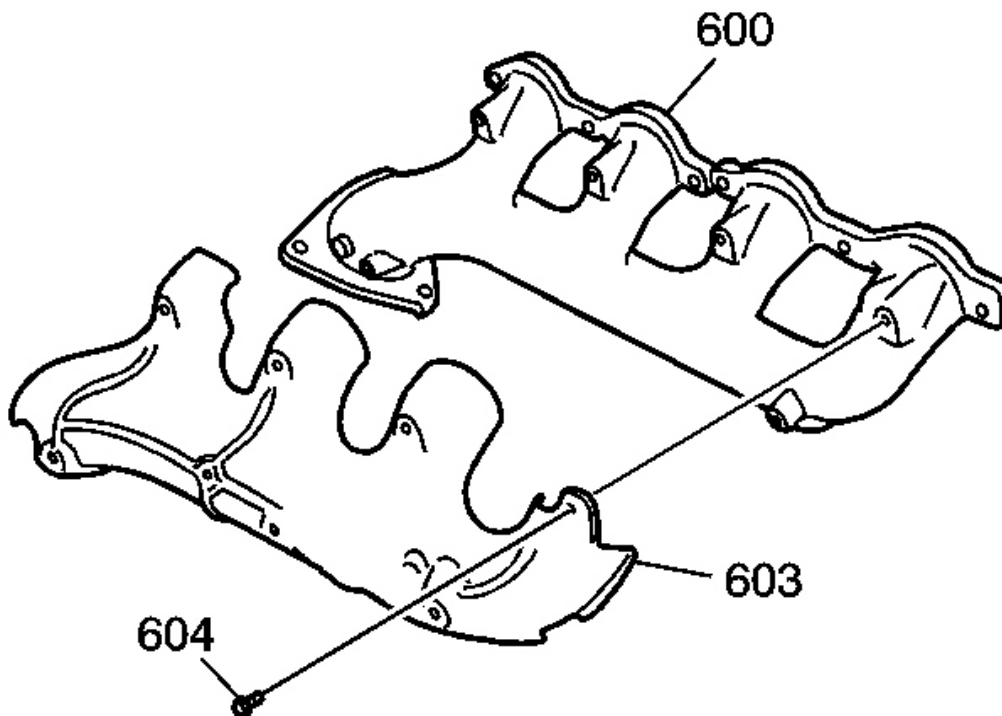
Fig. 706: View Of Exhaust Manifold Heat Shield & Bolts (Right)
Courtesy of GENERAL MOTORS CORP.

5. Install the heat shield (603) and bolts (604).

Tighten: Tighten the heat shield bolts to 9 N.m (80 lb in).

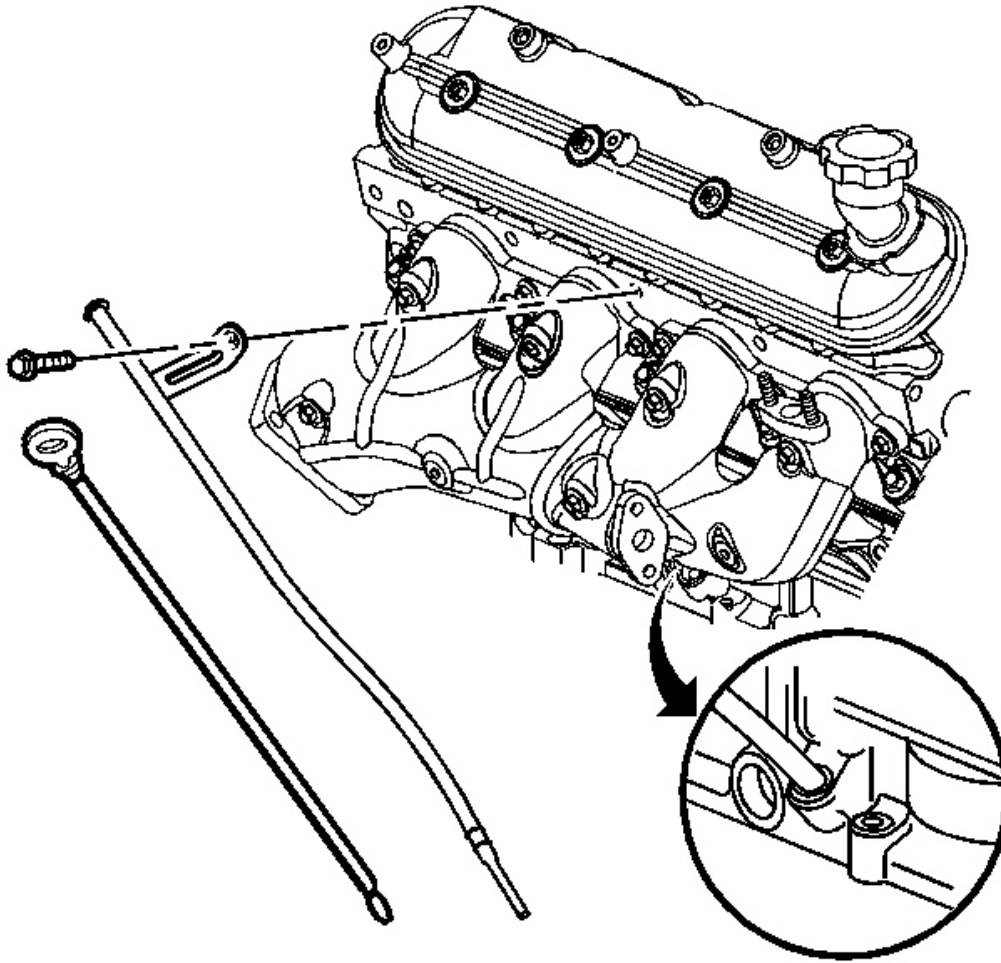
Fig. 707: View Of Oil Level Indicator, Tube & Bolt
Courtesy of GENERAL MOTORS CORP.

1. Inspect the O-ring seal for cuts or damage. If the oil level indicator tube O-ring seal is not cut or damaged, it may be used again.
2. Lubricate the O-ring seal with clean engine oil.
3. Install the O-ring seal onto the oil level indicator tube.
4. Install the oil level indicator tube into the engine block and rotate into proper position.

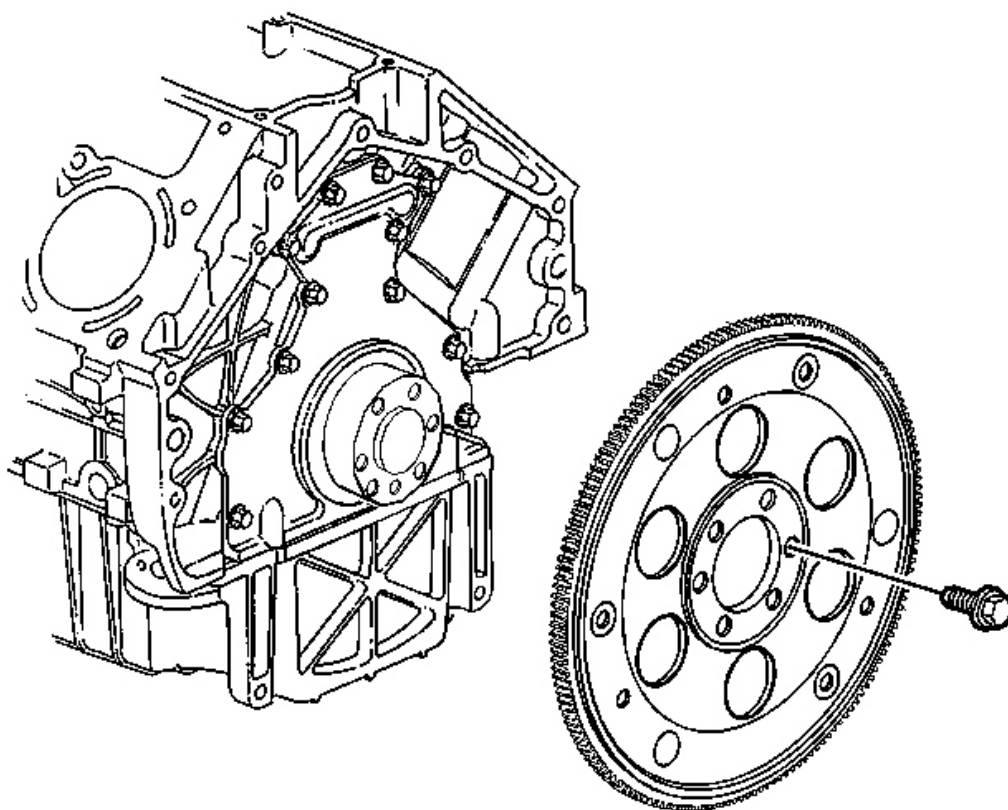
Fig. 708: View Of Engine Flywheel & Bolt
Courtesy of GENERAL MOTORS CORP.

IMPORTANT: The flywheel does not use a locating pin for alignment, and will not initially seat against the crankshaft flange, but will be pulled onto the crankshaft by the engine flywheel bolts. This procedure requires a three stage tightening process.

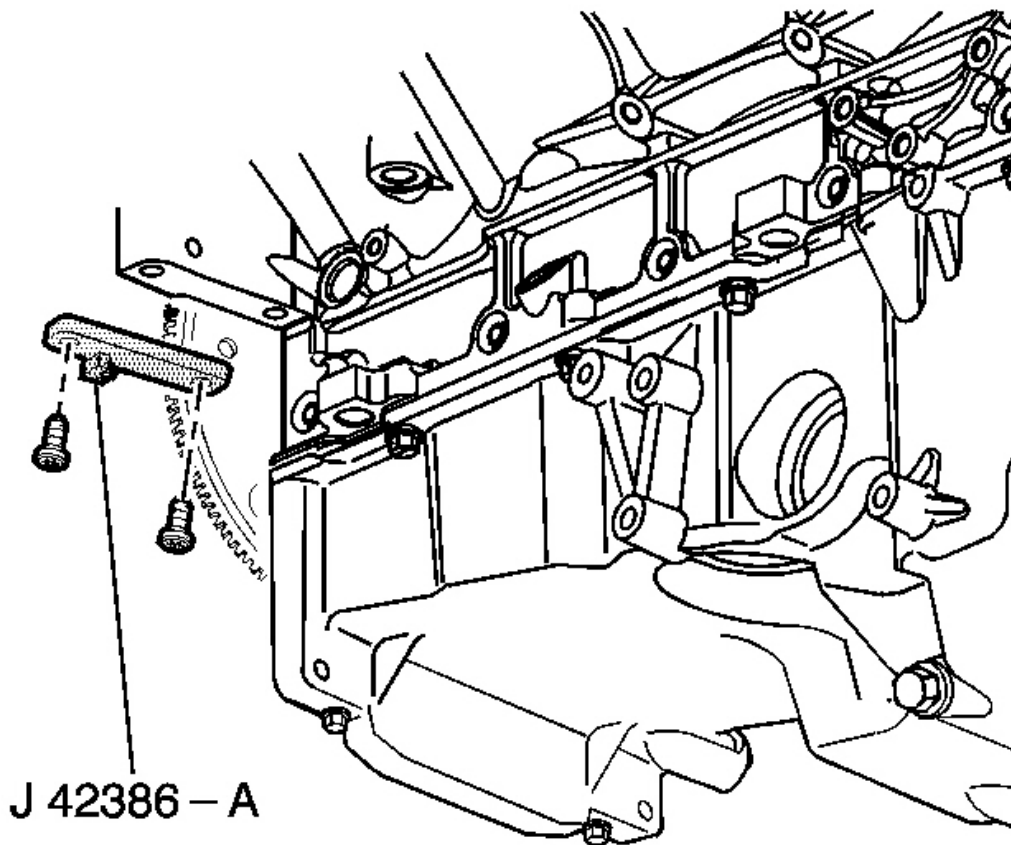
Fig. 710: View Of J 42386-A Flywheel Tool
Courtesy of GENERAL MOTORS CORP.

Use one M10 - 1.5 x 120 mm and one M10 - 1.5 x 45 mm bolt for proper tool operation.

Tighten: Tighten the **J 42386-A** bolts to 50 N.m (37 lb ft). See Special Tools and Equipment.

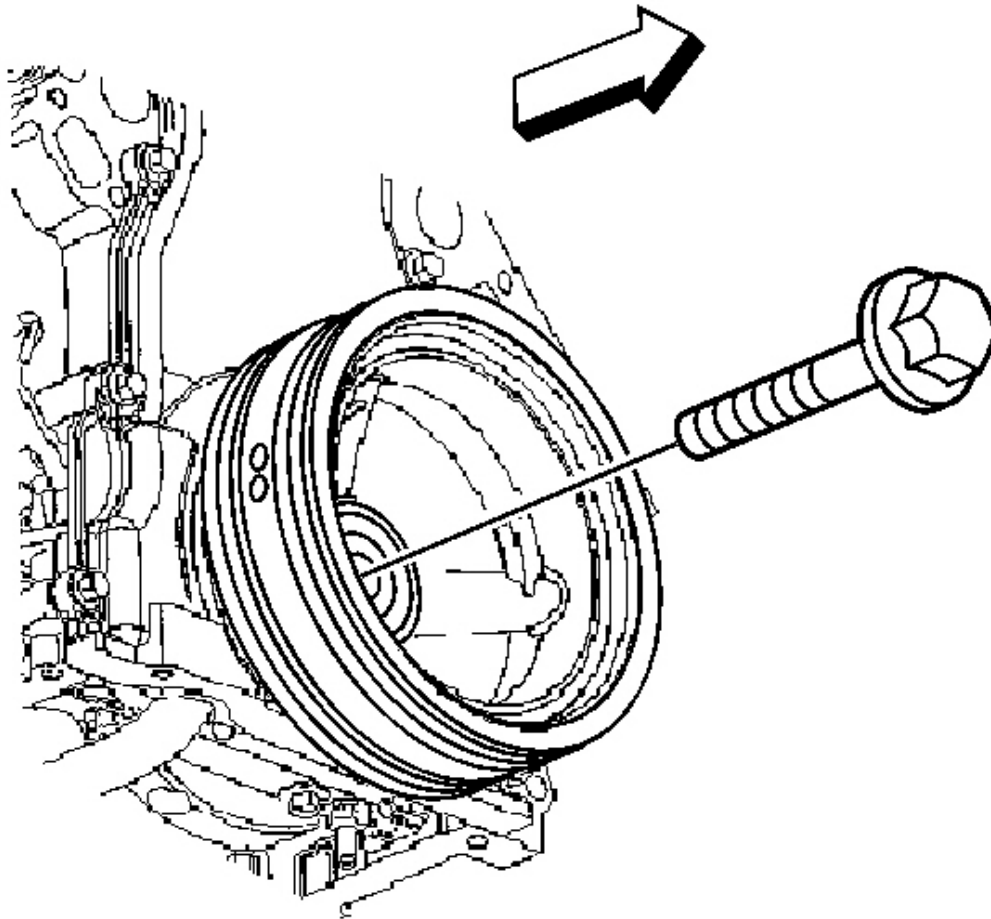
Fig. 711: Crankshaft Balancer And Retaining Bolt
Courtesy of GENERAL MOTORS CORP.

IMPORTANT: The balancer should be positioned onto the end of the crankshaft as straight as possible prior to tool installation.

2. Install the balancer onto the end of the crankshaft.

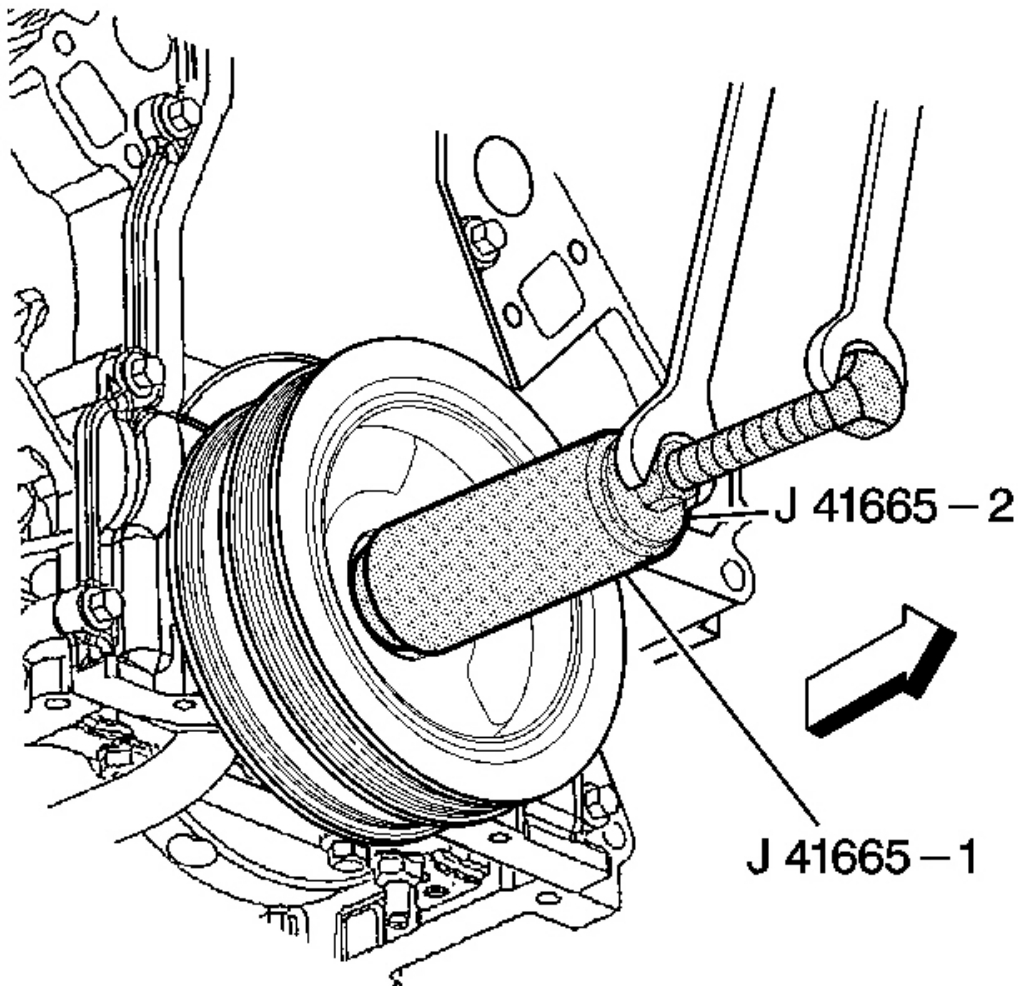
Fig. 712: Installing Balancer Using J 41665
Courtesy of GENERAL MOTORS CORP.

3. Use the **J 41665** in order to install the balancer. See **Special Tools and Equipment**.

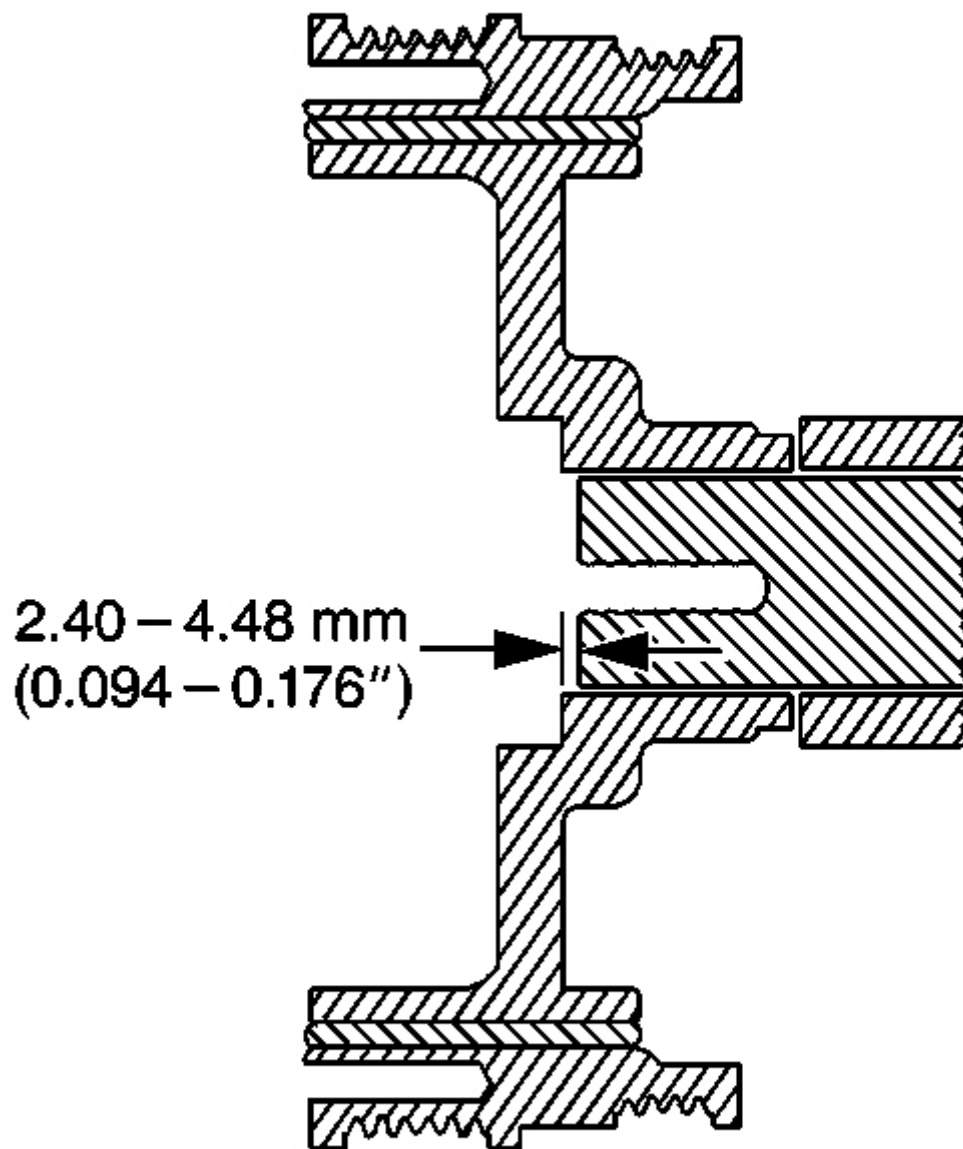
Fig. 713: Identifying Hub To Crankshaft Distance
Courtesy of GENERAL MOTORS CORP.

IMPORTANT: The nose of the crankshaft should be recessed 2.4-4.48 mm (0.094-0.176 in) into the balancer bore.

6. Measure for a correctly installed balancer.

If the balancer is not installed to the proper dimensions, install the **J 41665** and repeat the installation procedure. See **Special Tools and Equipment**.
