2004 Isuzu Ascender LS

2004 ENGINE Engine Mechanical - 4.8L, 5.3L, and 6.0L - Ascender

Engine Mechanical - 4.8L, 5.3L, and 6.0L - Ascender

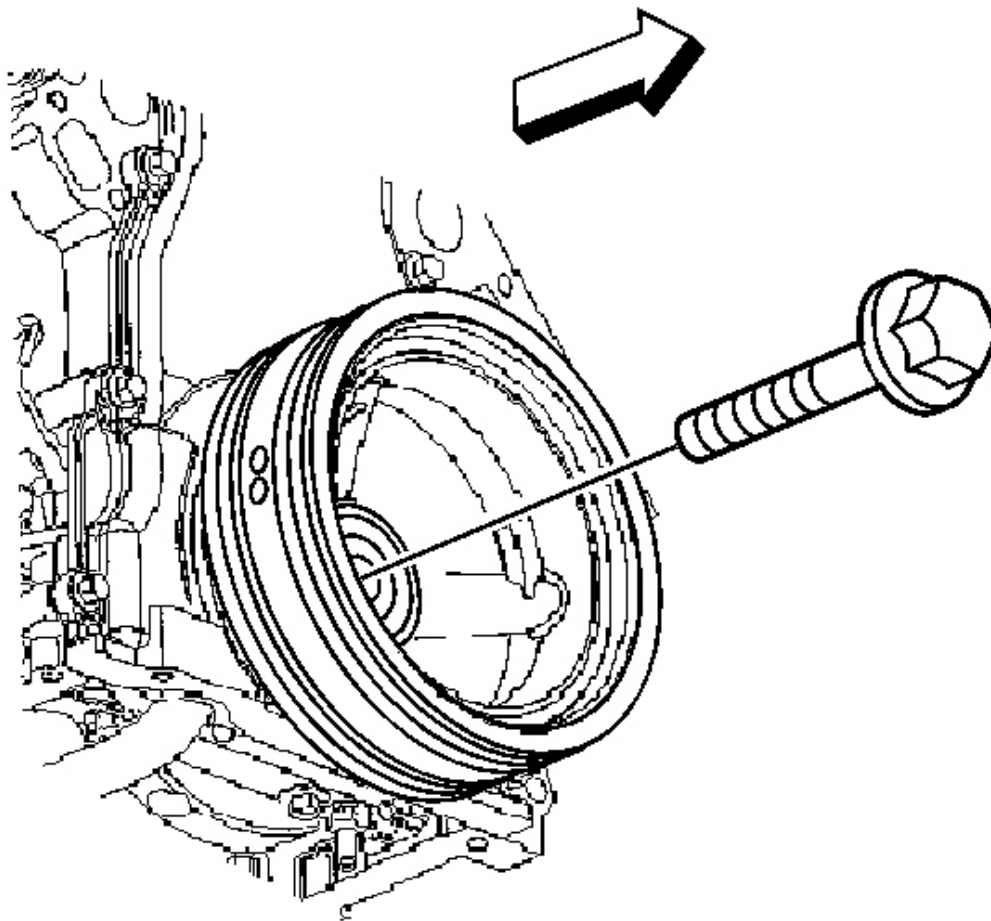
Fig. 714: Crankshaft Balancer And Retaining Bolt
Courtesy of GENERAL MOTORS CORP.

7. Install the NEW crankshaft balancer bolt.

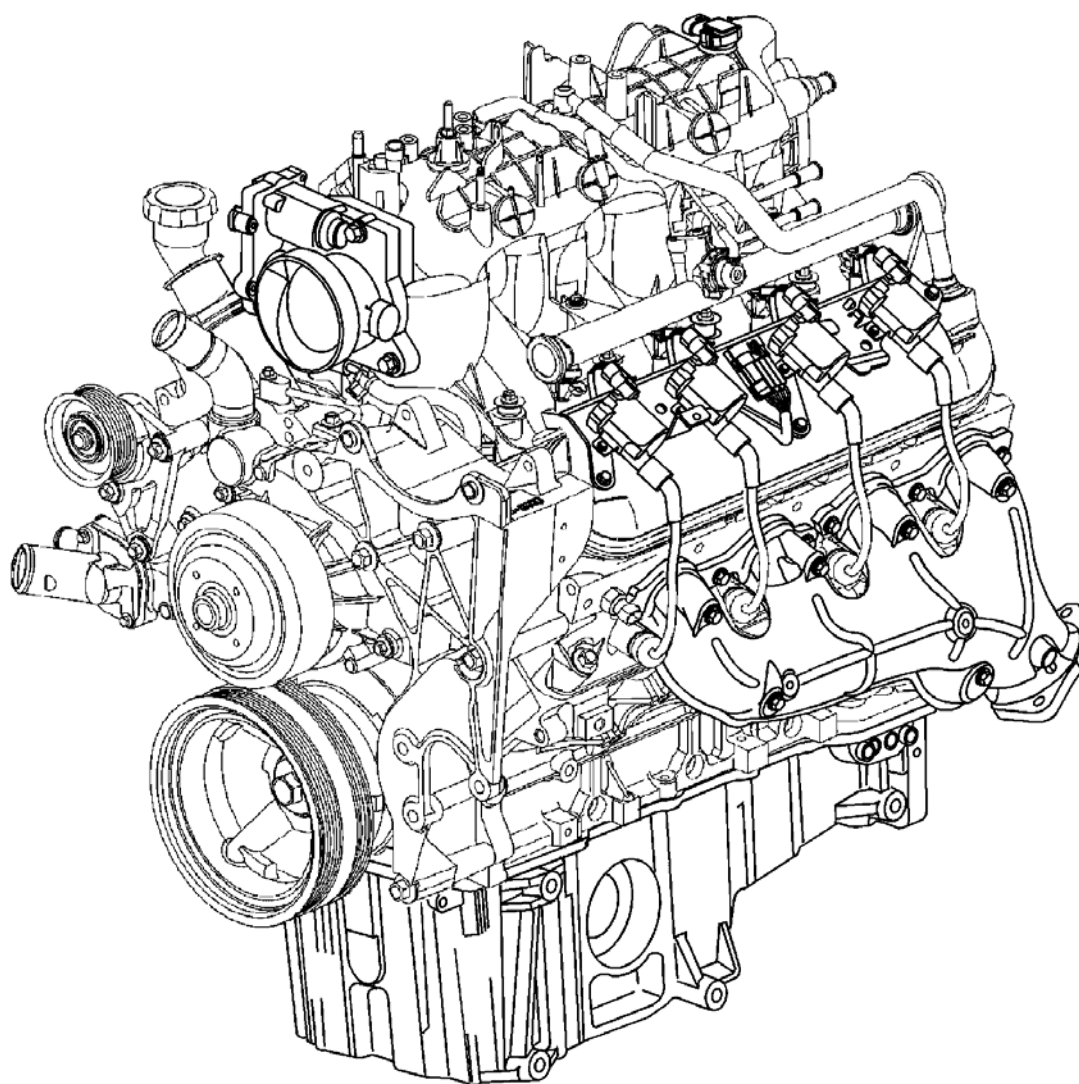
Fig. 715: The 5.3 Liter V8 Engine**Courtesy of GENERAL MOTORS CORP.**

The 5.3 Liter V8 engine is identified as RPO LM4 VIN P.

The pistons are cast aluminum. The pistons use two compression rings and one oil control ring assembly. The piston is a low friction, lightweight design with a flat or recessed top and barrel shaped skirt. The piston pins are chromium steel, have floating fit in the piston, and are retained by a press fit in the connecting rod. The connecting rods are powdered metal. The connecting rods are fractured at the connecting rod journal and then machined for the proper clearance. 2004 applications use a piston with a graphite coated skirt. The piston, pin, and connecting rod are to be serviced as an assembly. The piston, pin, and connecting rod are to be serviced as an assembly.

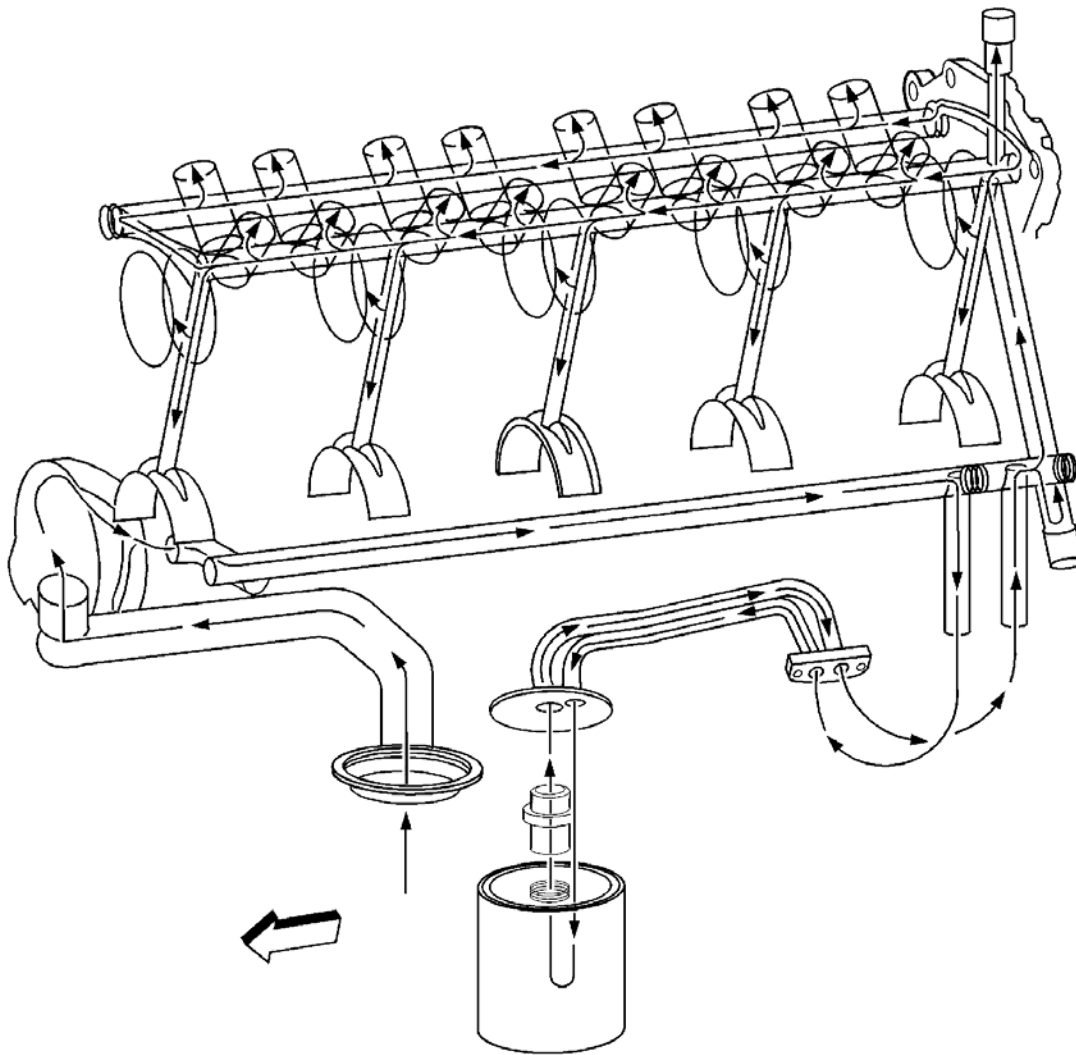
Fig. 716: View Of Lubrication Flow Schematic
Courtesy of GENERAL MOTORS CORP.

Engine lubrication is supplied by a gerotor type oil pump assembly. The pump is mounted on the front of the engine block and is driven directly by the crankshaft sprocket. The pump gears rotate and draw oil from the oil pan sump through a pick-up screen and pipe. The oil is pressurized as it passes through the pump and is sent through the engine block oil galleries. Contained within the oil pump assembly is a pressure relief valve that maintains oil pressure within a specified range. Pressurized oil is directed through the lower gallery, through the oil pan, to the full flow oil filter where harmful contaminants are removed. A bypass valve is incorporated into the oil pan at the oil filter boss, which will permit oil flow in the event the filter becomes restricted. At the rear of the block, oil is then directed to the upper main oil galleries, which are drilled just above the camshaft assembly. From there oil is then directed to the crankshaft and camshaft bearings. Oil that has entered the upper main oil galleries also pressurizes the valve lifter assemblies and is then pumped through the pushrods to lubricate the valve rocker arms and valve stems. Oil returning to the pan is directed by the crankshaft oil deflector. Oil pressure is monitored by a sensor.

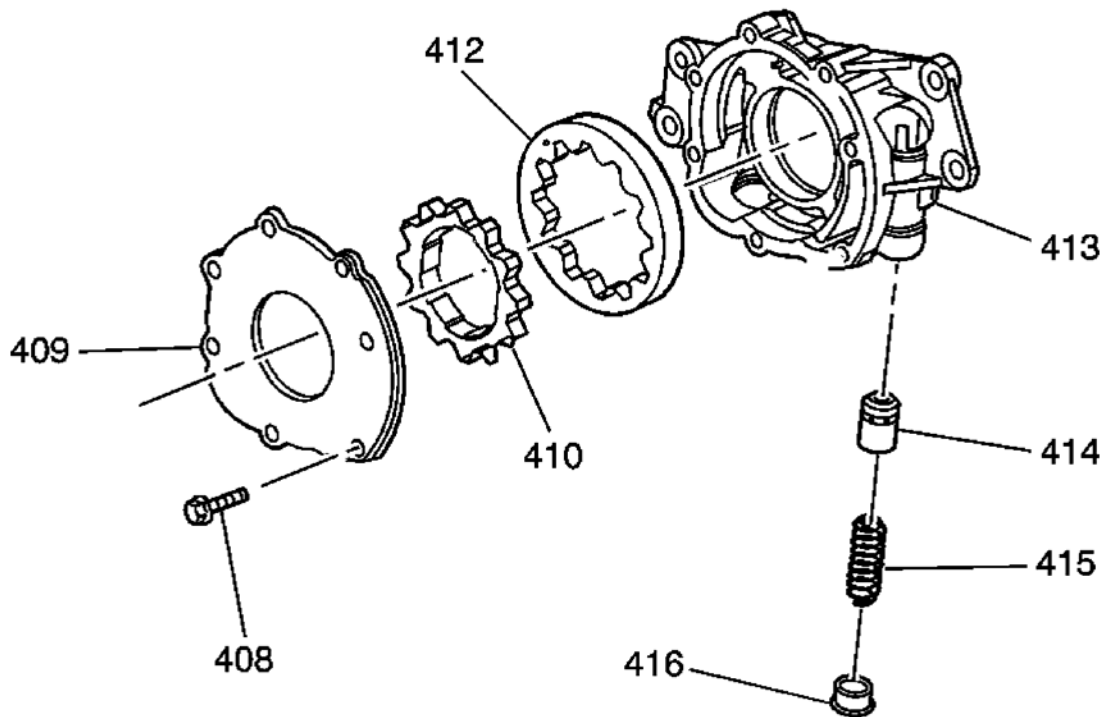
Fig. 717: Exploded View Of Oil Pump Assembly
Courtesy of GENERAL MOTORS CORP.
