2008 Isuzu Ascender LS

2008 Driveline/Axle Propeller Shaft - Ascender, Envoy & Trailblazer

Propeller Shaft - Ascender, Envoy & Trailblazer

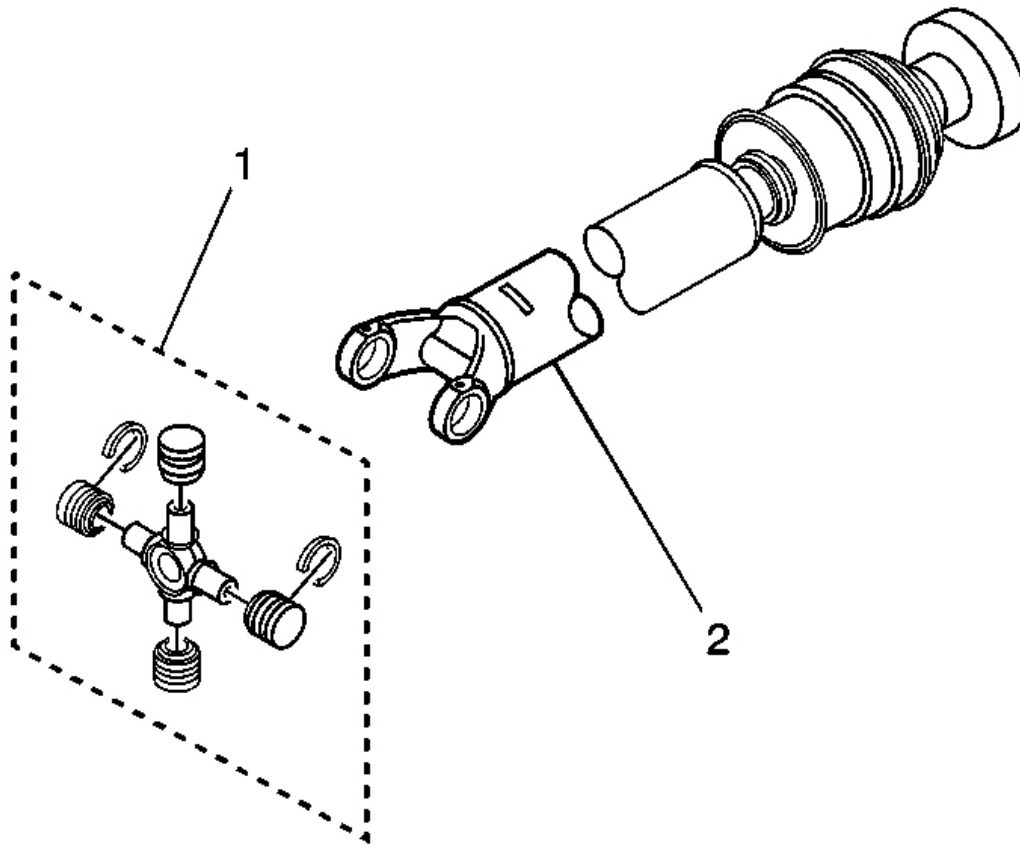
Fig. 1: View Of Front Drive Propeller Shaft
Courtesy of GENERAL MOTORS CORP.

Callout	Component Name
1	Universal Joint Spider Assembly
2	Propeller Shaft Tube Assembly

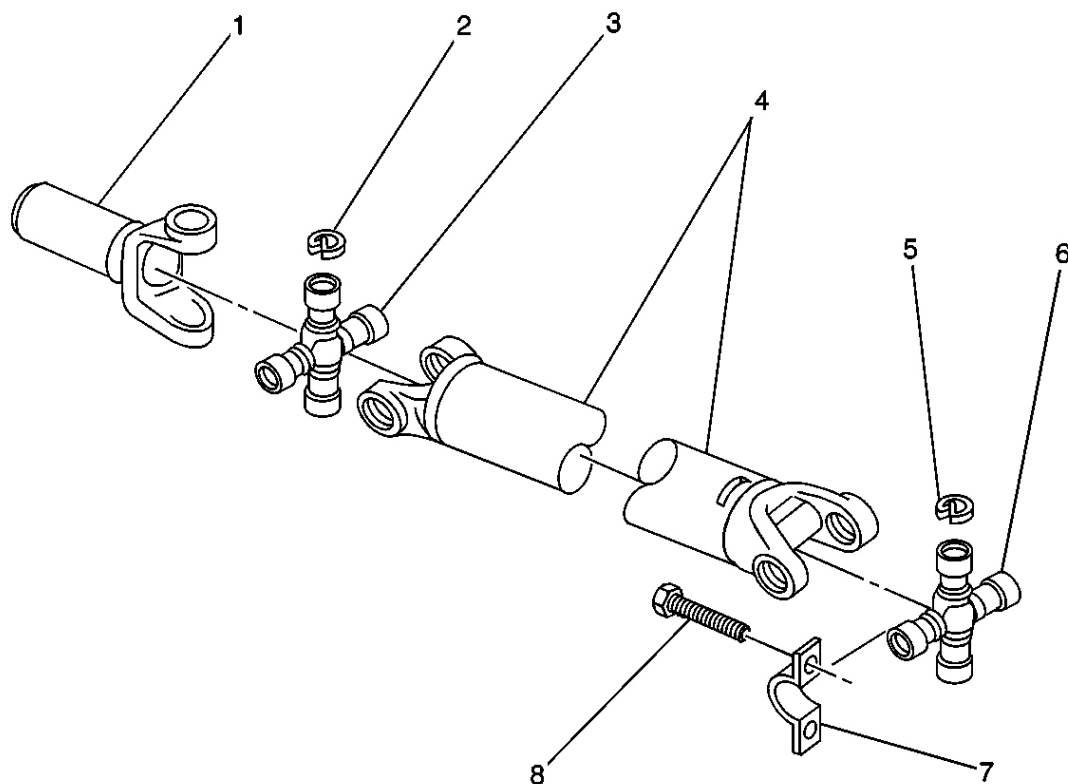
Fig. 2: One-Piece Propeller Shaft Component View
Courtesy of GENERAL MOTORS CORP.

Callout	Component Name
1	Propeller Shaft Slip Yoke
2	Propeller Shaft Universal Joint Spider Bearing Retainer Ring
3	Propeller Shaft Universal Joint
4	Propeller Shaft Tube
5	Propeller Shaft Universal Joint Spider Bearing Retainer Ring
6	Propeller Shaft Universal Joint
7	Propeller Shaft Bearing Retainer
8	Propeller Shaft Bearing Retainer Bolt

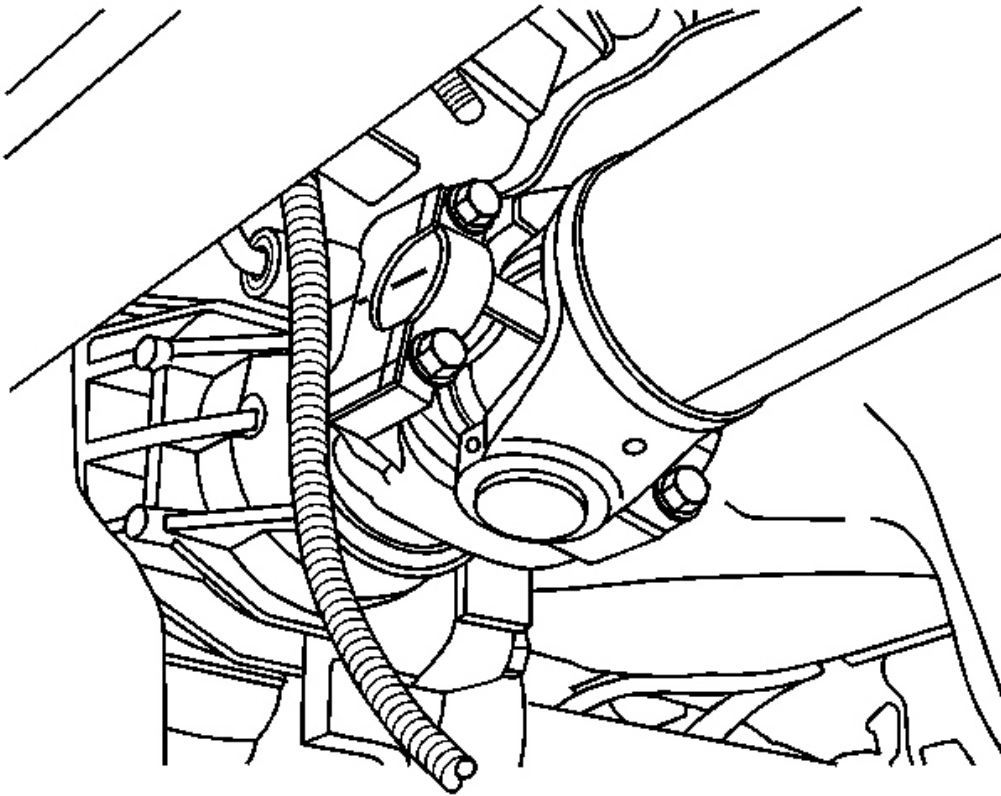
Fig. 3: Locating Propeller Shaft To Front Axle Pinion Yoke Reference Mark
Courtesy of GENERAL MOTORS CORP.

1. Raise the vehicle. Refer to **Lifting and Jacking the Vehicle** .
2. Remove the steering gear crossmember. Refer to **Rear Steering Gear Crossmember Replacement** .
3. Reference mark the relationship of the propeller shaft to the front axle pinion yoke.
4. Remove the yoke retainer bolts and yoke retainers from the front axle pinion yoke.

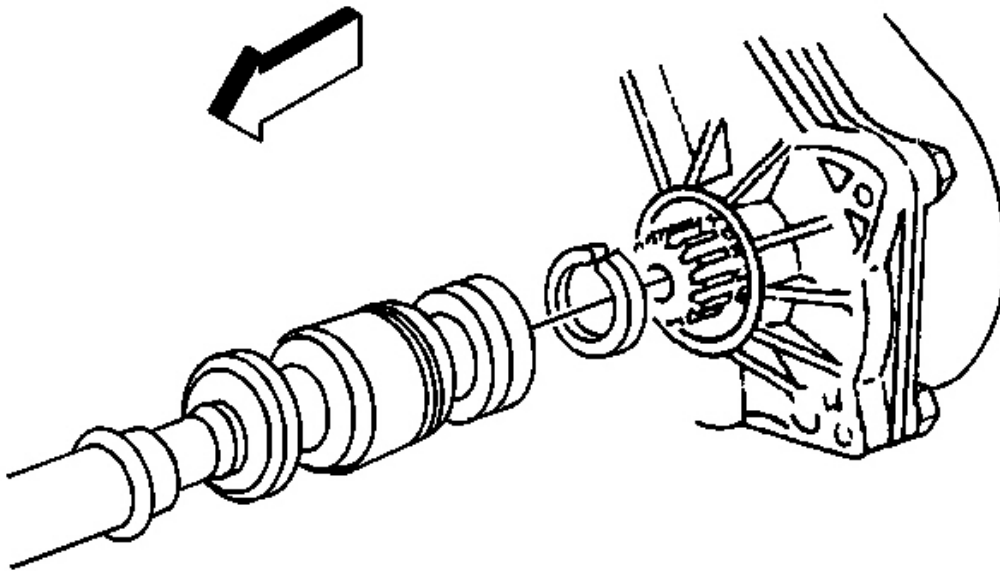
Fig. 4: View Of Propeller Shaft At Transfer Case
Courtesy of GENERAL MOTORS CORP.

6. Remove the front propeller shaft from the transfer case.

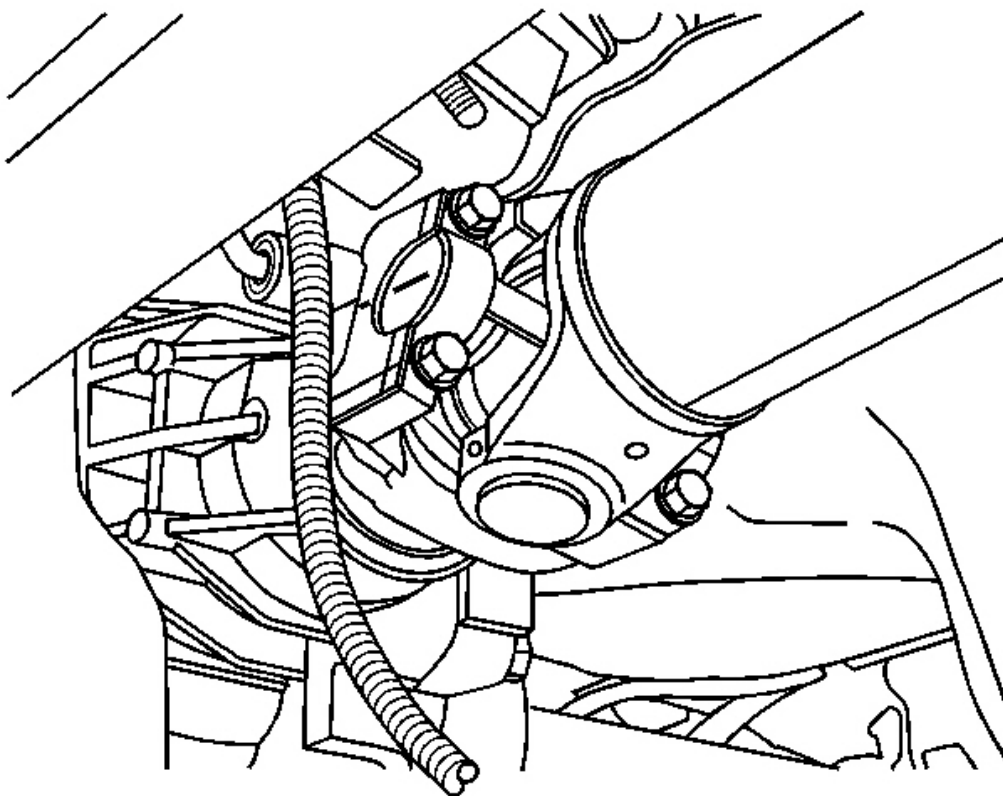
Fig. 5: Propeller Shaft To Front Axle Pinion Yoke Reference Mark
Courtesy of GENERAL MOTORS CORP.

1. Install the propeller shaft in the transfer case.
2. Align the reference marks made during removal.

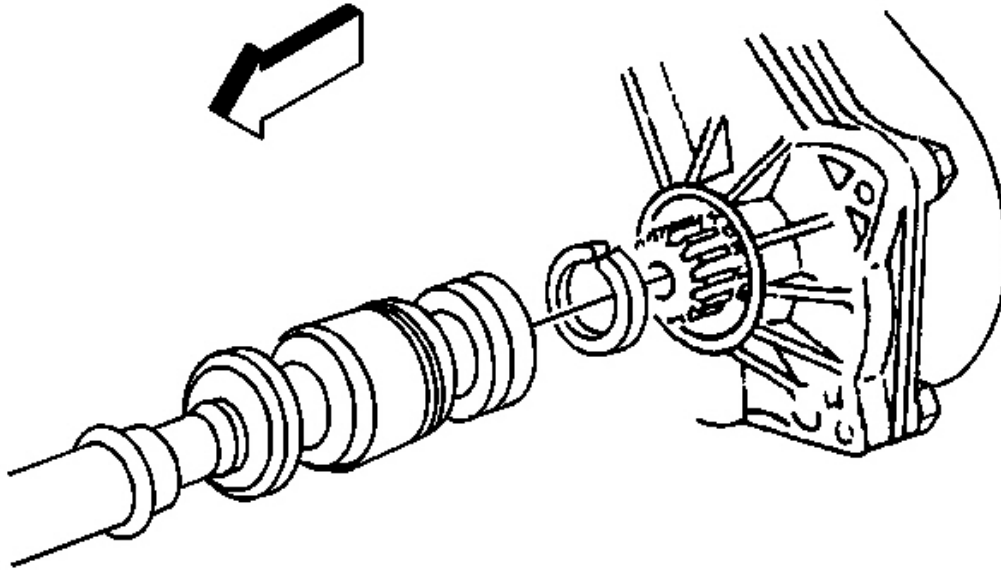
Fig. 6: View Of Propeller Shaft At Transfer Case
Courtesy of GENERAL MOTORS CORP.

IMPORTANT: Ensure that the propeller shaft assembly is fully engaged into the slip yoke. The retaining ring will produce a snapping noise when the shaft is properly engaged.

3. Install the propeller shaft to the front axle pinion yoke.

4. Install the yoke retainers and the bolts.

Tighten: Tighten the front propeller shaft yoke clamp bolts to 20 N.m (15 lb ft).

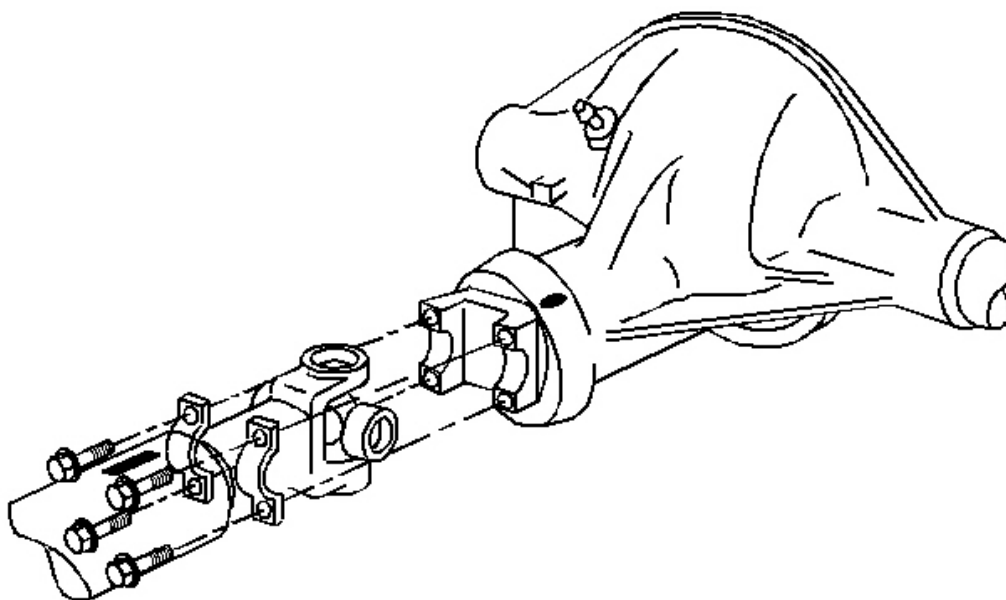
Fig. 7: View Of Pinion Flange Bolts
Courtesy of GENERAL MOTORS CORP.

4. Remove the bolts and the yoke retainers from the rear axle pinion yoke.

5. Slide the propeller shaft forward in order to disconnect the propeller shaft from the rear axle pinion yoke.

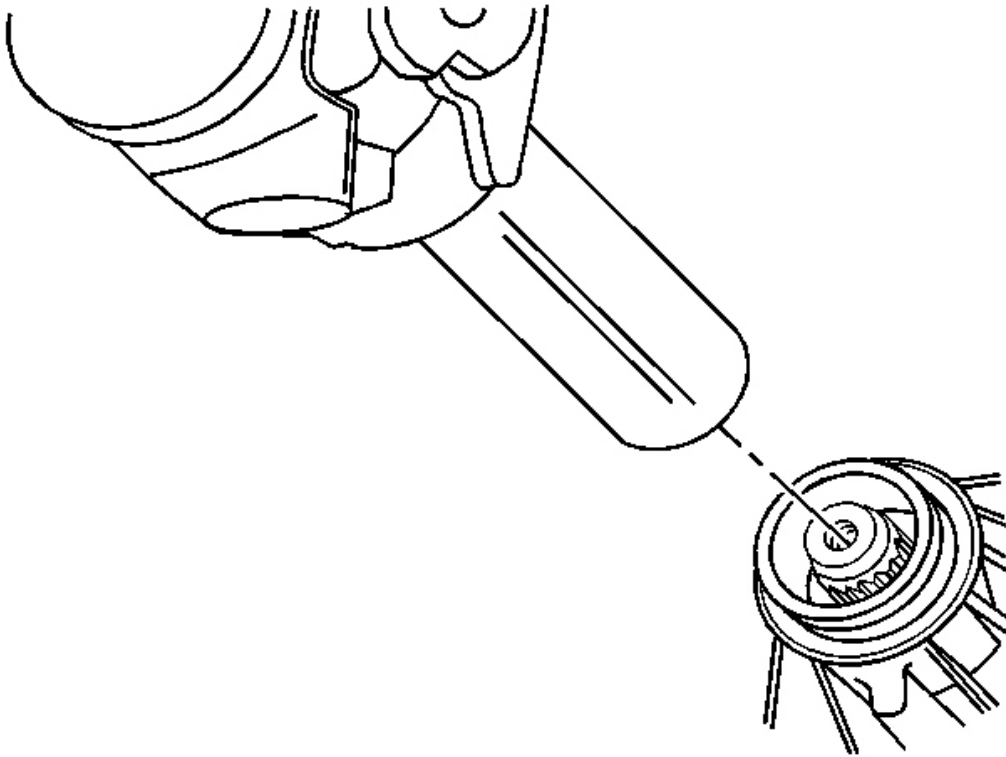
Fig. 8: View Of Propeller Shaft To Transmission Or Transfer Case
Courtesy of GENERAL MOTORS CORP.

6. Slide the propeller shaft rearward in order to disconnect the propeller shaft from the transmission or transfer case.
7. Remove the propeller shaft.

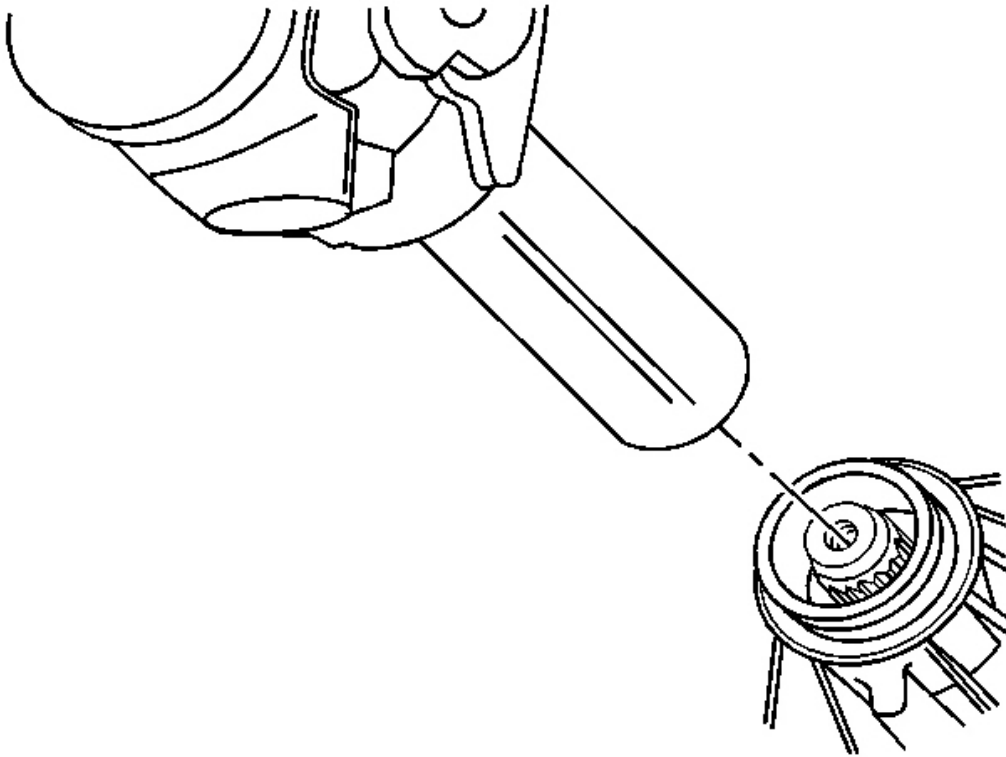
Fig. 9: View Of Propeller Shaft To Transmission Or Transfer Case
Courtesy of GENERAL MOTORS CORP.

2. Install the propeller shaft into the transmission or transfer case.

Align the reference marks made during removal.

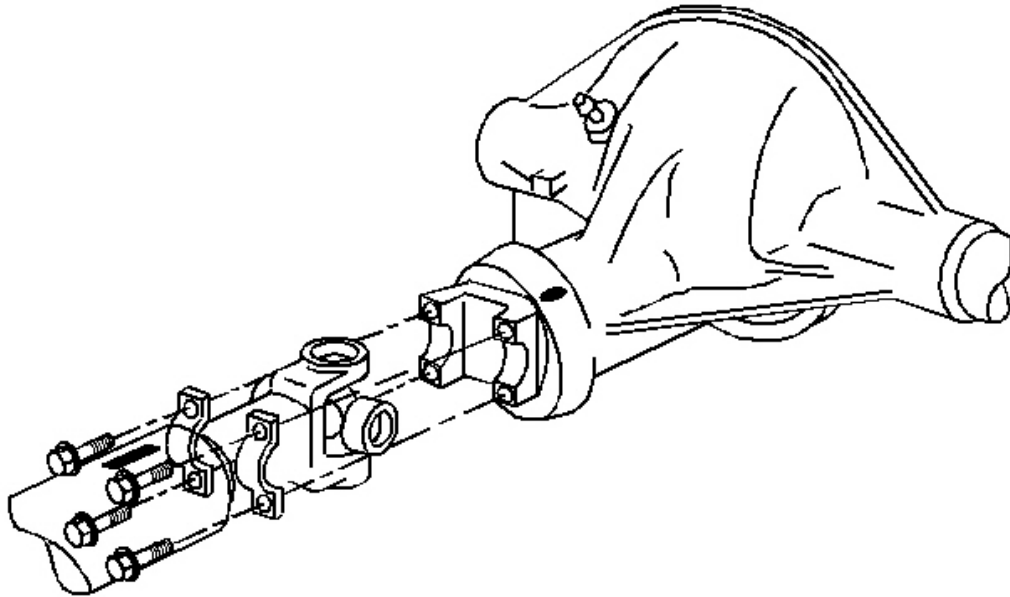
Fig. 10: View Of Pinion Flange Bolts
Courtesy of GENERAL MOTORS CORP.

3. Install the propeller shaft to the rear axle pinion yoke.

4. Install the yoke retainers and the bolts.

Tighten: Tighten the bolts to 20 N.m (15 lb ft).

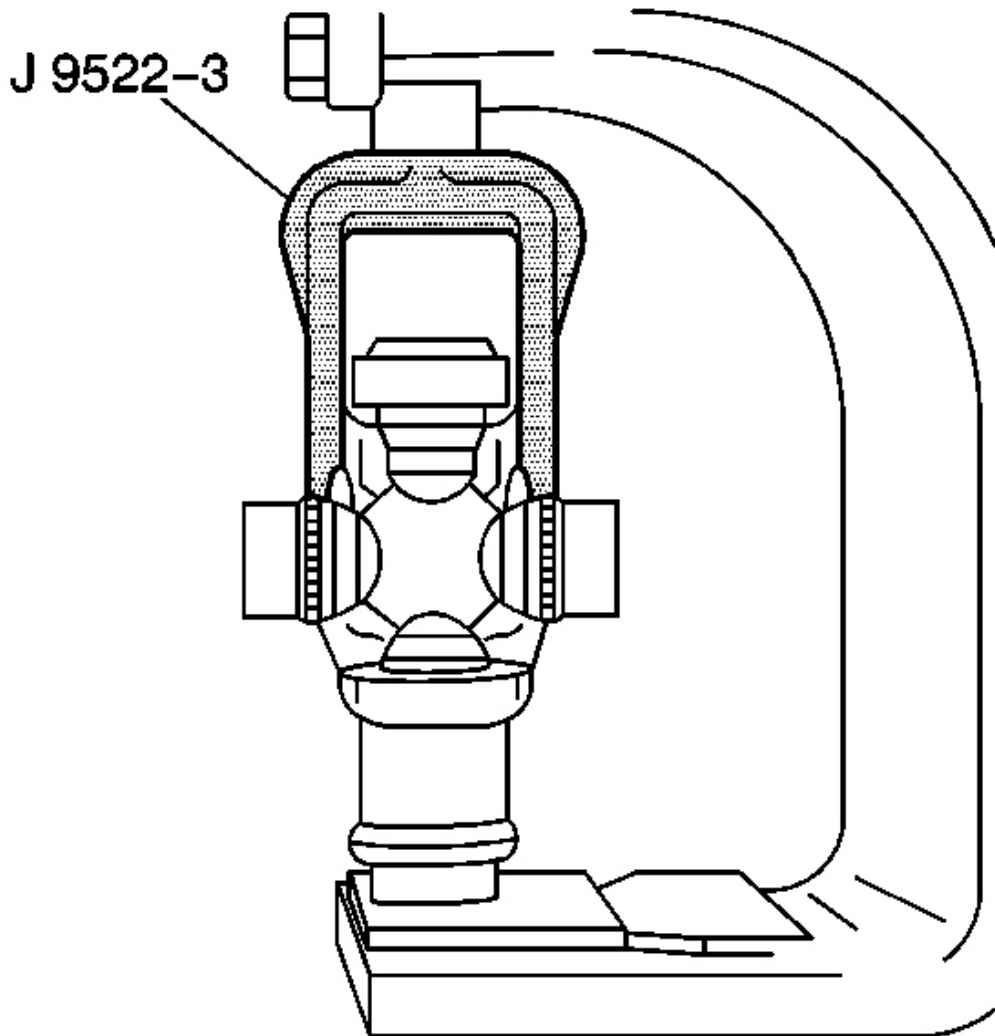
Fig. 11: Assembling Universal Joint

3. Place the universal joint so that the lower ear of the yoke is supported on a 30 mm (1 1/8 in) socket.

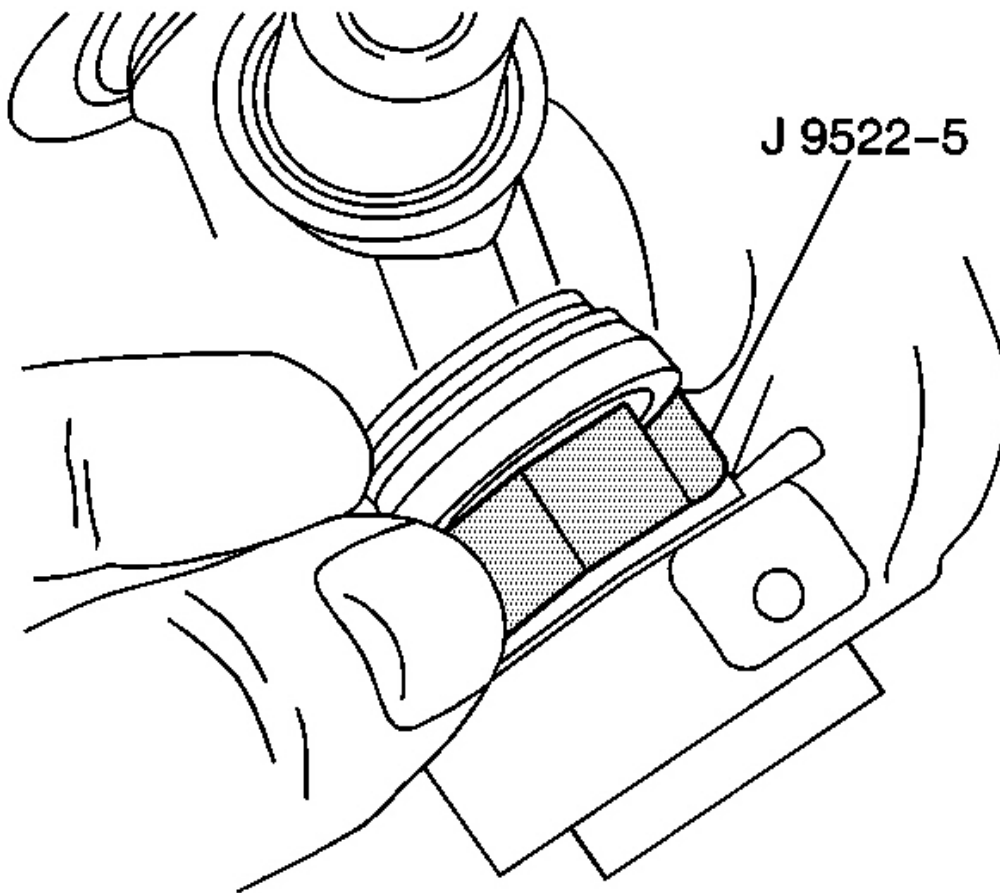
Fig. 12: Inserting J 9522-5 Between Seal & Bearing Cup
Courtesy of GENERAL MOTORS CORP.

4. In order to shear the plastic retaining ring on the bearing cup, place **J 9522-3** on the open horizontal bearing cups. See **Special Tools**. Press the lower bearing cup out of the yoke ear.
5. If you do not completely remove the bearing cup, lift the cross and insert **J 9522-5** between the seal and the bearing cup you are removing. See **Special Tools**. Continue to press the bearing cup out of the yoke.
6. Rotate the propeller shaft. Press the opposite bearing cup out of the yoke.
7. Mark the orientation of the slip yoke to the tube for proper reassembly.
8. Remove the cross from the yoke.

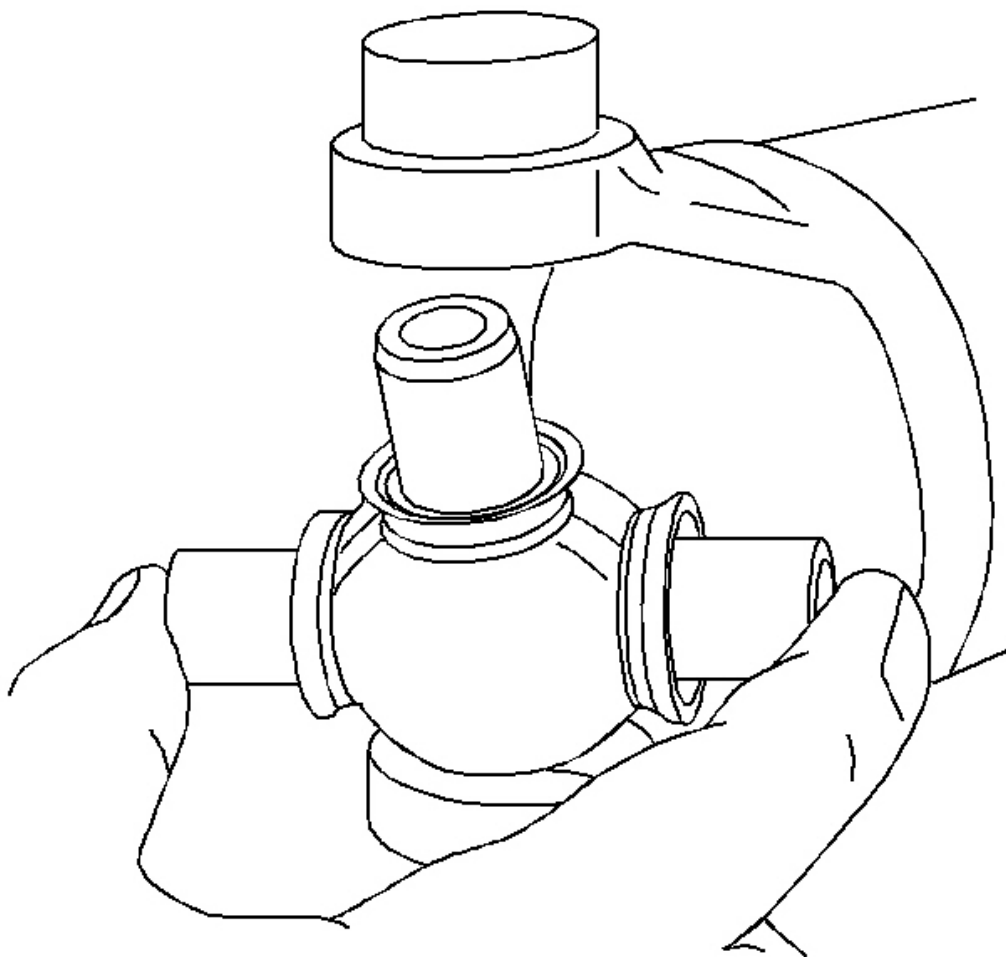
Fig. 13: Assembling Trunnion Into Yoke
Courtesy of GENERAL MOTORS CORP.

2. Assemble 1 bearing cup part way into 1 side of the yoke.
3. Turn the yoke ear toward the bottom.
4. Assemble the cross into the yoke so the trunnion seats freely into the bearing cup.
5. With the trunnion seated in the bearing cup, press the bearing cup into the yoke until the bearing cup is flush with the yoke ear.

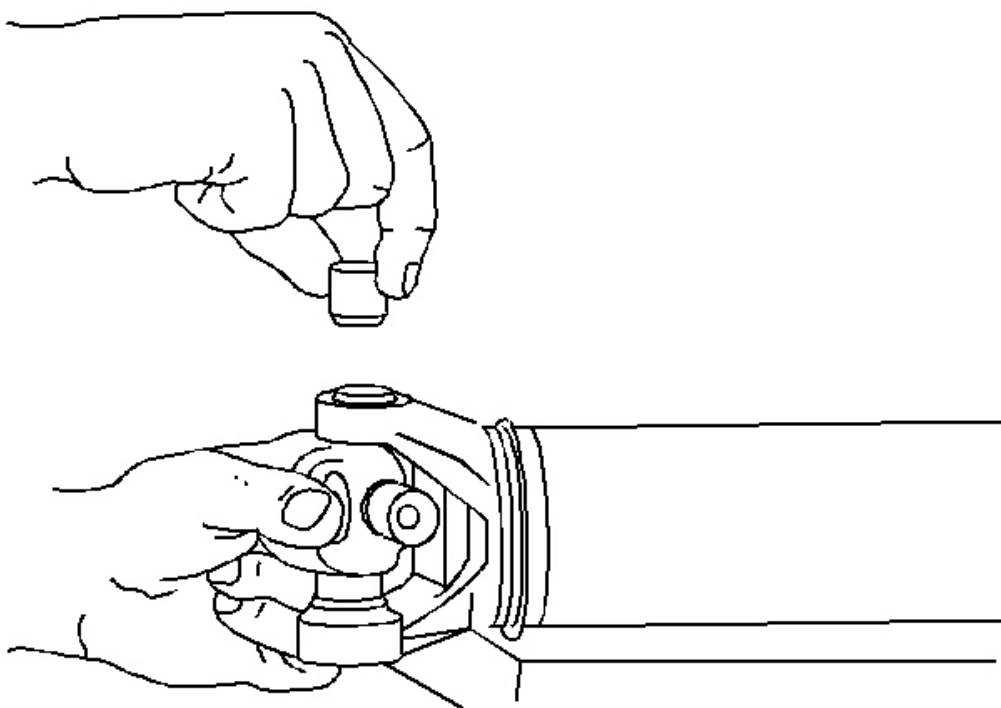
Fig. 14: Installing Bearing Cup Into Yoke Ear
Courtesy of GENERAL MOTORS CORP.

6. Assemble the opposite bearing cup part way into the yoke ear.
7. Ensure that the trunnions start straight and true into both bearing cups.
8. Press the opposite bearing cup into the yoke ear while working the cross all the time in order to inspect for a free unbinding movement of the trunnions in the bearing cups.

9. Press the bearing cup into the yoke until the bearing retainer groove clears the inside of the yoke.

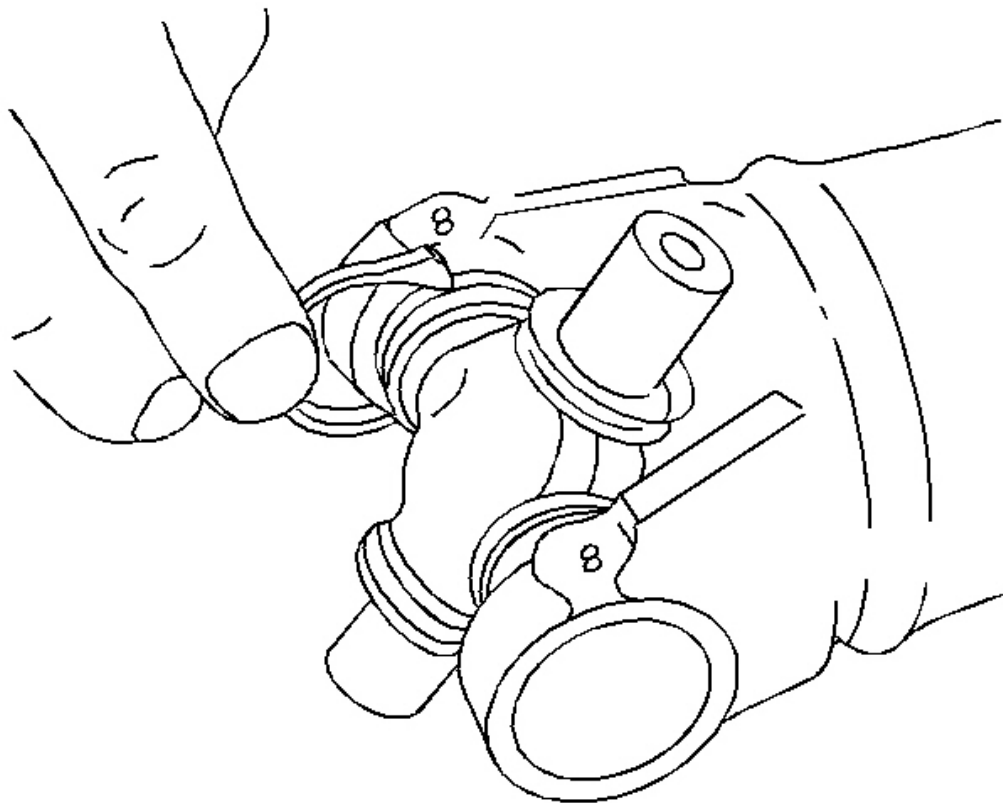
Fig. 15: Assembling Bearing Retainer In Retainer Groove
Courtesy of GENERAL MOTORS CORP.

10. Assemble the bearing retainer in the retainer groove.
11. Continue pressing until you can snap both retainers into place.

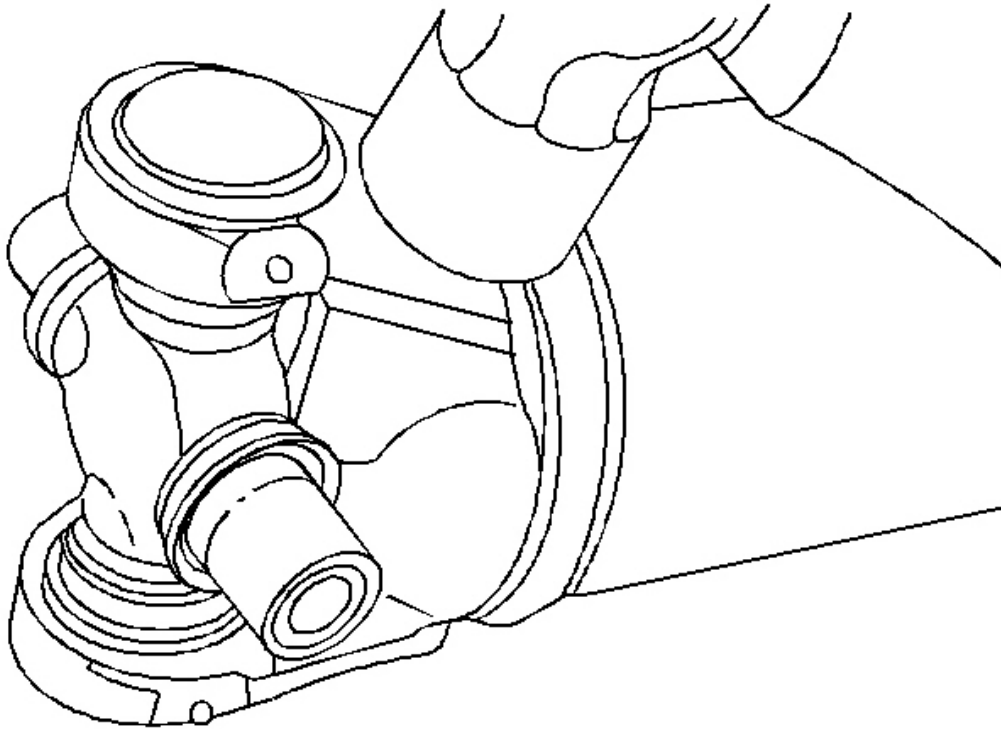
Fig. 16: Springing Yoke Using Hammer
Courtesy of GENERAL MOTORS CORP.

12. If seating the retainer is difficult, spring the yoke slightly with a firm blow from a dead blow hammer.
13. It may be necessary to lubricate the snap ring with a slight amount of chassis grease so the snap ring seats in the bearing cup groove.

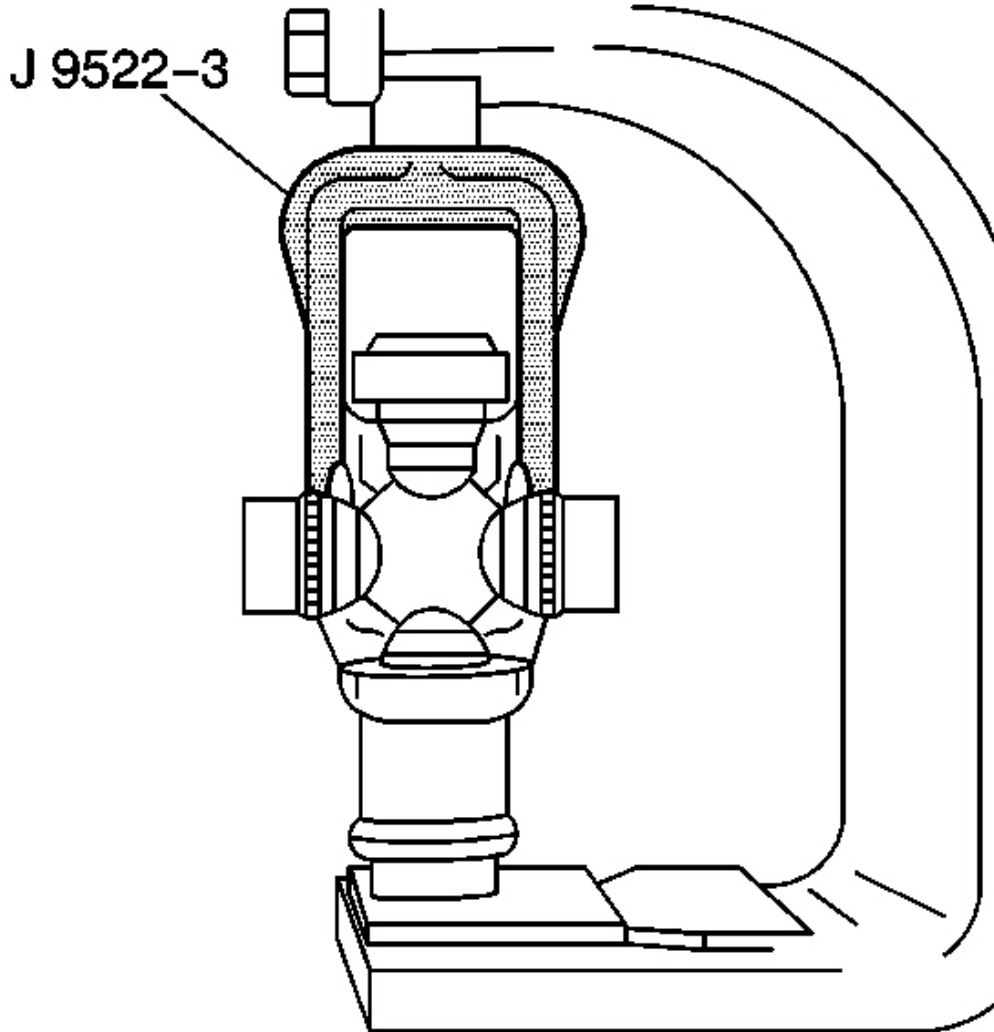
Fig. 17: Assembling Universal Joint
Courtesy of GENERAL MOTORS CORP.

5. Place the universal joint so that the lower ear of the yoke is supported on a 30 mm (1-1/8 in) hex head socket or a 27 mm (1-1/16 in) socket.

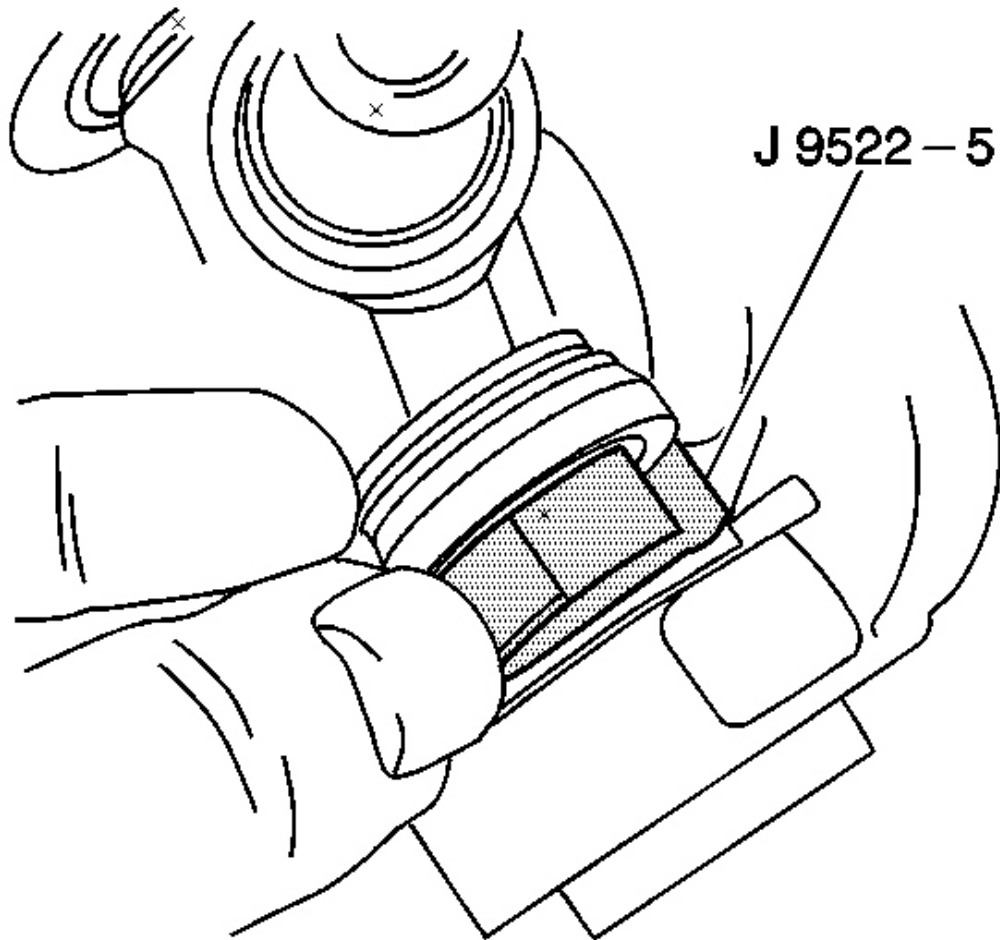
Fig. 18: Placing J 9522-5 Between The Seal & The Bearing Cup
Courtesy of GENERAL MOTORS CORP.

6. Place **J 9522-3** on the open horizontal bearing cups. See **Special Tools**. Press the lower bearing cup out of the yoke ear.
7. If you do not completely remove the bearing cup, lift the cross and insert **J 9522-5** between the seal and the bearing cup you are removing. See **Special Tools**. Continue pressing the bearing cup out of the yoke.

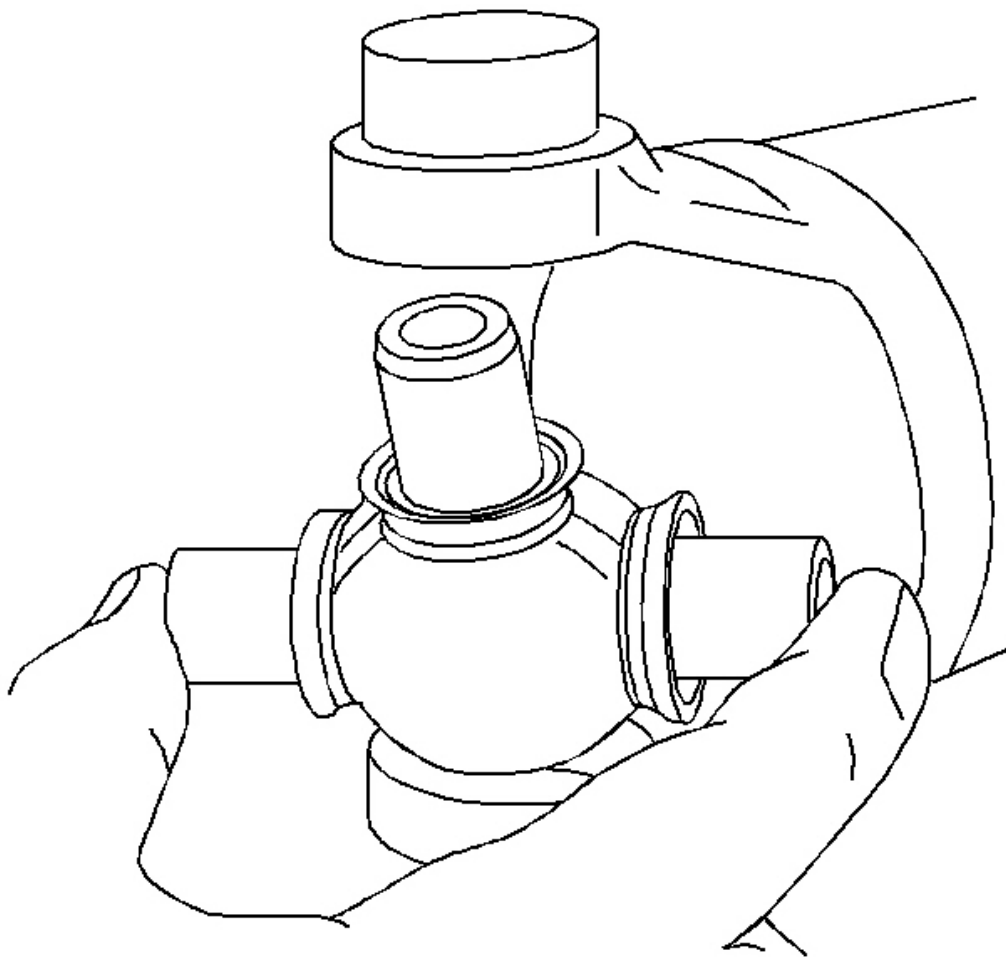
Fig. 19: Assembling Trunnion Into Yoke
Courtesy of GENERAL MOTORS CORP.

2. Assemble 1 bearing cup part way into 1 side of the yoke. Turn the yoke ear toward the bottom.
3. Assemble the cross into the yoke so that the trunnion seats freely into the bearing cup.

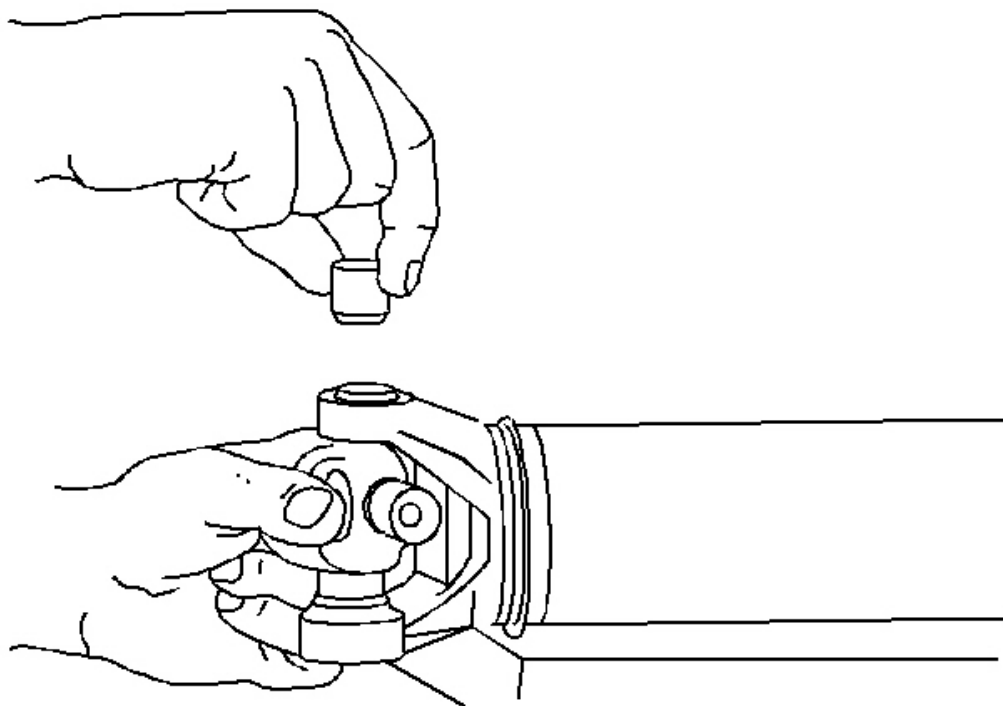
Fig. 20: Installing Bearing Cup Into Yoke Ear
Courtesy of GENERAL MOTORS CORP.

4. With the trunnion seated in the bearing cup, press the bearing cup into the yoke until the bearing cup is flush with the yoke ear.
5. Install the opposite bearing cup part way into the yoke ear.
6. Ensure that the trunnions start straight and true into both bearing cups.
7. Press the opposite bearing cup into the yoke ear while working the cross all the time in order to inspect for free unbinding movement of the trunnions in the bearing cups.

8. Press the bearing cup into the yoke until the bearing cup retainer groove is visible over the top of the bearing cup.

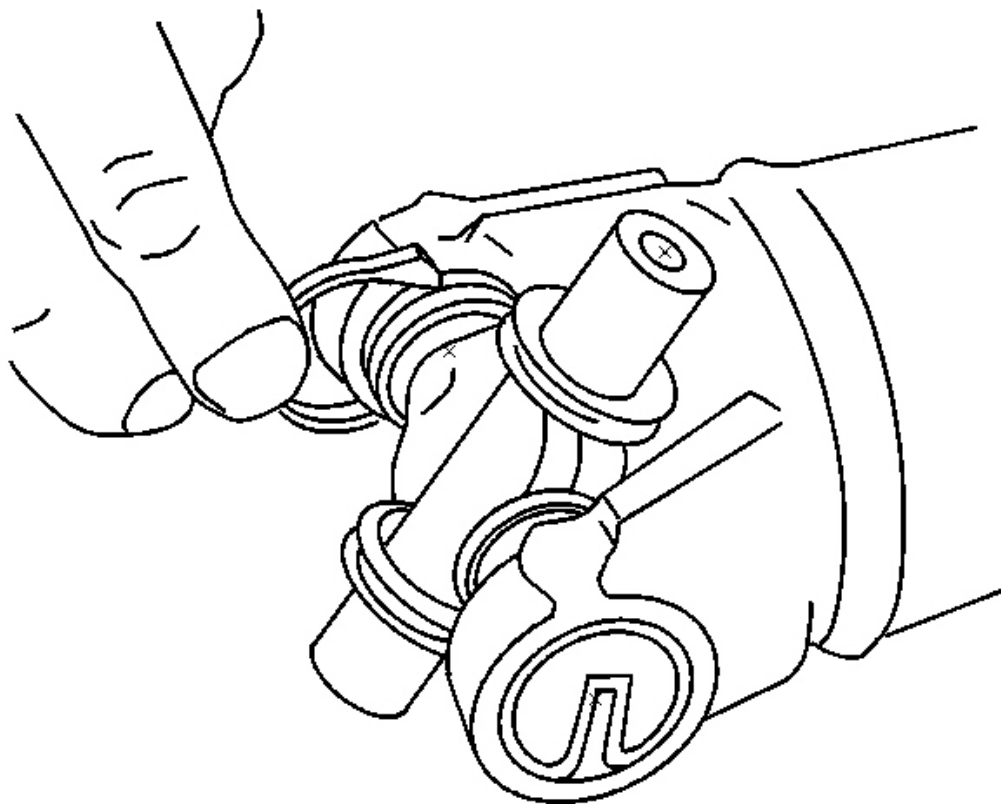
Fig. 21: Assembling Bearing Retainer In Retainer Groove
Courtesy of GENERAL MOTORS CORP.

9. Assemble the bearing retainer in the retainer groove.
10. Continue pressing until both retainers can be snapped into place.

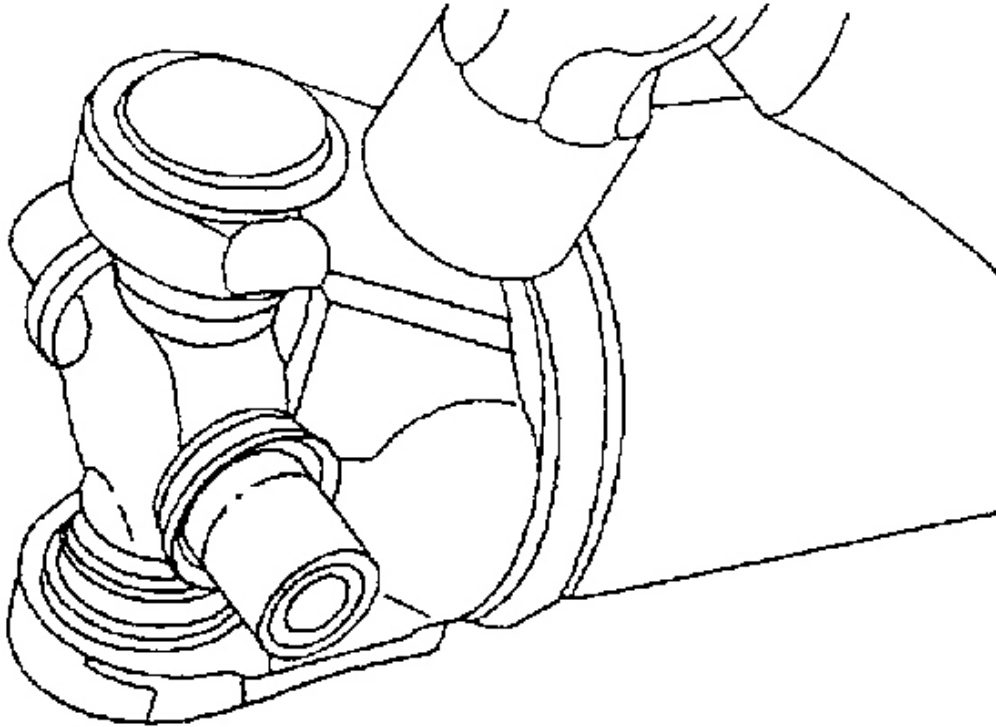
Fig. 22: Seating Retainer Using Hammer (External Snap Ring)
Courtesy of GENERAL MOTORS CORP.

11. If the retainer is difficult to seat, the yoke can be sprung slightly with a firm blow from a dead blow hammer.
12. It may be necessary to lubricate the snap ring with a slight amount of chassis grease so that the snap ring seats in the bearing cup groove.
